## Wimmera Catchment Management Authority

# Geomorphic Categorisation and Stream Condition Assessment of the Wimmera River Catchment

Job 2901049.008 & 2901049.009

April 2003

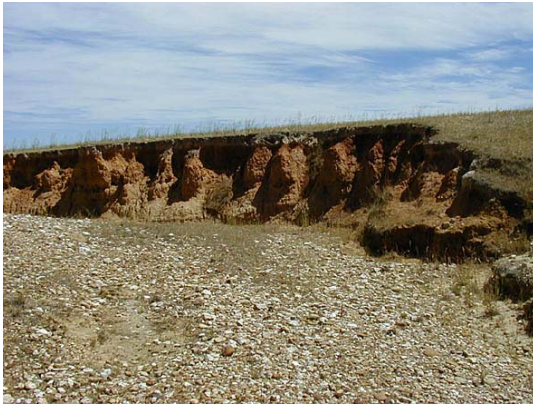
**FS#30 – Unknown 6**

Physical Form Score: 0/10

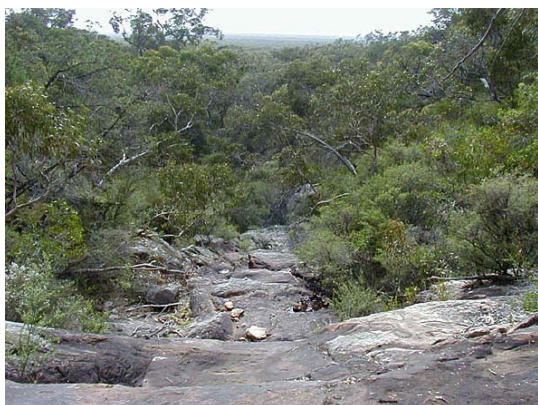
**FS#21 – Golton Creek**

Physical Form Score: 8/10

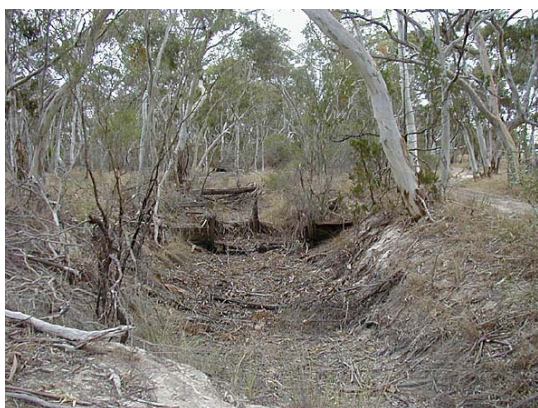
**FS#6 – MacKenzie Creek**

Streamside Zone Score: 8/10

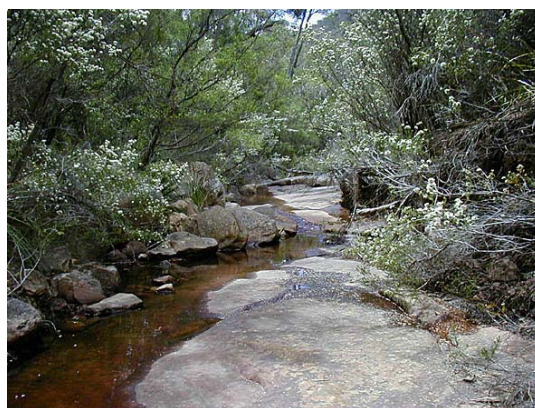
**FS#17 – Seven Dial Creek**

Streamside Zone Score: 9/10

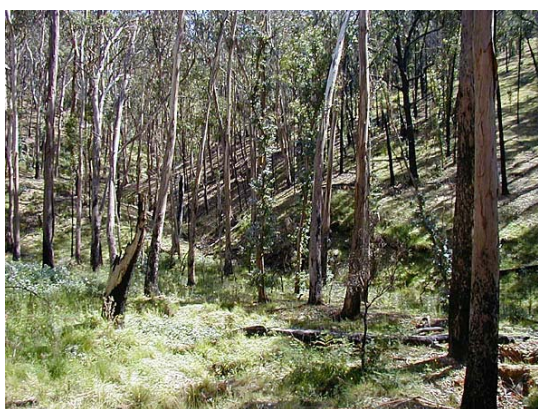
**FS#34 – Glenpatrick Creek**

Streamside Zone Score: 9/10

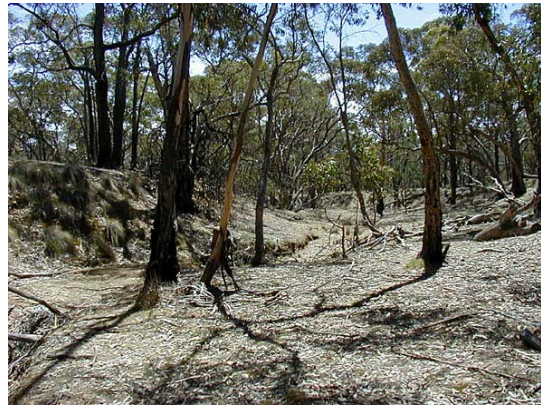
**FS#32 – Unknown 8**

Field Confirmation – Incised Alluvial Discontinuous

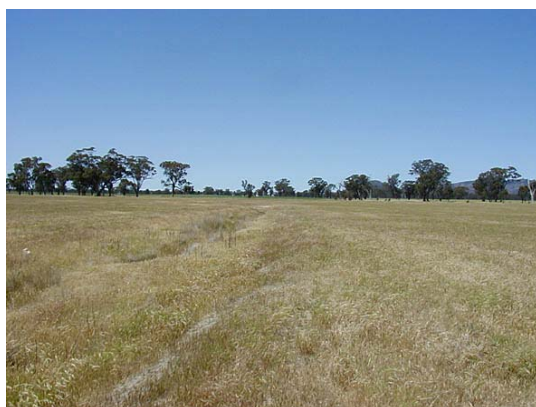
**FS#4 – Unknown 1**

Intact Valley Fill

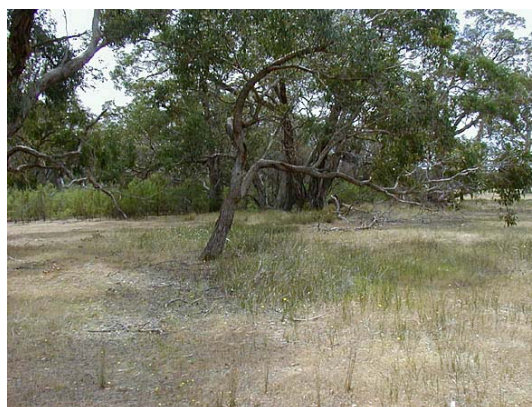
**FS#22 – Unknown 3**

Intact Valley Fill

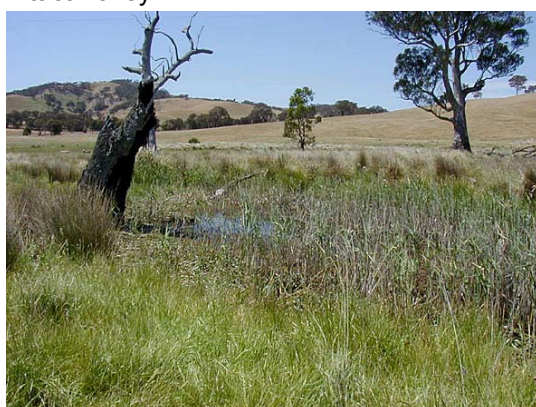
**FS#38 – Glenlofty Creek**

Chain of Ponds

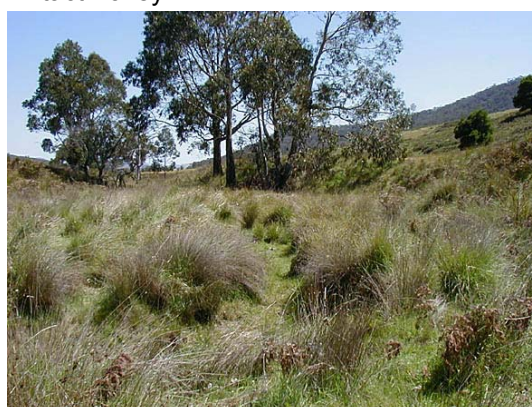
**FS#39 – Glenlofty Creek**

Chain of Ponds

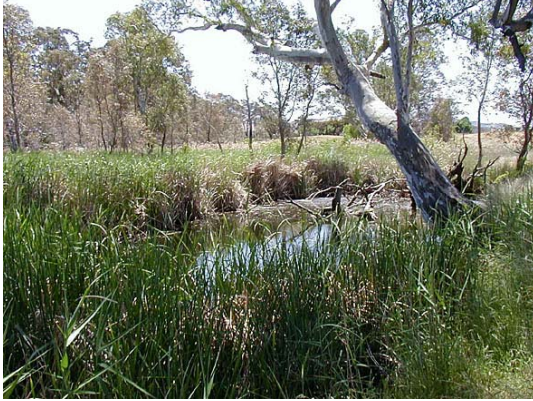
FS #38: Glenlofty Creek

Many incised or modified systems in the Wimmera River Catchment were once Chain of Ponds. In some waterways, a process of infilling by sediment is occurring. This is a recovery phase of the process in which the Chain of Ponds systems attempt to return to their original geomorphic form.

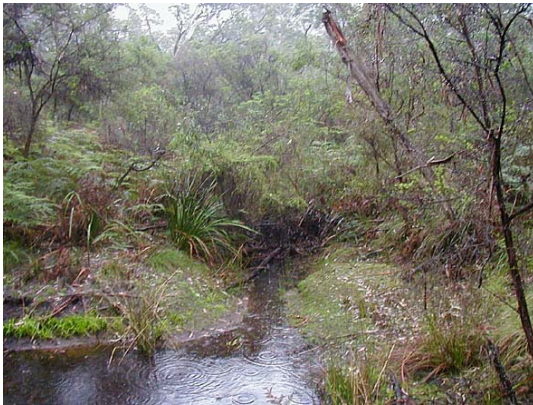
FS#12 – Boggy Creek

Physical Form Score: 8

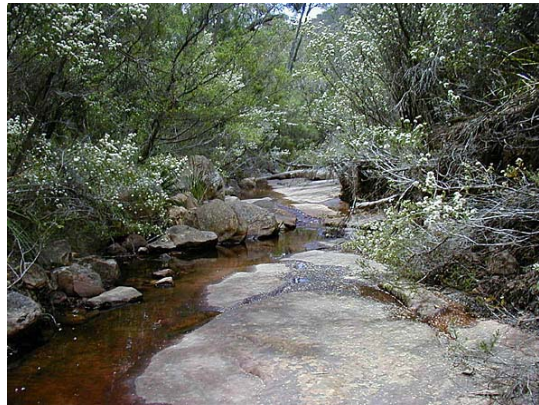
FS#17 Seven Dials Creek

Physical Form Score: 7

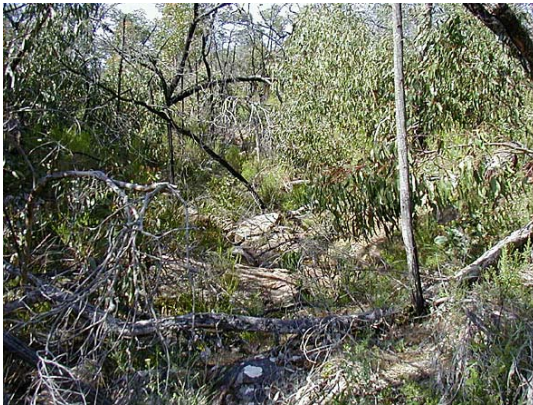
FS#20 – Golton Creek

Physical Form Score: 8

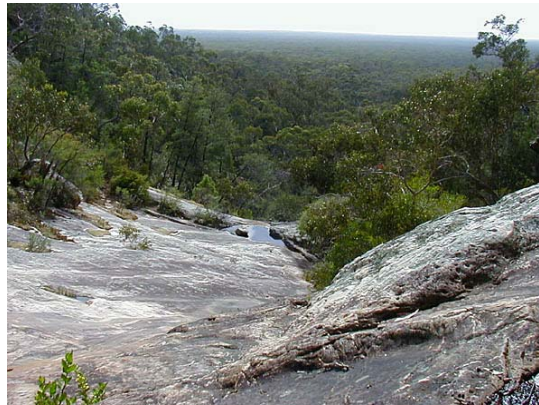
FS#21 – Golton Creek

Physical Form Score: 8

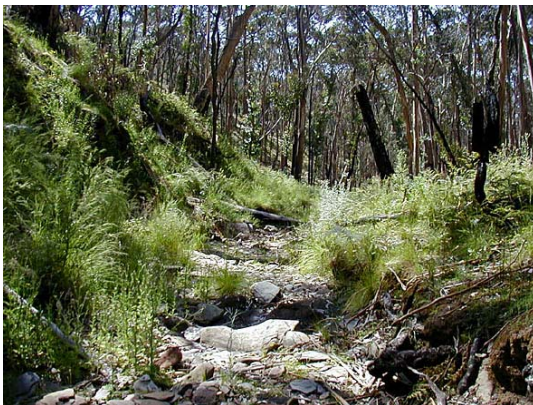
FS#34 – Glenpatrick Creek

Physical Form Score: 8
