Spring & Tuckers Creek Waterway Action Plan

- Final
- 4 August 2006

Sinclair Knight Merz
McGuigan Lane (rear of 153 Gray Street)
Hamilton VIC 3300 Australia
Tel: +61 3 5571 9535
Web: www.skmconsulting.com

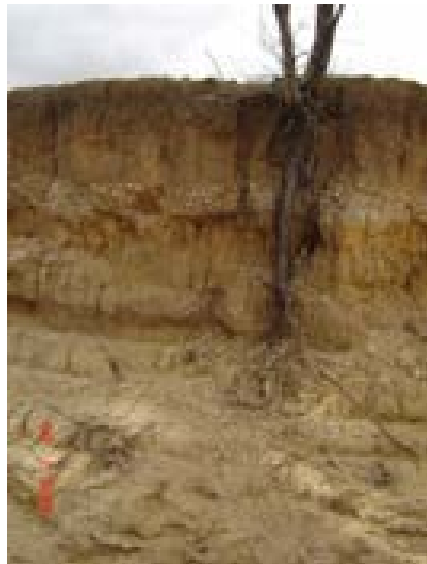
■ **Figure 4-1 Soil cross sectional profile downstream of Eversley-Crowlands Rd.**

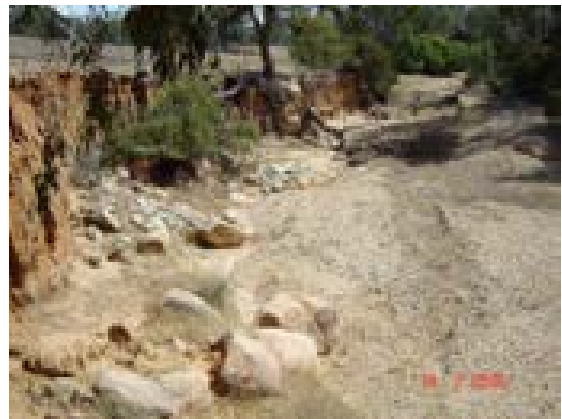
■ **Figure 4-2 Previous rock treatment to try and prevent bank erosion**

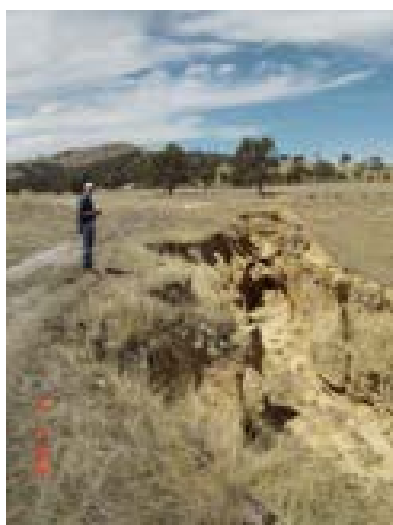
The past severe erosion of tributary S1/3 has been treated with batter laybacks, a gully plug dam and new overflow. Unfortunately, these assets are in a serious state of failure with a new 4 m deep gully formed along the new overflow line and the past battered gully is totally bare and seriously eroding. Upstream and east of Spring Flat Road, a number of hillslope gullies need to be watched for further deterioration.

■ **Figure 4-3 Deep gully on S1/3**

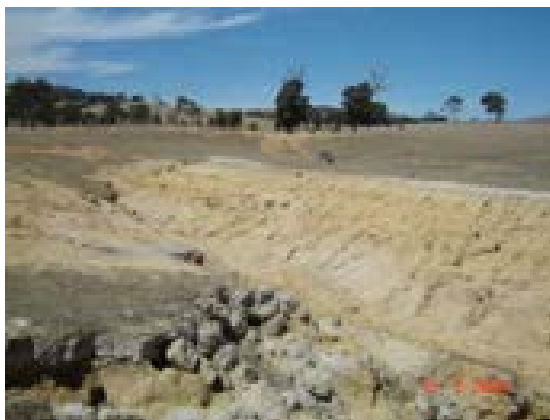
■ **Figure 4-4 Failed batter laybacks on S1/3**

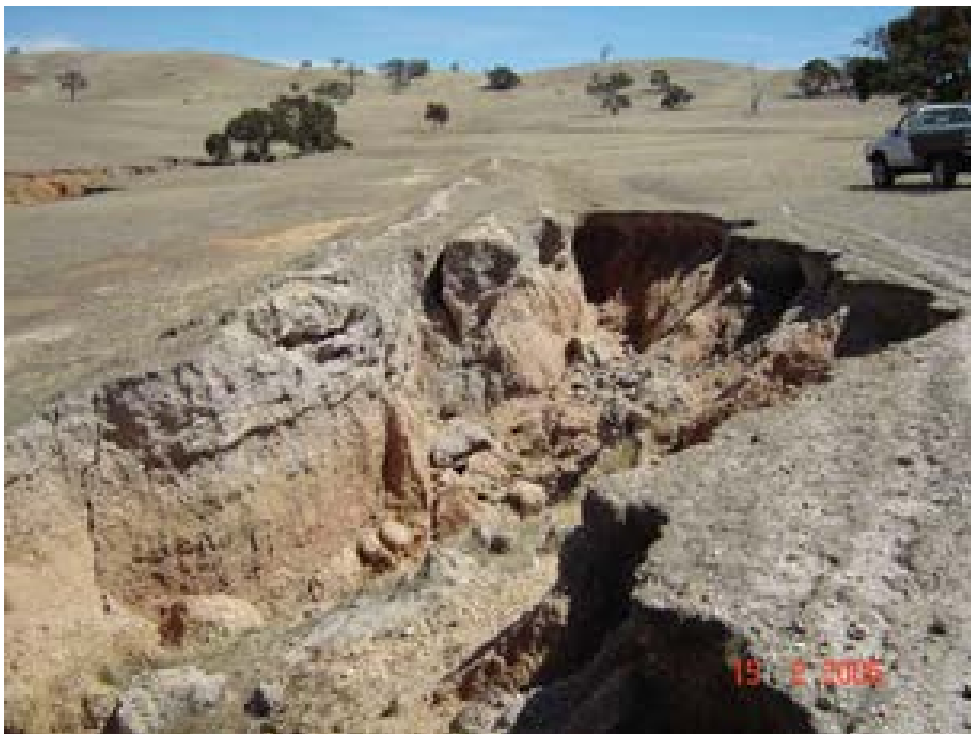
Tributary S1/5 is in a very seriously eroded state with not only the deep incision of the main valley line, but also the spectacular failure of old SCA style works. A diversion bank system that was installed to divert the flows around the eroding stream has been breached and a massive 5 m deep erosion head developed. This will require very detailed analysis to resolve but a significant and comprehensive structural solution will be required involving bed controls re-entry chutes and possibly trickle pipes, plus rehabilitation of the diversion bank system.

■ **Figure 4-5 Failed diversion levee on S1/5 has resulted in major erosion**

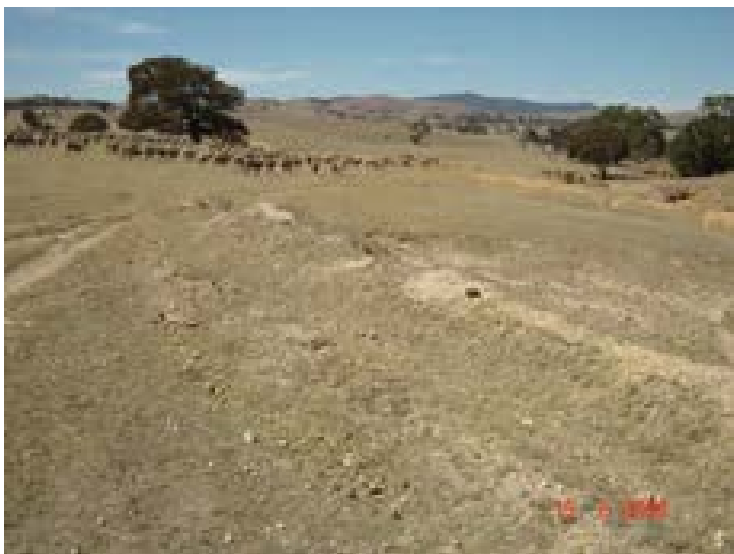
Many factors have contributed to the decline in health and extent of riparian vegetation within the reach. The pressures of drought conditions in combination with uncontrolled stock access are having a significant impact on the existing riparian vegetation and habitat values within the reach. Scattered trees along the riparian zone represent the only remaining native vegetation in many paddocks. These trees provide shelter for stock which, in turn, impact the stream zone (refer to Figure 4-6).

■ **Figure 4-6 Unrestricted stock access has degraded many sections of Spring Creek and its tributaries.**

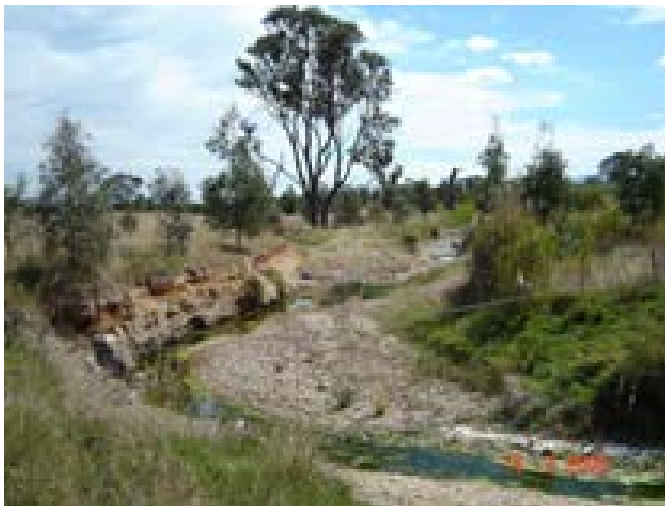
Water quality in this reach is of real concern. Under low flow conditions as observed during the field inspections, a small saline flow (estimated to be in the order of 5,000 μS) was observed in the mainstem. Growths of filamentous algae were evident in the mid segment pools near Spring Flat Road. After this the flows were mostly subsurface.

■ Figure 4-7 Algal bloom in pools on S1

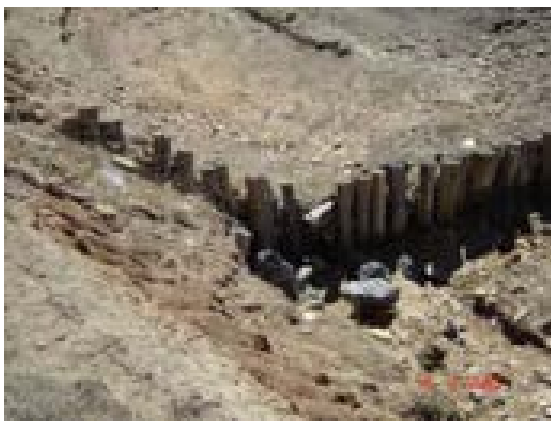
■ **Figure 5-1 Failing pile field on S1**

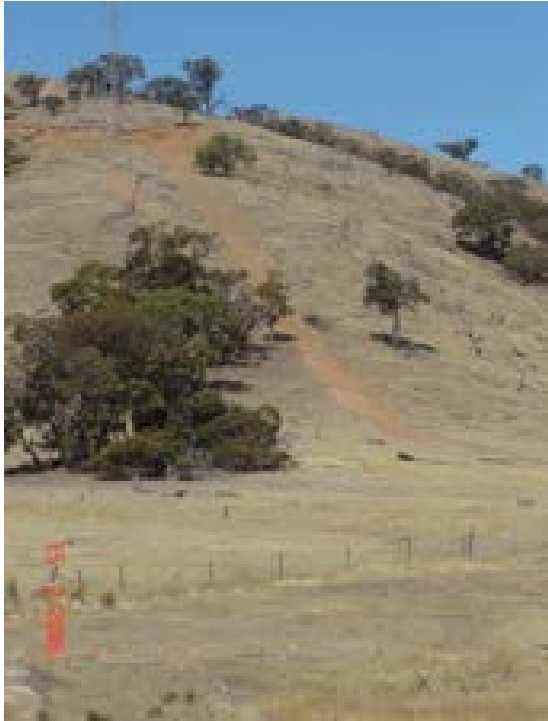
A major problem at the head of the S2/1 valley is occurring following the installation of the fibre optic cable up the very steep slope without any significant erosion control measures put in place (Figure 5-3). The trench line is gullying out significantly and erosion products being transported into the stream. This issue needs to be followed up with the constructor or asset owner as a matter of urgency.

Figure 5-3 Fibre optic cable trenchline adjacent to S2/1

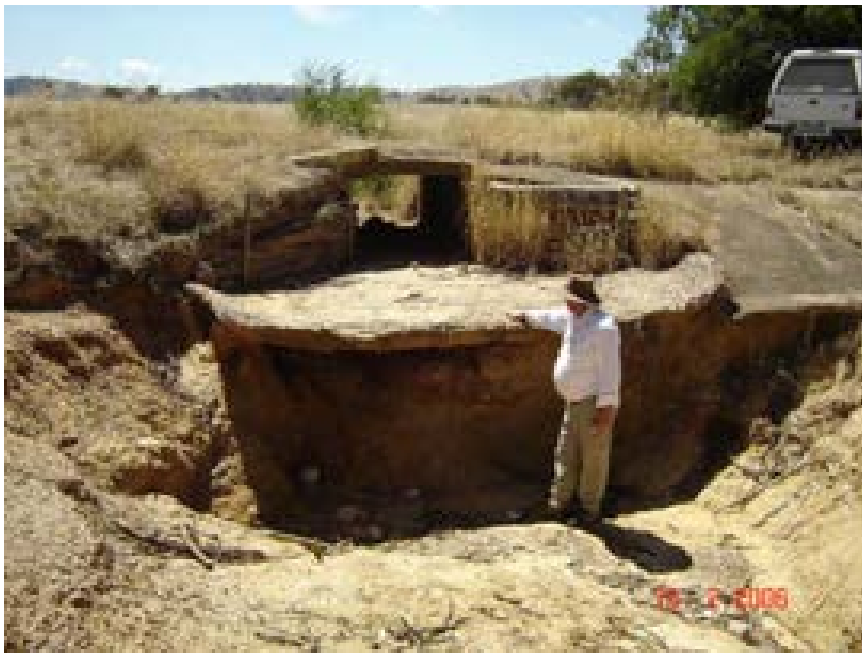
- **Figure 6-1 Ford crossing that is providing grade control but is in danger of being undermined**

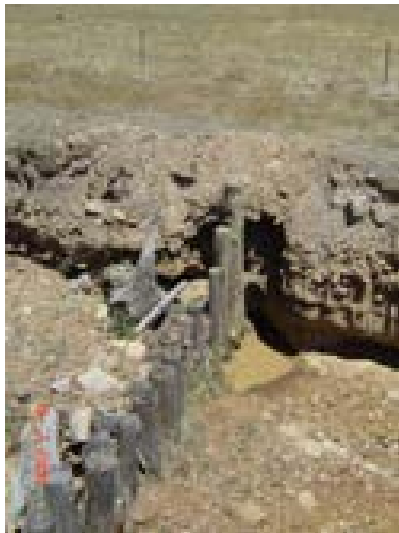
■ **Figure 7-2 Outflanked pile field**

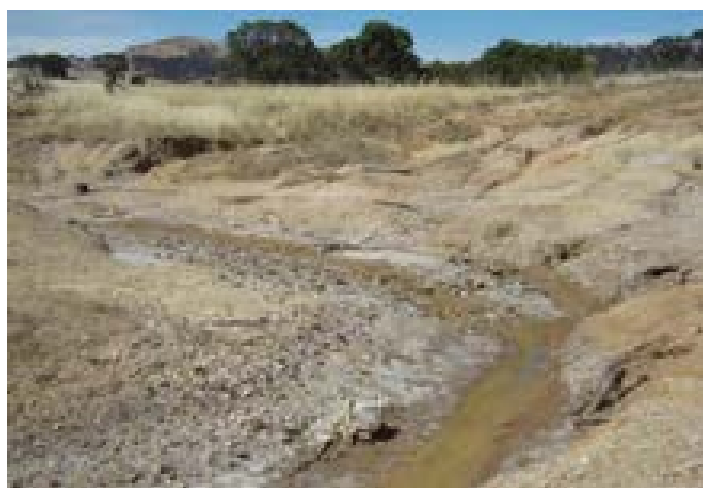
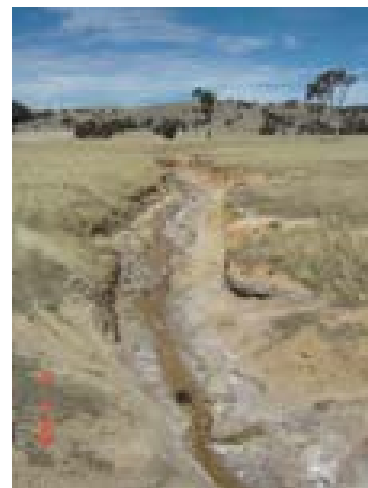
■ **Figure 7-4 Hyper-saline conditions along the mid sections of Tuckers Creek (Reach T2)**
