Wimmera Catchment Management Authority

Geomorphic Categorisation and Stream Condition Assessment of the Wimmera River Catchment – Appendices

Job 2901049.008 & 2901049.009

April 2003

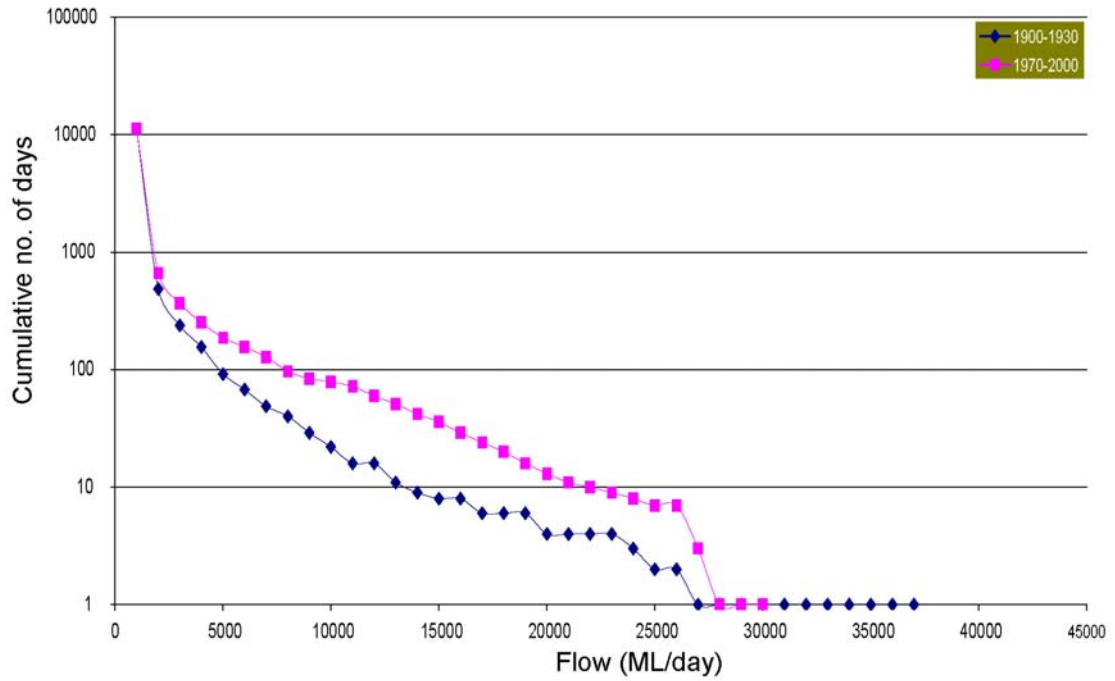
Figure J1 Flow Duration Curves – Avoca River Coonoor Gauge (408 200)

Flow duration curves indicate the amount of time for which river flows occur within a particular flow range. The duration of time in which flows are within a flow range are indicated by cumulative number of days for which a flow is exceeded over a time period. From the curve the amount of time (number of days) for which mean daily flows are above a particular flow is indicated, for example at the Coonooer gauge post regulation period mean daily flows greater than 15,000 ML/day occurred for 32 days of the 31 year period, Figure J1.

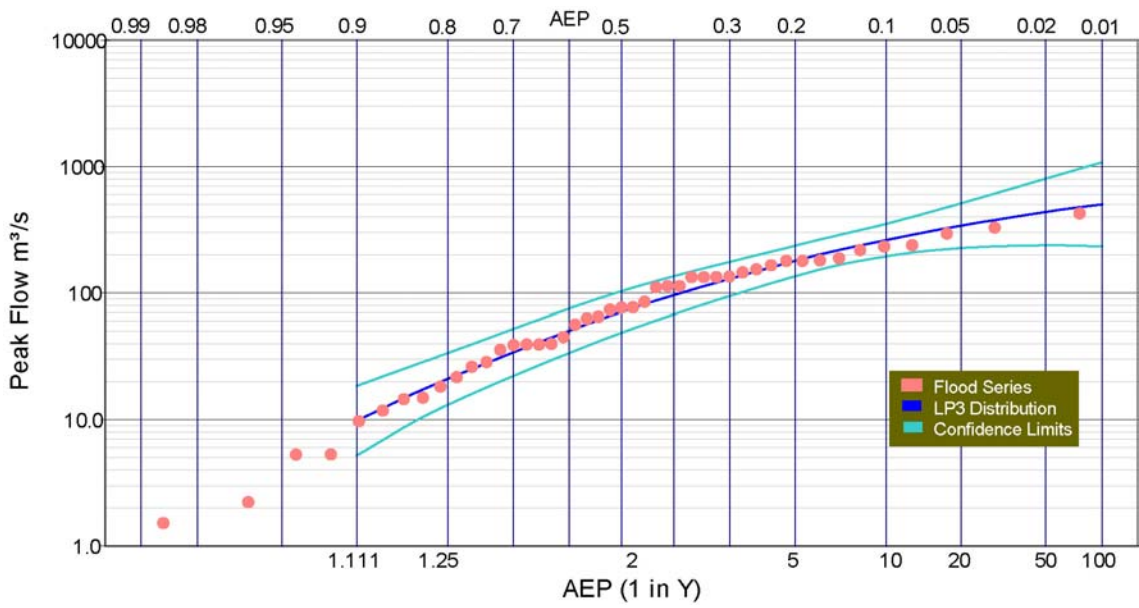
Figure J2 Flood Frequency Curve – Avoca (1900 – 1930)

The results for the Avoca River flood frequency analysis indicate that the floods in the 1970 –2000 period were greater than those in the period 1900 -1930. The flow duration analysis indicates that flows were greater in the 1970 –2000 period than that in the 1900-1930 period.

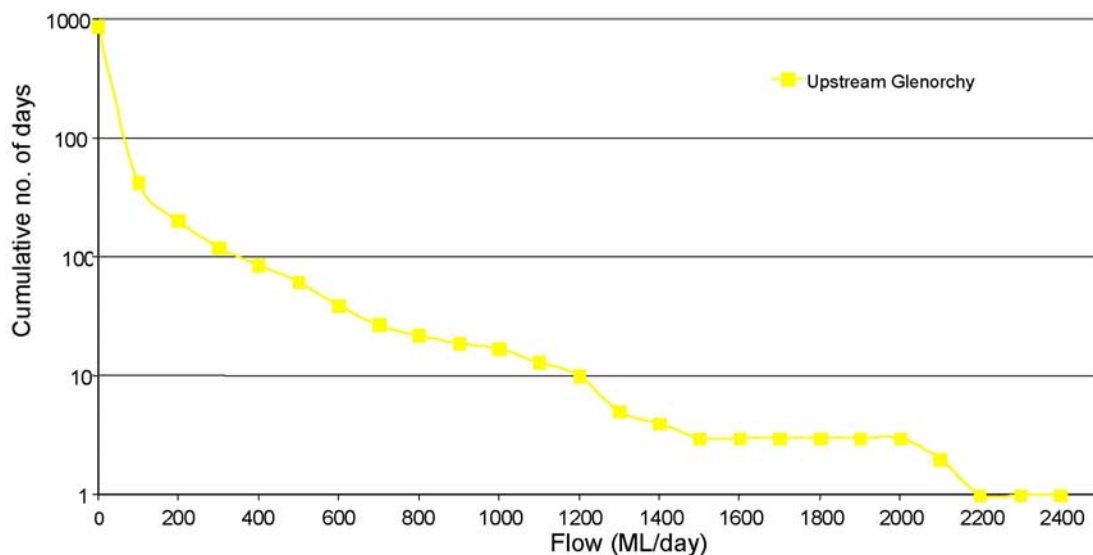
Figure J4 Flow Duration Curve Wimmera River – Upstream of Glenorchy (415 206 and 415 237)

The flow duration curve for the section upstream of the main diversions and regulations was obtained from the mean daily flow data by combining the flows from the Glynwylln station with those for Concongella Creek with a day lag. The period is 24 years from 1977 – 2000 inclusive, the longest period of combined record. No pre regulation dates were considered for Glynwylln.

The period of data is not equal to that chosen for the downstream flow duration curve and as such the curve is not for flow comparison purposes between sites but an indication of the trend in flow duration in the upper catchment, Figure J4. Data has been used for sediment transport investigations

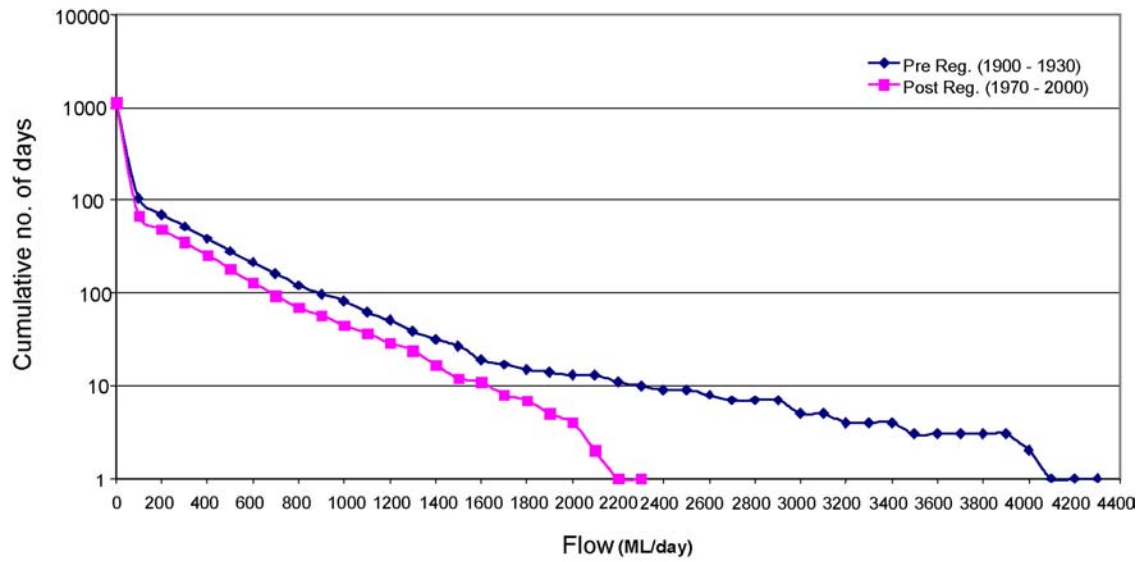
Figure J5 Flow Wimmera River Horsham Gauge (415 200)

To ensure a relative comparison, periods of equal length were chosen for pre and post conditions. The periods of flow were separated into pre regulation, 1900 – 1930 inclusive and post regulation, 1970 – 2000 inclusive. Both data periods are 31 years, Figure J5.

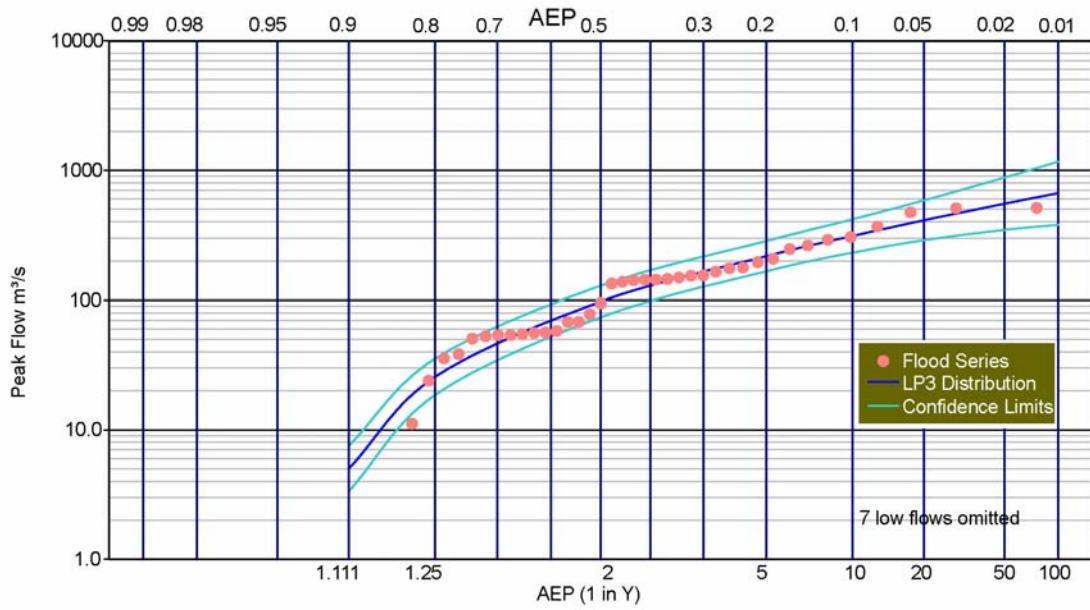
Figure J6 Horsham Pre Regulation 1900 – 1930

These results suggest a reduction in flood magnitude in the post regulation period when compared against the pre regulation period. This is in contrast to the results for the Avoca River gauge. The analysis suggests that the reduction in stream flow and flood magnitude in the Wimmera River is likely to be the result of human intervention (flow regulation) alone and not associated with temporal variation in hydrology.

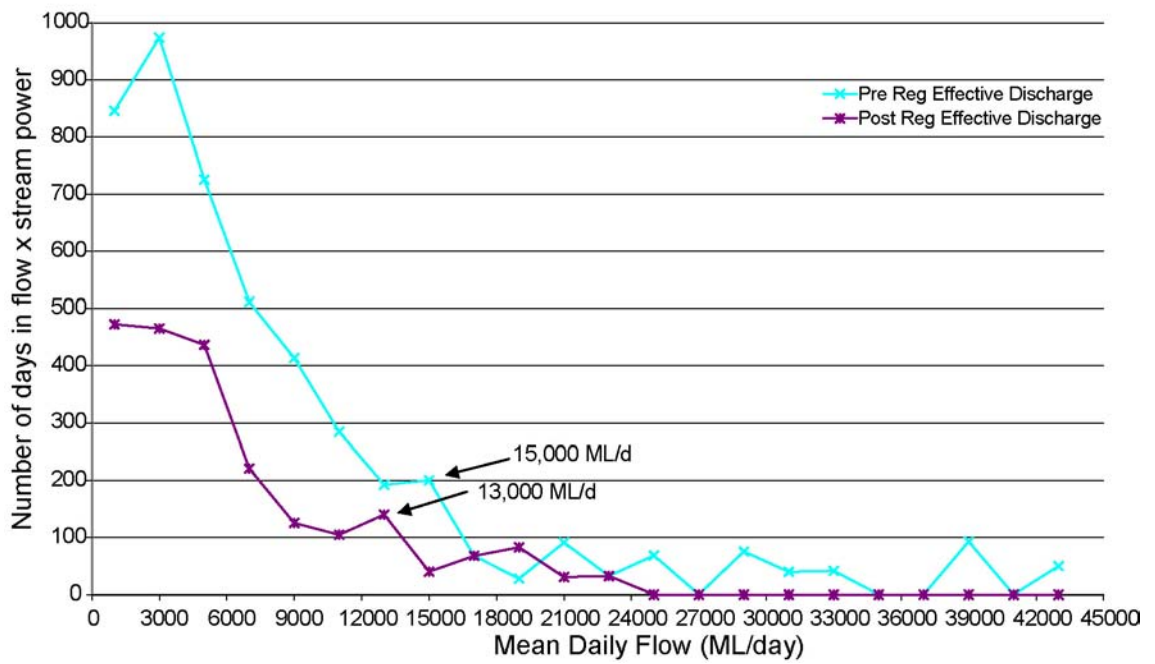
Figure J10 Effective Discharge Analysis – Downstream Horsham

Because the process of channel adjustment is slow (dependant on sediment supply and transport capacity) and the introduction of regulation relatively rapid, there has been a period of reduced probability of overbank flooding attributable to the flow regulation. The bankfull flow of approximately 175 m³/s has an AEP of 10% on the post regulation flood frequency curve. In essence the large channel is operating within an environment of reduced flow.

Channel contraction should occur (albeit slowly) and as a result it would be expected that the occurrence of overbank flooding is likely to increase. However, review of the flood frequency curve for the post regulation flow regime reveals that the average exceedence probability associated with a flow of 150m³/s, (the post regulation effective discharge) is approximately 20% (ie a 5 year ARI event). This is the same as the annual exceedence probability of the pre regulation effective discharge. In essence, if the channel capacity of the Wimmera River adjusts to the new effective discharge, the occurrence of overbank flooding will not be significantly different to that which occurred prior to regulation.
