Wimmera
Catchment Management
Authority

Wattle Creek Waterway Action Plan

- Final
- 29 September 2005

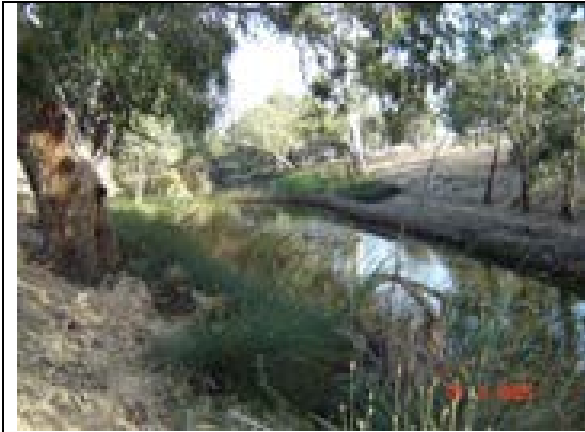
■ **Figure 4.2 – high value pools at the downstream end of Heifer Station Creek in Reach 1.**

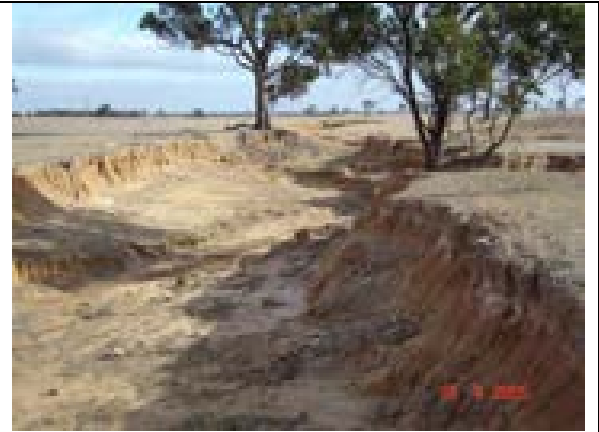
Figure 4.3 – Active erosion in Reach 1

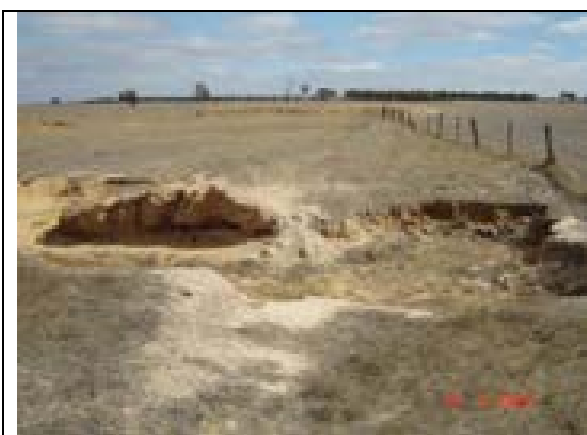
■ **Figure 5.2 – Breached levee bank (old SCA works)**

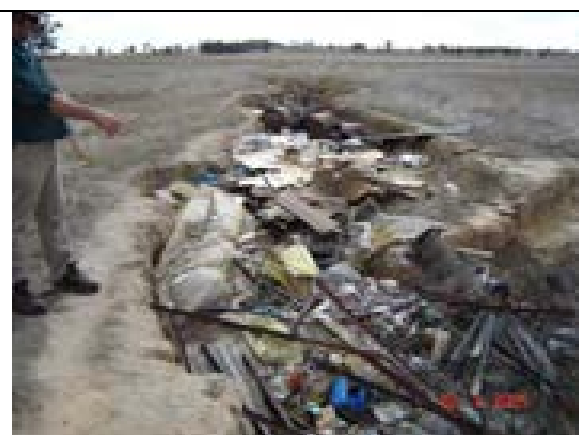
Evidence of rubbish dumping in areas where bank and bed erosion has occurred in upstream tributaries in this reach was observed (Figure 5.3).

Figure 5.3 – Rubbish dumping in eroded tributary

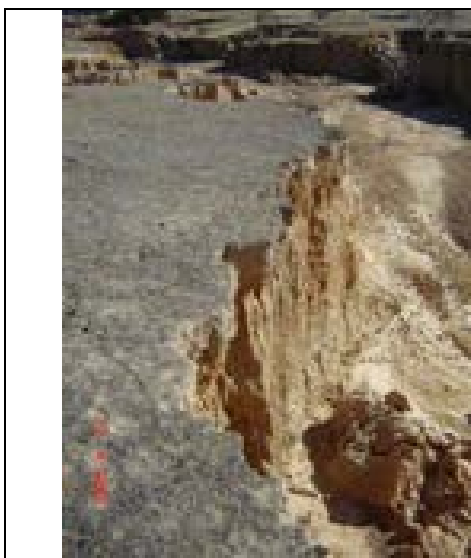
■ **Figure 6.2 – Active Bank Erosion**

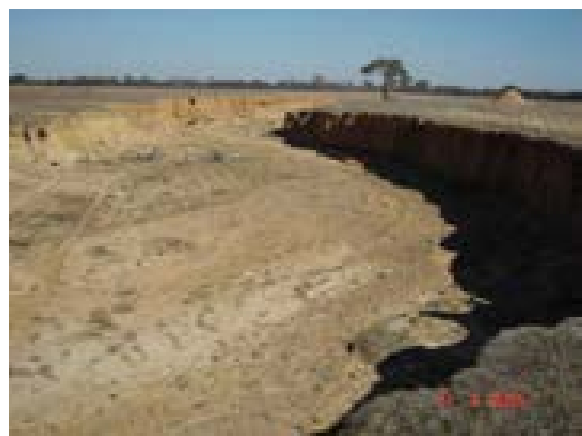
Figure 6.3 – Oversized Channel

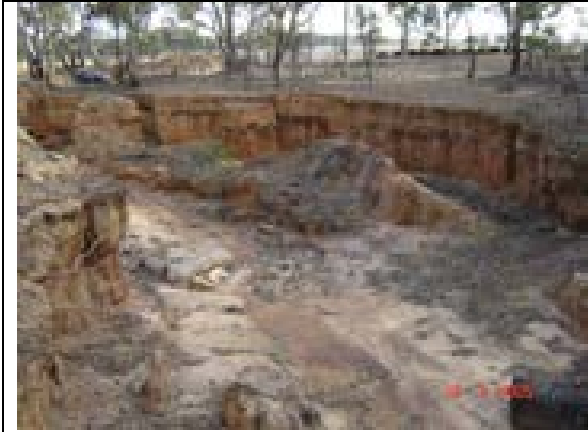
■ **Figure 7.2 – Block bank failure downstream of Stawell-Avoca Road**

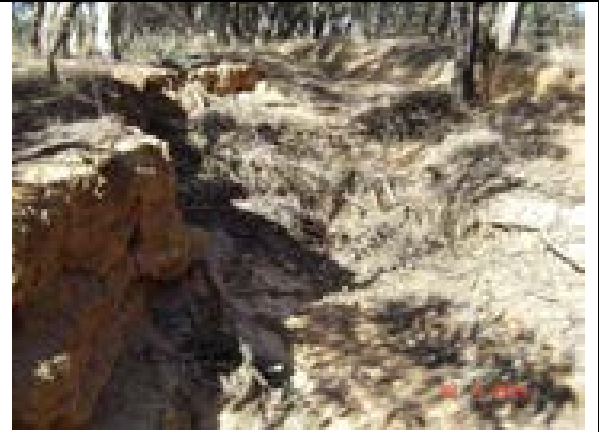
Figure 7.3 – Erosion head in drain along Tulkara Road

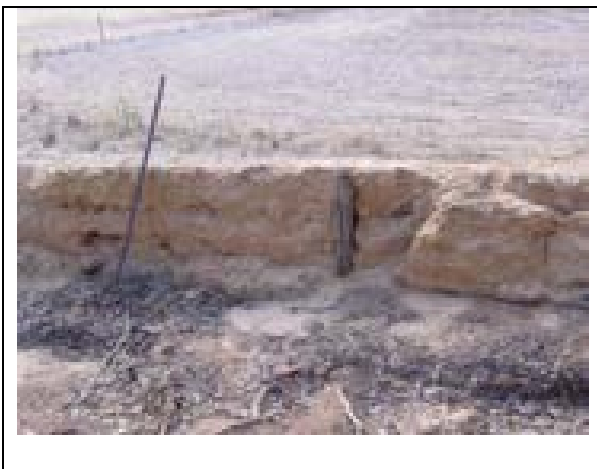
■ **Figure 7.4 – Major sediment deposition is Evidenced by buried fence posts**

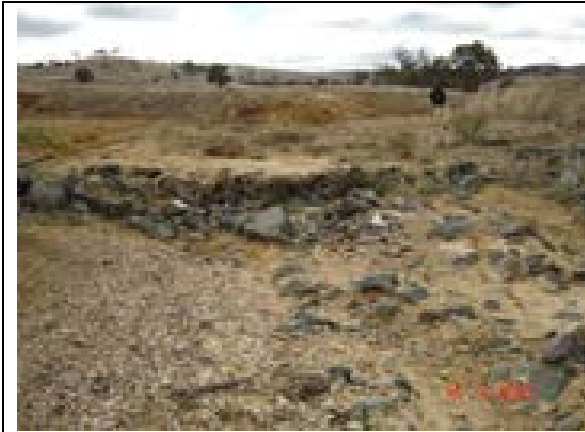
■ **Figure 8.2 – Failed Chute**

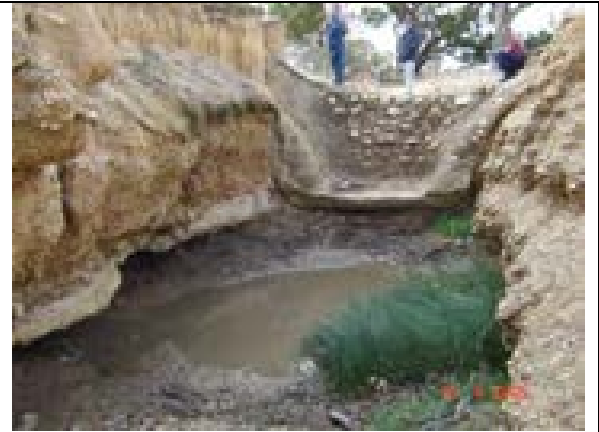
Figure 8.3 – Maintenance required on SCA Structures

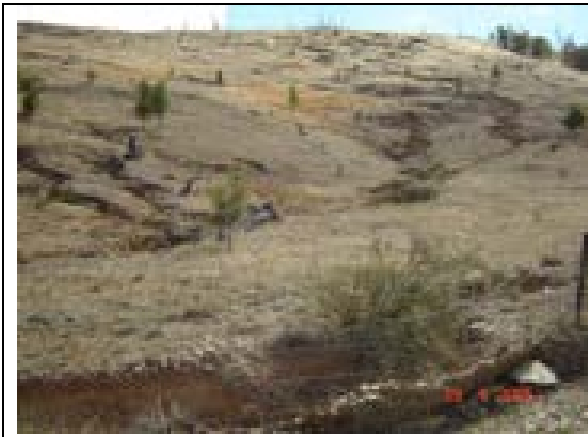
■ **Figure 9.2 – Active hillslope erosion**

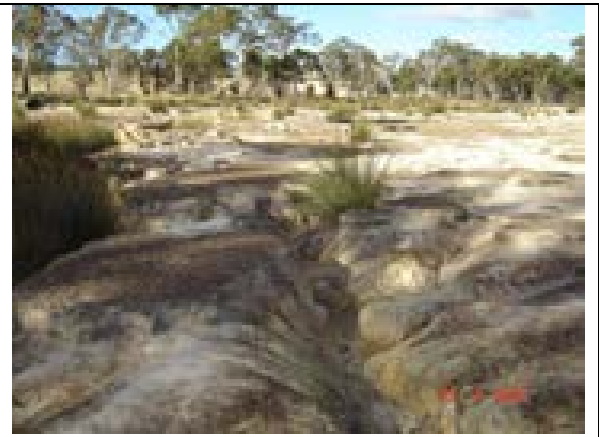
Figure 9.3 – Severely salt affected area requires collaborative rehabilitation

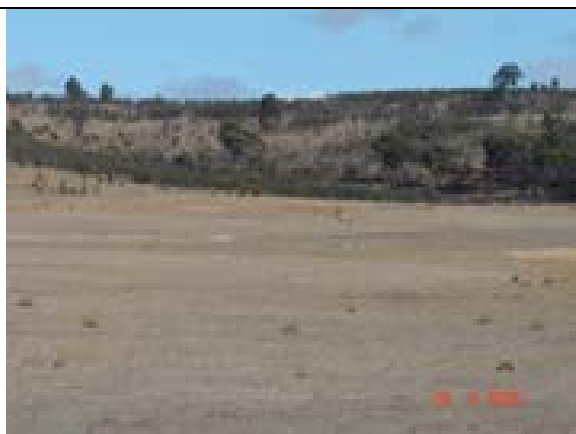
■ **Figure 11.2 – Active erosion**

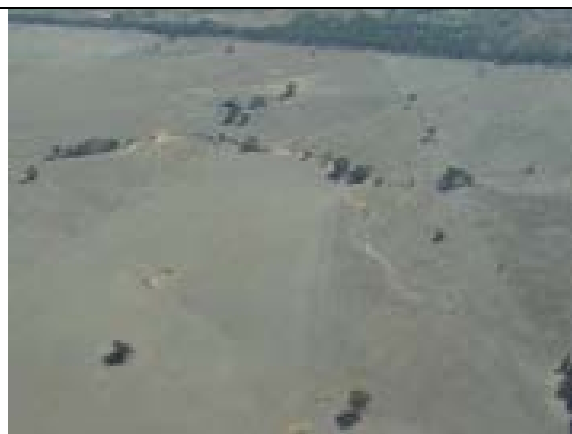
Figure 11.3 – Site requires monitoring and partnership program with landholders

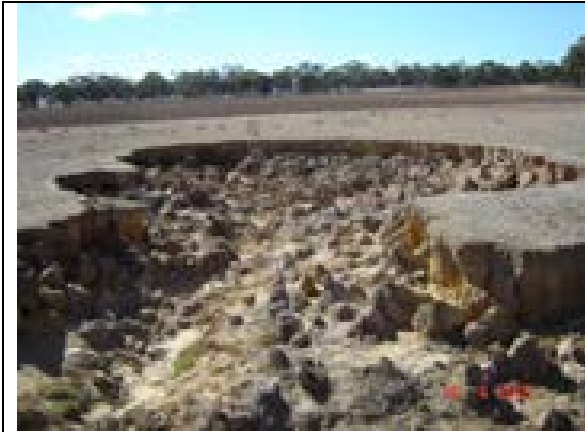
■ **Figure 12.2 – Active erosion**

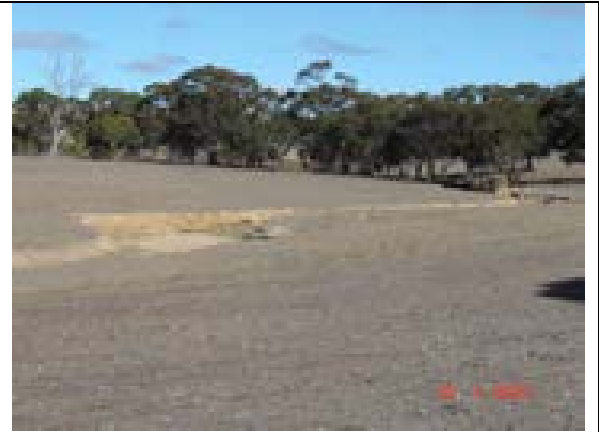
Figure 12.3 – Active erosion
