Wimmera
Catchment Management
Authority

Glendhu Creek Waterway Action Plan

November 2004

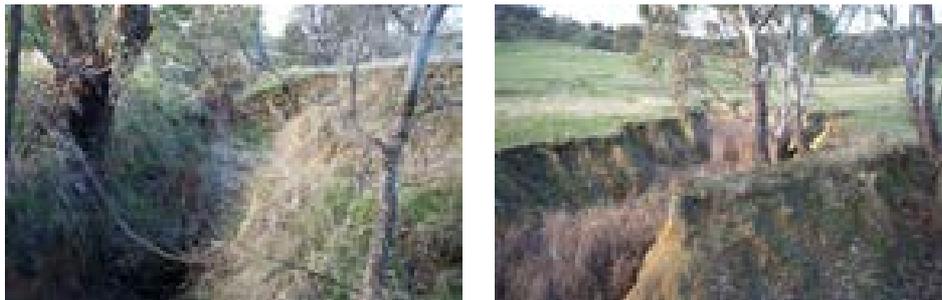
The right bank has a higher density of tributary channels than the left bank. Tributaries are poorly vegetated and are therefore actively eroding previously intact valley fill and slope material.

Figure 8. A well vegetated stream channel and minor gully erosion in Reach 2 of Glendhu Creek (August 2004).

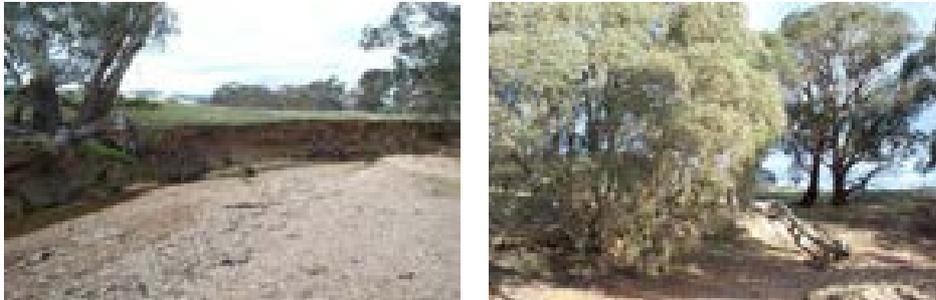
Figure 9. Evidence of sediment deposition with in Reach 3 (August 2004).

Tributaries entering Reach 3 are very degraded with bare banks and quite poor riparian vegetation. Tributaries such as these are delivering large quantities of sediment to the main trunk of the Glendhu Creek. This sediment is then transported further downstream. A number of the tributaries have been battered and sown with pasture. Some of these are now beginning to re-incise and without intervention the gully initiation process is likely to begin again.

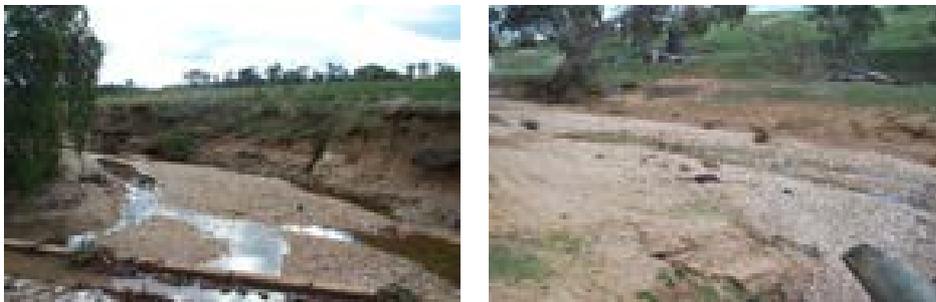
Many of the tributaries entering Reach 4 have bare banks, are actively eroding, and are depositing large quantities of sediment into the main trunk. Some of these have previously been battered and sown with pasture. However, they are now beginning to re-incise and the gully initiation process will begin again. Some of the gully battering that has previously been done is successful and it is thought that a combination of bank diversions, gully plug dams and revegetation using woody species is contributing to the success of these projects.

Figure 8. The view upstream and downstream from the Ararat-St Arnaud Road crossing. Note the volume of coarse sediment within the channel (August 2004).

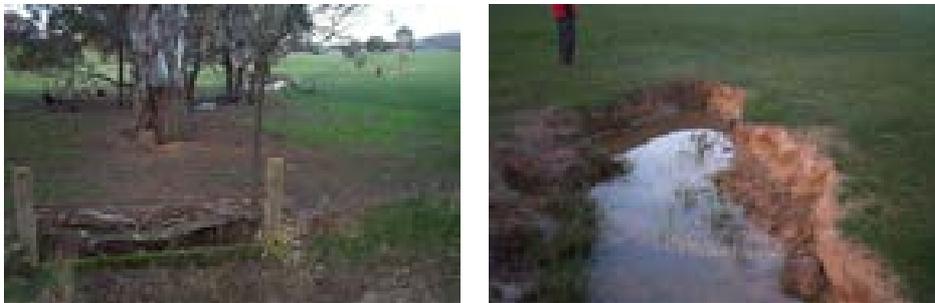
Reach 6 is dominated by a broad, low-gradient valley that is well vegetated with pasture grasses. As a result, it has experienced little, if any headward incision. The channel is poorly defined and it is likely that much of the catchment took this form prior to European settlement. This reach is therefore considered to have high intrinsic value and is a site that should be preserved. A drop structure approximately 3m high on the downstream side of the Joel Joel-Crowlands Road and another small structure approximately 0.5m high on the upstream side of the road have prevented any headward incision from migrating upstream through the reach.

Figure 12. A small drop structure and remnant vegetation alongside the Joel Joel-Crowlands Road. The photo on the right shows a minor headcut in this reach (August 2004).

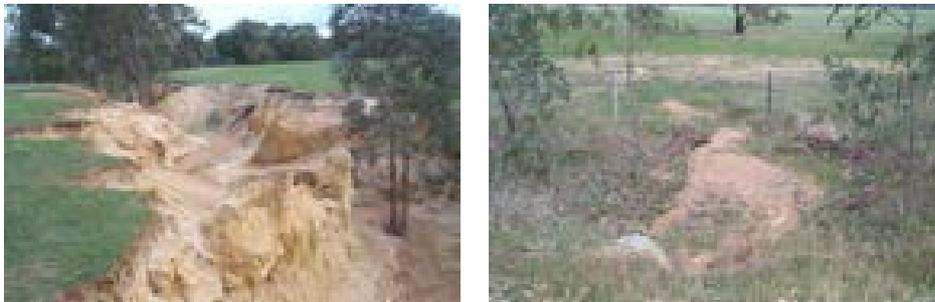
Immediately downstream of the Joel Joel Road is a 3m high concrete drop structure that is preventing any further incision that may extend into Reach 6 upstream of the road. Below the road crossing, the stream runs parallel to the road and is incised with bare banks. Due to the relatively low gradient in the reach, there is little active erosion of either the bed or the banks of the channel. As the channel progresses downstream, the channel capacity decreases. This is thought to be in-part controlled by the old railway line that has been raised above the level of the floodplain. Part, or all, of this reach may have been modified and channelised in a similar fashion to the contemporary channel in Reach 5 upstream of the drop structure. Low gradients and sediment deposited from both the Wimmera River and Glendhu Creek may be infilling the pre-existing channel.

Figure 13. A relatively stable gully upstream of the Joel Joel-Crowlands Road and sediment deposition downstream of the Joel Joel-Crowlands Road in Reach 7 (August 2004).
