## Glenpatrick & Nowhere Creek Waterway Action Plan

- Final
- 4 August 2006

Wimmera  
Catchment Management  
Authority

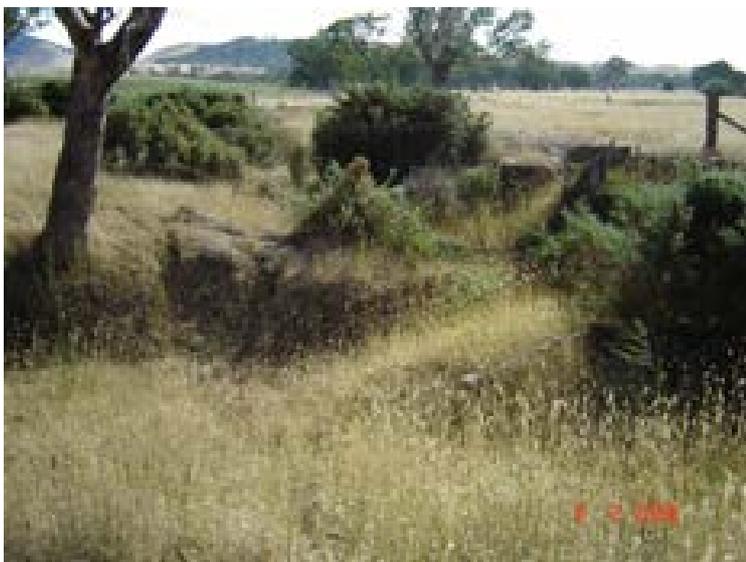
A stream diversion has taken place in the lower catchment following an old course line with this being directed towards a dam and the overflow making its way across the floodplain in a very small almost indiscernible channel. This man made intervention is fairly old and land use patterns have established around the works. Floods are still likely to follow both courses across the wide flood plain at this point.

■ **Figure 2-2 Stream diversion in the lower reach of Glenpatrick Creek**

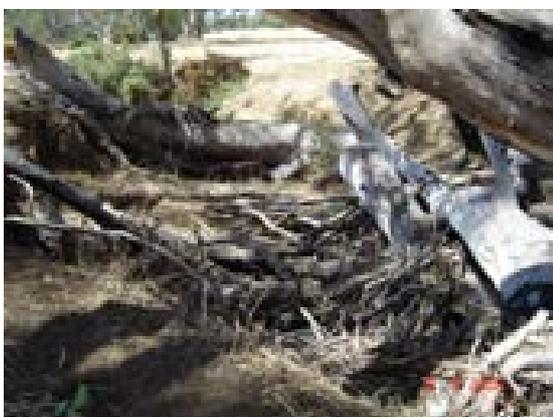
Upstream of the junction with Nowhere Creek the stream continues as an enlarged channel with a sand and gravel substrate. Scour holes are evident and, in particular, a large woody debris jamb about 300 m upstream of Nowhere Creek Road is in the process of creating an avulsion. Simple management of the larger pieces of timber and realignment of the rest will resolve this problem.

■ **Figure 4-1 Woody debris jamb on G1/2 upstream of Nowhere creek road**

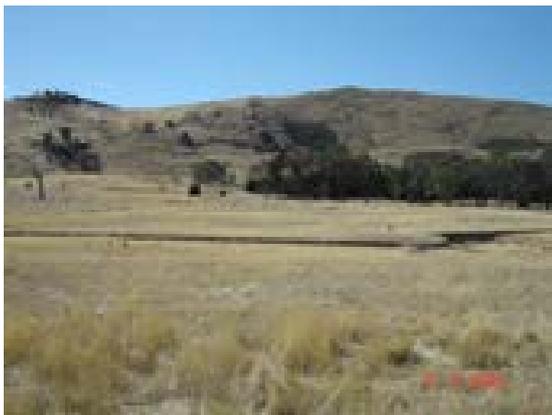
■ **Figure 4-3 Cleared hills are contributing significantly increased runoff volumes**

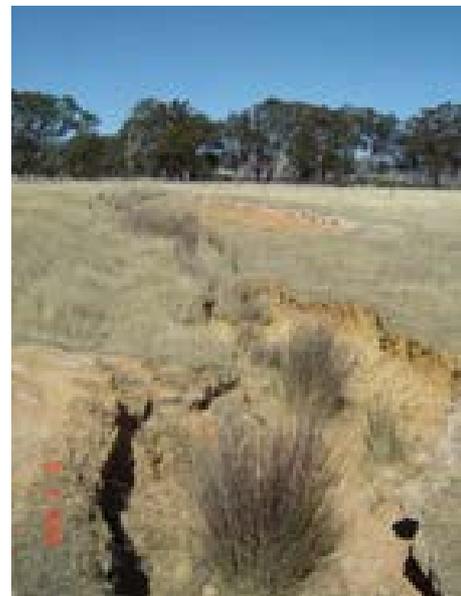
■ **Figure 4-4 SCA style works on G1/2 require maintenance to secure ongoing integrity**

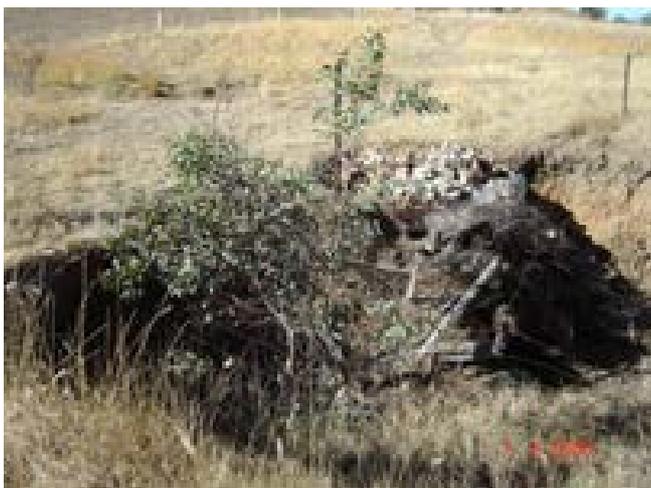
G 1/3 has some erosion problems at the Glenpatrick Road with a large multiple erosion head upstream of the road. Further significant channel erosion exists in the diverted and channelised channel of G1/3/1 with incision up to 3.5 m deep head on the north side of the road. These activities need fairly urgent attention before they advance further and require significant resources to repair.

■ **Figure 4-5 erosion head on G1/3**

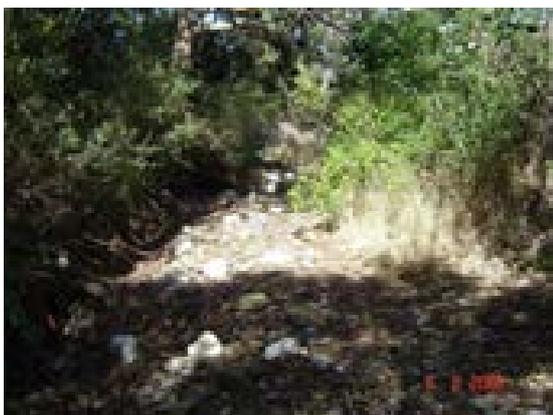
A road crossing at Akers Lane has had a rock chute and bank armouring installed to stabilise the crossing but it appears that this is failing due to wrong rock sizes and steep tailslopes. Upstream the bed appears to be stable with incision process less active and the bed imbricated. An increased riparian density, albeit weedy, also assists in stabilising the stream. One area near the junction of G2/8 appears to have been used as a cobble and gravel mining area. This may need some stabilisation effort. The incised channel continues up into the forest for about 1km upstream of the last ford crossing on Glenpatrick Road.

■ **Figure 5-2 Weeds and mobile cobbles downstream of Akers lane**

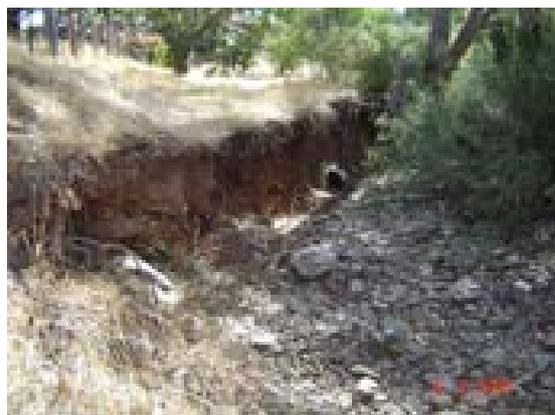
■ **Figure 5-3 bank erosion due to historic stream straightening of Glenpatrick Creek**

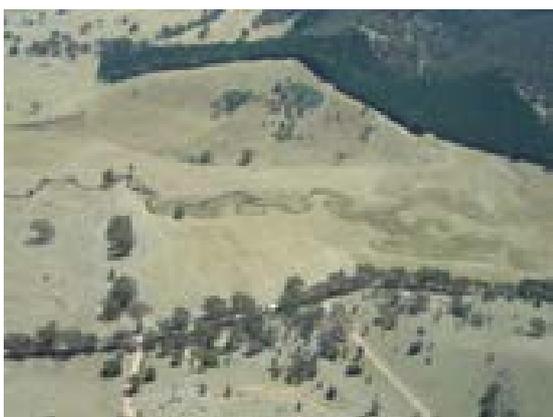
■ **Figure 6-1 Sediment deposition area at the break of slope on the mainstem of Nowhere Creek (N1)**

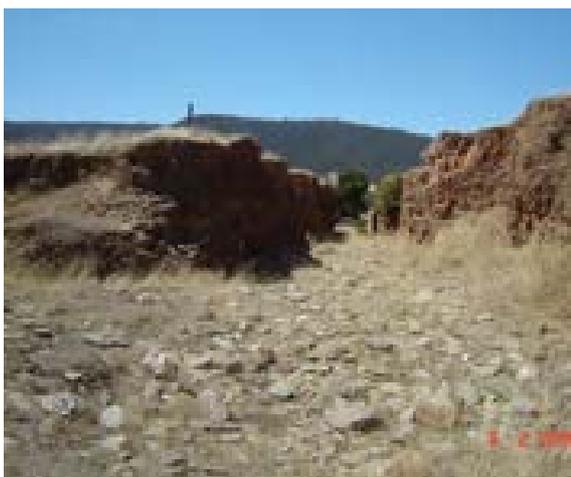
■ **Figure 7-1 Impacts of gold mining have had a significant impact on the catchment**

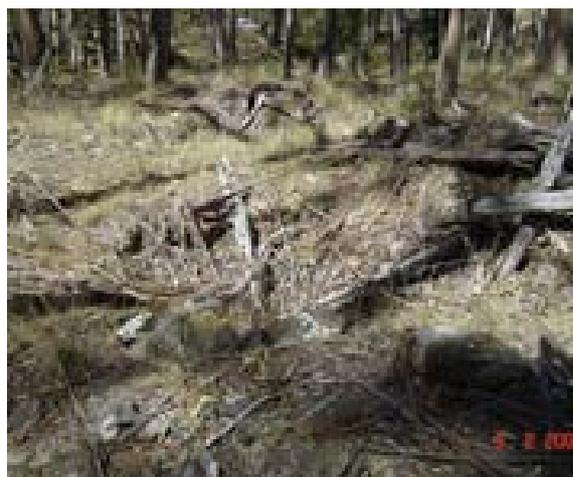
■ **Figure 7-2 Mulloch heaps are prevalent in the forested upstream catchment**

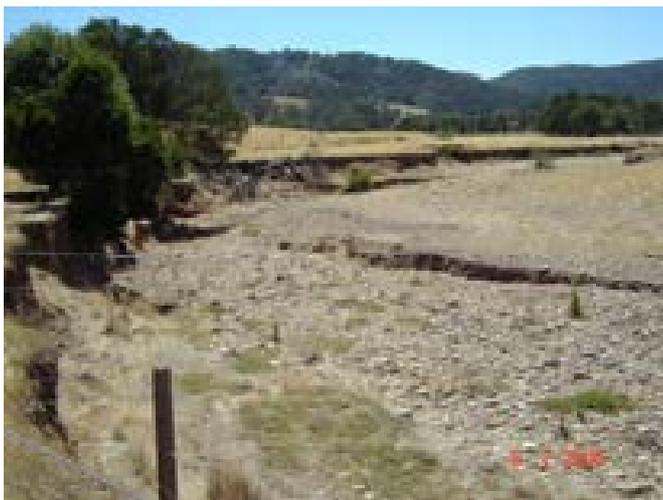
Spring Creek has been subjected a series of puzzling channelisation and realignment activities. Whilst no information is available to the study team, it appears that either sluice mining activity has occurred or the area has been used as a mine for cobble supply. The straightened channel cuts through a colluvial slope at a depth of nearly 6 m and has widths up to 20 m, with the smaller old course well out on left bank. Other old courses indicate that this area has been significantly altered historically, probably for mining. The current condition is poor with active bed and bank erosion and waves of cobbles along the stream. The age class of some Blackwood in the lower portion of this area suggests that some rehabilitation has been attempted in the last 30 years. Some follow up works to establish a stable channel and fence out stock access will assist in stabilising this area.

■ **Figure 7-4 Bed & bank erosion as a result of stream straightening and diversion**
