# Seven Mile Creek Waterway Action Plan

Job 2901049.014

April 2003

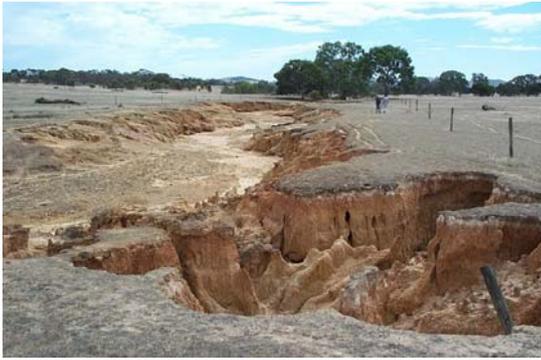
*Figure 2: Active erosion head in Reach 2*

Management Actions	Priority for Works
Treat active erosion heads in upper section of reach.	High
Fence and revegetate in upper and mid section to control erosion and sediment movement.	High
Control saline groundwater discharge into Seven Mile Creek through re-vegetation and the establishment of deeper-rooted pastures in groundwater recharge zones.	High
Investigate stability of drop structures in upper section and repair or maintain as appropriate.	High
Restrict stock access to lower reach.	Medium
Improve riparian vegetation in lower section to extend the high value of Reach 3 and to act as a buffer to the high value Reach 3.	Medium

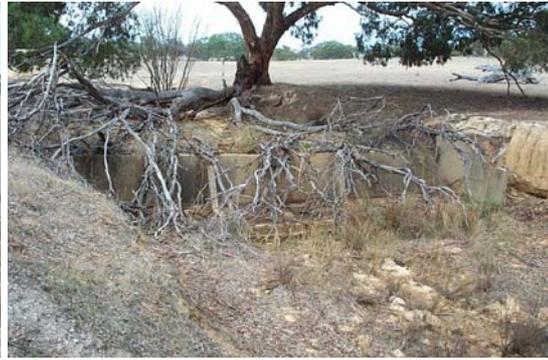
The upper section of the reach has undergone incision in the past and attempts have been made to address this. The upper section contains numerous concrete drop structures. The structures are estimated to be 20-30 years old and showing deterioration. The structures have controlled the previous bed incision. New erosion heads are currently working away from the main channels as a result of the failure to secure the previous work. The headward erosion is producing sediment, which is currently being transported downstream as bed load. Immediately upstream from the drop structures, the channel appears to be stable.

*Figure 3: Drop structure at upstream end of Reach 2*

**Risk** - High risk to Reach 3 and lower parts of catchment due to failure of structures releasing large volumes of sediment.

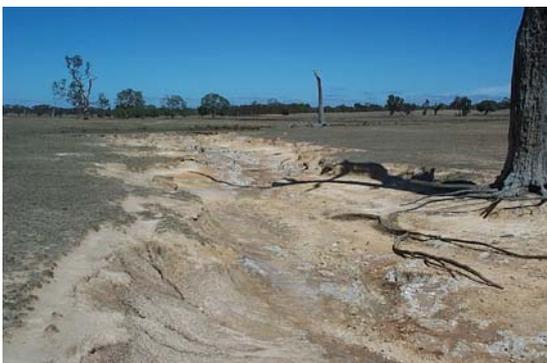
There is a marked lack of in-stream habitat in the mid section, resulting from the large sediment bedload, lack of geomorphic features and very limited riparian vegetation. Discharge of saline ground water exacerbates the lack of vegetation cover and highly saline water is unsuitable for aquatic animals.

Figure 4: Salt affected creek in mid section of Reach 2

**Opportunity** - Limit /control saline groundwater discharge into the active channel and increase vegetation along the banks to help filter runoff before it enters the main channel.

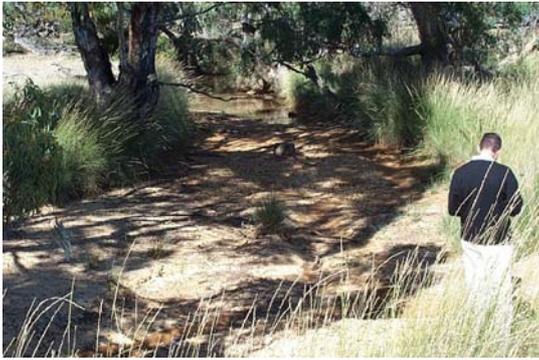
The section of Reach 3 upstream from the actively eroding tributary is in good condition. The channel contains pools, point bars and lateral bars. The sediments are usually fine, with sand occurring on some of the point bars. It is difficult to tell whether the channel naturally contains sand, or if it has accumulated on the point bars after migrating into the system from the eroding reaches upstream.

Figure 5: High value section in upstream extent of Reach 3

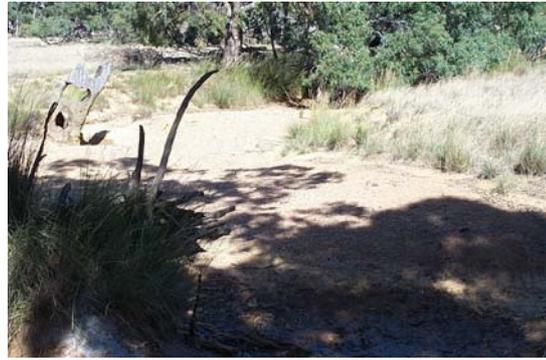
Figure 6: Sediment load in Reach 3, downstream from the actively eroding tributary

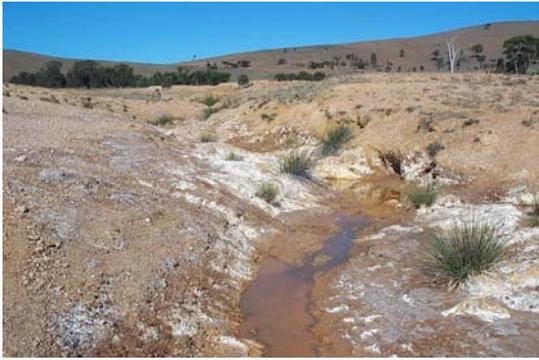
**Risk** - Sediment from erosion in the tributary and failure of structures poses a significant risk.

**Risk** - Stock are permitted to access the tributary. Whilst the tributary would cease to flow for much of the year, nutrients and sediment could be contributed to Seven Mile Creek from rainfall events.

Figure 7: Actively eroding tributary in Reach 3

Management Actions	Priority for Works
Treat active erosion heads in tributary.	High
Investigate stability of drop structures in the tributary and repair or maintain as appropriate.	High
Vegetate to control sediment movement in tributary and manage stock access.	High
Implement sediment management at confluence of tributary and Seven Mile Creek.	High
Control saline groundwater discharge into tributary through re-vegetation and the establishment of deeper-rooted pastures in groundwater recharge zones.	Medium
Monitor structures in the upper reaches of the Concongella Hill tributary.	Low

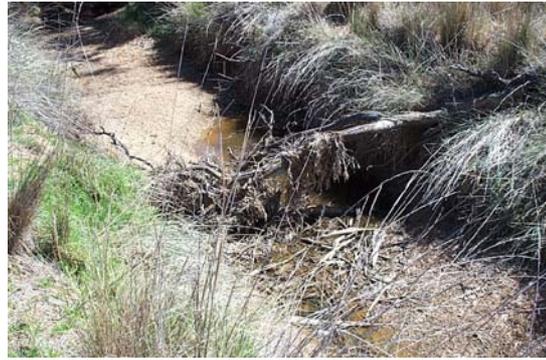
Figure 8: Sediment load in high value lower section of Reach 3

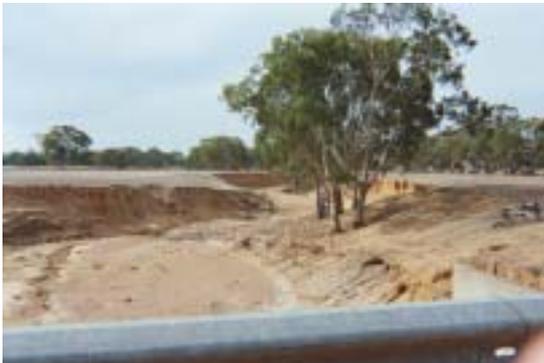
The upper section of the reach is typically 3 to 4 m deep, with a width of 10 to 15 m. The banks of the channel are vertical and the channel is sediment starved. The channel is checked from migrating upstream, due to a drop structure incorporated into Vineyard Road. Outer bank erosion is threatening Potters Road, due to its close proximity, height and inferred instability of the vertical banks. The lower part of the channel has a more natural form and does not have a bedload of sand and gravel that is commonly found in the higher reaches.

Figure 9: Over enlarged channel of Seven Mile Creek downstream from Vineyard Road

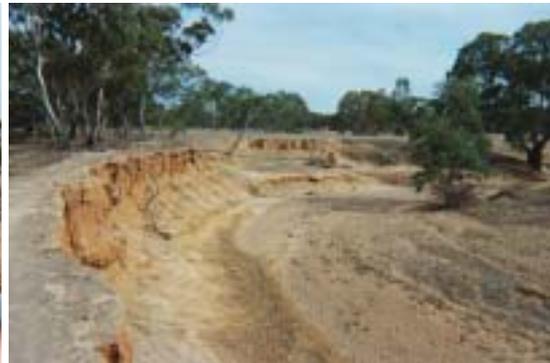
Figure 10: Outer bank erosion on Seven Mile Creek threatening Potters Road

<b>Reach 4</b>					
4.1	Fence and revegetate	2400	m	6.00	14,400	
4.2	Rock beaching to protect Potters Road				5,000	Requires survey and assessment
	<b>Reach 5</b>					
5.1	Repair drop structures if required				2,000	
5.2	Monitor drop structures	1	each	100	100	
5.3	Fencing and revegetation	5000	m	6.00	30,000	
	<b>Reach 6</b>					
6.1	Repair drop structures if required	8	each	1,500	10,000	Requires assessment
6.2	Monitor drop structures	8	each	100	800	
6.3	Fencing and revegetation	3000	m	6.00	18,000	
					<b>\$298,500</b>

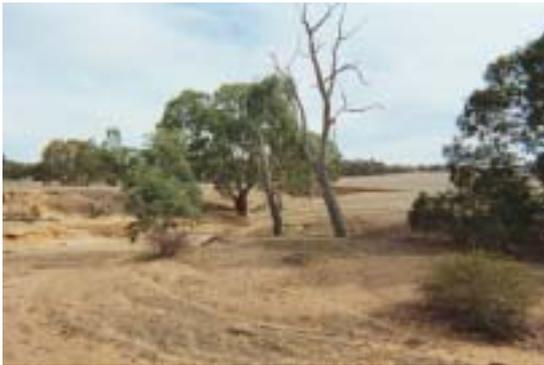
Figure 11: Seven Mile Creek in Reach 4

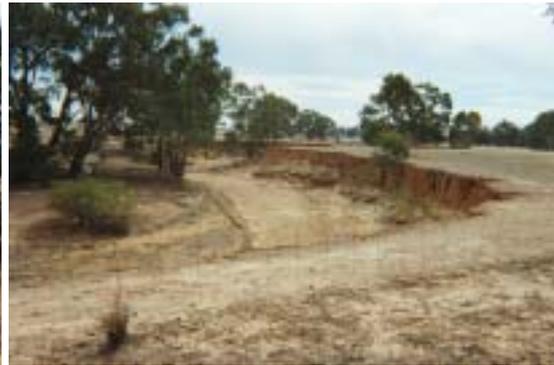
The water quality in this reach is generally poor. This is due to the poor state of the channel and the unfenced riparian zone that allows the stock access to the channel.

Figure 12: Enlarged channel & uncontrolled stock access to Seven Mile Creek, Reach 4

**Opportunity** - The restriction of stock and the introduction of vegetation will help to improve water quality in this reach.

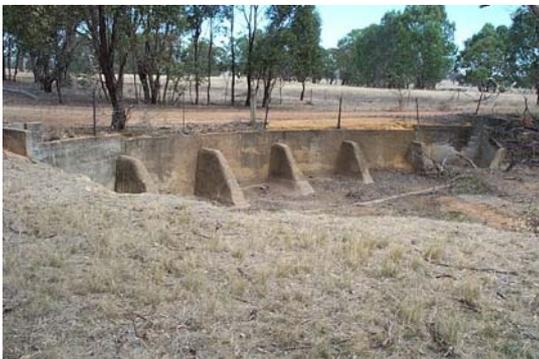
Figure 13: Structure on tributary of Seven Mile Creek at the corner of Martins Road and Potters Road

Management Actions	Priority for Works
Determine the condition of the drop structure on Martins Road and repair / maintain as appropriate.	Medium
Fencing and revegetate along creek to improve water quality, stream form and riparian ecology.	Medium
Monitor the condition of the drop structure on Martins Road.	Low

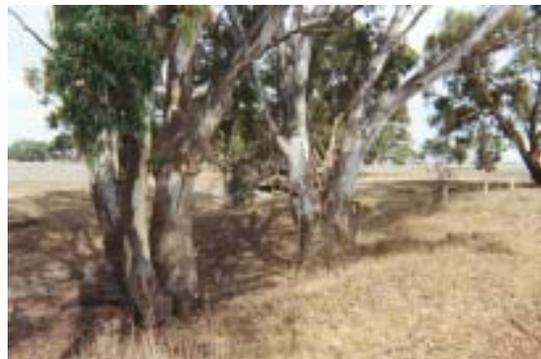
Figure 14: Wimmera River flood runner upstream from confluence with Seven Mile Creek

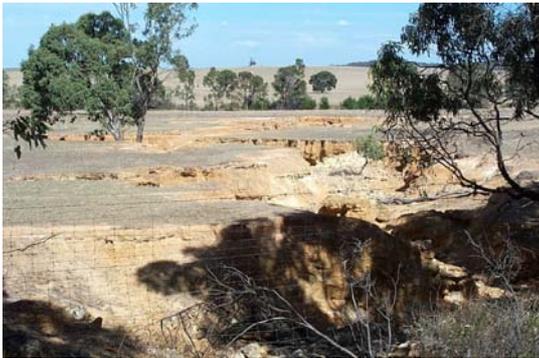
Figure 15: Eroding tributary of Surridge Creek

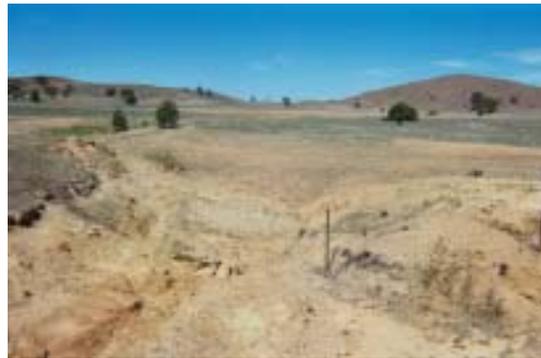
Surridge Creek has a satisfactory physical condition. The channel is recovering from past incision and excessive sediment loads. Sediment generation has been controlled throughout the catchment and now appears to be trapped and stored in the upper reaches by structures and in the lower reaches by vegetation.

Figure 16: Treated upper reach of Surridge Creek catchment

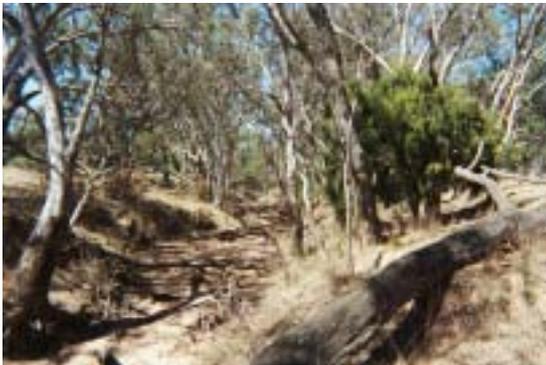
*Figure 17: High value section of Surridge Creek*

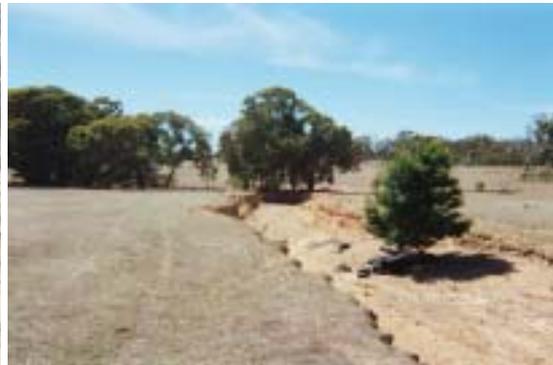
**Risk** of new erosion through failure of structures.

*Figure 18: Upper reach of Surridge Creek. Structures in this section under threat from uncontrolled stock access*

Management Actions	Priority for Works
Determine the condition of the drop structures and repair / maintain as appropriate.	Medium
Monitor the condition of structures throughout the reach.	Medium
Fencing and revegetation along creek to improve water quality, stream form and riparian ecology.	Low
