Wimmera
Catchment Management
Authority

Shays Creek Waterway Action Plan

November 2004

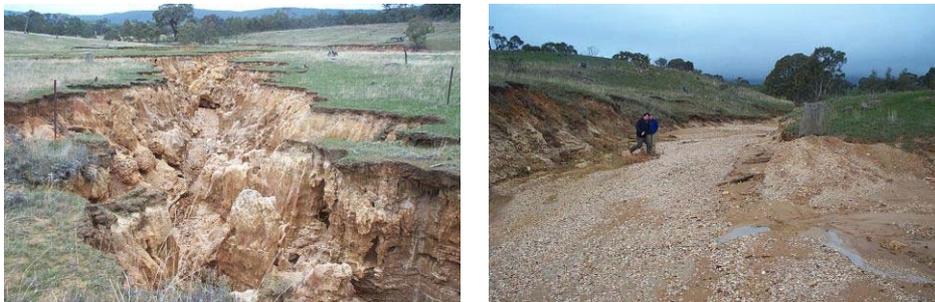
Reach 1 incorporates the steep slopes of the catchment headwaters and the main channel of Shays Creek. The majority of the gullies dissecting the steep hill slopes are deeply incised with the depth of incision decreasing upslope. There is evidence that a number of these drainage lines have been previously battered, however, some of these sites are undergoing a second phase of incision. At the base of the steep slopes the gradient is considerably flatter and here the floodplain acts as a sediment storage zone. At these locations sediment is deposited in large fans that have significant headcuts up to 2m deep extending back upstream. Due to the sodic nature of the soil in this area these active headcuts have a high potential to continue eroding.

Many of these gullies have not yet reached full depth of incision and only some have widened, therefore without treatment large volumes of sediment are likely to be exported from these eroding channels.

Figure 6. Photo left: deep incision occurring in the upper catchment. Photo right: sediment deposition in the downstream end of the main stem of Reach 1 (August 2004).

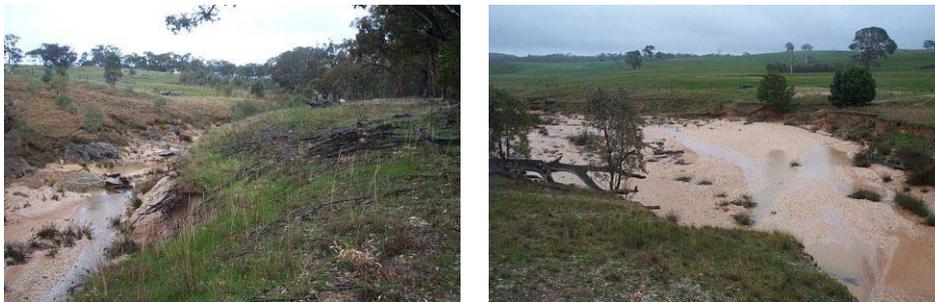
Approximately 1.3km downstream from the crossing with the Shays Flat-Malakoff Road, the valley widens, decreasing the channel confinement. The channel within the lower section of Reach 2 is over-widened, with some areas having maximum channel widths of 50m and depths of 2 to 3m. It is not obvious if this increase in channel width has been due to natural events causing erosion, or whether much of the reach has previously been part of a gravel extraction operation. However, the dramatic increase in channel width for the position in the catchment suggests that the latter may have been the case. Bars and benches are now re-forming in the channel bed and are slowly becoming colonised with native vegetation. In time, provided channel stability is maintained, these bars and benches will continue to aggrade. **This reach has a high potential to store large quantities of sediment in the channel zone as increased channel capacities allow for increased rates of sediment deposition.**

Figure 7. Photo left: Bedrock control of the channel and banks confining the channel in the upstream end of Reach 2. Photo right: Widening and sediment deposition in the downstream end of Reach 2 (August 2004).

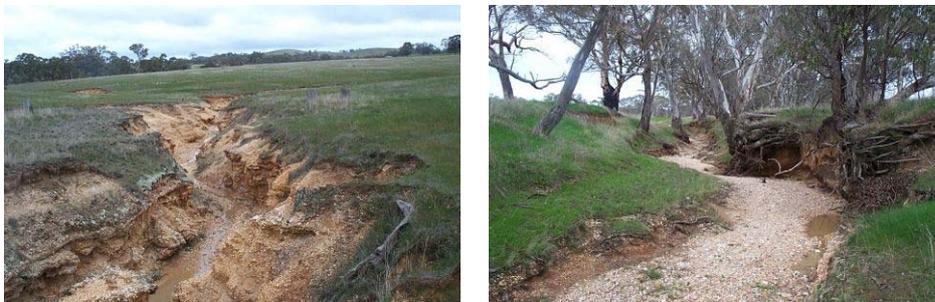
Sediment transport through this reach is low to moderate. In-stream vegetation has allowed gravel benches and bars to develop, which decreases sediment delivery to the main trunk of Shays Creek. The intact nature of the vegetation and the amount of natural regrowth that is currently occurring suggest that stock have been excluded from the channel zone throughout the entire reach. Towards the upper portions of the reach, however, large active headcuts threaten the remaining intact valley fill. These headcuts are approximately 3-4m high and have the potential to continue incising unless appropriate action is taken. The surrounding paddocks contain some of the best, most diverse remnant native grassland vegetation in the Wimmera region and are considered to be of very high value.

Figure 8. Photo left: Active erosion in the upstream end of the reach. Photo right: Sediment storage in the downstream end of Reach 3. Note the presence of stabilising vegetation (August 2004).

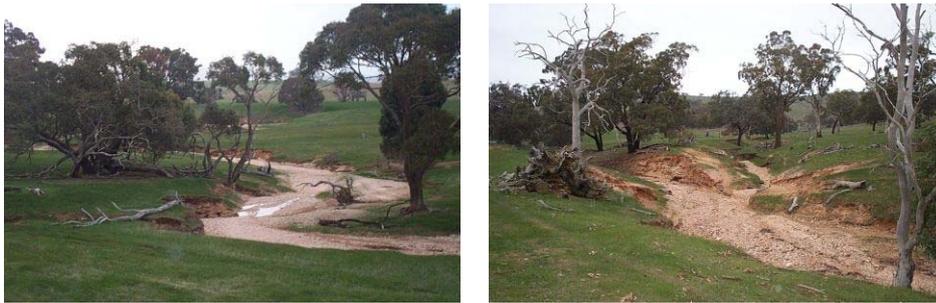
The main channel and a number of the tributaries entering Reach 4 have bare banks. These are actively eroding and depositing large quantities of sediment in the main channel. Some of these have previously been battered and sown with pasture. These areas are beginning to re-incise as the gully initiation process begins again. Numerous soil conservation works have been undertaken in Reach 4, however not all have been successful. Examples of works that show evidence of failure include contour banks and gully plug dams.

Figure 9. Photos showing sediment deposition in the flatter gradient area downstream of the steep hill slopes in Reach 4 (August 2004).

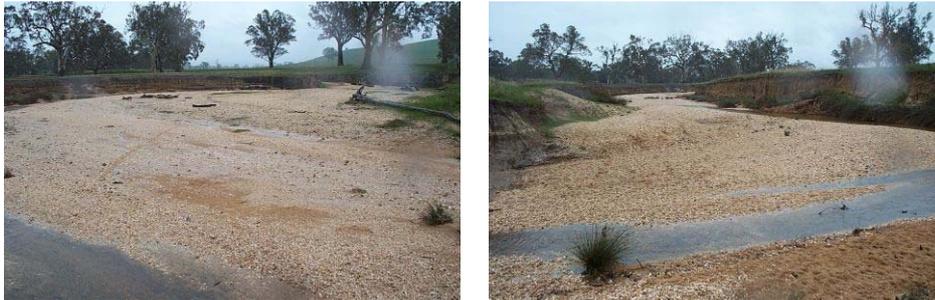
The channel at this location has moderate to high sinuosity, reflecting the decreasing valley gradient and increasing width. The channel is up to 60m wide in places while most of the reach is approximately 35m wide and 3-4m deep. Gravel bars and benches are present throughout and are slowly aggrading with the assistance of small areas of vegetation in the channel bed. In these areas the low flow channel has developed a moderate sinuosity between the gravel bars. Due to a lack of vegetation in much of the channel bed there is still a large proportion of actively mobile sediment. Bank erosion is active where no riparian trees exist.

Figure 10. Sediment aggradation in the flatter gradients of Reach 6. Note that this sediment is highly mobile due to a lack of stabilising vegetation in the over widened channel (August 2004).

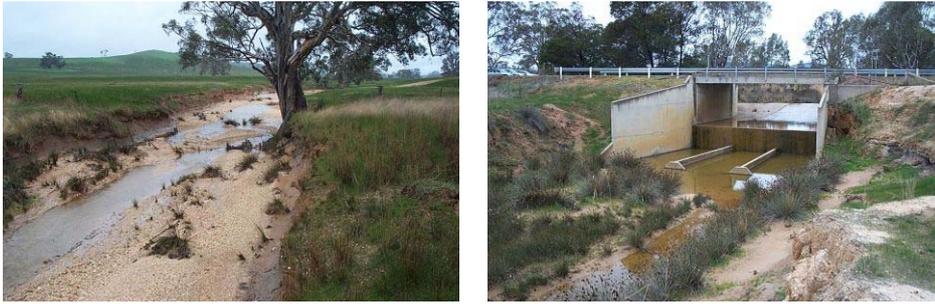
This process is also occurring upstream of a culvert/ford on Shays Flat Road. However, due to its small size, the extent of aggradation upstream of this structure is less than that caused by the structure on the Joel Joel -Crowlands Road. Below the Shays Flat Road crossing, the texture of the material in the channel has decreased from predominantly coarse gravel to fine gravel, sand and silt. Upstream of the Shays Flat Road, the sediment within the channel is predominantly sand and gravel that is still highly mobile due to the steeper streambed gradient.

Figure 11. Photo left: Sediment aggradation in the upstream end of Reach 10. Photo right: The drop structure on the Joel Joel – Crowlands Road crossing (August 2004).

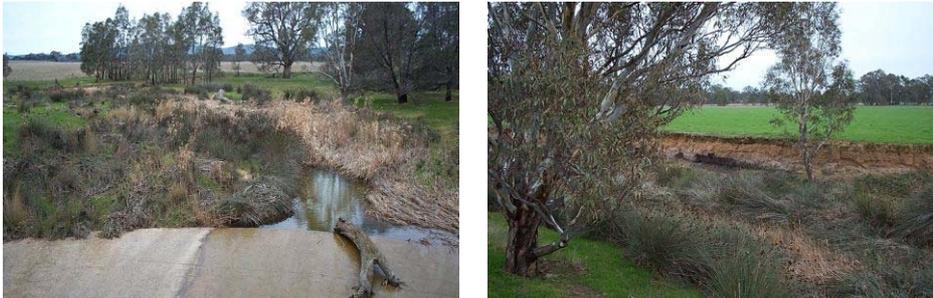
Downstream of the structure, the channel is very incised. Over the last 20 years, as the sediment above the drop structure has been retained, it has prevented large quantities of sediment from being deposited downstream. Approximately 0.5 - 1m of fine-grained sediment from the upstream catchment has been deposited over the floodplains of both Shays Creek and the Wimmera River. This sediment is most likely to be post European settlement alluvium as it has covered the existing organic-rich soil profile with sand and silt.

Figure 12. Photo left: The recovering channel on the upstream side of the Joel Joel – Crowlands Road drop structure. Photo right: The channel downstream of the drop structure with the bed stabilised by Spiny Rush (August 2004).
