Six Mile Creek Waterway Action Plan

Job 6003046

September 2003

Wimmera Catchment Management Authority

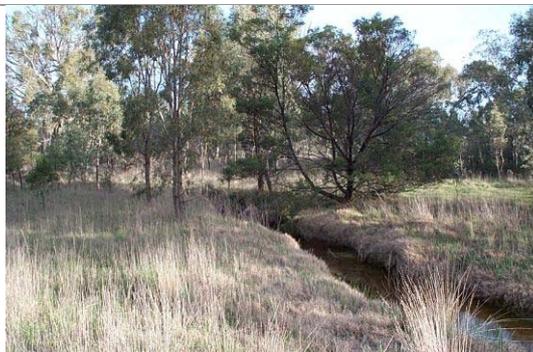
Figure 4: Reach 1

Upstream from Bulgana Road (Alluvial continuous 1). The physical form improves with improved riparian vegetation.

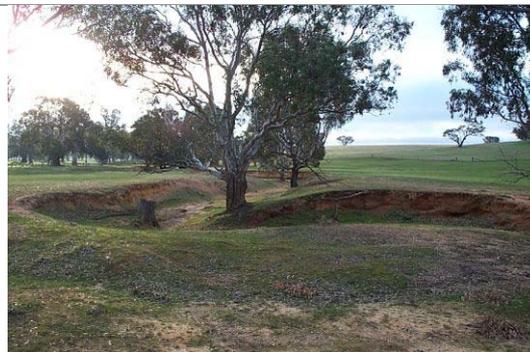
Figure 5: Reach 1

Most of the reach is within farmland and the upper sections are still recovering. (Alluvial continuous 5 in the photo)

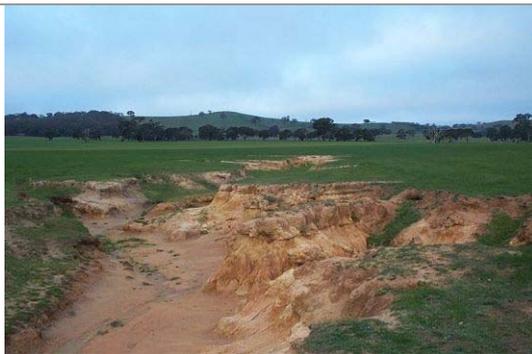
Figure 6: Reach 1

Stock access poses a minor threat to bank stability and the major risk to water quality.

Opportunity – Water quality could be improved by controlling stock access.

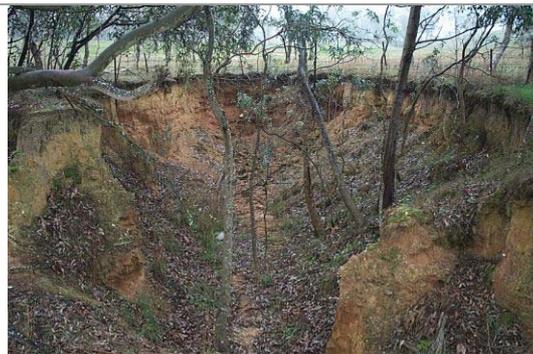
Figure 7: Reach 1

The channel gradient increases as the slope of the land increases towards the upper catchment. As a result, a number of small active erosion heads occur in the upper sections of the reach. These erosion heads should be treated as a priority.

Prompt action now to address the small erosion heads would mitigate the risks posed.

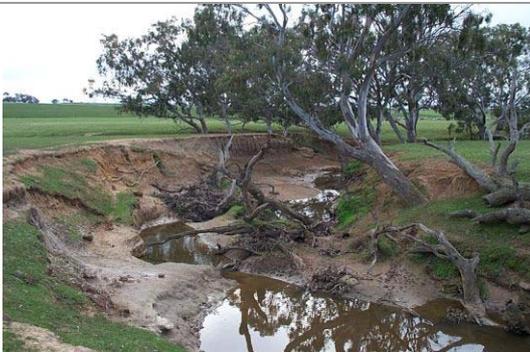
Figure 10: Reach 2

Instream habitat is improved through the occurrence of pools.

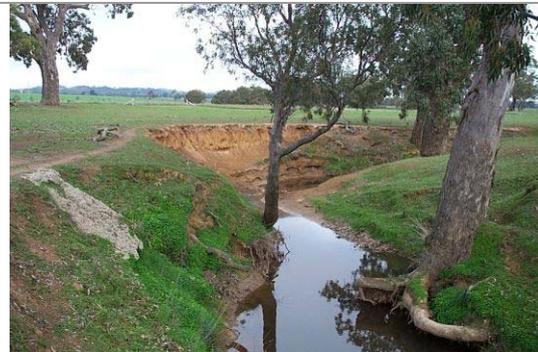
Figure 11: Reach 2

The surrounding land use is predominantly grazing. Consequently, there is a lack of regeneration.

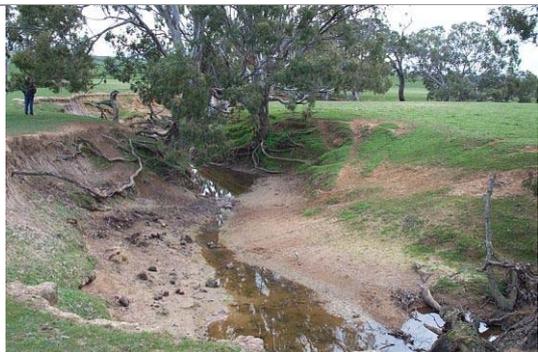
Figure 12: Reach 2

Stock access will continue to decrease water quality.

Opportunity – Control of stock would improve water quality.

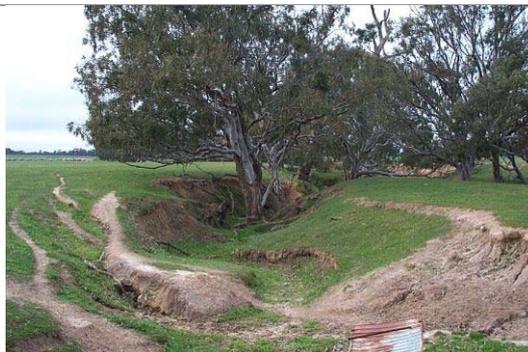
Figure 13: Reach 2

Grazing is affecting vegetation quality and regeneration.

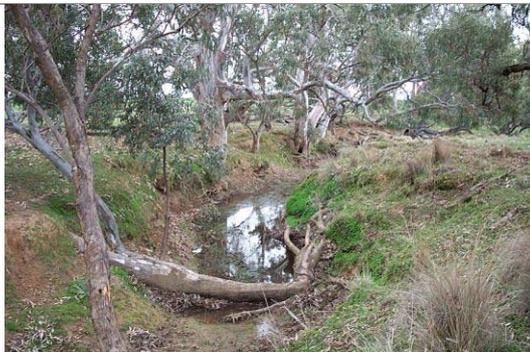
Figure 14: Reach 3

Large overstorey trees contribute significant amounts of debris and contain many hollows.

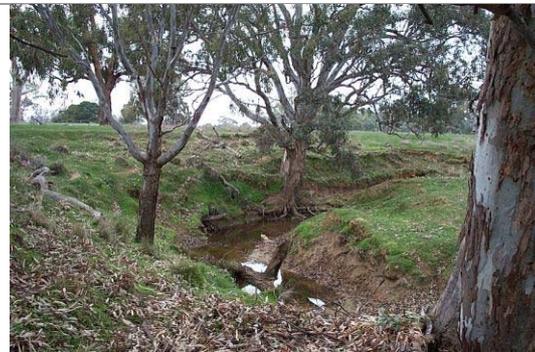
Figure 15: Reach 3

The channel has undergone historic incision and has recovered to a stable form.

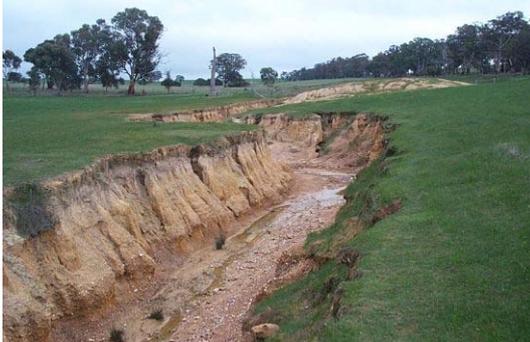
Figure 22: Reach 5

With large areas of uncontrolled stock access, poor riparian vegetation and some active erosion heads, water quality is expected to be poor.

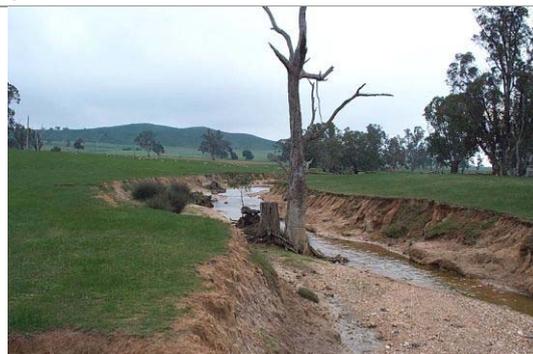
Figure 23: Reach 5

Overall, riparian vegetation in the reach is in poor condition.

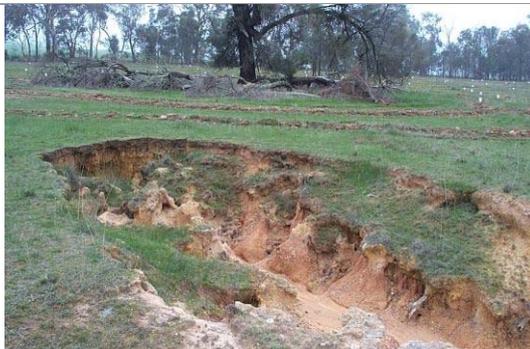
Figure 26: Reach 7

There are a number of small active erosion heads.

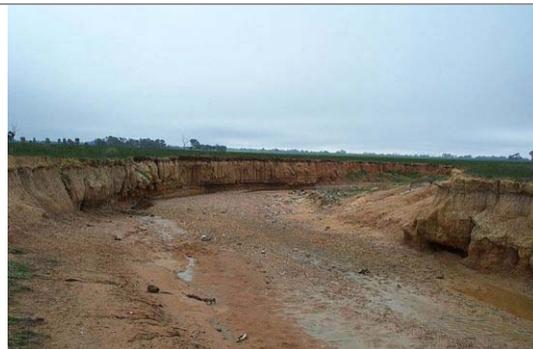
Figure 27: Reach 7

As stock have access and banks are actively eroding, water quality is expected to be poor.
