Wimmera River Reach 2 Waterway Action Plan

January 2003

Wimmera Catchment Management Authority

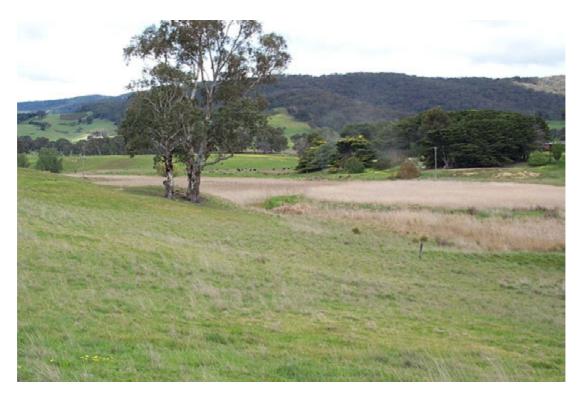
Figure 2 Typical Freshwater Meadow upstream of Pyrenees Highway

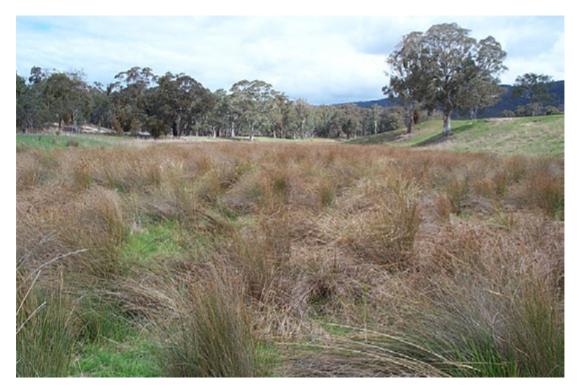
Figure 3 Upper section of Little Wimmera River in excellent condition

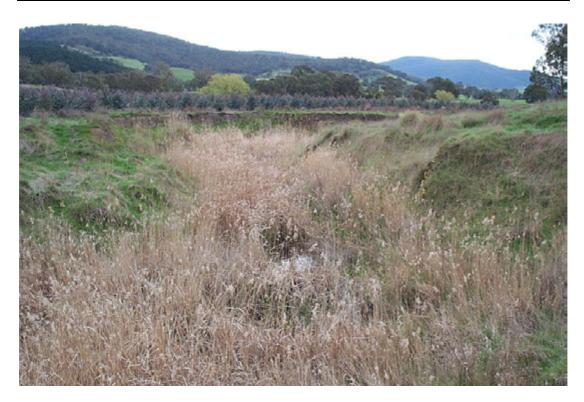
The creek, on private property, has incised up to three metres and more in some parts with vertical sides and localised instabilities. Previously active gully heads are currently stable and the creek itself is mostly stable. The biggest threat is from stock access and over grazing although a large portion of the creek is located within land used for tree plantations. Future logging operations may pose a threat if a vegetated buffer is not maintained between the logging and the stream banks. The main management objectives are to maintain creek stability and improve riparian vegetation to prevent impacts on downstream receiving reaches.

Figure 4 Tom the Tailor Creek, incised but stable - note plantation in the background

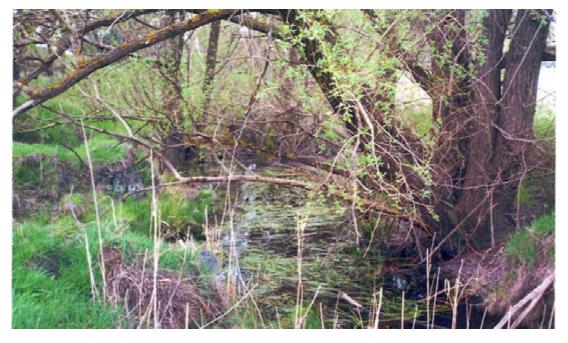
Immediately downstream of Hanging Swamp instream willows are growing almost to the confluence with Tom the Tailor Creek. The willows are effectively stopping the progression of further erosion heads from reaching the Hanging Swamp.

Figure 5 Willows holding erosion heads immediately downstream of Hanging Swamp

Recommended actions	Priority
Monitor and control, if necessary, erosion heads currently located among some willow roots	Medium
Poison and follow-up removal of willows and poplars through reach over approximately 400m.	
Install fencing on both sides of river to restrict stock access	
Fence out the left bank (400m) and repair damaged sections of the right fence	
Longitudinal bed survey	
Monitor erosion heads and implement stabilisation measures where required.

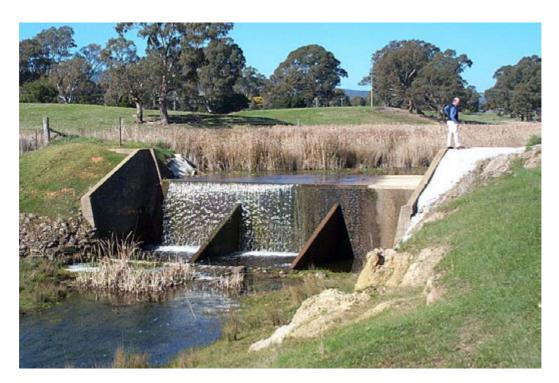
The end of the reach is defined by a drop structure upstream of the confluence of Hickman's Creek. The history of the structure is described above.

Figure 6: Drop structure on Wimmera River upstream of Hickman Creek

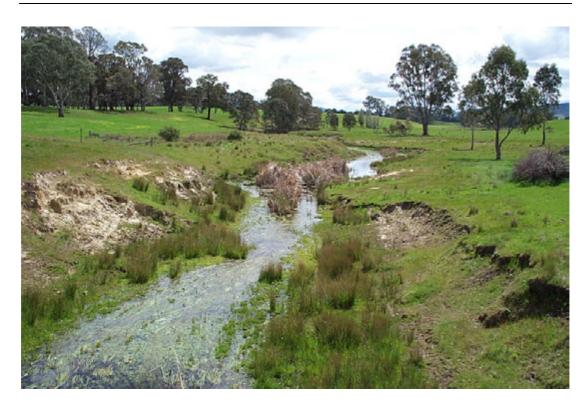
Figure 7 Looking downstream from concrete drop structure

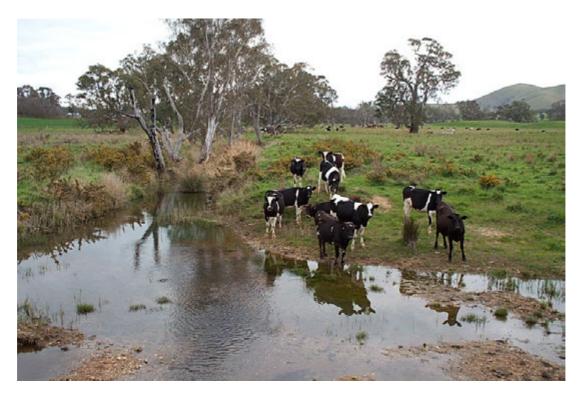
Downstream to the confluence with Glenlofty Creek the stream is incised with sediment in the streambed and banks are collapsing due to cattle access. Isolated Red gums appear along the banks and in the streambed. Gorse is beginning to take over in the riparian zone. Instream habitat is limited and water quality is very poor due to the sediment filled bed, cattle access and no LWD.

Figure 8 Gorse on banks and direct stock access at the downstream end of Reach 2

Recommended actions	Priority
Remove exotic vegetation from river in swampy section downstream of Rocky Creek confluence to 500 m upstream of Pyrenees Hwy (approximately 750m)	Medium
Remove exotic vegetation and fence left bank and revegetate both banks upstream of Pyrenees Hwy (170m)	Medium
Fence and revegetate right bank downstream of Pyrenees Hwy (470m)	
Remove exotic vegetation downstream of Pyrenees Hwy (470m)	
From Elmhurst Glenpatrick Rd Bridge to downstream property boundary of Eyrie Stud (ex deer farm)	Medium

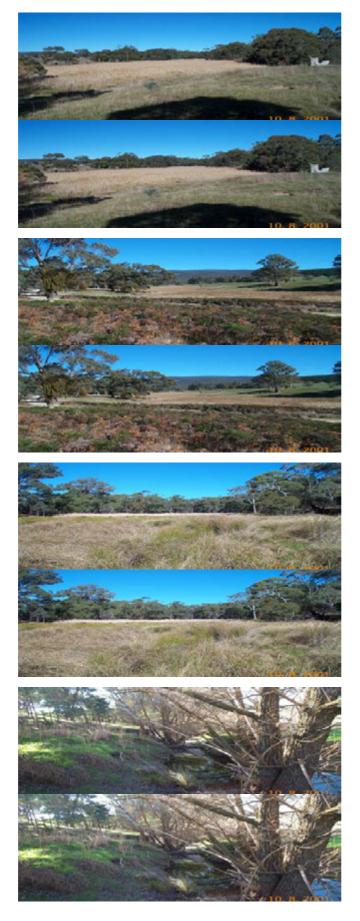
Plate 1 Wimmera River, Hanging Swamp looking upstream near downstream boundary
