## Wimmera River Reaches 3,4,5 & 6.1 Waterway Action Plan

- Final
- 4 August 2006

Wimmera  
Catchment Management  
Authority

Sinclair Knight Merz  
McGuigan Lane (rear of 153 Gray Street)  
Hamilton VIC 3300 Australia  
Tel: +61 3 5571 9535  
Web: [www.skmconsulting.com](http://www.skmconsulting.com)

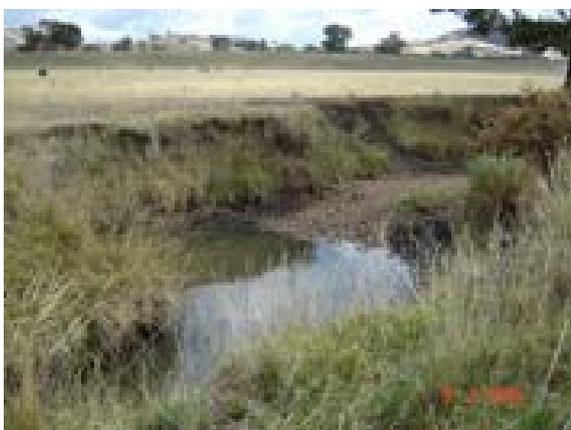
Generally, the mainstem may be regarded as stable except for extensive bank disturbance from uncontrolled stock access through the reach. This is exacerbated in places where the waterholes have been deepened by landowners to ensure access to the subsurface flows. It is interesting to note that the position of the River Red Gums in this reach, with the greater majority growing inside the channel margins with virtually none established on the verge, and all appear to be less than 100 years old.

■ **Figure 4-1 Broad floodplain at the upper end of reach 3**      ■ **Figure 4-2 River Red Gums growing inside that channel margins**

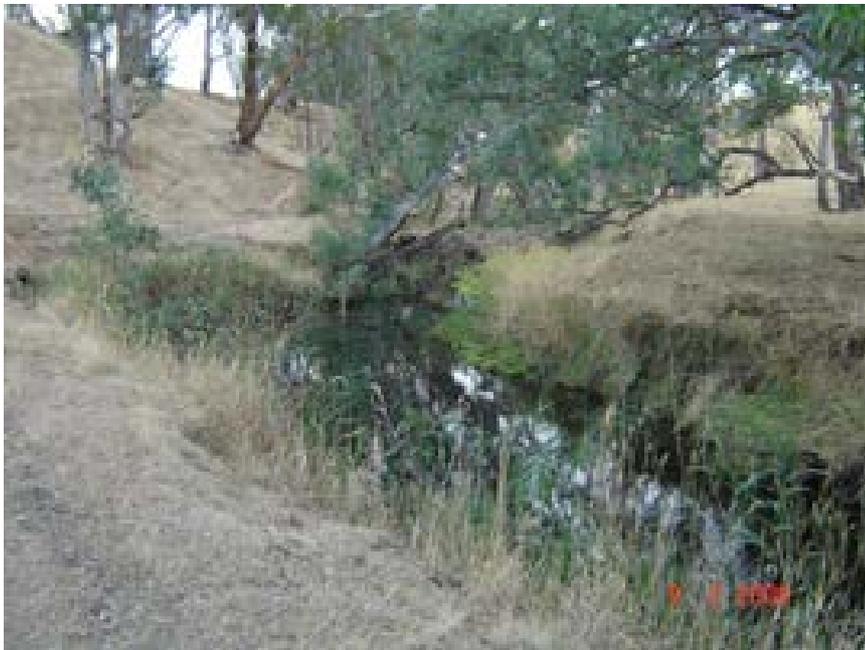
- **Figure 4-3 The first and most upstream valley choke near the Eversley gauging station**

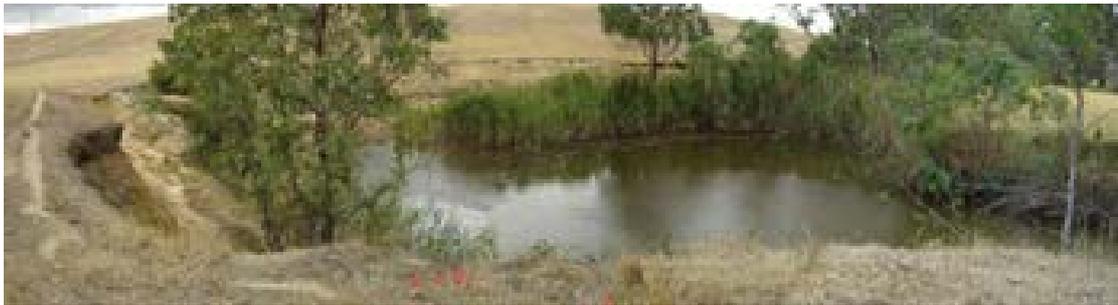
deepening and incision from the downstream reach (Reach 4) is in the process of migrating upstream through these rock controls. The sizes of some of the scour ponds at the upper end of the incisions are very large, indicating large energy transitions within the actively eroding portions.

■ **Figure 4-4 Excessively large channel capacity upstream of the Eversley-Crowlands Road bridge and immediately downstream of the second valley choke**

We recommend that the choke area is the subject of a detailed survey and hydraulic modelling, under a variety of flows, to quantify the stream power changes and potential rate of change in the channel. It is likely that a number of interventions (grade controls and controlled transitions of larger flows) will be required in this reach to prevent the channel from enlarging further with resultant loss of habitat values. Channel enlargement is also evident under the Eversley-Crowlands Road bridge with the abutment piers recently requiring structural support work.

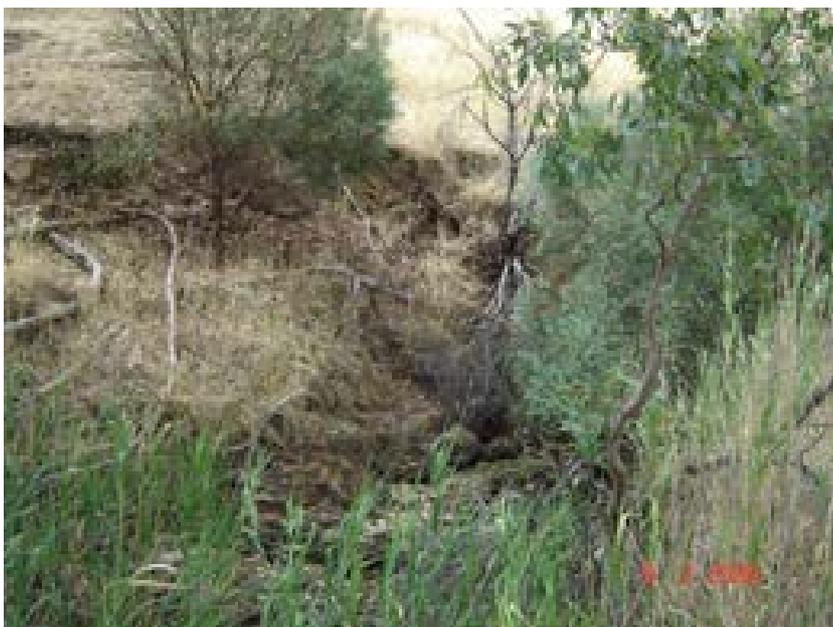
■ **Figure 4-5 Rock bars near the Eversley-Crowlands Road bridge are helping protect the second valley choke**

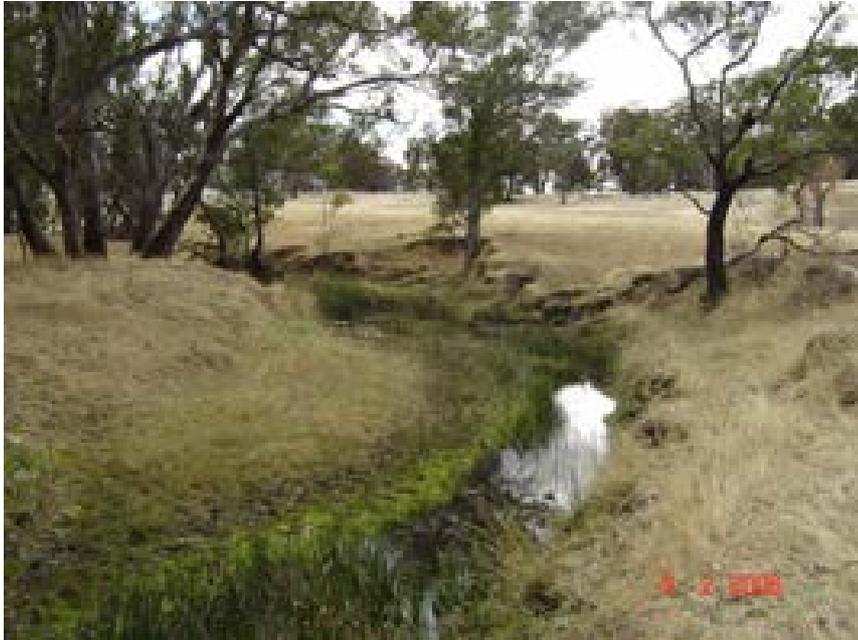
The majority of the streams length has uncontrolled stock access, which has resulted in the loss of native riparian vegetation, both in coverage and diversity. In-stream disturbances including erosion, salinity and sedimentation have accelerated riparian degradation in some areas. The provision of alternative water supplies for stock in conjunction with conservation fencing should be seen as a high priority for this reach and the Wimmera River in general. A revegetation program focussing mainly at the restoration of understorey should shortly follow.

■ **Figure 4-6 - Riparian vegetation at the valley choke near Eversley.**

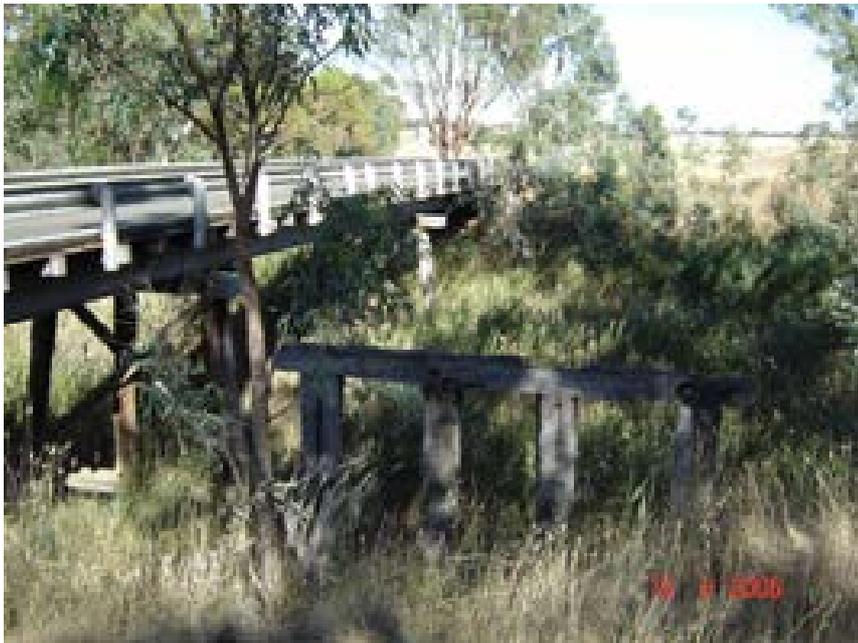
The only structural concern with respect to flooding was the Eversley-Crowlands Road bridge at the bottom of the reach where it can be seen that flood flows break across the eastern abutment and then back into the river downstream where the channel capacity is larger. A series of bank scours are observable at this location indicating serious over bank activity.

■ **Figure 4-7 - Eversley-Crowlands Road bridge.**

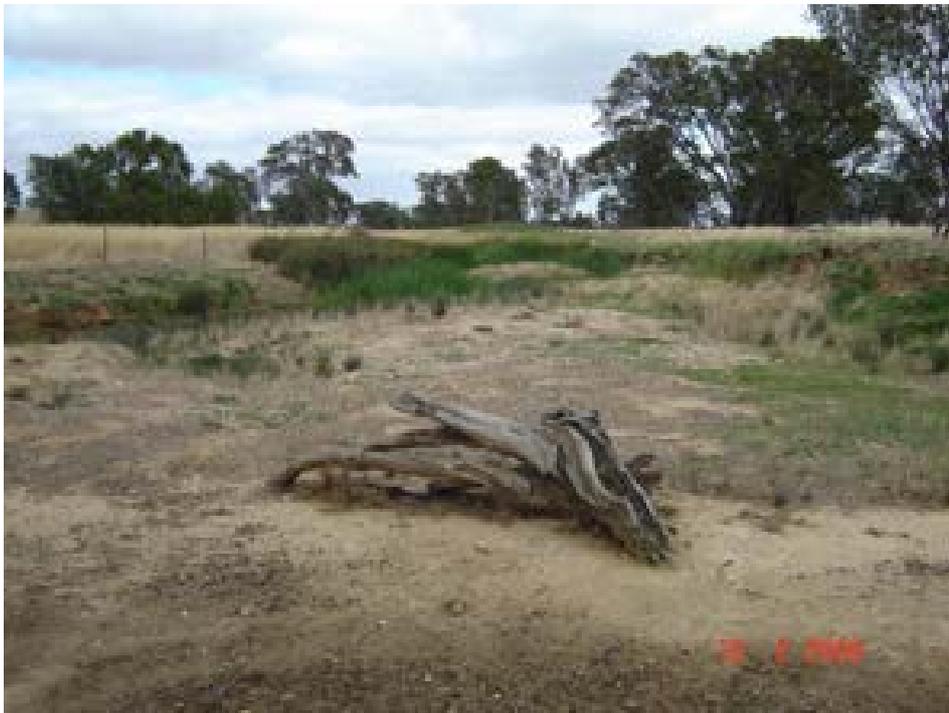
- **Figure 5-1 – Sediment deposition in the Wimmera River at the confluence with Spring & Tuckers Creeks.**

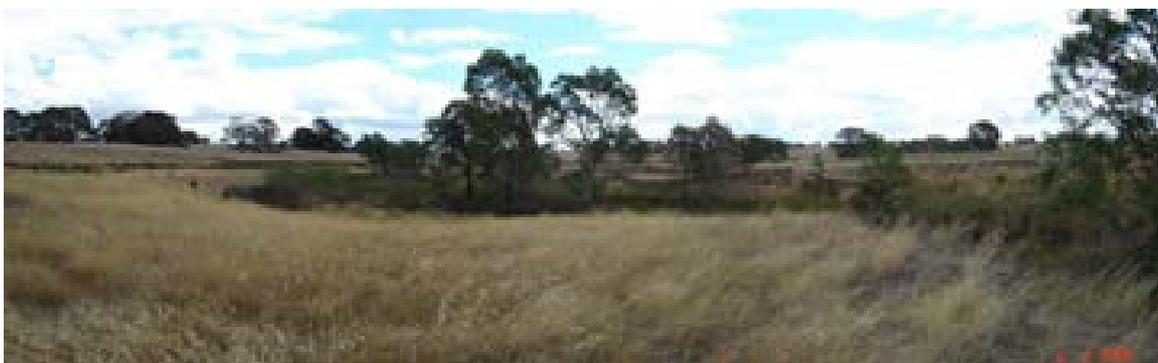
The stream has been modified since European settlement with the creation of a defined channel to interconnect the ponds and drain the floodplain. A number of old courses are visible in the current floodplain with many of these extensively colonised by Spiny Rush (*Juncus acutus*). The tributaries in this reach all enter from the left bank and are generally ephemeral. These have historically eroded into the slope but erosion activity is now slow and episodic. Both W4/1 and W4/2 show signs of past headward erosion with W4/2 being more active. Both streams exhibit relatively saline substrates and there is little vegetation on either bed or banks except for Spiny Rush. W4/2 needs to be monitored for erosion. W4/3 has active multiple head cuts which have been recently treated with car tyres. The same branch is also incised at its junction with the mainstem. The works recently done on the headcuts are unlikely to persist and should be monitored.

■ **Figure 5-2 An old course of the Wimmera River can be seen above, with the current and oversized channel located at the right of the picture**

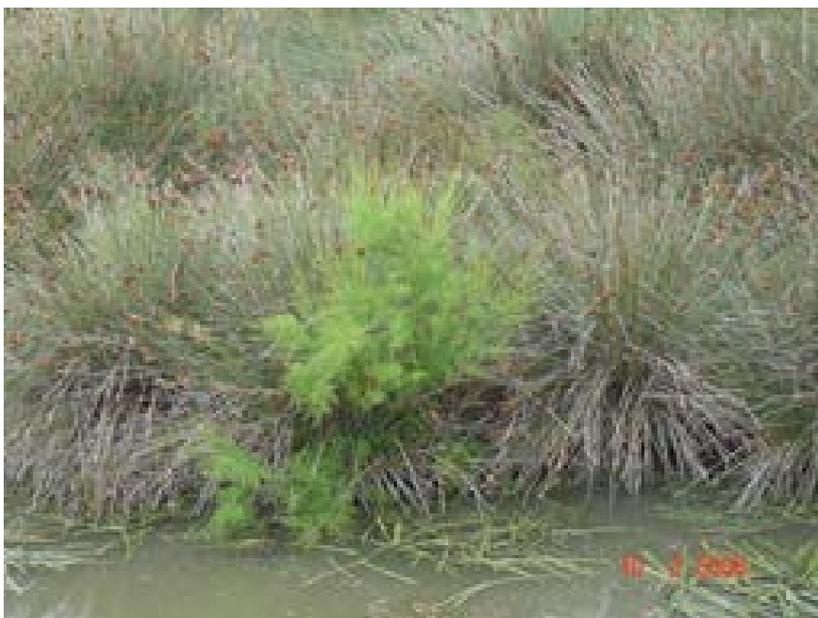
Stock access is generally unrestricted throughout the reach and this is affecting the recruitment of trees. The regeneration of River Red Gum is mainly confined to in-stream, where shallow and moist conditions have favoured germination.

- **Figure 5-3 - Tamarisk (*Tamarisk aphylla*) and Spiny Rush (*Juncus acutus*) can be found throughout Reach 4.**

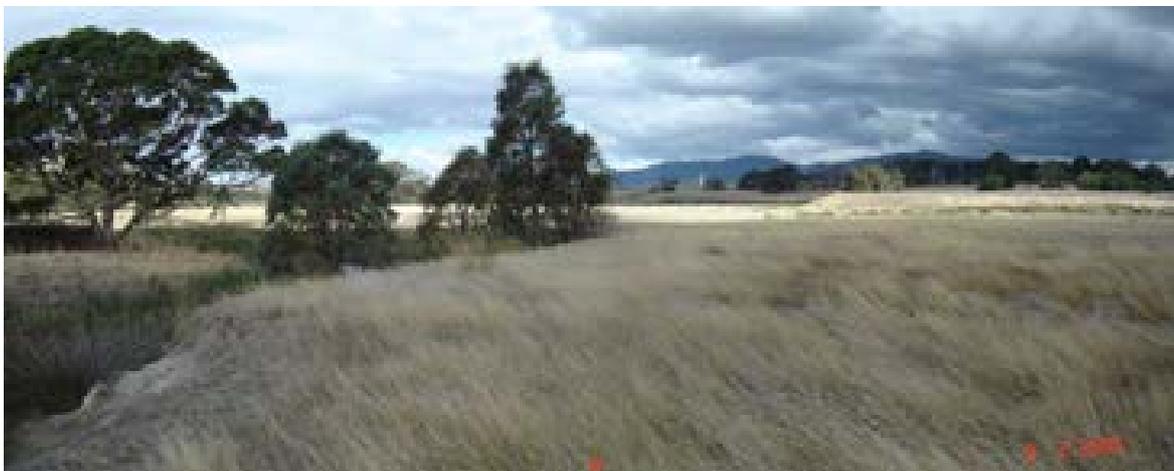
- **Figure 5-4 – Former Tulkara railway crossing (right) and typical stream characteristics throughout Reach 4.**

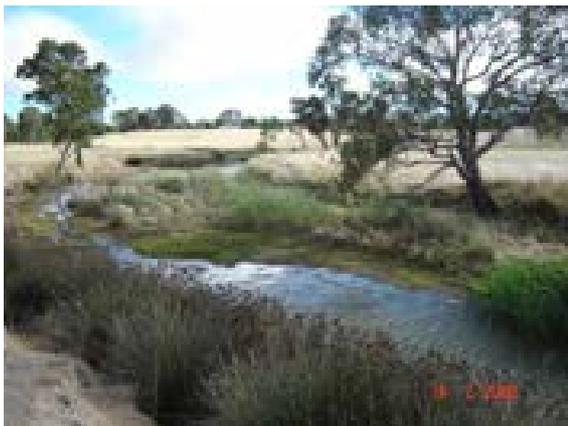
■ **Figure 6-1 Previous sediment removal site near Dunneworthy-Crowlands Road bridge**

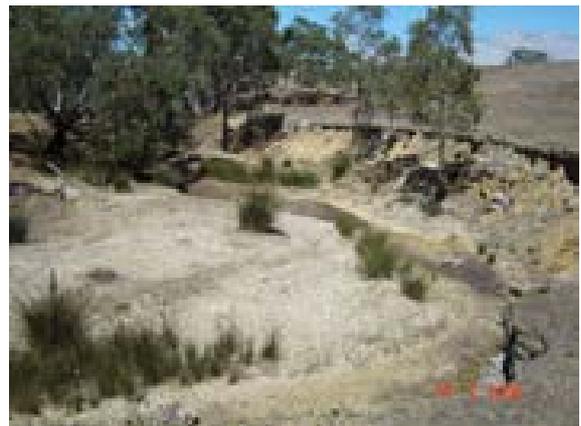
■ **Figure 6-2 Coarse bedloads are migrating through the Wimmera system**

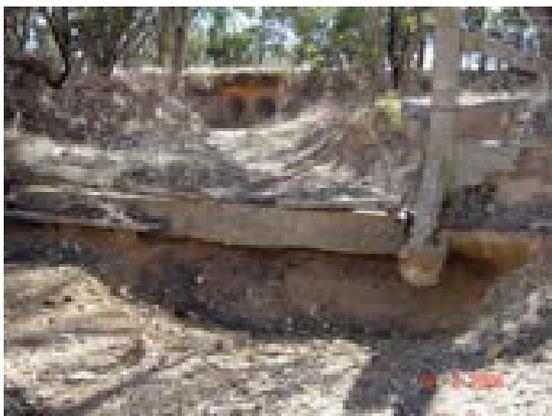
■ **Figure 6-3 headward erosion on W5/3/1/1 is undermining existing structures**

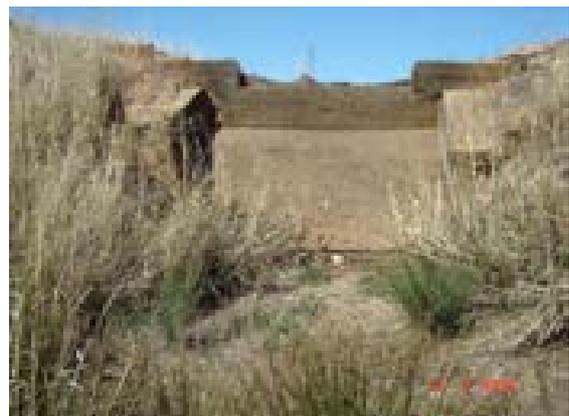
■ **Figure 6-4 Existing concrete drop structure on W5/3/1/2**

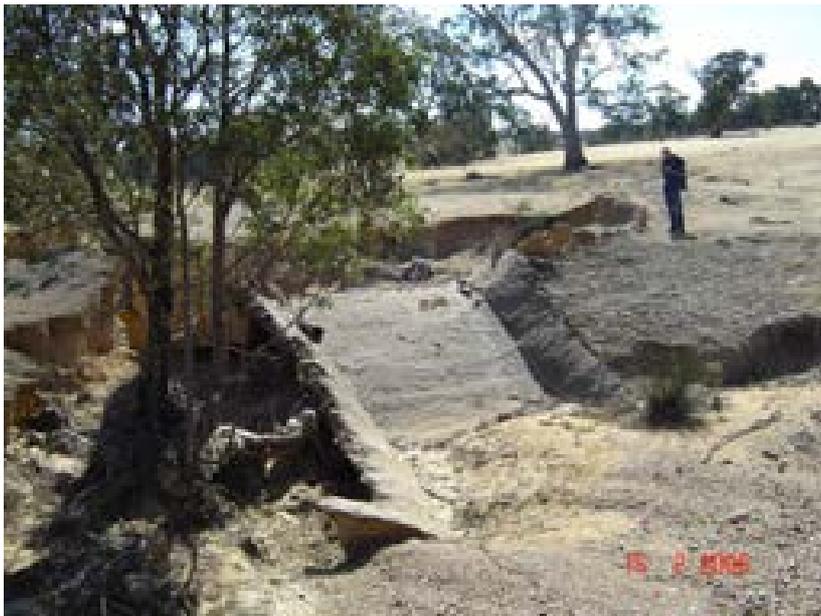
The unnamed tributaries W5/4, W5/4/1 and W5/4/2 are major concerns as these display very active bed and bank erosion downstream, upstream and west of Woodlands Road. The sediment from this erosion has little attenuation through the former swampy areas, although these could be readily reengaged to assist with the protection of the high value segments of the Wimmera River. The erosion in W5/4/1 is unabated and is very active following the total failure and undermining of the SCA style concrete chute about 500 m west of Woodlands Road. This failure has reactivated the headward erosion and a substantial amount of eroded material is being transported downstream.

■ **Figure 6-5 SCA style concrete chute on W5/4/1 has failed**

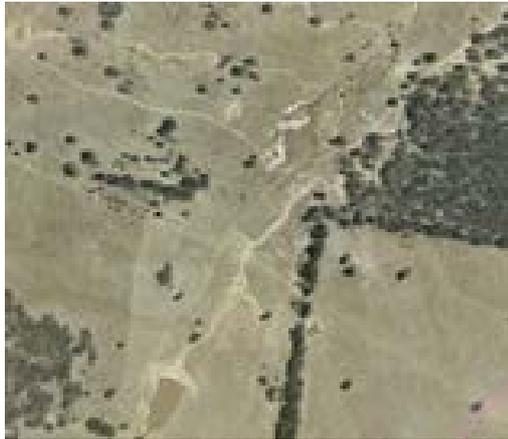
The longer W5/4/2 tributary is very serious and the most active of all erosion observed in this Wimmera River study area. High sediment and salt loads are generated by multiple incision and bank erosion processes along the channel. This is compounded by a series of very serious multiple headed gullies at the upper end near the foothill break of slope and further up those slopes. Valiant attempts of tree planting along the verge in the flatter valley areas have been made by some land owners, but little has been done to address the primary channel erosion problem along the whole length of the channel for a distance of nearly 4 km. The level of activity ranks as highly as that of

■ **Figure 6-6 Active erosion in W5/4/2 is threatening an upstream dam**

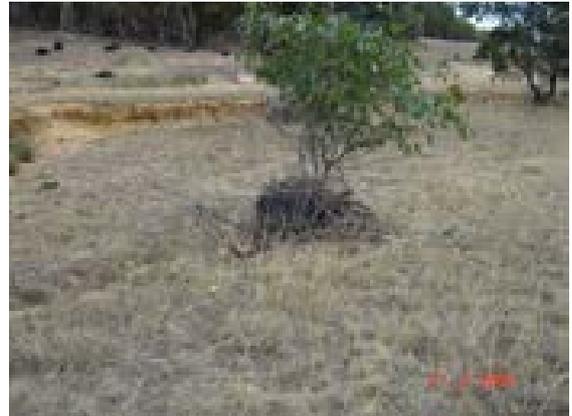
■ **Figure 6-7 Flood debris in W5/4/2 suggests that the catchment generates large flows**

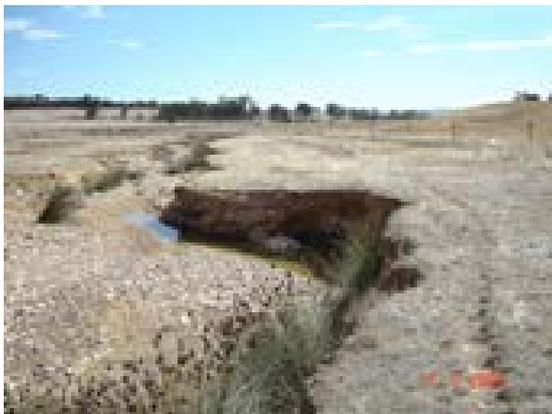
This area of stream has deteriorated in the last two years, with the gullies showing significant expansion after the 2004 aerial photography run. The generation of high loads of both coarse bedloads and fine suspended sediments is of high concern for the health of the Wimmera River, particularly given the lack of attenuation in any wetlands. Also of concern is the relatively recent construction of two gully plug dams, both of which can be seen to have overflow erosion problems, creating another potential point of erosion. The salt loads being generated in this catchment are very high and there is a serious infestation of Spiny Rush along most of the stream. Only a few sparse Grey Box and River Red Gums exist along the verge.

■ **Figure 6-8 high salt loads and eroding bed and banks in W5/4/2**

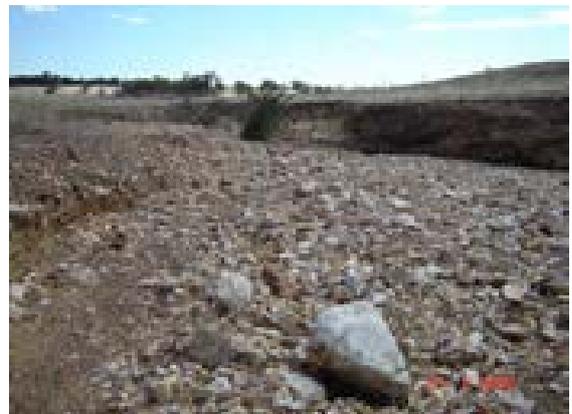
■ **Figure 6-9 Coarse bedloads are being transported from W5/4/2 into the Wimmera River**

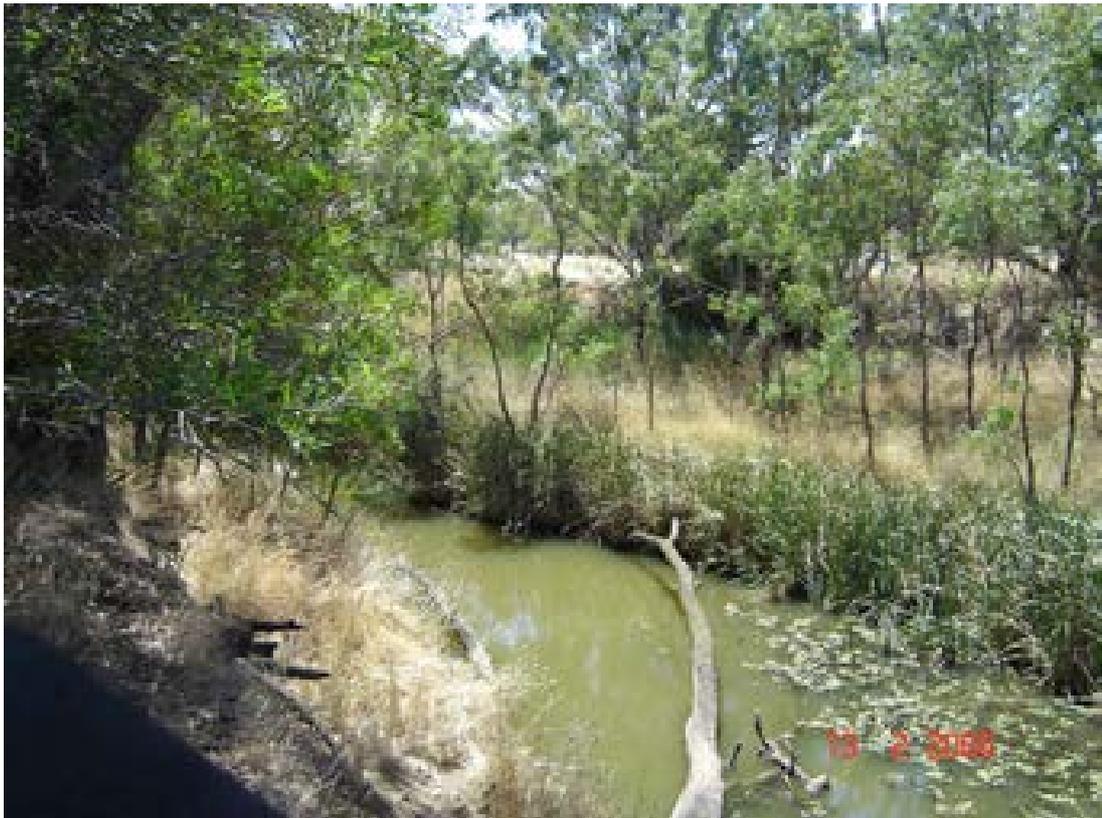
■ **Figure 6-10 Riparian and in-stream vegetation south of Bulgana Road**

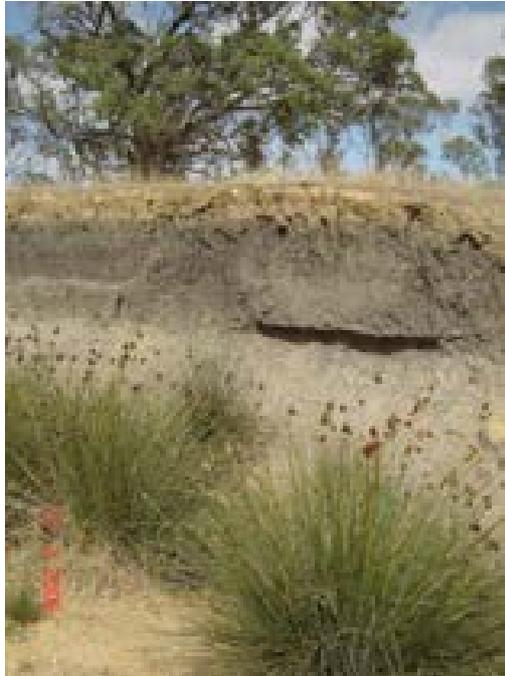
The current floodplain is lower than the former floodplain and consists of very old deposits that are resistive dark silty clays. The upper stratum is some 0.5m thick and consists of post settlement alluvium (PSA) of light coloured fine silty clays and sands (refer to Figure 7-1). This PSA is likely to have been sourced from large exports predominantly from both Shays and Glendhu Creeks, but contributions from other catchments such as Mt Cole Creek would have also impacted.

- **Figure 7-1 Post-settlement alluvium (PSA) layer of brown sands and silt are distinct throughout this reach.**
- **Figure 7-2 Straightened section of the Wimmera River with young River Red Gums and a lack of woody debris.**

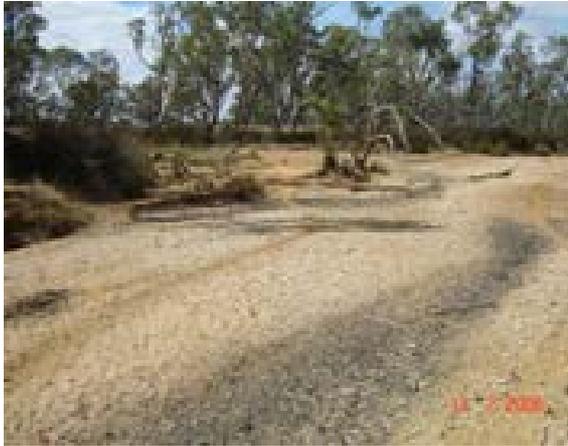
The sediment load from Glendhu Creek has resulted in a large deposit at the Wimmera River junction. Indeed, deposition of material transported down Glendhu Creek, along with finer material from Shays Creek, can be seen to impact over the whole reach. Few ponds remain along this reach, due to the instream deposition and flow is now often conveyed through the bed material. To counter this, some landowners have dug stock waterholes into the bed of the river. The loss of the deep ponds represents a significant loss of channel diversity and high quality habitats. The deposition process is still quite active and the whole cut and fill process is dynamic and likely to impact on this reach and other downstream areas for a long time.

- **Figure 7-3 Coarse sediments entering the Wimmera River at the junction with Glendhu Creek.**
- **Figure 7-4 Ponds are being infilled with coarse and fine sediments**

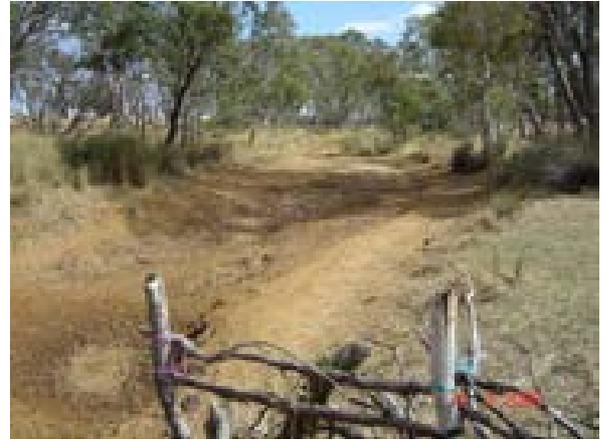
The impact of this sediment load on the channel is marked with large overbank drapes plus bed deposits and point bar development. These infill areas are colonised by Phragmites and also a generally young age class of River Red Gums. The River Red Gums appear to be about 40-50 years old indicating that channel disturbances and or the infill process occurred in the wet sequence after WW2. Interestingly, there is generally a very low presence of large woody debris indicating a history of desnagging along the channel.

The control of stock access would allow vegetation cover to re-establish and slow the current dynamic nature of adjustment processes. Fencing along with provision of alternate watering systems should be investigated. Importantly, however, there is little available data on the channel geometry (or its change over time) and a series of geomorphic monitoring sites should be established to help inform appropriate management responses.

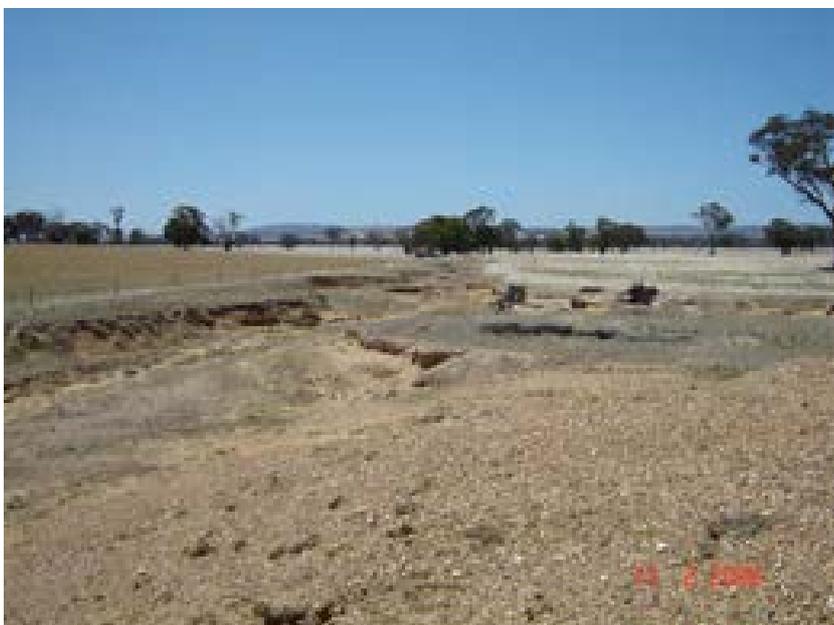
■ **Figure 7-5 Channel incision and erosion along W6.1/2**

The same array of responses will be required in W6.1/3 but the scale of response required, is far lower.

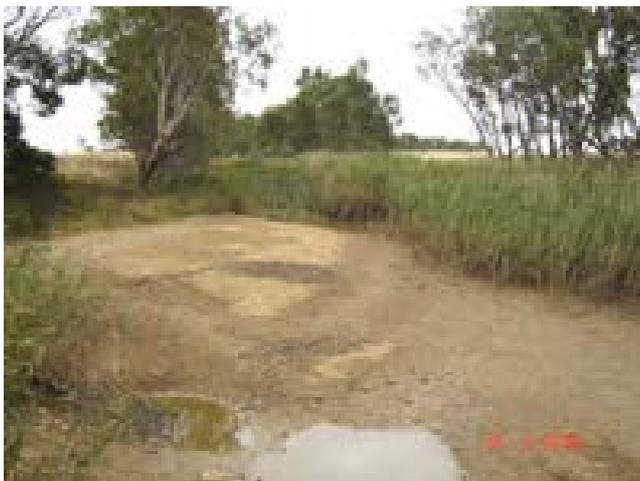
■ **Figure 7-6 - Large sediment deposits have provided ideal growing conditions for Phragmites**
