Regional Flood Mapping Lower Wimmera – Hydraulics (R03)

January 2017

Project Name	Regional Flood Mapping - Lower Wimmera
Client	Wimmera CMA
Client Project Manager	Abdul Aziz
Water Technology Project Manager	Ben Tate
Report Authors	Tim Cooke/Ben Hughes/Ben Tate
Job Number	3795-01
Report Number	R03
Document Name	3795-01_R03Final_Hydraulics.docx

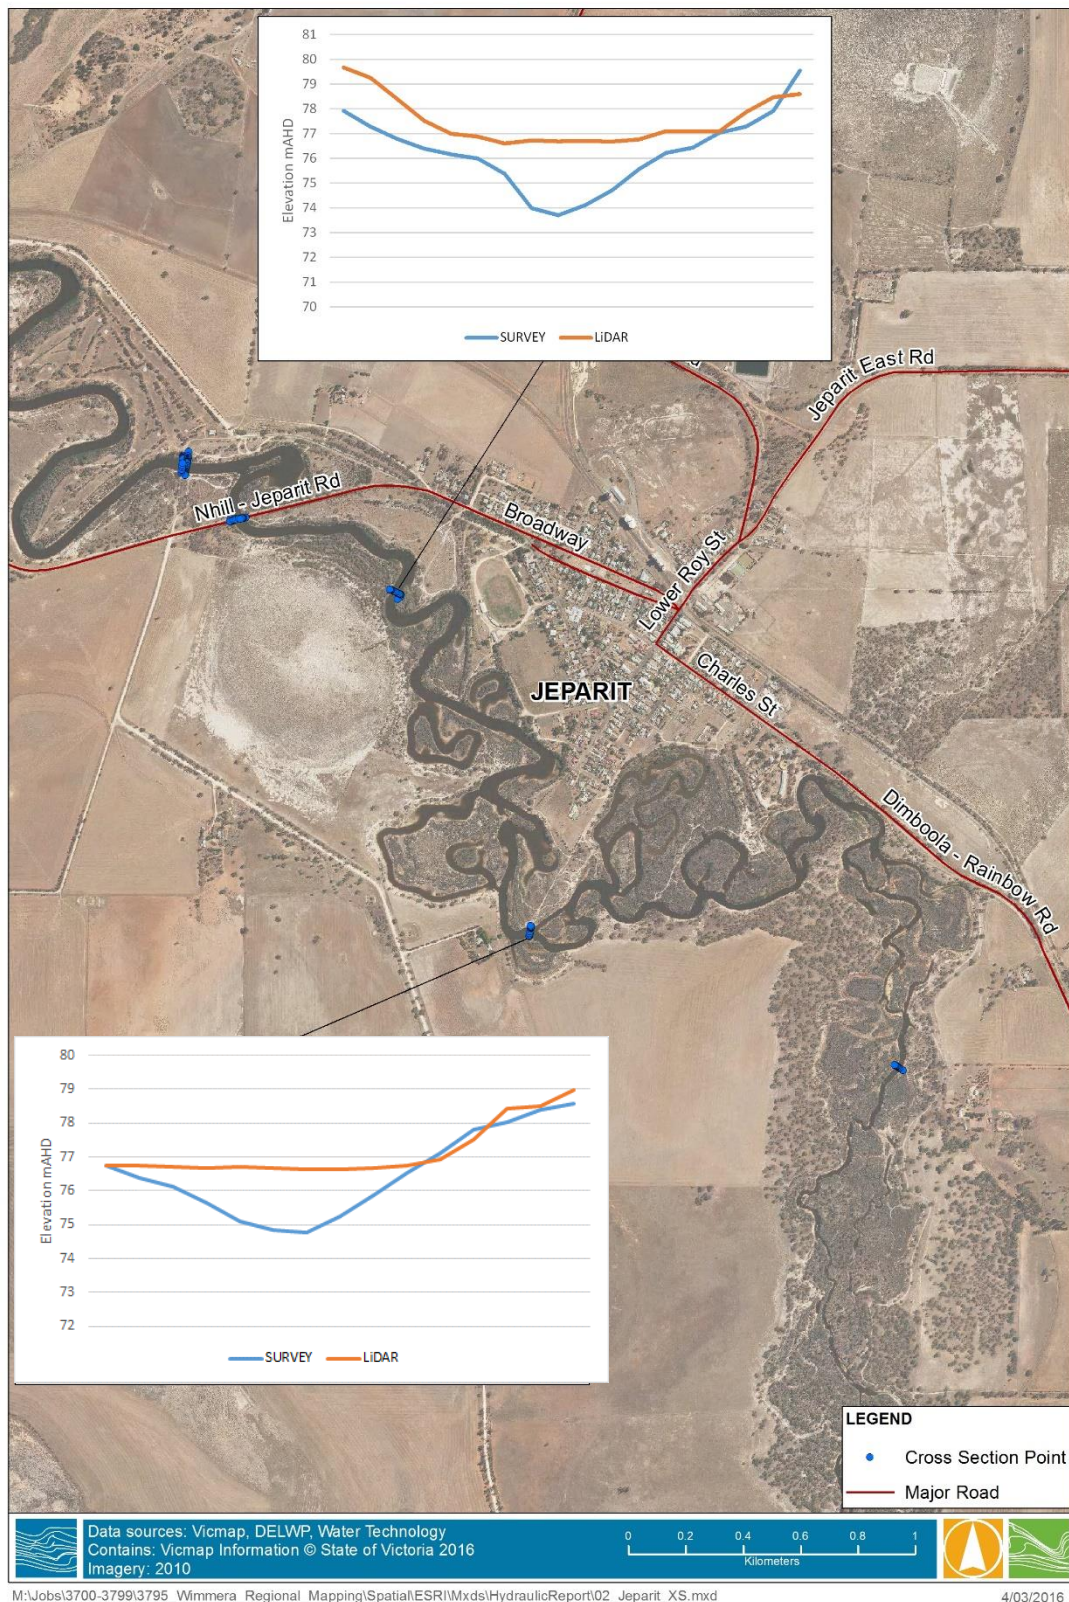
Figure 3-2 Wimmera River cross section – Survey, LiDAR data and corrected model topography comparison

To ensure the river bed was represented within the topography the relevant elevations within the model mesh were lowered from the original LiDAR values to represent a linear interpolation of river bed level between, and including the lowest point of each survey cross section.

After adjustment of the river bed level upstream of Jeparit Weir, comparison to the LiDAR downstream of Jeparit Weir also suggested the LiDAR was also detecting the water surface level. To resolve this the river bed level between Jeparit Weir and Lake Hindmarsh was lowered to match survey-adjusted levels upstream of the weir.

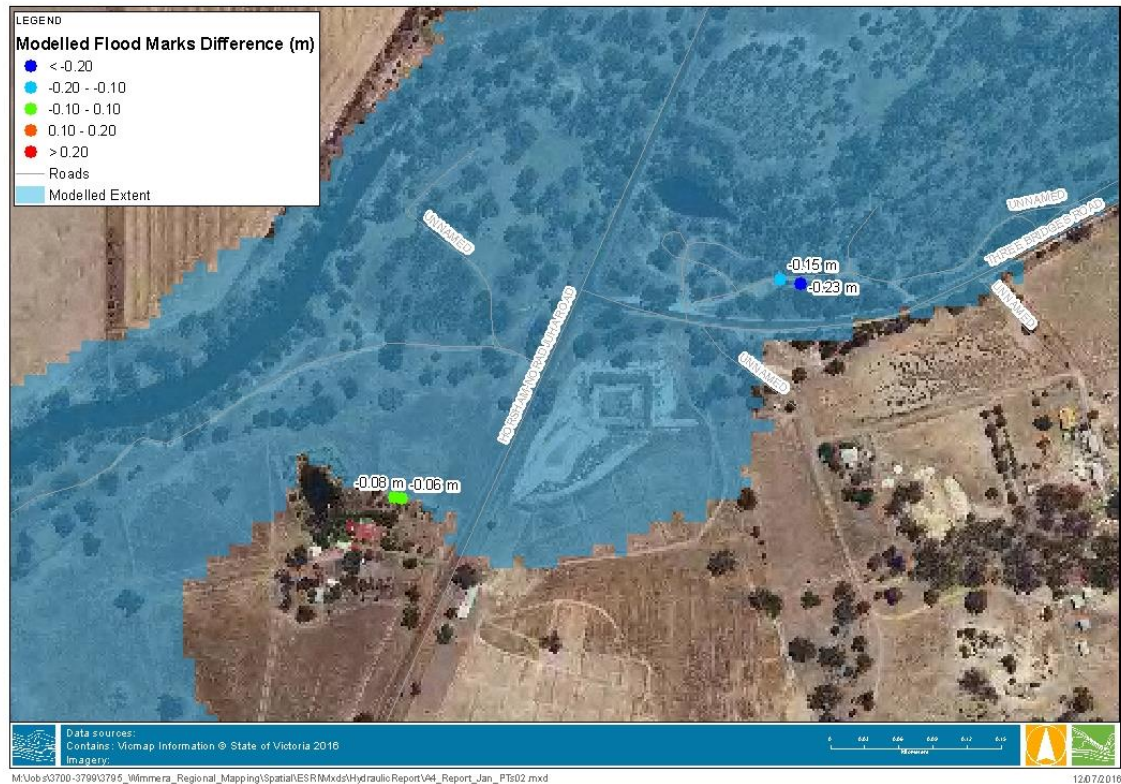
Figure 4-2 Modelled minus observed flood levels, points greater than 200mm – January 2011

33 surveyed peak flood heights were recorded by Wimmera CMA post the January 2011 event. A comparison between the peak hydraulic model water levels and surveyed flood heights showed an excellent match, with the modelled water levels within 100 mm of the surveyed flood levels at 20 of the 33 points. A further 10 points showed modelled peak water levels within 200 mm of that surveyed. The locations of the survey marks with the surveyed and modelled water level comparison is shown in Figure 4-1. The remaining three points with a greater than 200 mm difference between modelled and surveyed water levels were located off Three Bridges Road and north of Polkemmet. These points are further discussed in Table 4-1 and shown respectively in Figure 4-2 and Figure 4-3.
