Warracknabeal and Brim Flood Investigation – Final Report

July 2016

Project Name	Warracknabeal and Brim Flood Investigation
Client	Wimmera CMA
Client Project Manager	Clare Wilson
Water Technology Project Manager	Ben Hughes
Report Authors	Ben Hughes
Job Number	3532-01
Report Number	R04
Document Name	Final Report

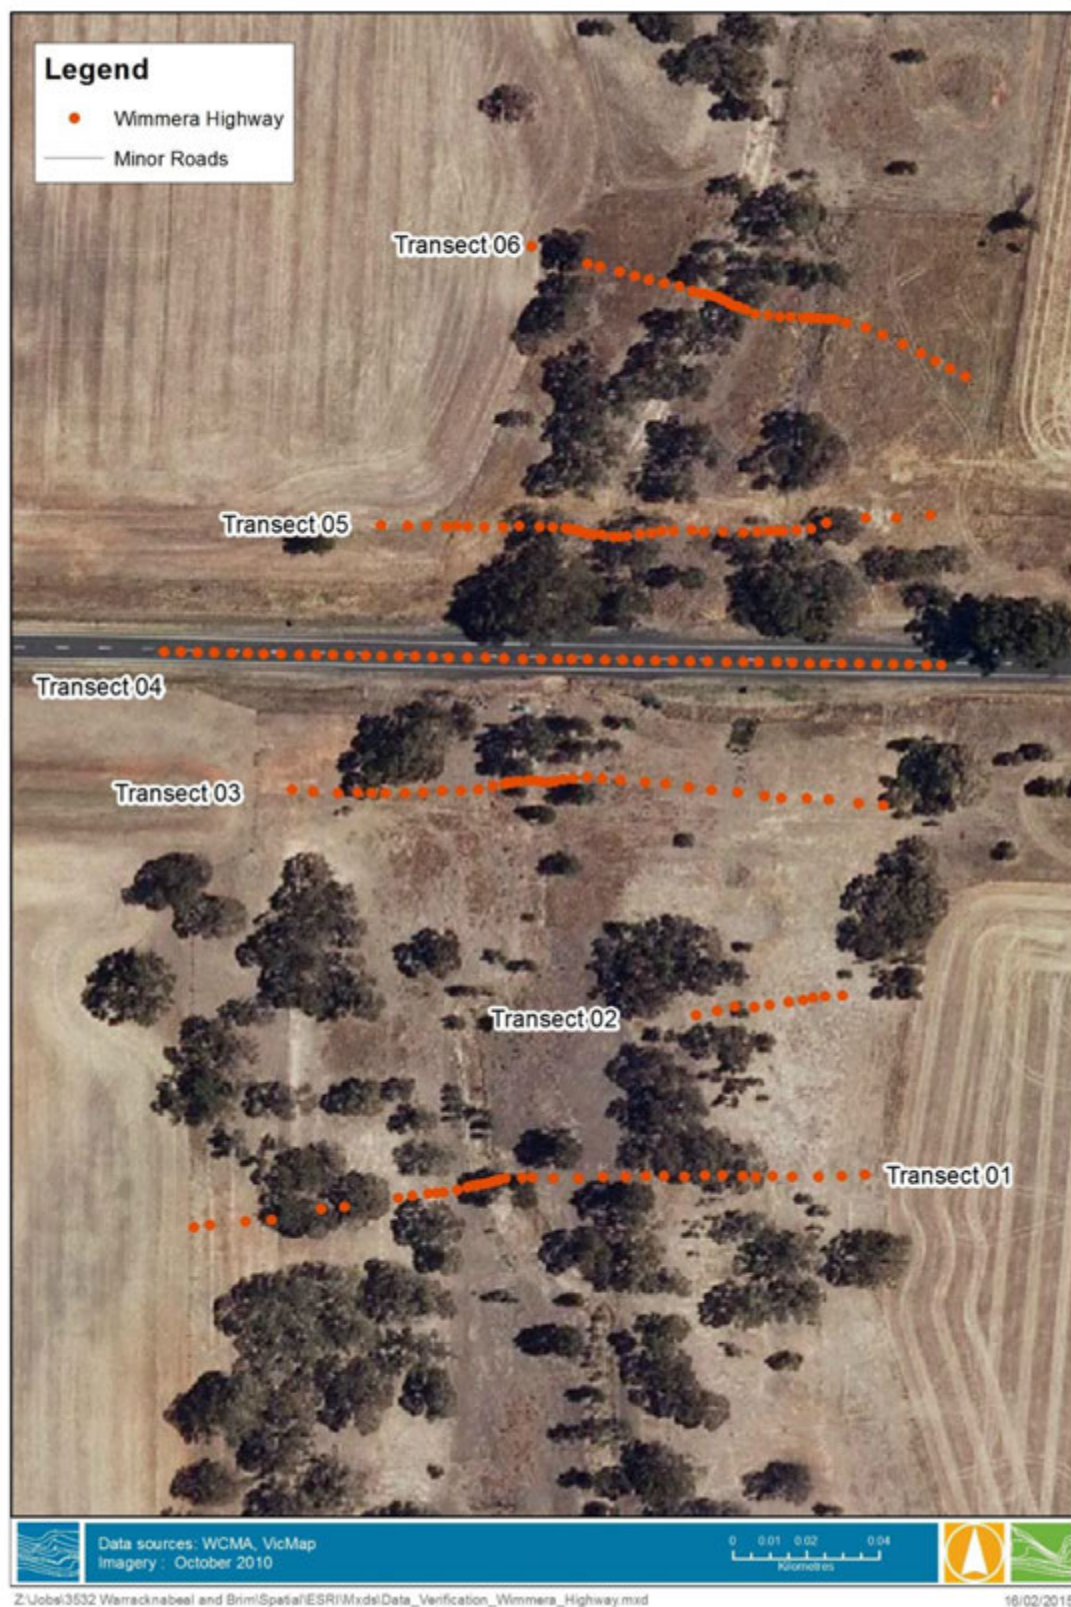
Figure 5-7 Wimmera Highway transect locations

The topographic comparison at the Wimmera Highway and the waterway transects show the 2010 LiDAR to be consistently higher than the survey and the 2005 LiDAR. It also shows a lack of Yarriambiack Creek channel definition in the 2010 LiDAR, indicating the presence of water when the LiDAR was flown. The 2005 LiDAR compares well to the survey.

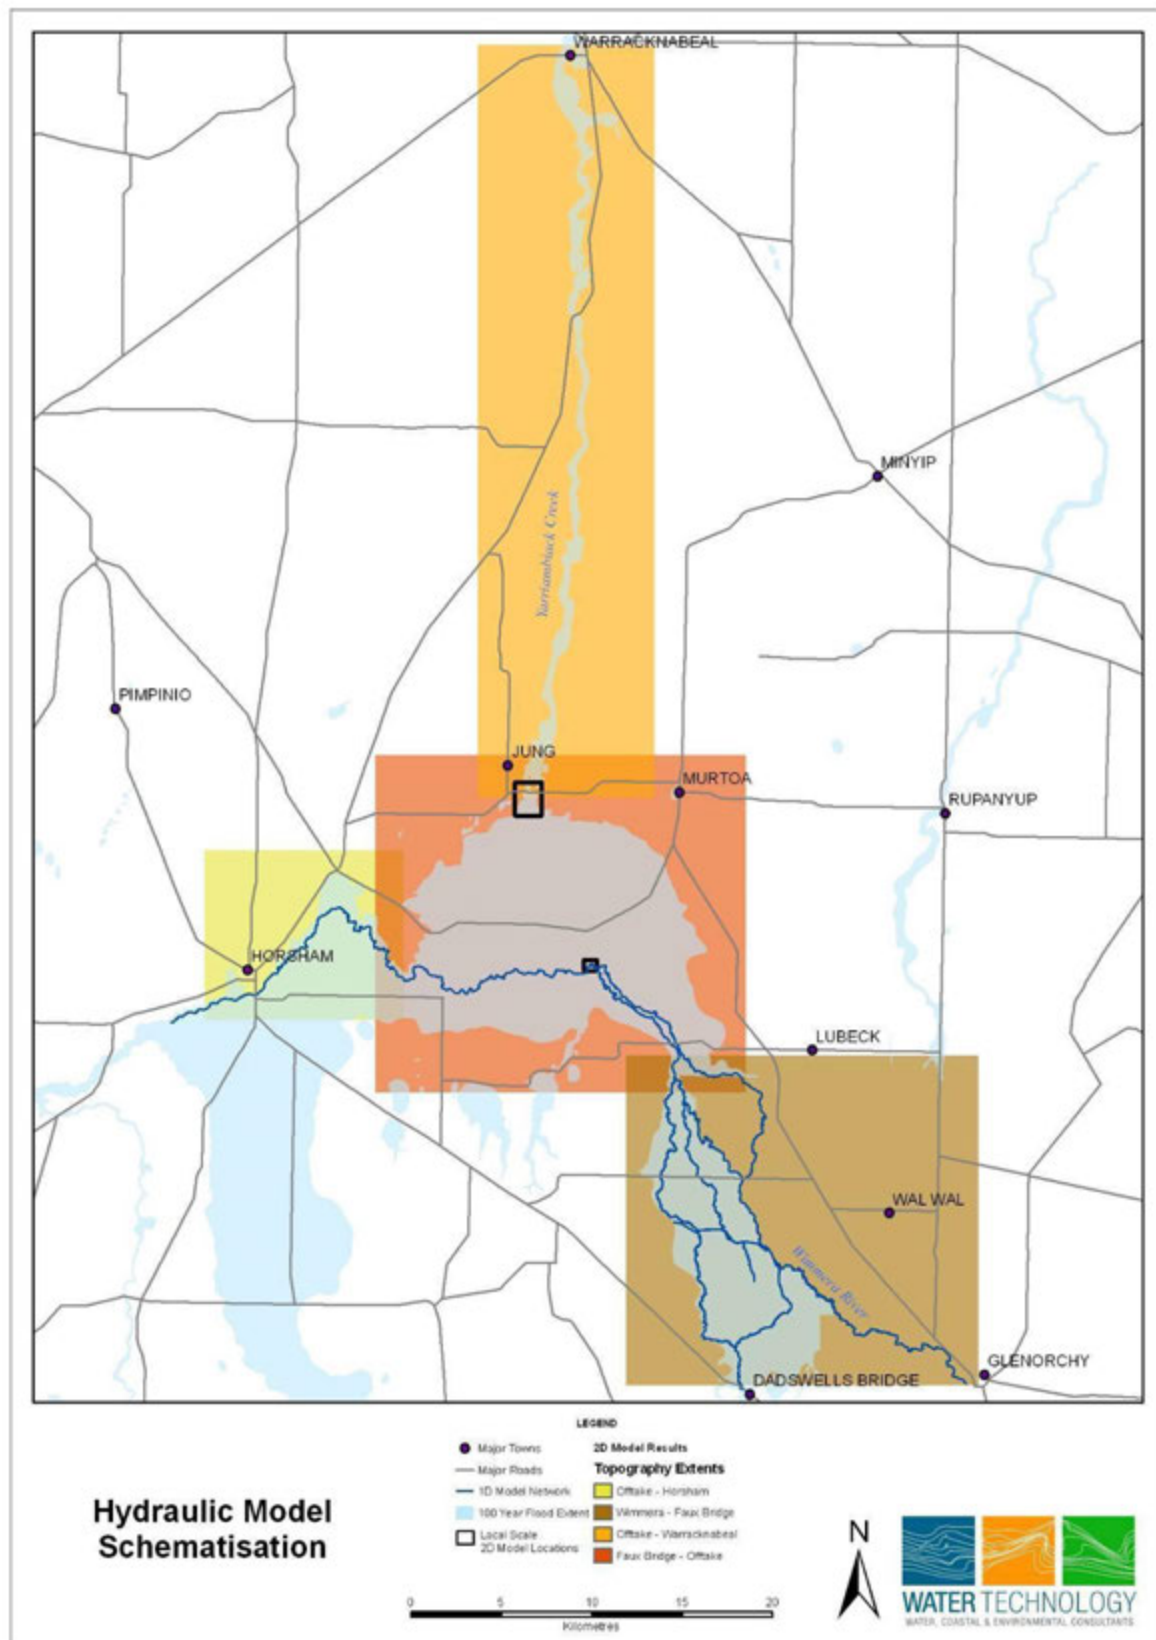
Figure 6-12 Separate hydraulic model extents⁸

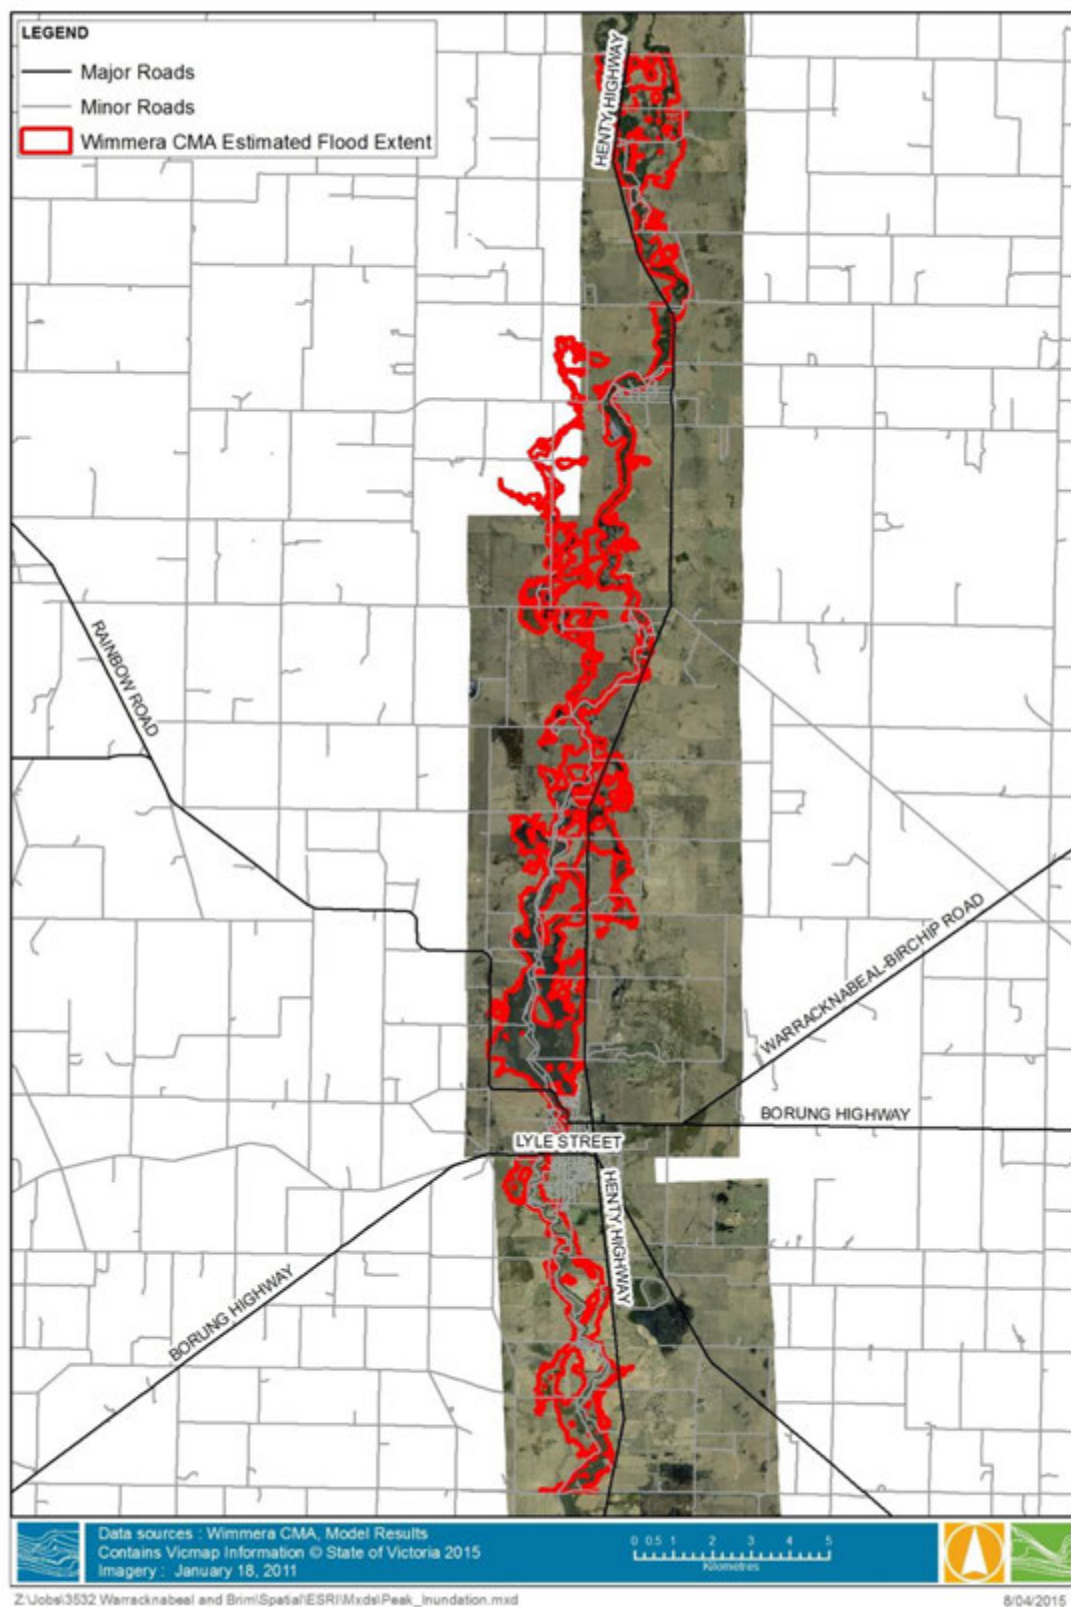
Figure 6-19 Peak inundation extent estimated by Wimmera CMA

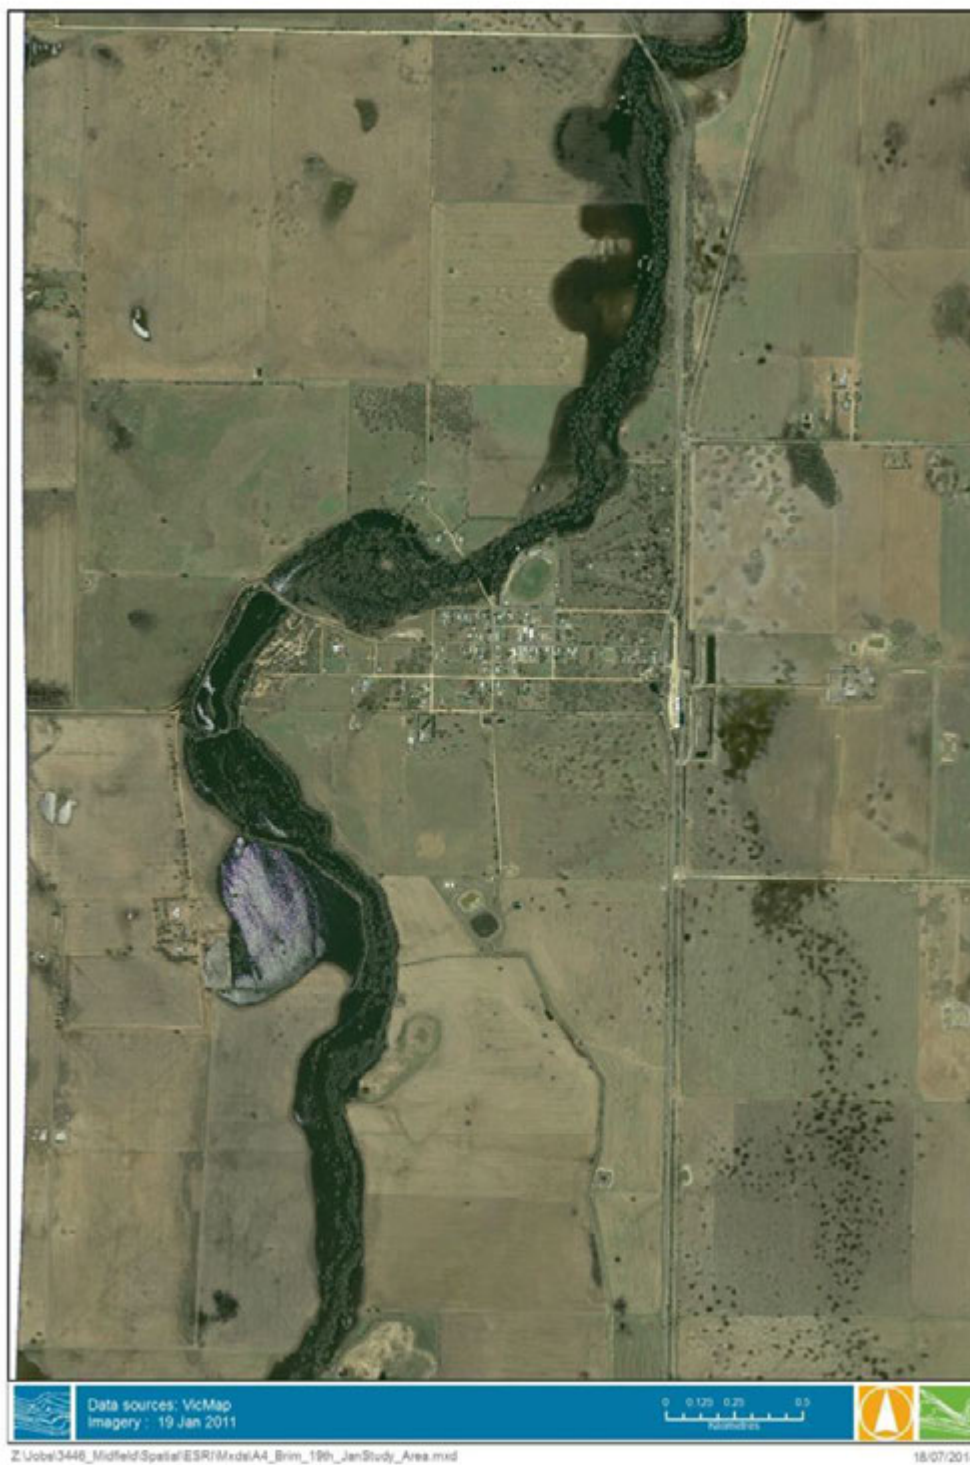
Figure 8-2 Inundation in Brim observed on 19 January 2011

Direct stormwater inundation is not as significant in Brim as in Warracknabeal, aerial imagery of the January 2011 event show some localised pooling of water however no properties were reported as inundated by Wimmera CMA, Yarriambiack Shire Council or during the site inspection.

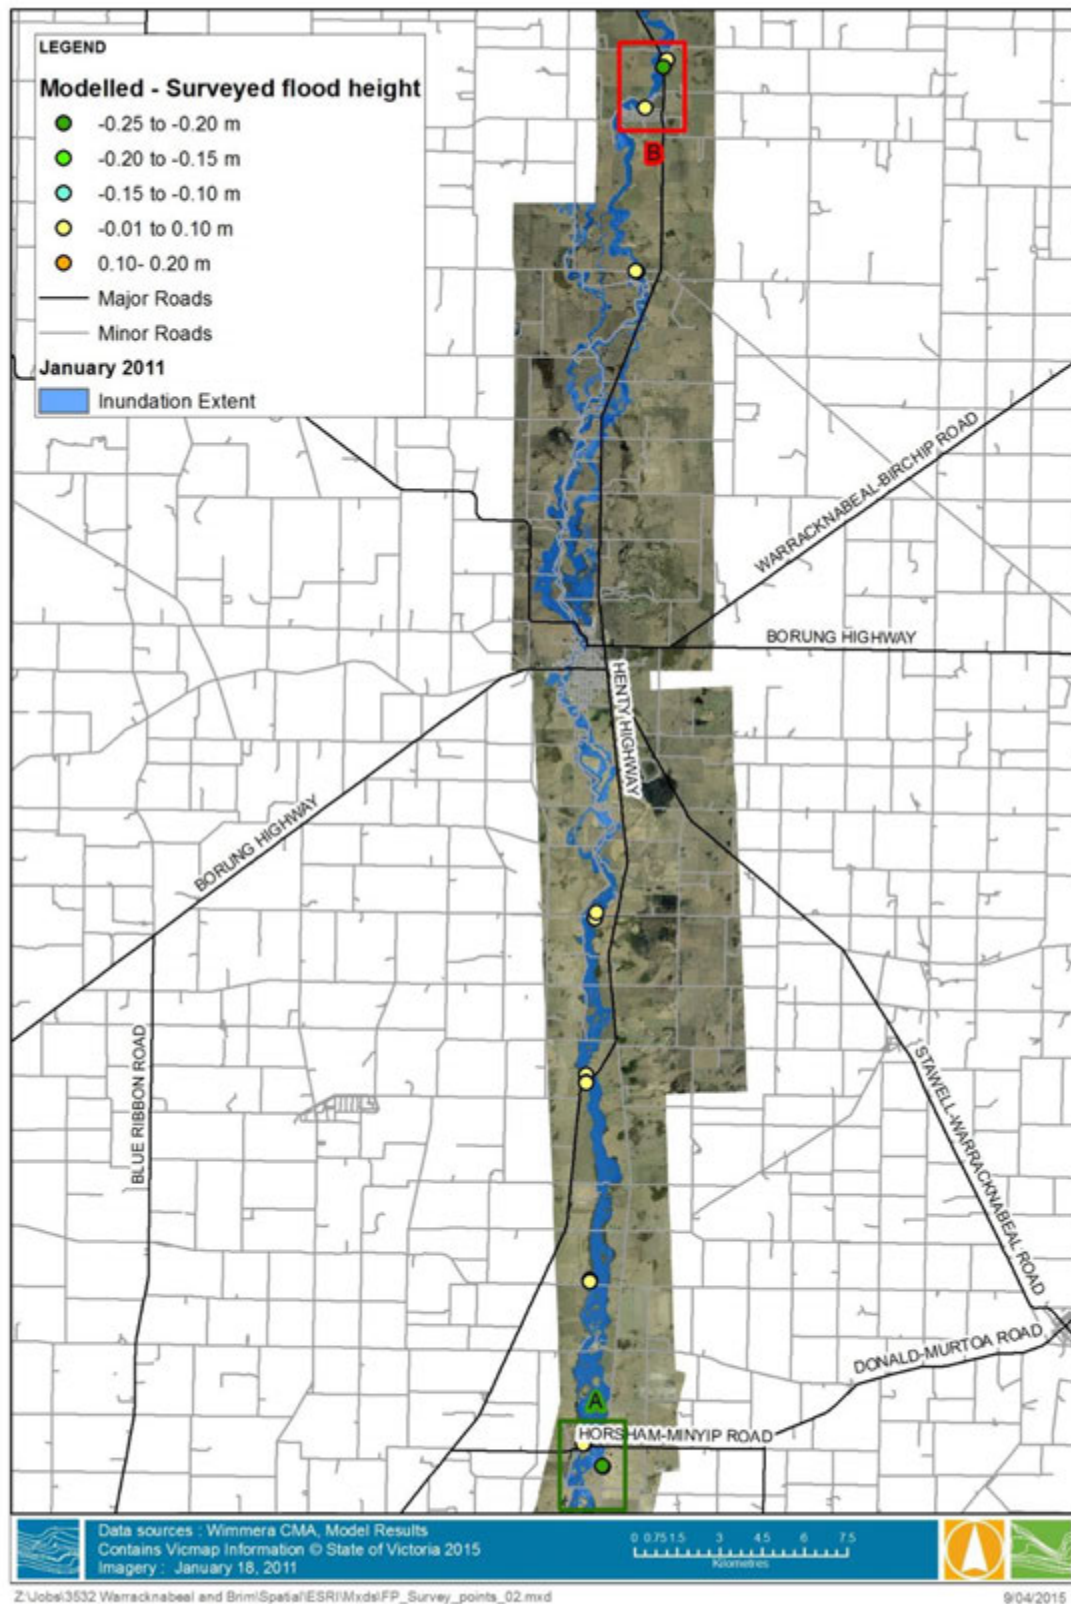
Figure 9-8 January 2011 – Ferguson and Perry Surveying peak flood height comparison

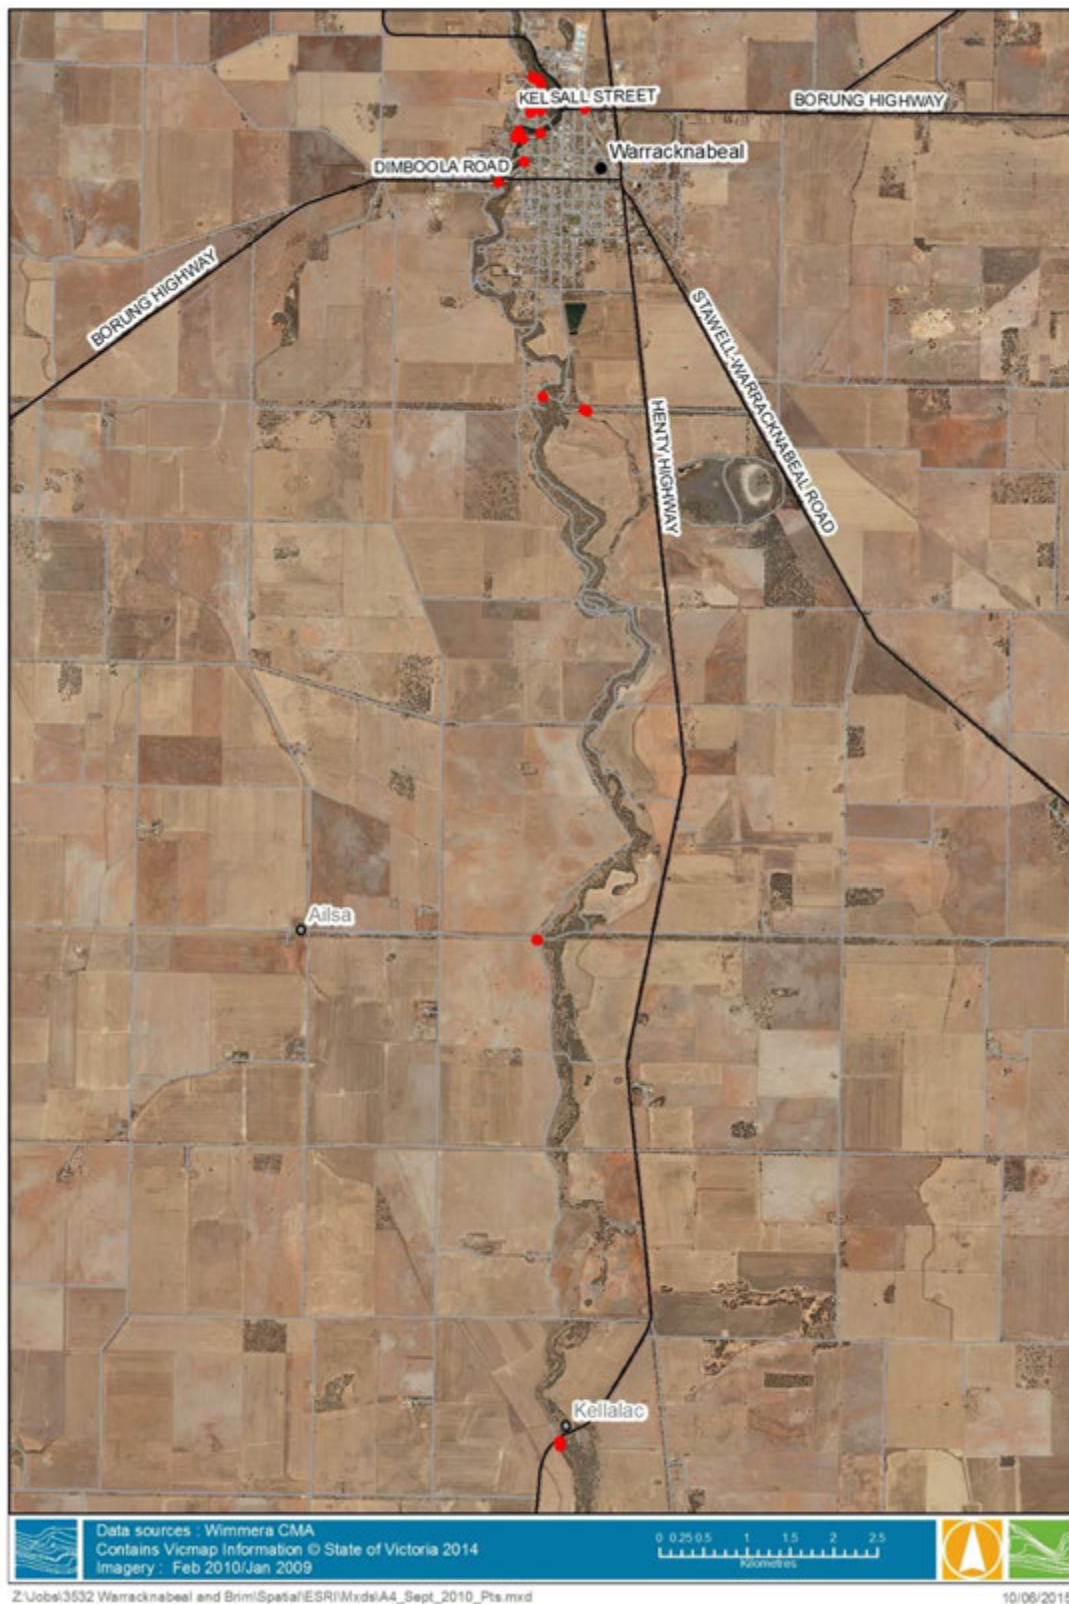
Figure 9-17 September 2010 surveyed peak flood heights

There were 22 peak flood heights surveyed along Yarriambiack Creek post the September 2010 event, their locations are shown in Figure 9-17. All of the points are located between Warracknabeal and Kellalac.

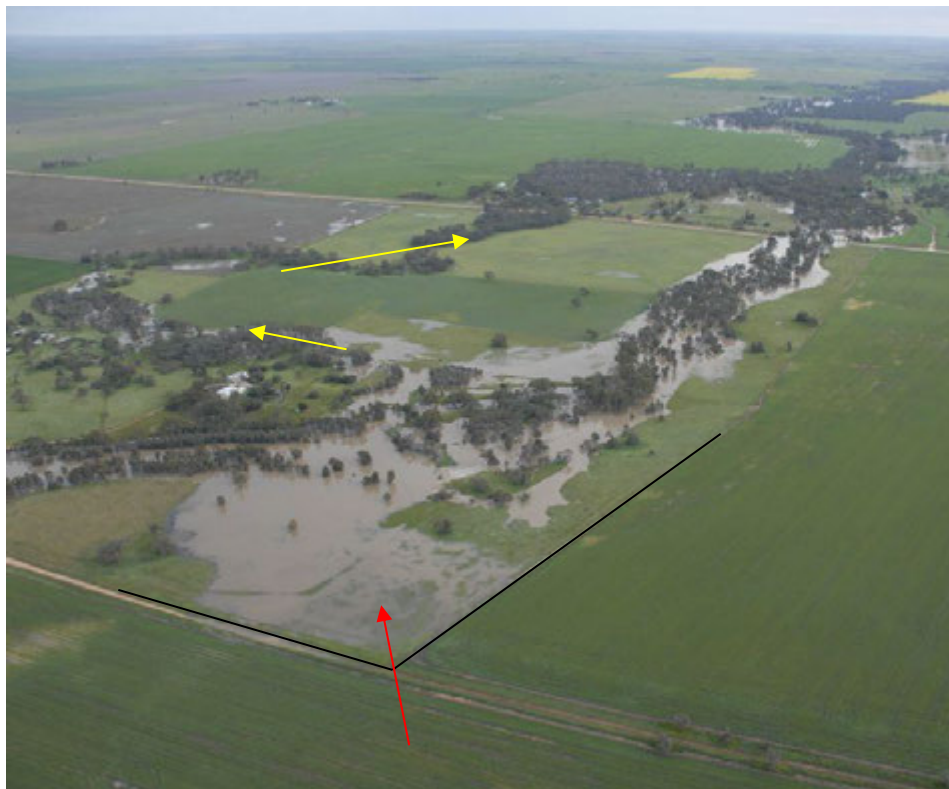
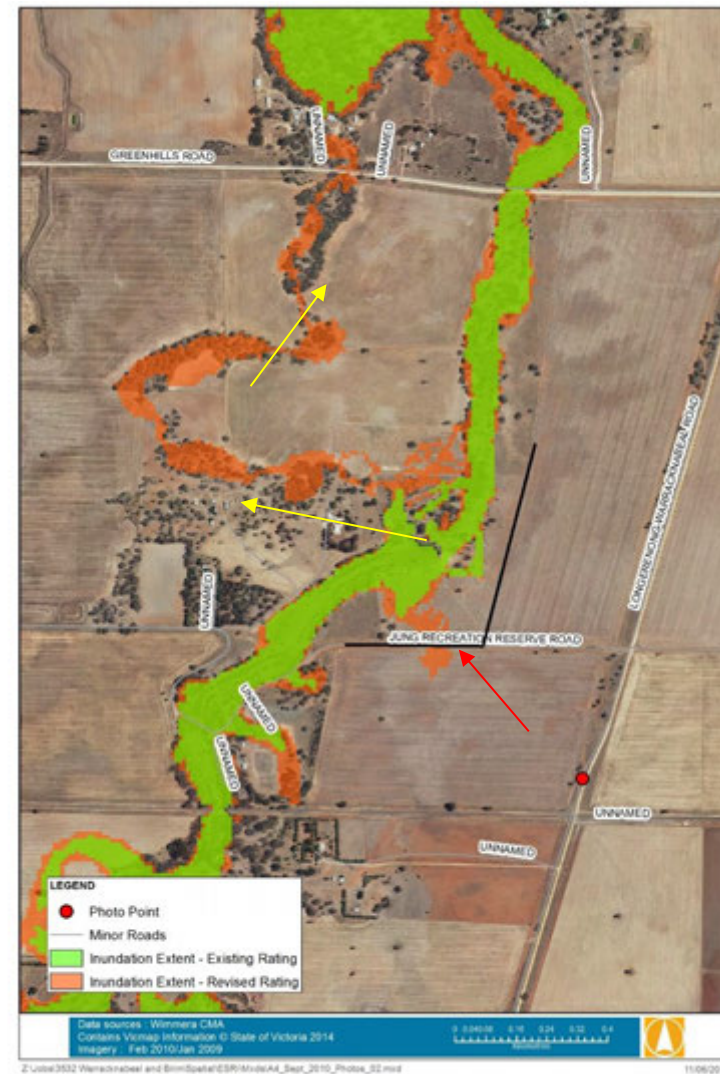
Figure 9-23 September 2010 modelled extent and captured aerial photography – Location 01

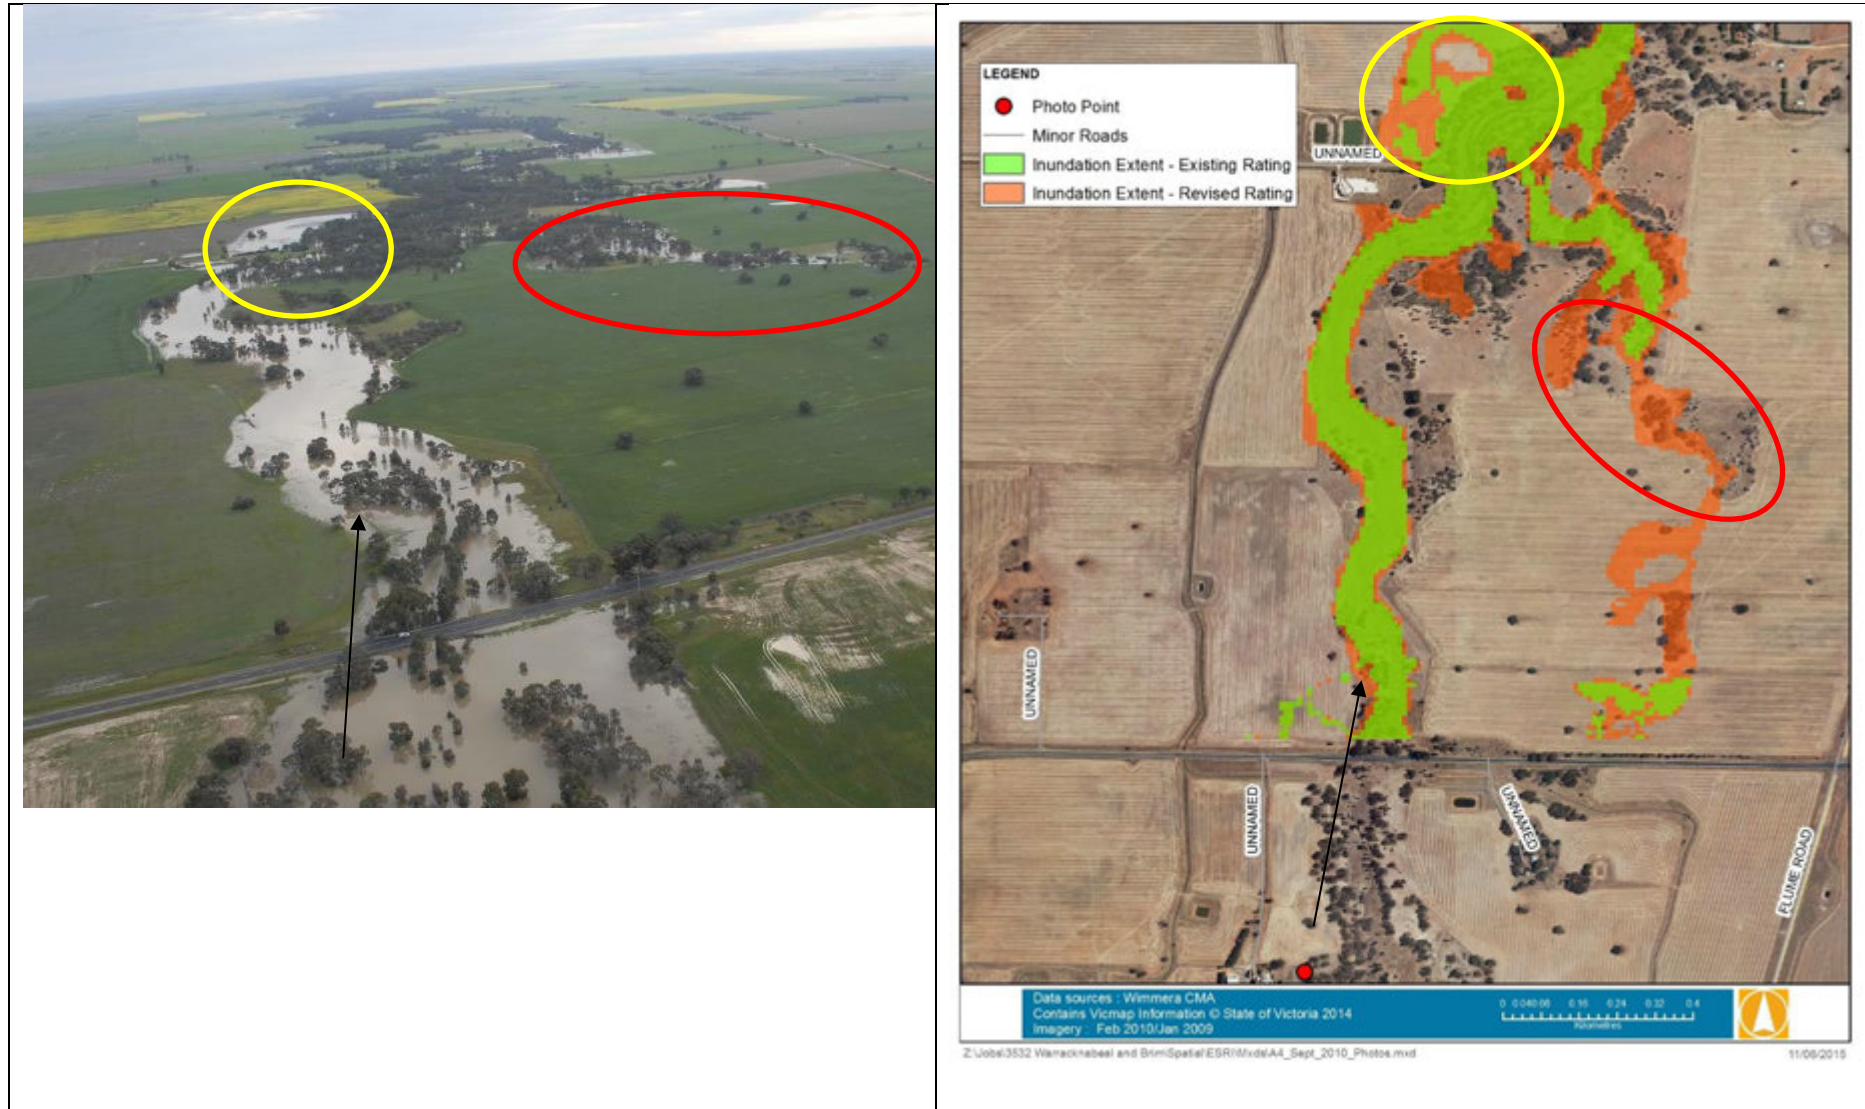
Figure 9-24 September 2010 modelled extent and captured aerial photography – Location 02

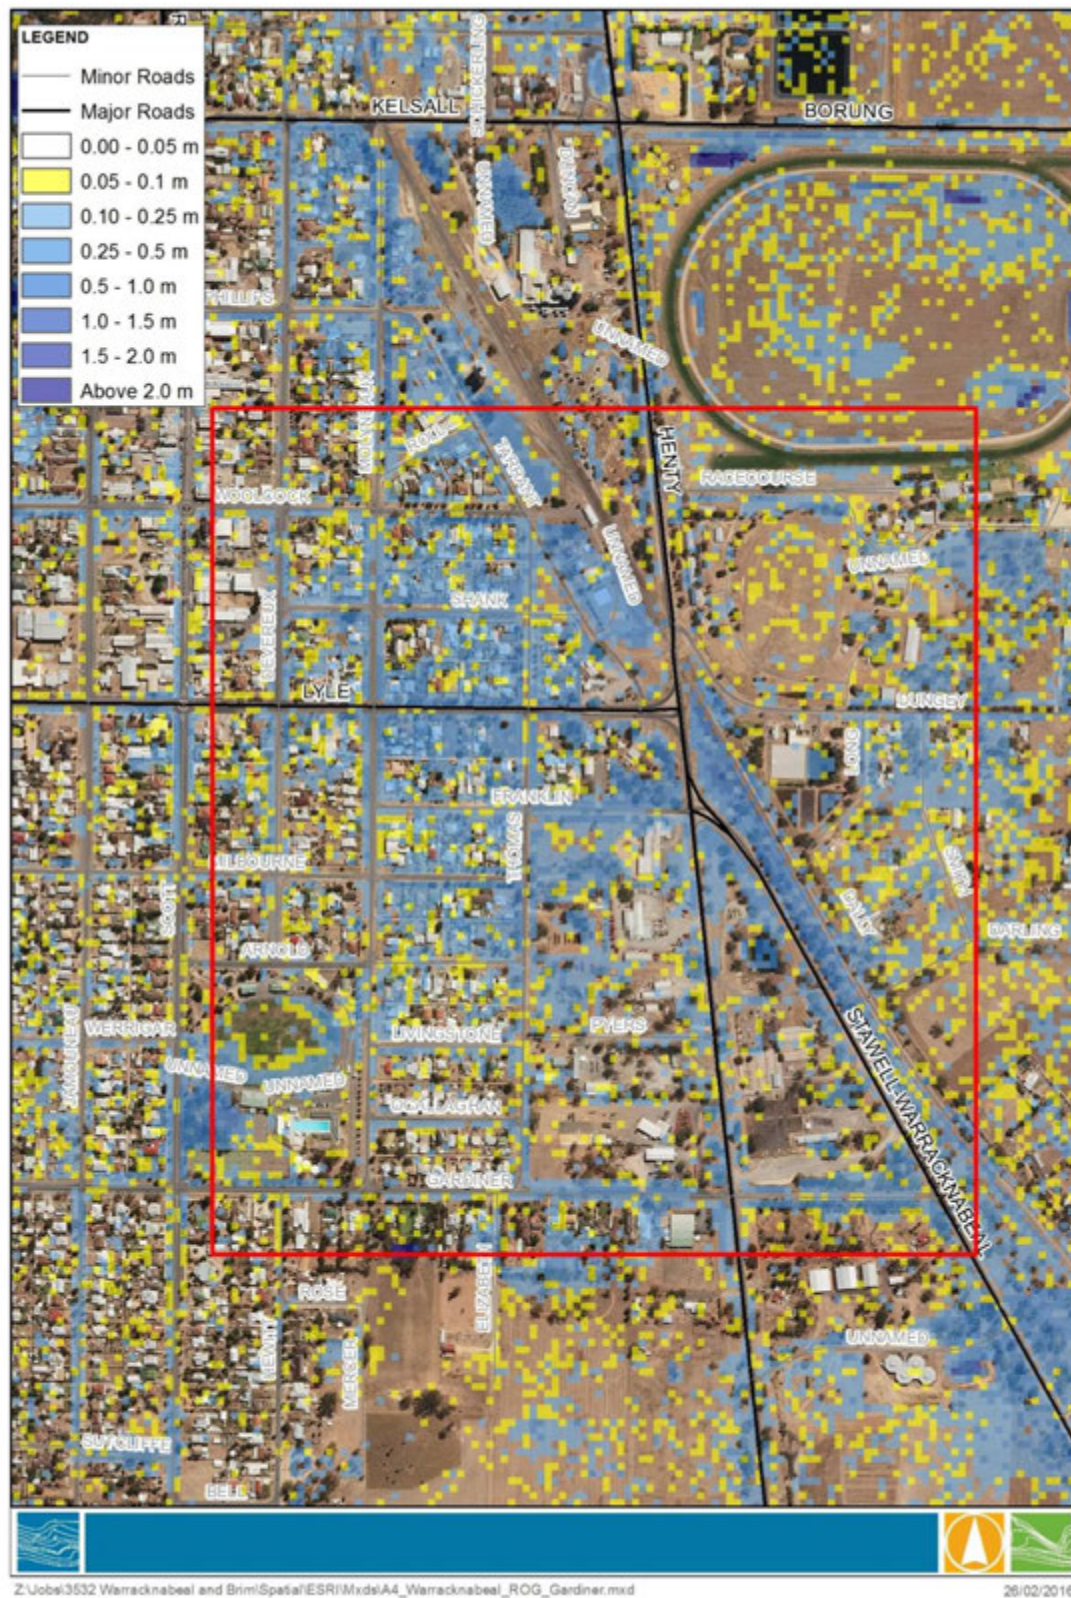
Figure 9-47 Warracknabeal problem areas north of Gardiner Street - 1% AEP 2hr Duration Flood Event Inundation

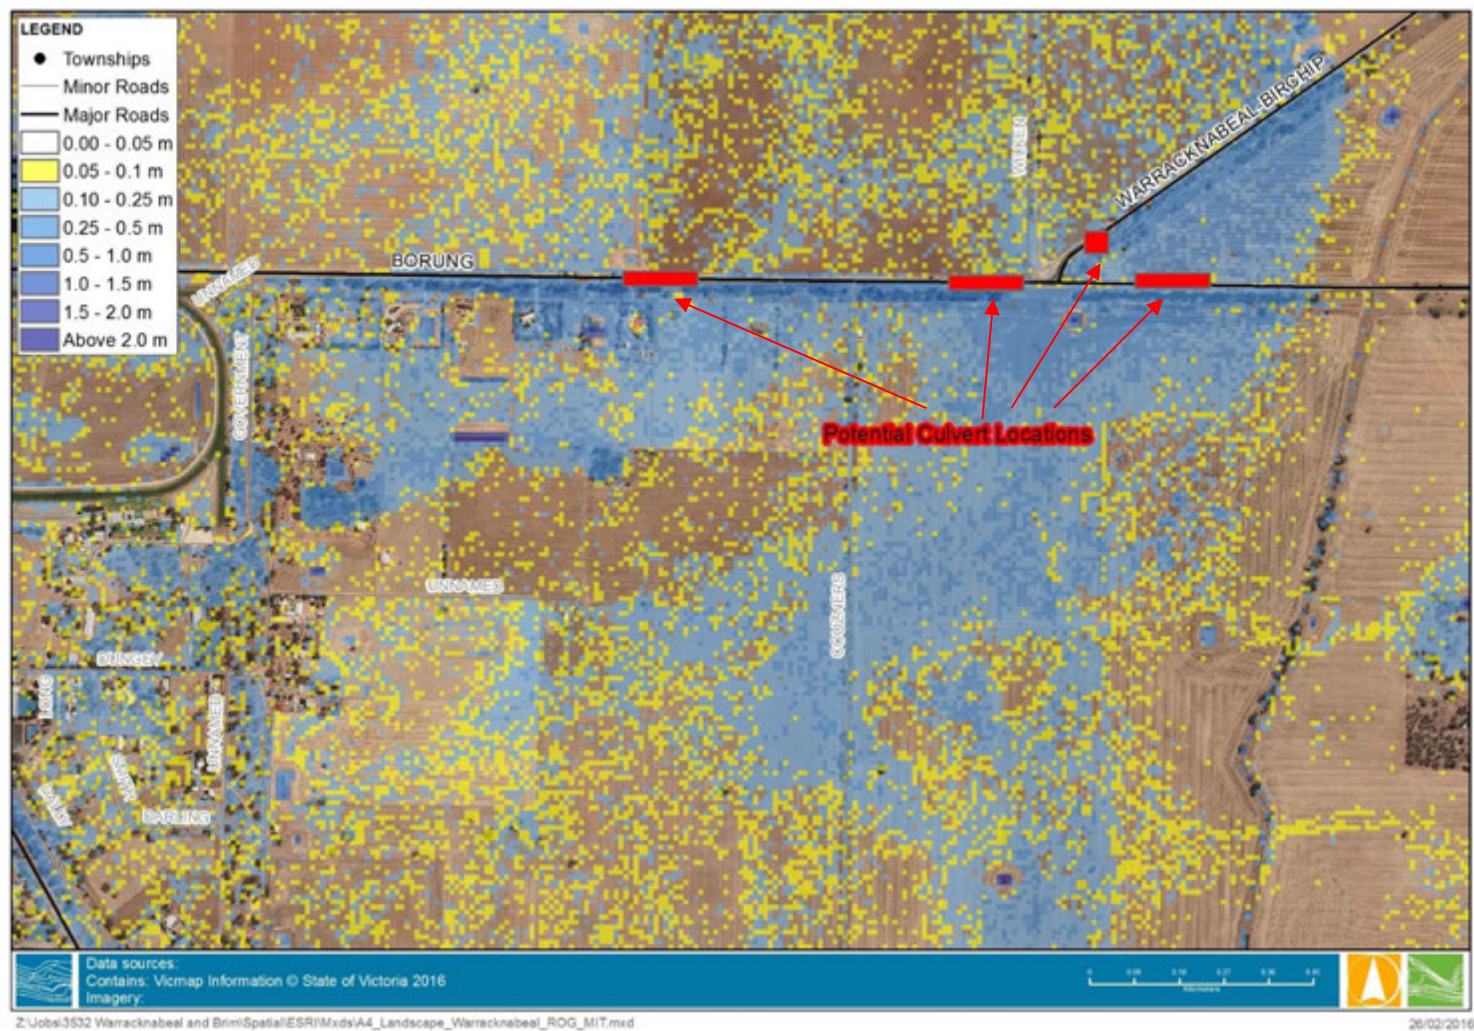
Figure 9-48 Borung Highway, example culvert locations - 1% AEP Flood Event Inundation

It is recommended the frequency of flooding in these areas be reviewed and the potential for upgrades be considered.

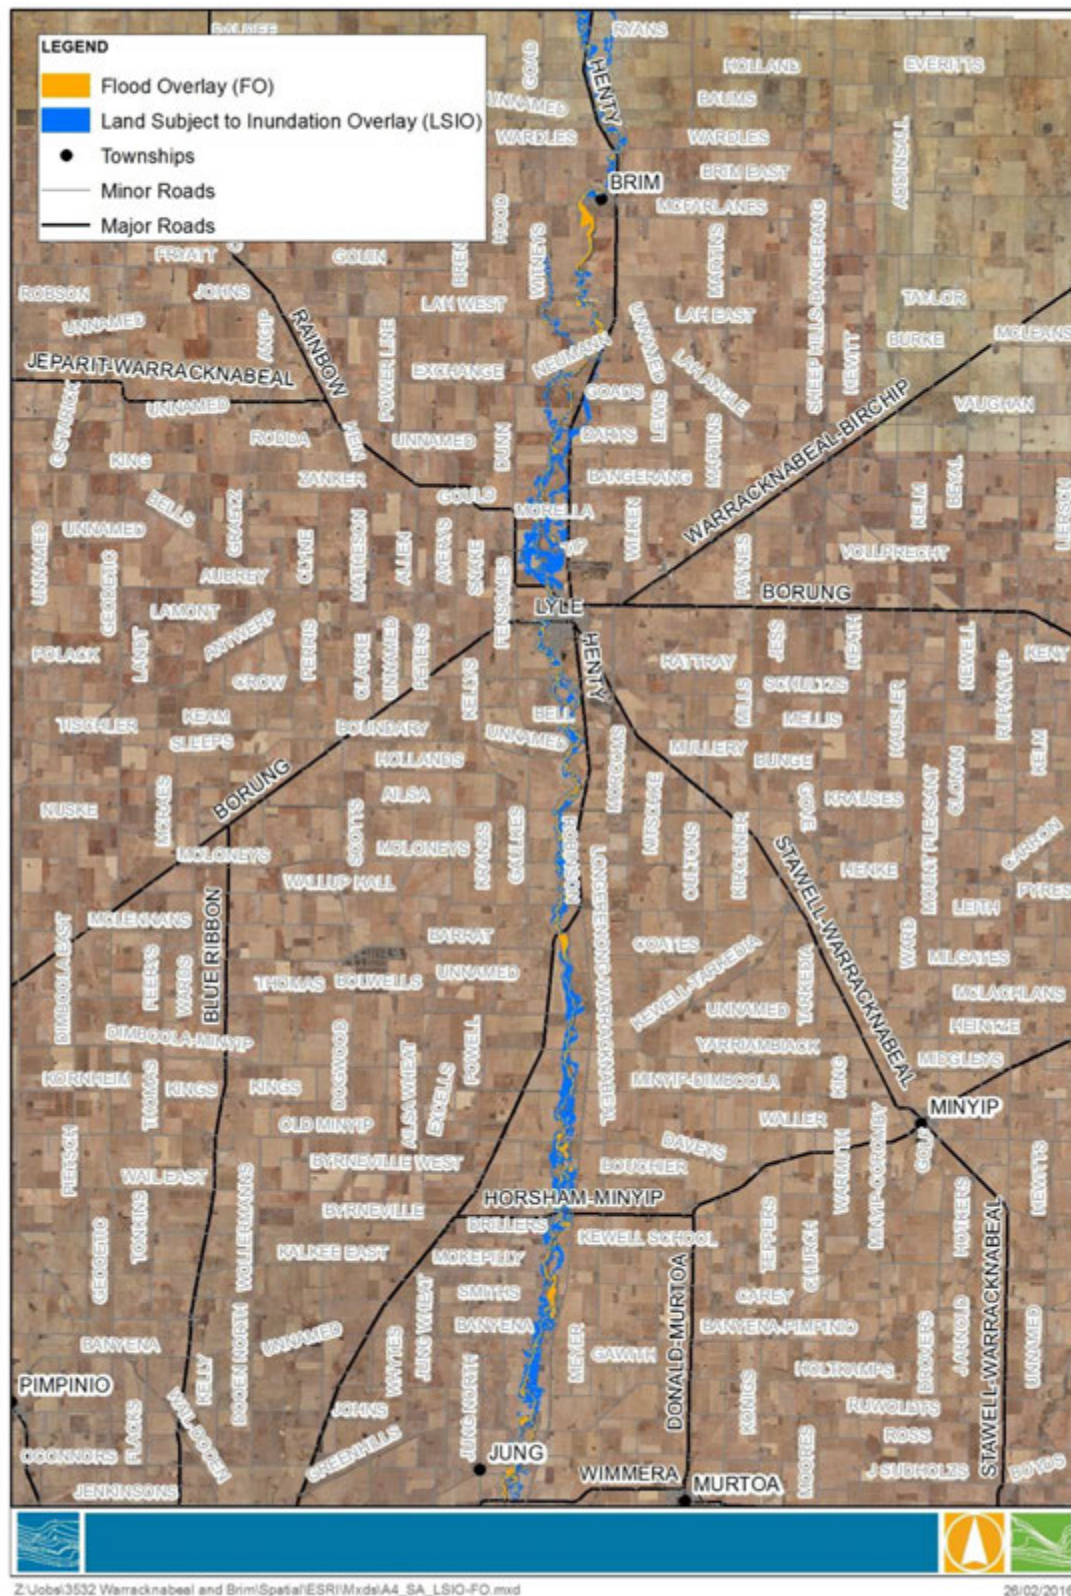
Figure 10-4 Draft LSIO and FO Map for Existing Conditions for the entire study area

Therefore, to define areas of FO, all that is required is to envelope the 10% AEP extent with areas of the 1% AEP of depth greater than 0.5 m and areas of the 1% AEP of velocity greater than 1.5 m/s. Figure 10-4 shows the proposed FO for the entire study area, and Figure 10-5 and Figure 10-6 for Warracknabeal and Brim respectively.

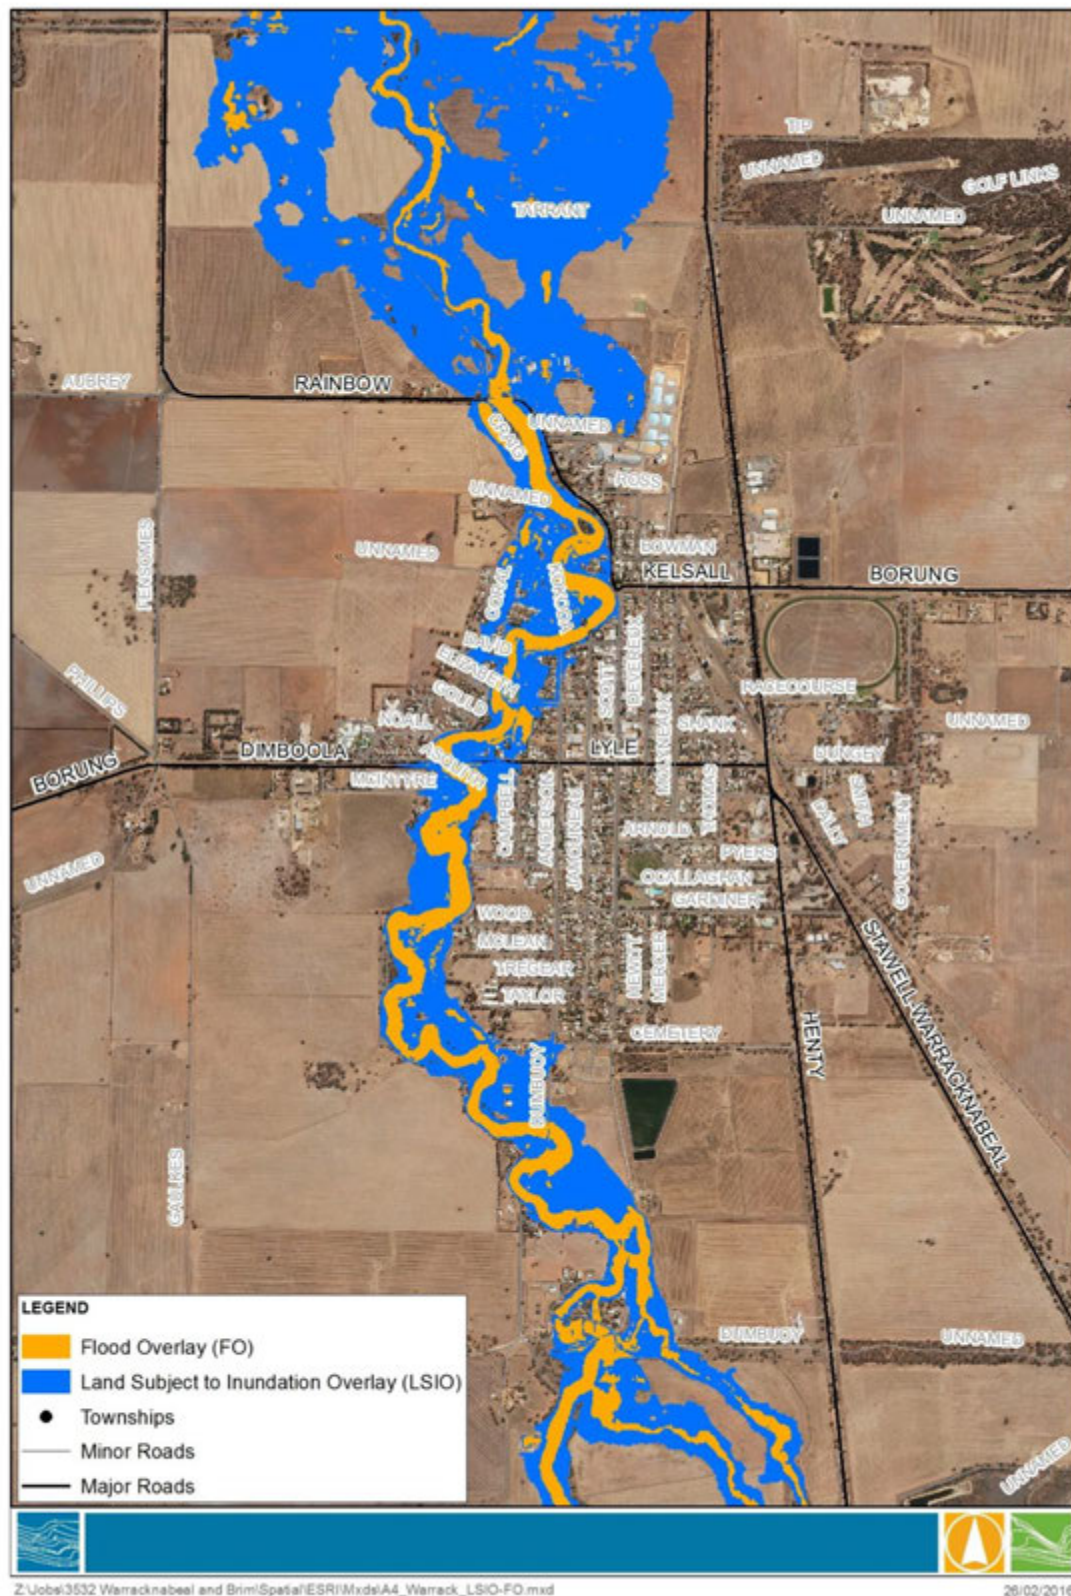
Figure 10-5 Draft LSIO and FO Map for Existing Conditions for Warracknabeal

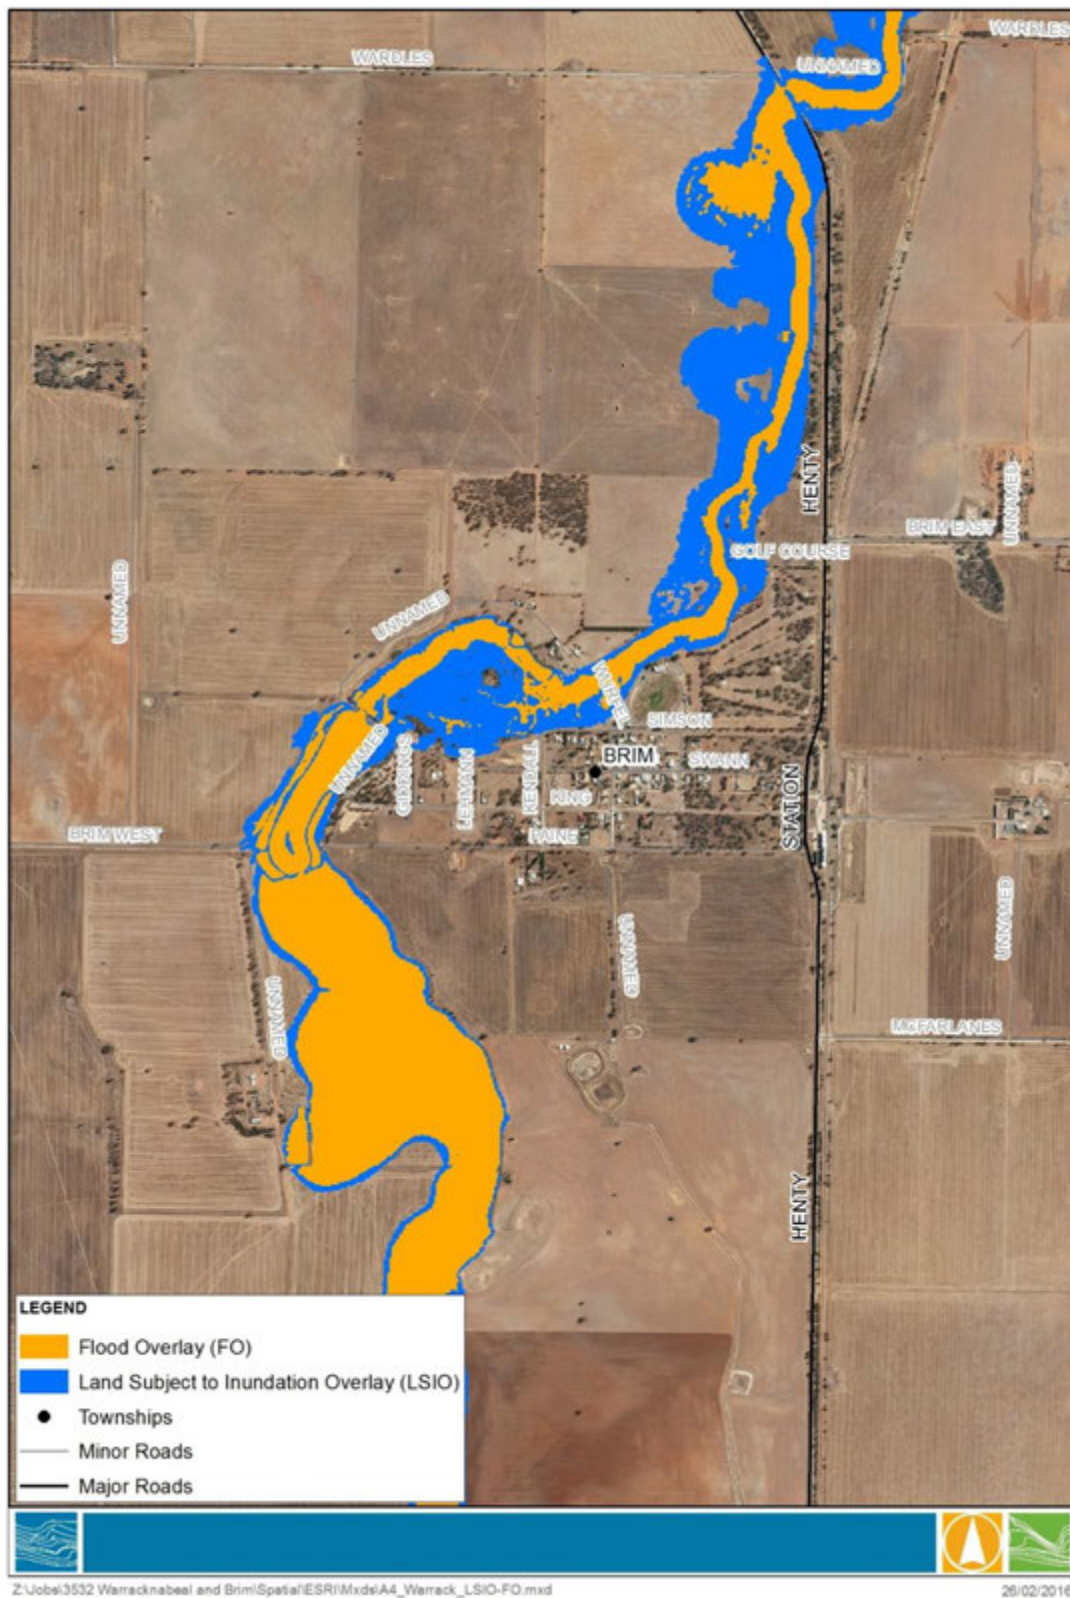
Figure 10-6 Draft LSIO and FO Map for Existing Conditions for Brim
