Warracknabeal and Brim Flood Investigation – Final Report

July 2016

Project Name	Warracknabeal and Brim Flood Investigation
Client	Wimmera CMA
Client Project Manager	Clare Wilson
Water Technology Project Manager	Ben Hughes
Report Authors	Ben Hughes
Job Number	3532-01
Report Number	R04
Document Name	Final Report

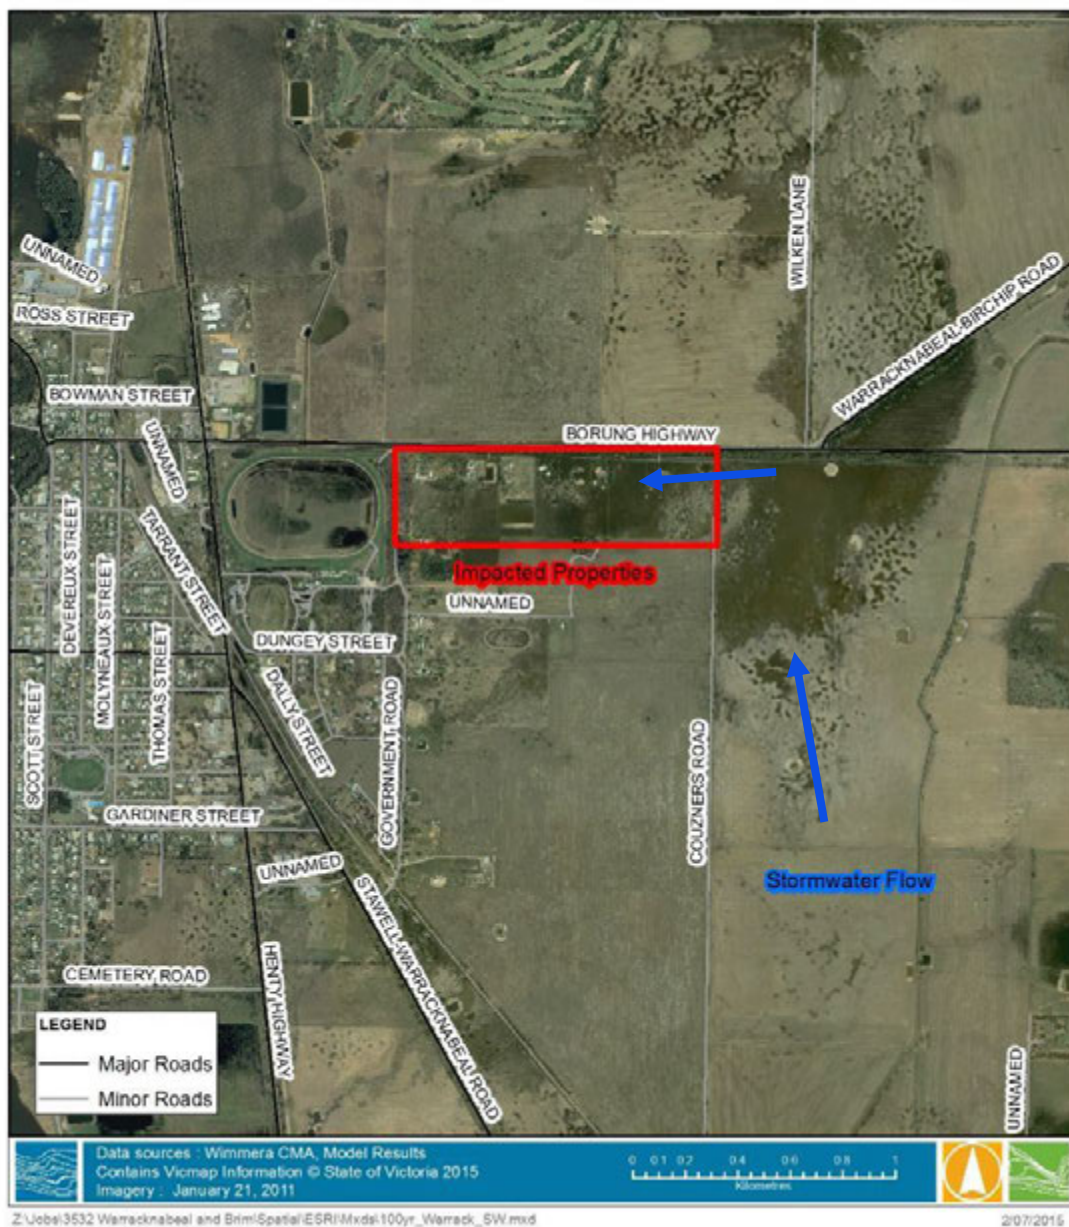
Figure 10-10 Inundation east of Warracknabeal during the January 2011 event caused by the Borung Highway restricting overland flow

Stormwater inundation south of the Borung Highway is largely caused by a blockage to overland flow at the highway. The inundation observed during January 2011 event is shown in Figure 10-10. There may be options to add additional drainage culverts under the highway and improving the passage of overland flow. This will be assessed as part of the Warracknabeal stormwater modelling.

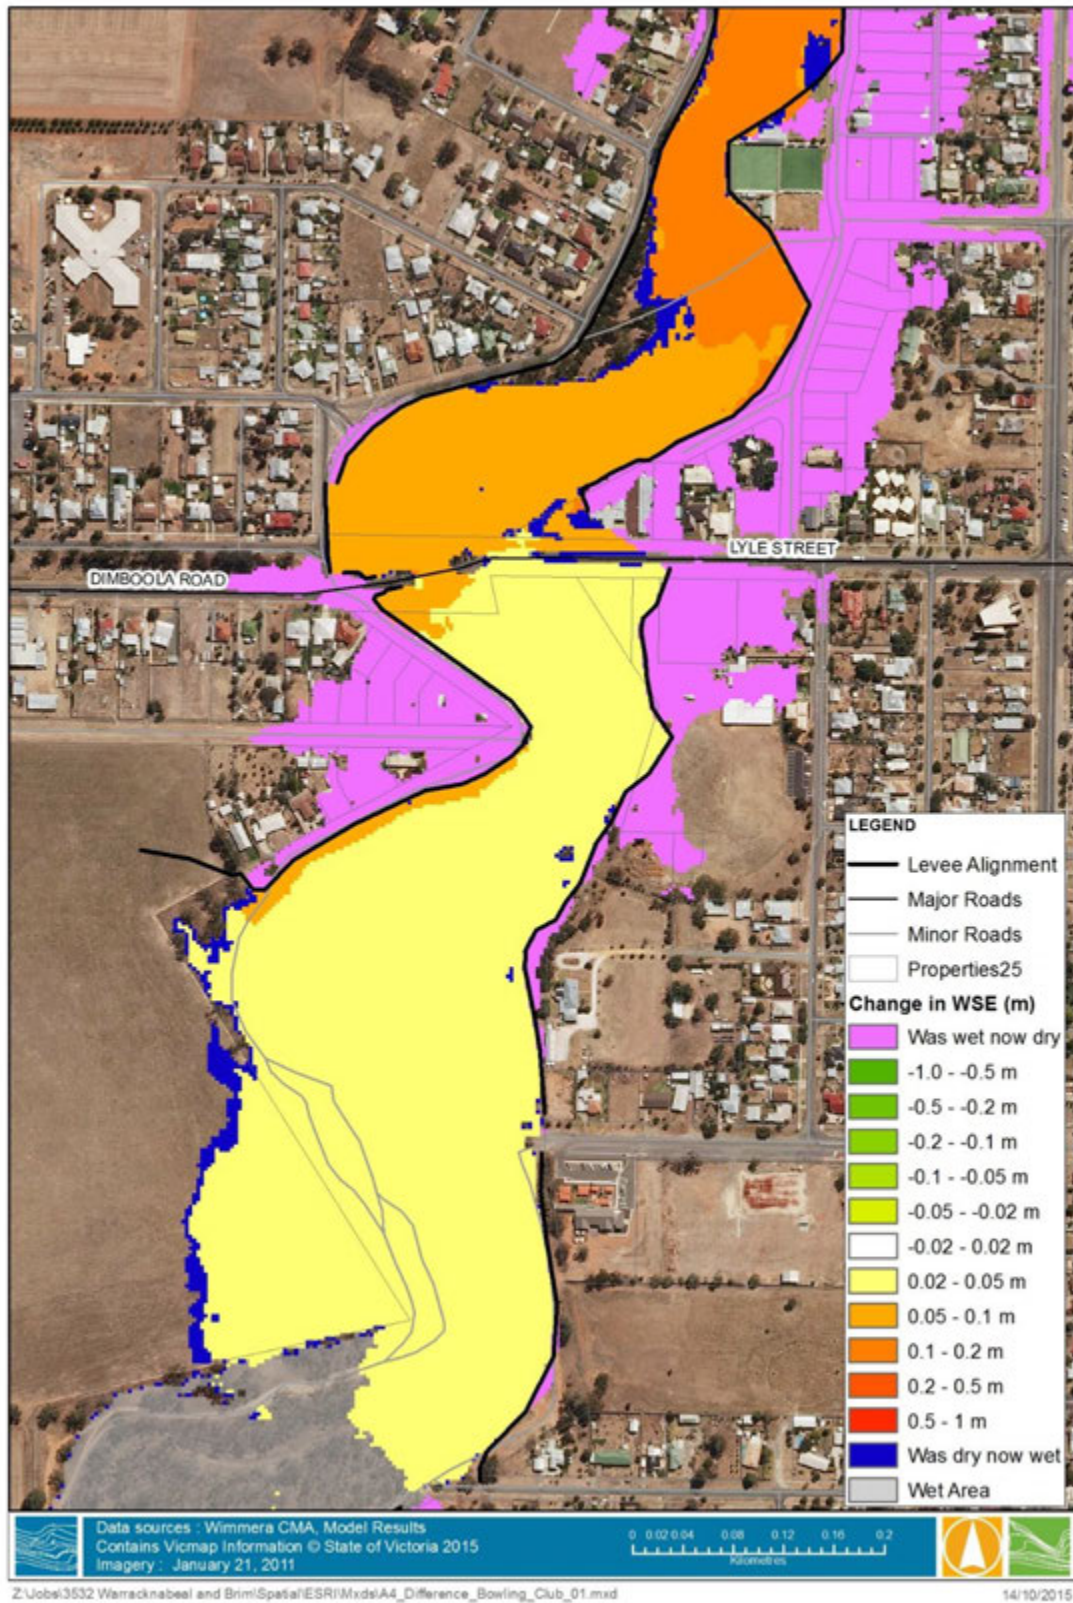
Figure 10-22 Change in water levels - The inclusion of a levee around the Bowling Club as a modification to the January 2011 levee compared to existing conditions

The lack of increase in water levels upstream of the Bowling Club is due to the lack of floodplain conveyance across the site when it is inundated.

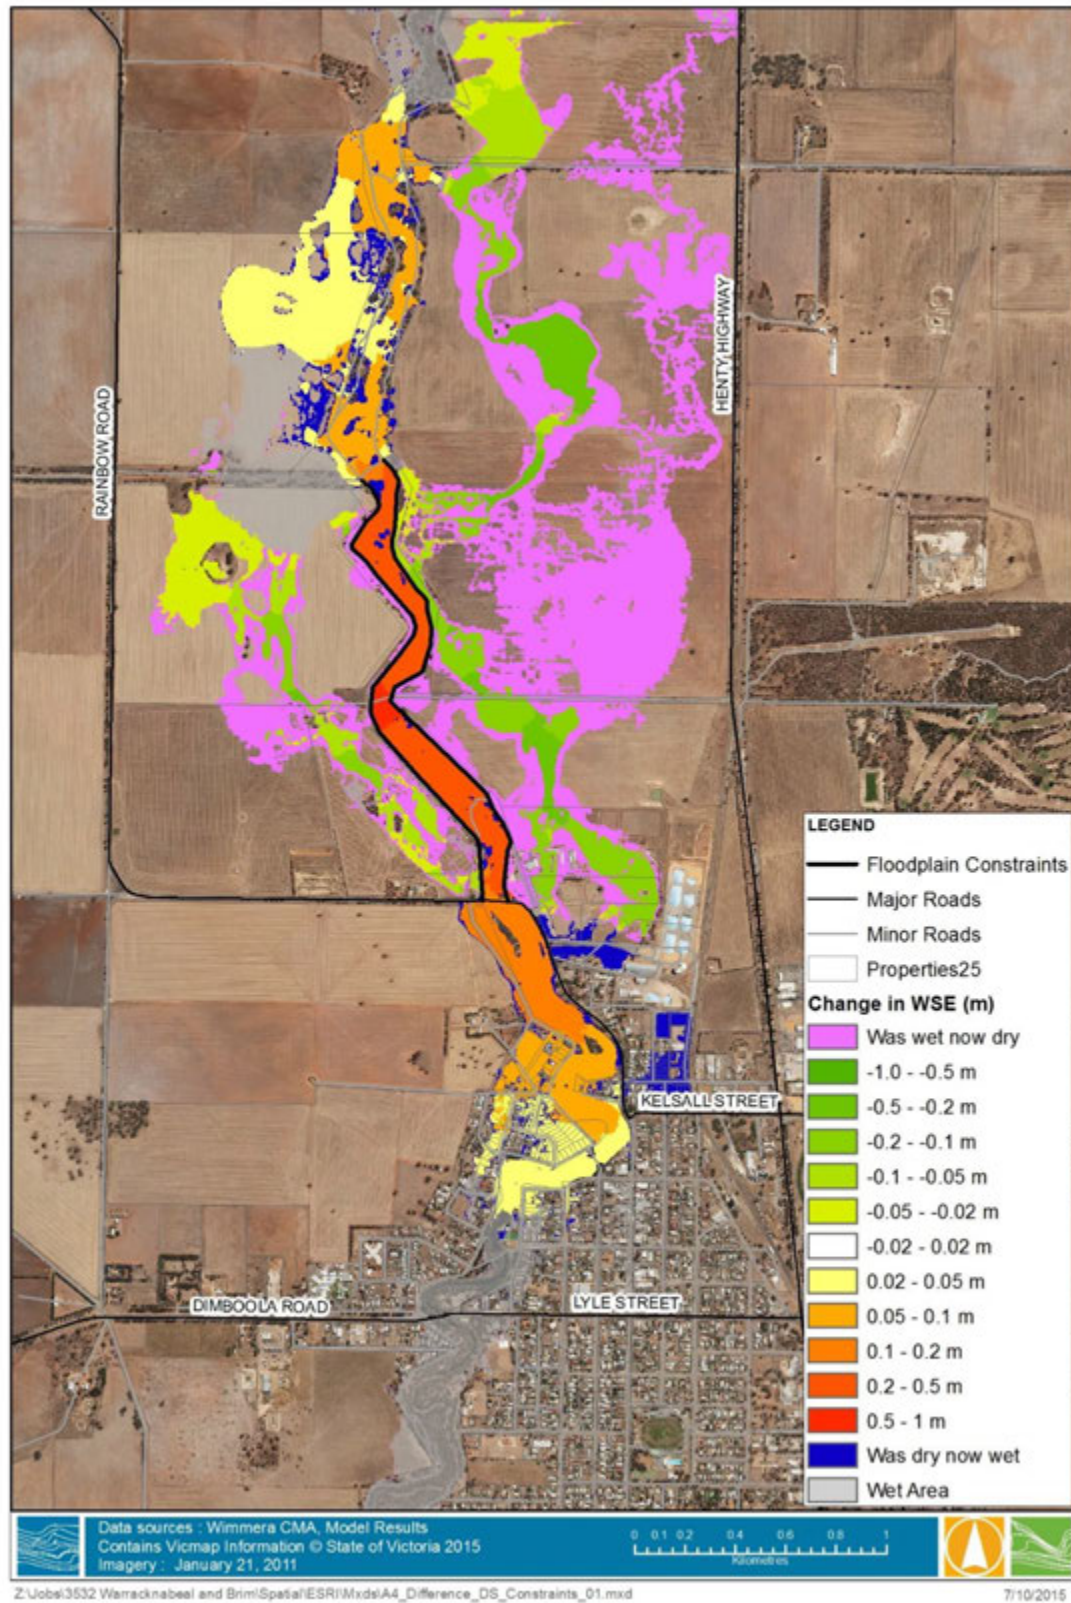
Figure 10-25 Change in water levels – Loss of floodplain storage downstream of Warracknabeal Weir

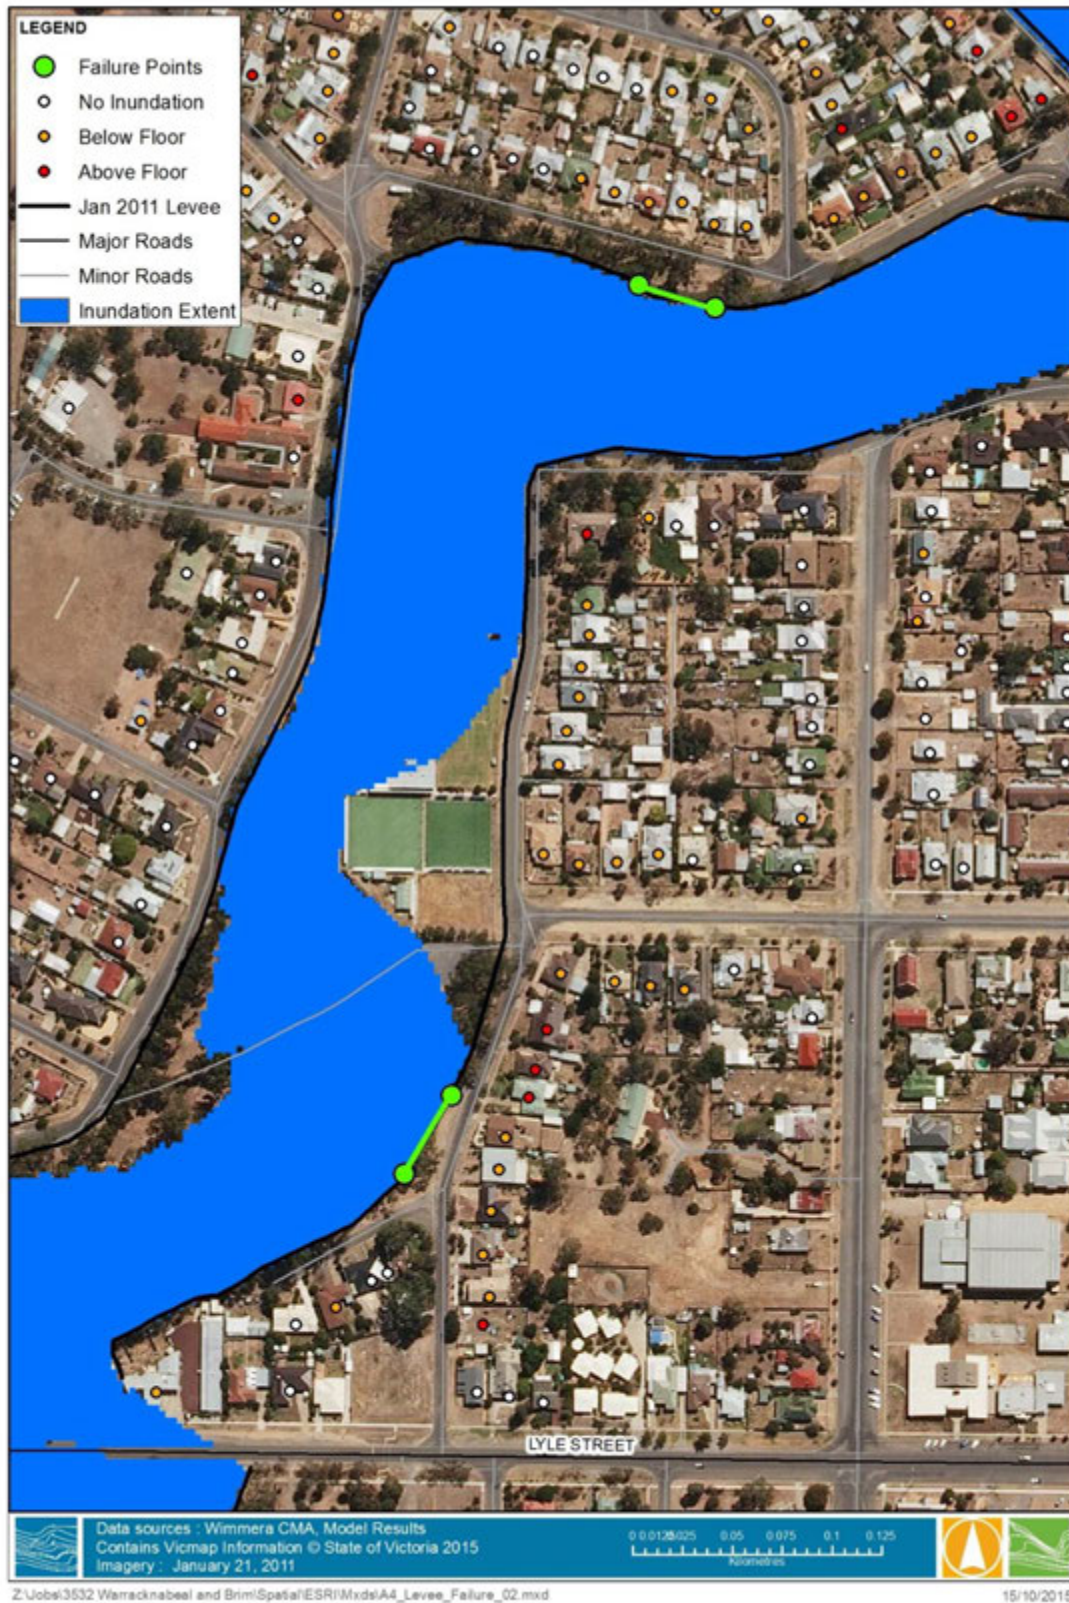
Figure 10-30 Levee failure locations

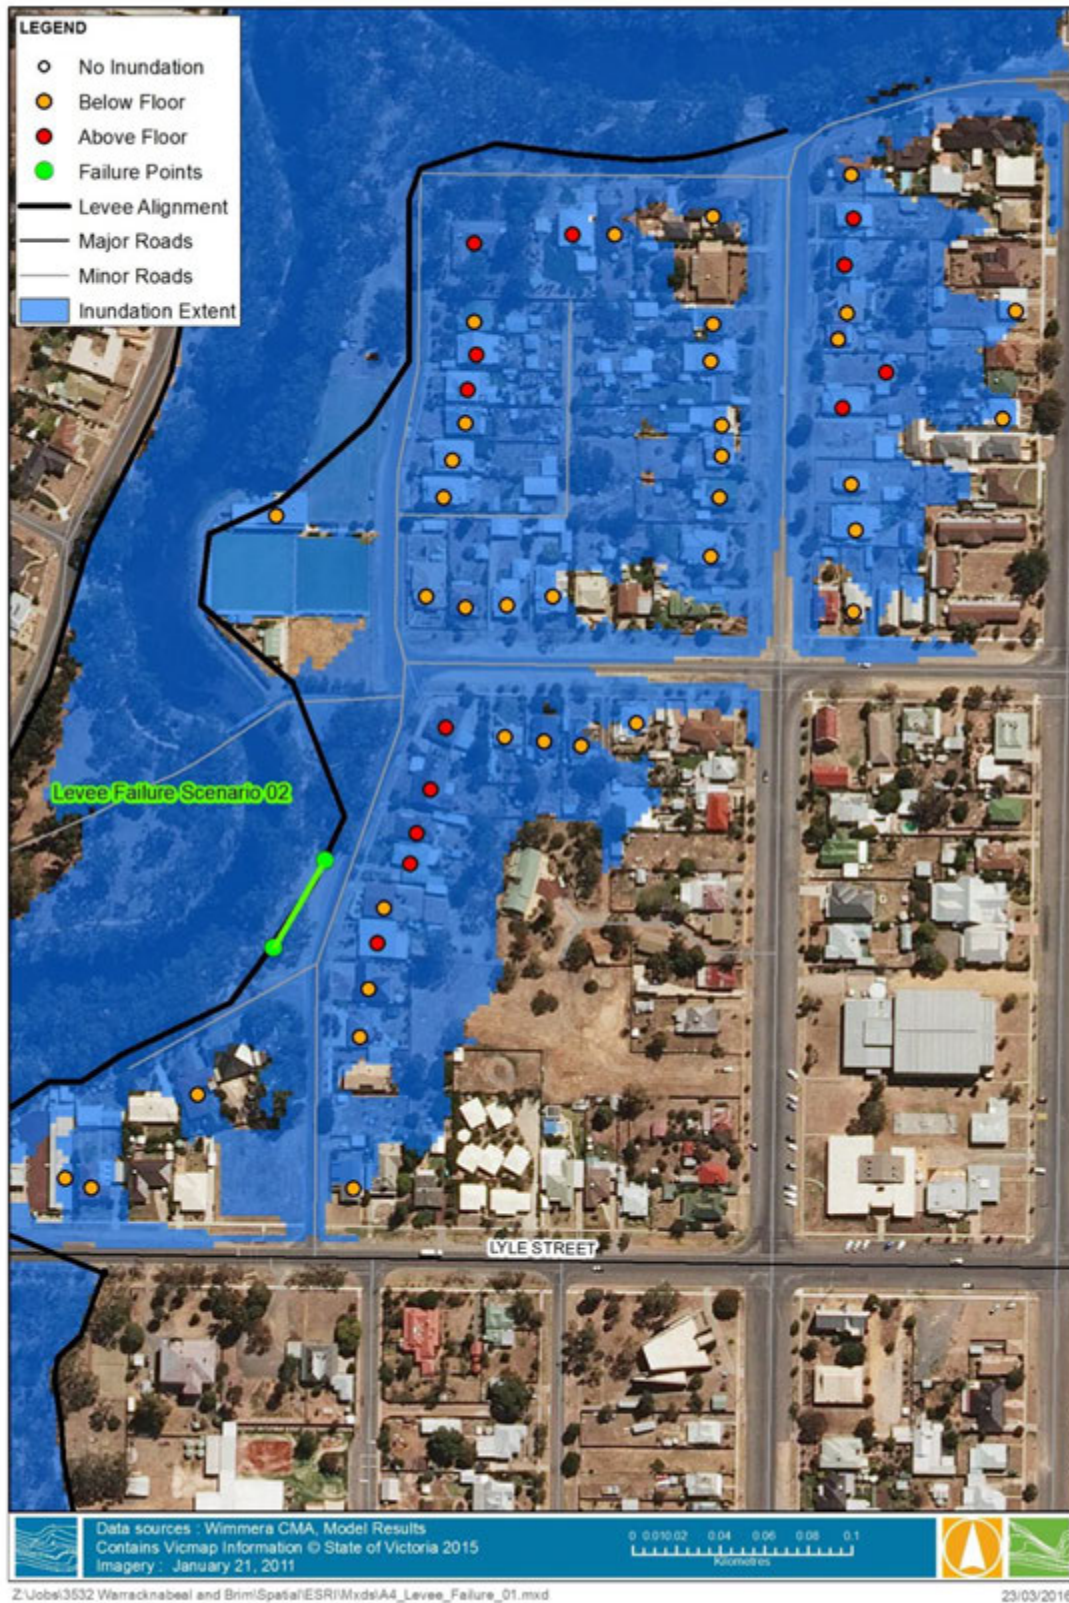
Figure 10-32 Levee Failure Scenario 02 – Inundation extent and properties flooded above floor

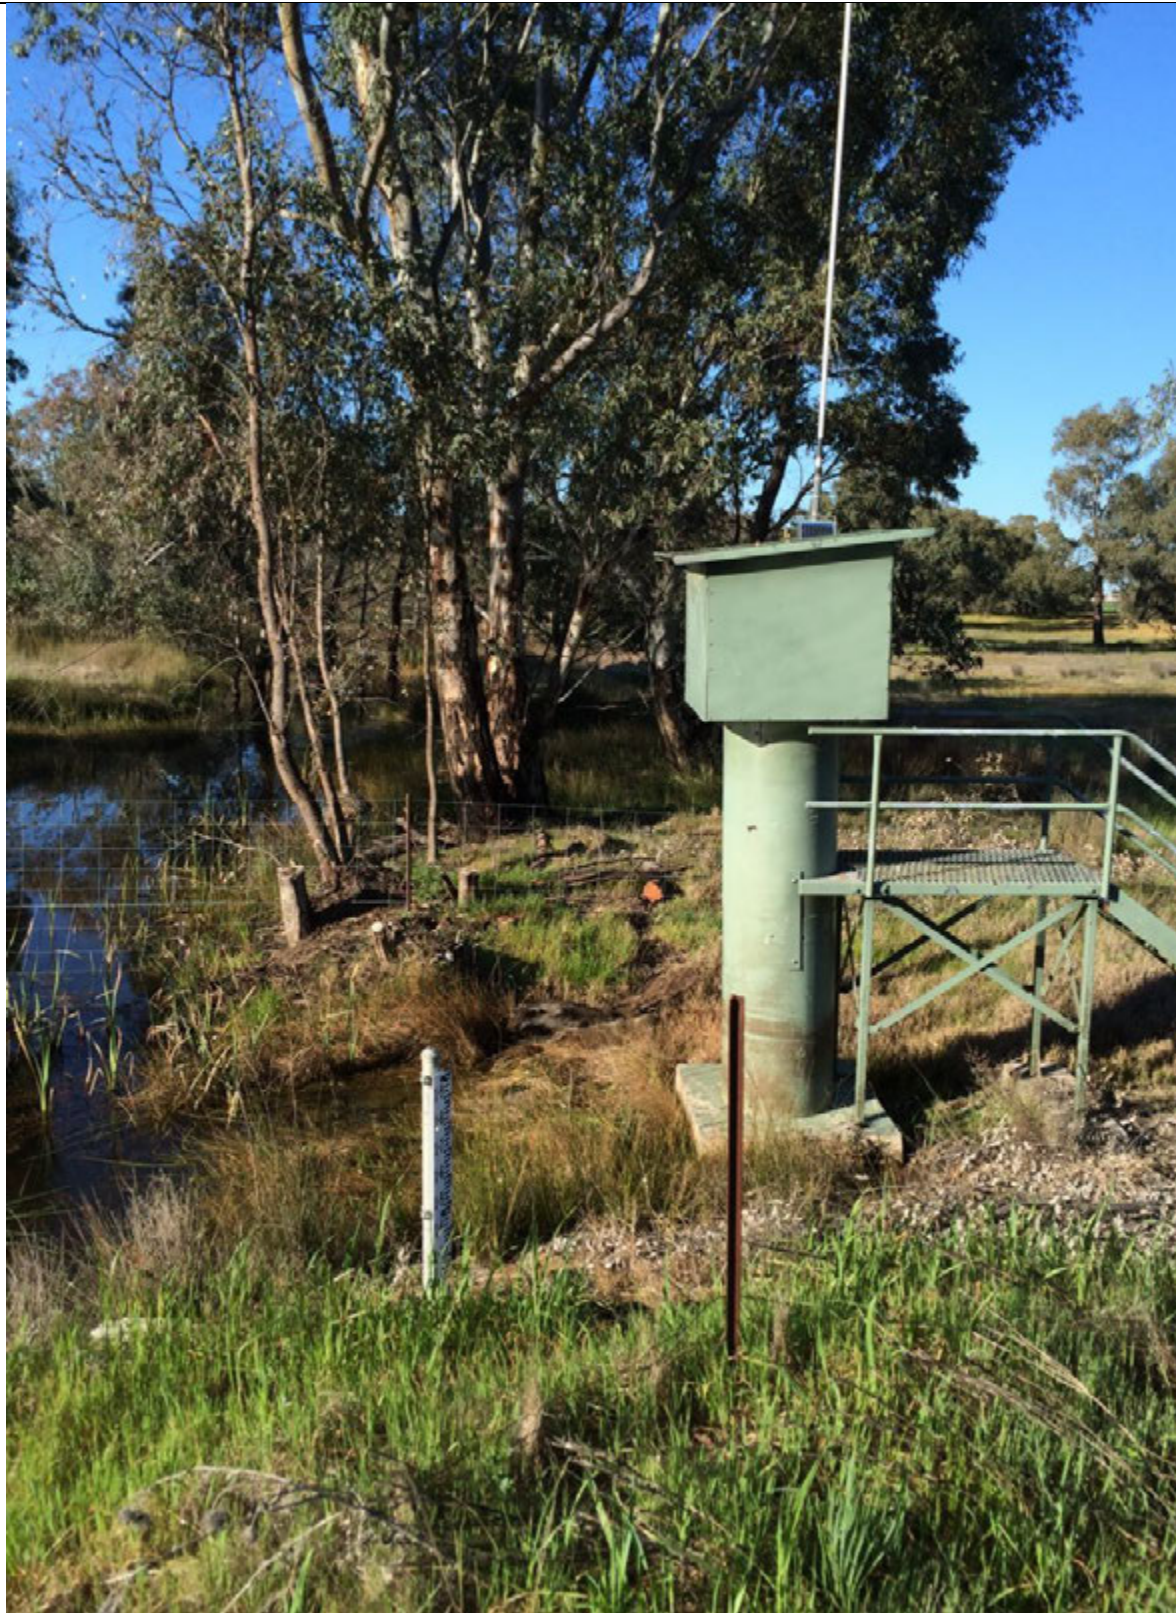
Photo 04 – Yarriambiack Creek gauging station at the Wimmera Highway

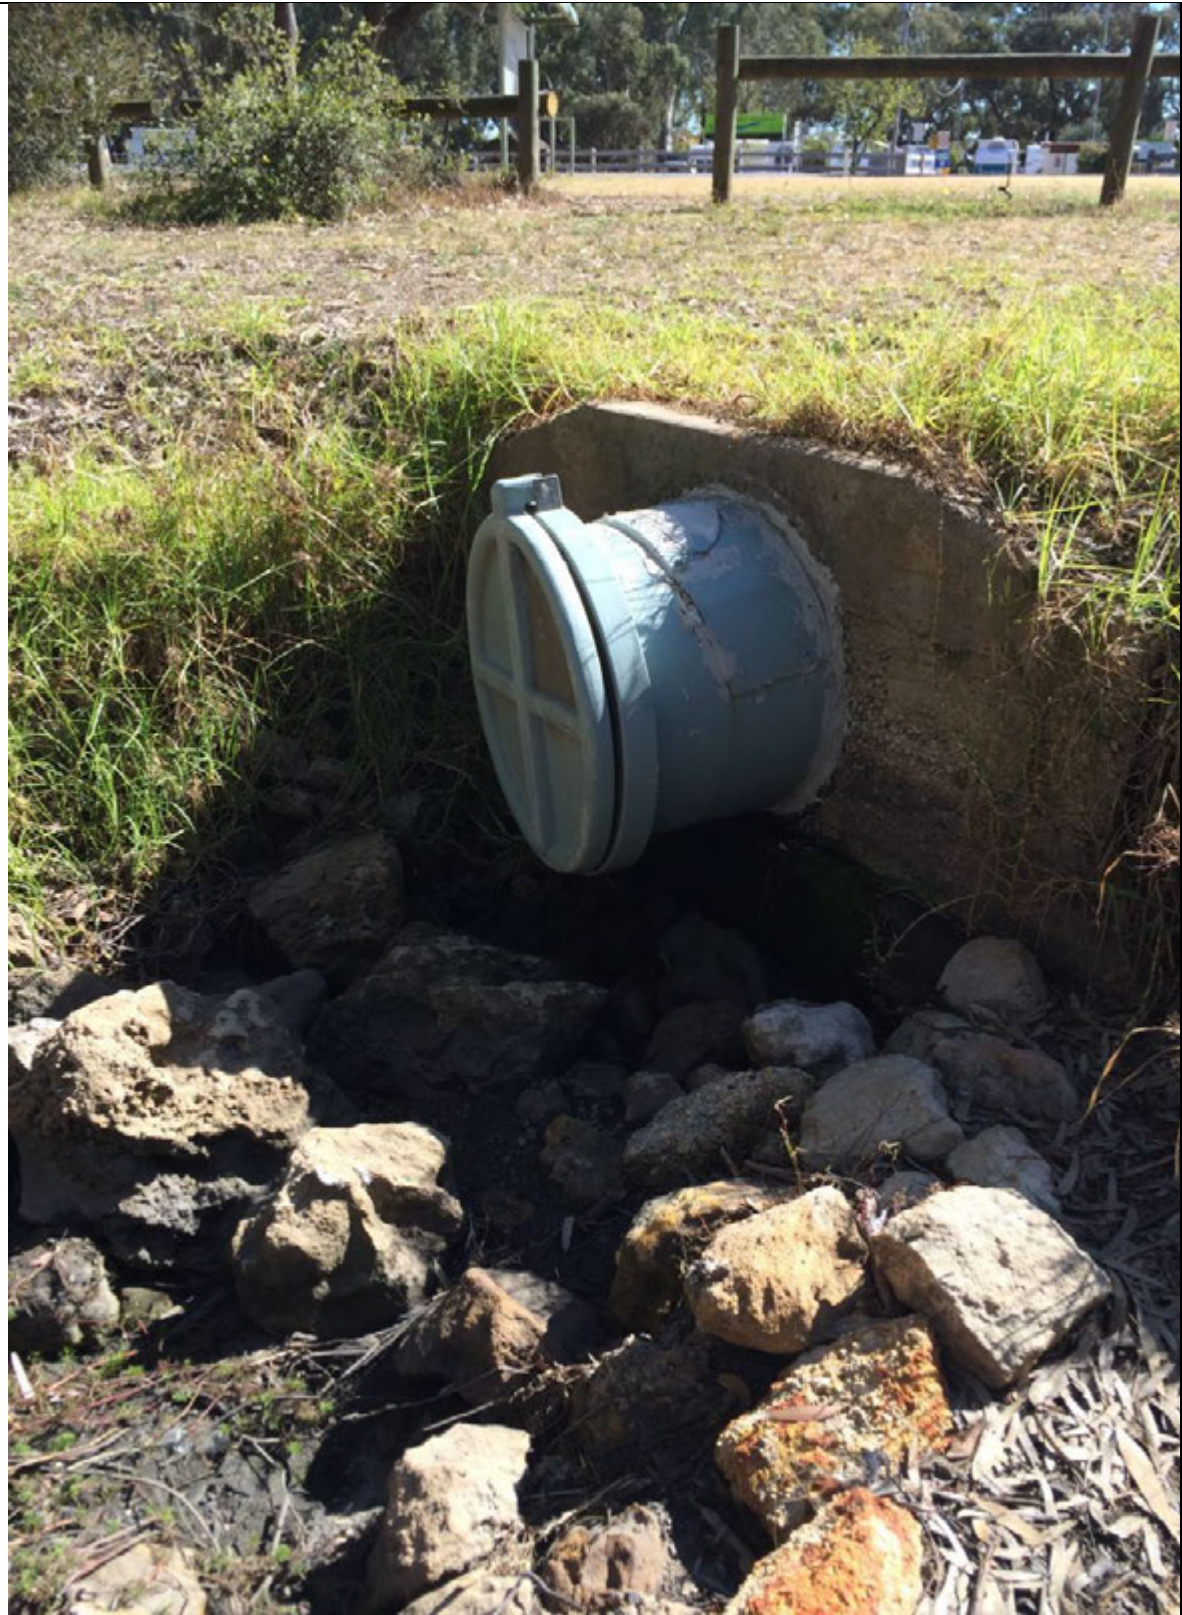
Photo 09 – One way culvert at Lyle St

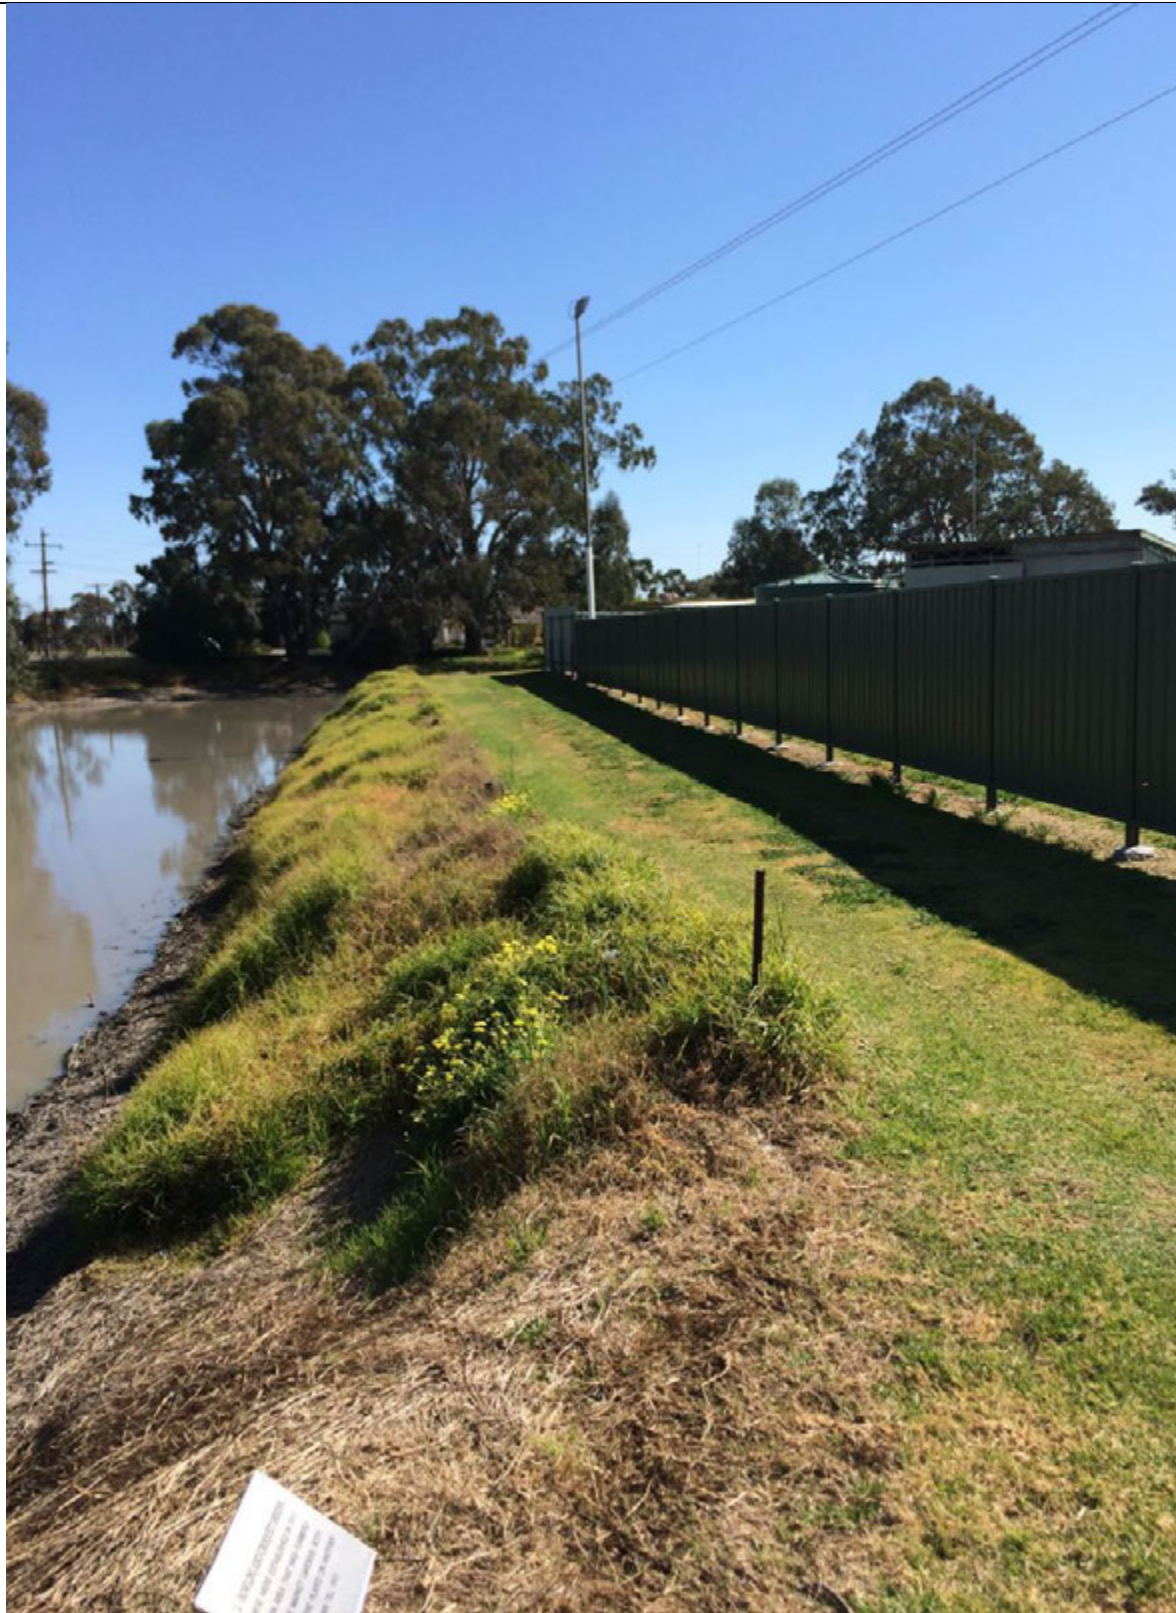
Photo 10 – Potential Levee location behind the lawn bowls club

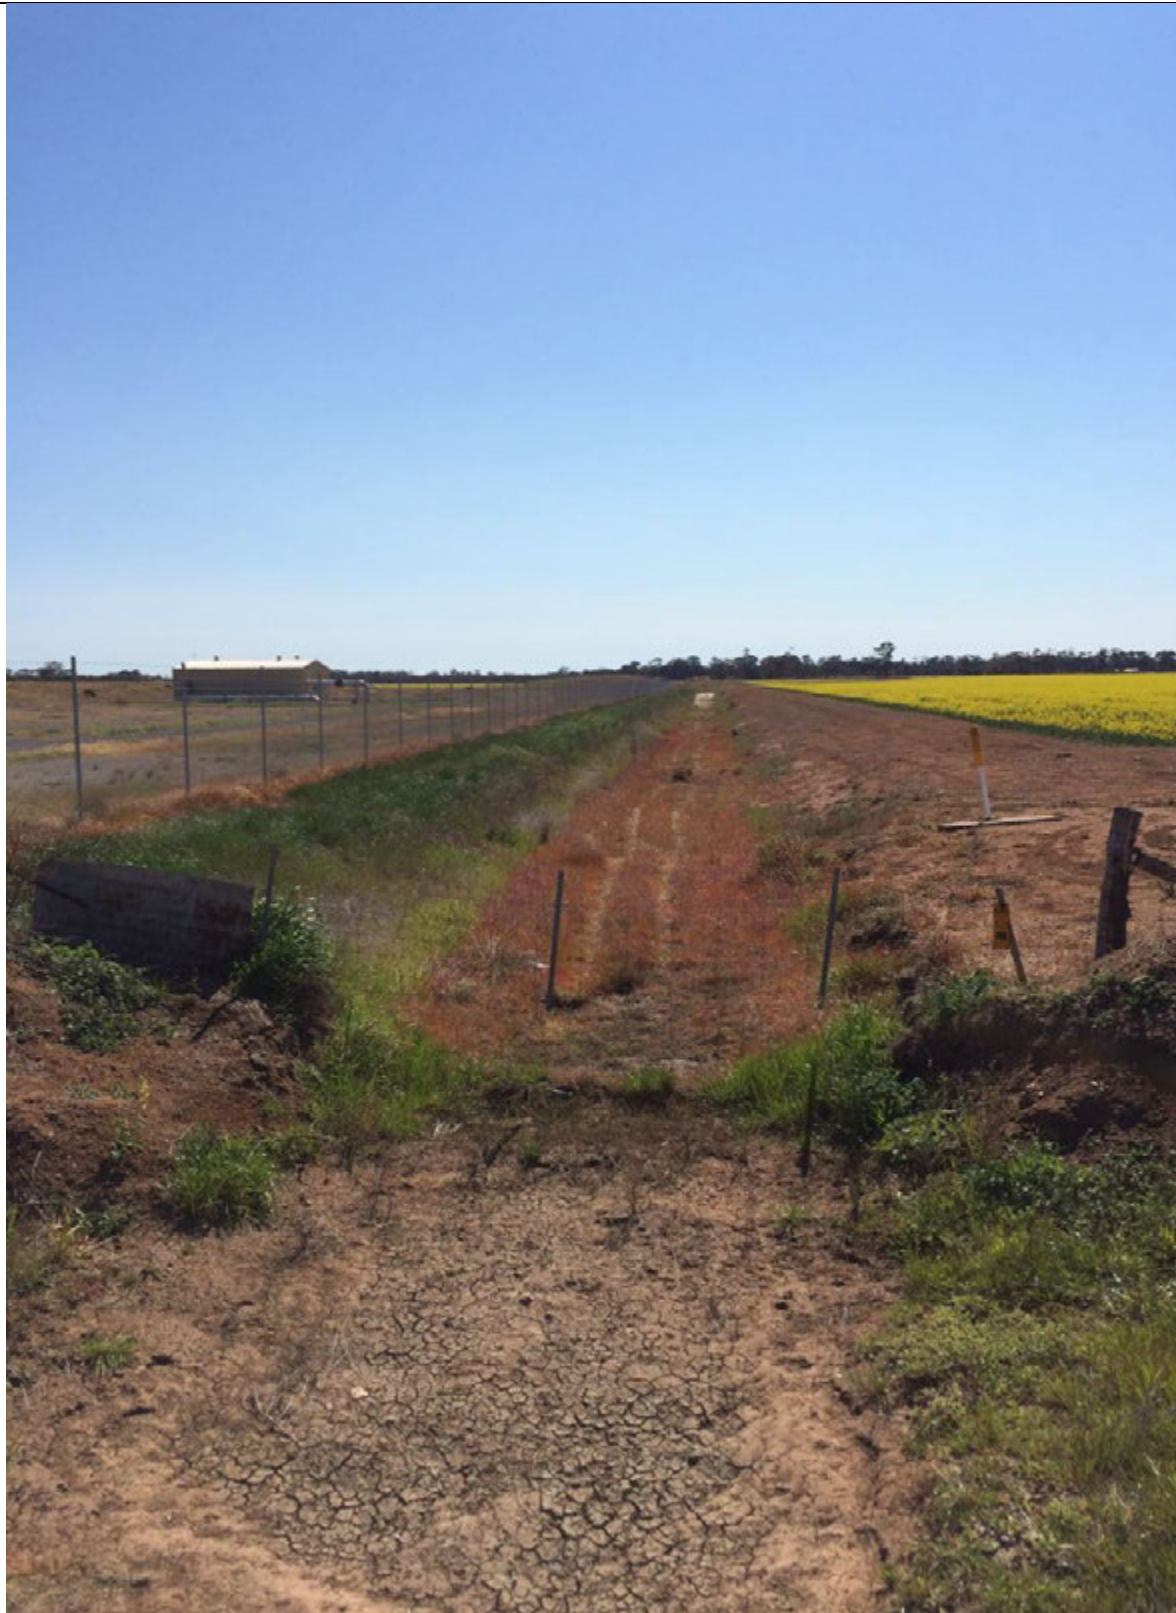
Photo 16 – Previous GMMWater Channel on Borung Highway (facing north)

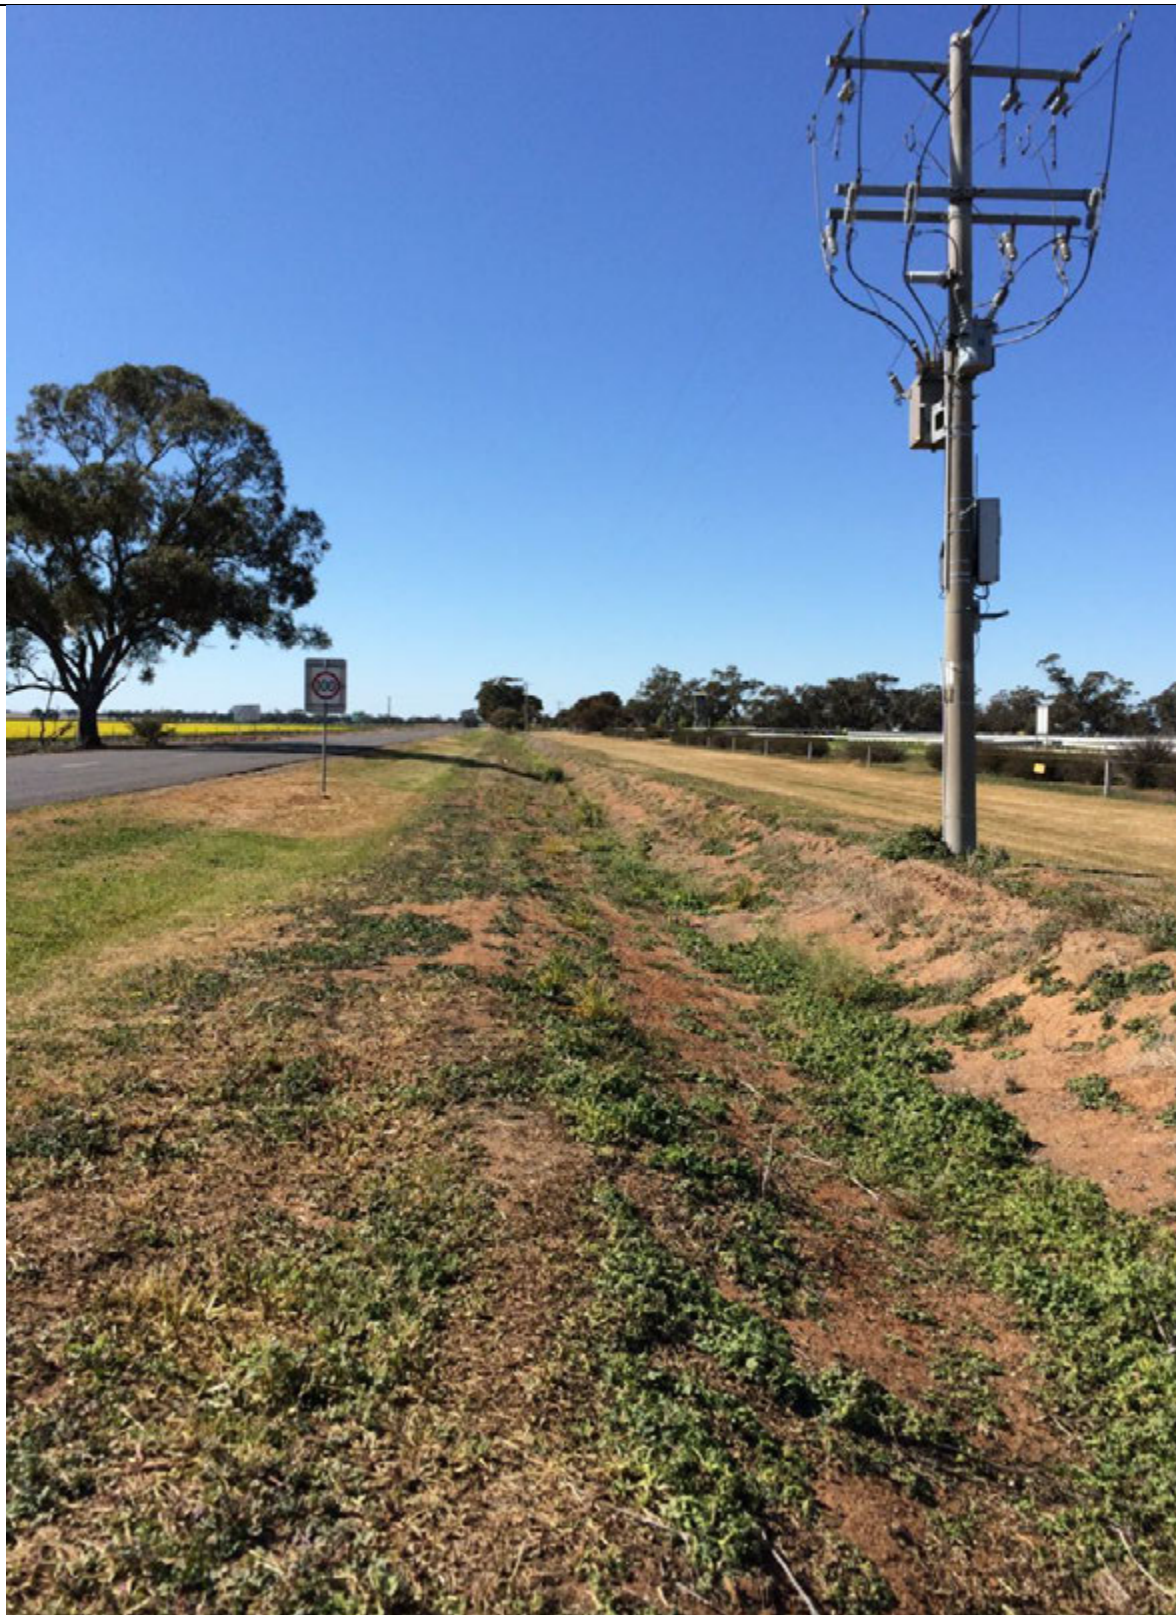
Photo 18 – Previous GMMWater channel on Borung Highway (facing east)

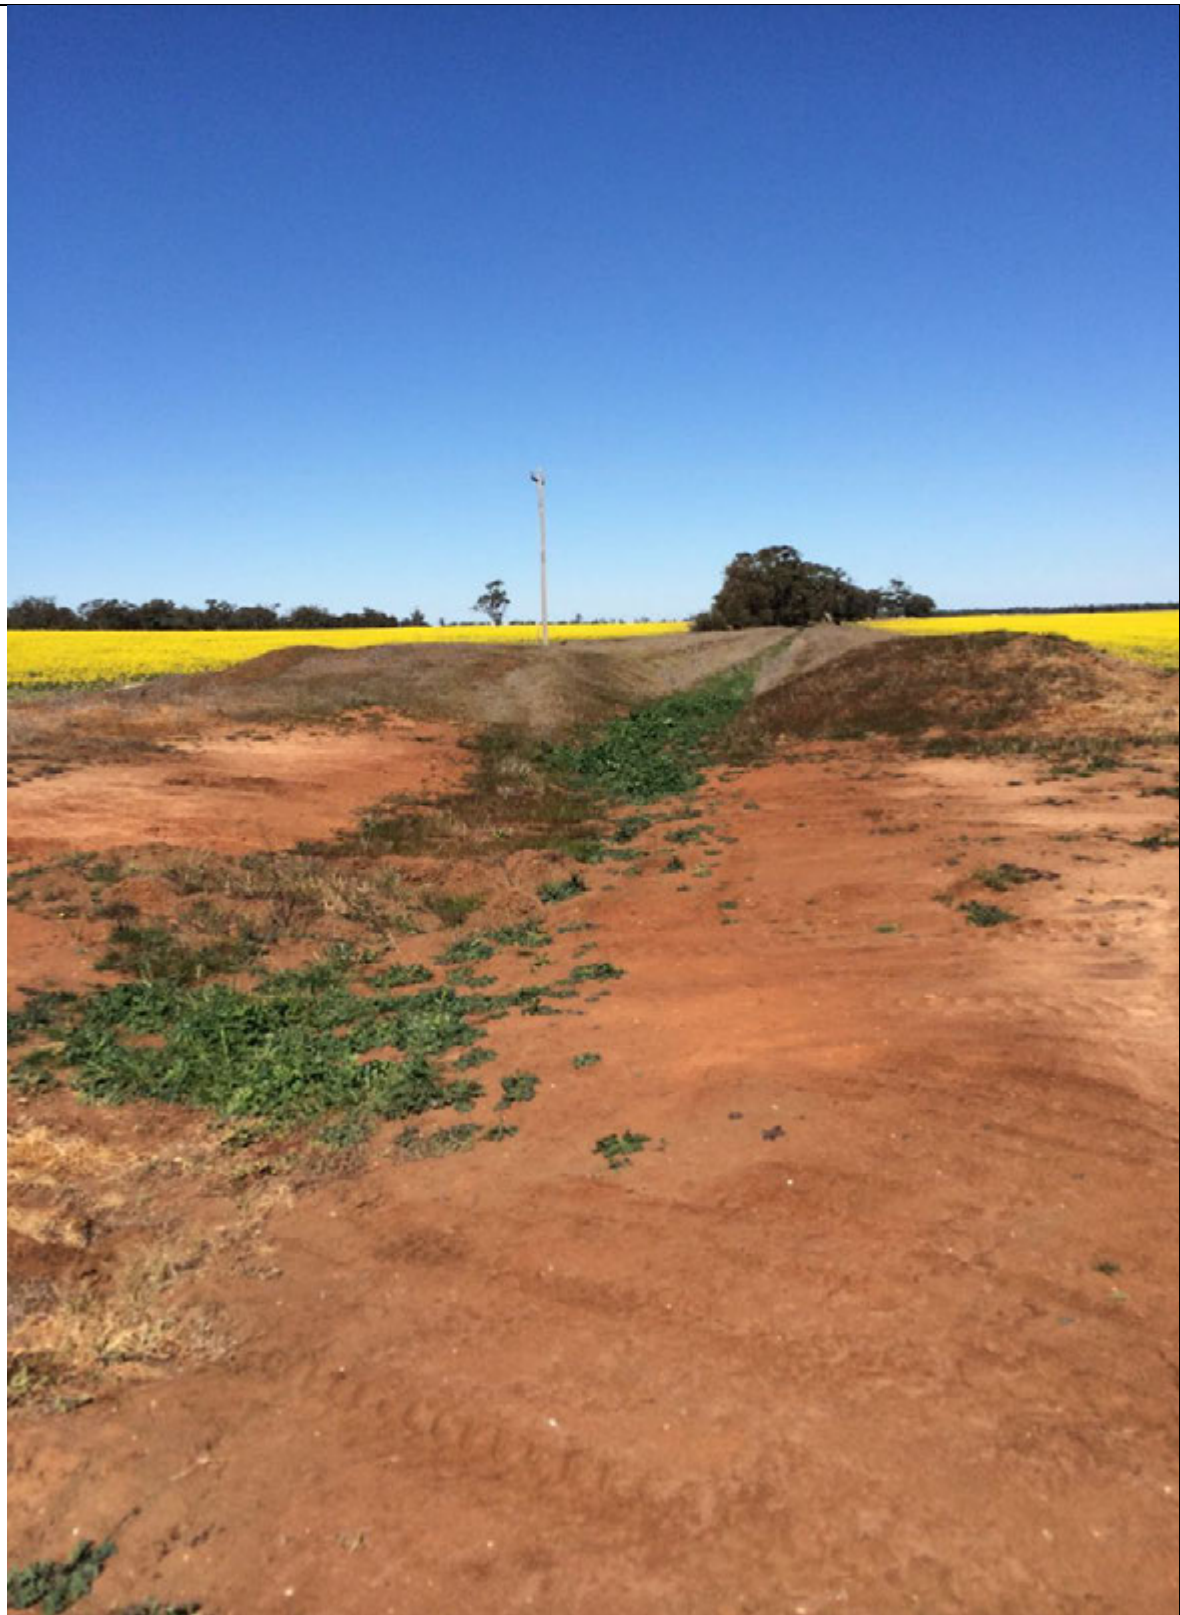
Photo 19 – Previous GWMWater channel on Borung Highway (facing south)

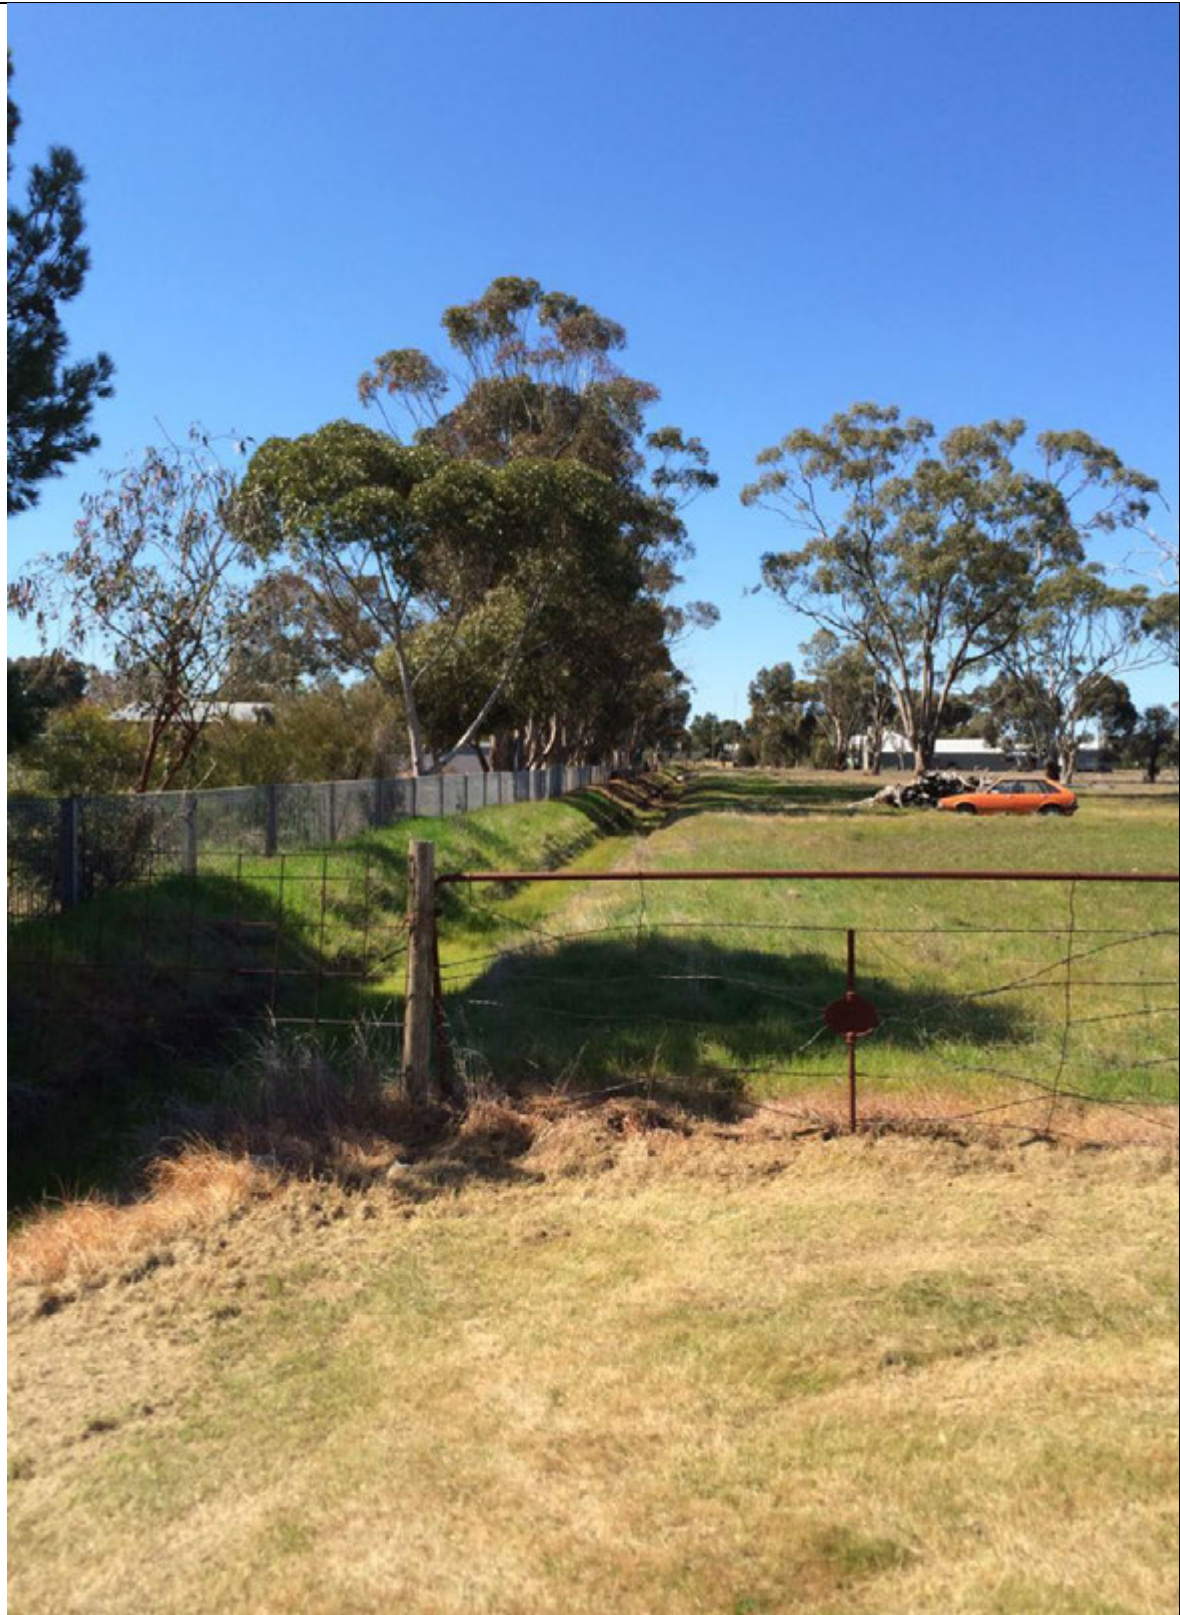
Photo 21 – Drainage through Wilken grain silos
