Warracknabeal and Brim Flood Investigation – Final Report

July 2016

Project Name	Warracknabeal and Brim Flood Investigation
Client	Wimmera CMA
Client Project Manager	Clare Wilson
Water Technology Project Manager	Ben Hughes
Report Authors	Ben Hughes
Job Number	3532-01
Report Number	R04
Document Name	Final Report

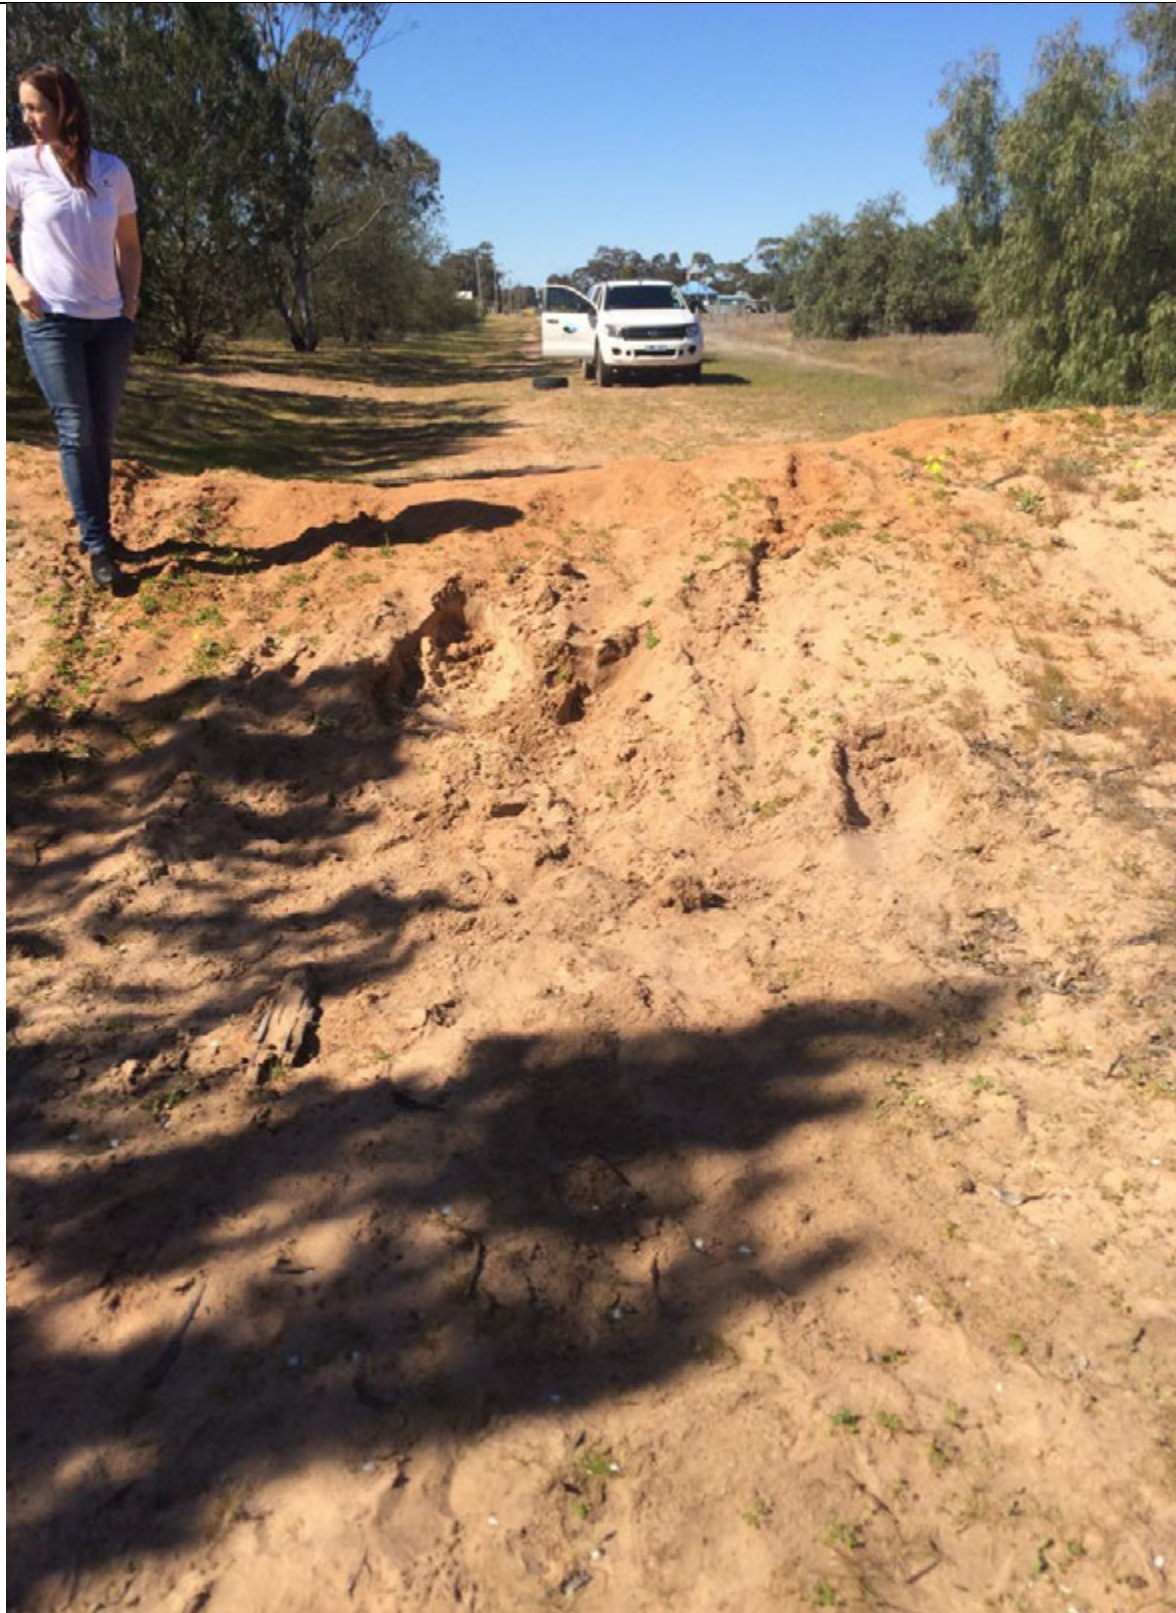
Photo 22 – Levee at Kings Street Brim

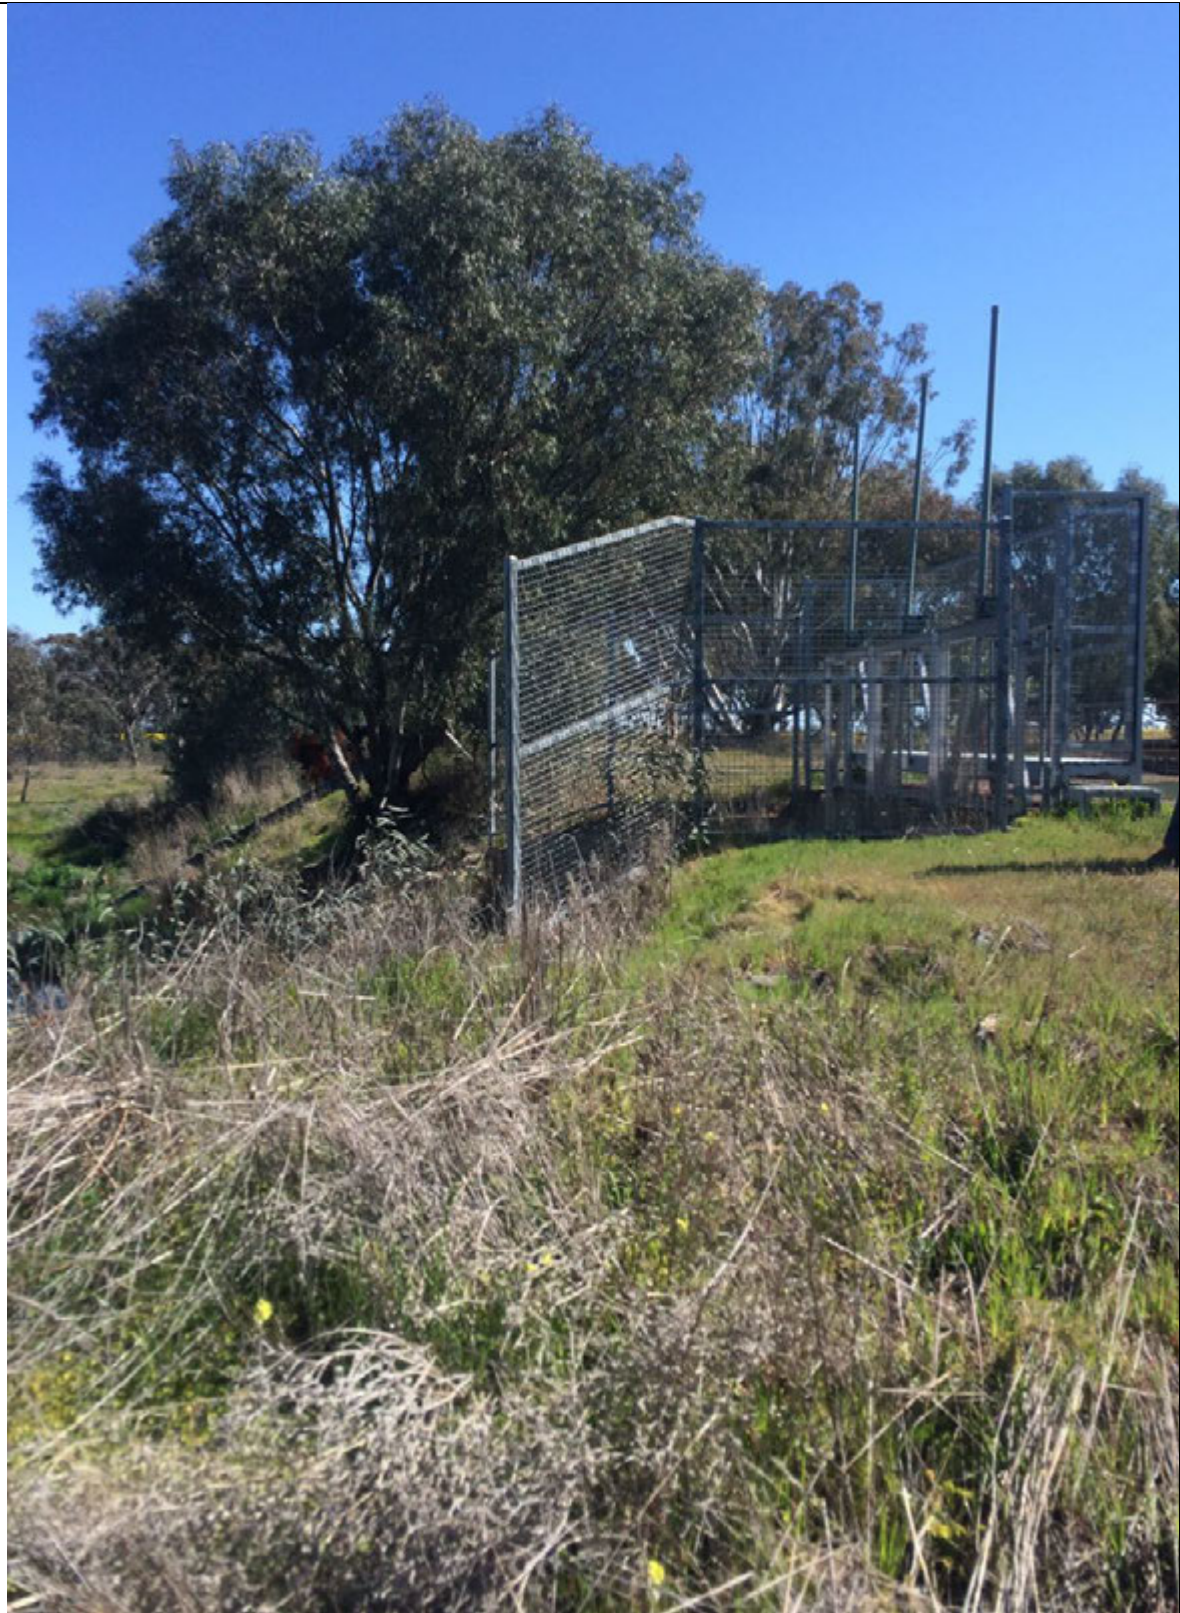
Photo 23 –Brim Weir Upstream

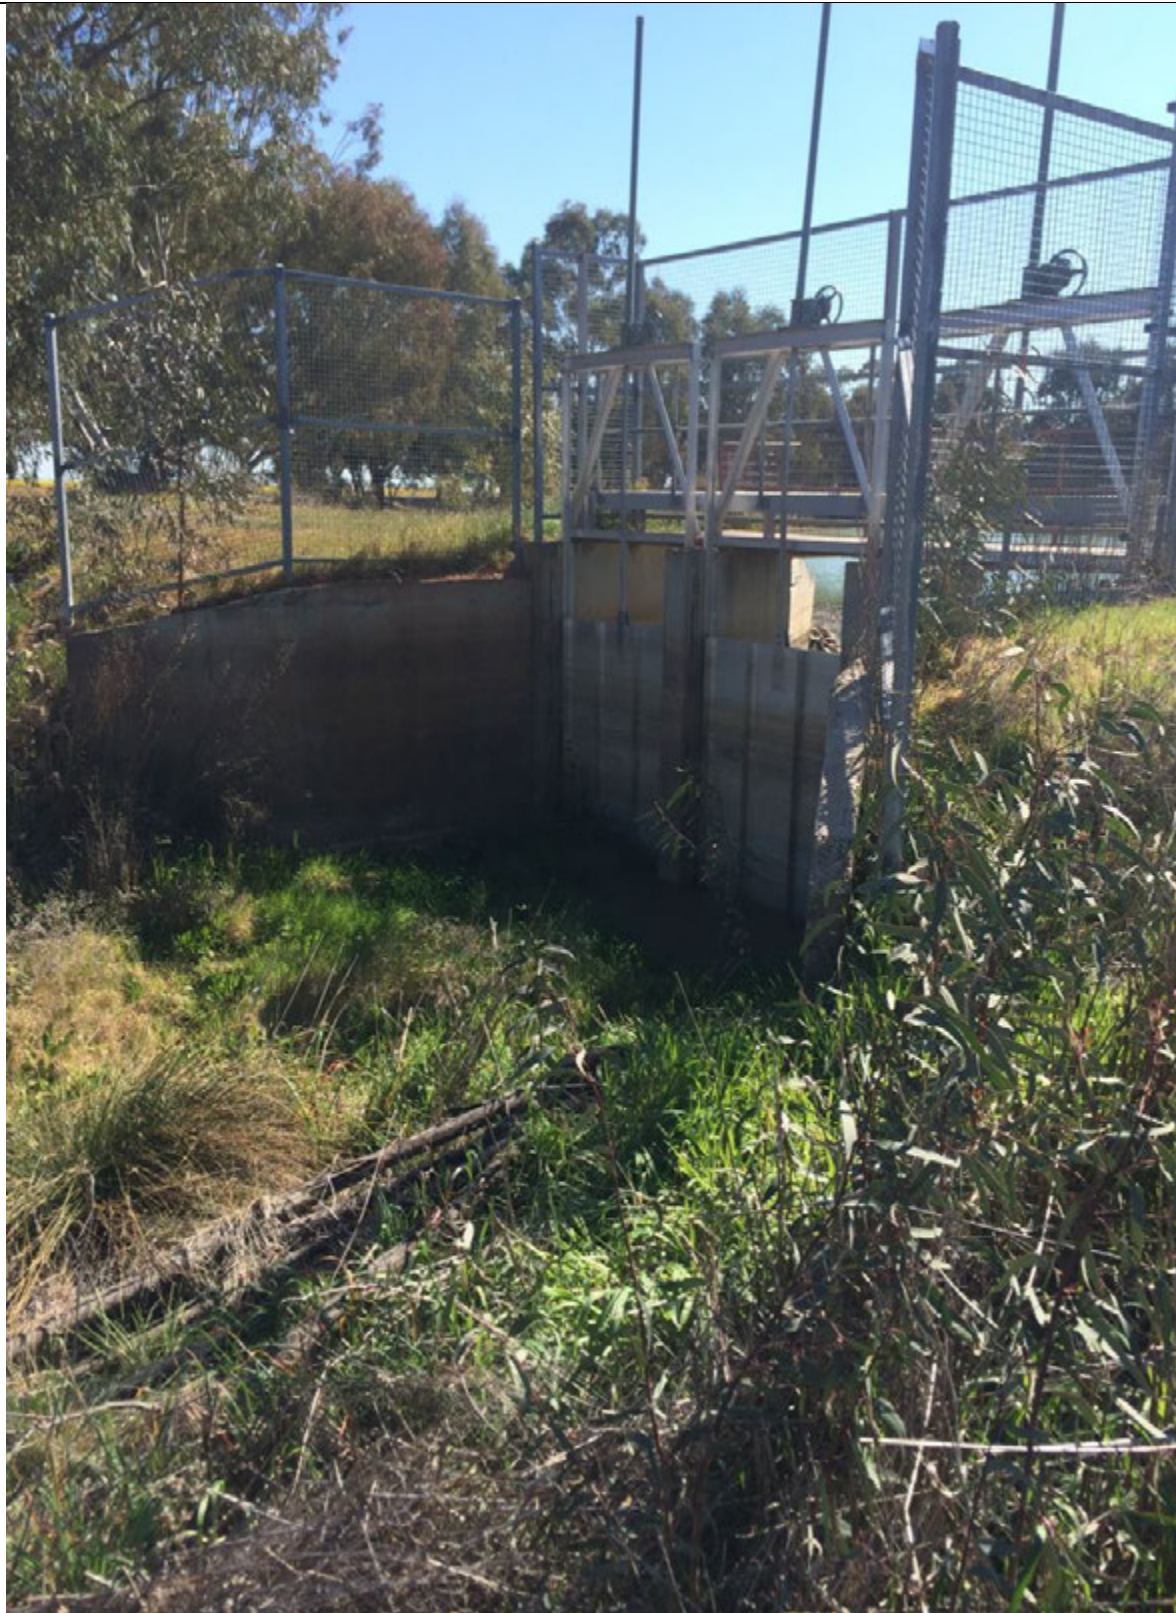
Photo 24 –Brim Weir upstream gates

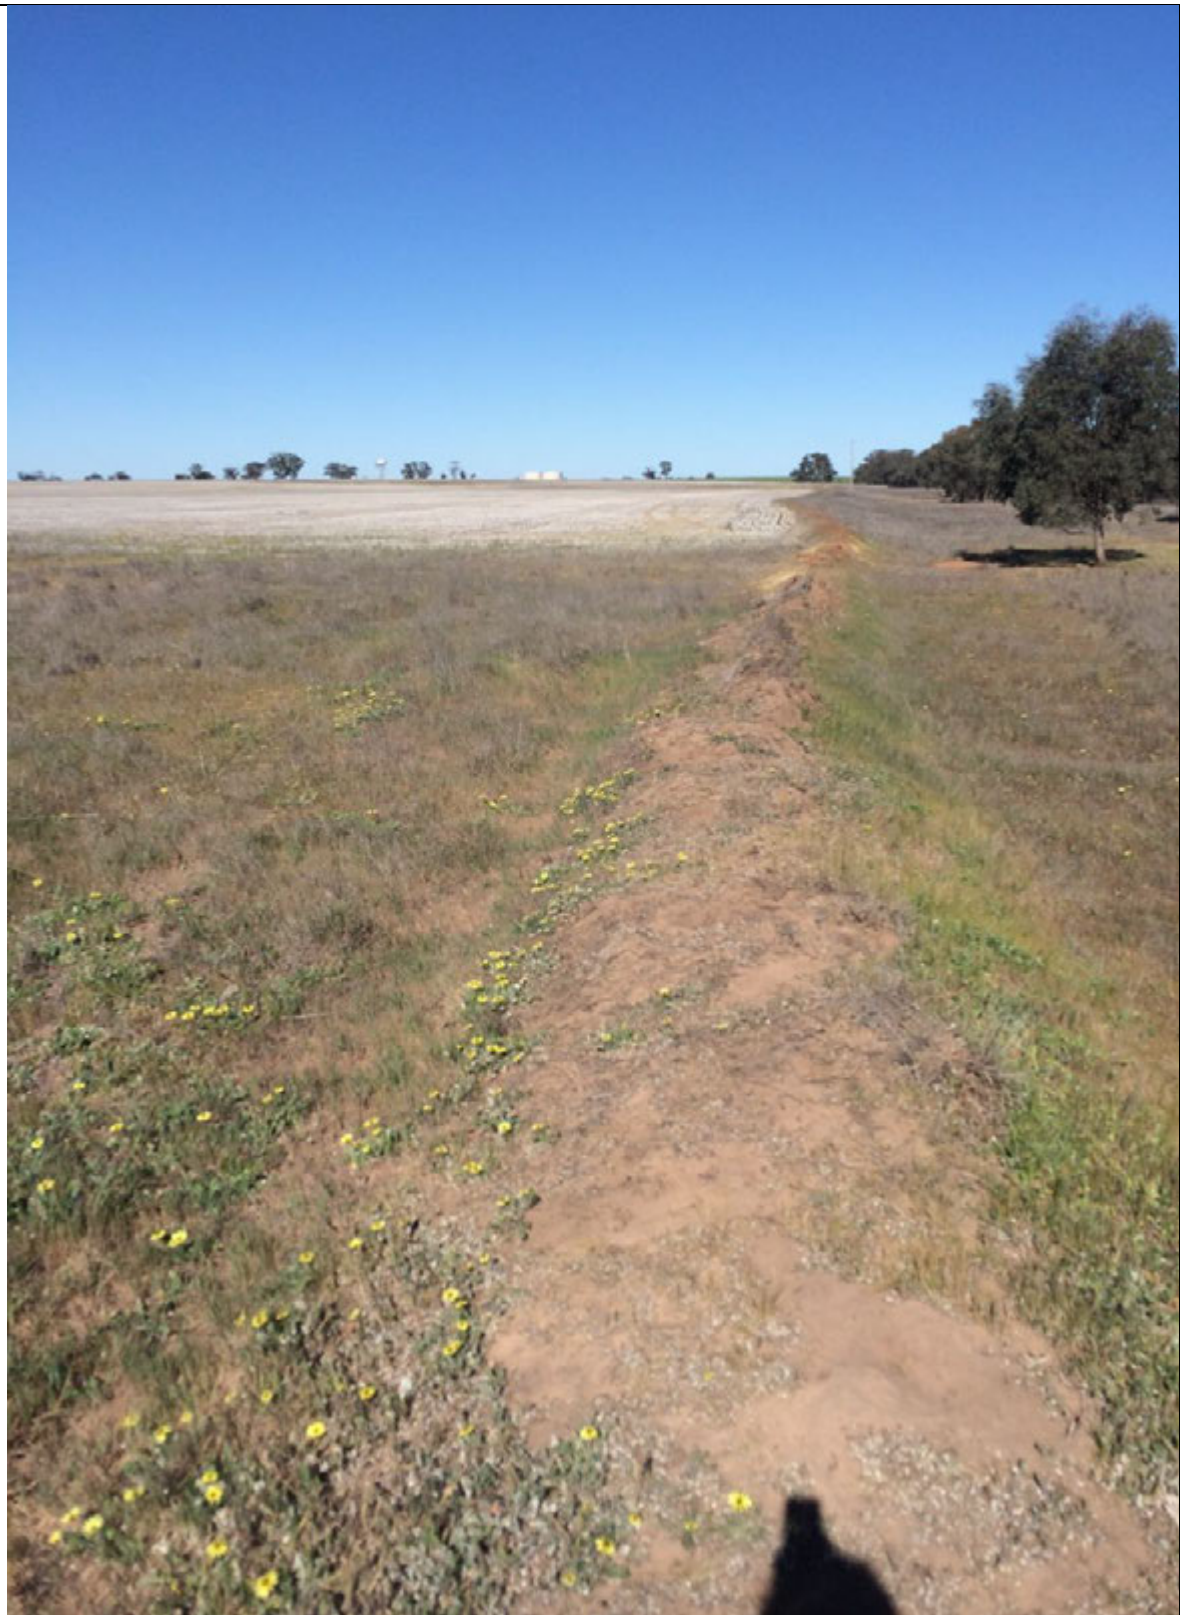
Photo 25 –Levee along private property boundary south east of the weir pool

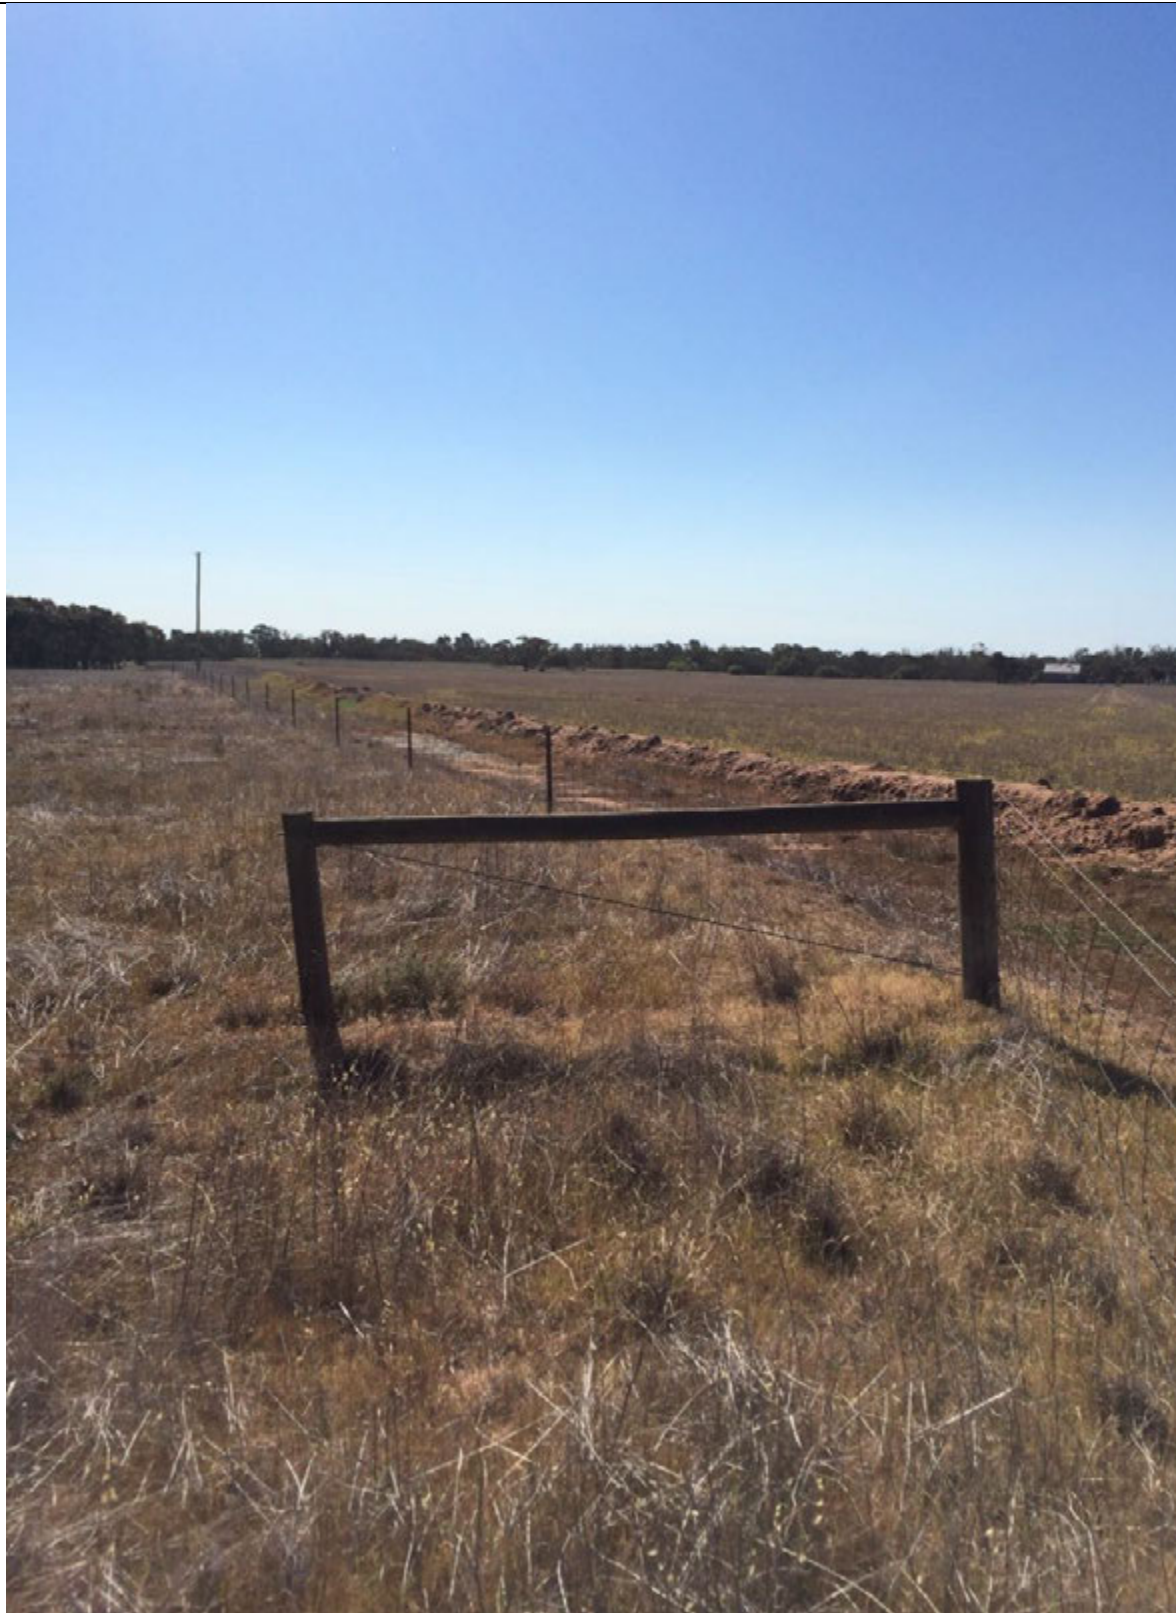
Photo 26 –Levee along private property boundary south east of the weir pool

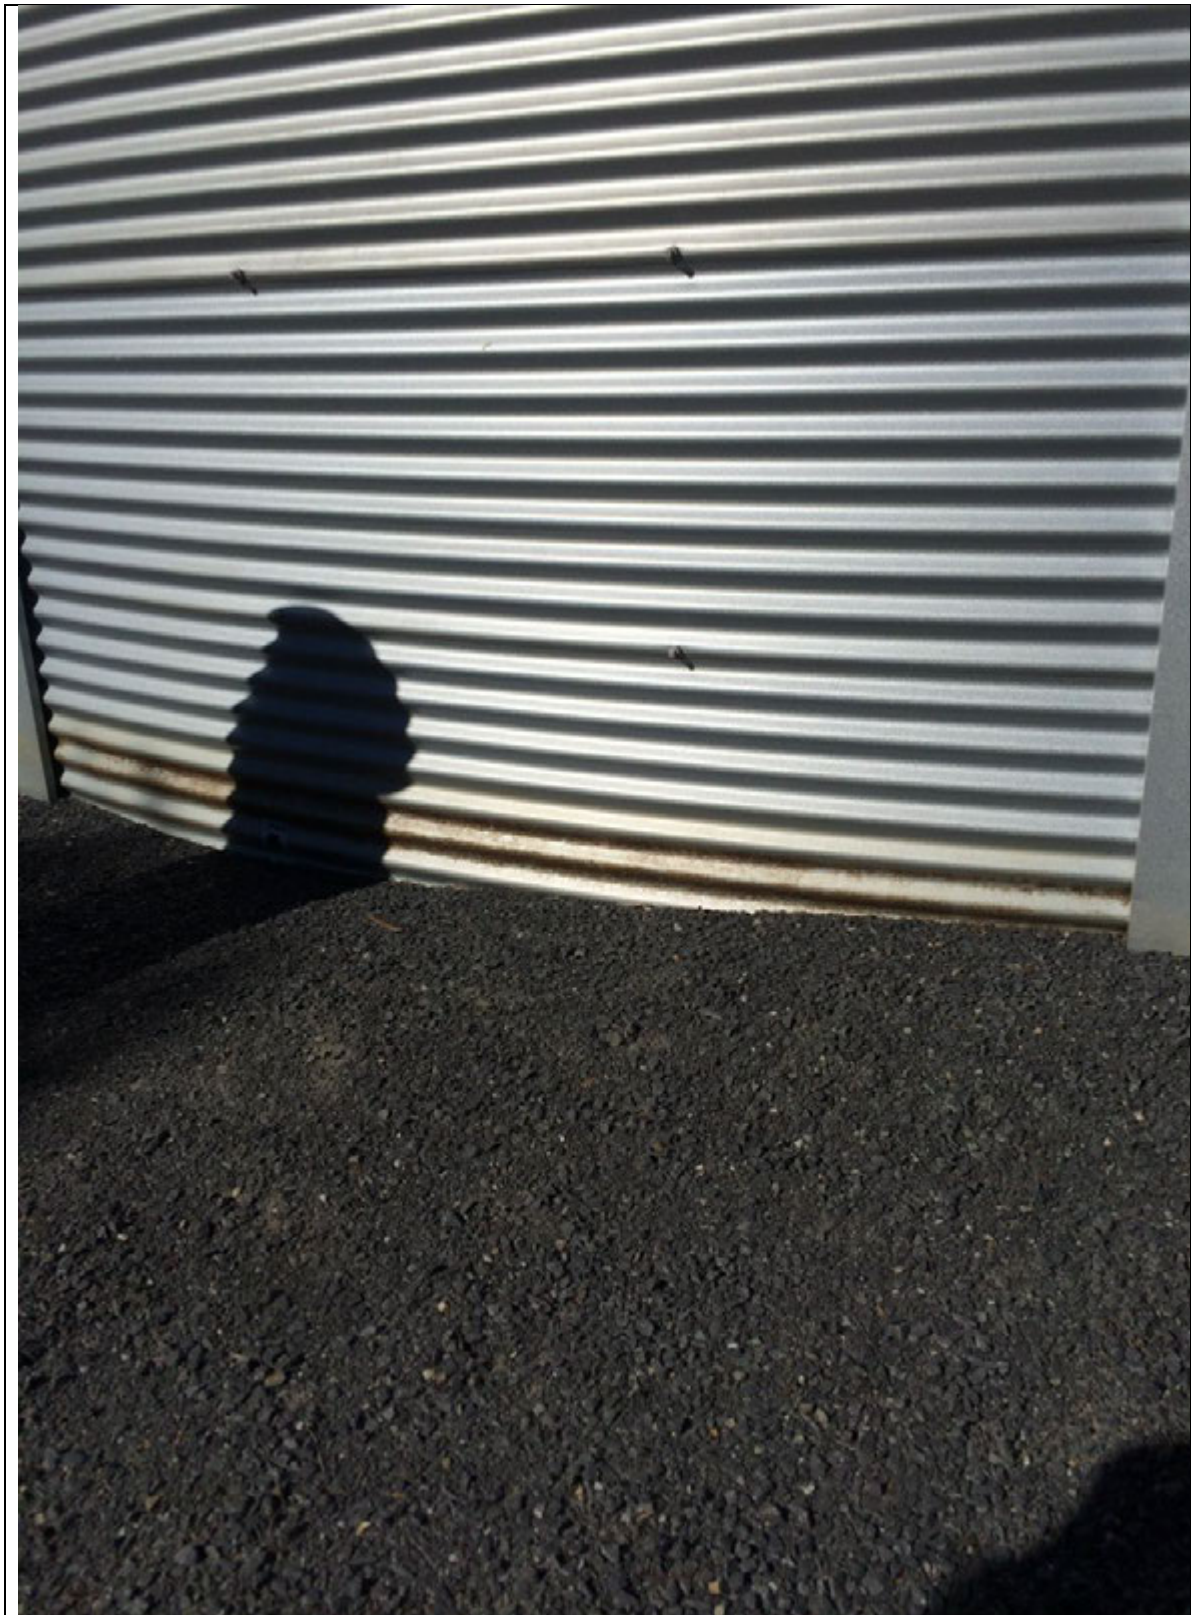
Photo 27 – Flood level on the Brim Recreation Reserve water tank

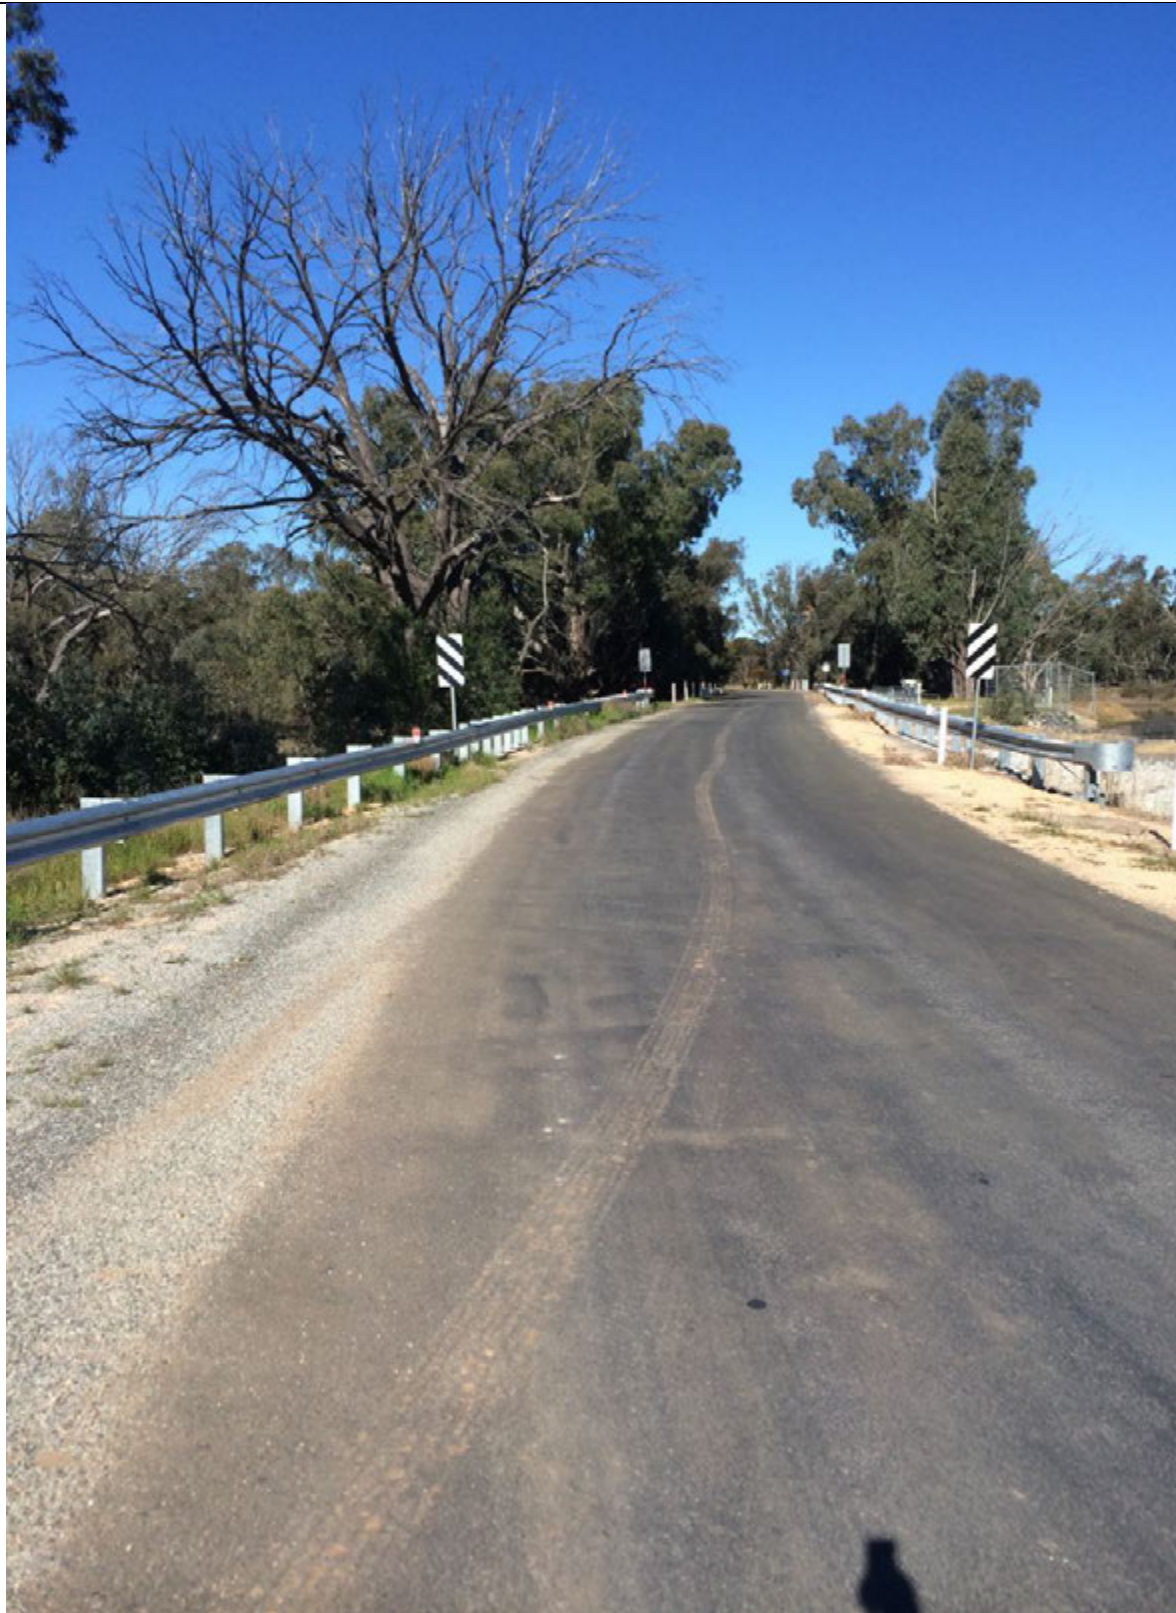
Photo 30 – Brim weir downstream
