Mount William Creek Flood Investigation Final Report

Reference: R.M20045.007.01.FinalReport.docx
Date: December 2014

Prepared for: Wimmera Catchment Management Authority

Prepared by: BMT WBM Pty Ltd (Member of the BMT group of companies)

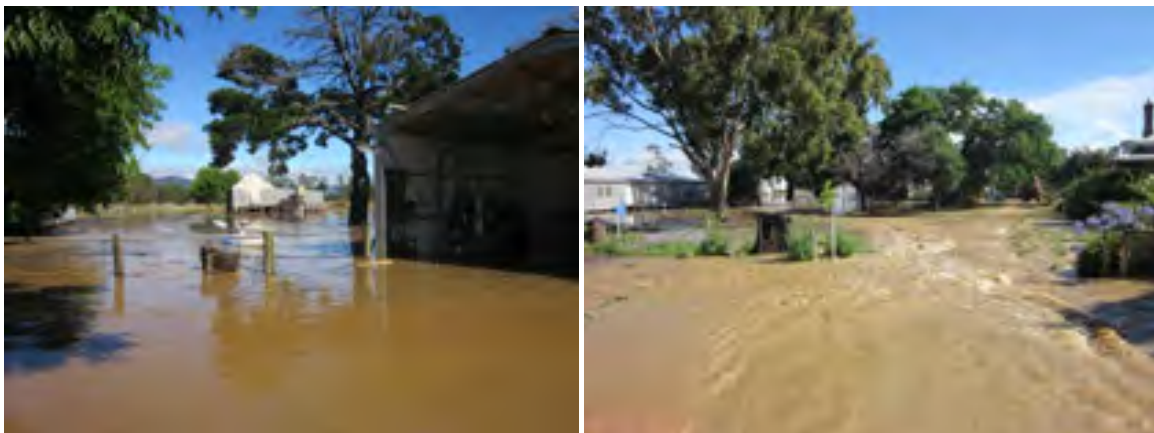
Figure 3 Flooding of a property on Ararat – Halls Gap Road, Jallukar (left photo 1, right photo 2)

Flood marks and photographs collected in the Jallukar region clearly highlighted the initial calibration of the January 2011 flood event was not adequately reproducing the flooding extents. Figure 1 shows the initial calibration (shown in red) compared with the final calibration (shown in blue). The initial model calibration shows flooding confined to Mount William Creek which does not extend into the surrounding floodplain. However flood photos and flood marks collected (pink dots) for the region show significant flooding in the area during the January 2011 flood event. Refer to figure 2 for photo 1 and 2. The location of where these photos were taken is shown in figure 1.
