Warracknabeal and Brim Flood Investigation – Hydrology and Hydraulics

Project Name	Warracknabeal and Brim Flood Investigation
Client	Wimmera CMA
Client Project Manager	Clare Wilson
Water Technology Project Manager	Ben Hughes
Report Authors	Ben Hughes
Job Number	3532-01
Report Number	R01
Document Name	Hydrology and Hydraulics Report

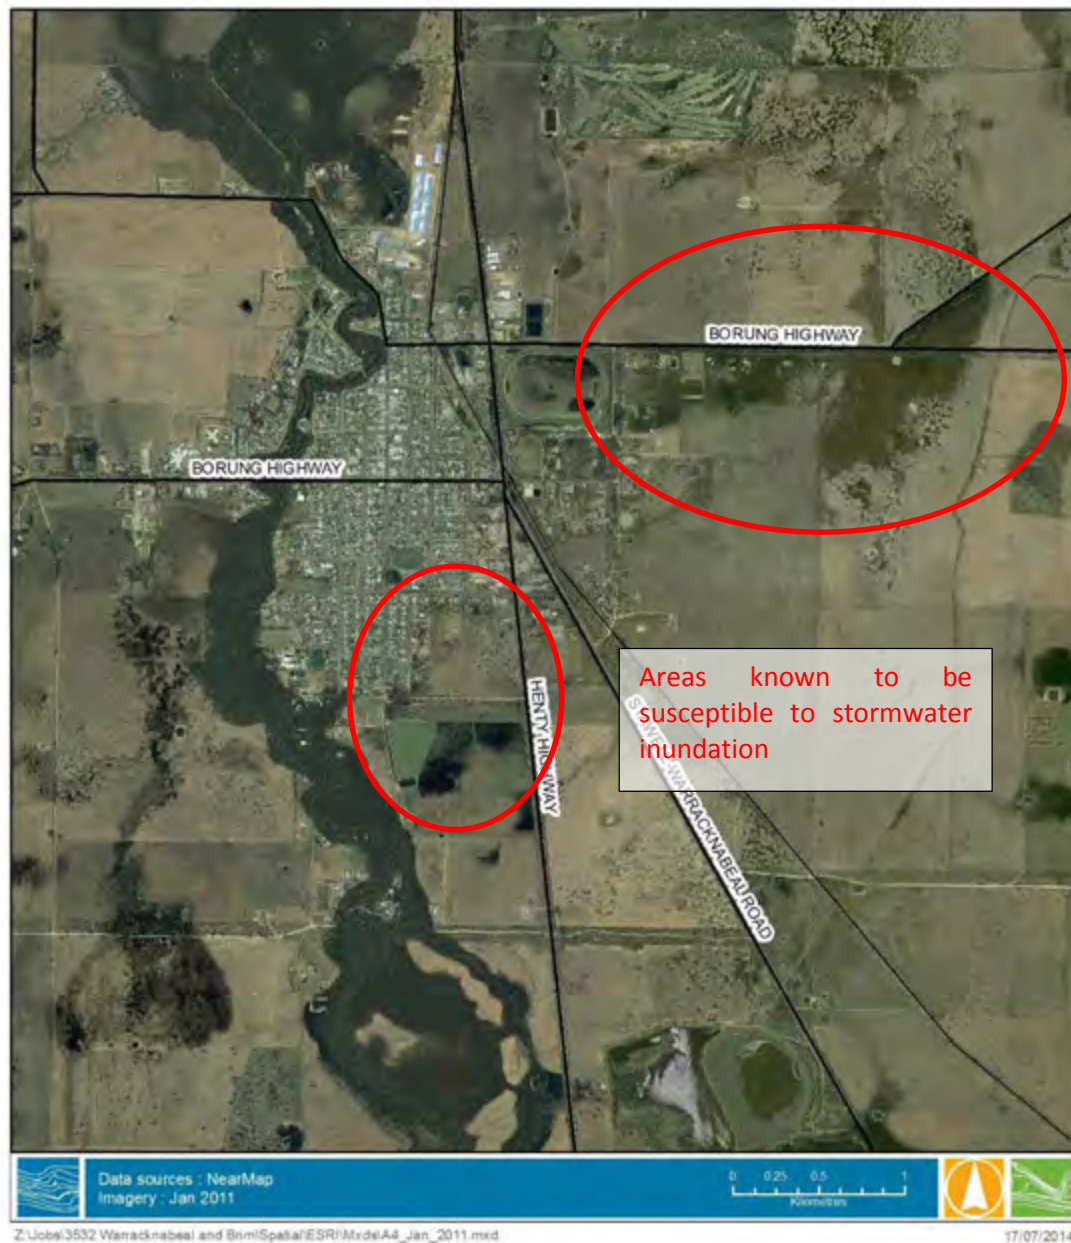
Figure 6-1 Inundation in Warracknabeal observed 19th January 2011 (NearMap)

This is demonstrated in Figure 6-1, showing inundation in Warracknabeal during the January 2011 storm event. These areas were not inundated from the creek but from local runoff. The impact of the Borung Highway and Warracknabeal Birchip Road is highlighted especially well. This area was visited during the site inspection and issues surrounding the localised catchment area to the south and former GWMWater infrastructure were raised. Gardiner and Cemetery Street were highlighted as areas with potential stormwater issues by Yarriambiack Shire Council Staff. There were several properties in these areas inundated below floor.

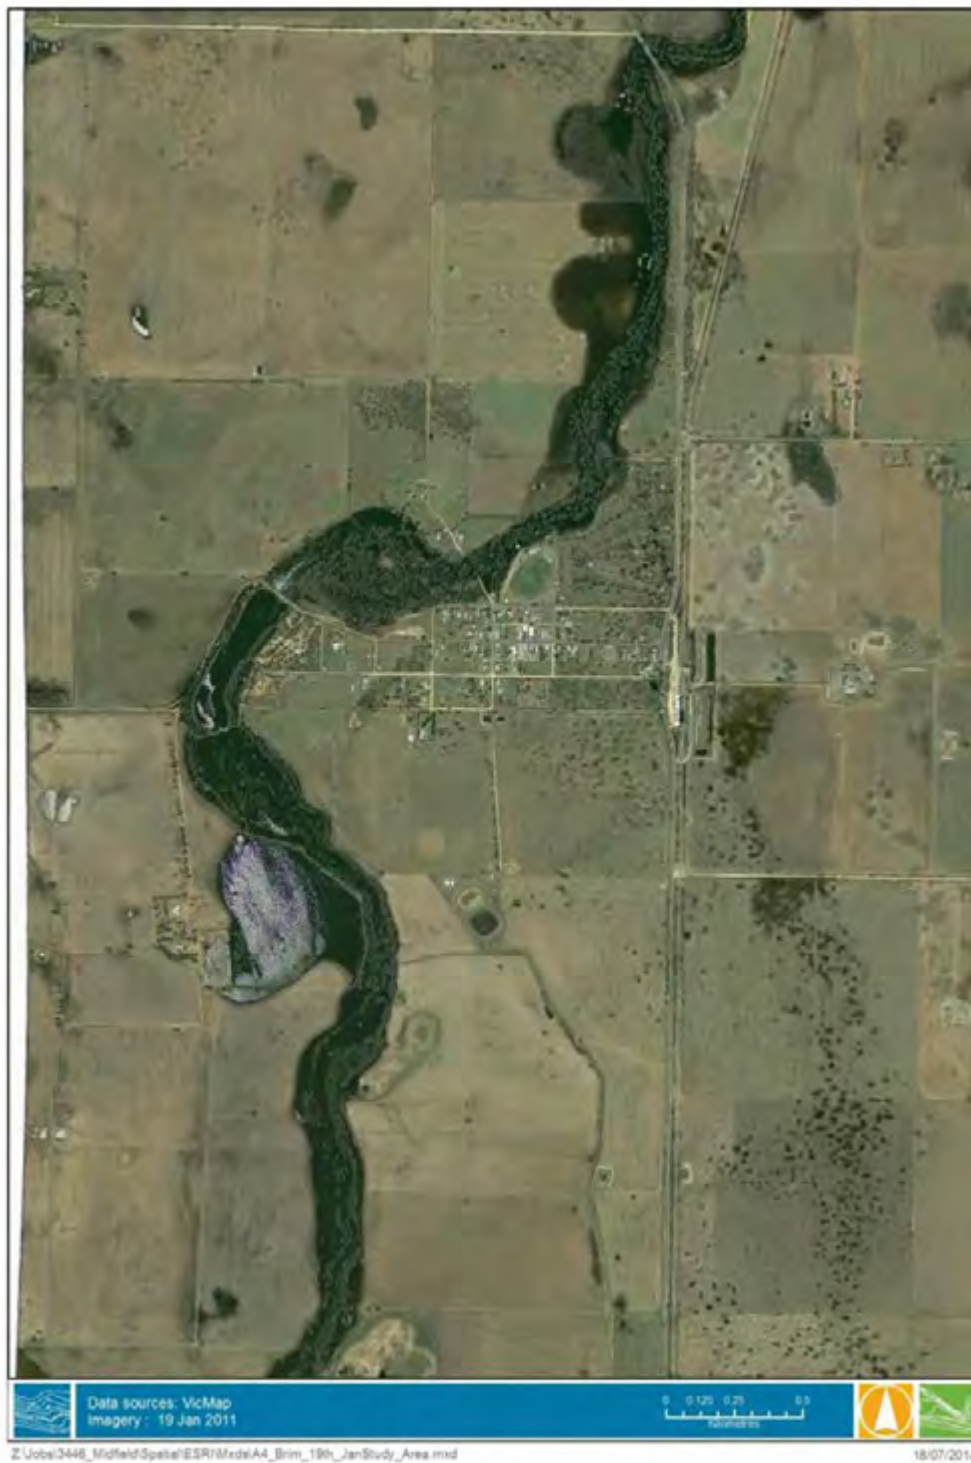
Figure 6-2 Inundation in Brim observed on 19 January 2011

Direct stormwater inundation is not as significant in Brim as in Warracknabeal, aerial imagery of the January 2011 event show some localised pooling of water however no properties were reported as inundated by Wimmera CMA, Yarriambiack Shire Council or during the site inspection.

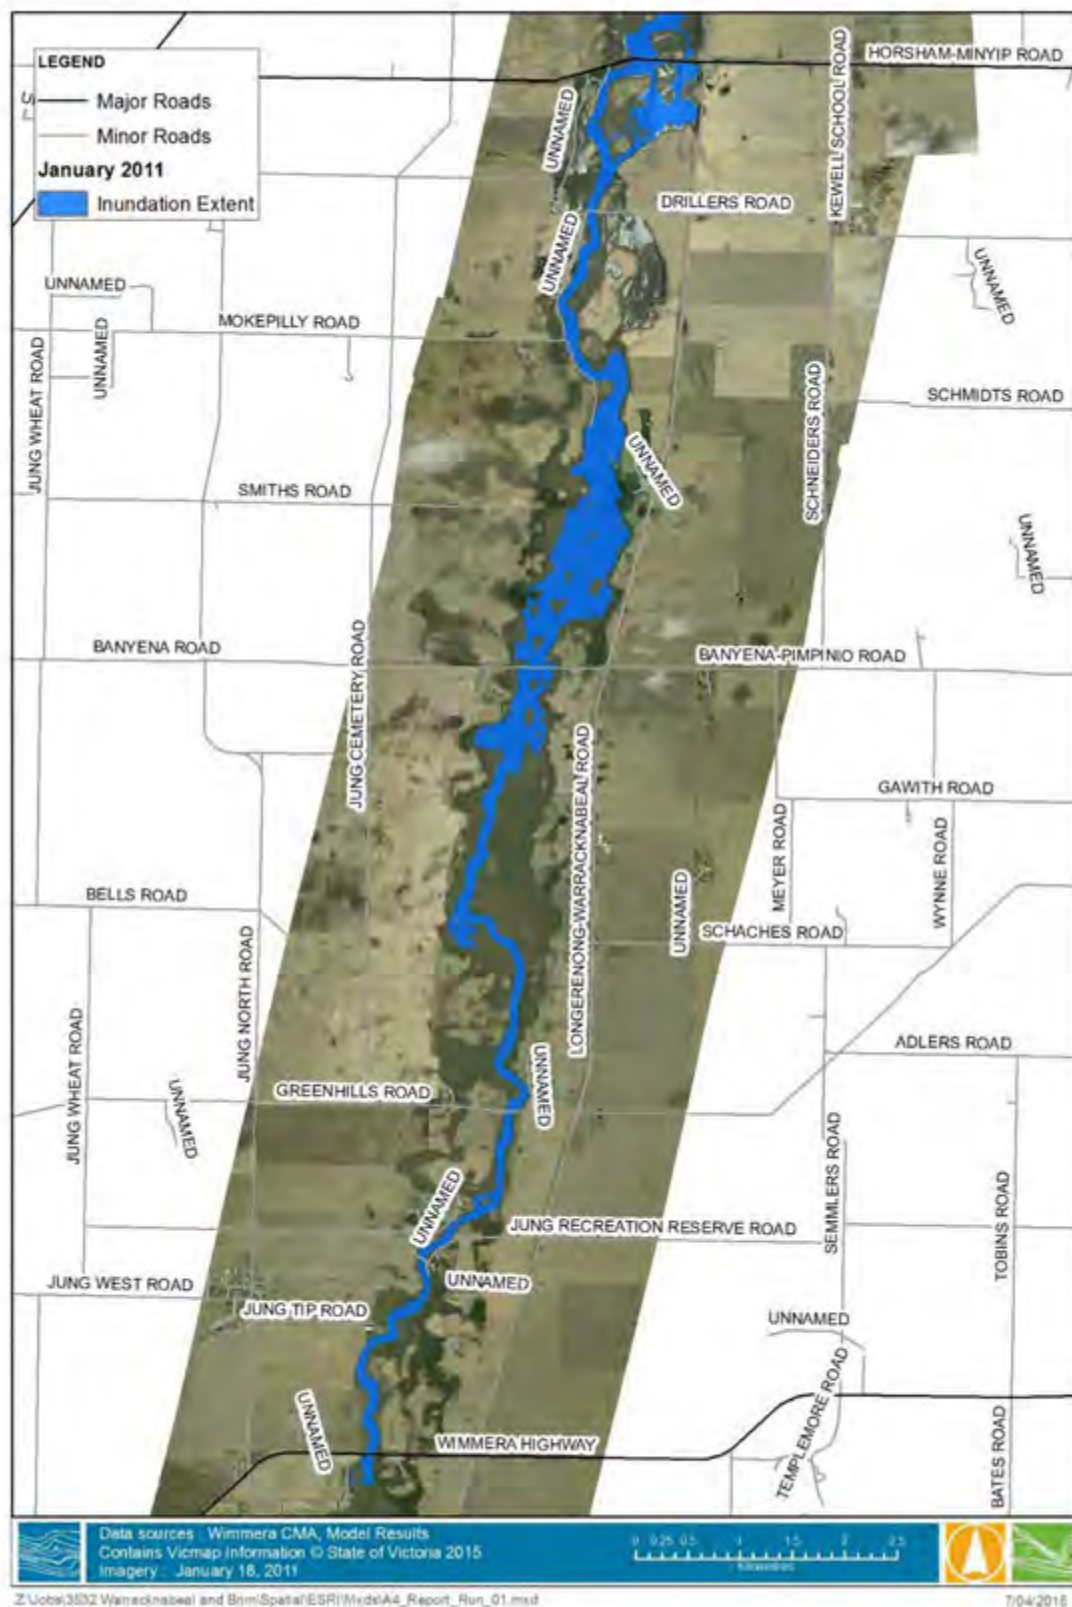
Figure 7-5 Yarriambiack Creek floodplain model – January 2011 gauged flow flood extent

Once it became apparent matching the current rating curve was not possible, the broader Yarriambiack Creek floodplain model was tested using the current adopted January 2011 hydrograph to broadly test how the gauged flows and observed peak water levels matched. The comparison indicated the current flow estimates of the January 2011 event were well below that which actually occurred. A comparison of the modelled extent overlayed on aerial imagery captured during January 2011 is shown in Figure 7-5, showing a significant underestimation.

Due to the large difference in observed inundation and model results using the January 2011 gauged flows the revised rating curve determined by the Wimmera Highway gauge model was used to determine a revised January 2011 hydrograph.

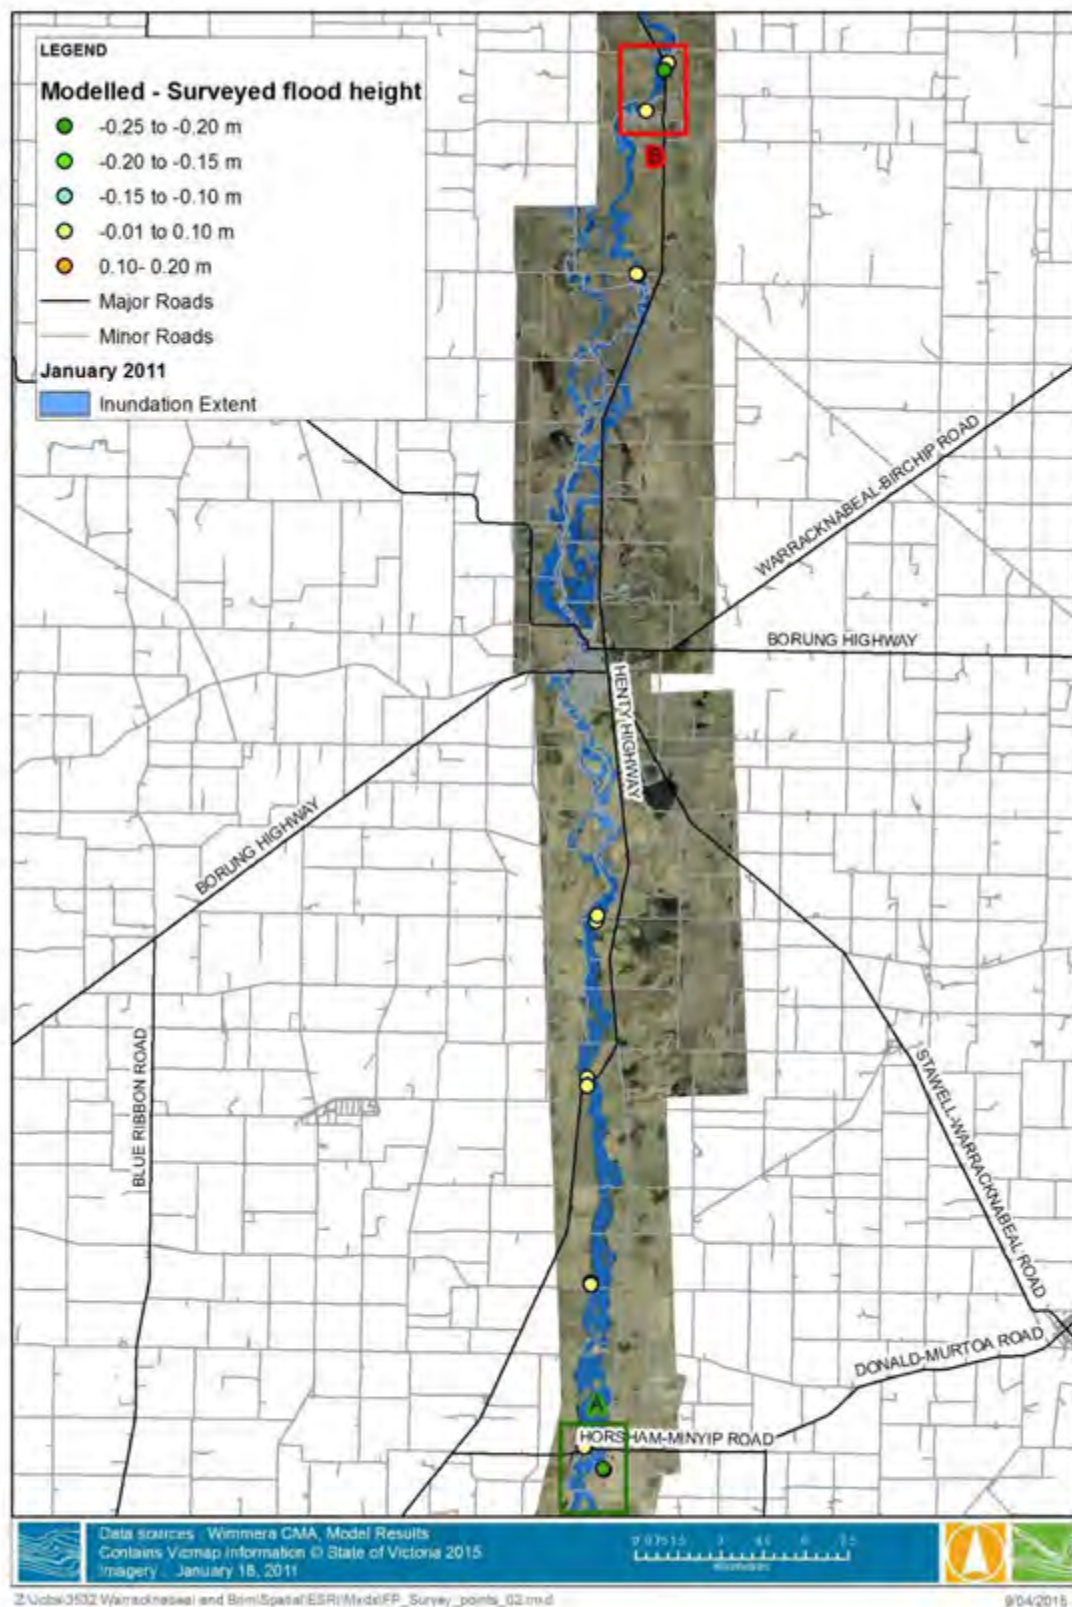
Figure 7-8 January 2011 – Ferguson and Perry Surveying peak flood height comparison

The Ferguson and Perry dataset included 24 flood marks spread across Yarriambiack Creek and the entire study area. The model calibration of the January 2011 event matched all of the observed flood heights within 0.25 m. Table 13 shows the range of differences between the modelled and surveyed peak flood heights with a graphic representation shown in Figure 7-8.

Figure 7-8 identifies the locations of the three points where the difference between the modelled and observed levels is greater than 0.1 m as area A and B. A closer perspective of these areas is shown in Figure 7-9 and Figure 7-10 respectively.

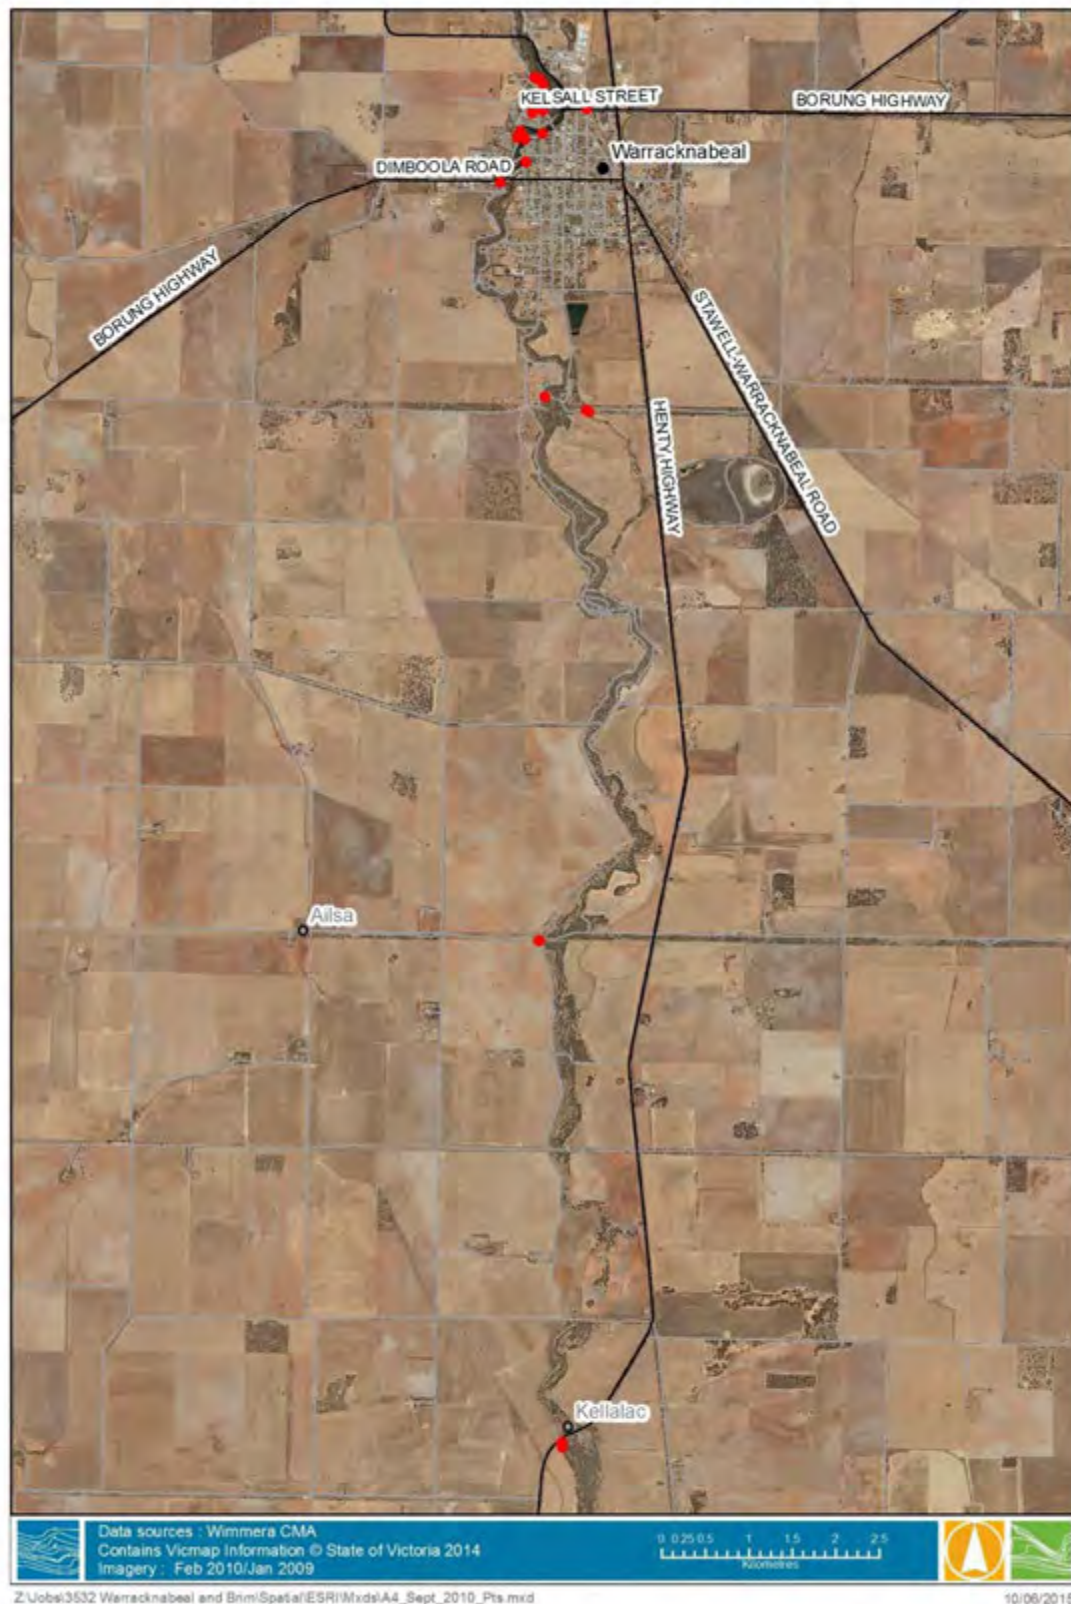
Figure 7-17 September 2010 surveyed peak flood heights

There were 22 peak flood heights surveyed along Yarriambiack Creek post the September 2010 event, their locations are shown in Figure 7-17. All of the points are located between Warracknabeal and Kellalac.

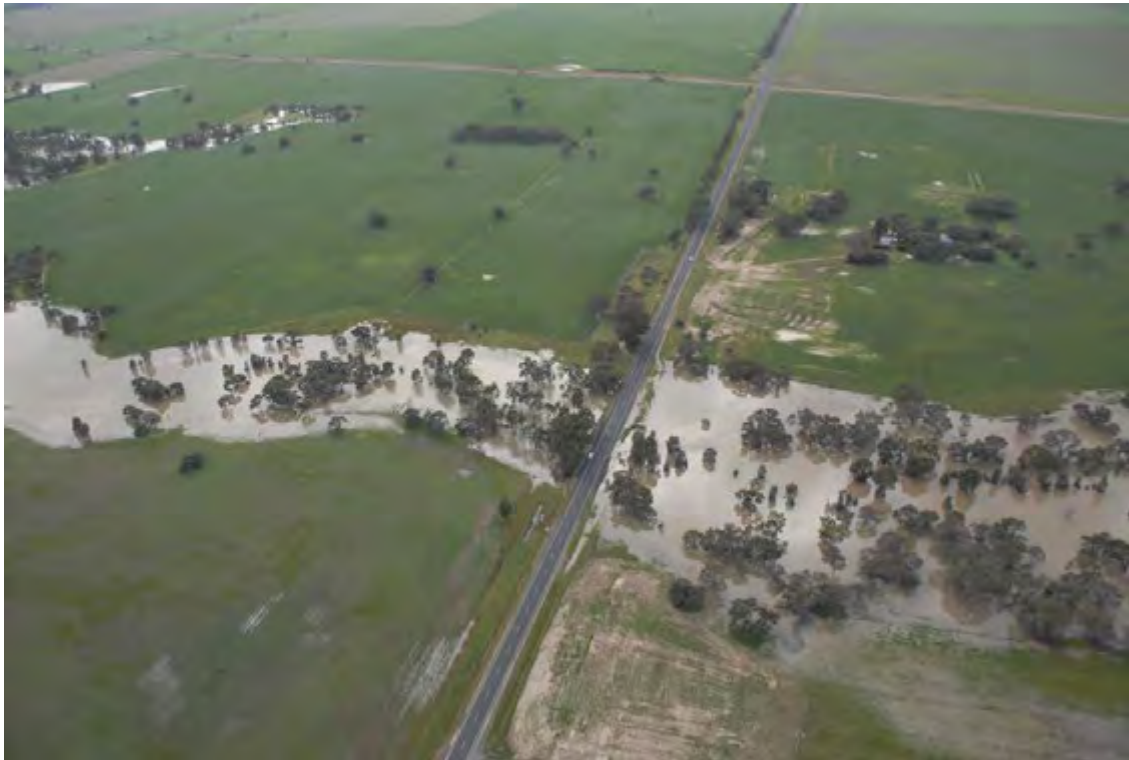
Figure 7-19 September 2010 – Aerial photography captured at the Wimmera Highway Bridge

The exact timing of the Main Western channel decommissioning is unknown but it did occur prior to the September 2010 event, as shown in Figure 7-19. This confirms the revised rating curve can be used to estimate the September 2010 flows.
