FINAL REPORT:

Millers Creek Waterway Action Plan

December 2017

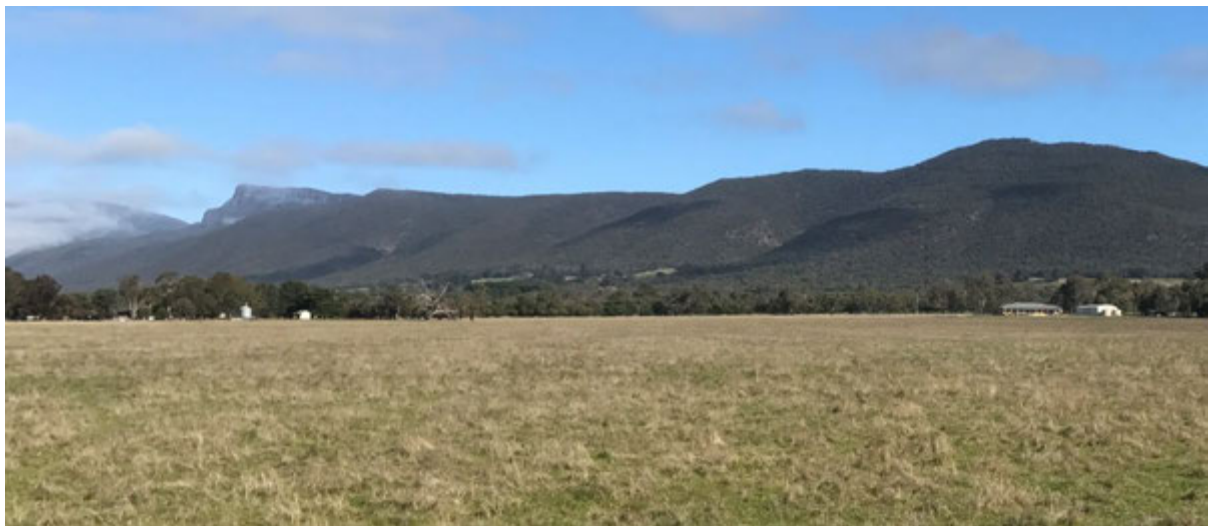
The Millers Creek catchment transitions from the steep headwaters of the Grampians Ranges in the upper catchment, through undulating terrain across the mid-catchment, to the extensive lowland floodplain downstream of Pomonal (Figure 3 to Figure 6). The landscape transitions sharply from mid-catchment to the lowland floodplain around Ararat-Pomonal Road.

Figure 3. *Millers Creek catchment view from lower catchment floodplain towards mid and upper catchment (July 2017)*

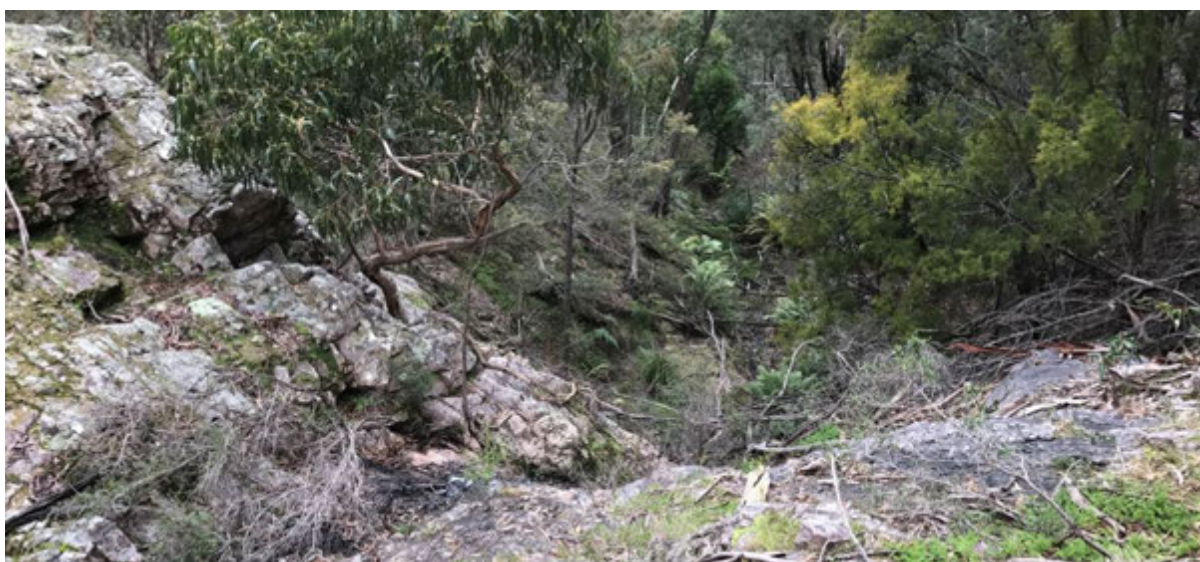
Figure 12. *Millers Creek upper catchment – view downstream along bedrock controlled steep headwater (site 29)*

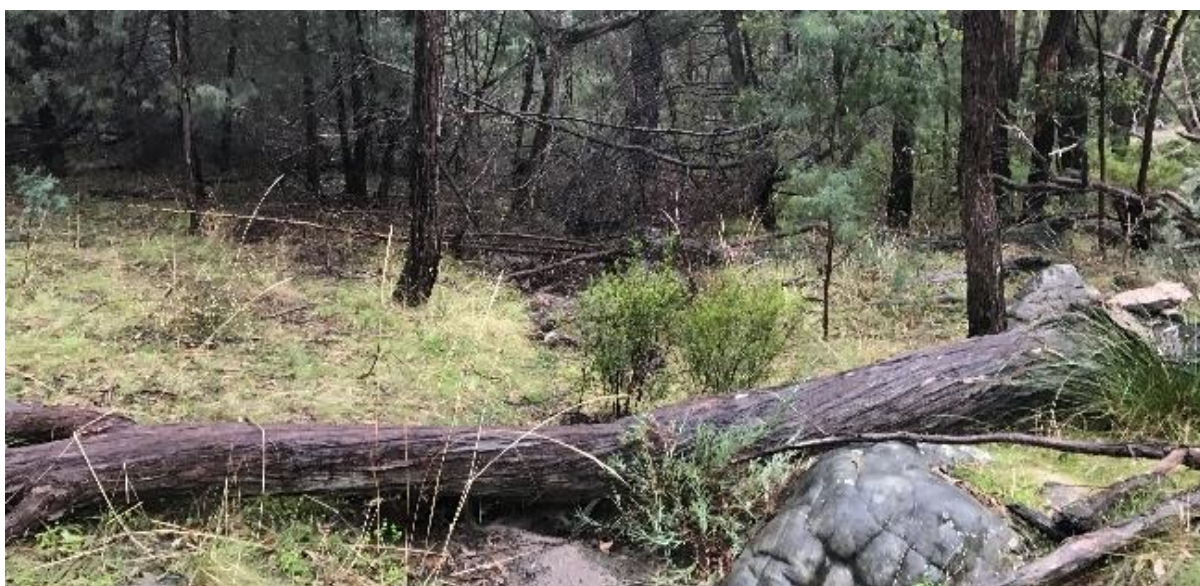
Figure 13. *Millers Creek upper catchment – view downstream along bedrock controlled steep headwater (site 36)*

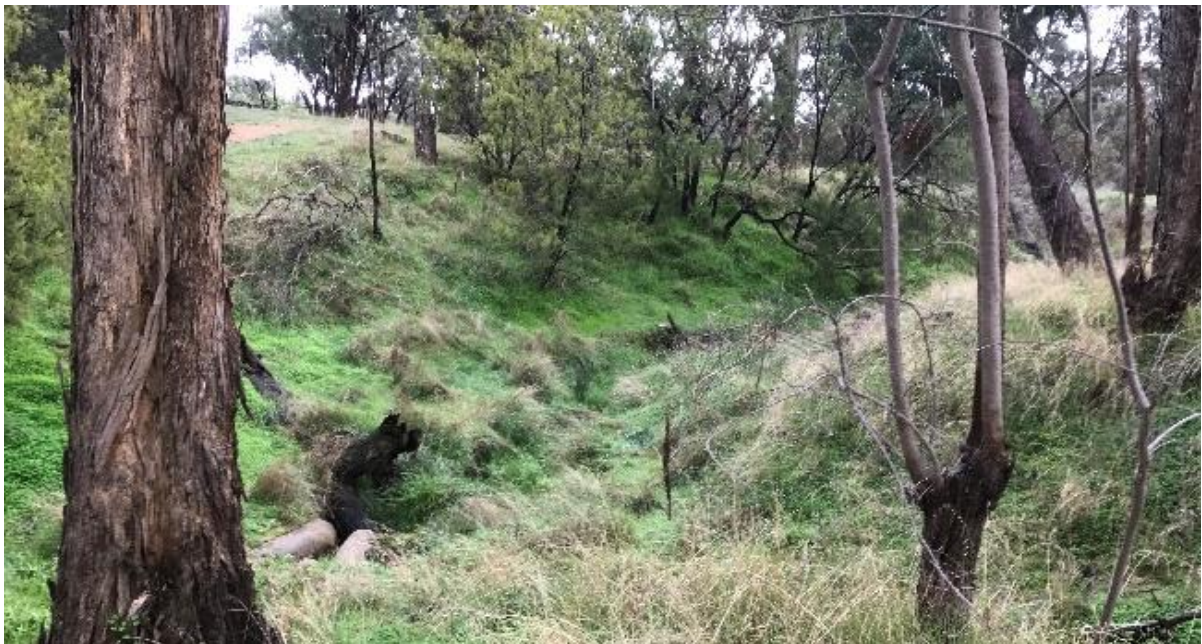
The erosion of the main Millers Creek channel extends approximately 1 km upstream from Pomonal to a bridge crossing with a culvert (Figure 15 to Figure 17). A bush reserve surrounds this reach, and is of high environmental, recreational and amenity value to the community. Informal walking tracks run along both sides of the creek, and there are multiple (over 12 observed during June 2017 inspections) informal paths crossing the channel.

Figure 15. *Millers Creek bush reserve reach – view downstream from culvert crossing*

Over the 1 km reach, a series of small headcuts are present in the actively deepening channel bed. These headcuts are in the order of 0.25 – 0.5 m vertical drops in bed elevation. These headcuts indicate that active incision (deepening and widening) is occurring. It is likely that this reach is still slowly adjusting to the historical channelisation downstream of Pomonal. The progression of the incision is likely to be a relatively intermittent process, with erosion occurring only during large rainfall events every few years.

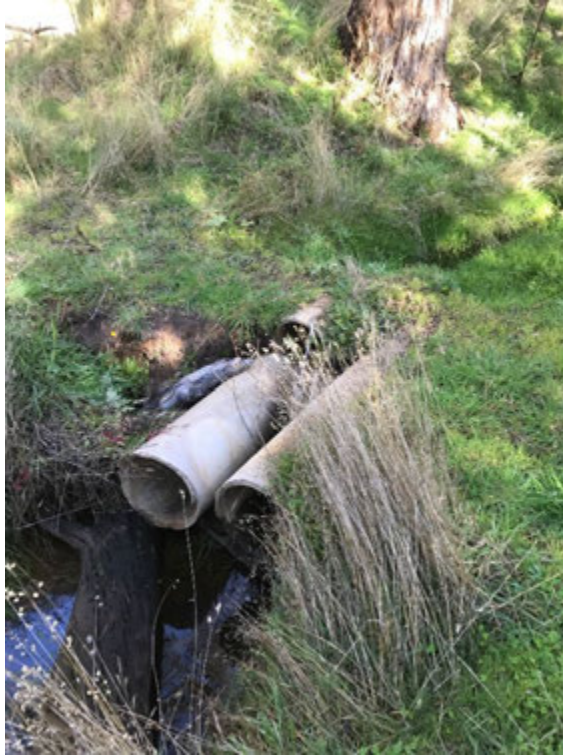
The incision is currently being held by a culvert and informal bridge crossing at the top of the reach, where a headcut (vertical drop) in the order of 1 – 1.5 m is present. If this culvert were to fail, there is a high likelihood that the incision will progress further up the main stem of the channel into an area of intact and high value swampy valley fill habitat, as well as upstream into an existing gully line that is already unstable and eroding towards a road. A program of works to address the erosion in this reach of stream (grade control, vegetation), minimise informal crossing/access (fencing / signposting), and enhance and maintain the amenity value of the reach (designated paths, signage etc.) is a high priority.

Figure 16. *Failing culvert crossing at upstream extent of eroding reach*

Two grade control structures (rock chutes) are likely required in this reach to halt the incision, one near the downstream end of the reach and the other at the upper end replacing the failing culverts. The downstream chute could possibly be located next to the primary school, and designed to provide a controlled point for public access and enhanced enjoyment of the creek. Concept and detailed designs are required to explore the scope of the works.

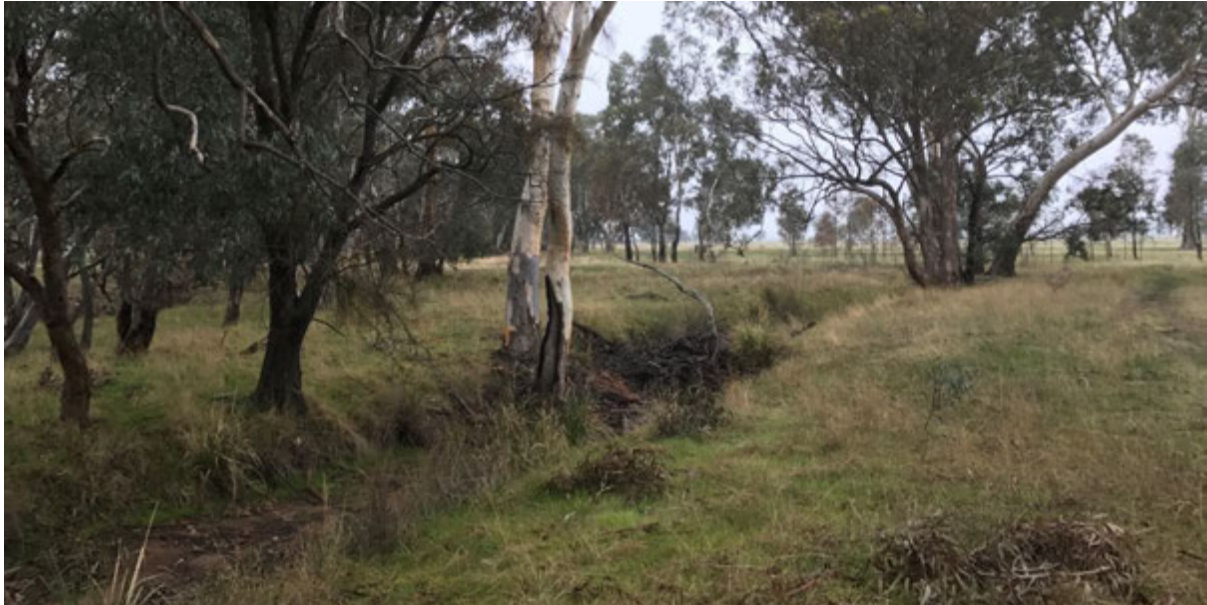
Figure 18. *Millers Creek – lower catchment – view along main creek line within a broad corridor of remnant vegetation*

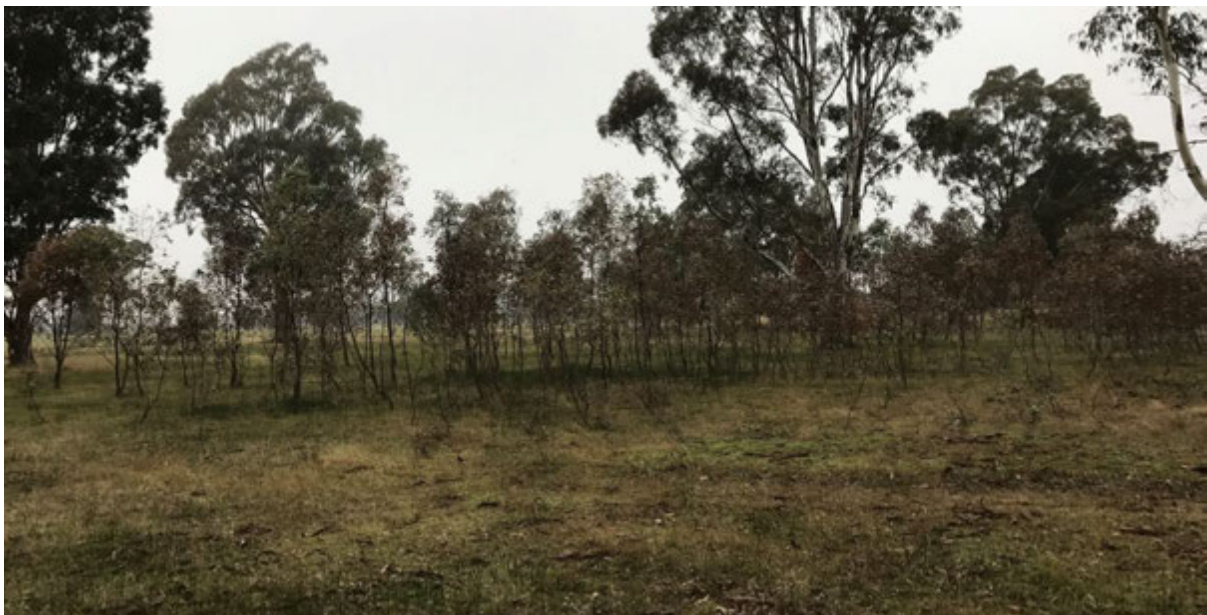
The majority of the main waterway corridor in the lower catchment of Millers Creek has been fenced, and stock impacts are relatively low. Remaining areas to be fenced are at the upstream and downstream extents of the lower catchment zone. Overall vegetation condition is good, with a broad riparian corridor (50 + m) reserved along much of the main waterway length, and good longitudinal connectivity of remnant vegetation. Scattered recruitment of native vegetation is evident where fencing has been present for several years. Weed infestation is still problematic through this zone.

Figure 19. *Natural recruitment of native vegetation in fenced areas with no stock access*

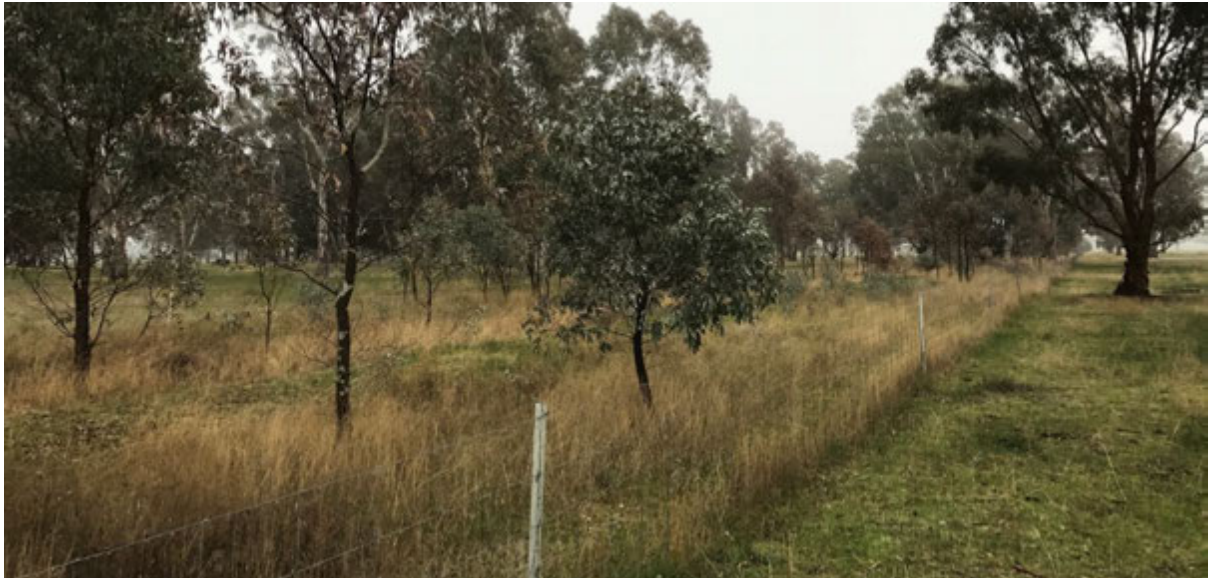
A mix of revegetation works and weed control programs have been undertaken in the past by landholders, the WCMA and Project Platypus. Well established revegetation works along the lower end of the channelised reach of Millers Creek are assisting stabilisation and rehabilitation of the waterway.

Figure 20. *Revegetation works along the lower end of the channelised Millers Creek reach*

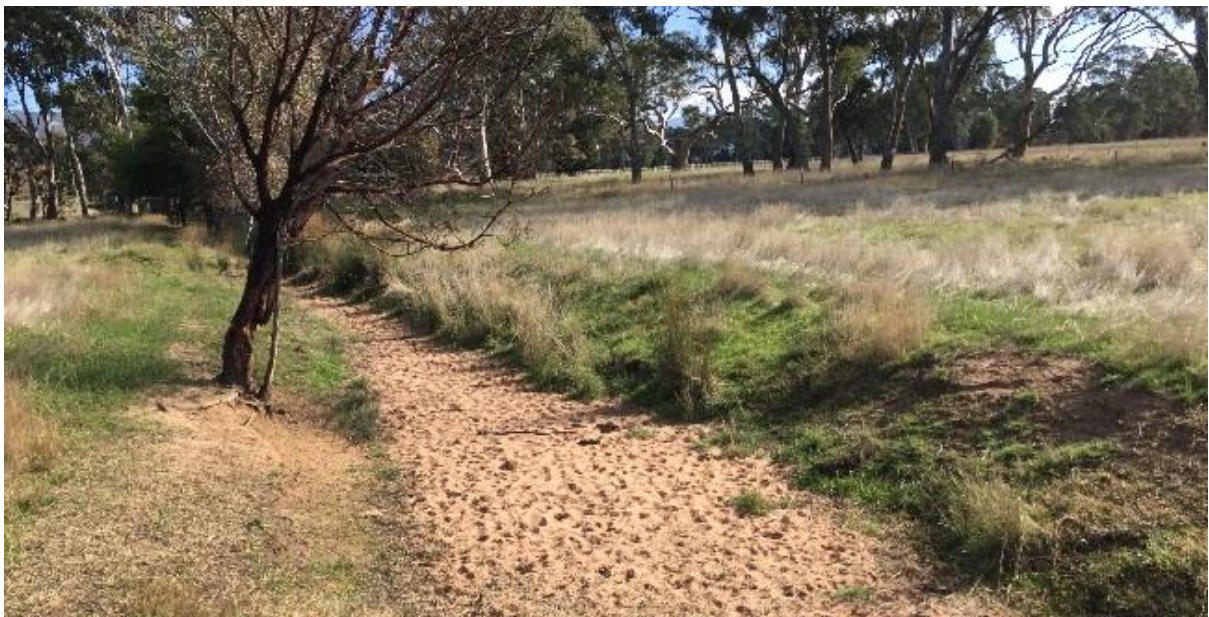
Figure 21. *Channelised reach of Millers Creek – section where fencing is absent and riparian vegetation is limited*

The remaining areas of Millers Creek where fencing is absent (Figure 21) are a priority for fencing and revegetation works, to improve bed and bank stability and overall waterway health.
