## Mt. Cole Creek Waterway Action Plan

- Final
- 3 September 2005

Wimmera  
Catchment Management  
Authority

Sinclair Knight Merz  
ABN 37 001 024 095  
590 Orrong Road, Armadale 3143  
PO Box 2500  
Malvern VIC 3144 Australia  
Tel: +61 3 9248 3100  
Fax: +61 3 9248 3400  
Web: [www.skmconsulting.com](http://www.skmconsulting.com)

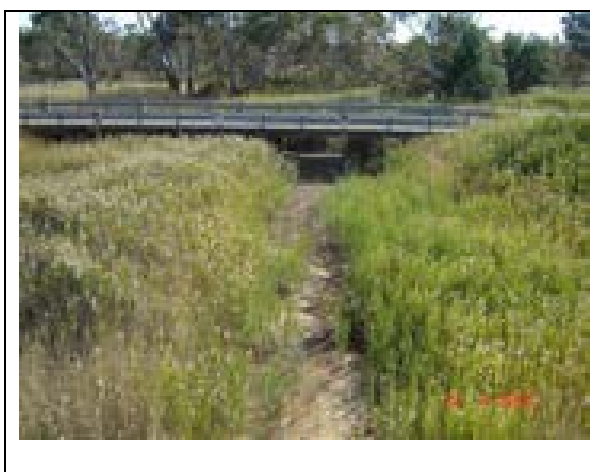
A large Phragmites and Typha swamp exists immediately downstream of the Pyrenees Highway indicating a change in stream and floodplain gradient. Here the floodplain is well connected to the stream and tends to trap the coarse sediment load from the upper catchment areas. This sedimentation has been blamed on the potential inefficiency of the large Armco culverts under the railway, but tailwater conditions due to a natural change in grade would see the sediment fall out readily in this area.

■ **Figure 4.2 – Potential Flood danger at the Pyrenees Highway at the change of grade in Mt. Cole Creek**

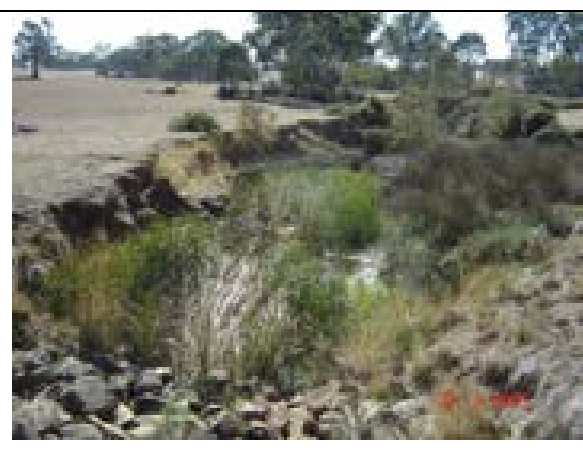
**Figure 4.3 – Big Hill Road crossing requires appropriate stabilisation to prevent further erosion**

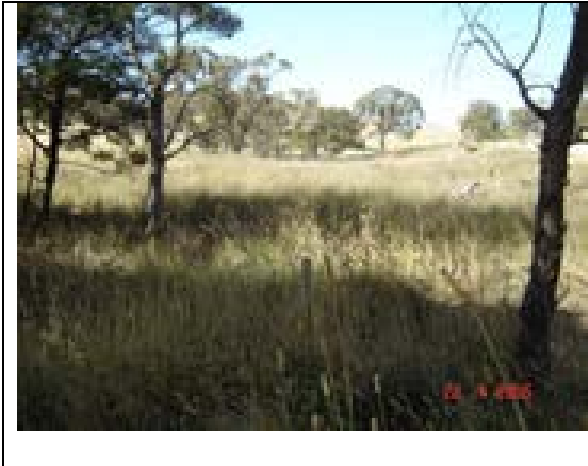
■ **Figure 5.2 – An intact valley floor that is not subjected to stock pressures**

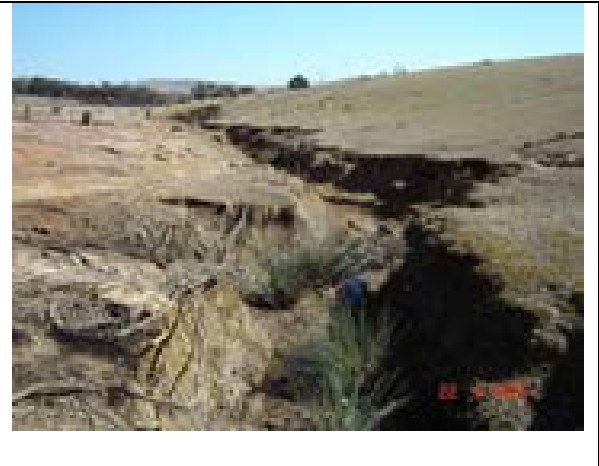
**Figure 5.3 – Erosion and a lack of habitat result in poor waterway health. Stock pressures are major contributors to these factors**

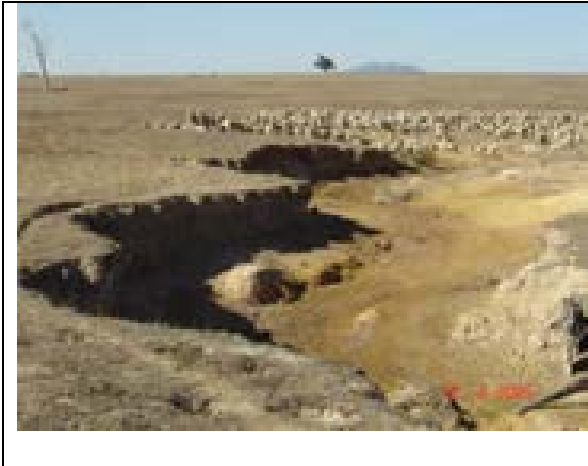
■ **Figure 7.2 – Developing off stream watering options is essential to help stabilise waterways**

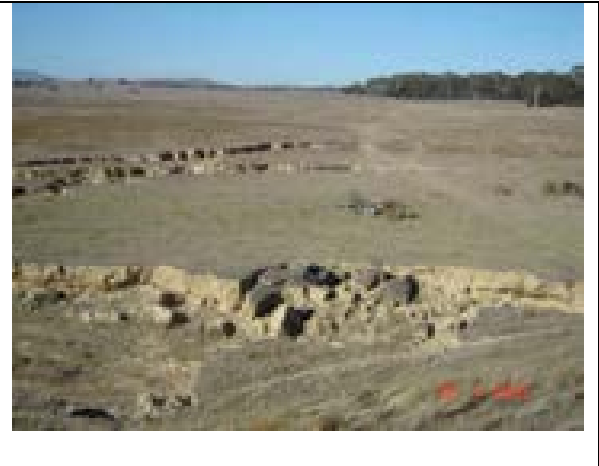
**Figure 7.3 – Tunnelling and subsurface flows are contributing to erosion**

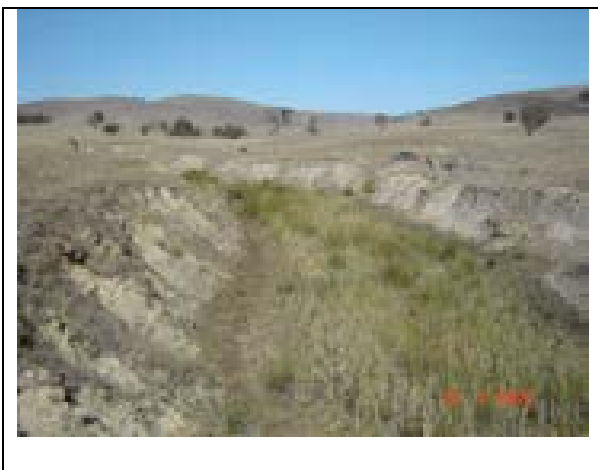
The hills are denuded in this reach. However, the salinity management program and the effort of a few landowners has recently seen the extensive revegetation of some areas of the very steep upper slopes where infiltration would occur. This work needs to be supported as it not only assists in addressing the salinity issues, it will also slow the rate of runoff from these steep and bony hills.

**Figure 7.4 – Revegetation of denuded hillslopes by landholders is to be applauded and encouraged**

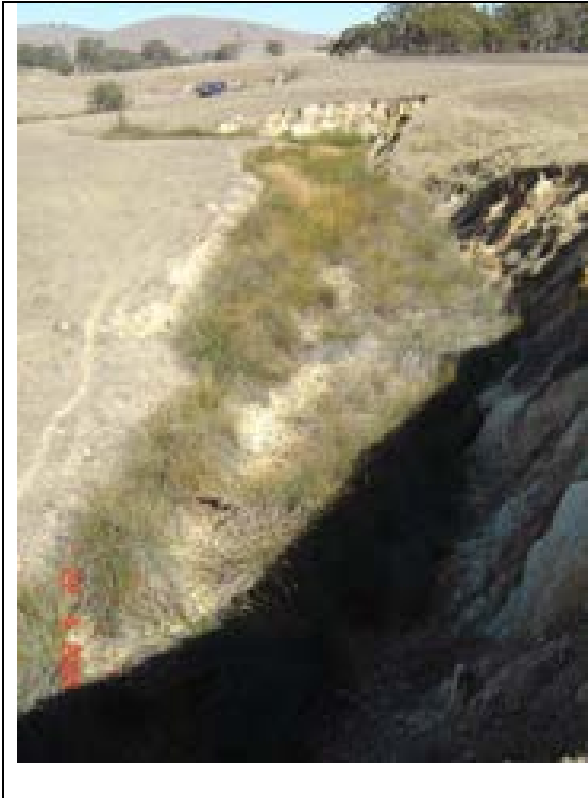
■ **Figure 8.2 – Spiny Rush is prevalent throughout the reach**

The trial of various macrophyte species as a replacement for Spiny Rush (habitat value and erosion control value) should be undertaken as part of the removal of Spiny Rush. Spiny Rush removal and control should also be undertaken in an ecologically sensitive fashion. In that entire patches of spiny rush should not be removed (physically or chemically) in a single episode, but rather to maintain some habitat (and erosion control) facilities and treat remaining areas at a future date, once replacement habitat has established.

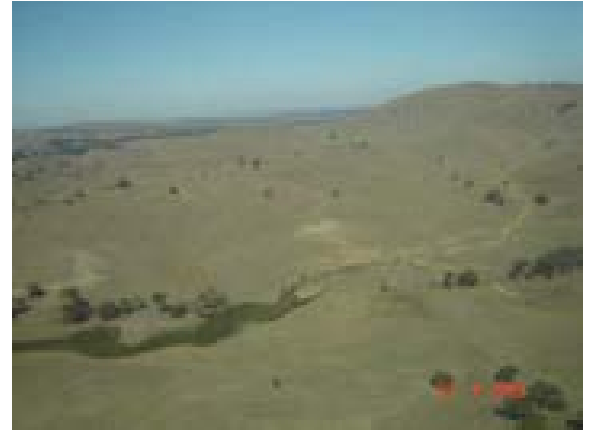
**Figure 8.3 – Spiny rush dominates the valley lines, particularly in swamp areas**
