Wimmera
Catchment Management
Authority

Heritage River Waterway Action Plan

December 2005

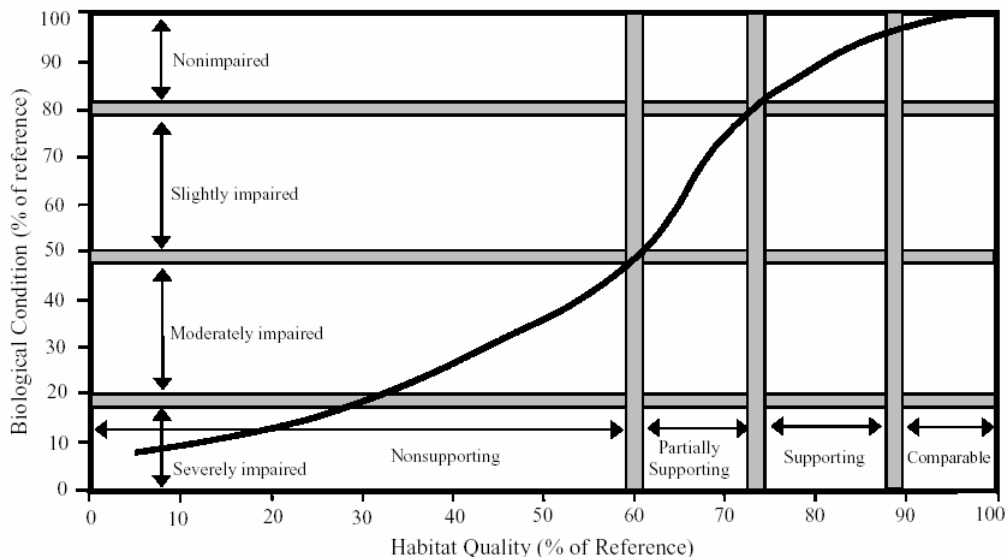
At each site, individual parameters are assessed and rated according to a continuum of scores that represent optimal, sub-optimal, marginal or poor condition (Figure 3). A total score is obtained for each site, and provides an assessment of the ability of the habitat to support the optimal biological condition of the region. Like the RHA, HABSCORE can be used to determine an overall assessment of habitat condition at the sampling site at a point in time – current condition. Once current condition is established, sites may be ranked according to condition, enabling goals, minimum standards and management priorities to be formulated.

Figure 3. The relationship between habitat and biological condition. From Parsons et al (2000).

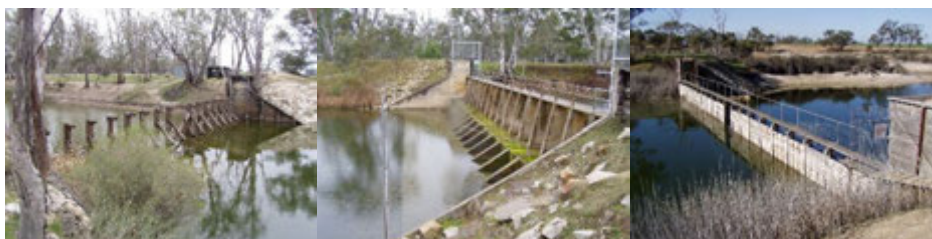
Antwerp Weir (Figure 5) has been effectively decommissioned.

Figure 5: Antwerp weir (left) Dimboola Weir (centre) and Jeparit Weir (right).

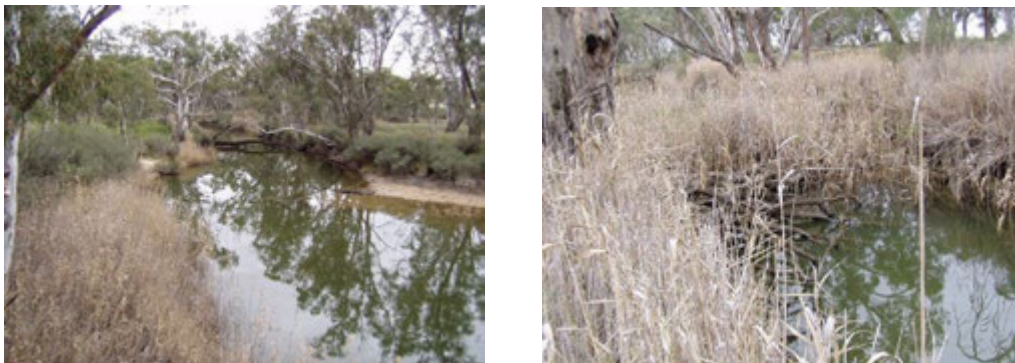
At Polkemmet Bridge, the river adopts an anastomosing form, that is, it comprises multiple channels separated by stable alluvium. Two u-shaped, low gradient channels dominate the river which is set within a wide symmetrical floodplain. The individual channels contain short deep pools separated by sandy vegetated riffles. These pools are flanked by dense stands of phragmites and the riffles are often completely covered by phragmites and native understorey species, providing what is locally termed a '*blockage*'. The low flows experienced over the past 8-10 years have encouraged the growth of phragmites on the riffles and have promoted the encroachment of larger vegetation onto areas that would normally have been inundated regularly.

Figure 6: Reach 14/15 looking downstream from Polkemmet Bridge (left), and phragmites encroachment downstream of bridge (right).

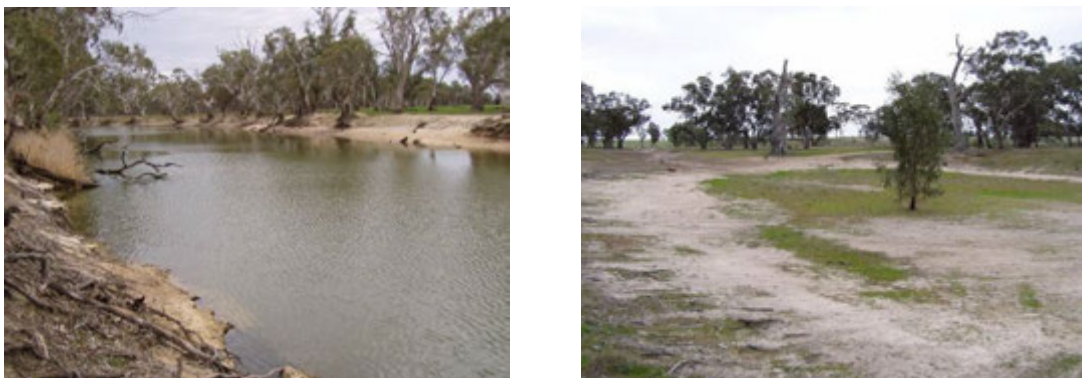
There is little phragmites present – except at the most upstream extent of the pool and the lack of riparian fencing and grazing access particularly on the right bank, has resulted in poor vegetative cover of the steep to almost vertical clay banks. The banks display active erosion scars, riparian tree roots have been exposed and there is the potential for more, serious, erosion during periods of high flow.

Figure 7: Wimmera River at Old Duchembegarra Road (Site 2) looking downstream (left), and saline left bank drainage line (right).

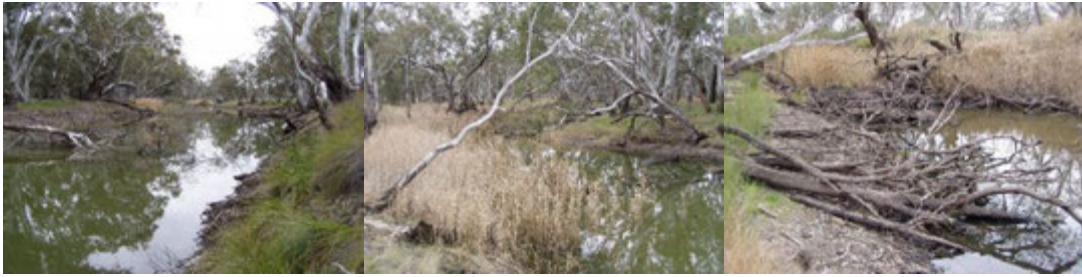
In this reach, the river comprises a series of pools separated by sandy riffles and bars initiated by large woody debris. Both the riffles and the bars have become colonised by phragmites, and dense stands are found along the banks at the narrowest sections of the river. There is some minor sedimentation and bar formation around large woody debris and stands of phragmites, but the bed of the river is typically stable. The lack of flows in the river has prevented the realignment of the large woody debris and consequently it acts to trap sediment. As with the section of reach 14/15 around Polkemmet, the low flows experienced over the past 8-10 years have encouraged the growth of phragmites on the riffles and bars surrounding the large woody debris. This may enhance the levels of flooding during the first high flows which may pass down this section of the river.

Figure 8: Wimmera River at Mackleys Road looking upstream (left), looking downstream (centre) and LWD blockage across the channel (right).

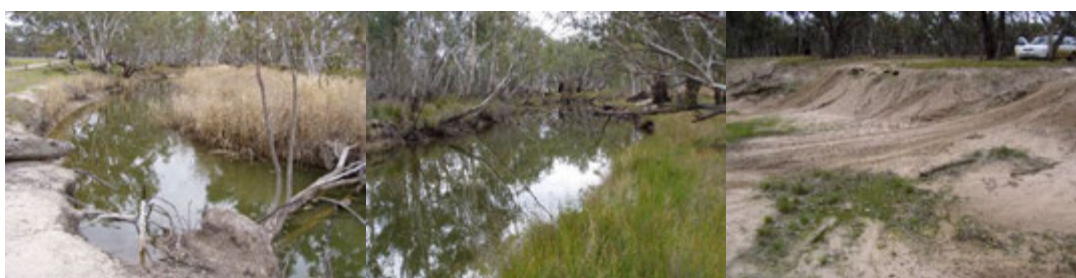
Two habitat assessments were conducted in this reach and the results are presented in Table 22. The basic stream structure of these sites is good, there is little sediment infilling, the stream retains a normal pattern and there is a high diversity in pool sizes which provides good variability in habitat. At site 3, the high volume of large woody debris provides excellent in-stream cover which means the potential for epifaunal colonisation and fish cover is high. This site also displays riparian vegetation which is in excellent condition, providing good vegetative protection for the stream banks, resulting in high bank stability and little stream bank erosion. Some firewood harvesting has reduced the volume of large woody debris within the riparian zone away from the river channel, which combined with weed invasion and reduced recruitment of woody species to reduced the RHA score for this site.

Figure 9: Wimmera River near abandoned bridge upstream of Ellis Crossing (left, centre), impact of recreational vehicle activity (right).

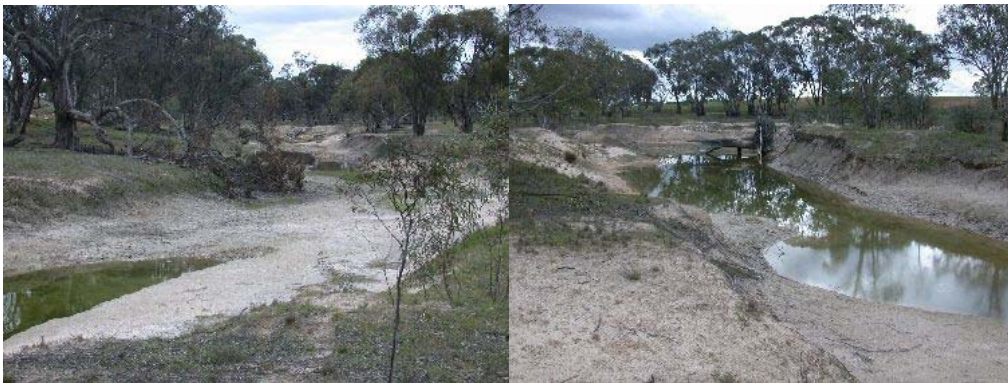
Over the past 60-70 years, the river has carved out a new path along the western margin of the channel belt downstream of site 3 (near Mackleys Road). This is likely to be along the path of an existing anabranch or paleochannel, but anecdotal evidence is that 60 years ago it was simply a depression on the floodplain. The widening and deepening of the anabranch has occurred over the lifetime of the present landholder and will have delivered very large amounts of sediment to the river. Presently, there is a large active channel on the floodplain the bare banks of which have the potential to continue to deliver sediment to the river until they stabilise (Figure 10).

Figure 10: Erosion of an developing anabranch at the end of Mackleys Road.

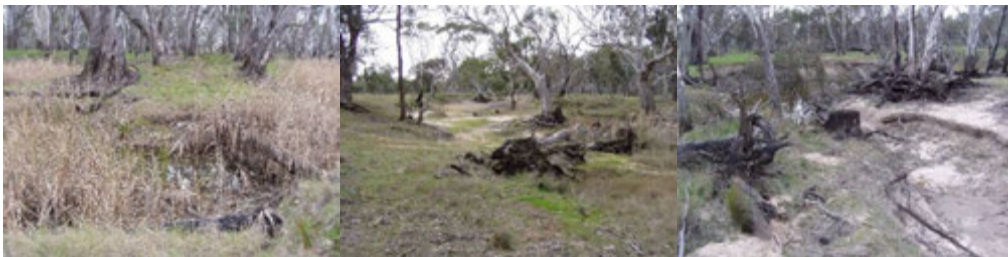
Works had previously been undertaken by the Wimmera CMA at the Mackleys Road site to prevent the river from adopting a new channel along the western margin of the channel belt as the main flow path. These works involved removing a ford across the main river channel at the end of Mackleys Rd and raising of the sill level at the upstream end of the anabranch through the placement of rock, earth and large woody debris.

Figure 11: Works undertaken previously at Site 3 by the WCMA include removal of a ford (left) and raising of the sill level at the entry into an actively eroding anabranch (centre). Large volumes of material have eroded from this anabranch, the main channel of which is shown left to right in the background of the photograph (right).

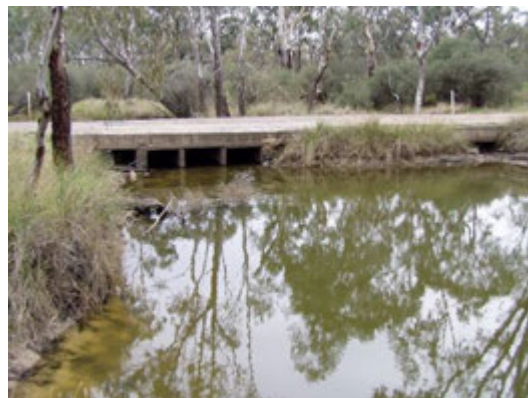
There is also a concern that the culverts at Ellis Crossing will be undersized to cope with some of the environmental flows proposed to commence in 3-4 years time. The crossing currently consists of five 1100 x 800mm box culverts overlaid with a concrete slab to form a trafficable surface (Figure 12).

Figure 12: Ellis Crossing

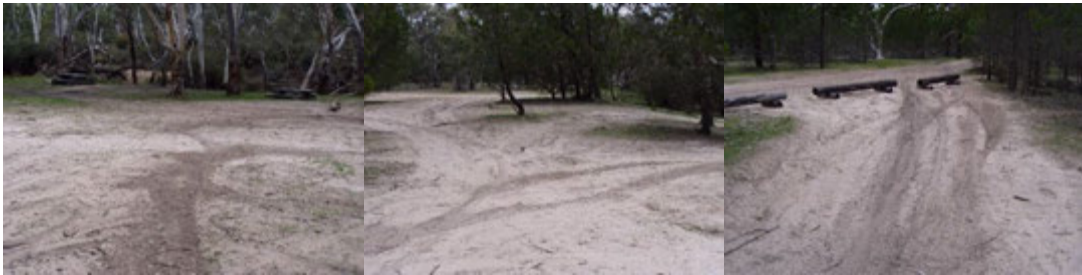
Figure 13: Absence of vegetative ground cover at the West Wail picnic sites.

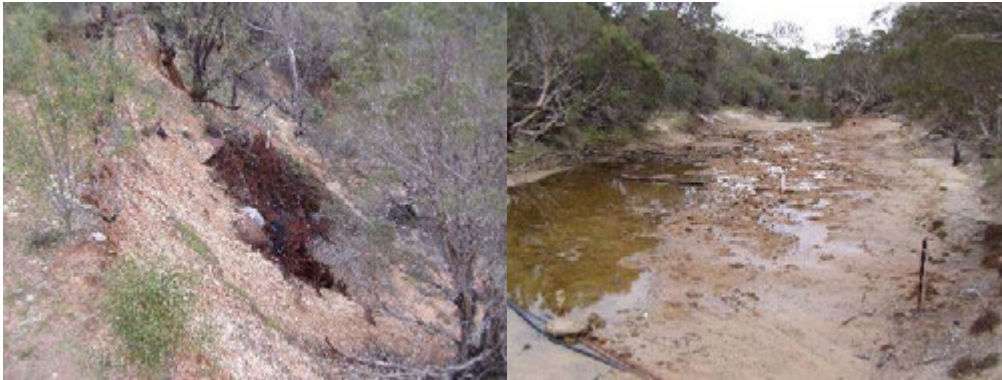
In this reach, the river typically comprises a series of large open pools separated by sand bars or riffles, mostly on short high angle beds. At West Wail Gauging station, the bed of the river intersects the partially lithified Parilla sands which has created a small section of soft bedrock riffle (Figure 14). The bed material of the river is predominantly fine grained with occasional soft gravel sized material. This reach would appear to be a deposition zone with a number of small sandy point bars extending into the river on the inside of the bends, typically associated with large woody debris.

Figure 14: West Wail Gauging Station. Rubbish on right bank upstream of gauge (left) and view downstream (right).

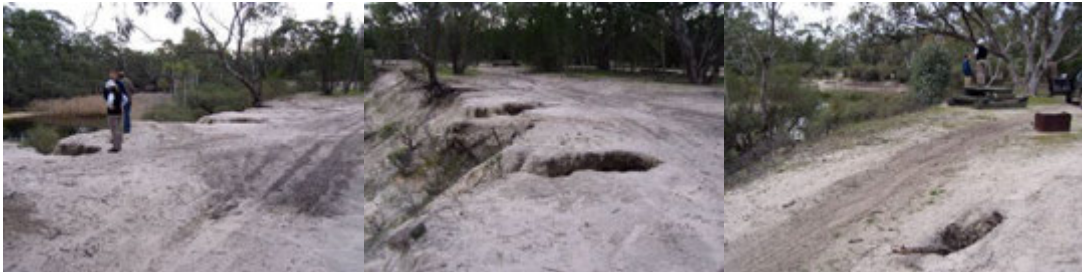
Degradation to vegetative cover is occurring in this reach because of the actions of recreational users and rabbit activity. A number of rabbits were observed within the Wail State Forest and a control program should be implemented to encourage vegetation recruitment and minimise soil instability derived from burrowing activity.

Figure 15: Erosion points at the West Wail picnic areas.

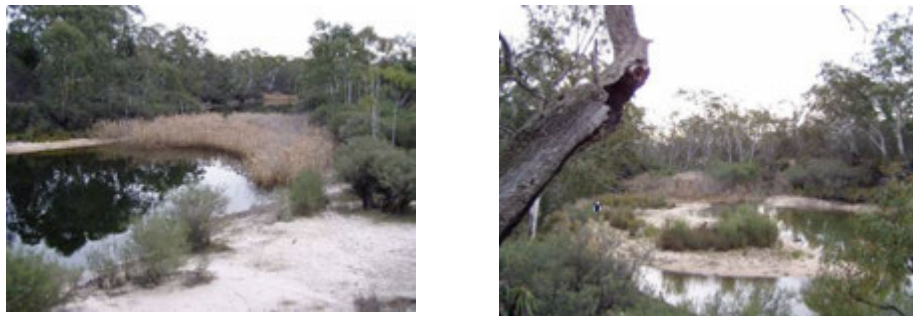
Eroded material from the picnic areas has deposited as sediment bars within the river and have subsequently been colonised by macrophytes.

Figure 16: Sediment bars formed by material eroded from the West Wail picnic areas that have been colonised by macrophytes.

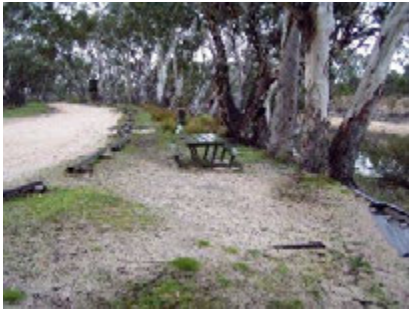
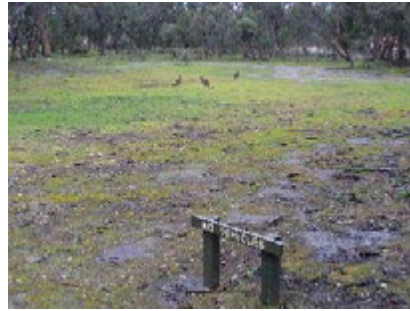
Intense recreational pressure is also having an effect on ground cover and woody habitat at the Horseshoe Bend picnic area, however at this site the tops of the banks tend to be better protected from access by vehicles. Remaining ground cover is predominately weeds. The site is also drains internally to a low lying lagoon which acts as a sediment trap before discharging to the river. This lagoon area was dry at the time of inspection and has vehicle skid marks across it.

Figure 17: Horseshoe bend picnic area bank protections (left) and low-lying internal drainage path (right).

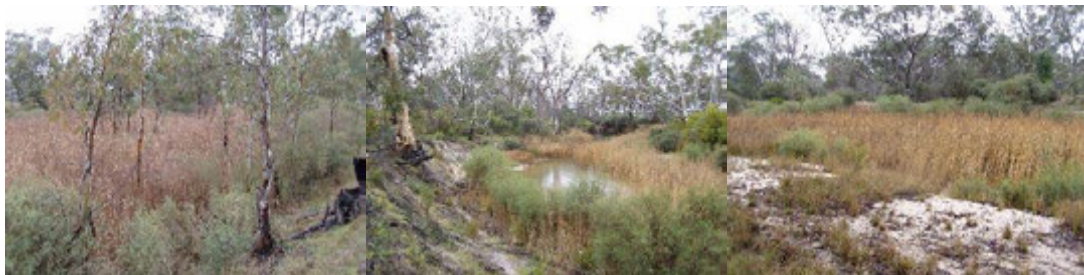
Examples of sand deposition can be seen below the Dimboola Weir, downstream of Lochiel Bridge and near the entrance into Datchak Creek (Figure 18).

Figure 18: Sand deposition and colonisation by vegetative growth downstream of the Dimboola Weir (left), near Lochiel Bridge (centre) and at the entrance to Datchak Creek (right).

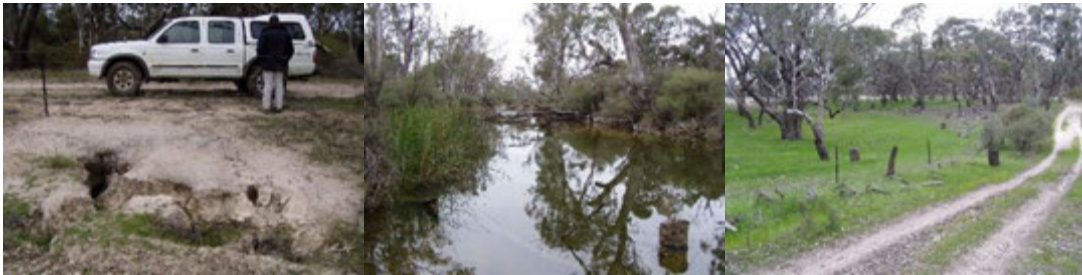
A site on the right bank of the Wimmera River approximately 600 metres upstream of Spears Crossing was noted as being subject to piping erosion, which is delivering eroded material from the adjacent agricultural land into the river (Figure 19).

Figure 19. Piping erosion upstream of Spears Crossing. Head of the piping (left) with the river in the background, the receiving pool (centre) and a possible route to redirect drainage water from the agricultural land to the river (right).

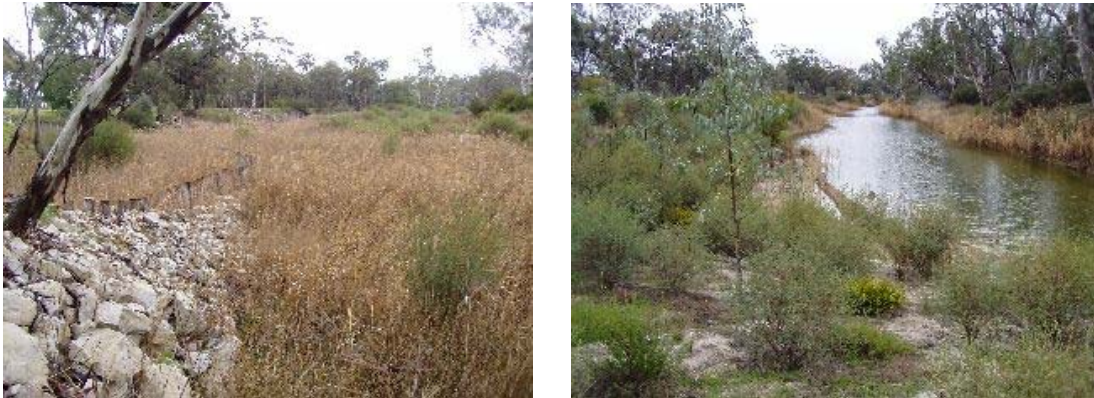
WCMA have previously conducted works in a number of locations along this reach. Erosion control works consisting of installation of rock beaching and pile fields were conducted on the left bank downstream of Lochiel Bridge, with battering and revegetation of the left bank performed downstream of Spears Crossing (Figure 20).

Figure 20: Pile fields downstream of Lochiel Bridge (left) and bank battering and revegetation works below Spears Crossing (right)

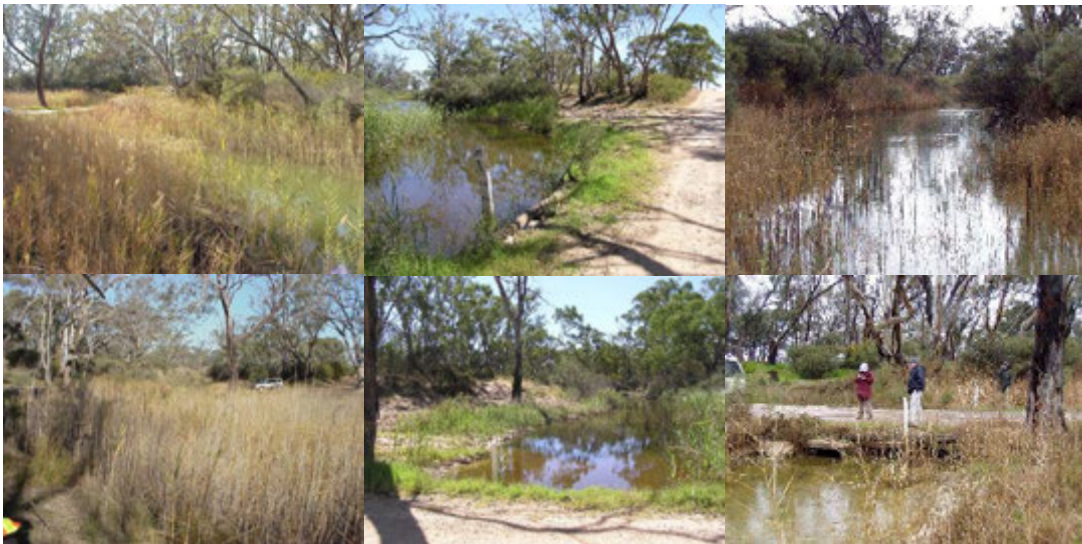
Works were undertaken by local landowners in 2003 to remove deposited sediment and phragmites in the vicinity of Wundersitz crossing. (Figure 21).

Figure 21: Upstream (top) and downstream (bottom) of Wundersitz Crossing before stream clearing works in 2003 (left), after completion in 2004 (centre) and at time of inspection in 2005 (right)

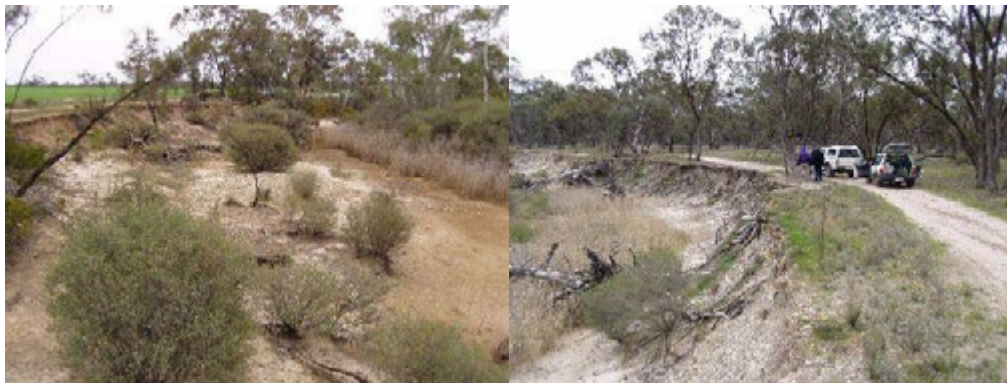
Erosion of the right bank has occurred due to colonisation of points bars at Collards Road and at a location between Klinge Road and Spears Crossing (Figure 22).

Figure 22: Erosion of right bank at Collards Road (left) and upstream of Spears Crossing (right)

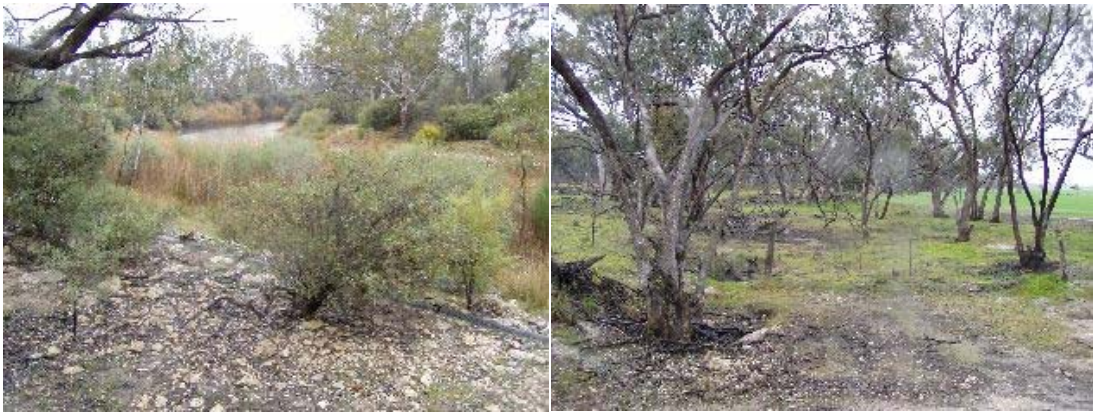
Reach 18A of the Wimmera Heritage River study reach corresponds to Datchak Creek, and is approximately 19.6 km long. Datchak Creek is a flattened u-shaped anabranch of the anastomosing Wimmera River which leaves the main channel at Lochiel and rejoins at Antwerp. It is set within a relatively narrow symmetrical floodplain which displays a number of flood channels, scours and billabongs. In 1982, works were undertaken by locals to raise the sill level of Datchak Creek and remove blockages in the main Wimmera River to prevent high volumes of water flowing along Datchak Creek (Figure 23). At the time of the field assessments the Creek was almost completely dry with only one groundwater fed pool still retaining water.

Figure 23: Datchak Creek. Works to raise the sill level of the entrance (left) and looking downstream (right) from the creek entrance.

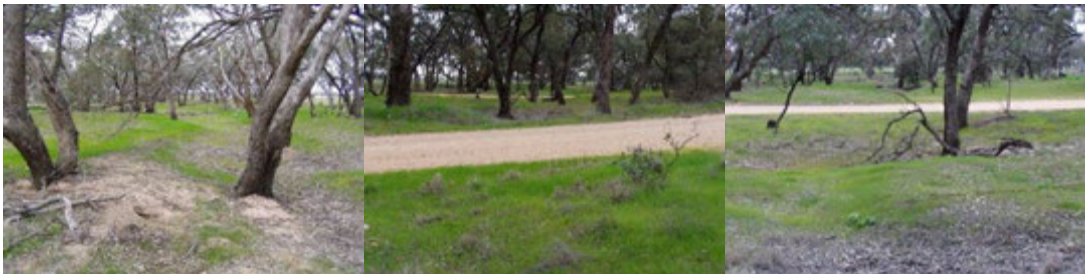
The bed of Datchak Creek comprises a series of pools of varying size separated by runs and sand riffles. There are rare outcrops of the very soft sandstone developed from the Parilla Sands and this will exert some controls on the lateral migration of the creek. Some parts of the creek are almost completely infilled with sand and for the most part the channel is quite small in comparison with the Wimmera River and poorly formed anabranches appear to exist across the adjacent cropped landscape (Figure 24). Five Chain Road and Collards Road are two road crossings over Datchak Creek that do not currently have culverts, hence any flow down the creek must overtop the road surface.

Figure 24: Datchak Creek at Five Chain Road (left, centre) and Collards Road (right). Note ill defined sand filled channel and lack of culverts under roads.

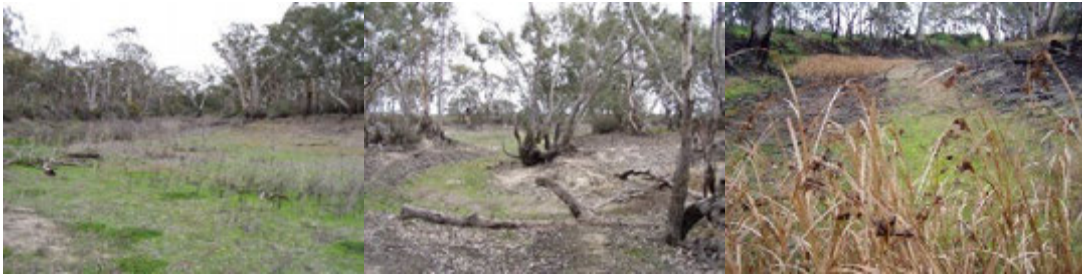
In contrast, Site 14 is a wide, well formed u-shaped channel with some large deep pools and backwaters which would have probably provided permanent water in all but the driest of times (Figure 25). There are some sand bars formed on the bed of the creek, but there is no obvious infilling of pools. This site has had most of the large woody debris removed and the base of the creek cleared of vegetation. There are some stands of phragmites present as well as a plethora of weed species. Also noted were stands of Spiny flat-sedge *Cyperus gymnocaulus* that would have been widespread throughout the area during the 1940's and 1950's, and that should be protected (Figure 25).

Figure 25: Site 14 on Datchak Creek. Note the large channel size in comparison with upstream section of the reach (left, centre) and remnant stands of indigenous reeds (right).

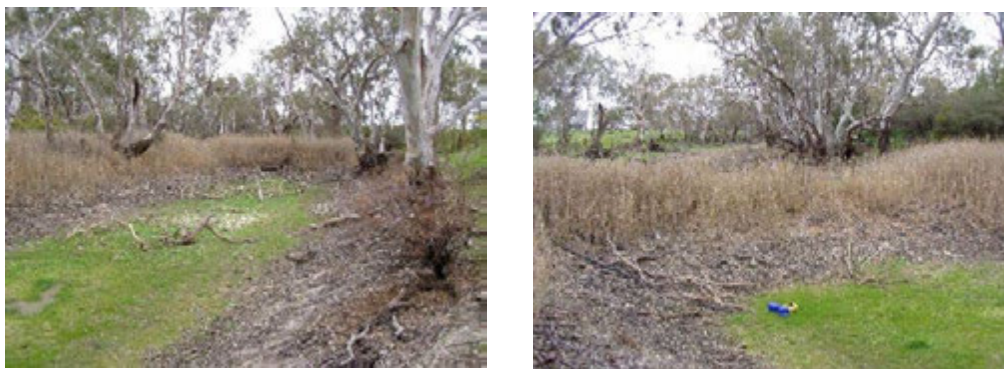
Figure 26: Banks pushed across Datchak Creek to form dam

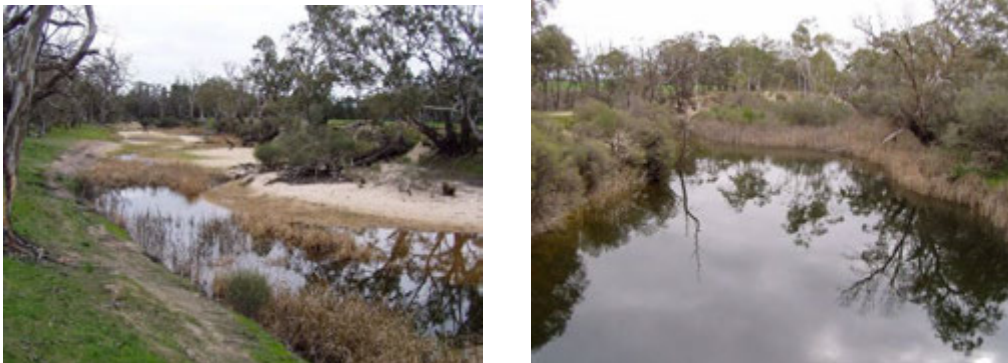
Figure 27: Depositional zone upstream of Antwerp Weir (left) and pool on downstream side of Tarranyurk Bridge (right).

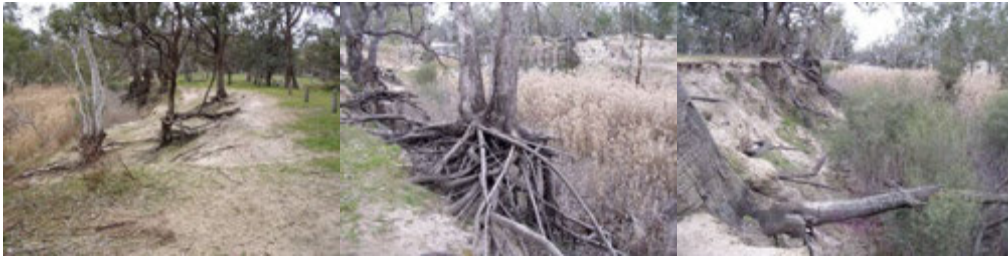
Figure 28: Erosion downstream of Antwerp Weir caused by stock access and flow diversion around a vegetation stabilised sediment bar

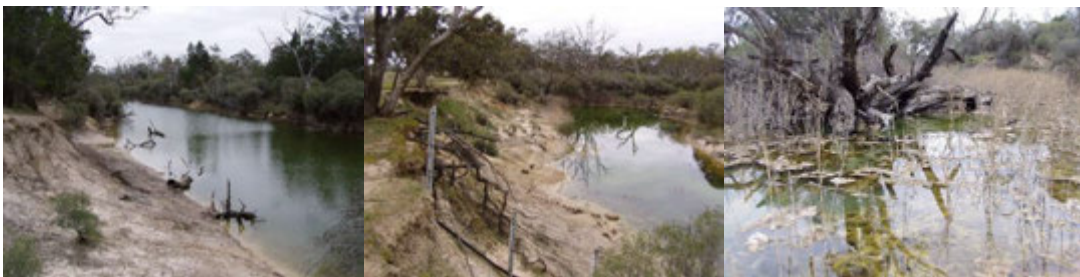
Figure 29: Sites of high salinity include Site 16 on River Road between Antwerp and Tarranyurk (left), and the Tarranyurk Gauging Station (centre, right).

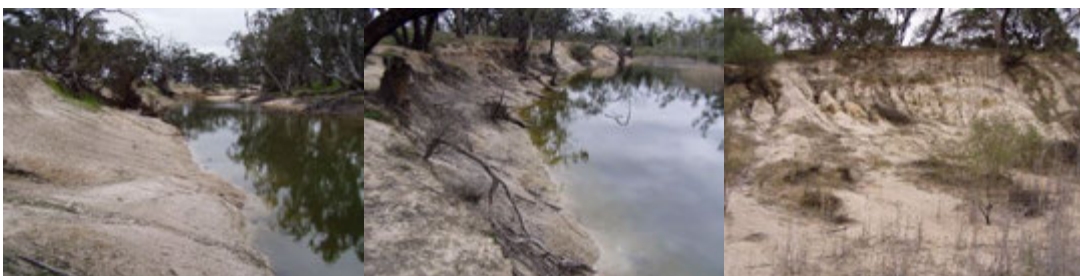
Figure 30: The effect of salinity and lack of flow on riparian vegetation and bank salinity is demonstrated upstream of Antwerp Weir (left), downstream of Tarranyurk bridge (centre) and at Tarranyurk Gauging Station (right).

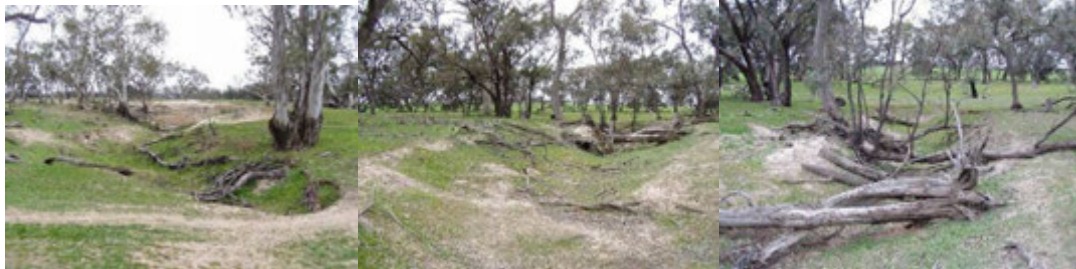
Figure 31. Right bank gully upstream of Antwerp Weir.

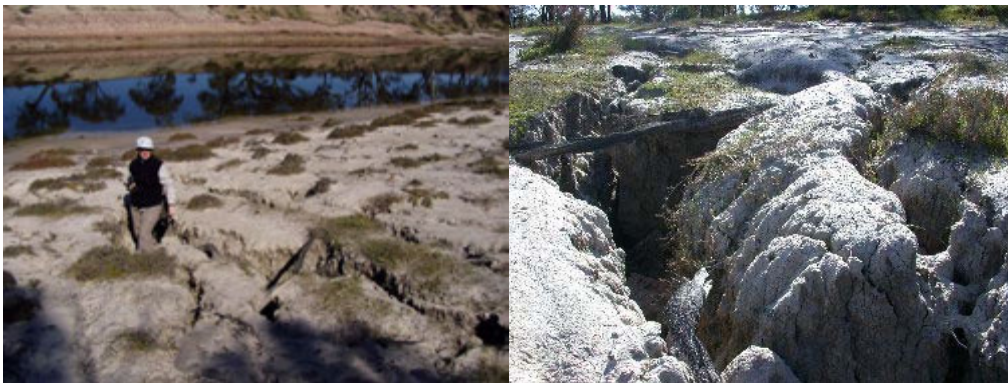
Figure 32: Serious rill erosion of the right bank downstream of Jeparit Weir.

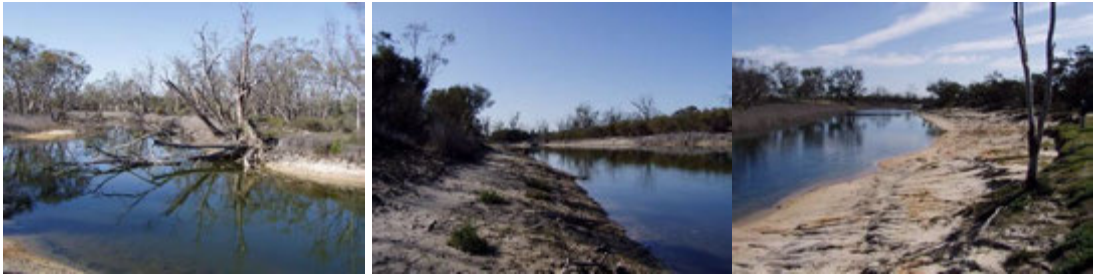
Figure 33: Channel form and riparian vegetation just south of Jeparit (left), at Site 24 upstream of the Jeparit Weir (centre), and downstream of Jeparit at the Hindmarsh Ski clubrooms (right).

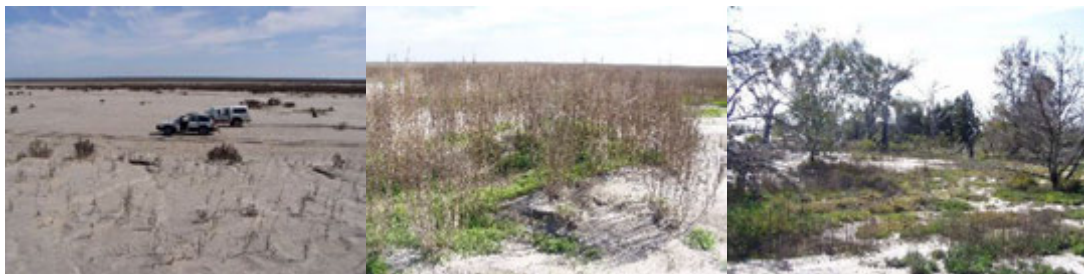
Figure 34: Lake Hindmarsh from top of mobile dune on western side (left), native annual colonising the dry lake bed (centre), interdunal vegetation on western side (right).

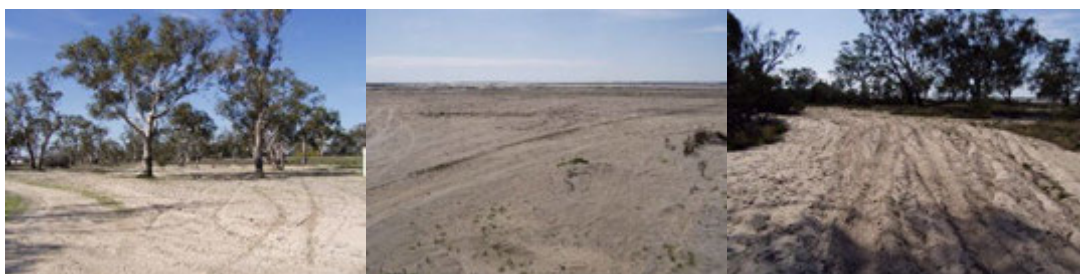
Figure 35: Four Mile Beach camping ground (left), vehicle tracks on the bed of Lake Hindmarsh (centre) and through the dunes on the south-western side of the lake (right).

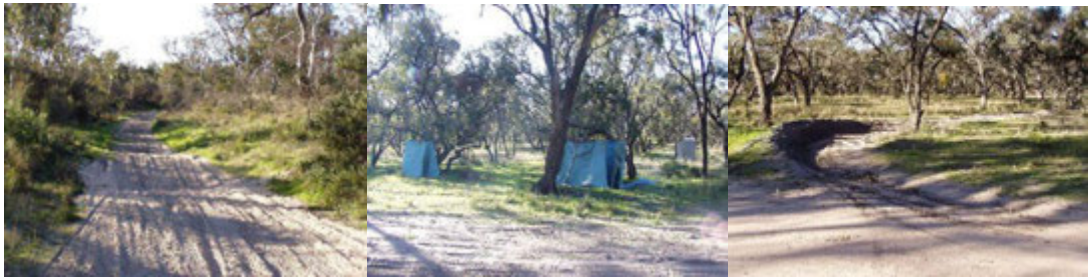
Figure 36: Impacts of recreational use on Outlet Creek north of Lake Hindmarsh. Creekbed used by trailbikes as a sandy track (left), derelict camping structures in the informal camping ground on Outlet Creek on the northern end of Lake Hindmarsh (centre) and evidence of trail-bike racing in the camping ground (right).

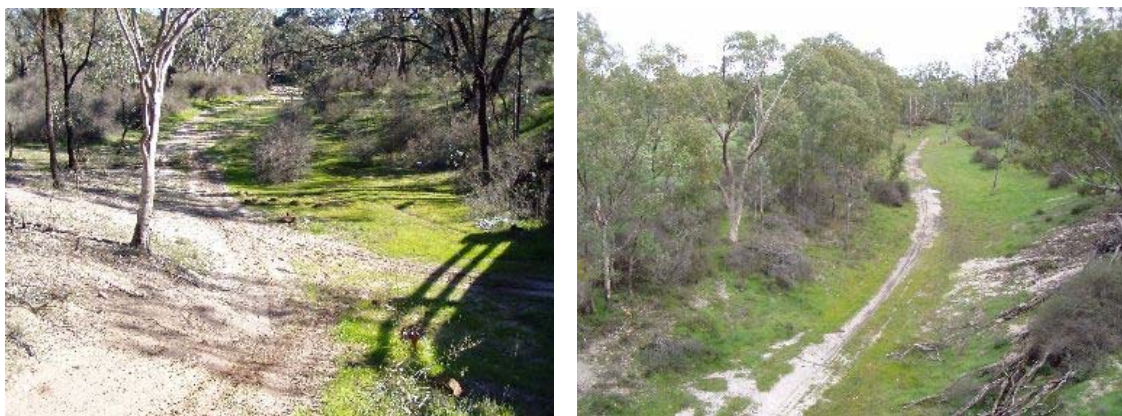
Figure 37: Trailbike tracks in the bed of Outlet Creek at Site 22 on Rainbow Rises Road (left) and Site 19 at Western Beach Road (right).

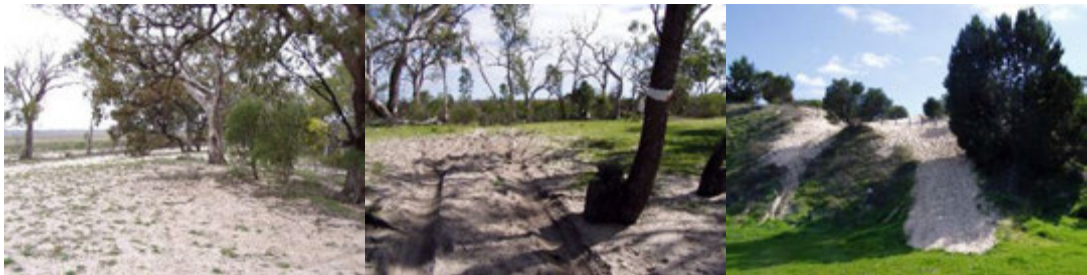
Figure 38: Instability due to effect of human access on vegetative ground cover at Dorrington Point (left), Jordon Valley camping ground (centre) and dunes on the north-eastern side of Lake Albacutya (right).

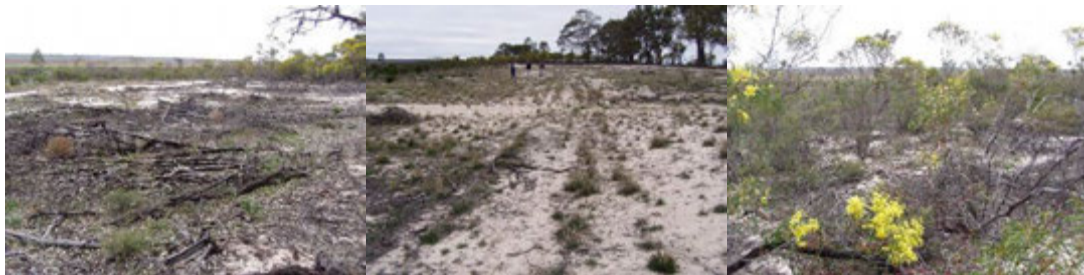
Figure 39: Large scale clearing of native vegetation at Lake Albacutya. Unburnt cleared vegetation with uncleared area in background (left), drill lines of Perennial Veldt-grass (centre) and the area of uncleared vegetation at the tip of Dorrington Point (right).

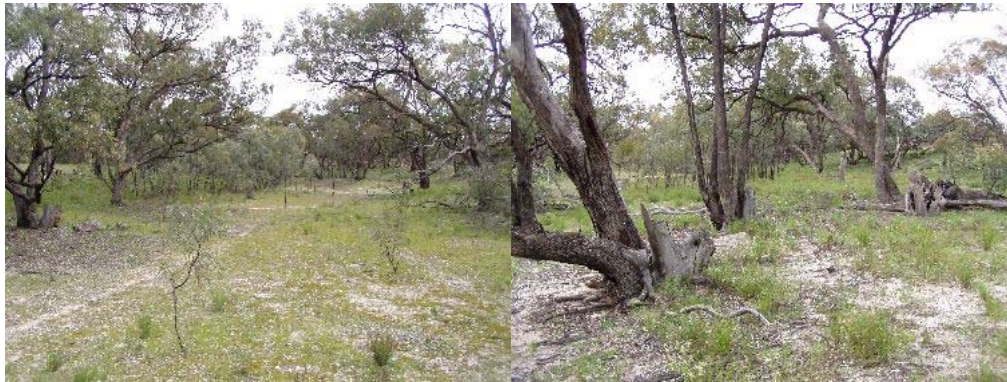
Figure 40: Outlet Creek north of Lake Albacutya. Well vegetated creek bed (left) and recoppiced trees showing evidence of previous timber harvesting (right).

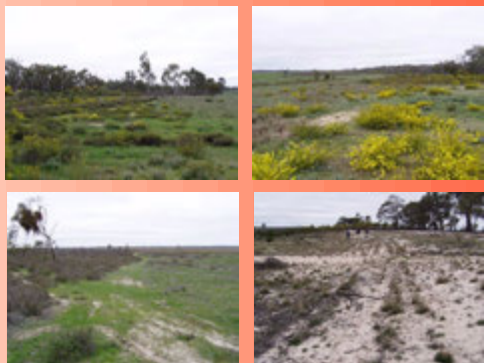
23/Western foreshore
Action 23-60 Monitor and initiate re-vegetation and management project for ecological burn area north and south of Dorrington Point if required. Review use of Perennial Veldt-grass for dune stabilisation in Heritage River Corridor.

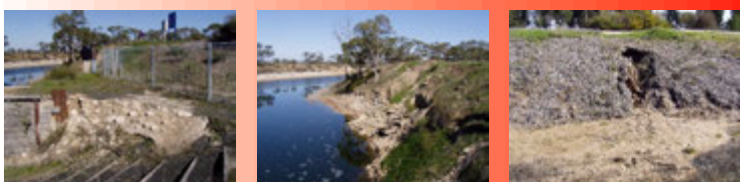
20/Jeparit Wier
Action 20-47 Undertake more appropriate bank stabilization and revegetation works at/downstream of weir

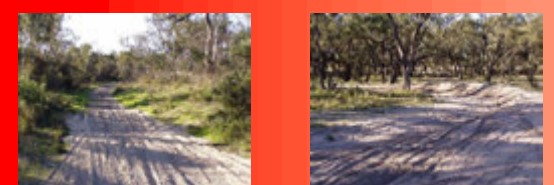
22/All Sites
Action 22-58 Limit 4WD and motorbike access to creek bed

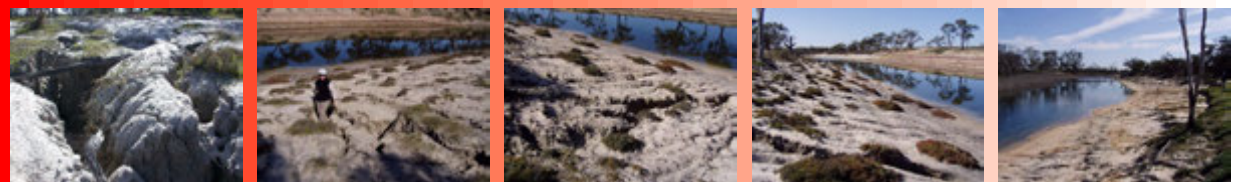
20/Between Jeparit Wier and Lake Hindmarsh
Action 20-48 Undertake bank stabilization and revegetation works on eroding banks between weir and Lake Hindmarsh, including around Hindmarsh Ski Clubrooms

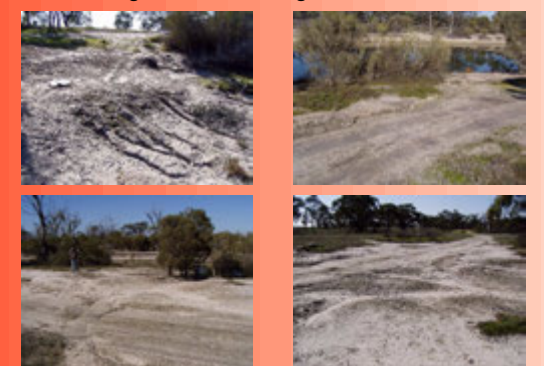
20/024
Action 20-46 Limit vehicle access to riparian zone, stabilise existing scoured tracks and encourage re-colonisation from existing stands of native grasses and herbs
