Review of Halls Gap Flood Investigation – Final Report

May 2017

Project Name	Review of Halls Gap Flood Investigation
Client	Wimmera CMA
Client Project Manager	Abdul Aziz
Water Technology Project Manager	Ben Hughes
Report Authors	Ben Hughes
Job Number	4148-01
Report Number	R04v03
Document Name	Final Report

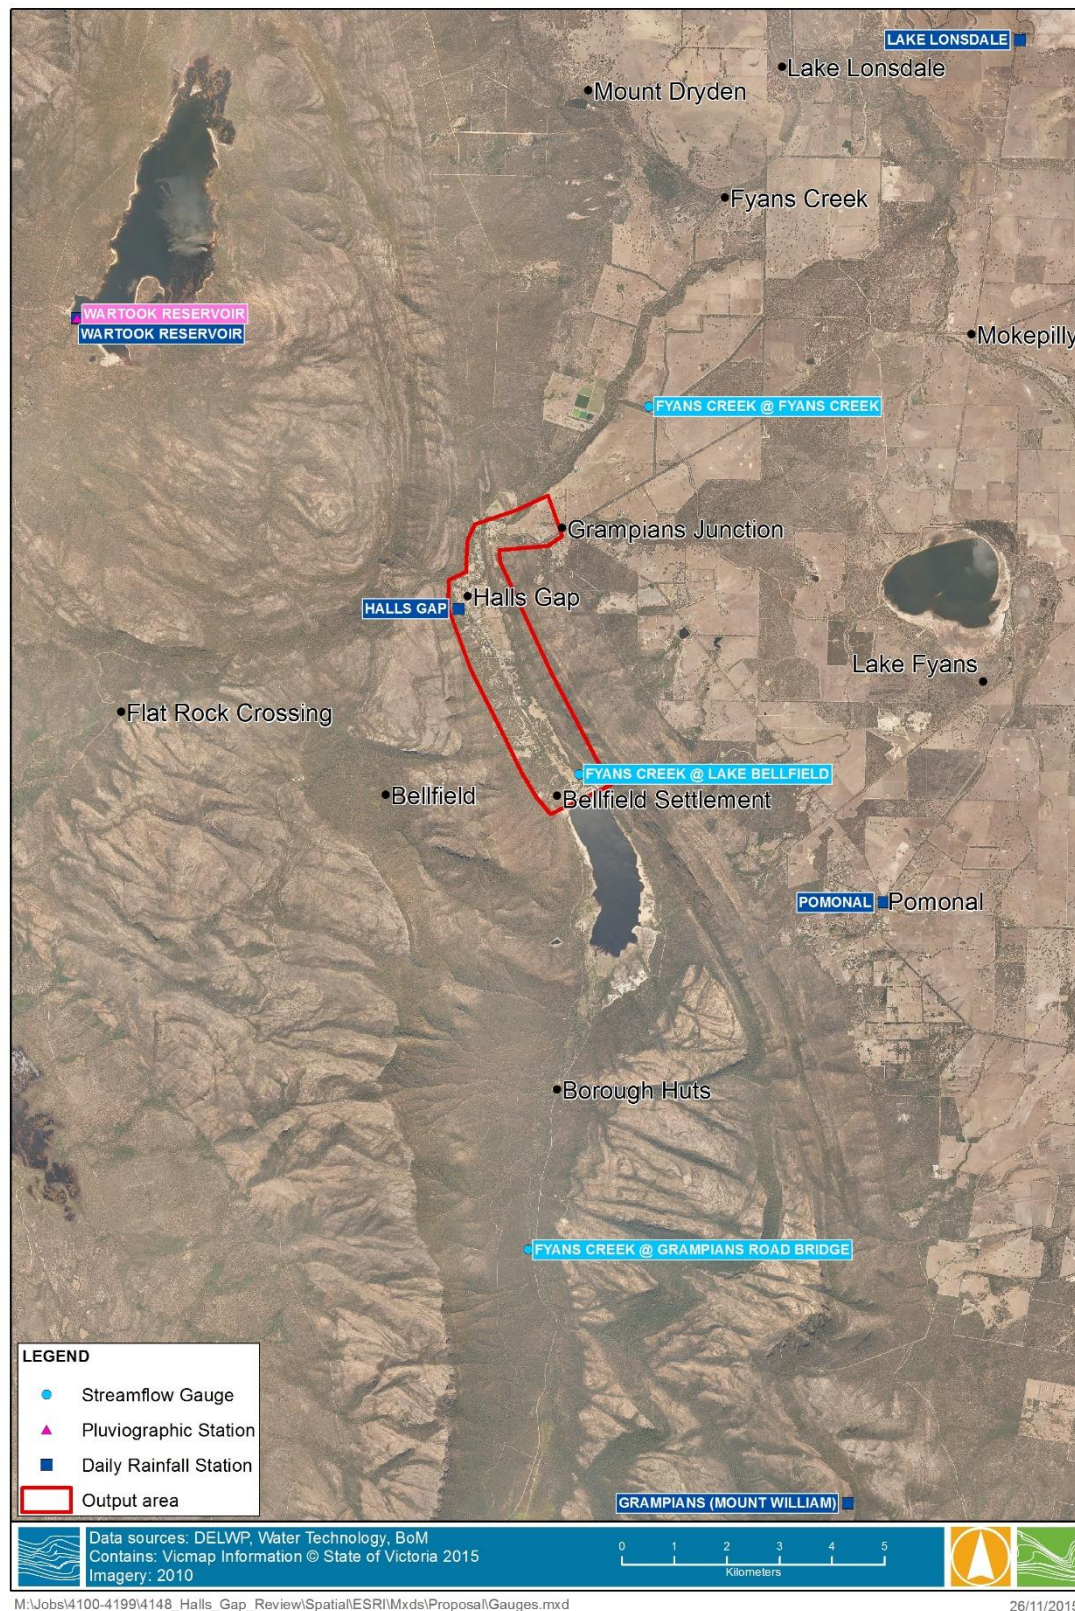
Figure 3-1 Streamflow and Rainfall Gauges around Halls Gap

The location of rainfall gauges within and surrounding the study area is shown in Figure 3-1, aside from the non BoM gauges for which the exact coordinates are unknown.

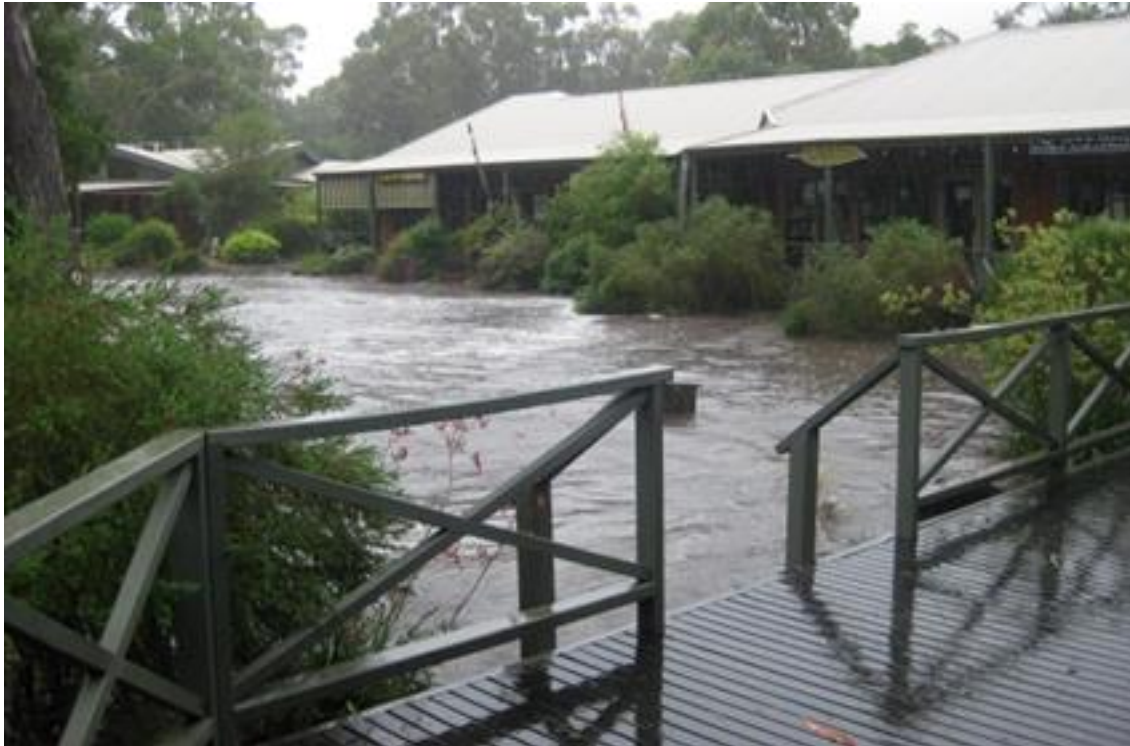
Figure 4-2 Inundation through the Stoney Creek shopping complex

Landslides were observed throughout the Grampians National Park which severely restricted access to some areas. Inundation through the Stoney Creek shopping complex is shown in Figure 4-2.

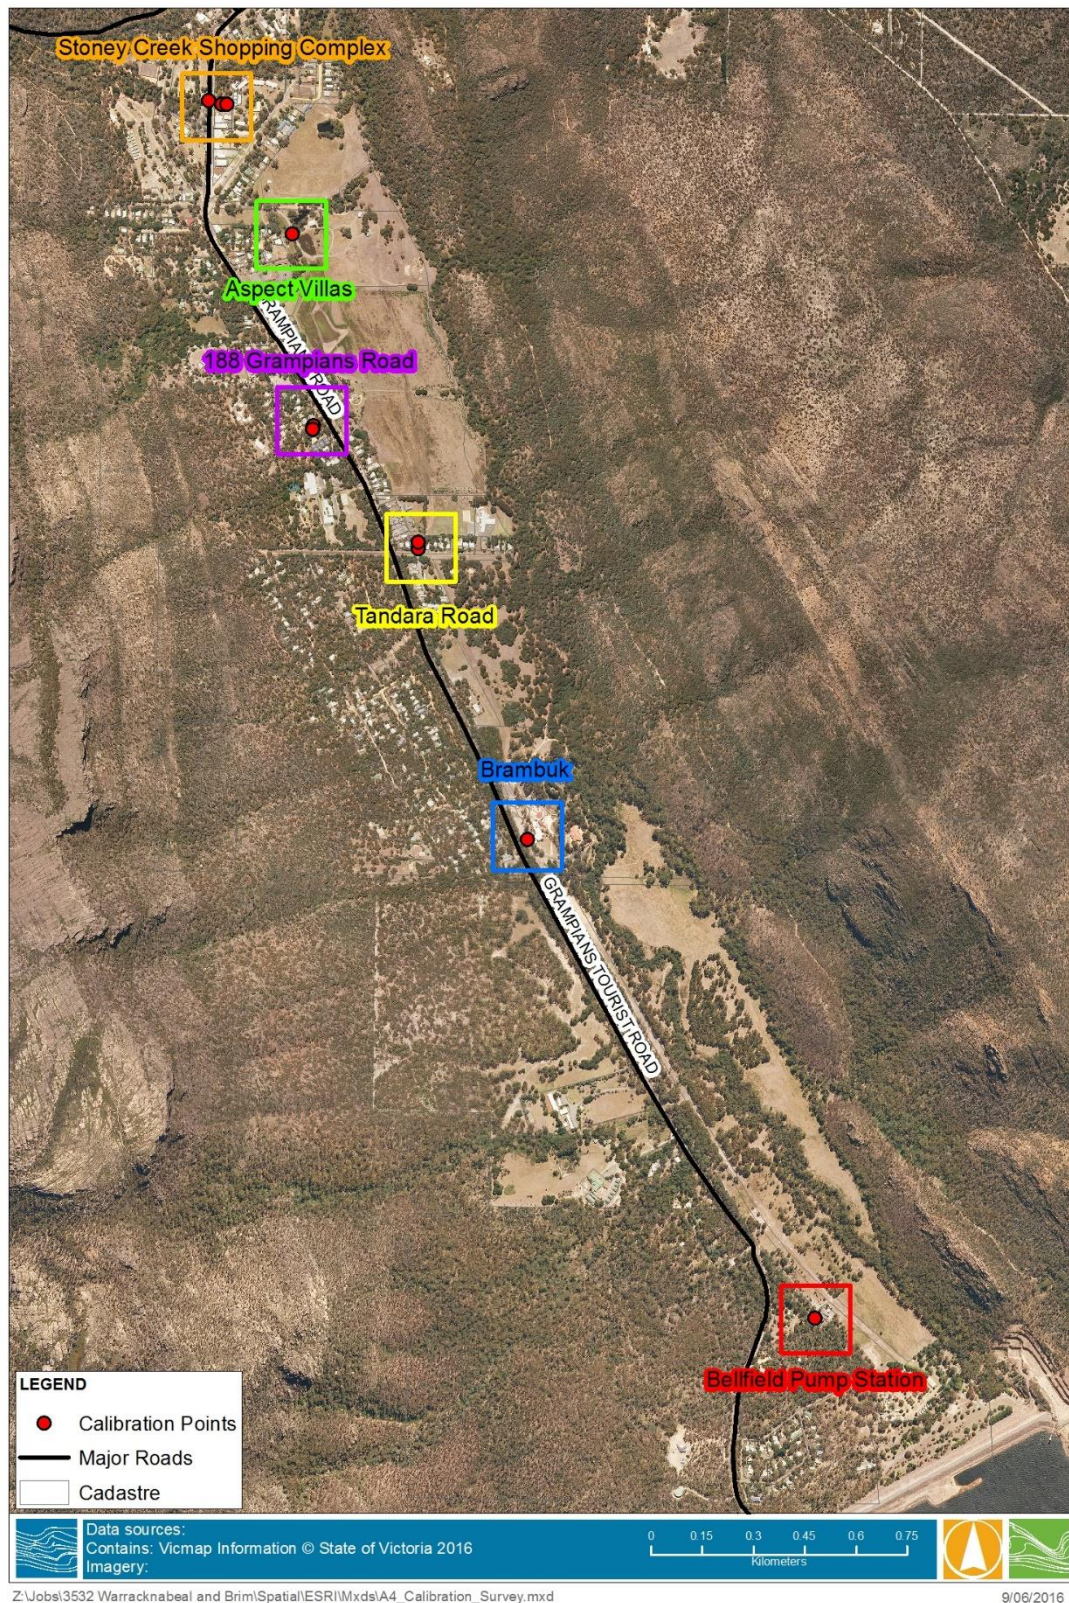
Figure 4-3 Survey flood height locations

These locations are shown in Figure 4-3. Half of the surveyed locations are in steep terrain, including Brambuk, 188 Grampians Road and Bellfield Pump Station. Levels in the Stoney Creek Shopping Complex, Tandara Road and Aspect Villas are more representative of floodplain levels along the valley floor. In areas of steep terrain flood heights are difficult to survey and did not match with modelling due to the steep water surface grade, impact of localised structures and debris. This is especially the case for Halls Gap where large debris flows occurred during January 2011. An example of the impact

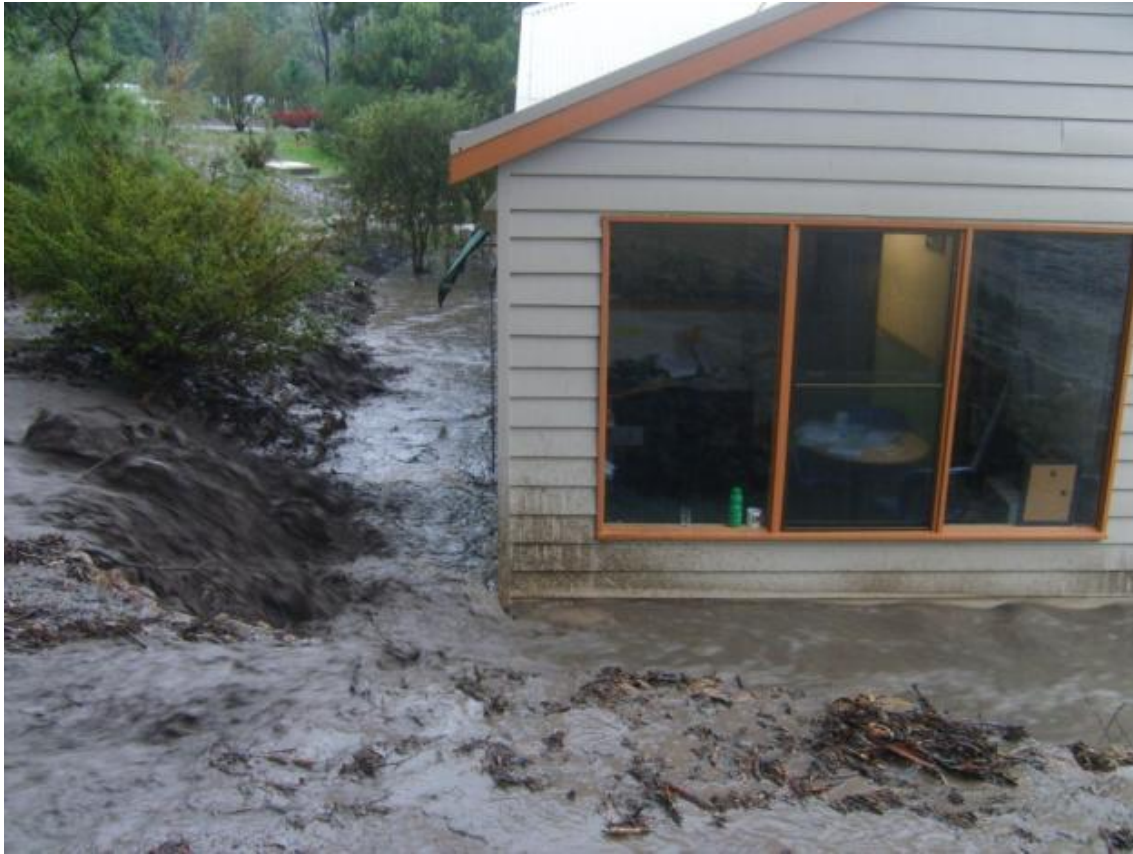
Figure 4-4 **Photo taken in Halls Gap during January 2011**

a building can have on flood levels which could not be represented by floodplain modelling is shown in Figure 4-4.

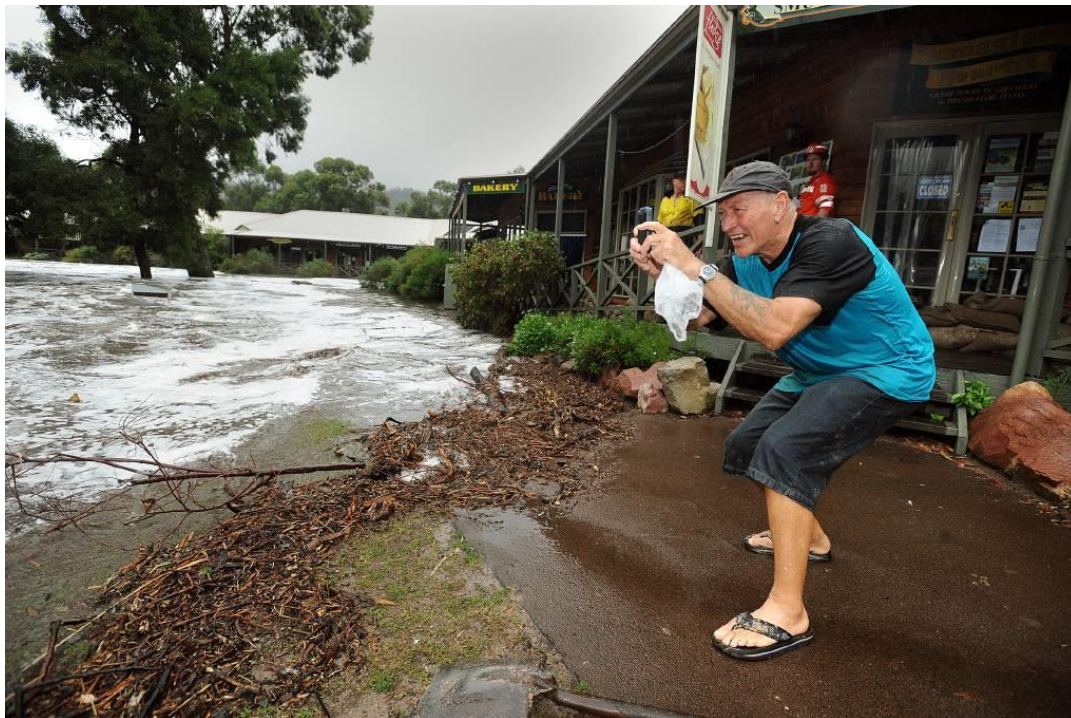
Figure 6-7 January 2011 – Flooding in the Stoney Creek shopping complex looking west from the Stoney Creek Bridge²¹

Several ground based photos were also available to verify the hydraulic model results, Figure 6-7 shows a photo taken in the Stoney Creek Shopping Complex looking along Stoney Creek. The photo was taken after the peak of the event on Stoney Creek with a debris line above the captured water level. This extent is matched closely with the model results. The photo also appears to show water pushing up against the shopping complex walkway. This can also be seen in Figure 6-8.

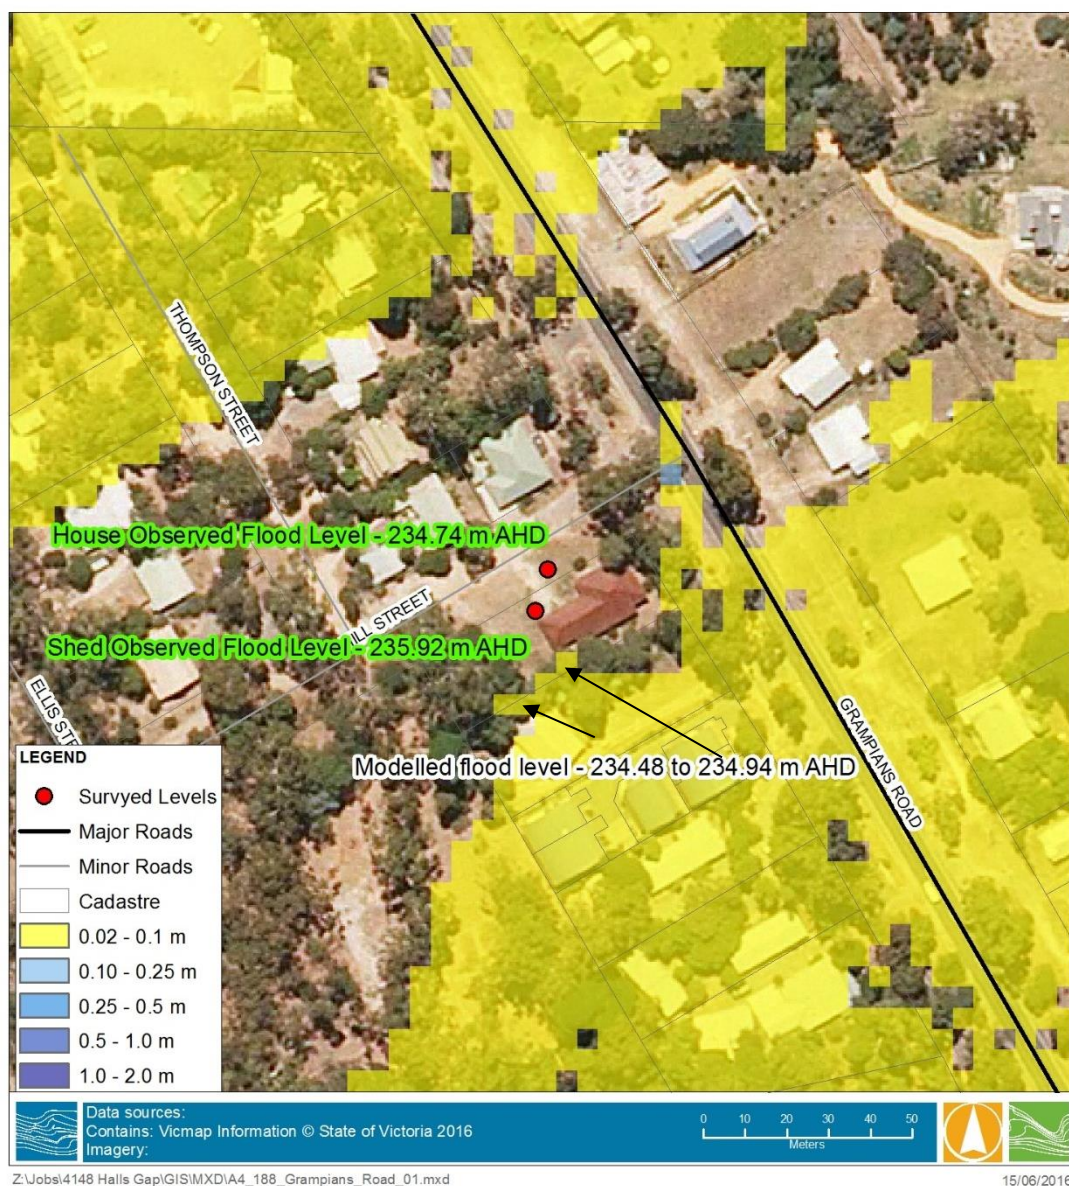
Figure 6-10 January 2011 – Observed flood levels and modelled extent at 188 Tandara Road, Halls Gap

These surveyed levels were provided at two coordinate locations, as shown in Figure 6-10. The figure shows neither surveyed points close to a shed to the level determined for the house at no near the building on the property where the points are located. Review of the addresses available on Google Maps reveals that the address where points are located is 1 Hill Street, with 188 Grampians Road is on the other side of Hill Street to the north. The surveyed levels between the two locations are also quite different with a 1.2 m difference in flood level between the two locations.

Comparisons at this location were not able to be made due to inaccuracies in the survey.

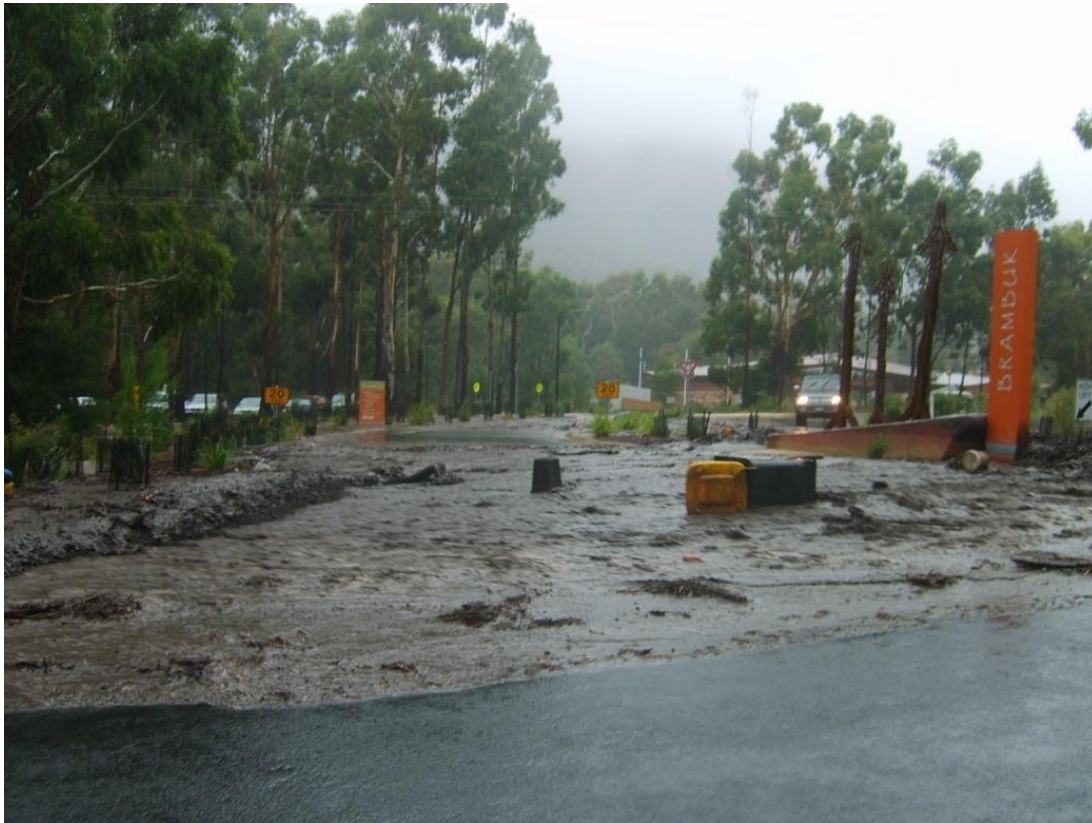
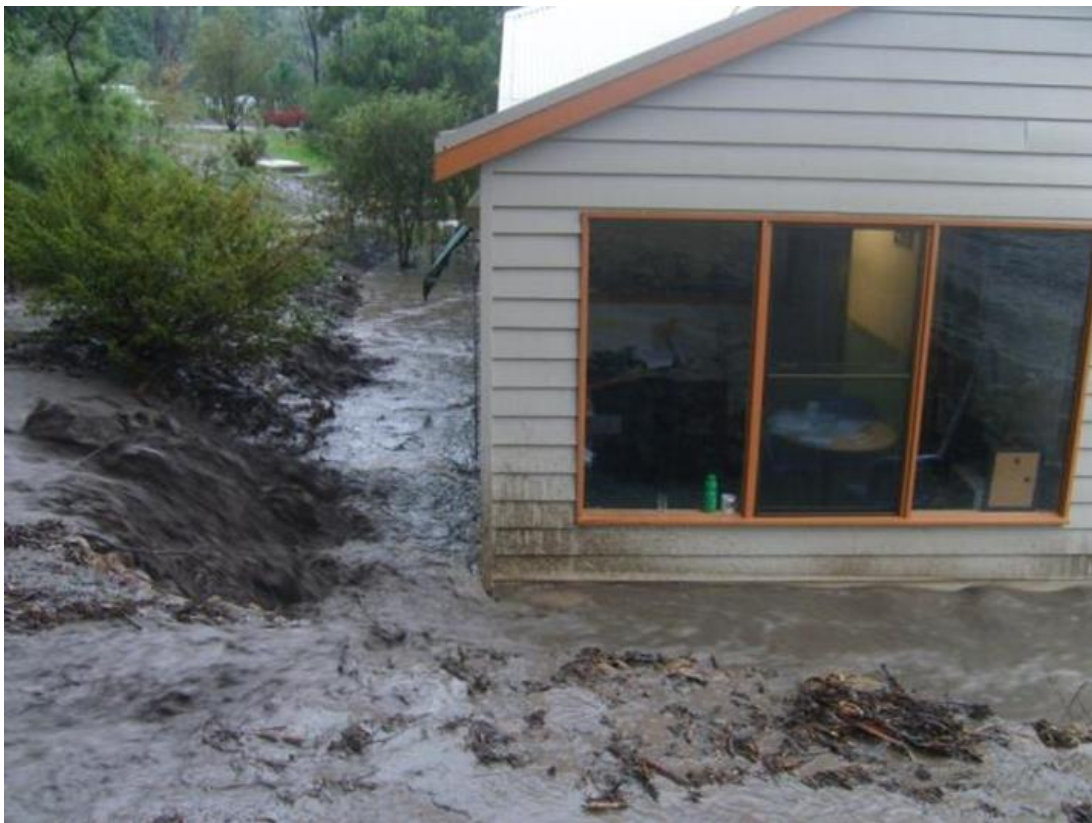
Figure 6-12 also highlights the Brambuk Cultural Centre entry and Parks Victoria Office building. Photos of these locations were captured by Parks Victoria staff during January 2011 and are shown in Figure 6-13 and Figure 6-14 respectively.

Hydraulic modelling of the January 2011 event replicates observations in the photos with water flowing along Grampians Road and at the Brambuk entry, as well as from the south west toward and through the Parks Victoria Office. Unfortunately, the survey is unclear and confusing and makes it difficult to draw any further comparison.
