Final Report

Horsham and Wartook Valley Flood Investigation

Wimmera CMA

16 August 2019

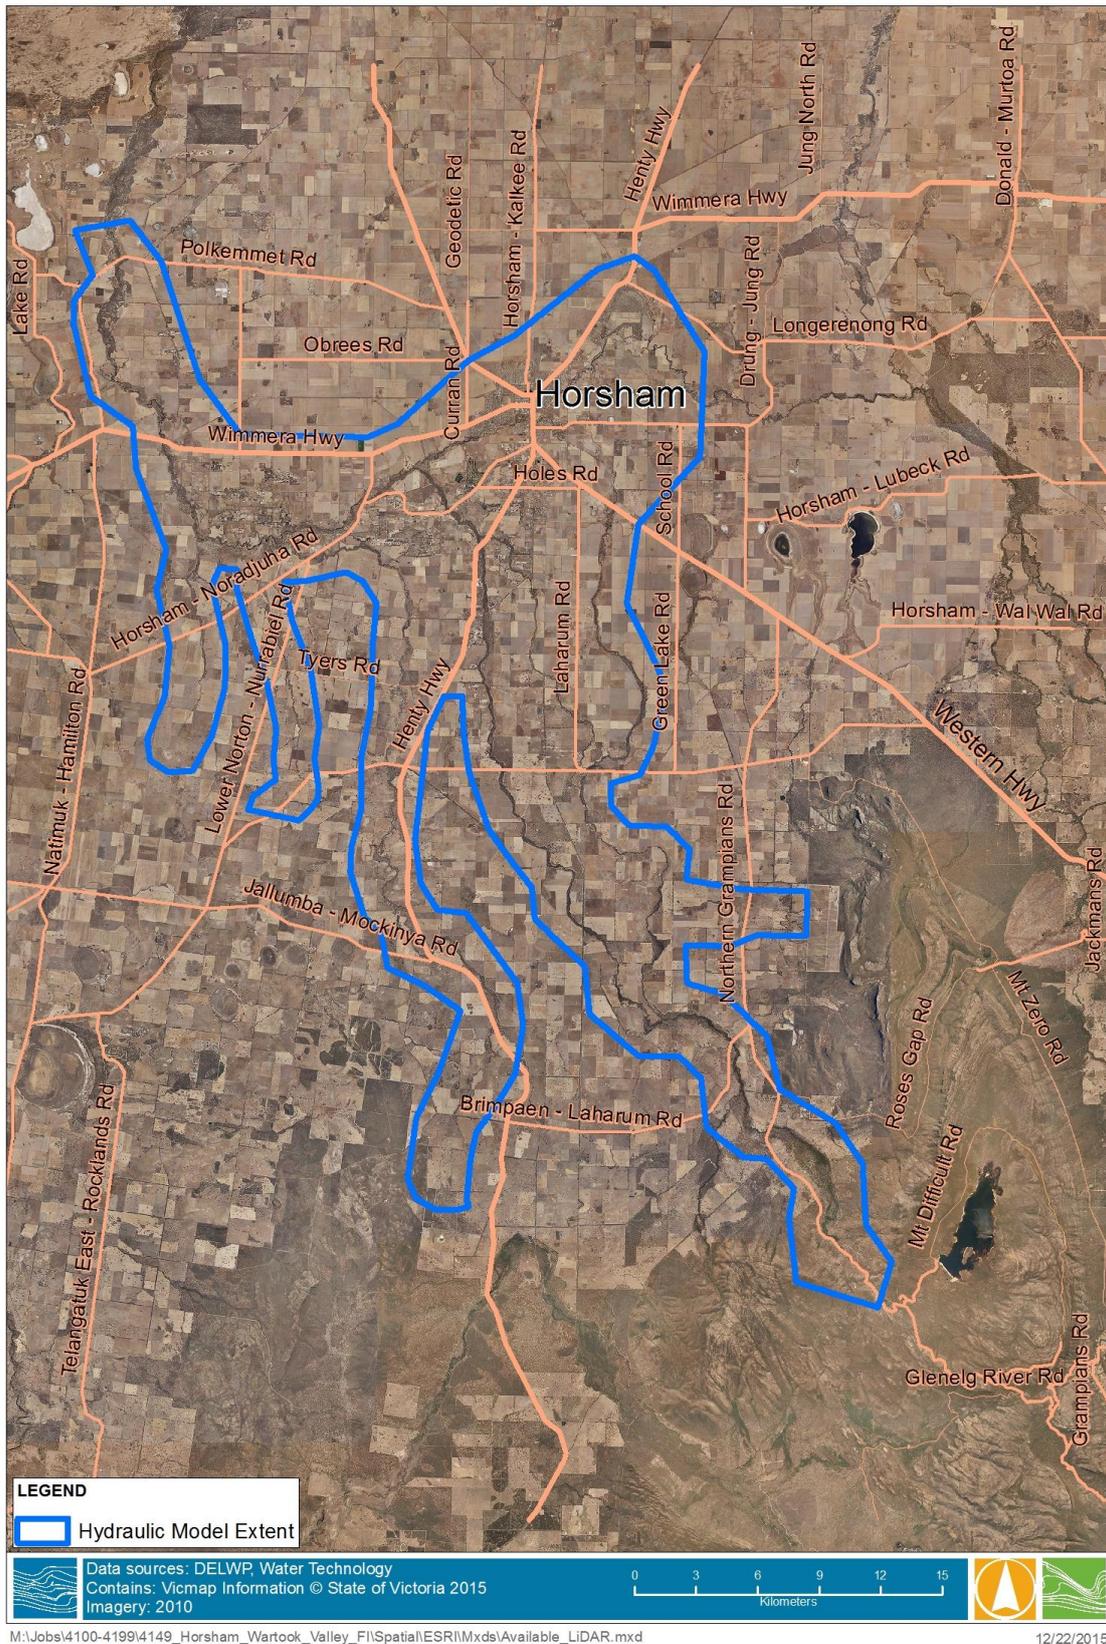
FIGURE 4-9 MIKEFM MODEL EXTENT
