Final Report

Lake Natimuk Weir Modification, Ecological Impact Report

Wimmera Catchment Management Authority

03 May 2019

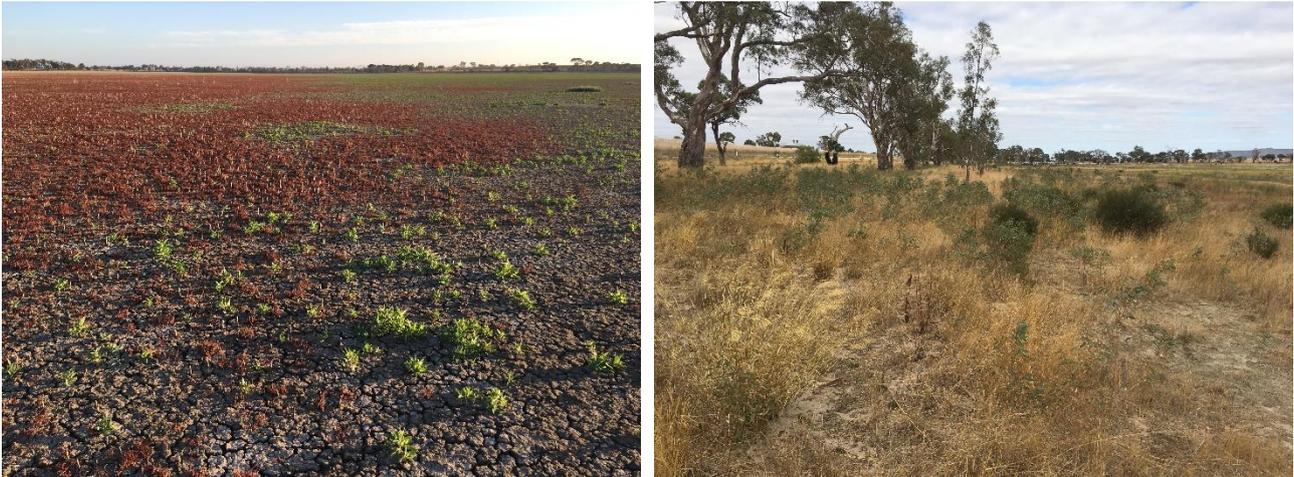
FIGURE 3-1 MIDDLE AND MARGIN OF LAKE NATIMUK

The bed of the lake was completely dry at the time of assessment so validation of the Lake Bed Herbland is difficult, however, is likely that once lake receives water, a herbland will present itself within the shallower extents of the Lake. The left image in Figure 3-1 is taken from the middle of Lake Natimuk showing *Crassula* sp. (red) and *Chenopodium* spp. (green) growing across the dry lake bed.

Despite being mapped as a mosaic, there were no mature patches of Red Gum Swamp within the bed of the lake. However the lake is fringed with large old and less mature River Red Gums around most of the perimeter. As with the Lake Bed Herbland, it is difficult to identify the herbaceous understorey associated with a Red Gum Swamp until the area receives water. The right image in Figure 3-1 is looking down the eastern lake margin showing the line of River Red Gums which may have affinities with Red Gum Swamp under wetter conditions. It should also be noted the mass of seedlings growing on the inside of the mature parents. These trees would be drowned out under a 'normal' hydrological regime and are a sign of the lake not filling in recent years.

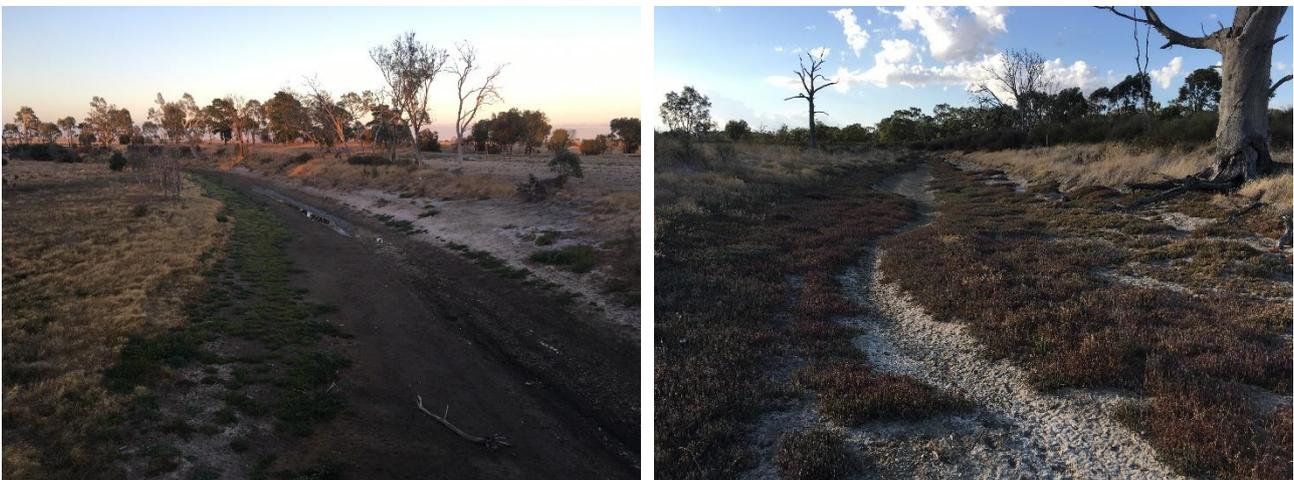
FIGURE 3-2 VIEWS UP NATIMUK CREEK, UPSTREAM OF LAKE NATIMUK

The 2005 EVC mapping suggested that EVC 679 Drainage-line Woodland occupies the creek bank and floodplain. Drought and/or salinity appears to have killed off the scarce River Red Gums. Salt tolerant Samphires dominate much of the channel while grasses dominate the floodplain with Tangled Lignum *Muehlenbeckia florulenta* abundant on the higher floodplain (Figure 3-2). There is currently little affinity with Drainage-line Woodland, particularly with the loss of trees. The drainage line and lower floodplain appears to be disturbed by clearing, grazing and salinisation, however the upper floodplain retains attributes of EVC 808 Lignum Scrub.

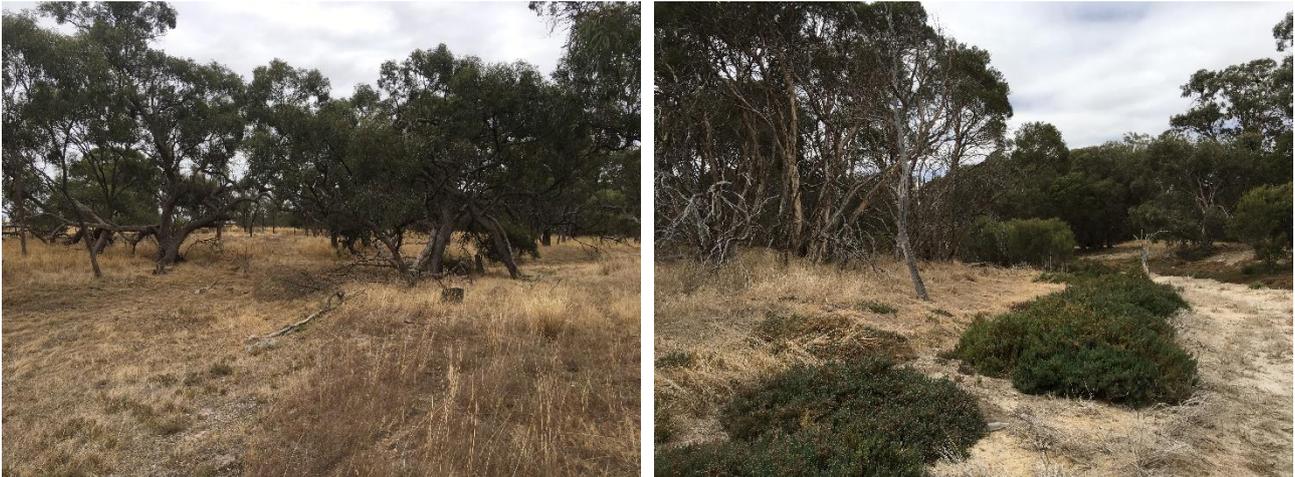
FIGURE 3-3 NATIMUK CREEK DOWNSTREAM OF LAKE NATIMUK

The 2005 EVC mapping suggested that EVC 741 Salt Paperbark Woodland / Samphire Shrubland Mosaic surrounds Natimuk Creek in this reach. This EVC is valid for the downstream half of the reach (see Figure 3-3 right photo), however the upstream half of the reach is more an open woodland and more synonymous with EVC 803 Plains Woodland (see Figure 3-3 left photo).

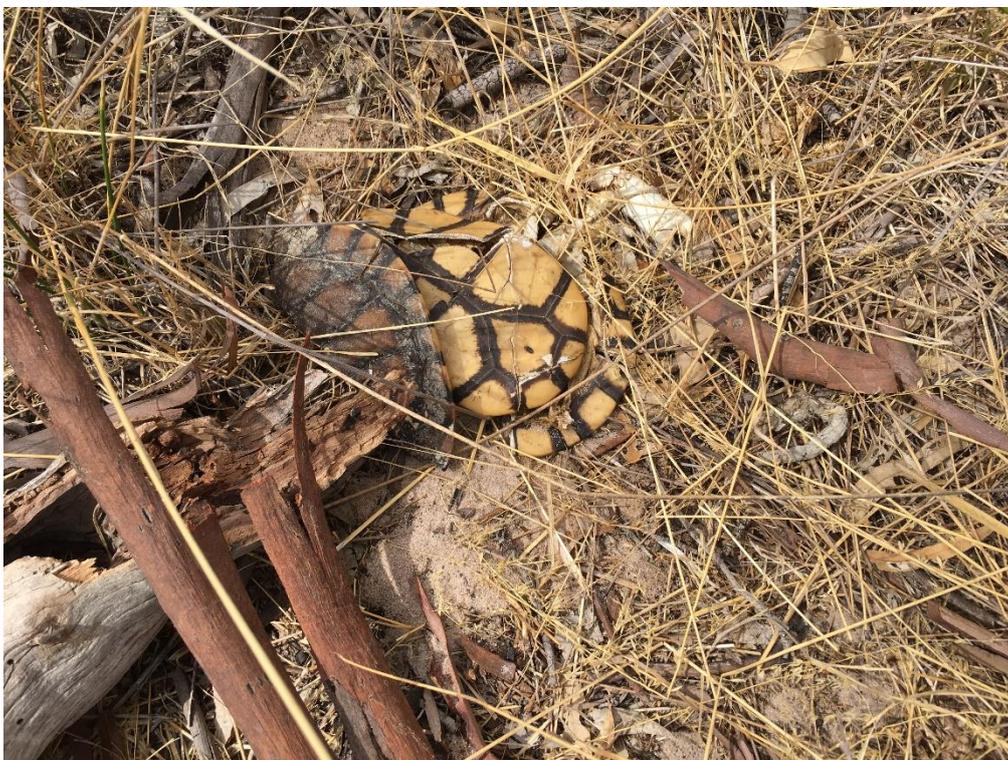
Skink holes in the sand were frequently observed. These are likely to be from the Large-striped Skink, a species previously recorded in the area. Indication of use by some species that succumbed to the lake drying out were evident. An Eastern Long-necked Turtle shell was observed on the western bank of the lake at the base of a large River Red Gum (Figure 3-4), possibly predated by a fox upon leaving the drying lake bed.

FIGURE 3-4 EASTERN LONG-NECKED TURTLE SHELL ON THE WESTERN BANK OF LAKE NATIMUK

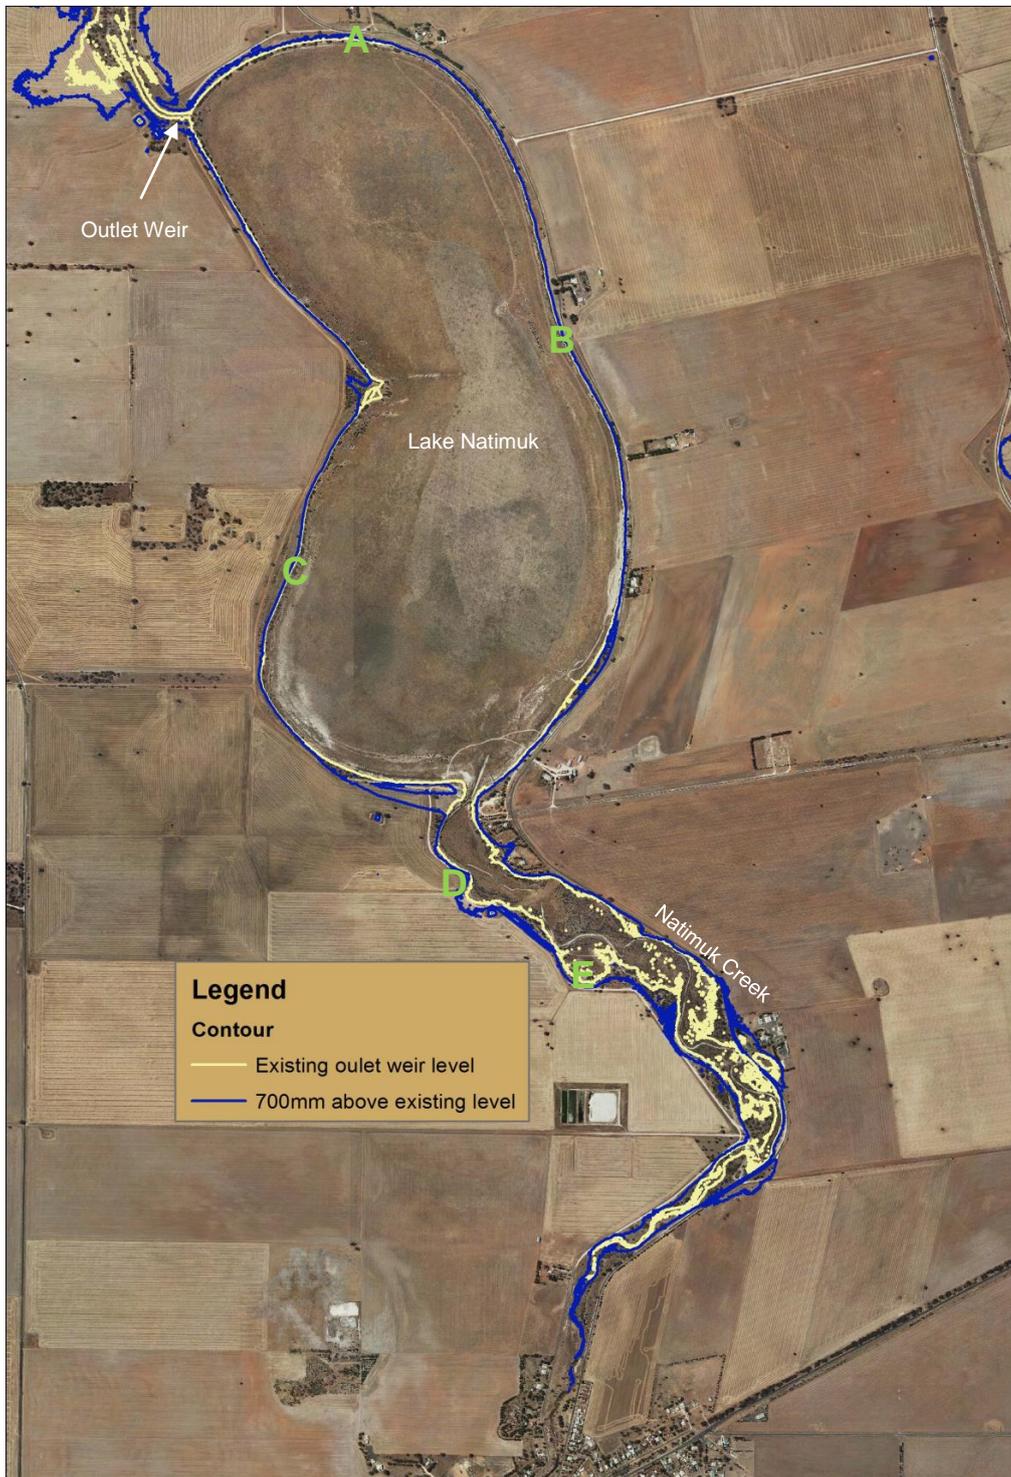
FIGURE 4-2 INUNDATION MAPPING WITH DISCUSSION SITE LOCATIONS

The maximum standing water level in existing and proposed conditions was mapped in plan view to show the extent of inundation around Lake Natimuk and upstream into Natimuk Creek. Figure 4-2 shows the extent of

inundation under existing conditions (yellow line) and the inundation extent should the 700mm higher weir were in operation (blue line). The 700mm higher weir is hereafter referred to as 'the proposed weir'.

The maximum increase in inundation area is generally relatively minor with the existing lake banks containing the inundation. The existing wet area of the lake is around 310 Ha, this would increase to 317 Ha in with the elevated weir height. No increase in water levels will occur downstream of the outlet weir.

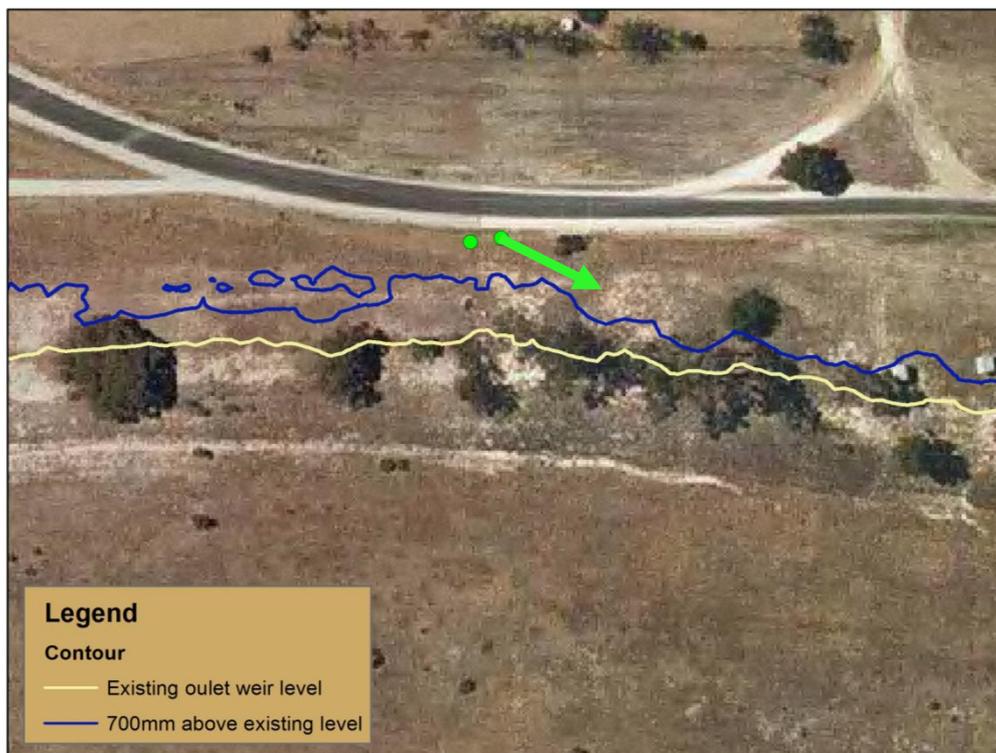
FIGURE 4-7 LOCATION A INUNDATION MAPPING AND PHOTO LOCATION

Figure 4-7 shows an aerial image of Location A on the northern shore of Lake Natimuk. This and subsequent aerial images of locations around and upstream of Lake Natimuk show a yellow line depicting the inundation level when the existing weir starts to spill, and the blue line models the extent of inundation when the proposed weir begins to spill. The area between the lines is the additional area that is expected to be inundated if the proposed weir is commissioned. The green dots in the following figures represent photograph locations, while the green arrows indicate the direction of photographs within this report.

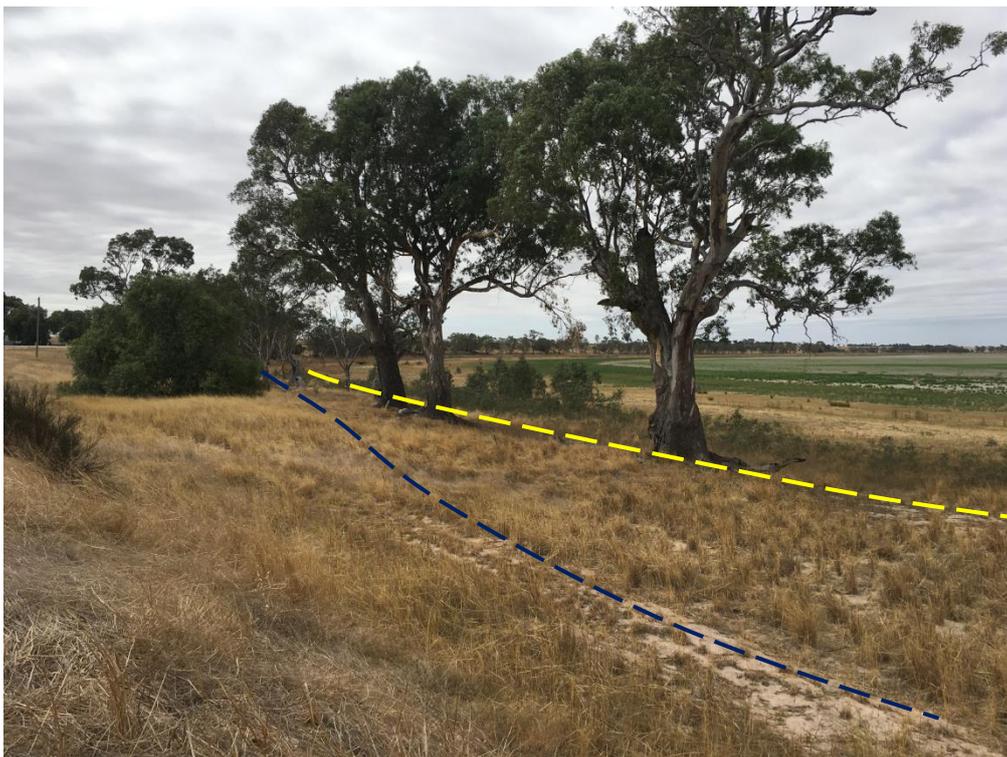
FIGURE 4-8 LOCATION A PHOTO WITH APPROXIMATE INUNDATION EXTENTS

- The existing weir's level of inundation is closely aligned with the trunks of the large River Red Gums that surround the lake in this vicinity. If the proposed weir is commissioned, the large River Red Gums will be inundated to a depth approximating 700mm at the time of spilling. The inundation is expected to be infrequent (i.e. many years apart) and the duration of inundation is expected to be relatively long (i.e. a number of months). River Red Gums can tolerate inundation for extended periods and are unlikely to be adversely affected by this higher water level. However, the higher water level may lead to increased erosion around the trunk and roots (see Location B notes on erosion).

- The additional area of inundation varies in width from about 5 – 15m.
- The area being inundated is covered mostly in grasses, both exotic and native. Some of these grasses may be temporarily or permanently lost or disturbed during inundation events, however, substantial change in ground cover composition is not anticipated as the duration of inundation is not expected to be long.

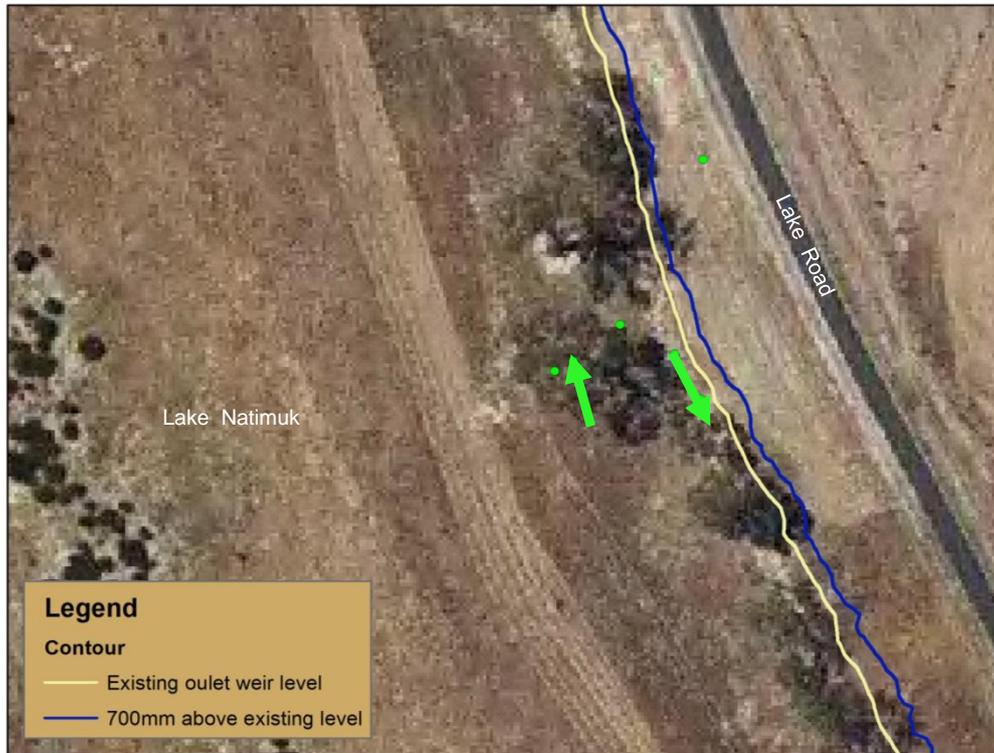
FIGURE 4-9 LOCATION B INUNDATION MAPPING AND PHOTO LOCATIONS

Figure 4-9 show an aerial image with the inundation lines and Figure 4-10 photo locations (green arrows). The bank/margin of the lake is relatively steep in this vicinity, hence the inundation lines are close together. This relative steepness is presumably due to there being a lunette on the eastern side of the lake.

- The higher water level associated with the proposed weir may extend above the existing bank rockwork. This may necessitate the extension of rockwork up the bank to protect it from erosion. More detailed survey may be required to identify the exact location of the proposed weir inundation level and consider the potential costs of additional rockwork prior to commissioning.

- Trees on the eastern side of the lake within the current high water mark have been rocked to protect the soil around root systems. Assuming trees within the proposed weir high water mark may require a similar treatment, and since most of the existing trees are located close to the current weir high water mark, a substantial amount of rock may be required.

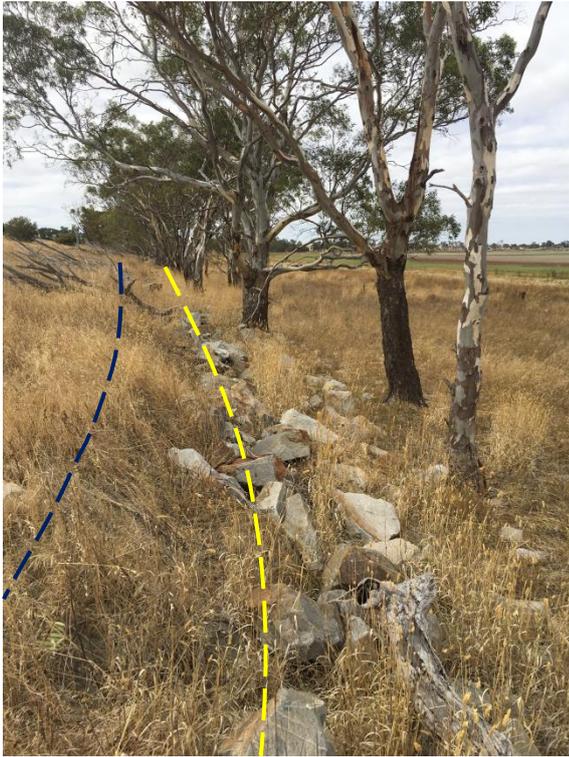
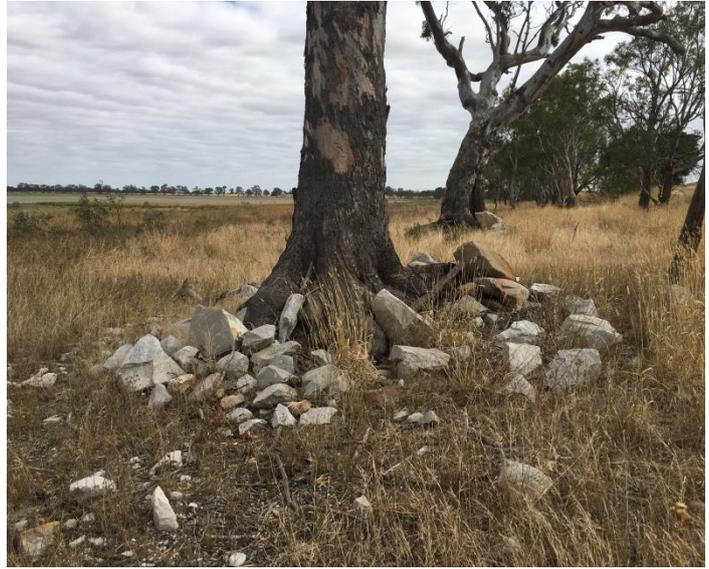
FIGURE 4-10 LOCATION B PHOTO WITH APPROXIMATE INUNDATION EXTENTS, AND ROCKED BASE OF RIVER RED GUM

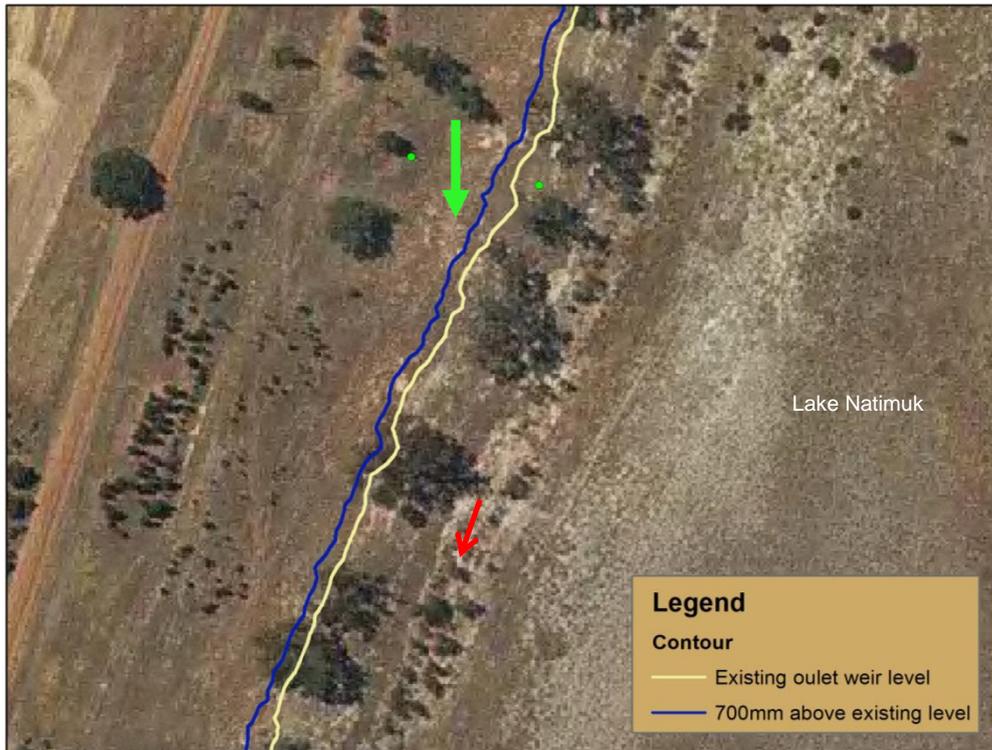
FIGURE 4-11 LOCATION C INUNDATION MAPPING AND PHOTO LOCATION

Location C on the western shore has a gentle consistent slope where the difference between the existing and proposed weir levels is consistently around 4 - 5m. As with the Locations A and B, the existing weir high water mark correlates with around or just above the trunkline of the existing large River Red Gums.

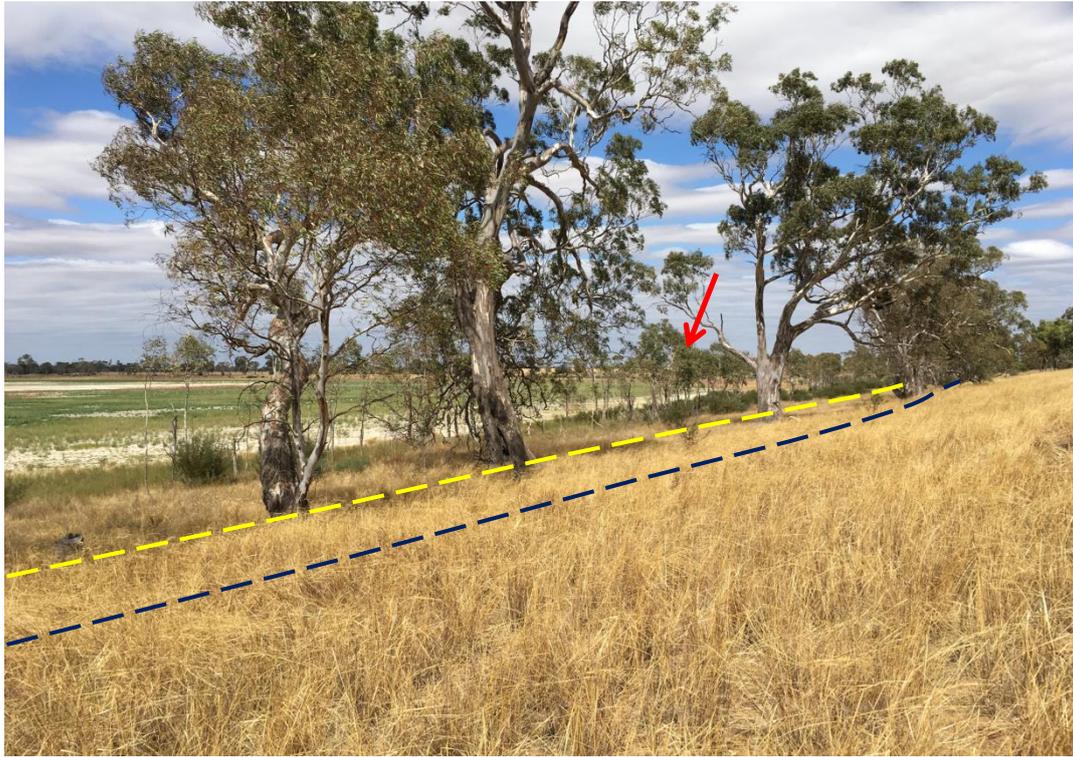
FIGURE 4-12 LOCATION C PHOTO WITH APPROXIMATE INUNDATION EXTENTS

- Inundation around the trees has the potential to strand arboreal animals if present, however most animals have some swimming ability and the duration of inundation is expected to be short. Therefore, inundation around these trees is not expected to pose a high risk to fauna.

- Repeated years of dry conditions have led to terrestrialisation of the wetland, as evidenced by trees and shrubs growing on the lower edge of the lake margin (see red arrows in Figure 4-11 and Figure 4-12). This woody vegetation is likely to have germinated from seed near the wetted margin of the lake and subsequent years have not filled the lake to sufficient depth to drown this vegetation. Now that this vegetation has established and is tall enough to extend well above any high water level, the trees may persist into the future. The River Red Gums are likely to persist, however the shrub species are expected to drown if there are a few consecutive wet years.

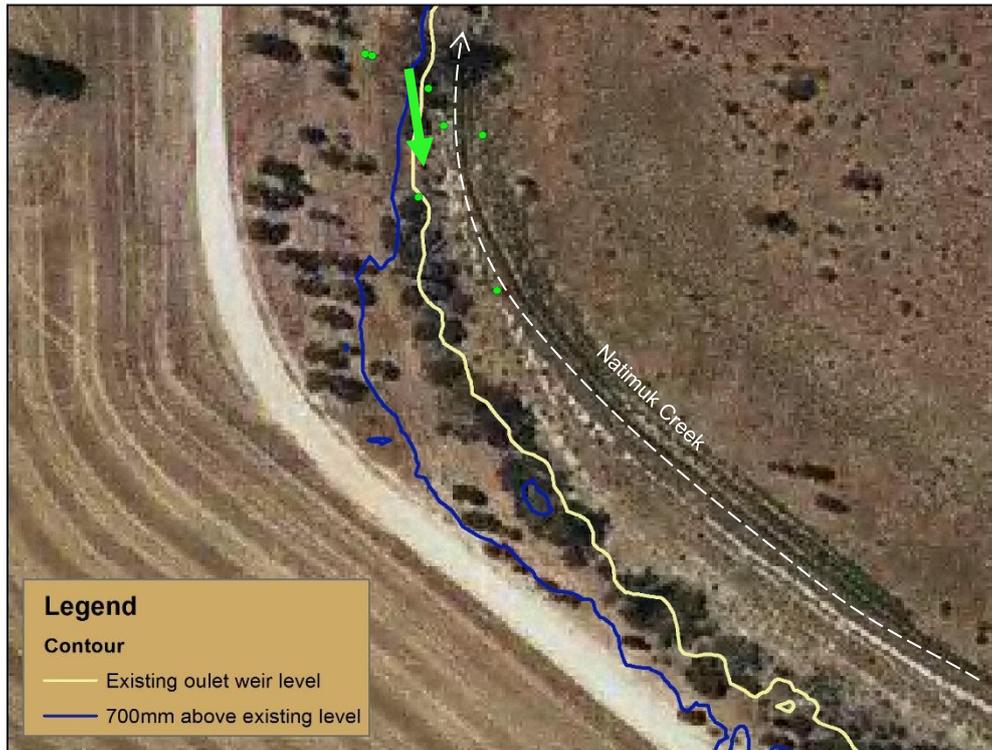
FIGURE 4-13 LOCATION D INUNDATION MAPPING AND PHOTO LOCATION

Location D is situated on the left bank of the Natimuk Creek, approximately 250m upstream from the lake. The creekline in this location has a relatively broad floodplain off the right bank. The current weir level is high on the relatively steep bank and almost mimics the edge of a continuous line of Tangled Lignum, *Muehlenbeckia florulenta*.

- Figure 4-13 shows that an increase in weir height is likely to cause the inundation of the lignum and other shrubs and ground covers persisting above the current weir height. There are numerous saltbush and grass species that may be displaced to higher margins should inundation occur regularly or for a prolonged period.
- The established Lignum is not expected to be adversely affected by deeper inundation and may expand its distribution back to the limit of the proposed weir inundation extent.
- Trees further offshore behind the Lignum are closer aligned to the proposed weir inundation extent and should not be adversely affected.
- There has been a considerable amount of revegetation around and downstream of Location D. Some of the planted shrub species may be susceptible to waterlogging if within the proposed weir inundation extent.

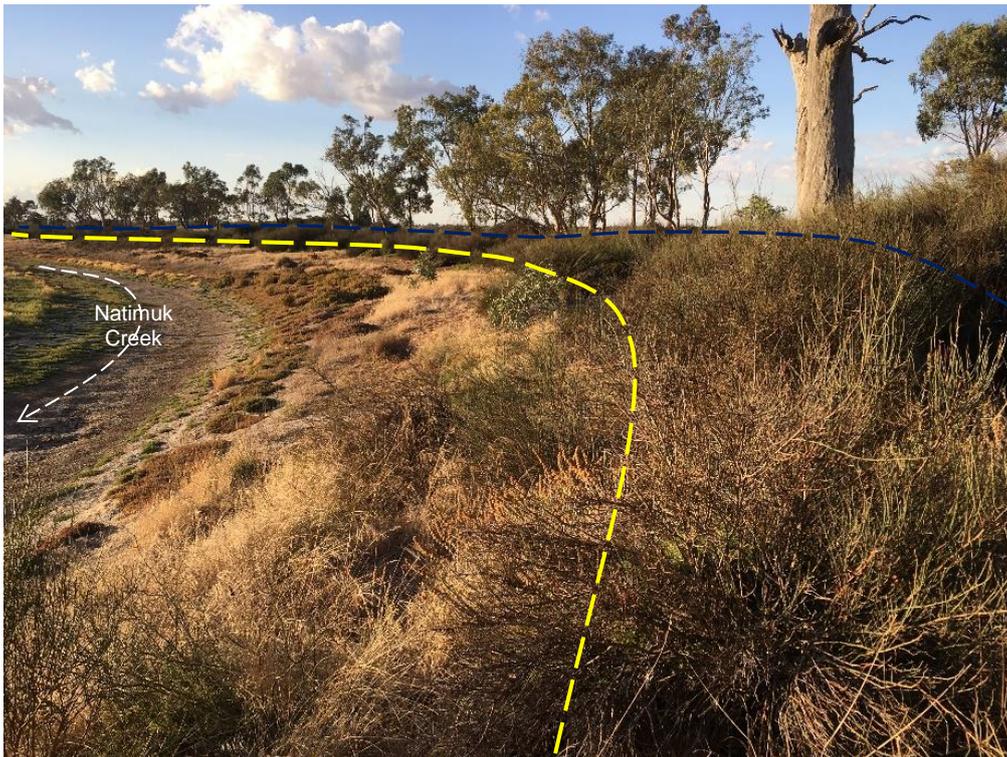
FIGURE 4-14 LOCATION D PHOTO WITH APPROXIMATE INUNDATION EXTENTS

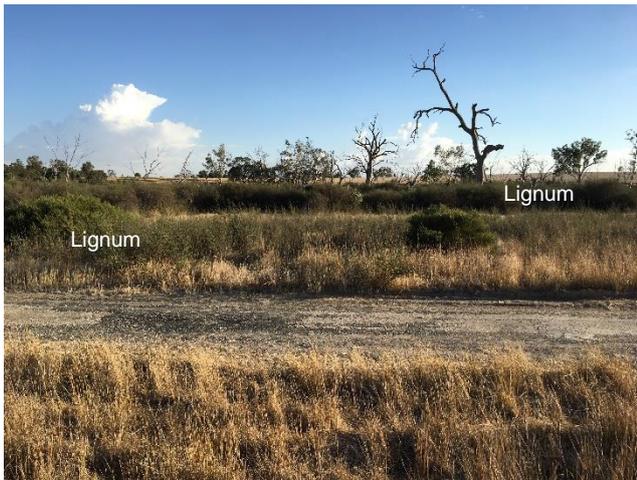
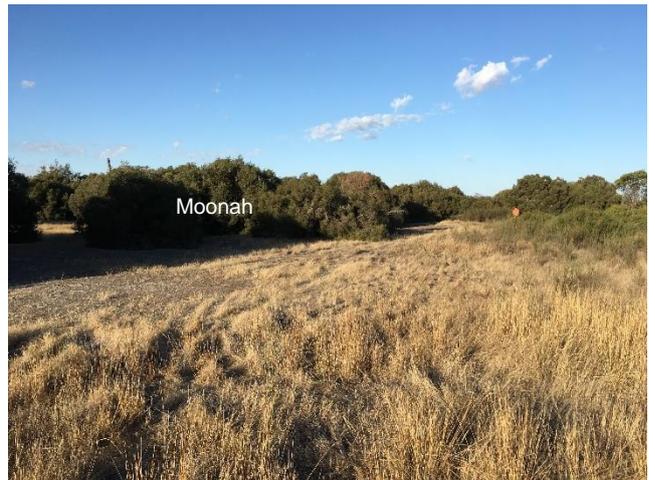
FIGURE 4-16 VIEW TOWARDS THE CREEK SHOWING LIGNUM AND DEAD TREES, AND OFFSTREAM TOWARDS MOONAH

- Lignum is situated within the existing outlet weir inundation level. The proposed weir will inundate these shrubs to a greater depth, however it is unlikely to totally submerge the plants nor occur for sufficient duration to damage the plants.
- The proposed weir inundation extent is expected to inundate, or more deeply inundate, Moonah trees in the vicinity of Location E. Moonah has high tolerance to waterlogging and salinity and should not be affected by periodic inundation.
- There are numerous dead trees near the main channel of Natimuk Creek in the vicinity of Location E. Most of these dead trees were relatively young/small when they died. It is presumed these are River Red Gums that have succumbed to drought/water stress, possibly during the recent Millennium Drought, or salinisation.

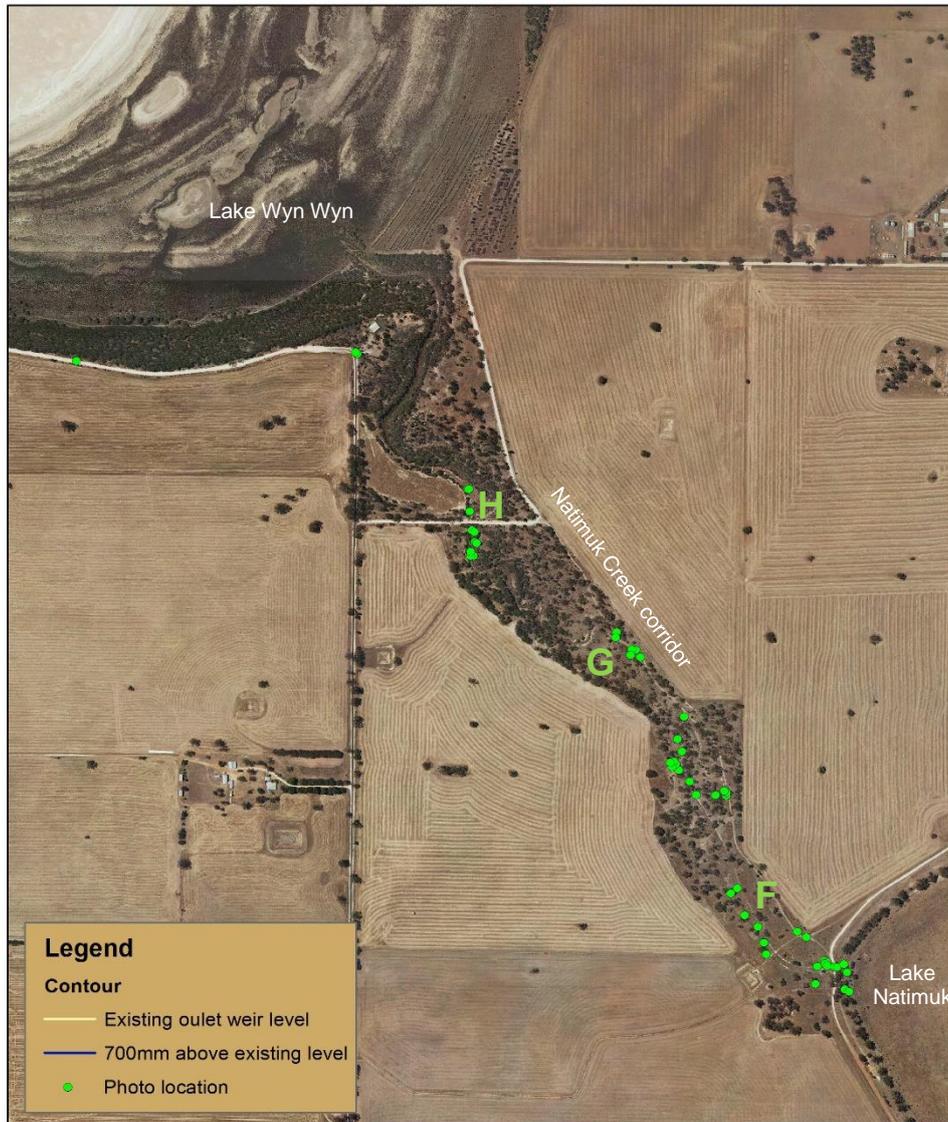
FIGURE 4-17 NATIMUK CREEK DOWNSTREAM OF LAKE NATIMUK

Natimuk Creek flows for approximately 2.5km north-westerly from Lake Natimuk to Lake Wyn Wyn (Figure 4-17). Lake Wyn Wyn is supplied by saline groundwater, local runoff, direct precipitation and overflow from Lake Natimuk via Natimuk Creek.

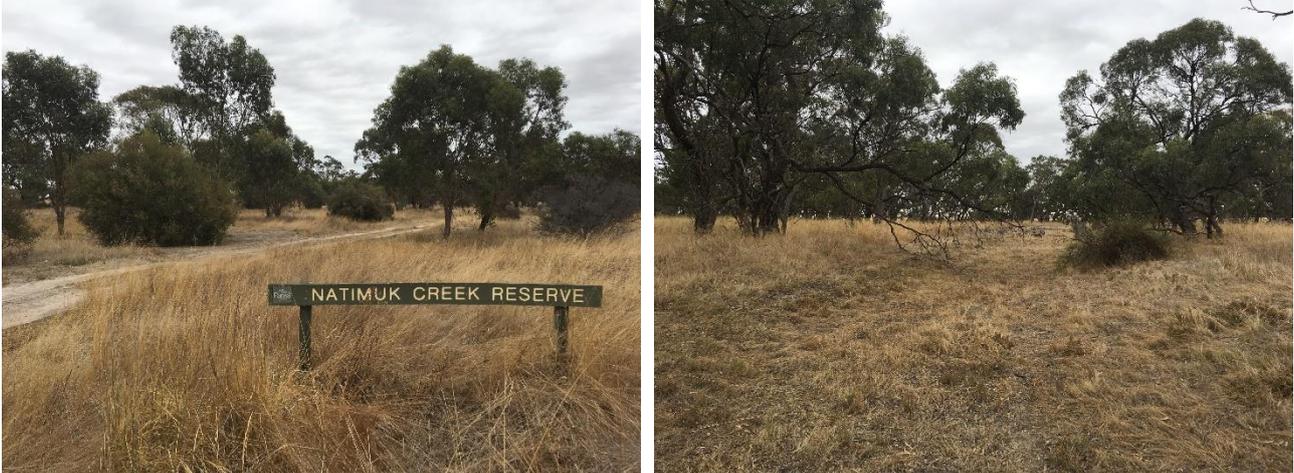
FIGURE 4-18 NATIMUK CREEK RESERVE, AND GRASSED CHANNEL

There are no highly water dependent species observed within the channel and banks, indicating that the creek flows very infrequently and mostly receives localised runoff. Trees are dominated by Black Box, *Eucalyptus largiflorens*, rather than River Red Gum. Depending upon groundwater availability, depth and salinity, Black Box have been observed to survive inter-flood dry-periods exceeding 30 years, whereas River Red Gums have a maximum inter-flood dry-period of 3-4 years (Rogers and Ralph 2011). The absence of River Red Gum along this section of creek indicates that the Natimuk Creek rarely flows and surface and groundwater is saline and insufficient to support the species.

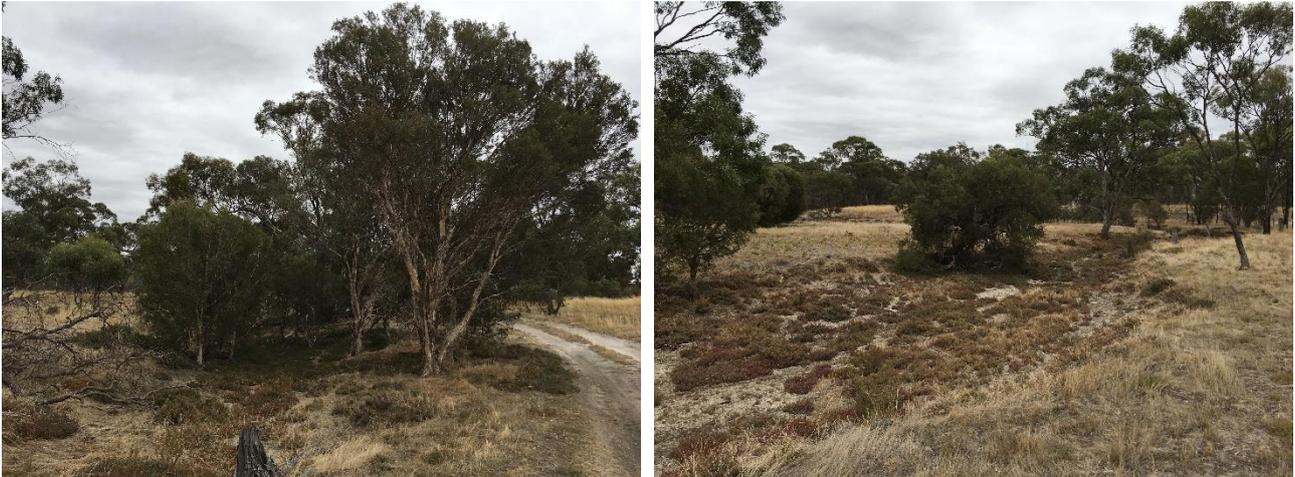
FIGURE 4-19 LOCATION G WHERE THE MOST UPSTREAM PAPERBARKS WERE OBSERVED, THE CHANNEL NOW SUPPORTING SALTMARSH SPECIES.

When moving downstream the first Salt Paperbarks, *Melaleuca halmaturorum* ssp. *halmaturorum*, were identified at Location G, 1km downstream from Lake Natimuk. At this location and downstream, saltmarsh vegetation (e.g. Noon-flower, *Disphyma* sp.) is now present in the bed of the creek (Figure 4-19). Both the Salt Paperbark and Noon-flower are highly salt and waterlogging tolerant. It is unknown if there is saline groundwater present however it is suggested that this location is around the upstream limit of backwater from Lake Wyn Wyn when it is full.

The presence of Salt Paperbarks suggests that this vegetation is receiving water from the channel more often or regularly than further upstream. The water source is therefore presumably not from Lake Natimuk and may be localised runoff, Lake Wyn Wyn backwater or groundwater fed. Although this vegetation is likely to benefit from flows from Lake Natimuk, it is assumed it is not critically reliant on those flows although, again, there may be localised groundwater recharge benefits.

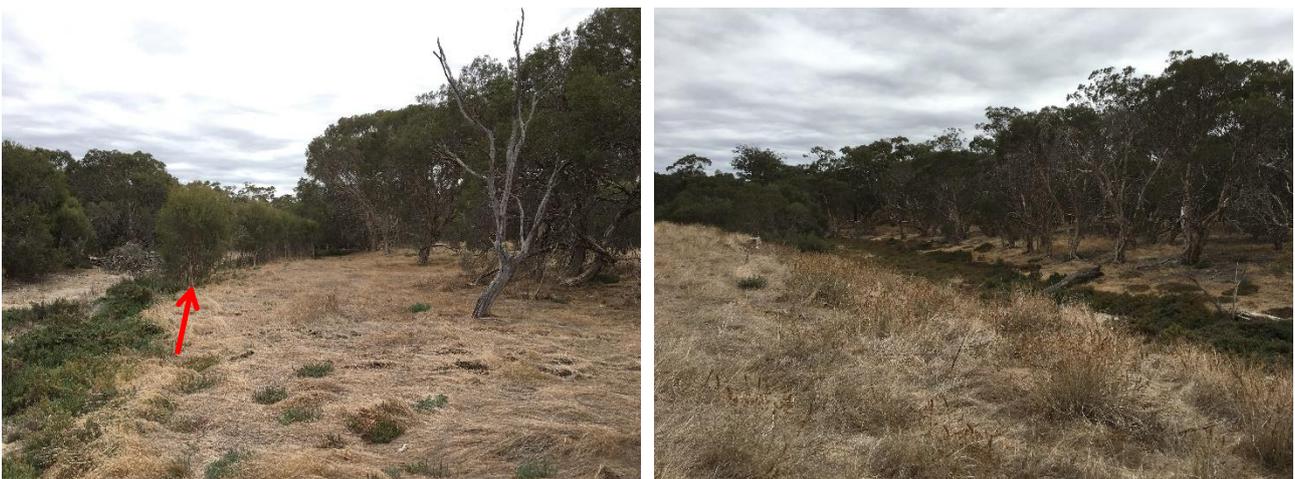
FIGURE 4-20 NATIMUK CREEK UPSTREAM AND DOWNSTREAM OF LAKE AVENUE

The creek around Lake Avenue clearly backwatered by Lake Wyn Wyn when full. The channel is occupied by an abundance of salt tolerant shrubs and herbs and the adjacent banks are lined with Salt Paperbark (Figure 4-20). As with Location G, although the creekline vegetation is likely to benefit from fresh water from Natimuk Creek, the vegetation appears to be influenced more by saline water from the Lake Wyn Wyn, localised runoff and potentially groundwater.

There is some evidence of recent dryer periods, and lack of inundation, with young Salt Paperbarks growing along the edge of the inset channel upstream of Lake Avenue (see red arrow Figure 4-20)

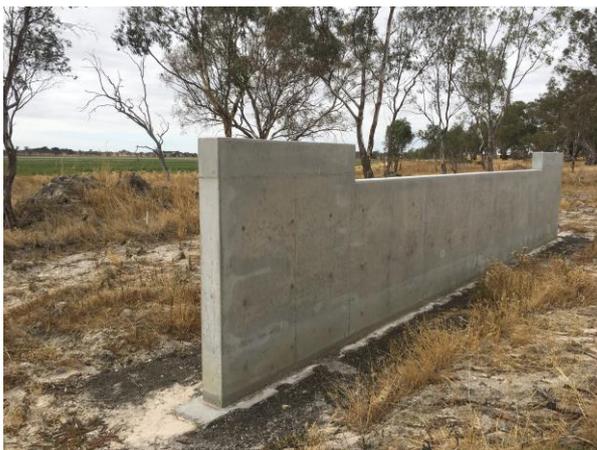
FIGURE 4-21 CONSTRUCTED WEIR WALL, EXCAVATION AND TREE DECLINE

- Lake Natimuk:
 - It was noted that there have been native vegetation losses associated with the prior construction of a concrete weir wall. Some large trees in the vicinity of the works are showing signs of poor canopy health which may be a symptom of tree root damage (Figure 4-21). Any future construction of the weir and adjacent abutments should avoid further damage to adjacent vegetation, particularly large River Red Gums. Soil has been excavated from the area around the pre-constructed wall and pushed around adjacent River Red Gums (Figure 4-21). This built up sandy soil should be reinstated to the depression lines or removed. The excavated depressions may be in preparation for the construction of abutment walls. Care must be taken to avoid further tree root damage and the soil returned as close as practicable to the natural surface level. If large trees die due to the previous works, the dead stags must be protected and preserved as habitat.
