FINAL REPORT:

Yarriambiack Creek Waterway Action Plan

June 2018

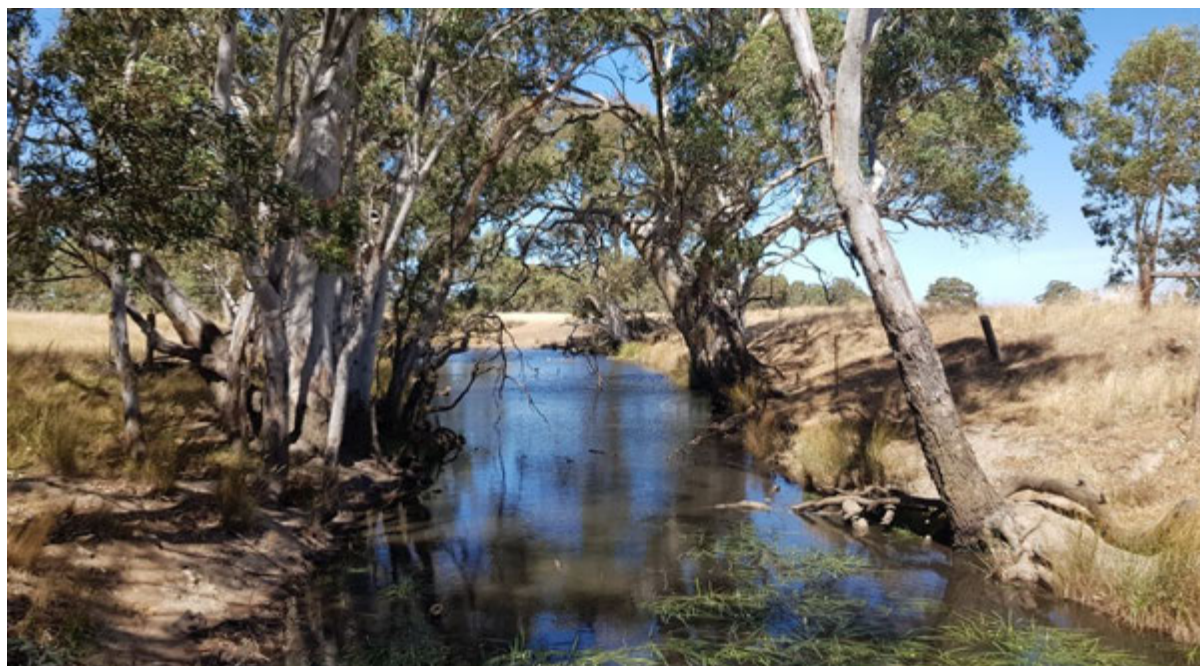
Figure 3. *Yarriambiack Creek at the upper catchment looking downstream away from the Wimmera River (March 2018).*

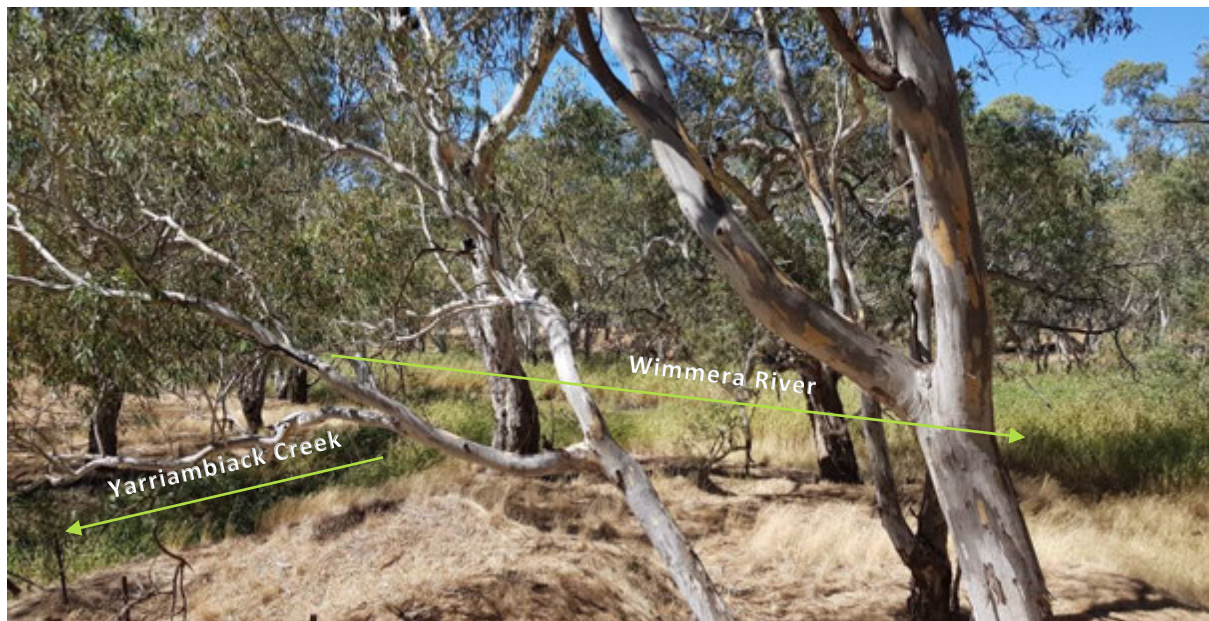
Figure 11. Yarriambiack Creek effluence, with the Wimmera River flowing left to right, the effluence in the centre and Yarriambiack Creek flowing towards the bottom left (site YAR001).

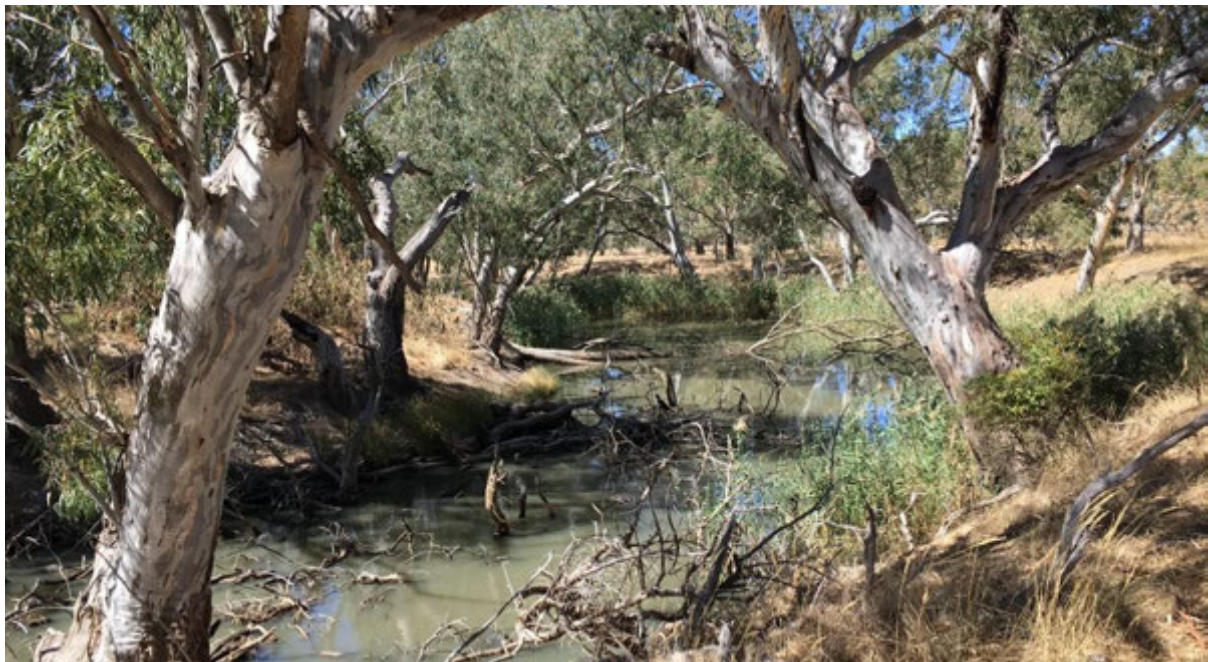
Figure 12. Yarriambiack Creek upper catchment – view upstream showing well defined channel towards the effluence with the Wimmera River (site YAR002)

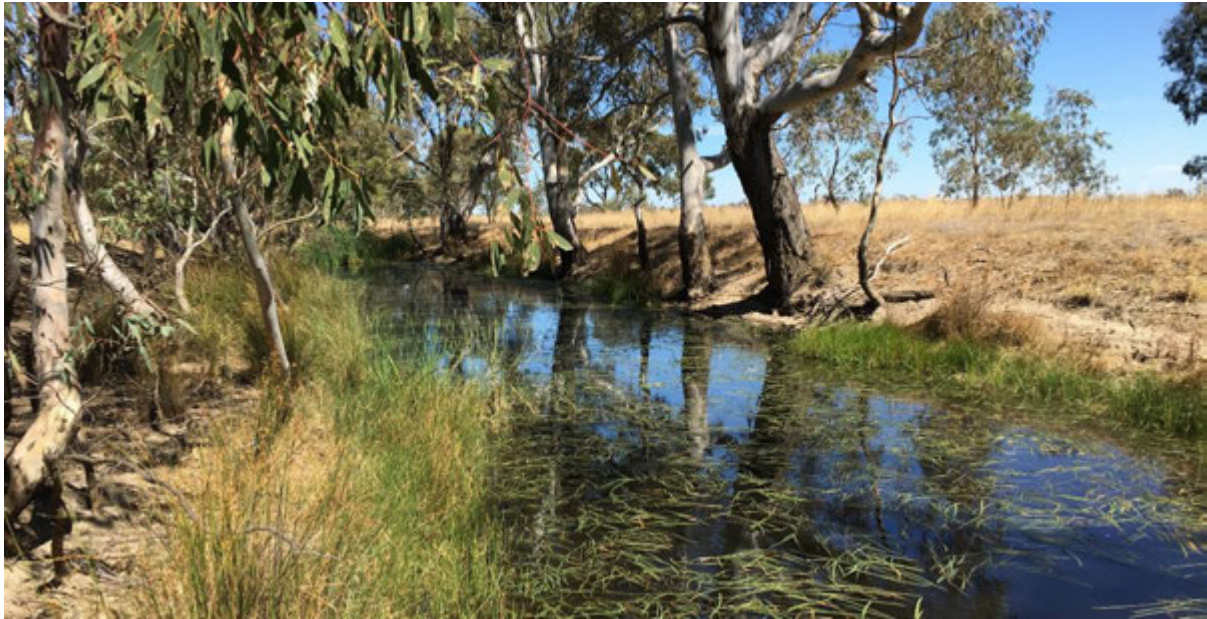
Figure 13. Yarriambiack Creek upper catchment – view downstream along well-defined channel with water ribbons (site YAR004)

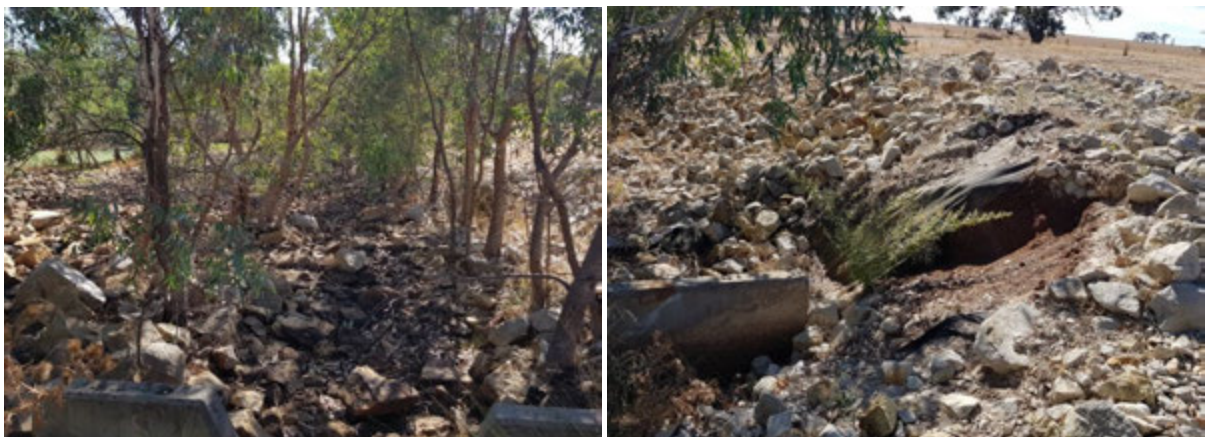
Scour at Jung Weir is evident with water outflanking the concrete bypass and scouring out behind the existing geofabric. Works are recommended to remove the smaller trees in the channel and carry out repairs to stabilise the banks.

Figure 14. Left: low flow bypass at Jung weir looking downstream, Right: scour of low flow bypass right bank (YAR011)

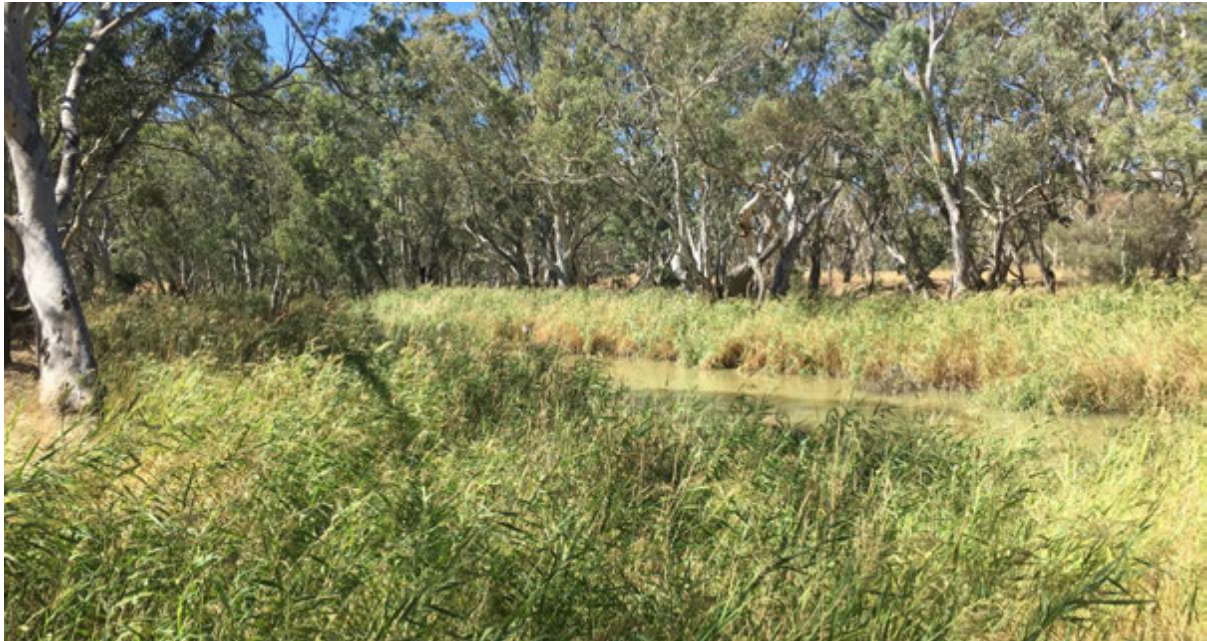
The upper reach shows clear evidence of regular flows, with the only occurrences of the Common Reed *Phragmites communis* recorded as dense strands along the creek bed in this reach. Also recorded in this reach was Willow Wattle *Acacia salicina*, an uncommon species in the Wimmera.

Figure 15. Common Reed *Phragmites communis* at the Yarriambiack Creek effluence with the Wimmera River (YAR001)

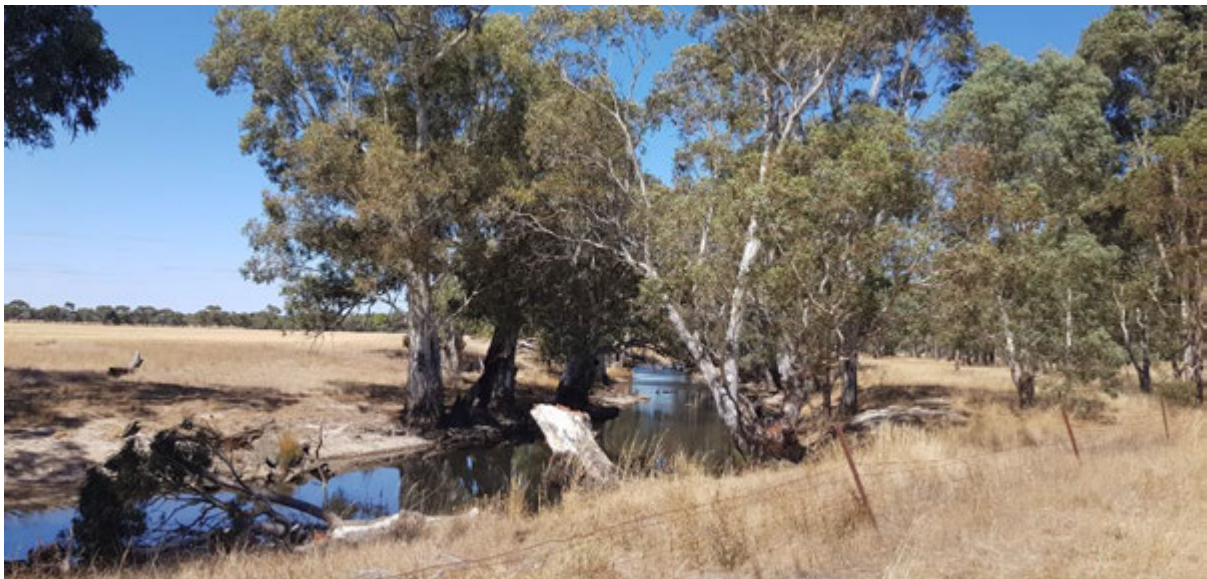
Figure 16. Grazed banks just downstream of Longerenong Road (Site YAR002)

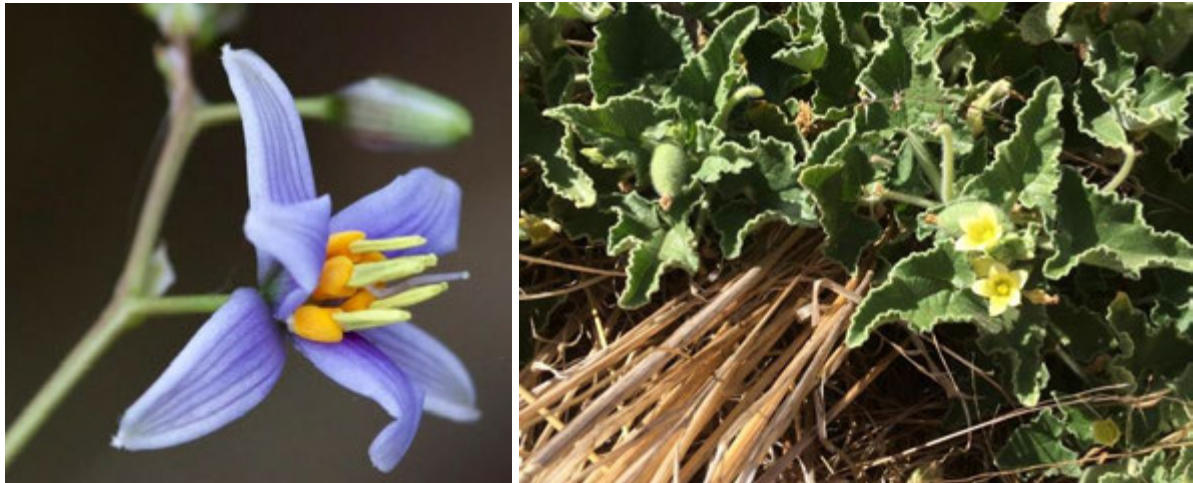
Figure 17. Left: Riverine Pale Anther Flax-lily *Dianella sp nov aff longifolia* 'Riverina' Photo: David Francis. Right: Squirting Cucumber *Ecballium elaterium* close to the old Jung tip

The creek reserve around Jung is a serious hotbed for invasive exotic weeds, with the only outbreaks for the survey of Squirting Cucumber *Ecballium elaterium* (Figure 17), Paspalum grass *Paspalum dilatatum* and Desert Ash *Fraxinus angustifolia*. On the other hand, the weir pool at Jung provided good habitat for a number of aquatic native species including Slender Spike-rush *Eleocharis gracilis*, Water Milfoil *Myriophyllum sp* and Eel Weed *Vallisneria spiralis*. The White Poplars *Populus alba* planted at the weir (Figure 18) are suckering and spreading, but at this stage are not showing evidence of becoming a threat, although, long term it would be wise to have them removed.

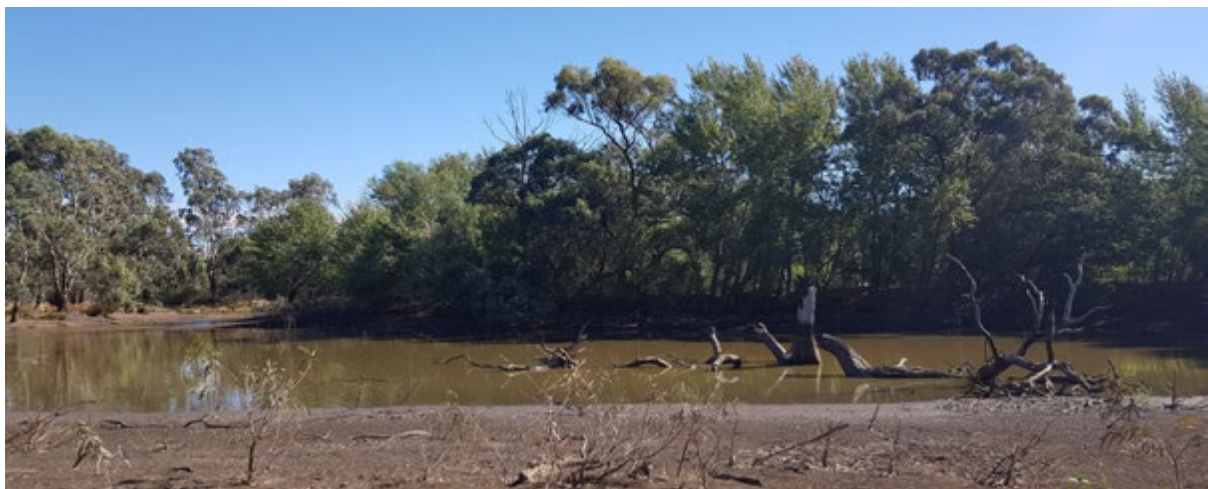
Figure 18. White Poplars *Populus alba* planted along Jung Weir (YAR011)

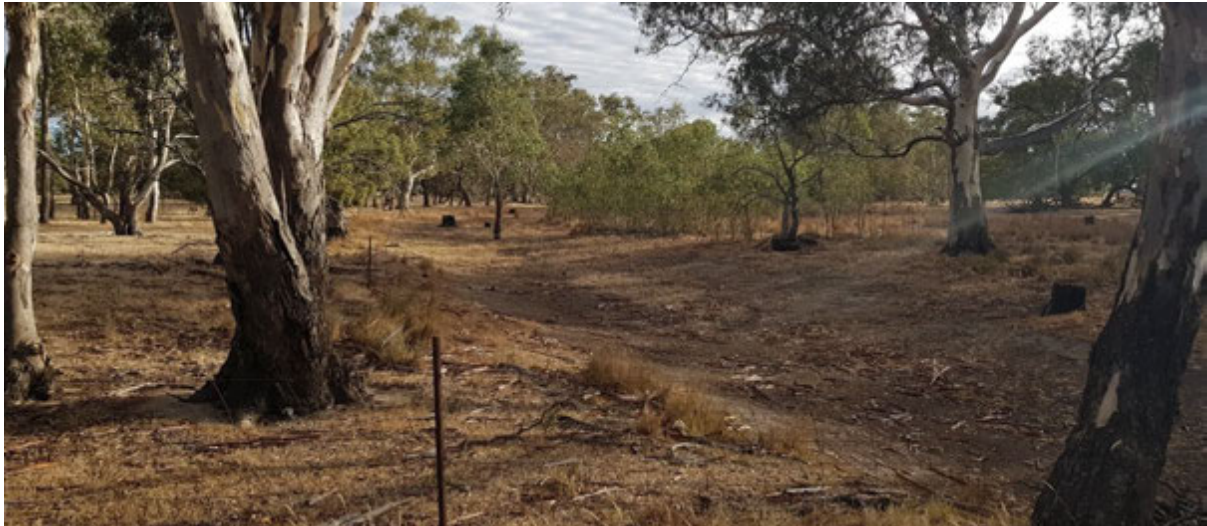
Waterways across the mid-catchment are much shallower than upstream and take the form of a slight depression within a wide floodplain. Channels are around 30-100 metres wide and 0.5 to 1.5 metres deep, with some minor anabranches. Waterways in this zone are more heavily impacted by stock than in the lower reach, with in corridor grazing being major threat to waterway health. Complete removal of understorey species through intense grazing exposes soil to both fluvial and aeolian erosion.

Figure 20. Wide, shallow channel form, looking downstream from Drillers Road (YAR020), typical of the mid catchment. This area appeared to be run as a grazing paddock, with little understorey vegetation.

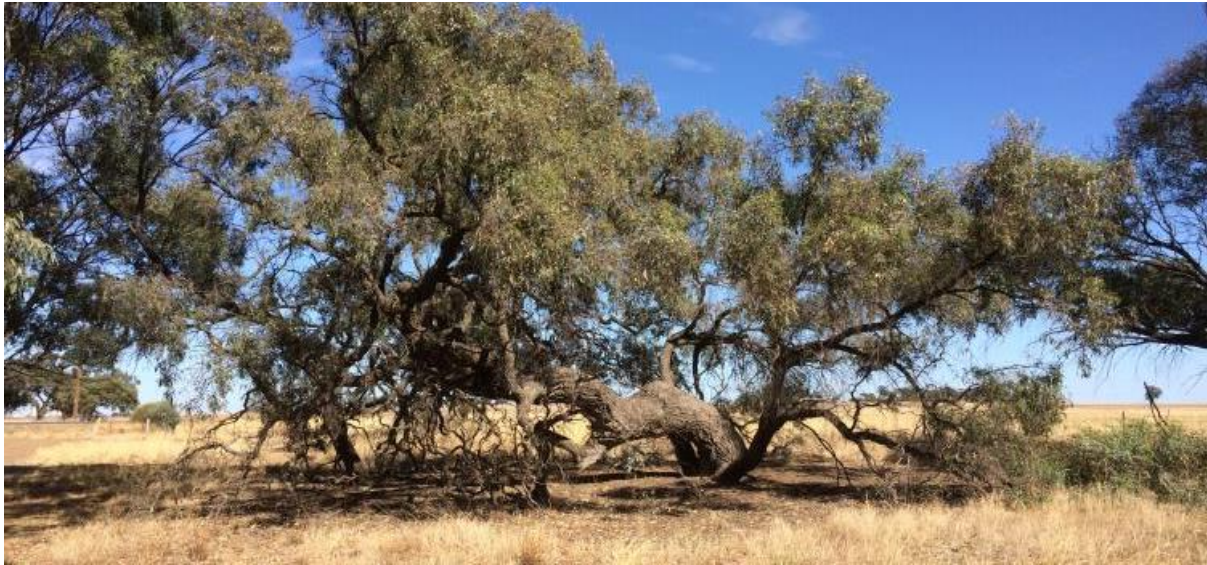
This mid-section of the creek supports superb areas of Buloke *Allocasuarina leuhmannii* Woodland. This community is listed under the EPBC Act as a threatened community. Most stands also supported rich native grassy woodland ground flora with species such as Blue Devil *Eryngium ovinum*, Scented Matrush *Lomandra effusa*, Bluebush *Maireana* sp, Pink Mulla *Mulla Ptilotus exaltatus*, Variable Sida *Sida corrugata* and Quena *Solanum esuriale*. This makes these sites some of the most important Buloke woodland remnants remaining in the Wimmera. There are also very important grassy woodland remnants growing with the dominant Black Box *Eucalyptus largiflorens* and Red Gum *Eucalyptus camaldulensis* overstorey.

Figure 21. Black Box *Eucalyptus largiflorens* over native grassland

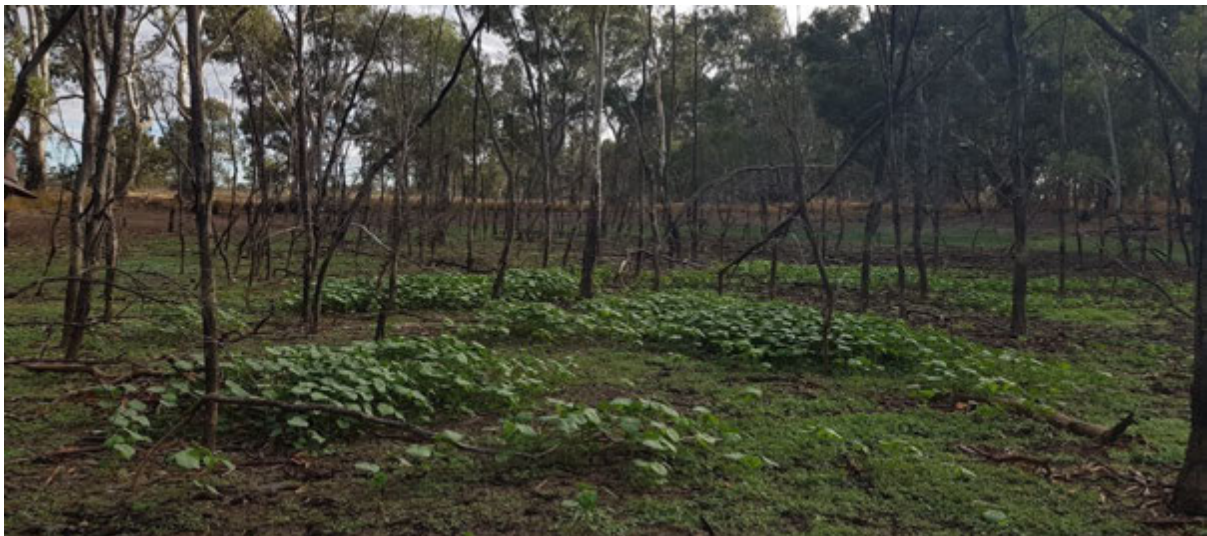
The mid-catchment also supports two stands of a new weed for the region Chigma Lantern *Abutilon theophrasti*. This is only the 2nd and 3rd record for the Wimmera of this invasive species, previously only recorded for the region at Natimuk.

Figure 22. Outbreak of the highly invasive Chigma Lantern *Abutilon theophrasti* in creekbed south of Drillers Road (YAR019).

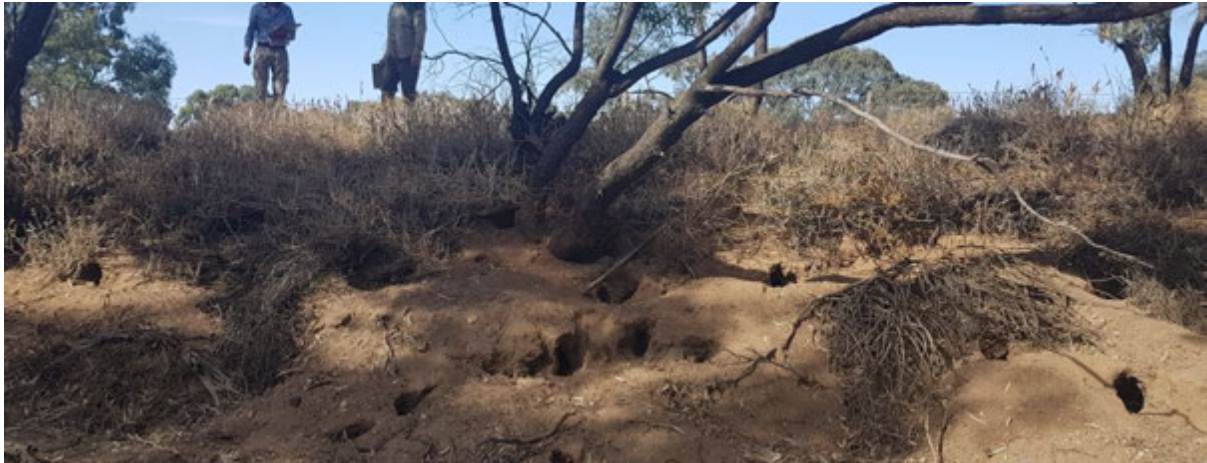
Figure 24. Prolific rabbit infestations in the northern catchment at Goyura West Road (YAR091 and YAR092)

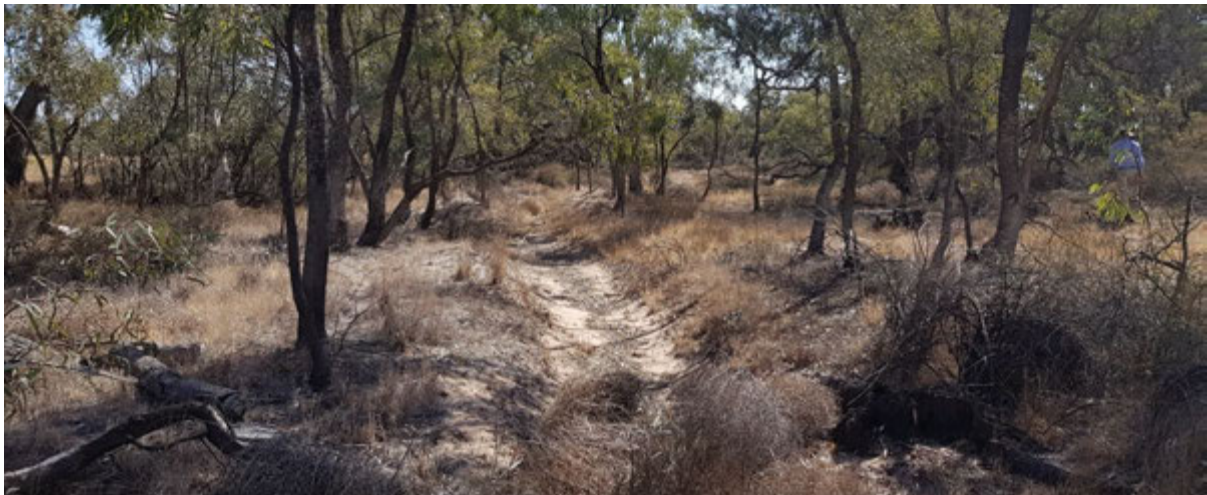
Figure 25. Looking downstream of the Henty Highway crossing near Ryans Road (YAR076). This area has no stock access and is in excellent condition with a densely vegetated riparian corridor 2-3 km downstream of Baums Road (above figure).

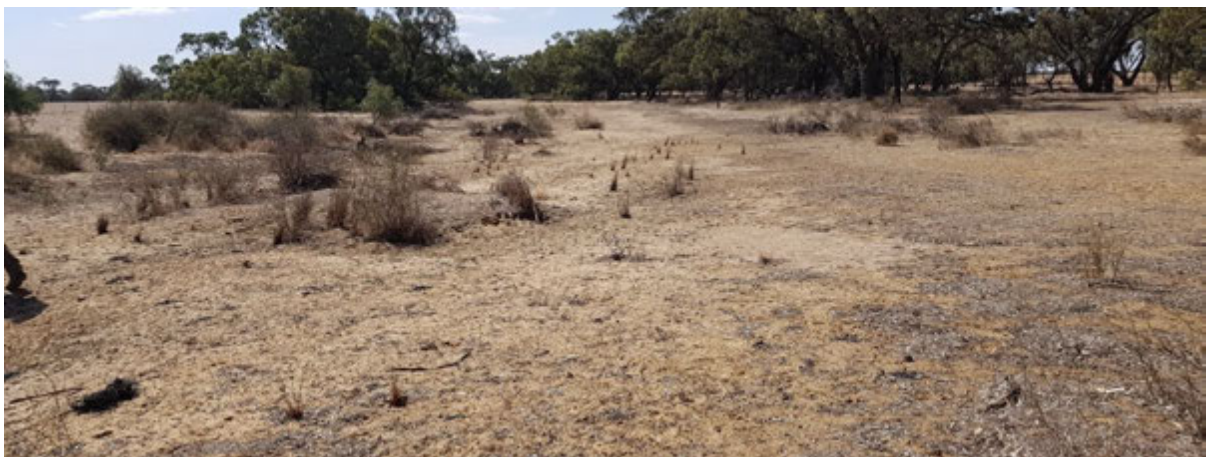
The majority of the waterway in the lower catchment has been fenced or is within cropped land with relatively low impact of stock (Figure 25). However, isolated pockets of stocking within the corridor need to be addressed (Figure 26).

Figure 26. A heavily stocked area looking upstream from Baums Road (YAR072). The very wide, shallow channel has been utilised as a grazing paddock, with very little vegetation growth or ground cover.

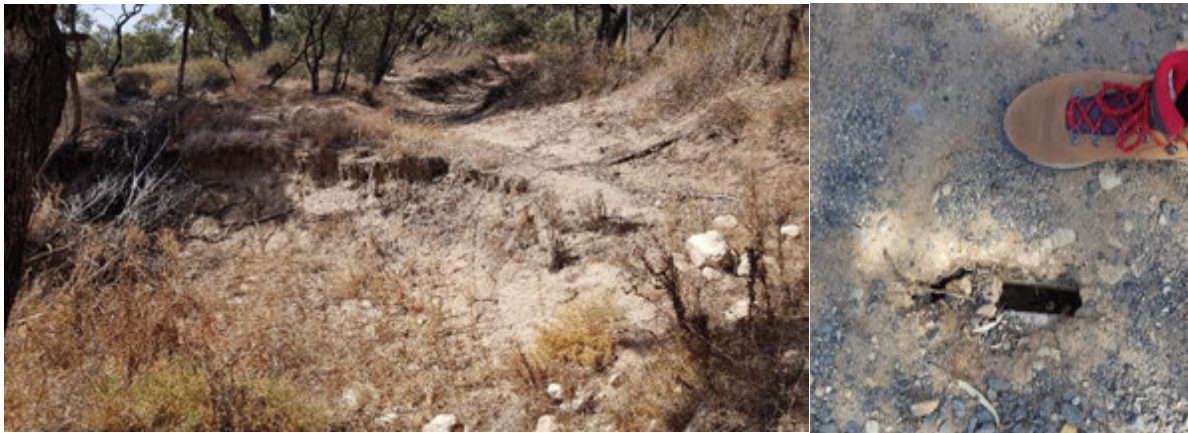
Minor, localised scour is evident around some culverts (Figure 27), however there is no evidence of large scale instabilities. Due to low flow volumes in this area of the creek, erosion is unlikely to liberate large quantities of sediment downstream and will remain localised. While remediation of culverts will not greatly improve river health, if structures become significantly unstable or unsafe, these works may become a higher priority.

Figure 27. Scour downstream of culvert (left) and tunnelling at Galaquil West Road (right) (YAR078).

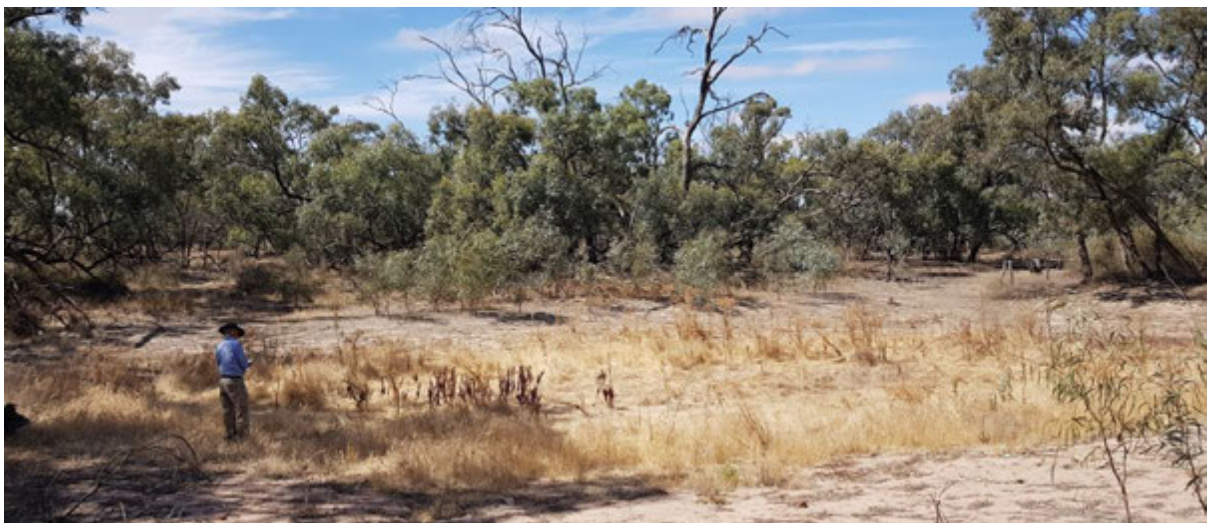
Figure 28. Natural vegetation recruitment in background in an area of no stock grazing, upstream of Windy Ridge Road (YAR090).

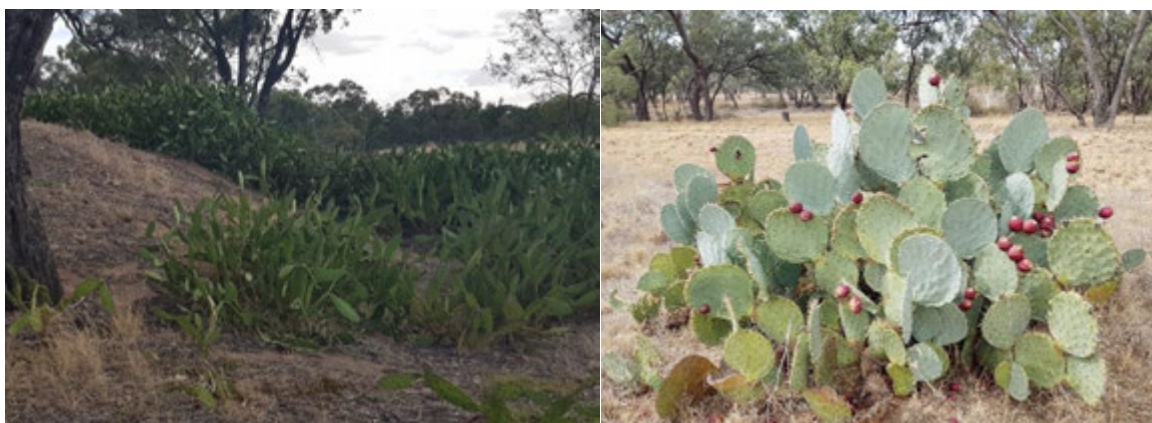
Of concern around the township of Brim and near the old Lah tip site were a number of serious invasive weeds along the creek reserve. Of particular note were Bridal Creeper *Asparagus asparagoides*, African Box-thorn *Lycium ferrosissimum*, Canary Island Date Palm *Phoenix canariensis* and Common Prickly Pear *Opuntia stricta* (Figure 29).

Figure 29. Common prickly pear infestations near Brim weir pool (left) and Lah Tip, south of Lah West Road (right)

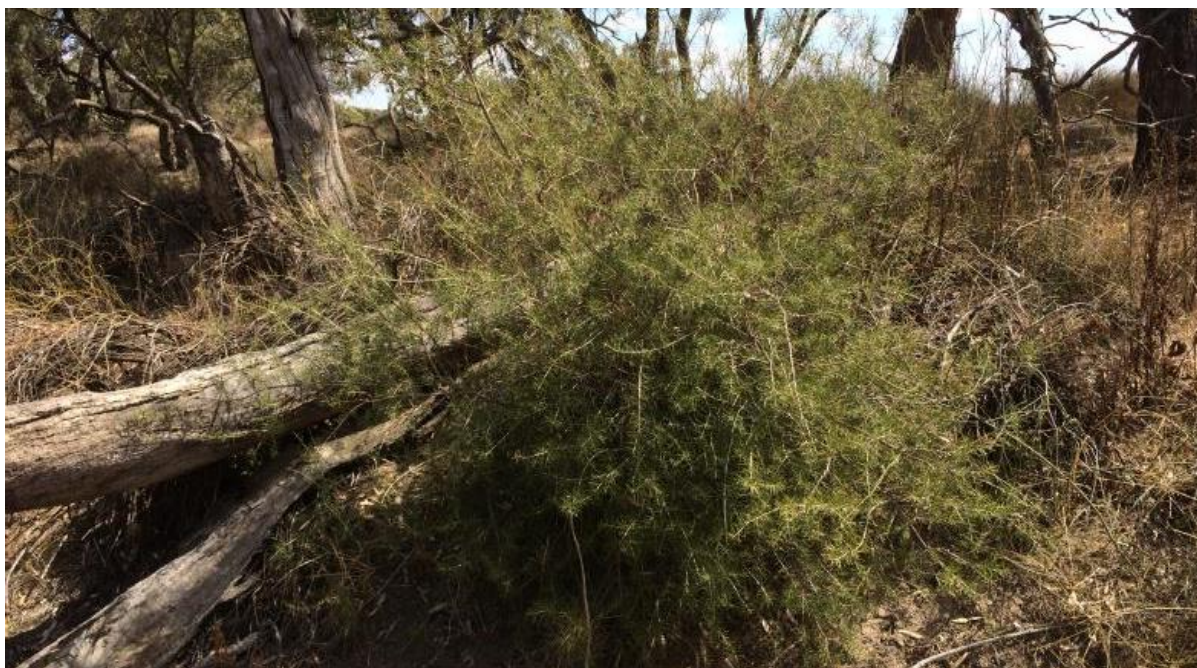
Other notable inland plants found in this section include numerous plants of Umbrella Mulga *Acacia oswaldii* which is a regionally rare species. Another extremely significant record for this section was the discovery of a population of Prickly Bottlebrush *Callistemon brachyandrus*, the first record for this region. The only other records for this species in Victoria are around Hattah Lakes and the adjacent Murray River.

Figure 30. Prickly Bottlebrush *Callistemon brachyandrus* on the banks of the Yarriambiack Creek

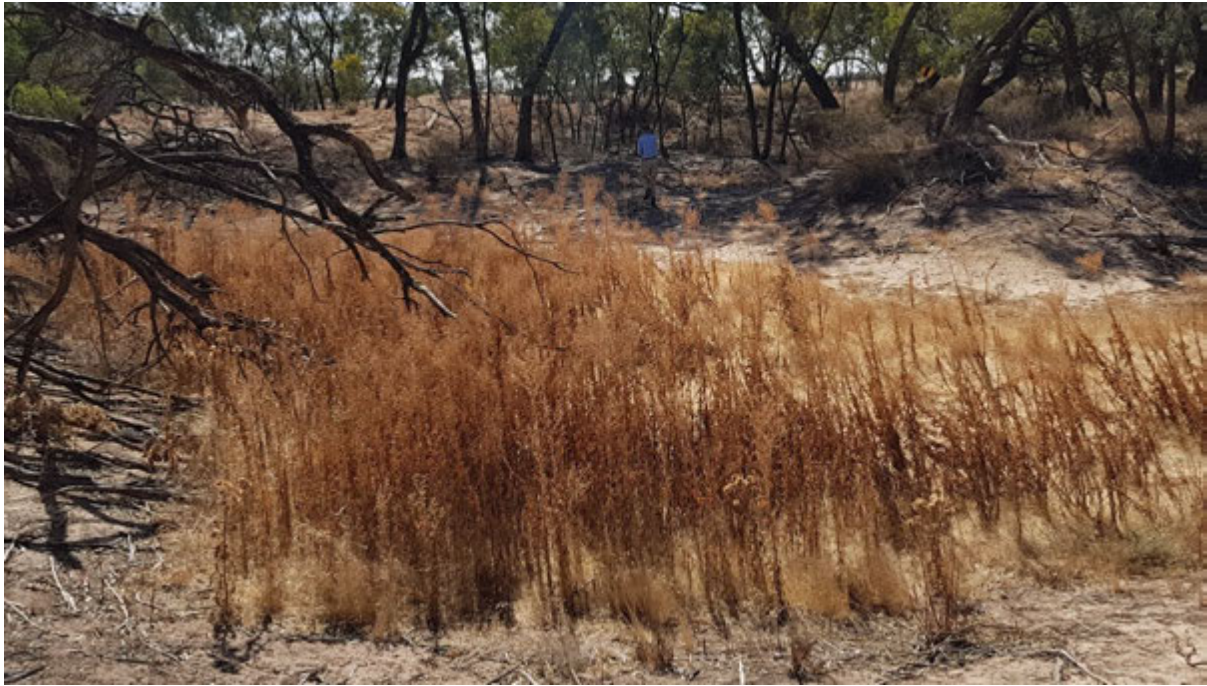
Large outbreaks of a number of invasive weeds are found throughout this reach, notably Spear Thistle *Cirsium vulgare* (Figure 31), Common Heliotrope *Heliotropium europaeum*, Prickly Lettuce *Lactuca serriola* and Horehound *Marrubium vulgare*. Most are located adjacent to human occupation or human disturbance such as road crossings.

Figure 31. *Spear thistle infestation in the northern catchment area at Roseberry-Rainbow Road (YAR088).*

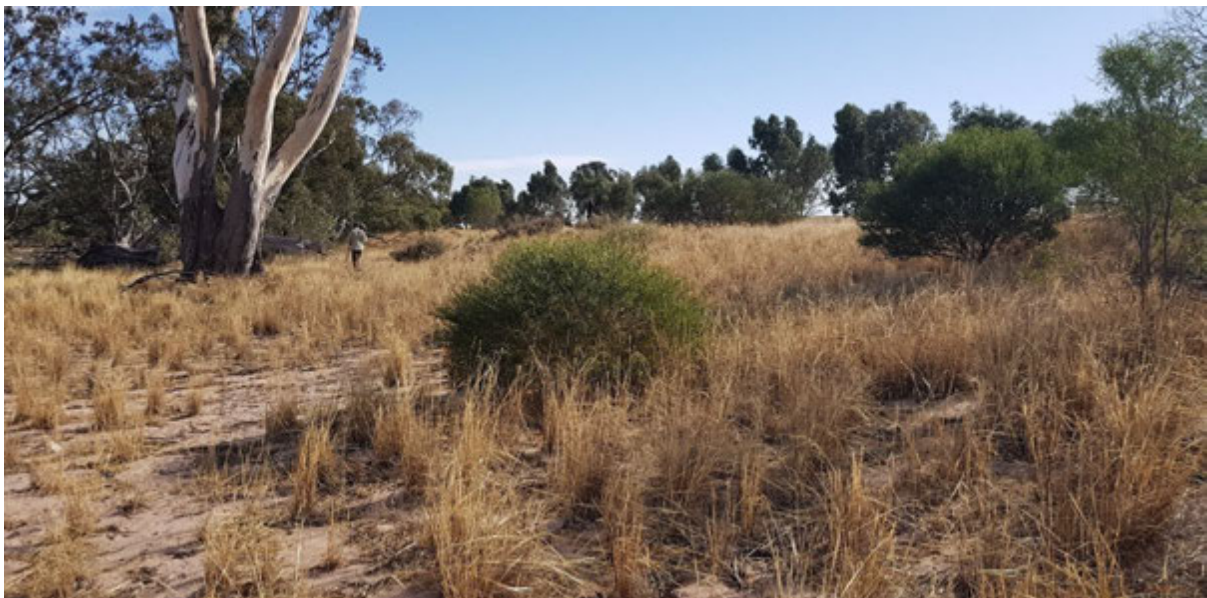
A large range of inland native plants are found at the mouth of the Yarriambiack Creek, where it flows into Lake Coorong. Of interest were the occurrence of good populations of Native Liquorice *Glycyrrhiza acanthocarpa*, Short-leaf Bluebush *Maireana brevifolia*, Tangled Lignum *Meuhlenbeckia florulenta* and Hedge Saltbush *Rhagodia spinescens*. In the surrounding lunette dunes were found a number of interesting inland plants including Small Cooba *Acacia ligulata* and Willow Wattle *Acacia salicina* (Figure 32).

Figure 32. *Native vegetation cover at the northern extent of the project area near Lake Coorong (COR004)*

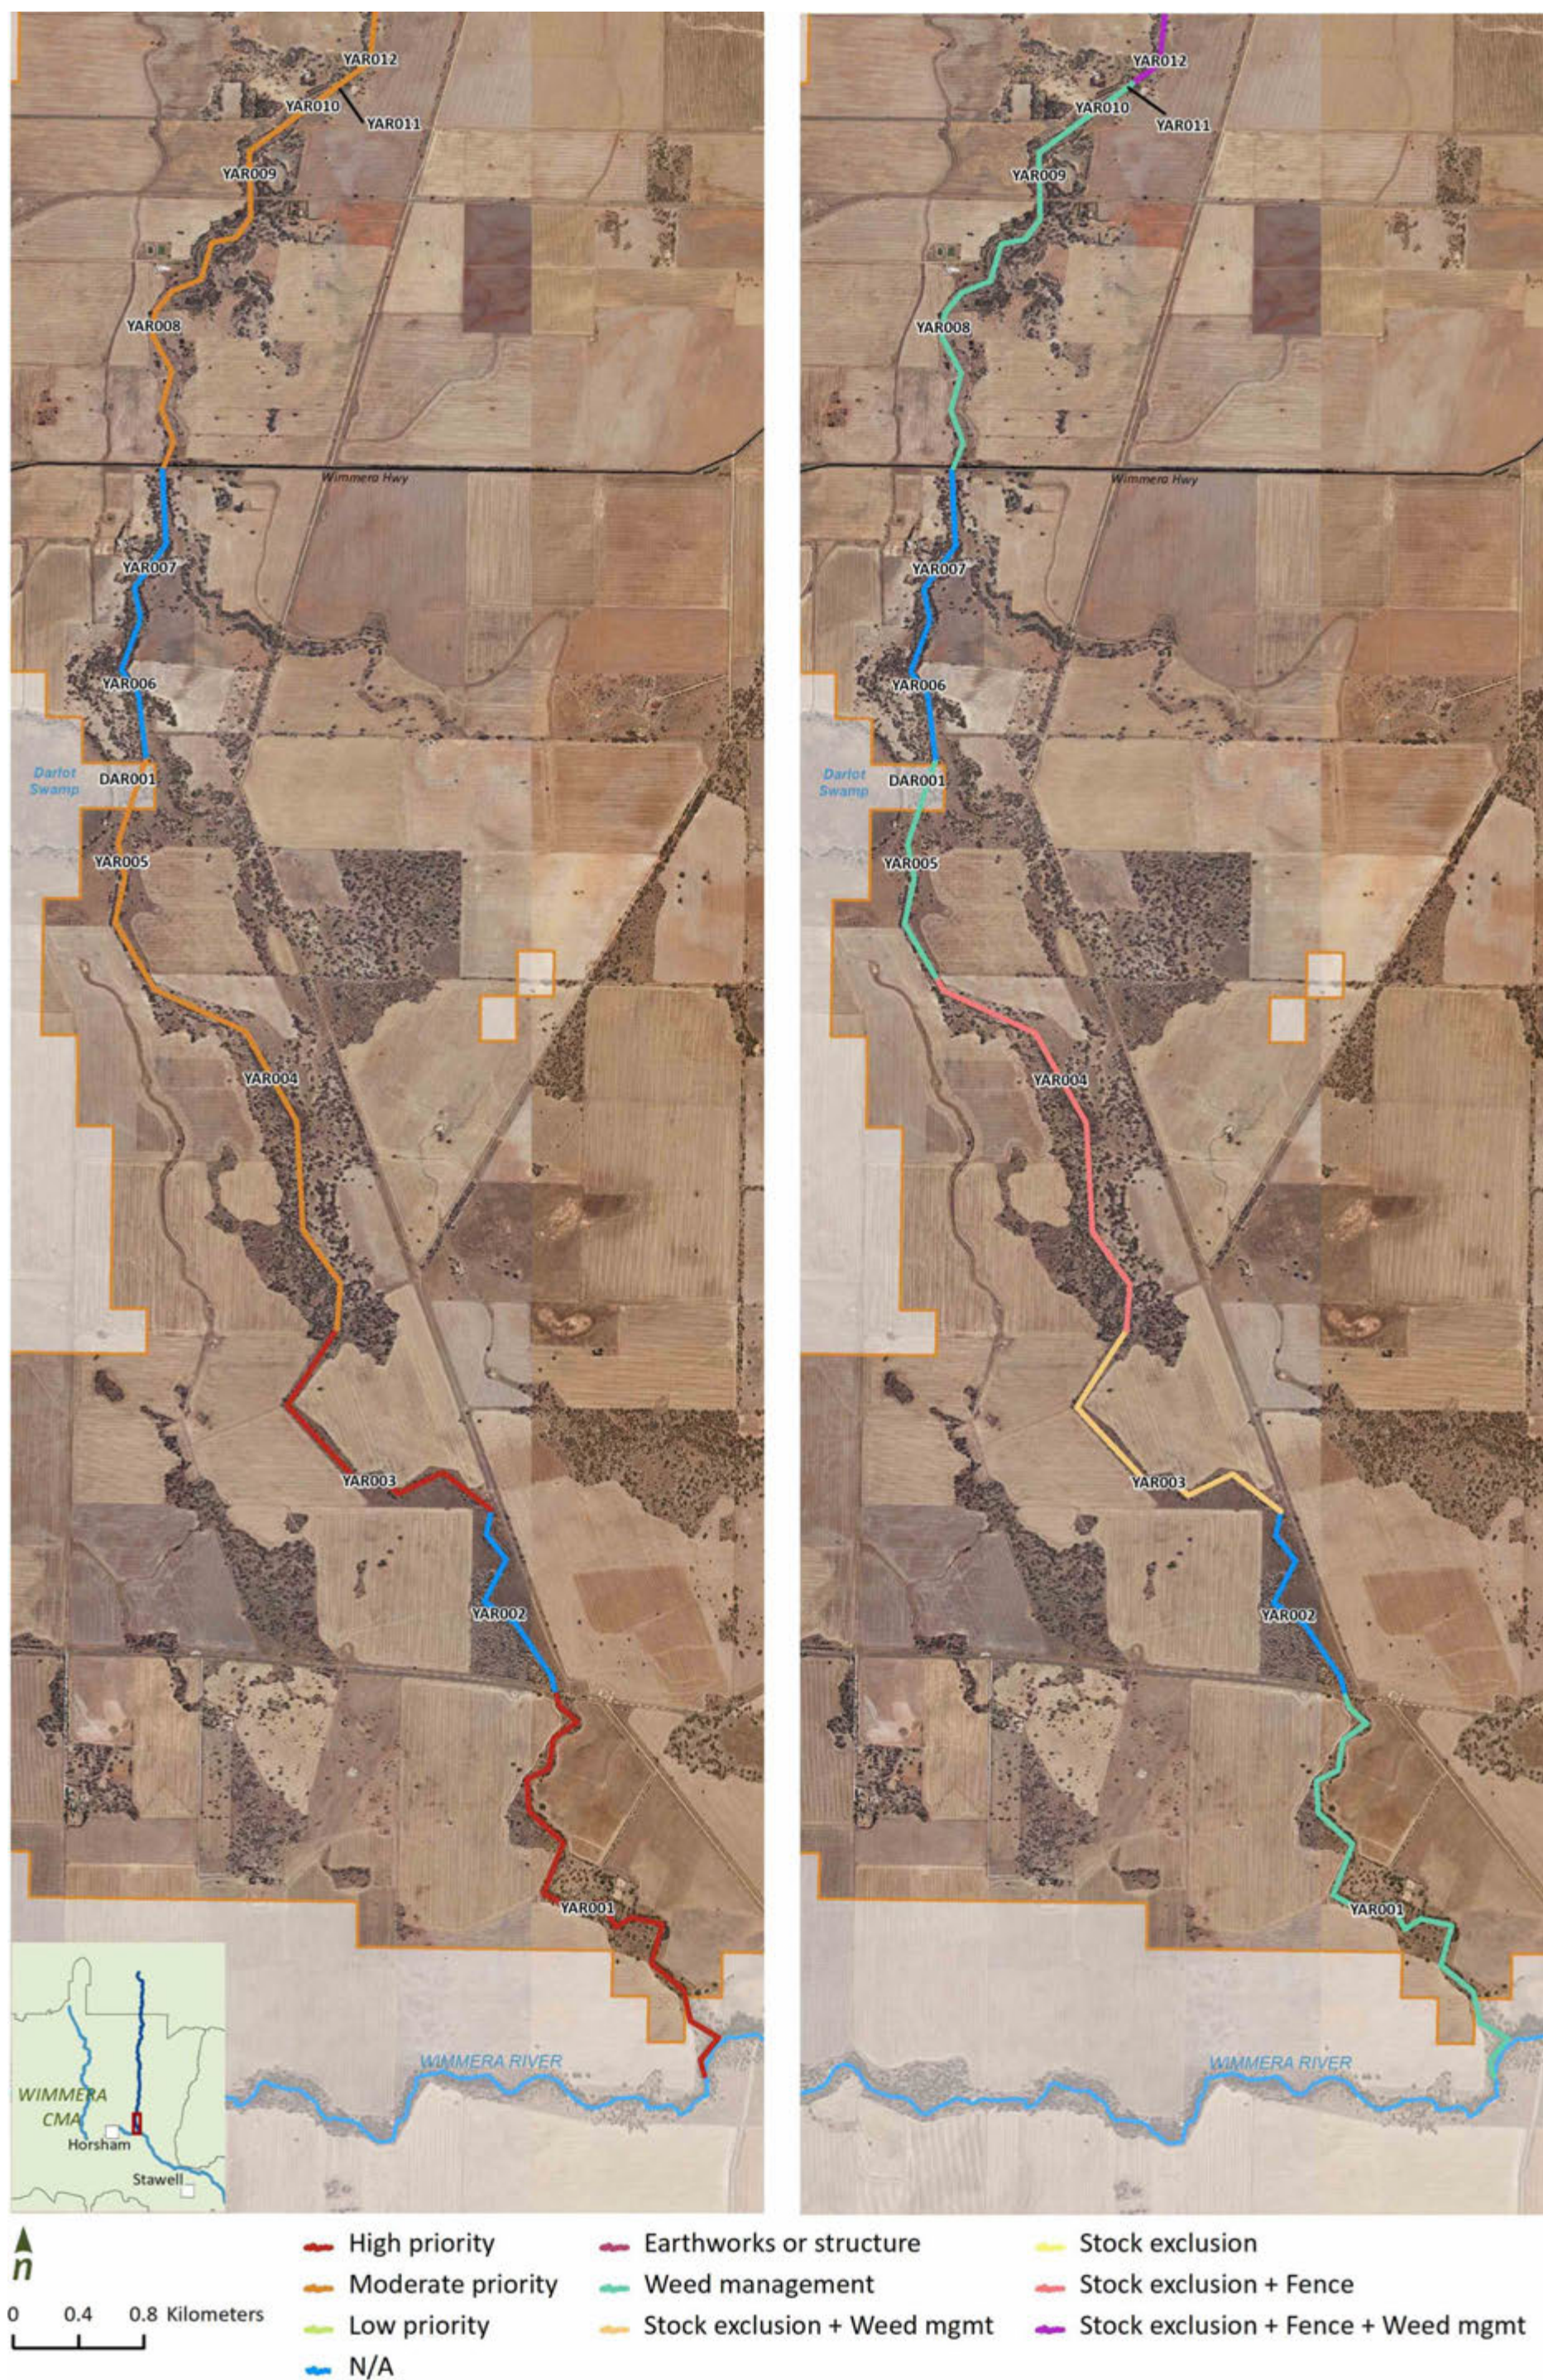
Figure 43. Priority ranking (left) and action (right) for the upper catchme
