Dunmunkle Creek Final Report

Wimmera CMA

May 2018

This report is the Final Report for the Dunmunkle Creek Flood Investigation. This report supersedes all other reports during the progress of the flood investigation.

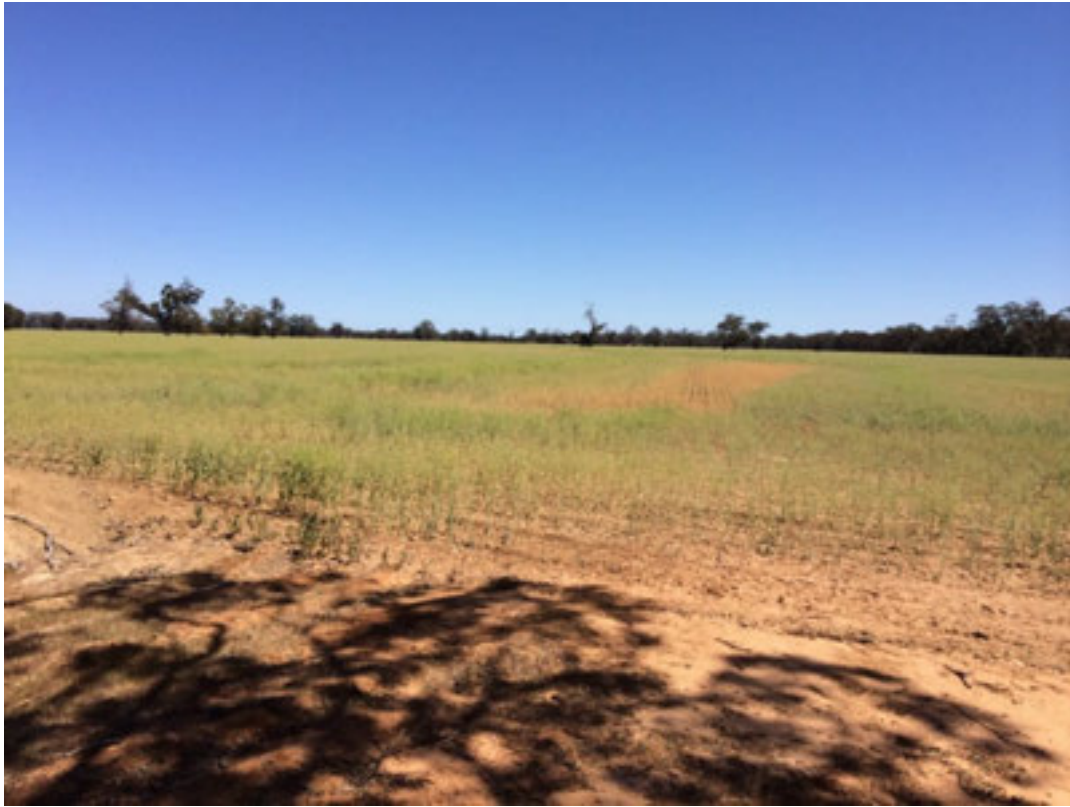
Figure 2-1 Decommissioned section of the Rocklands Lubeck Channel (immediately west of the Bryntirion Reserve)

During the site inspection both decommissioned and non-decommissioned channel infrastructure were observed. Figure 2-1 and Figure 2-2 show decommissioned and non-decommissioned sections of the Rocklands Lubeck Channel immediately west and within the Bryntirion Reserve. The brown section of canola indicates the previous channel embankment location. These photos are taken at the same location with the channel outside the reserve decommissioned, and the channel within the reserve still remaining.

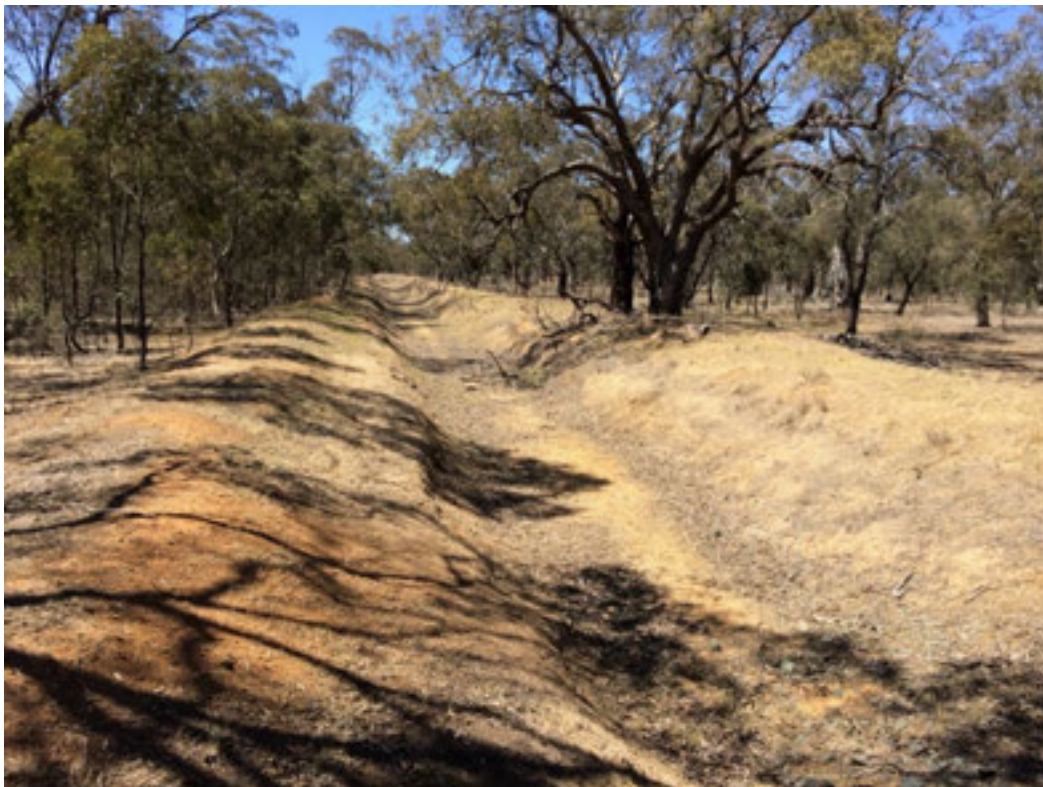
Figure 2-2 Remaining section of the Rocklands Lubeck Channel (Bryntirion Reserve)

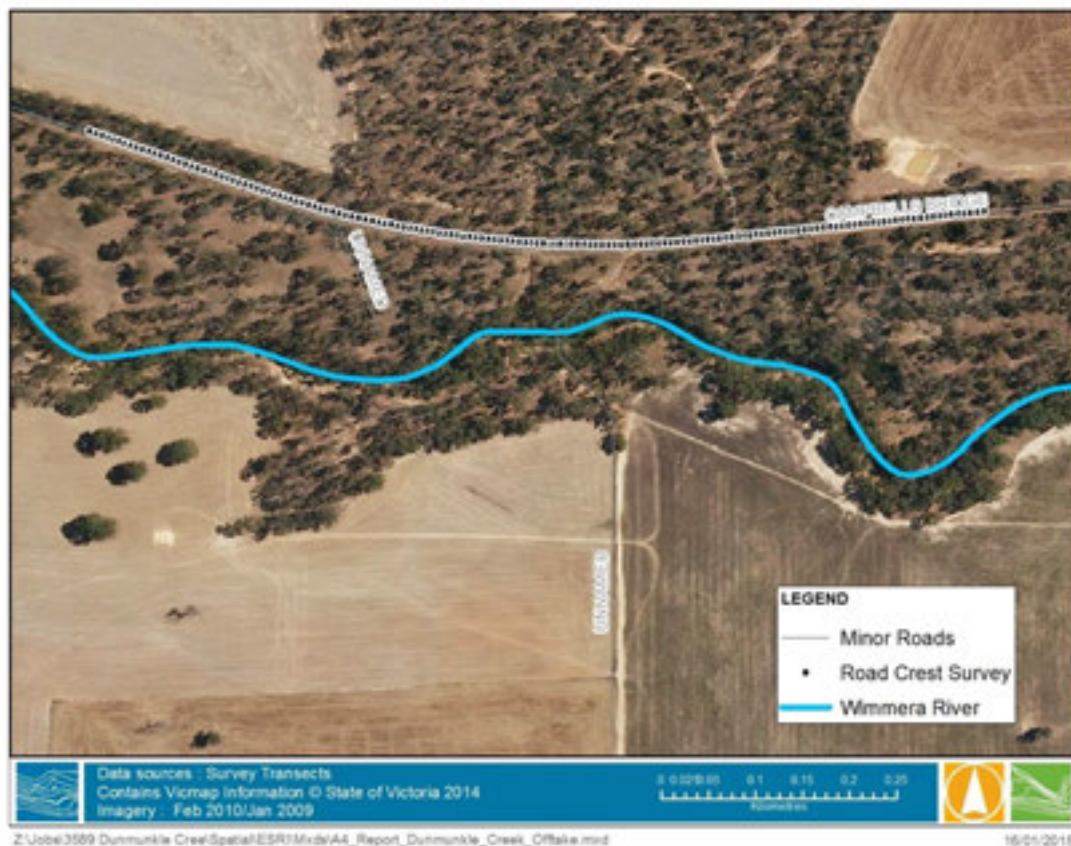
Figure 2-6 Campbells Bridge Road transect location

As discussed in Section 2.3.2, Campbells Bridge Road was surveyed as part of the Dunmunkle Creek Offtake survey. An 800 m transect was captured along the road, this transect was within the *South of Wimmera River Trench and Upper Wimmera River* LiDAR dataset. The survey and LiDAR levels were compared along the transect. The transect location and topographic comparison are shown in Figure 2-6 and Figure 2-7 respectively.

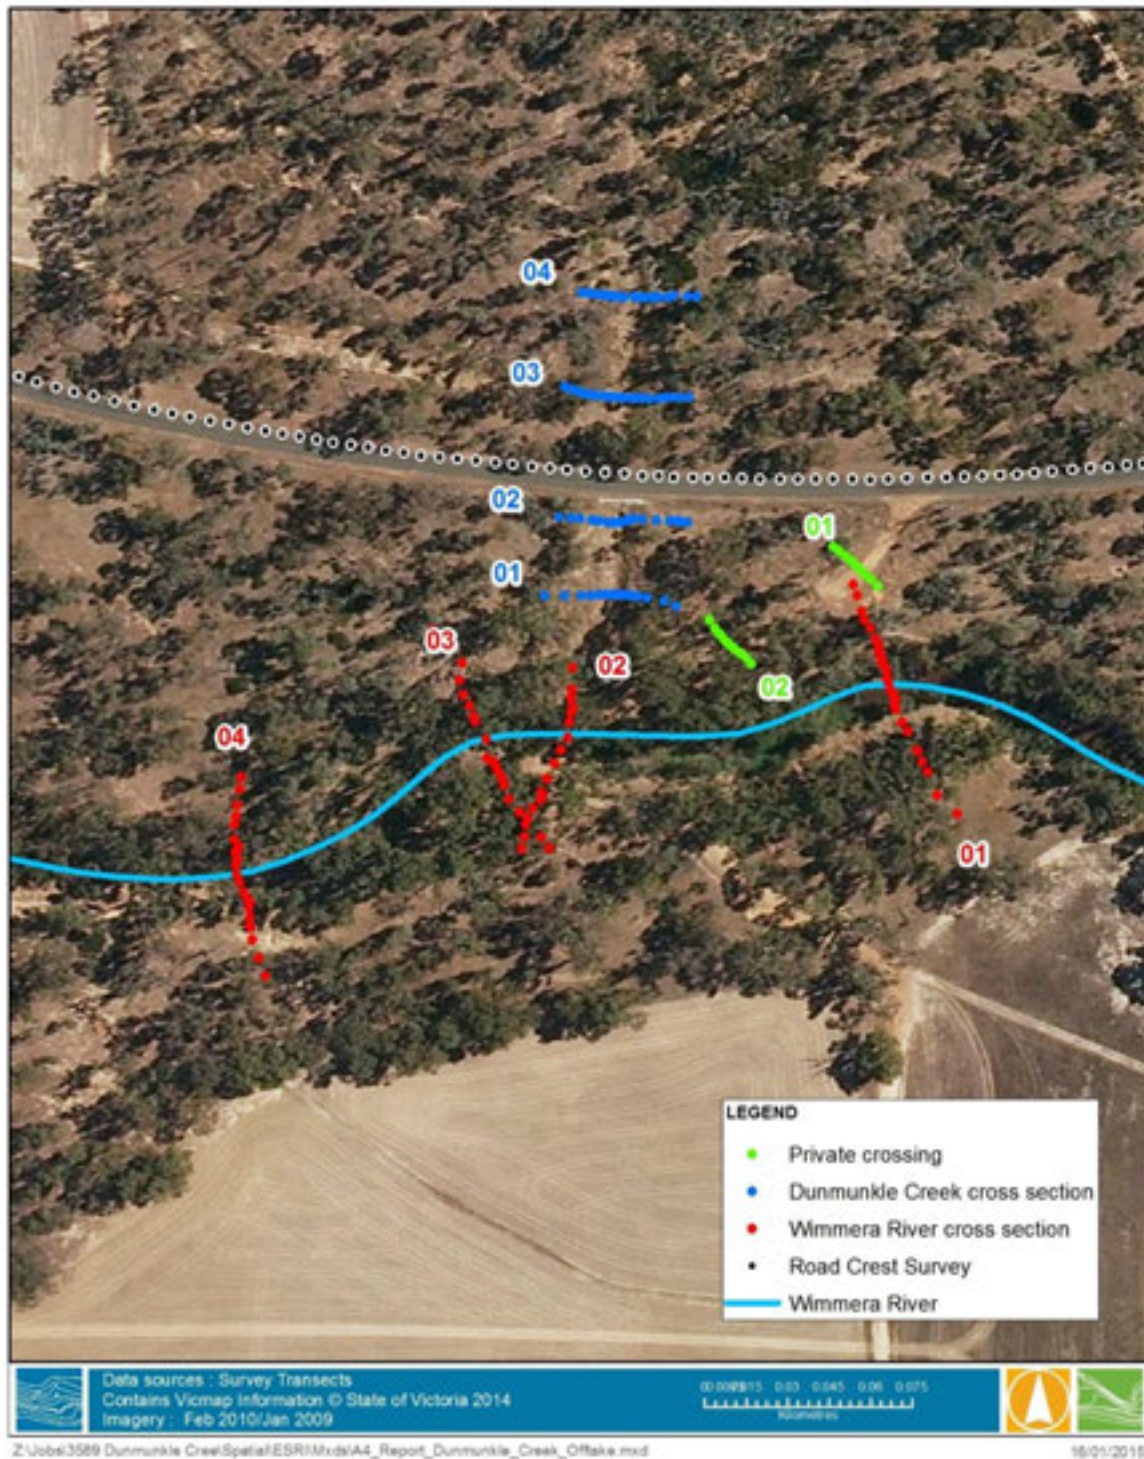
Figure 2-8 Wimmera River and Dunmunkle Creek cross section locations

The comparison showed the surveyed levels are consistently higher than the LiDAR levels, with the average difference in height 0.17 m. Due to this disparity comparisons were also made at each of the extracted Wimmera River and Dunmunkle Creek cross section locations to verify this finding. The location of the cross sections is shown in Figure 2-8 with the level comparisons shown in Figure 2-9 through to Figure 2-12 for the Wimmera River and Figure 2-13 through to Figure 2-16 for Dunmunkle Creek.

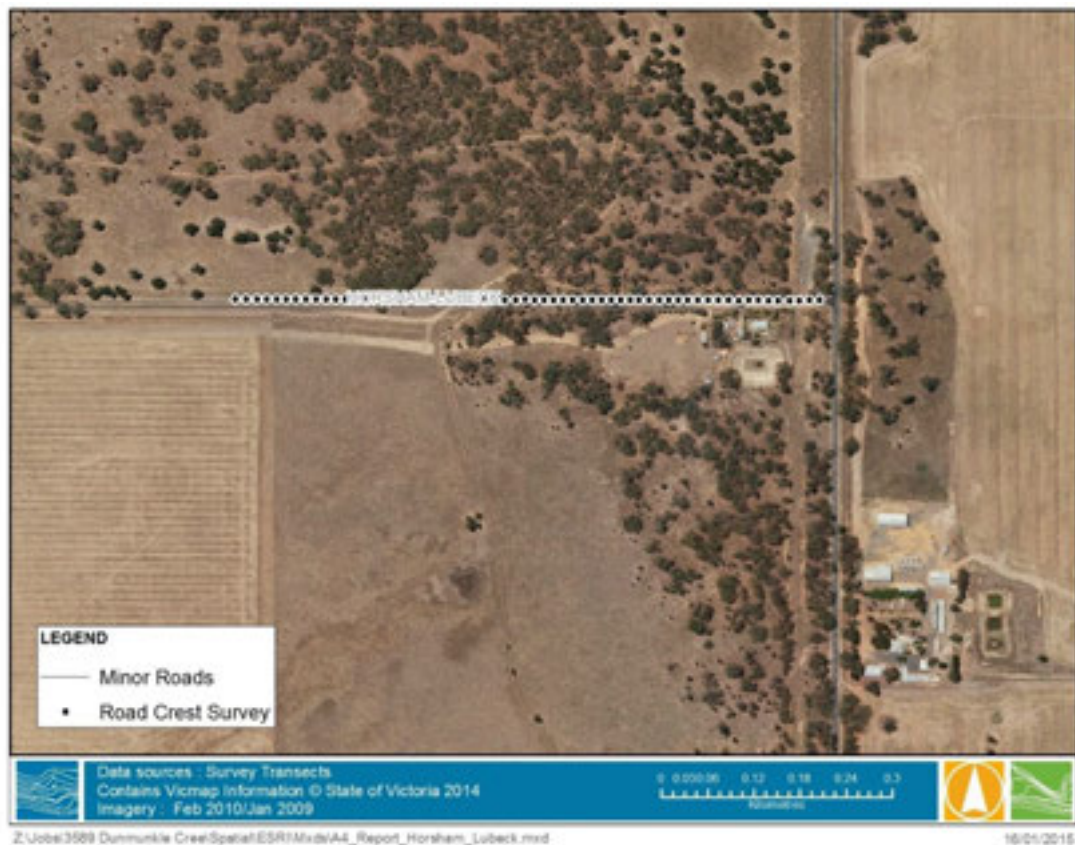
Figure 2-17 Horsham Lubeck Road transect location

A 600 m transect was surveyed along Horsham-Lubeck Road immediately west of the Warracknabeal Stawell Road. Survey was completed in an area covered by both the *ISC* and *Yarriambiack Creek and North East Flat Plains* LiDAR (2005).

The transect location and topographic comparison between the survey and LiDAR levels are shown in Figure 2-17 and Figure 2-18 respectively.

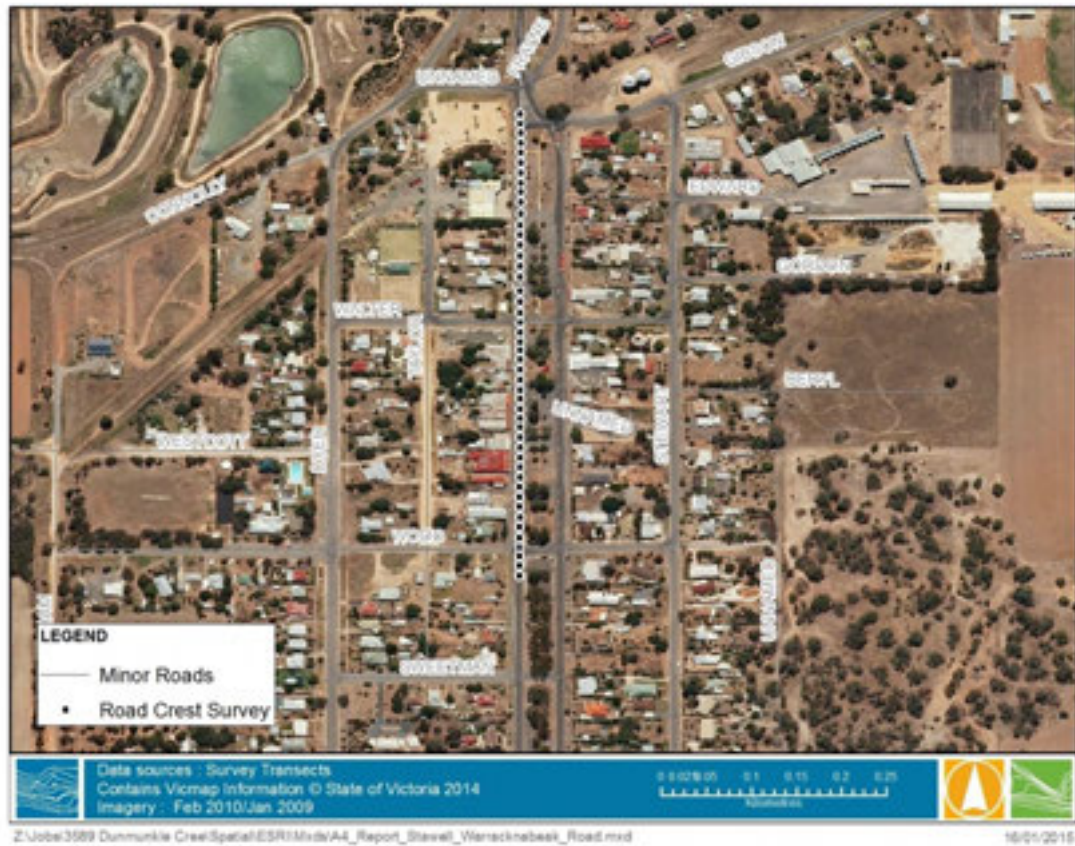
Figure 2-19 Stawell Warracknabeal Road transect location

The Stawell Warracknabeal Road was surveyed in Rupanyup, on the western side of the traffic division. The surveyed transect was 500 m long and was covered by both the *ISC* and *Yarriambiack Creek and North East Flat Plains* LiDAR (2005).

The Warracknabeal Stawell Road survey transect location and topographic levels are shown in Figure 2-19 and Figure 2-20 respectively.

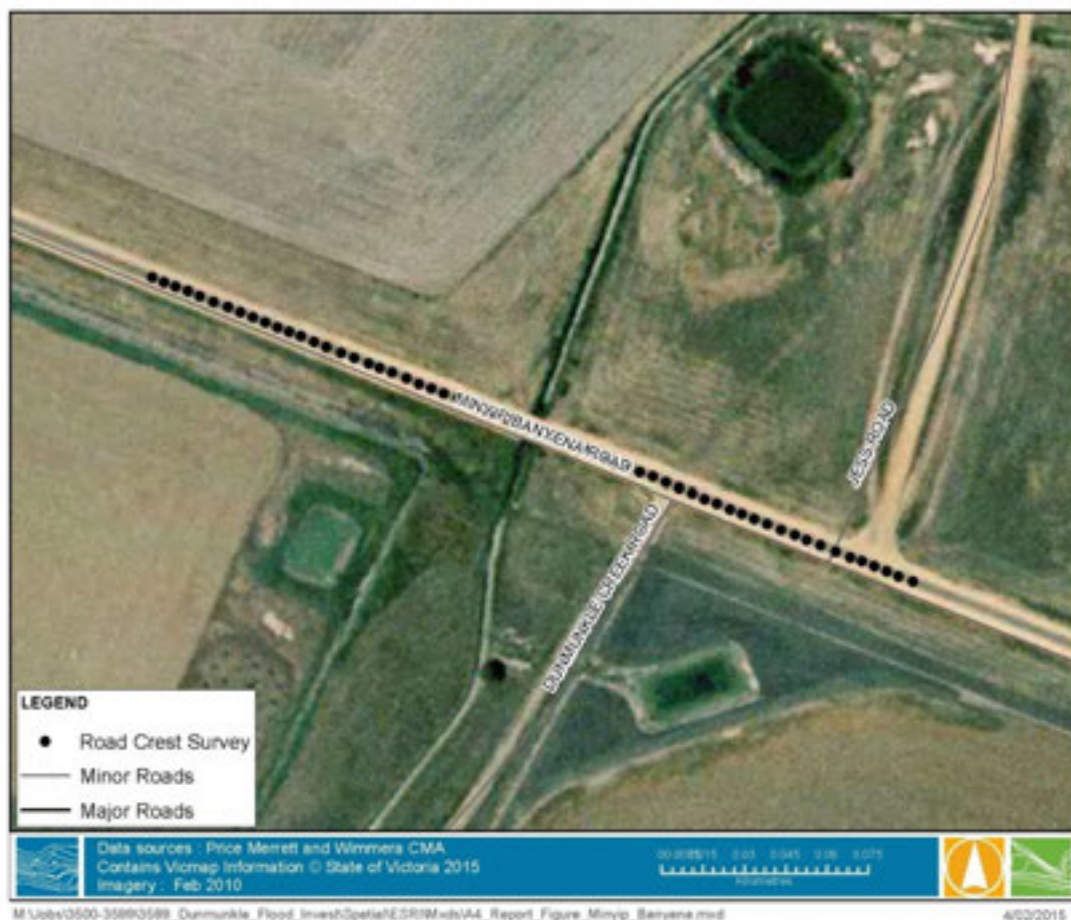
Figure 2-21 Minyip Banyena Road transect location

The Minyip Banyena Road was surveyed at the Dunmunkle Creek culvert. The surveyed transect was 300 m long and was covered by both the *ISC* and *Yarriambiack Creek and North East Flat Plains* LiDAR (2005).

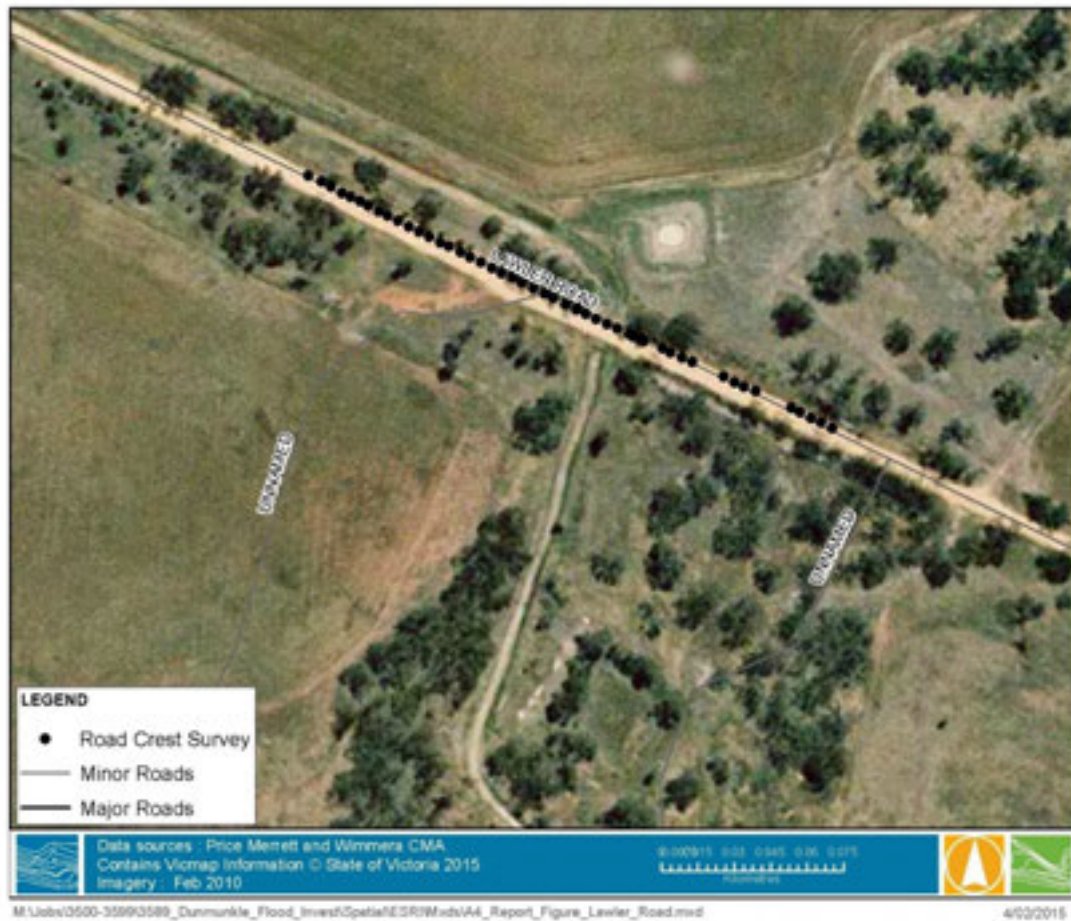
Figure 2-23 Boolite-Sheep Hills Road transect location

The Boolite Sheep Hills Road was surveyed at the official end of Dunmunkle Creek. The surveyed transect was 260 m long and was covered by the Yarriambiack Creek and North East Flat Plains LiDAR (2005) only.

The Boolite-Sheep Hills Road survey transect location and topographic levels are shown in Figure 2-23 and Figure 2-24 respectively.

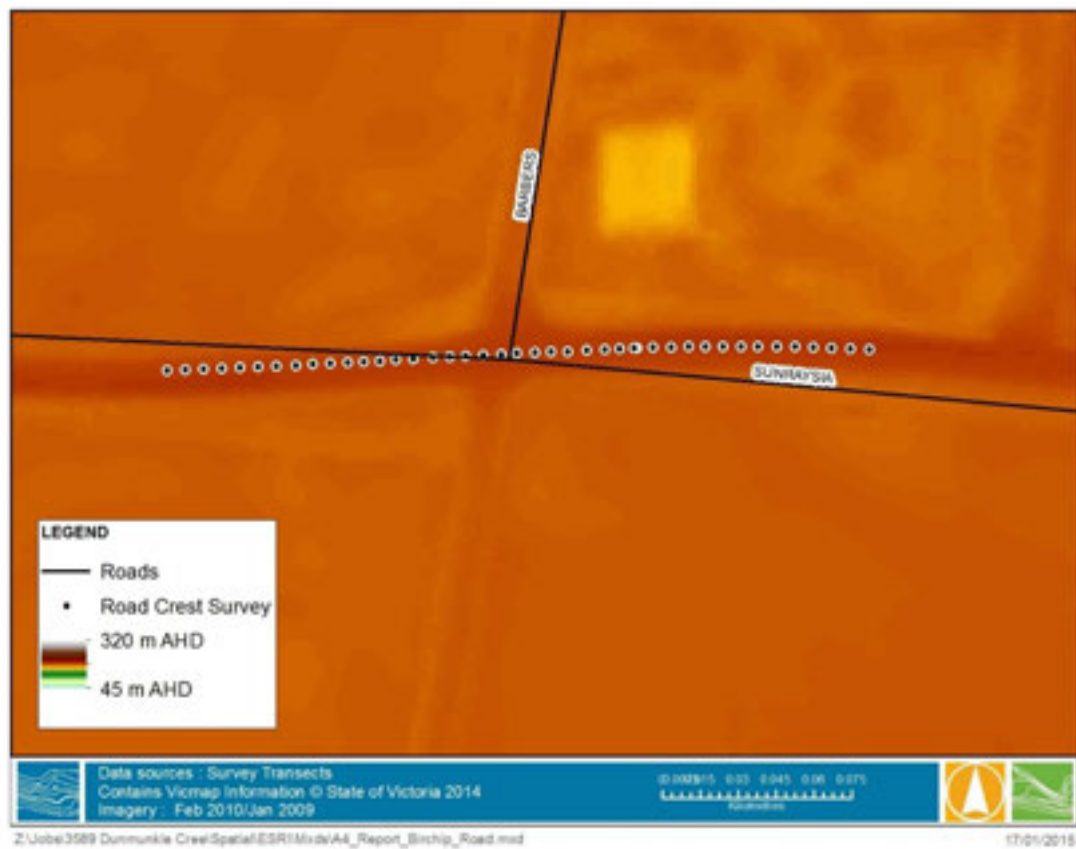
Figure 2-25 Birchip Rainbow Road transect location

The Birchip Rainbow Road transect was the furthest transect to the north and the only survey that was completed within the *WMPP* LiDAR dataset. The survey was completed outside the original study extent. The location of the Birchip Rainbow Road transect and the topographic data comparison are shown in Figure 2-25 and Figure 2-26 respectively.

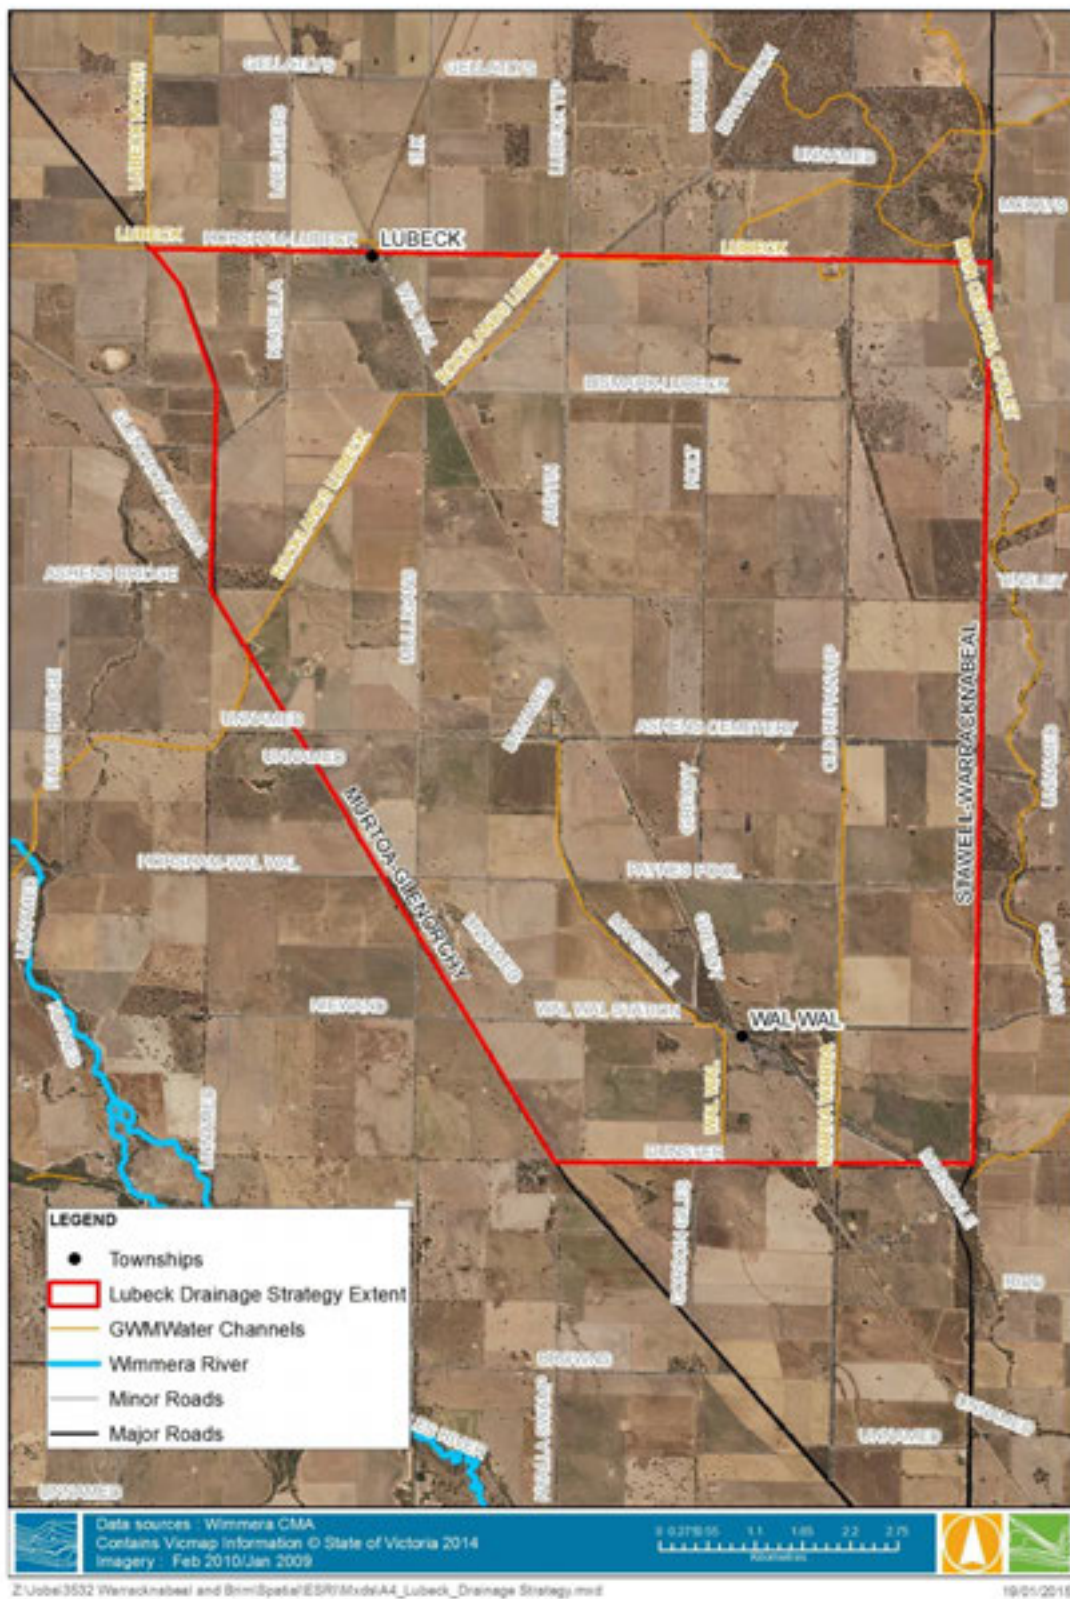
Figure 2-27 Wal Wal/Lubeck Water Survey Strategy extent

Reporting separated the survey area into five catchment areas with eleven points of discharge. A number of the points of discharge are listed as proposed and haven't been investigated in full as the topographic LiDAR data will show what has been constructed since the 1993 report. The approximate survey area is shown in Figure 2-27.

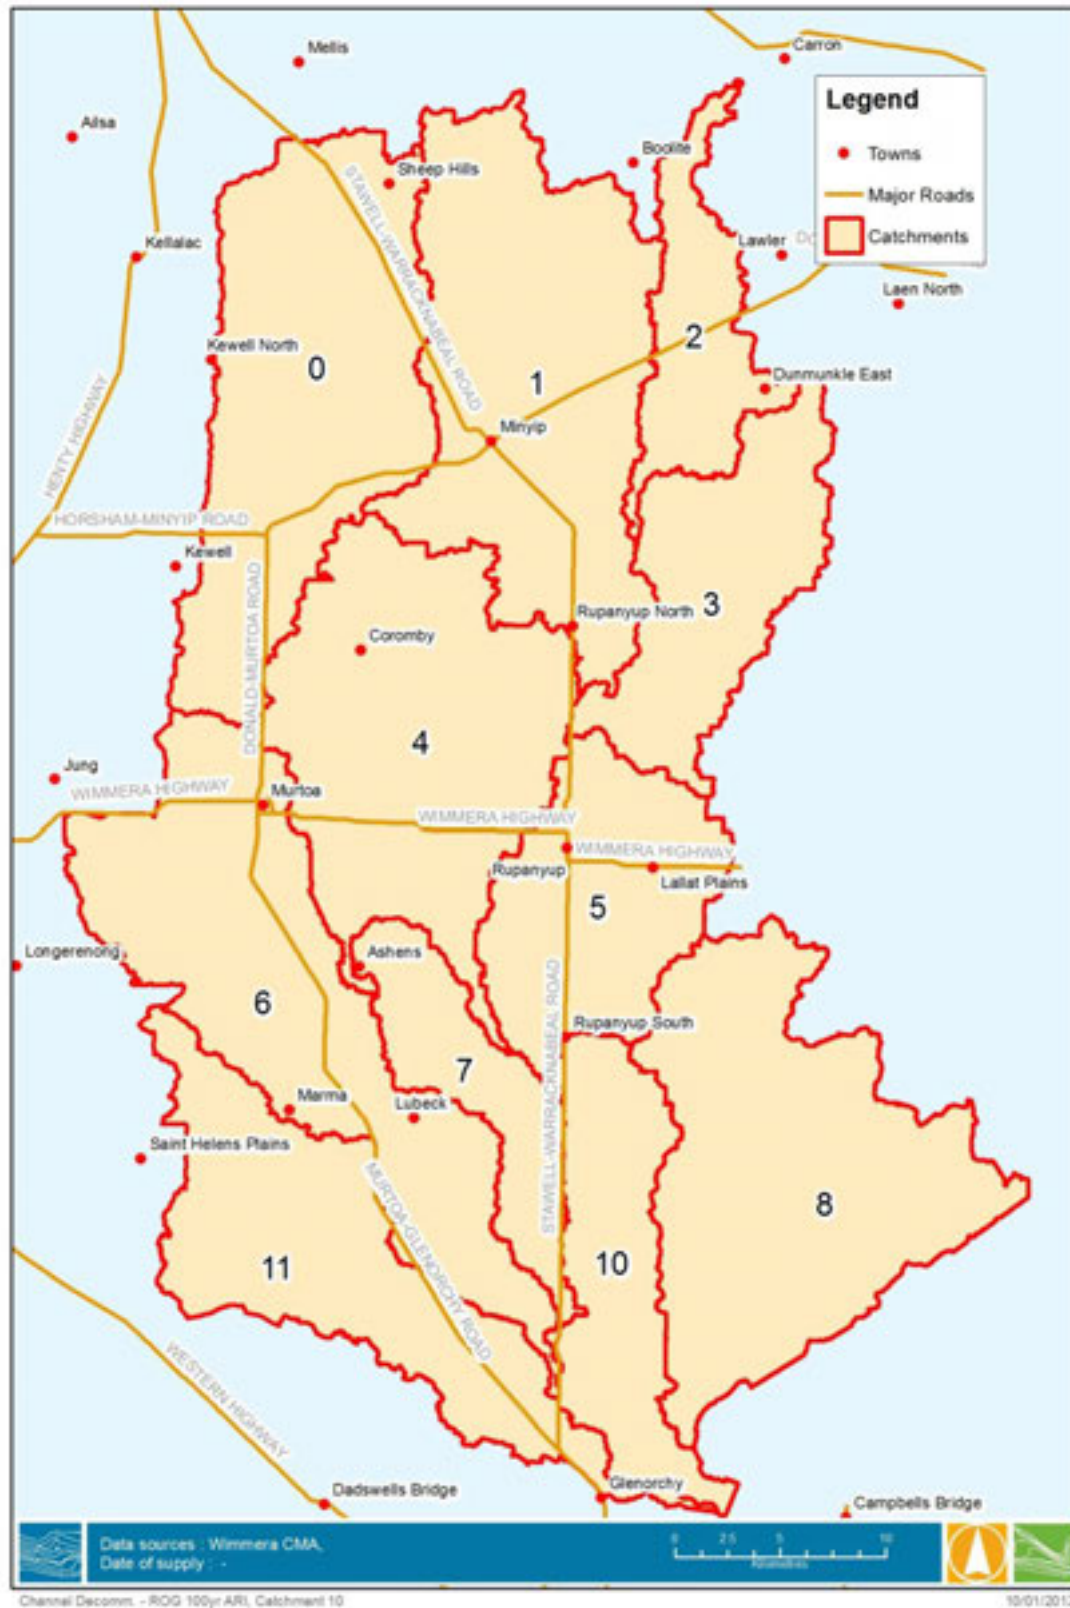
Figure 2-28 Channel Decommissioning Modelling – Study extent and catchment delineation

The study area with catchment delineation is shown below in Figure 2-28. An example of the results produced is shown in Figure 2-29.

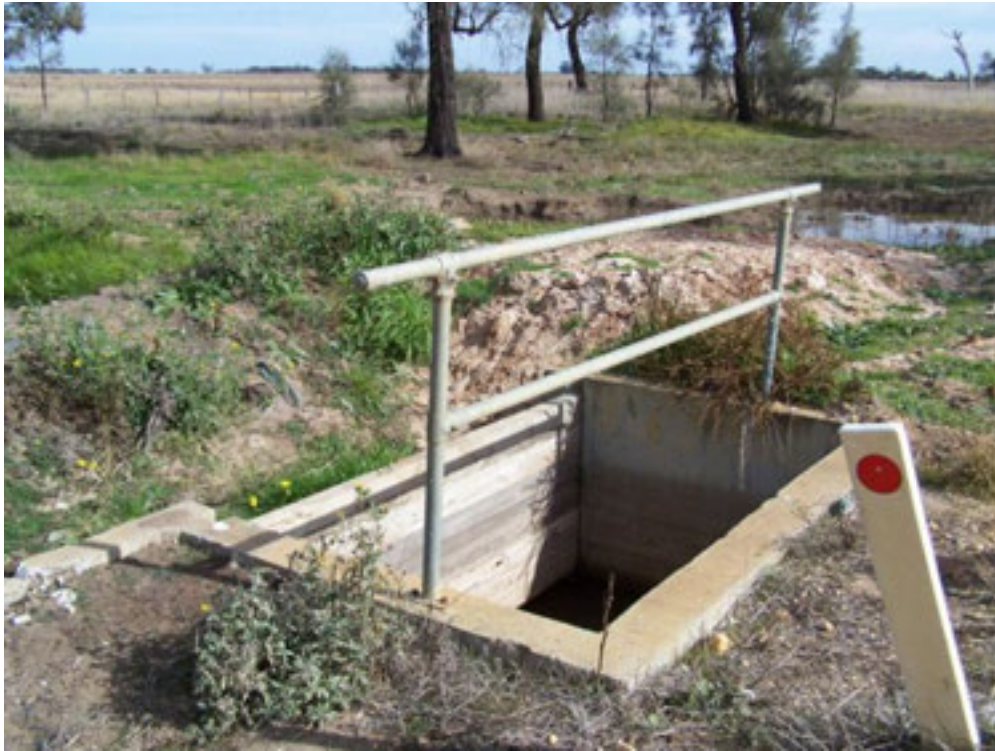
Figure 2-30 Blocked culvert at Lawler Road – Dunmunkle Creek/East Karkarooc Channel

- East Karkarooc Channel - The East Karkarooc Channel heads north from Rupanyup towards Boolite. The channel makes up a lower (northern) section of Dunmunkle Creek. The East Karkarooc Channel/Dunmunkle Creek is a designated waterway up until it meets Lawler Rd where the channel changes direction to the west and Dunmunkle Creek officially finishes. There is however, a title boundary and distinct tree line where the Dunmunkle Creek drainage line appears to continue on to the north for some distance. GWMWater had blocked the channel structure under Lawler Rd as part of their channel decommissioning as shown in Figure 2-30. This caused flooding upstream of the structure.

Various recommendations were made to divert overland flow and prevent the remaining (at the time of writing) channel system from exacerbating flood levels by capturing and transferring flow in partially decommissioned and blocked sections of channel.

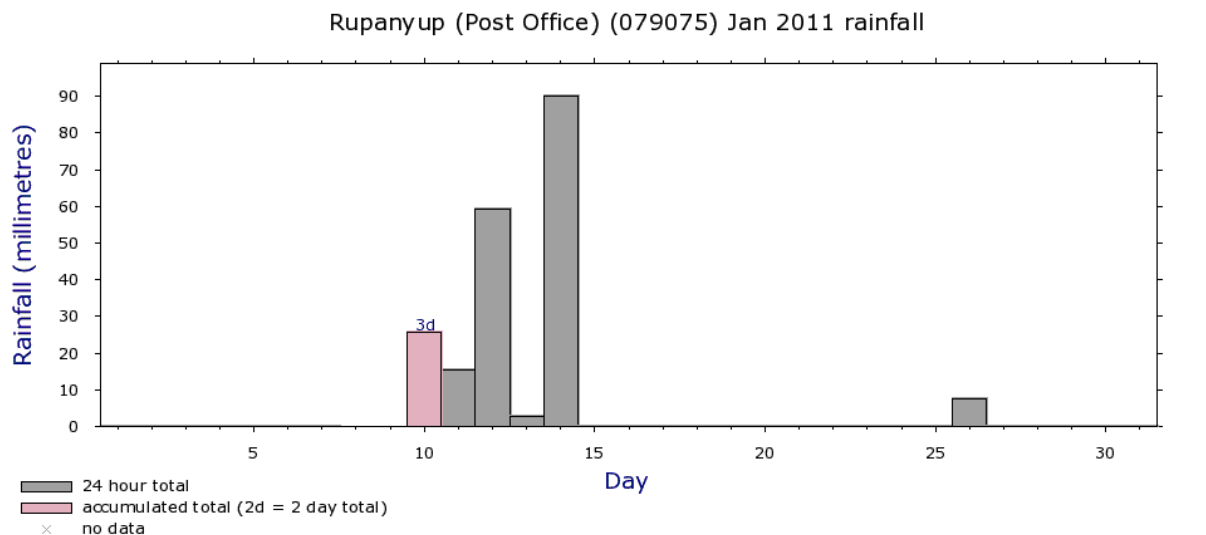
Figure 5-1 Rupanyup (Post Office) January 2011 daily rainfall records

The Rupanyup (Post Office) rainfall gauge recorded 59.2 mm and 90.0 mm on the 12th and 14th January 2011 respectively, as shown in Figure 5-1. This was verified by a local resident who recorded 59.5 mm and 92 mm for the same dates in Rupanyup. The 90 mm recorded on the 14th was the largest daily recording in the Rupanyup (Post Office) record beginning in 1901. The next largest daily total was 76.5 mm in December 1929.

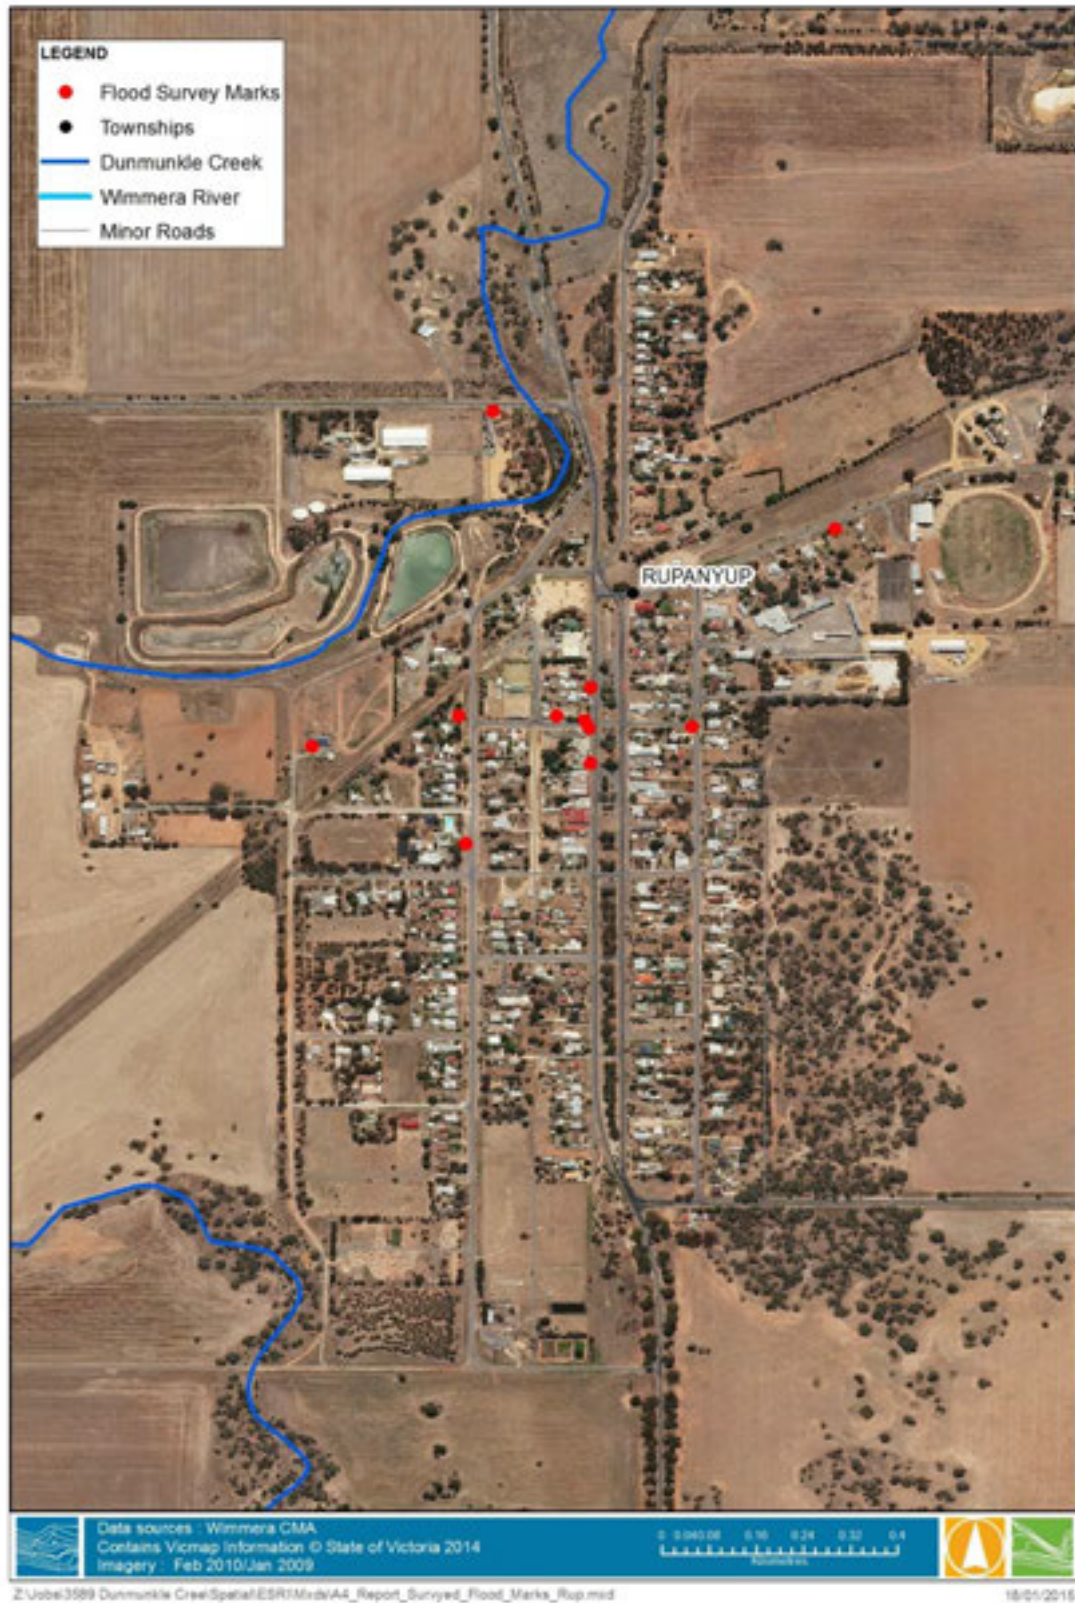
Figure 5-7 January 2011 – Surveyed flood marks around Rupanyup

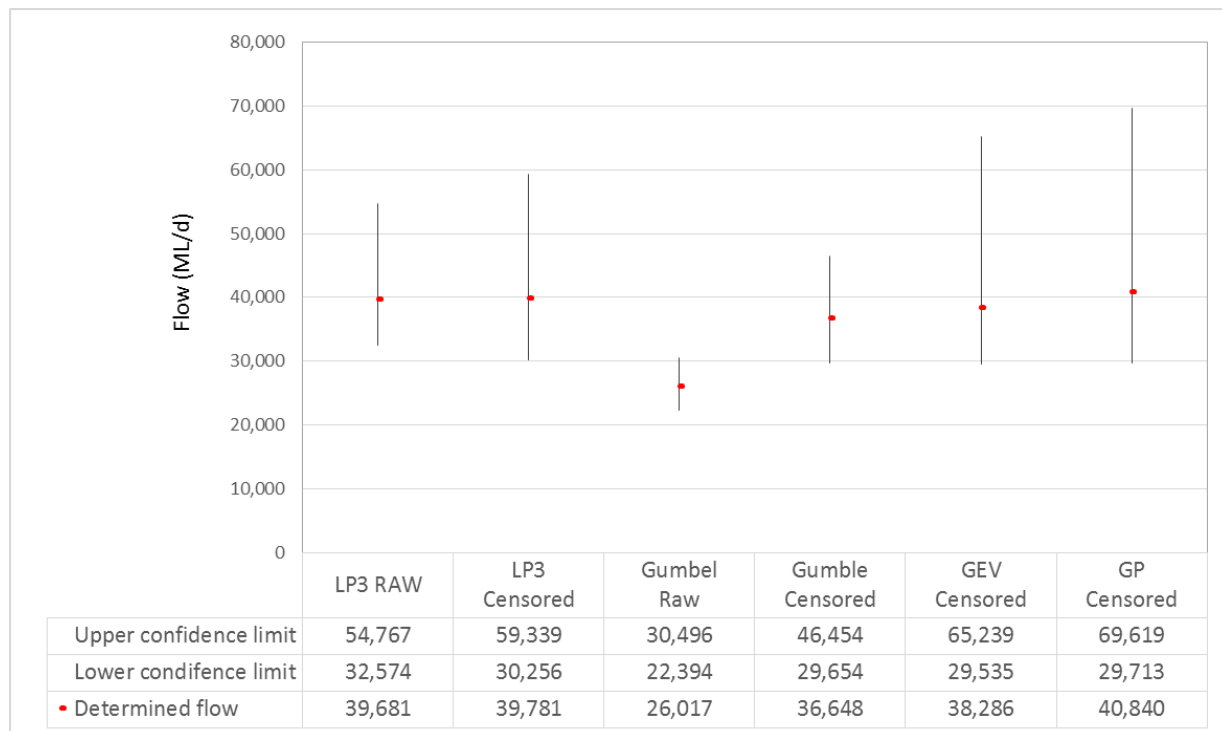
Figure 6-1 1% AEP FFA design flow estimates and confidence limits

The tested FFA distributions and annual series that matched the observed data are plotted in Figure 6-1, showing the confidence limits around the 1% AEP design peak flow. The plot shows the Gumbel Raw and low flow censored data had the narrowest confidence limits, followed by the LP3 Raw FFA.

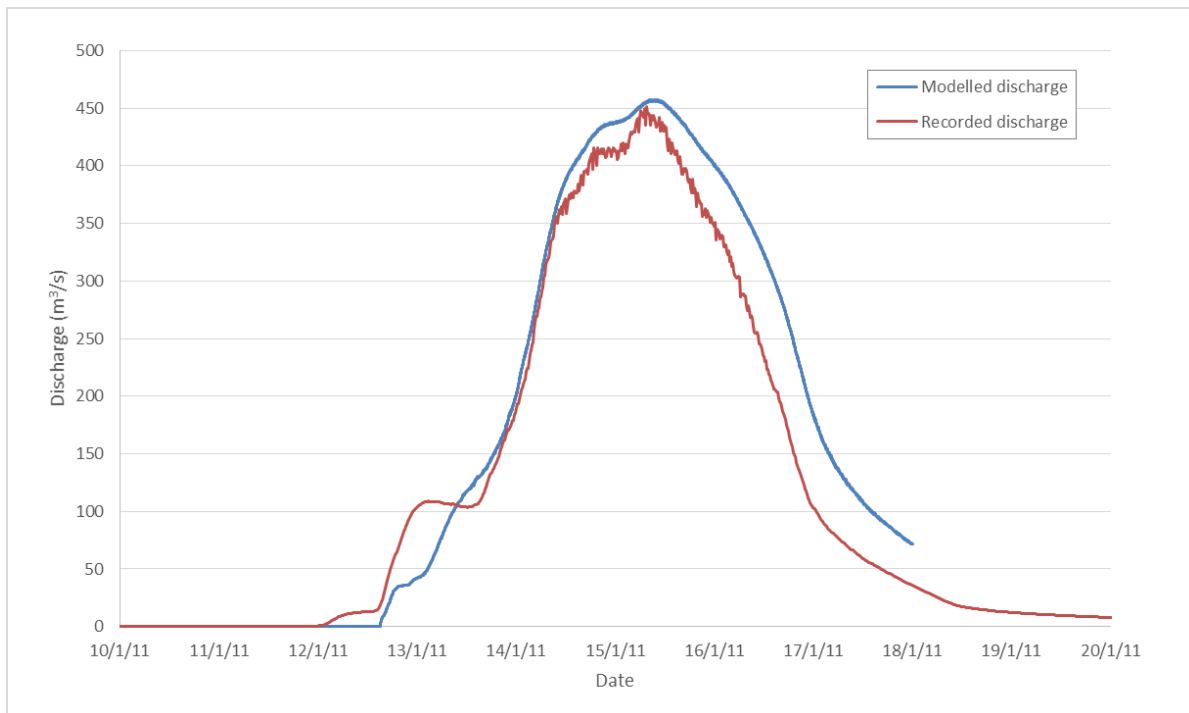
Figure 7-3 Model A – Recorded and modelled hydrographs at the Glenorchy gauge

A uniform Manning's 'n' of 0.05 was shown to provide the best match of observed and modelled levels, flows and timing. A comparison of modelled and observed hydrographs and water levels are shown in Figure 7-3 and Figure 7-4 respectively.

Observed	Modelled
Peak flow	451 m ³ /s	457 m ³ /s
Peak water level	168.81 m AHD	168.80 m AHD
Timing	15/01/2011 7:30 am	15/01/2011 9:30 am

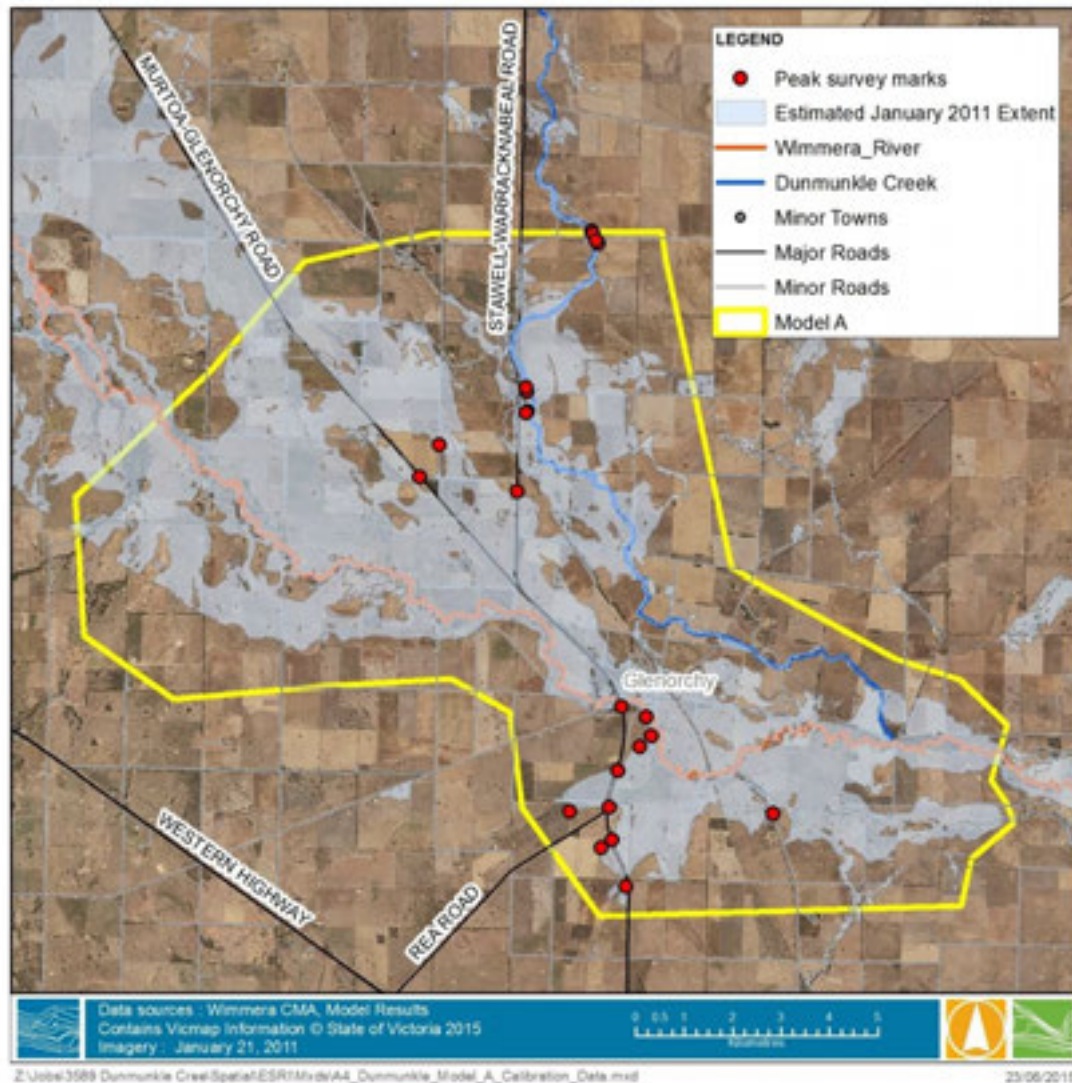
Figure 7-5 Model A – Peak flood survey marks and estimated January 2011 extent

Additional to the observed flows and water levels at the Glenorchy gauge there were 22 peak flood level survey heights marked by Wimmera CMA staff available for the model calibration and an estimated inundation extent within Model A. The inundation extent was determined by Wimmera CMA based on the available linescan, satellite and aerial photography available. The survey marks and estimated extent are shown in Figure 7-5 along with the Model A extent.

The model results were compared to the surveyed levels and estimated extents. The difference between the surveyed and modelled maximum flood levels were calculated as:

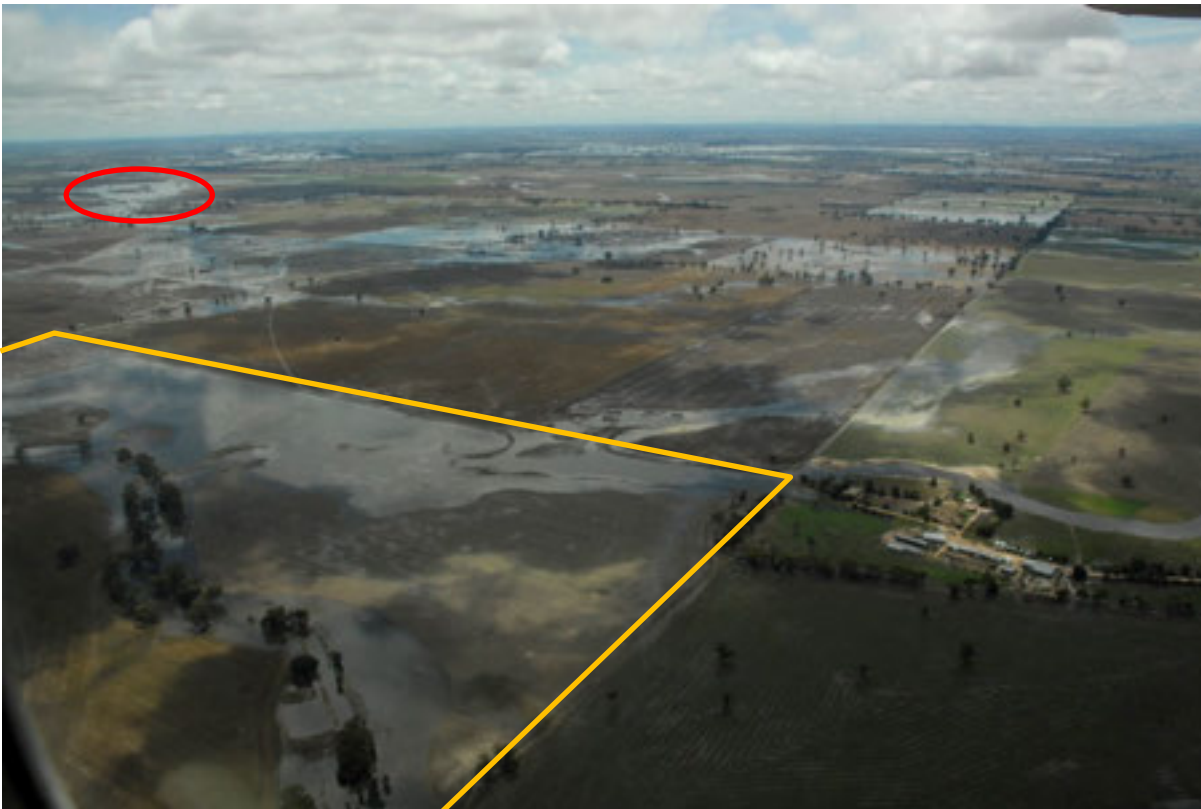
Figure 7-14 Model B – Aerial photo 243 captured at 11:54 am, 14th January 2011

The aerial image shows Dunmunkle Creek inundation exceeded that represented in the linescan image, between Minnieboro Road and Tinsley Road, even though it was captured very early in the event.

The aerial photo captured at 11:54 am, 14th January 2011 that best shows the areas highlighted in Figure 7-13 is image 243, as shown in Figure 7-14.

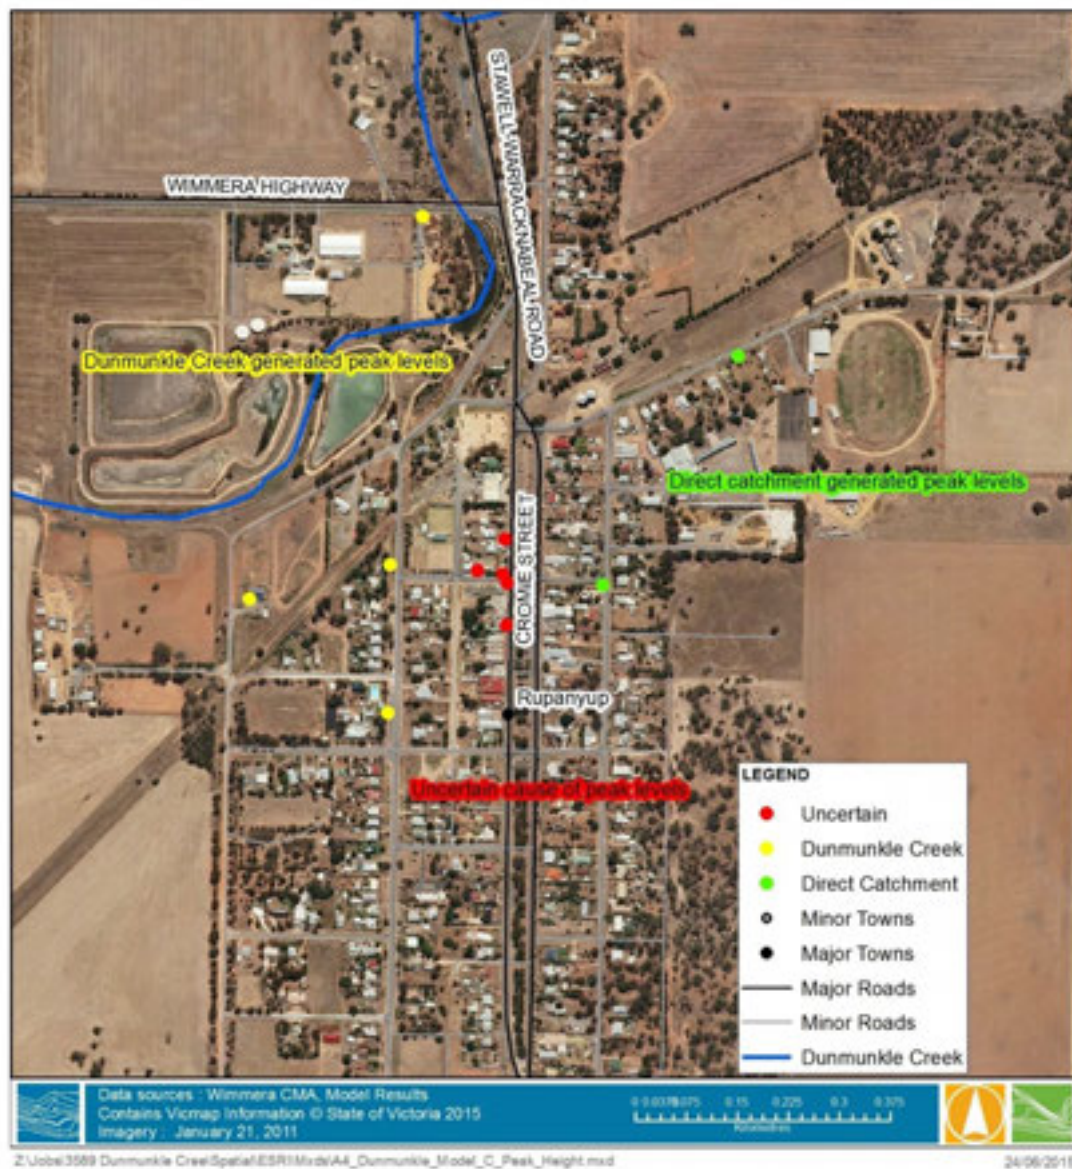
Figure 7-18 Model C – January 2011 Surveyed flood heights
