Dunmunkle Creek Final Report

Wimmera CMA

May 2018

This report is the Final Report for the Dunmunkle Creek Flood Investigation. This report supersedes all other reports during the progress of the flood investigation.

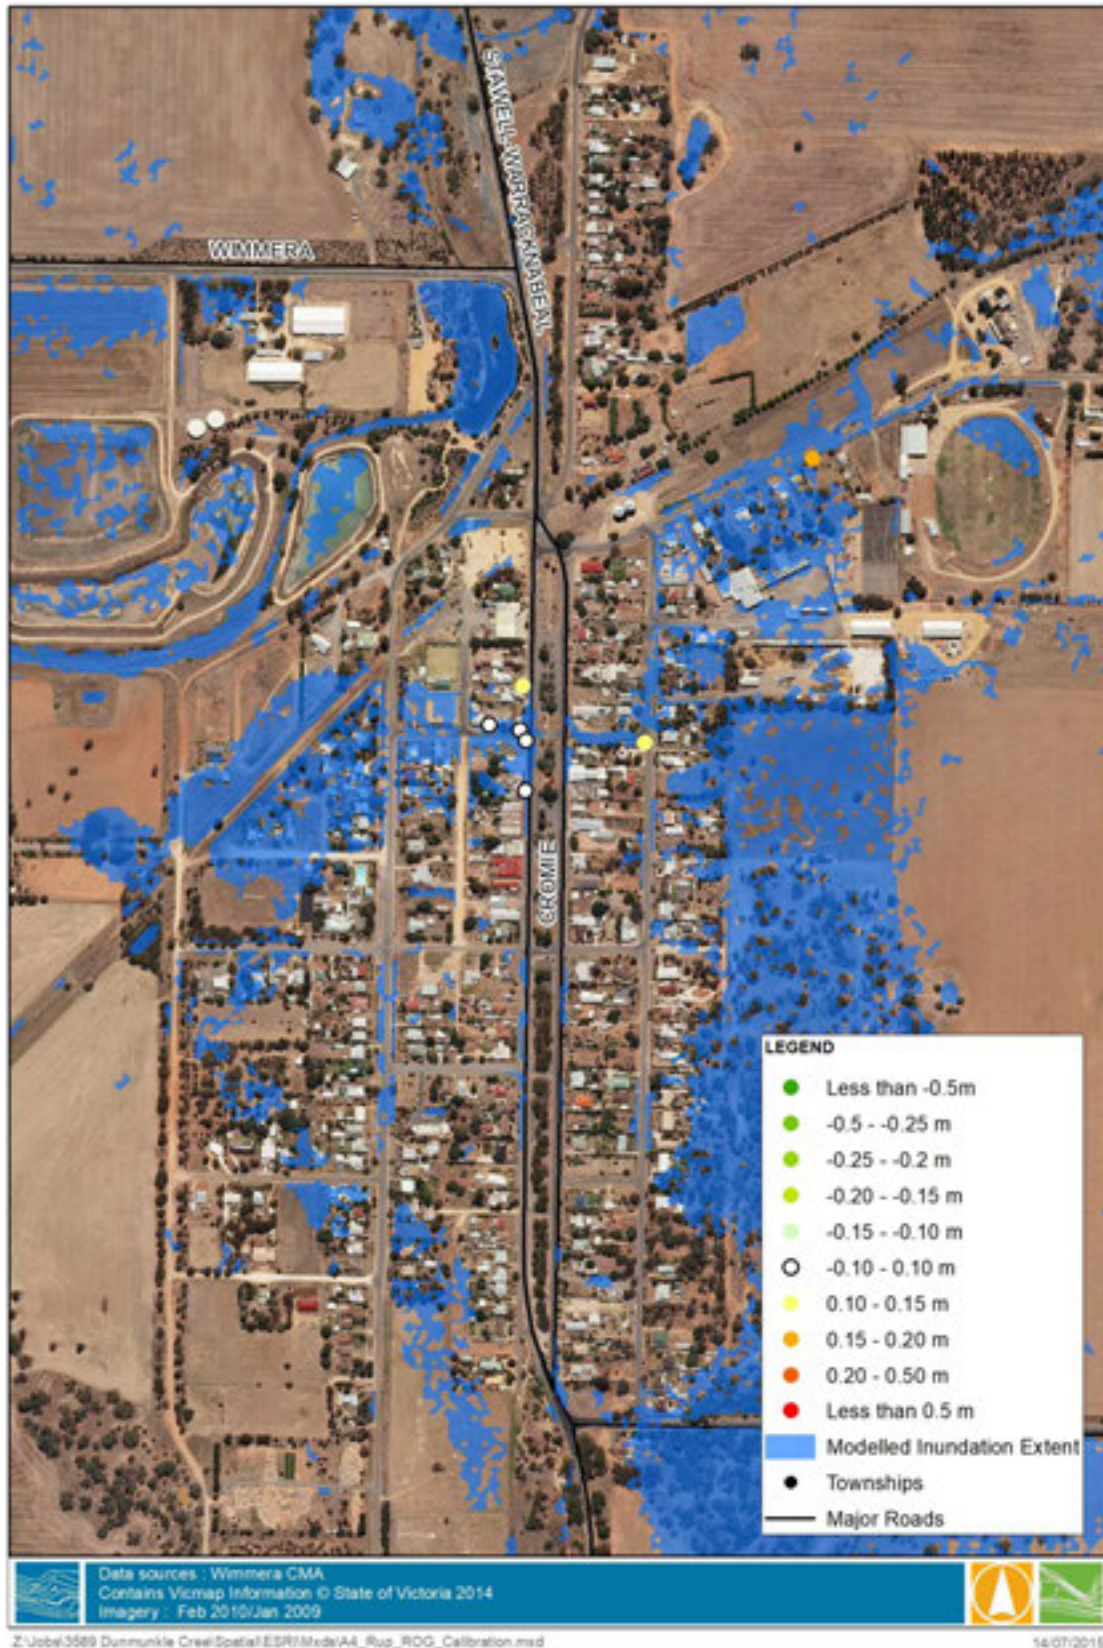
Figure 7-19 Model C – January 2011 direct catchment rainfall peak flood height comparison

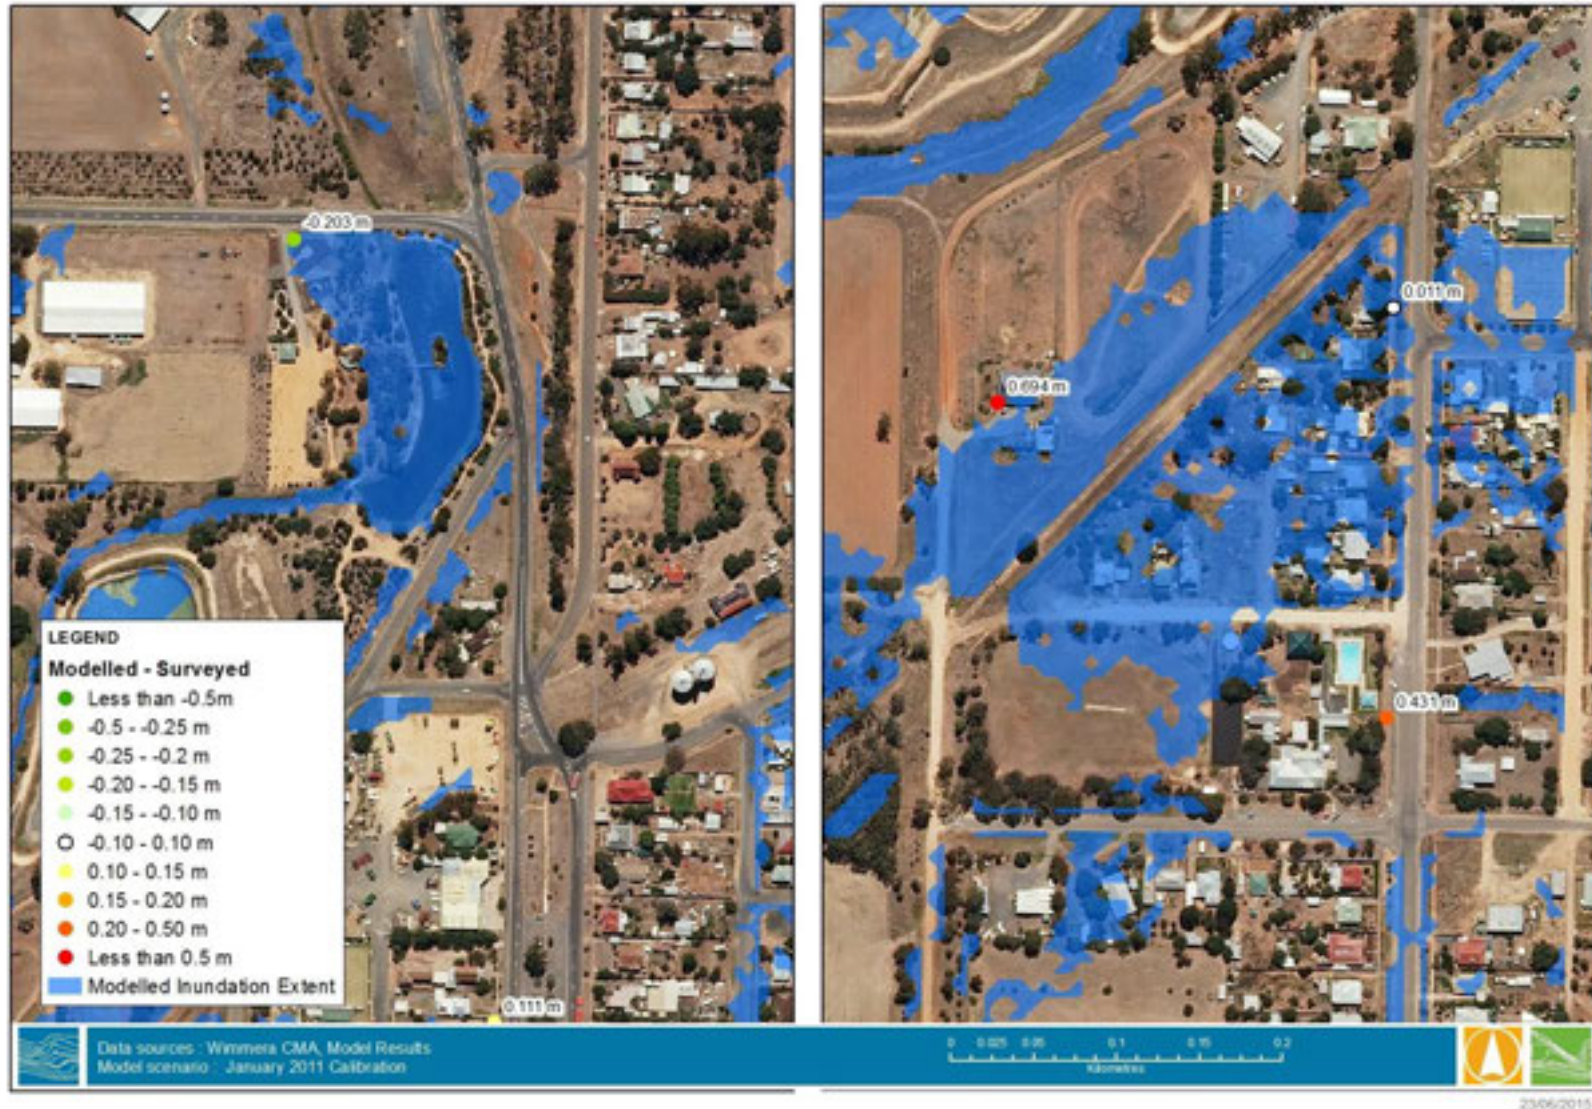
Figure 7-20 Model C – January 2011 direct catchment rainfall peak flood height comparison, differences greater than 0.2 m

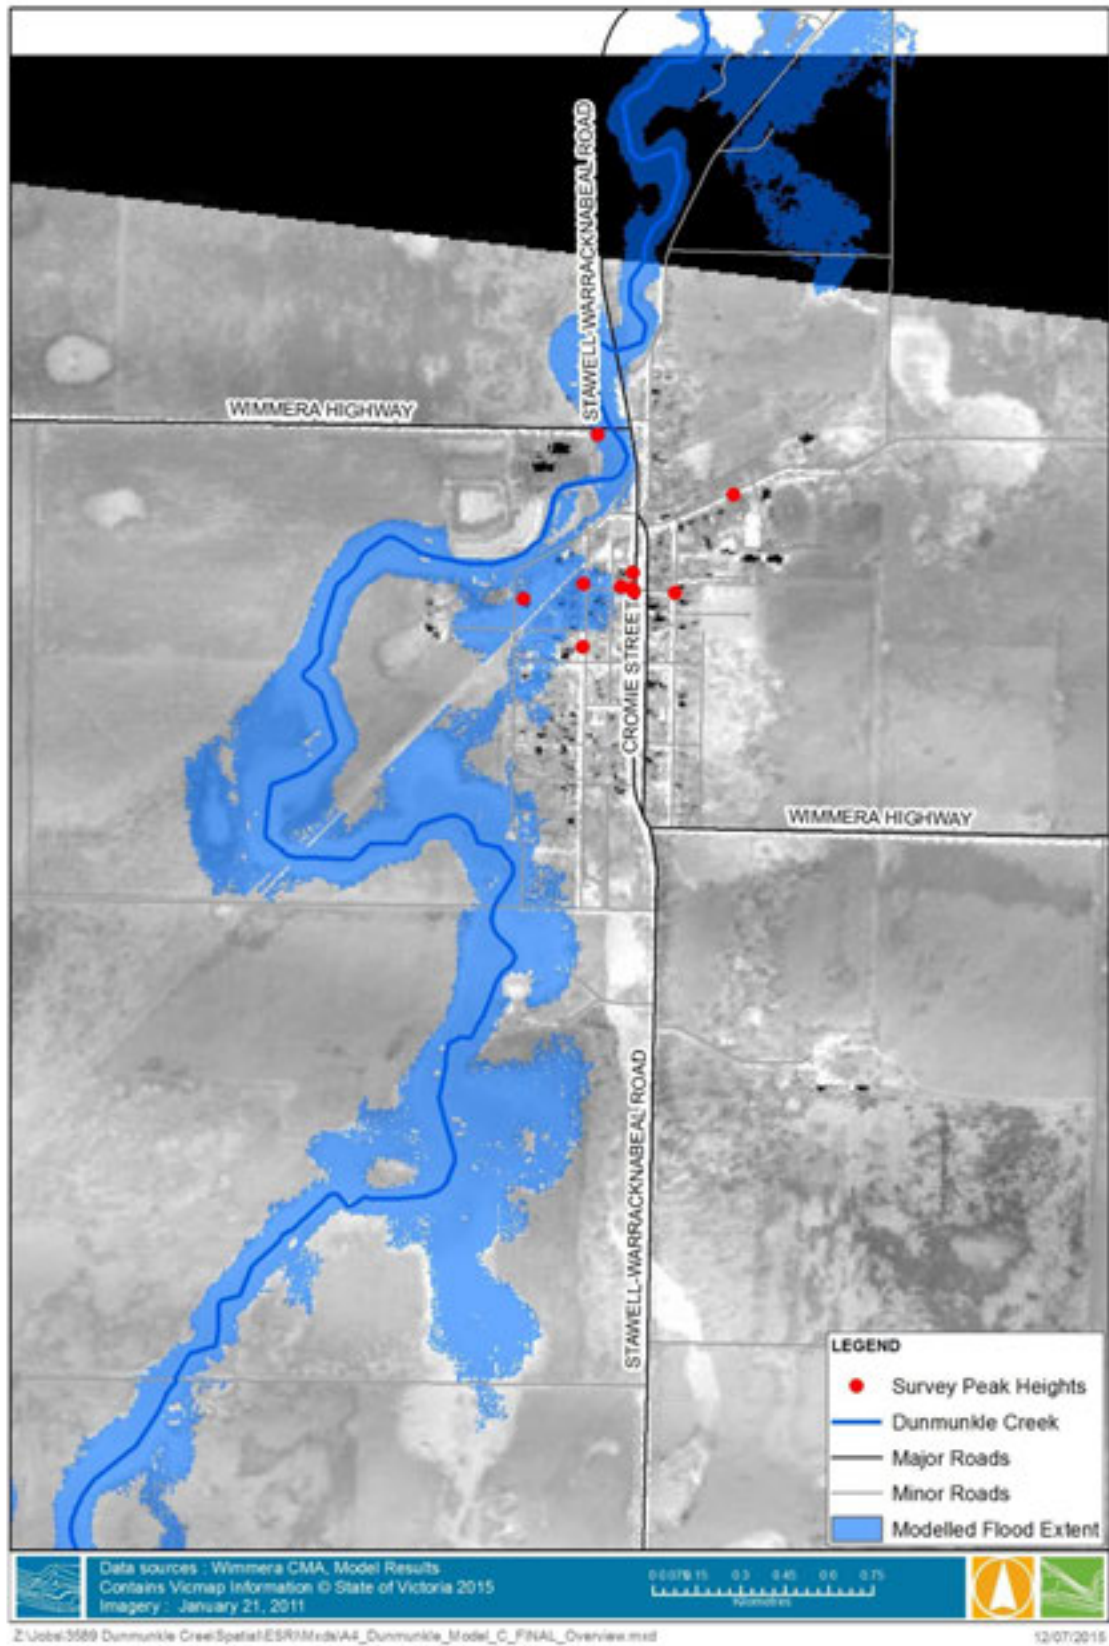
Figure 7-22 Model C – January 2011 Dunmunkle Creek inundation

The modelled extents match observations made by Rupanyup residents during community and steering committee meetings, with water spilling into the township and reaching the Warracknabeal Stawell Road but not overtopping it.

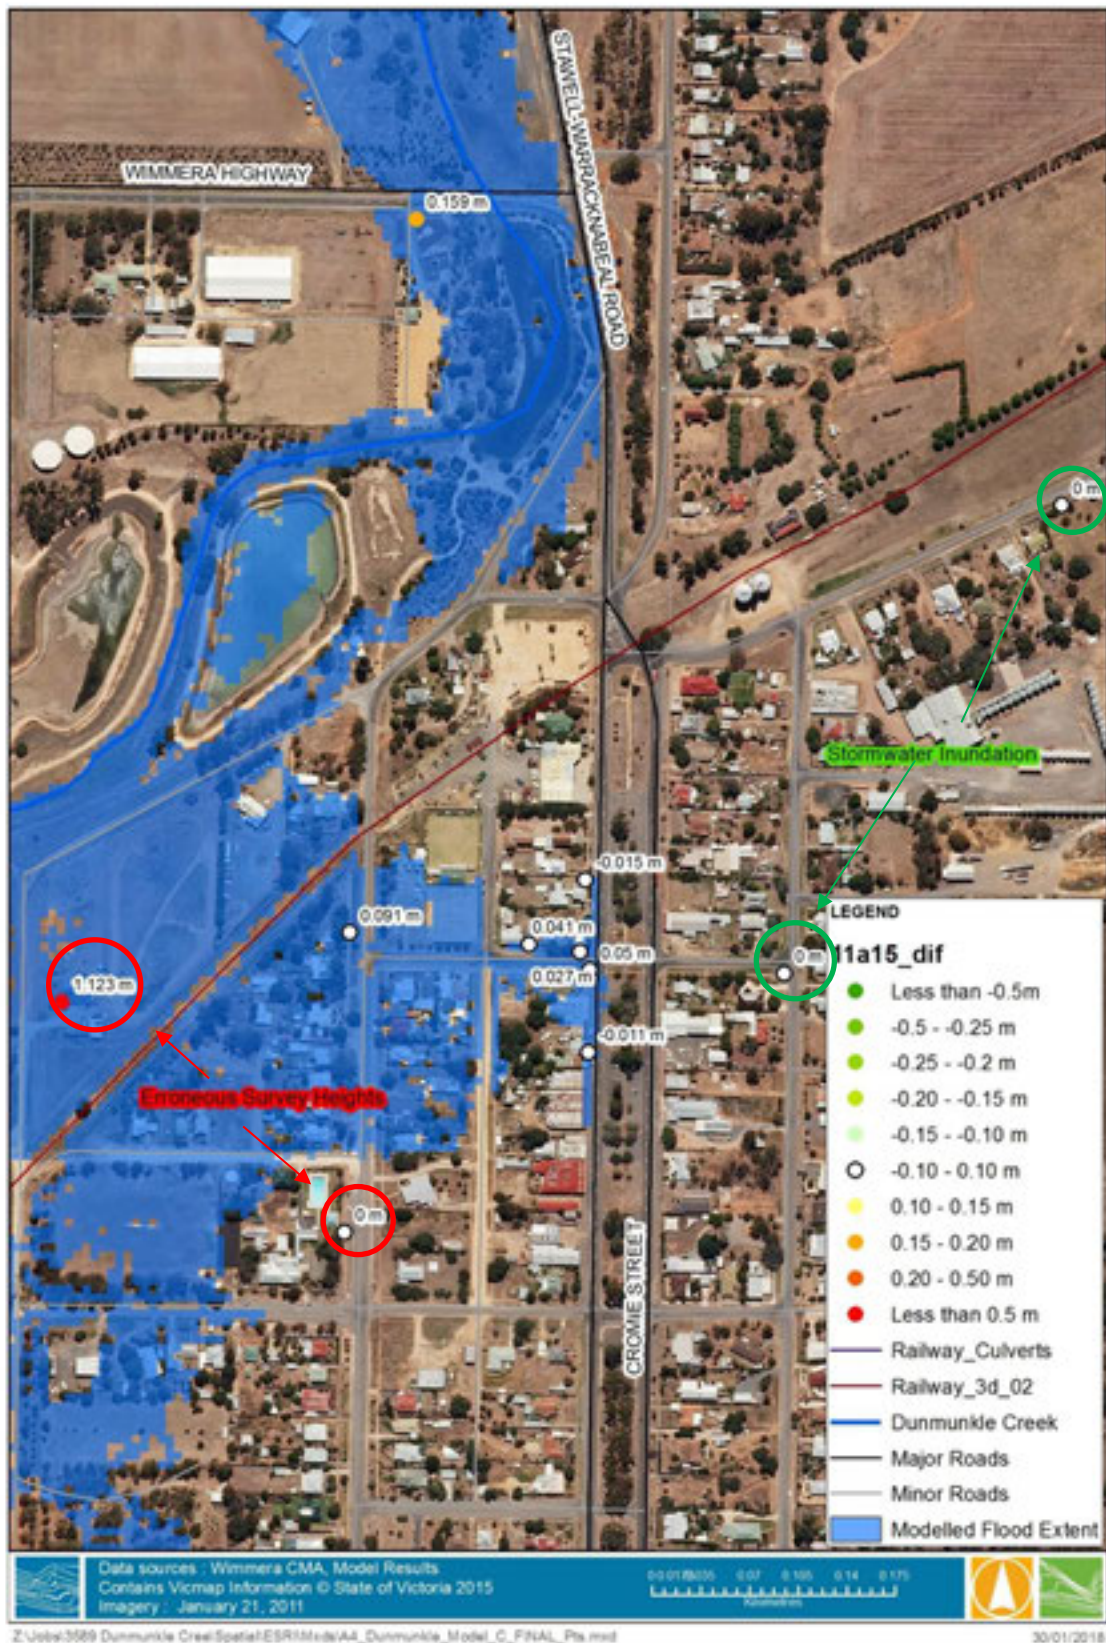
Figure 7-24 Model C – January 2011 Dunmunkle Creek inundation, modelled minus surveyed levels

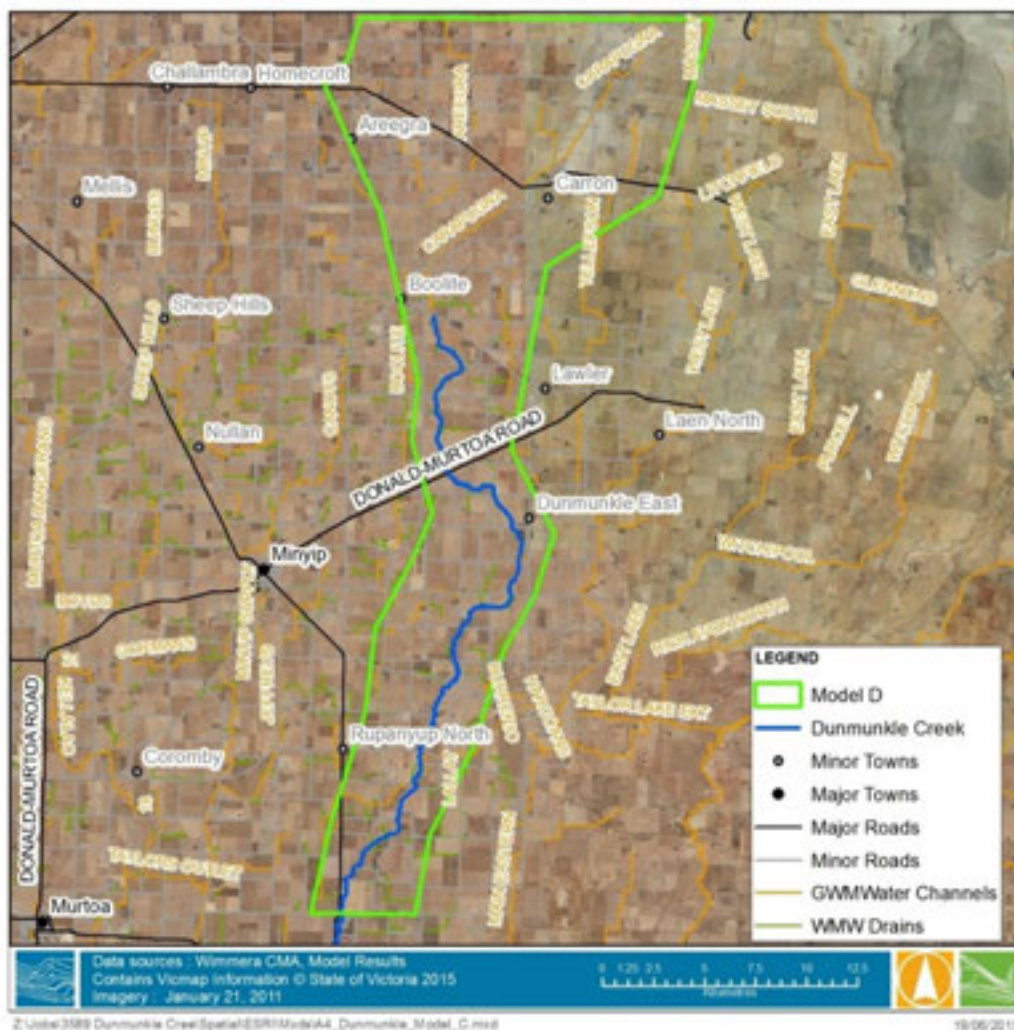
Figure 7-25 Model D - Hydraulic model structure

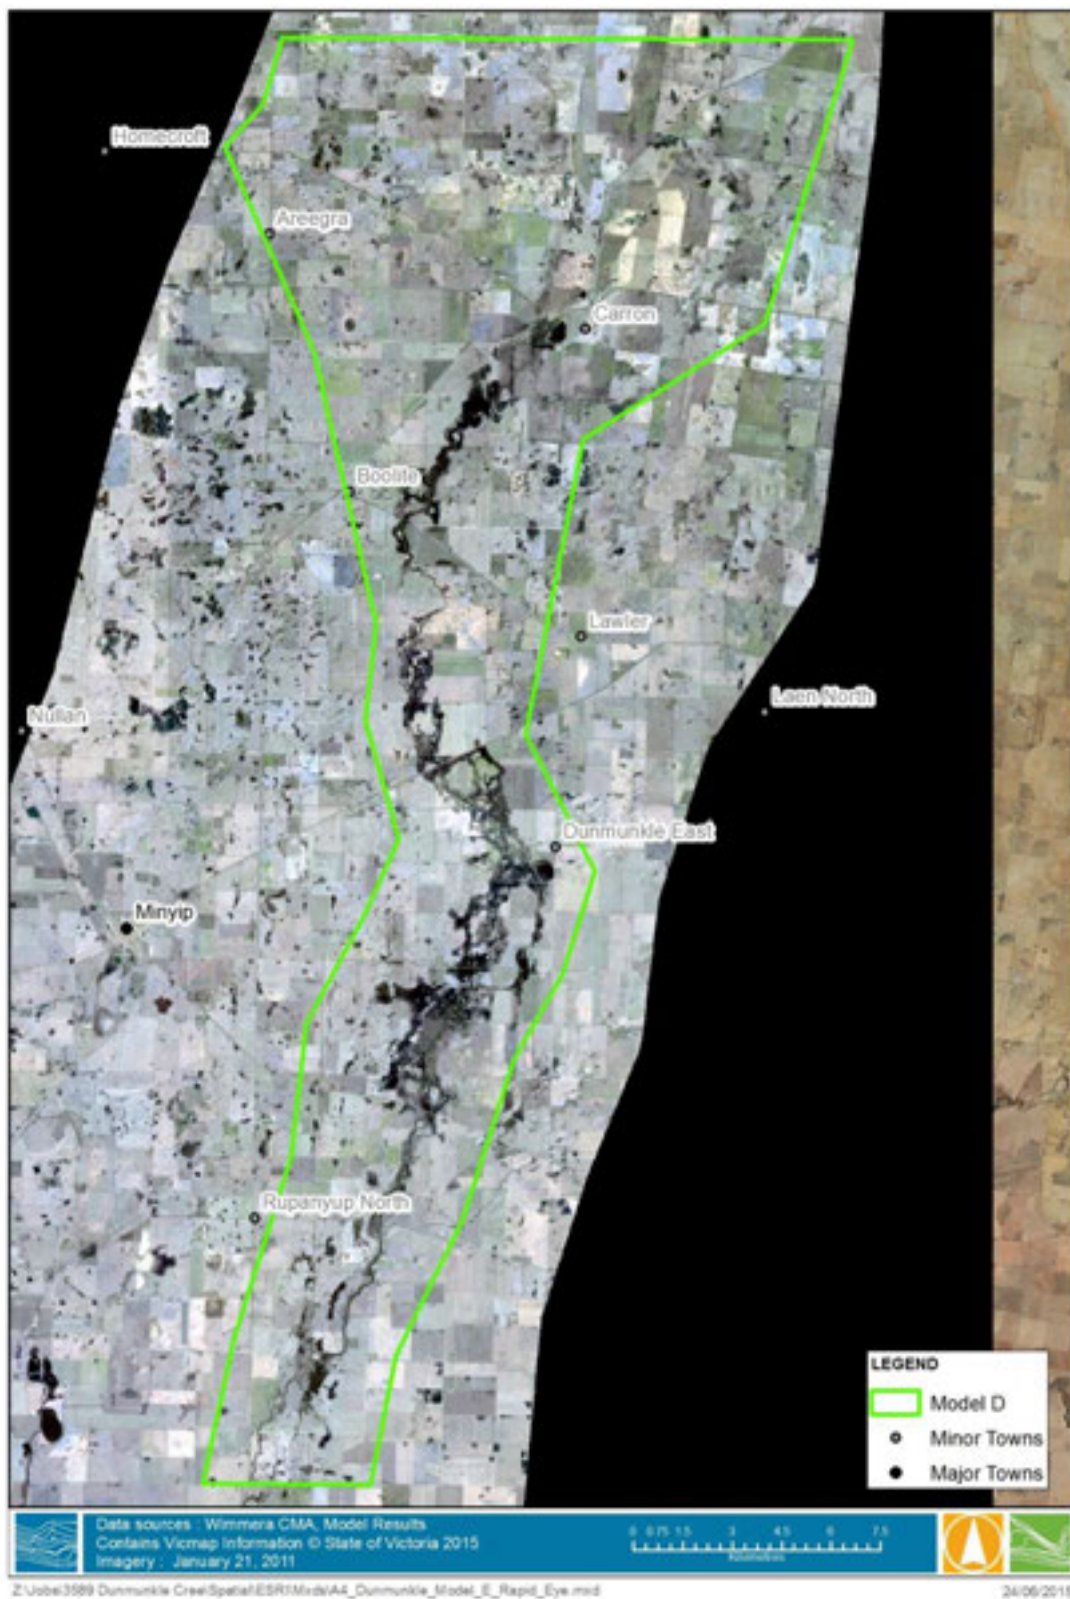
Figure 7-26 Model D – Rapid Eye Satellite Imagery

Model D is the final northern extension of the Dunmunkle Creek modelling. The model routes flow from Model C until it stops flowing and pools in depressions. There are no surveyed levels or Wimmera CMA estimated extents within Model D, with the hydraulic model calibration relying on imagery from Rapid Eye, Landsat Satellites and community observations. The extent of Model D is shown in Figure 7-25. The Rapid Eye and Landsat Satellite images available for Model D are shown in Figure 7-26 and Figure 7-27 respectively.

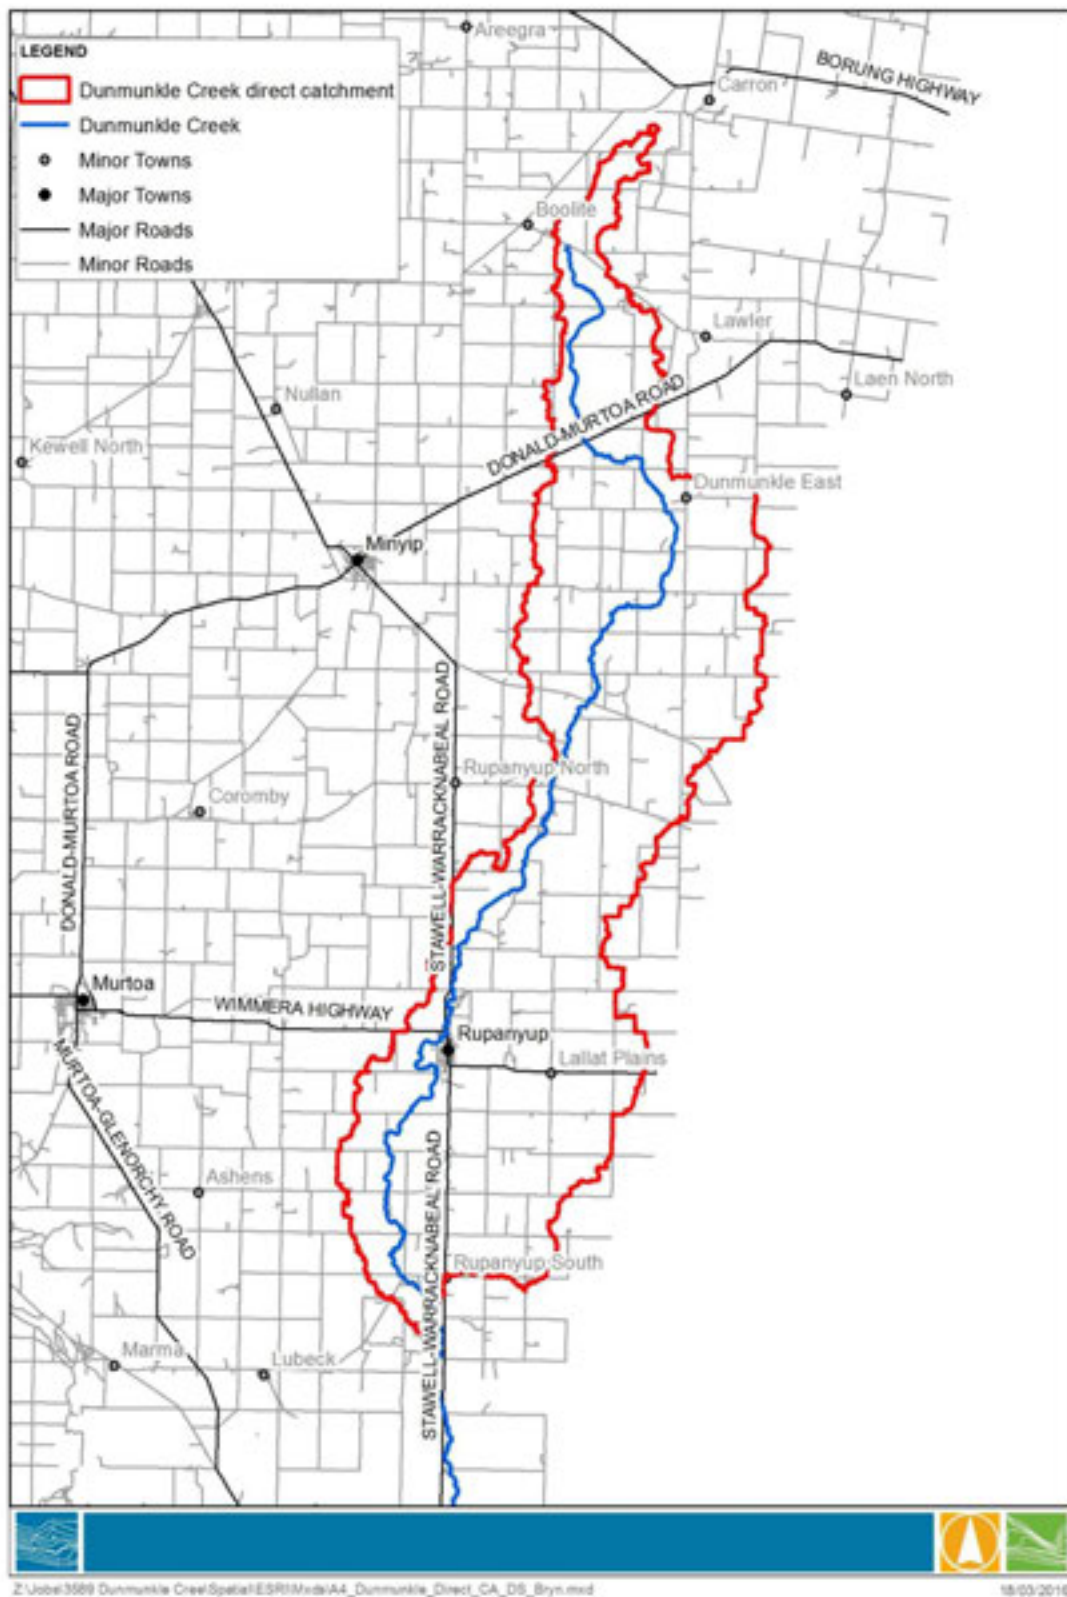
Figure 7-37 Dunmunkle Creek localised catchment area north of the Bryntirion Forest

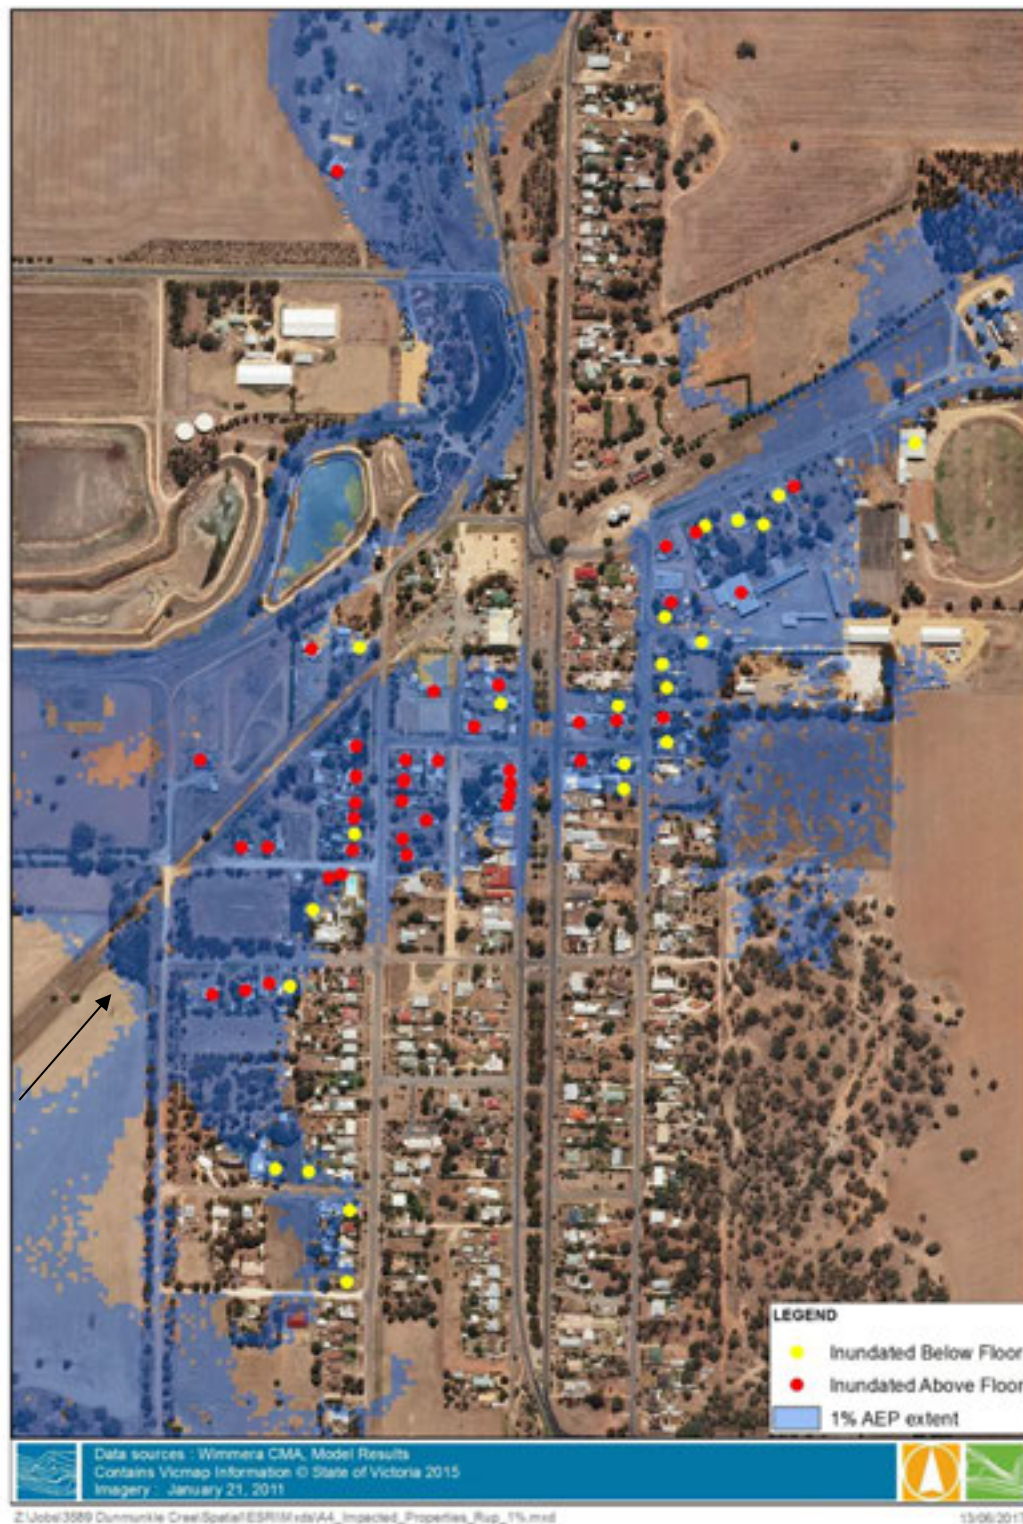
Figure 8-5 Model C - Dunmunkle Creek inundation, buildings inundated above floor for the 1% AEP flood extent

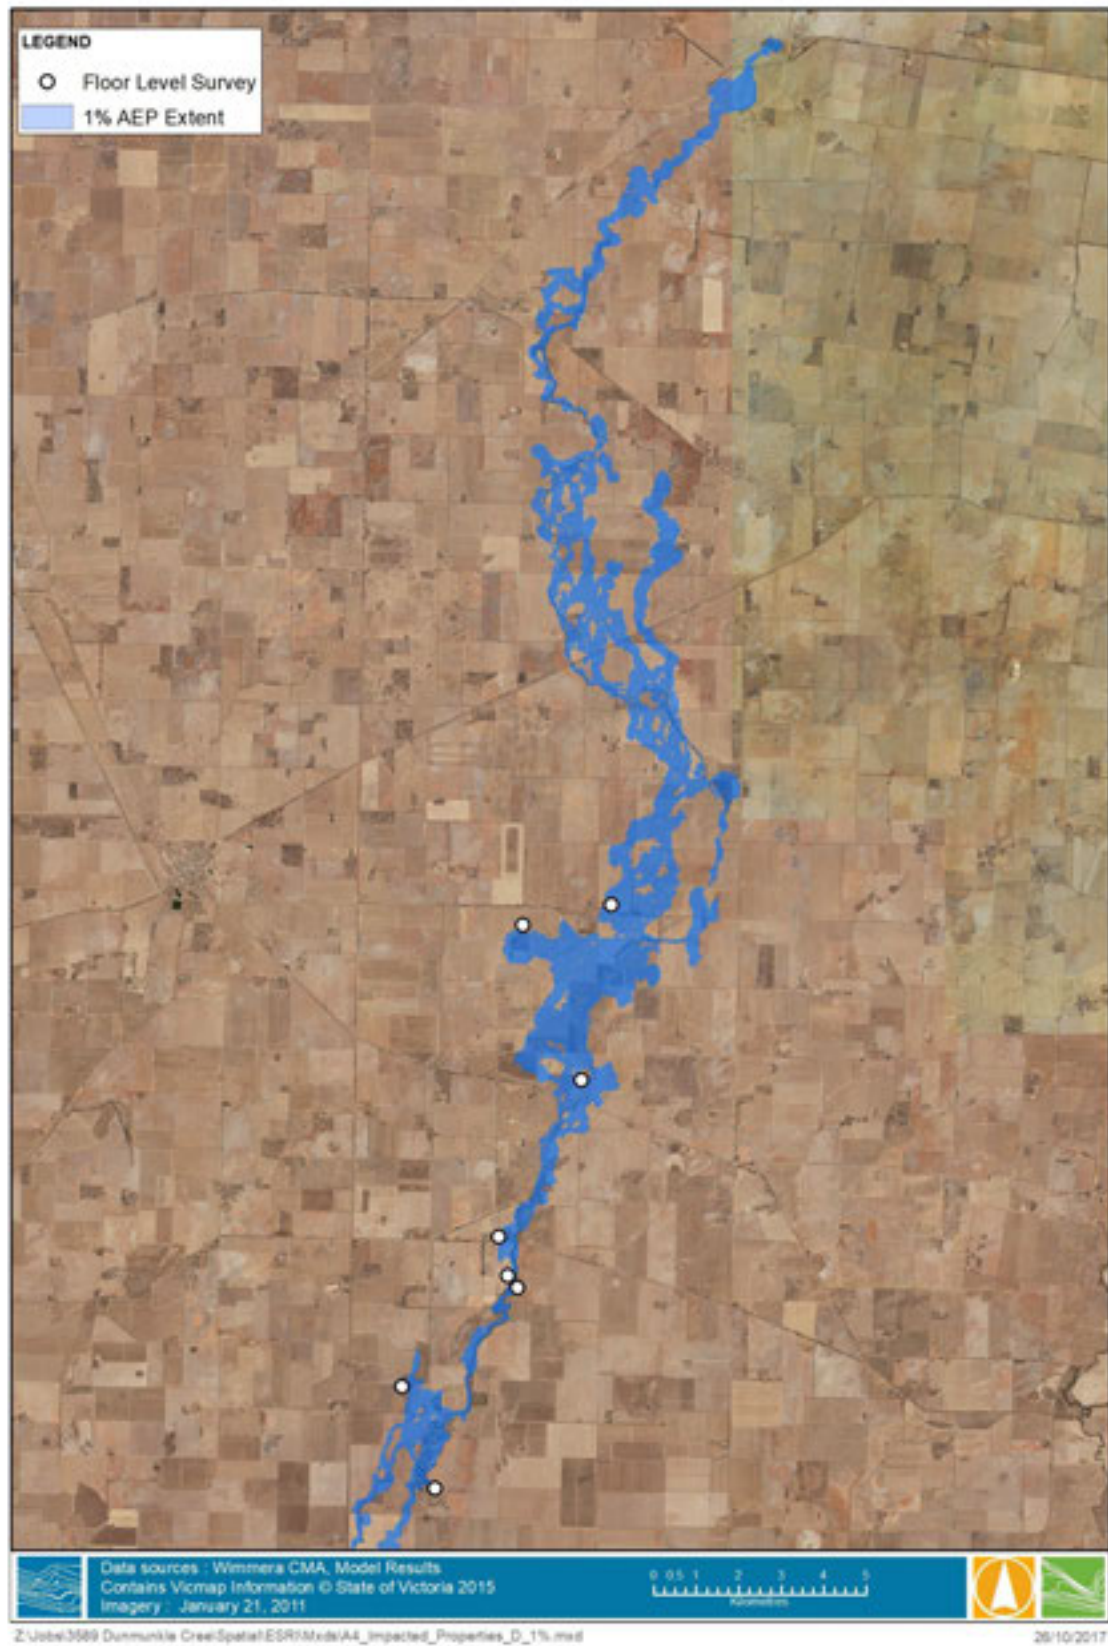
Figure 8-6 Model D - Dunmunkle Creek inundation, 1% AEP flood extent and surveyed buildings

The 1% AEP flood extent for Model D and the surveyed buildings are shown in Figure 8-6.

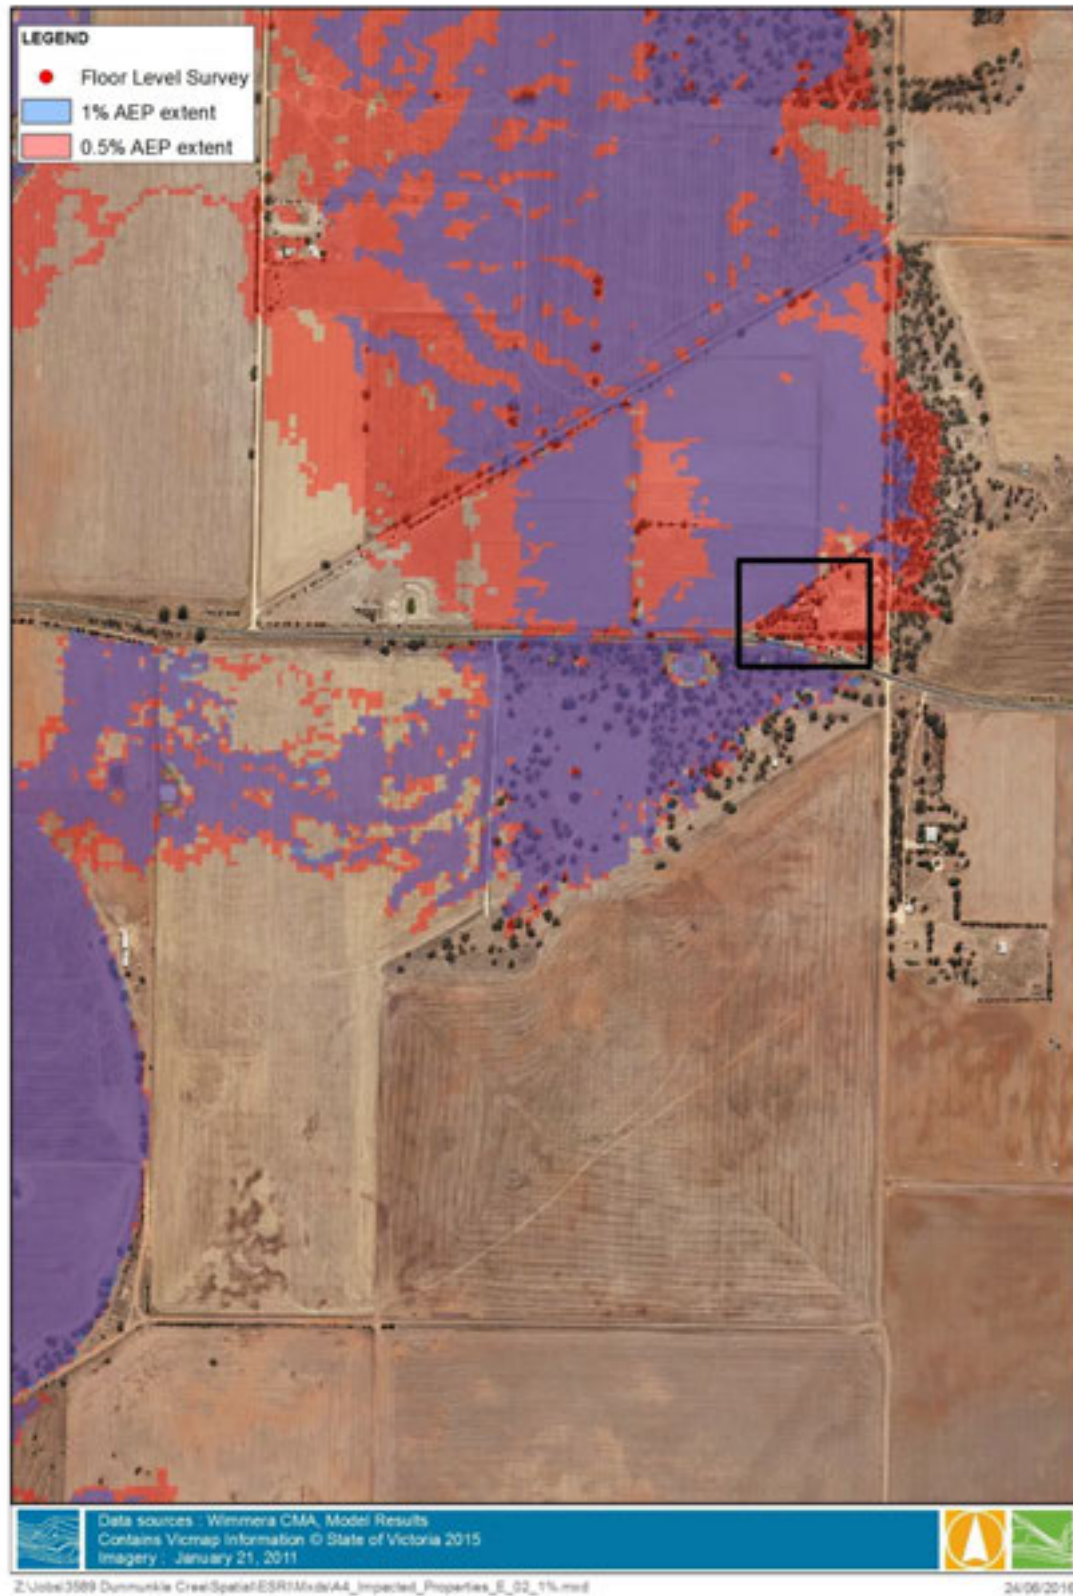
Figure 8-8 Model E - Dunmunkle Creek inundation, 0.5% and 1% AEP flood extent, highlighting property with missing survey

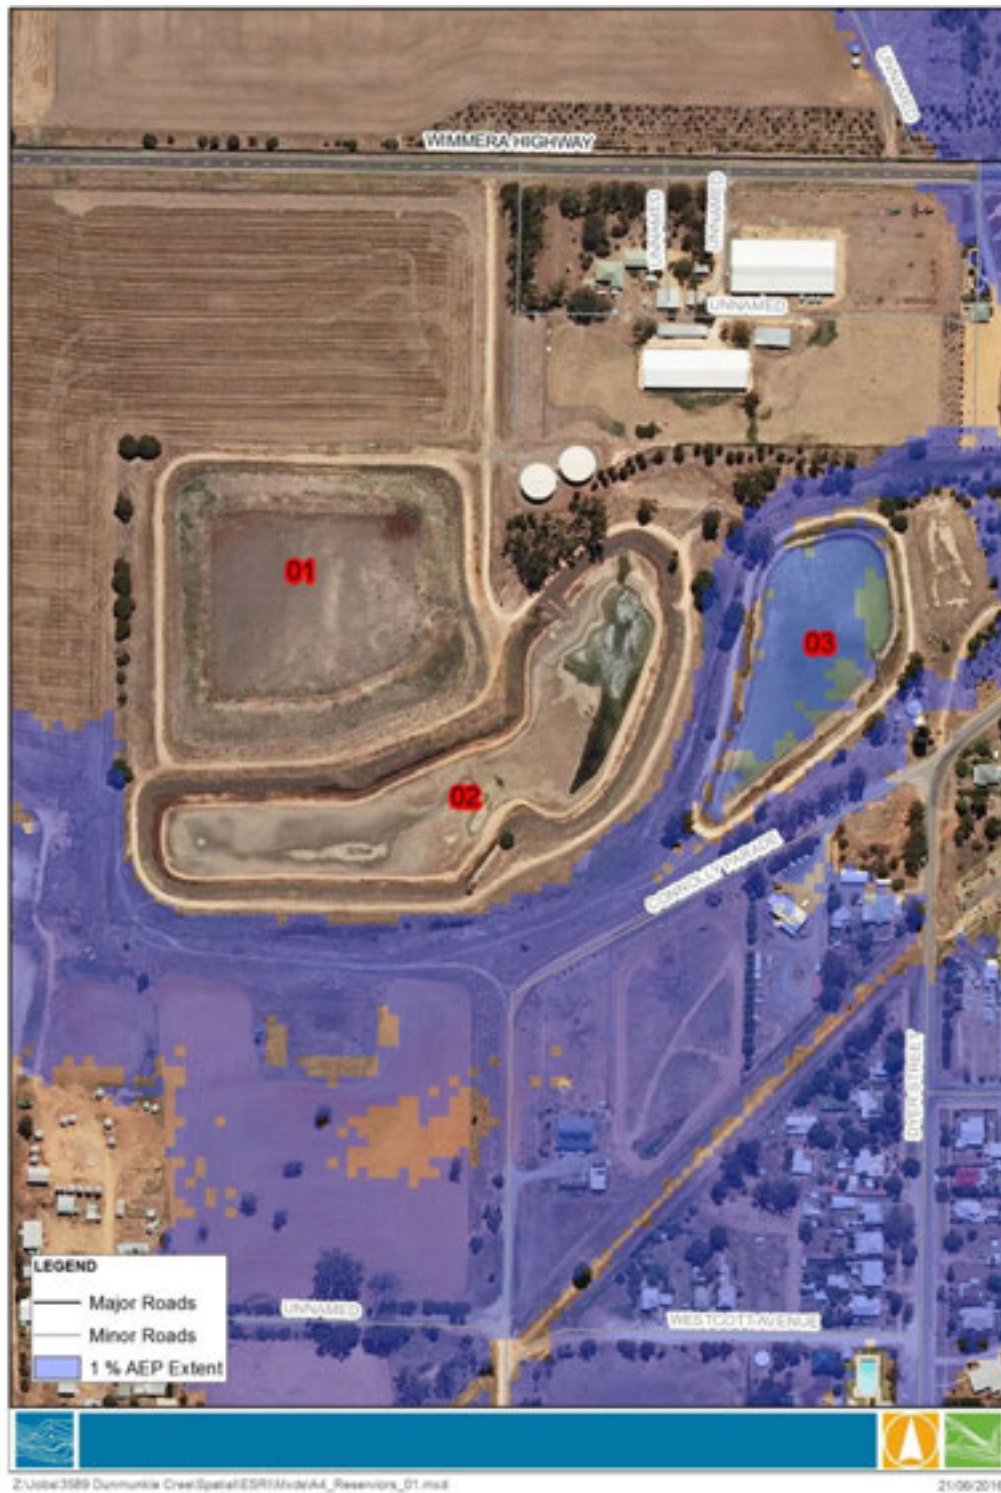
Figure 8-19 Rupanyup Reservoirs and 1% AEP flood extent

Reservoir 02 is clearly causing the most restriction, as shown by the considerable narrowing of the 1% AEP flood extent.

In the 1% AEP flood event, the drop in water level from one end of the reservoirs to the other is approximately 0.8 m, a significant difference given the extremely flat nature of the Dunmunkle Creek Floodplain. The reservoirs have been labelled as 01, 02 and 03, as shown in Figure 8-19.

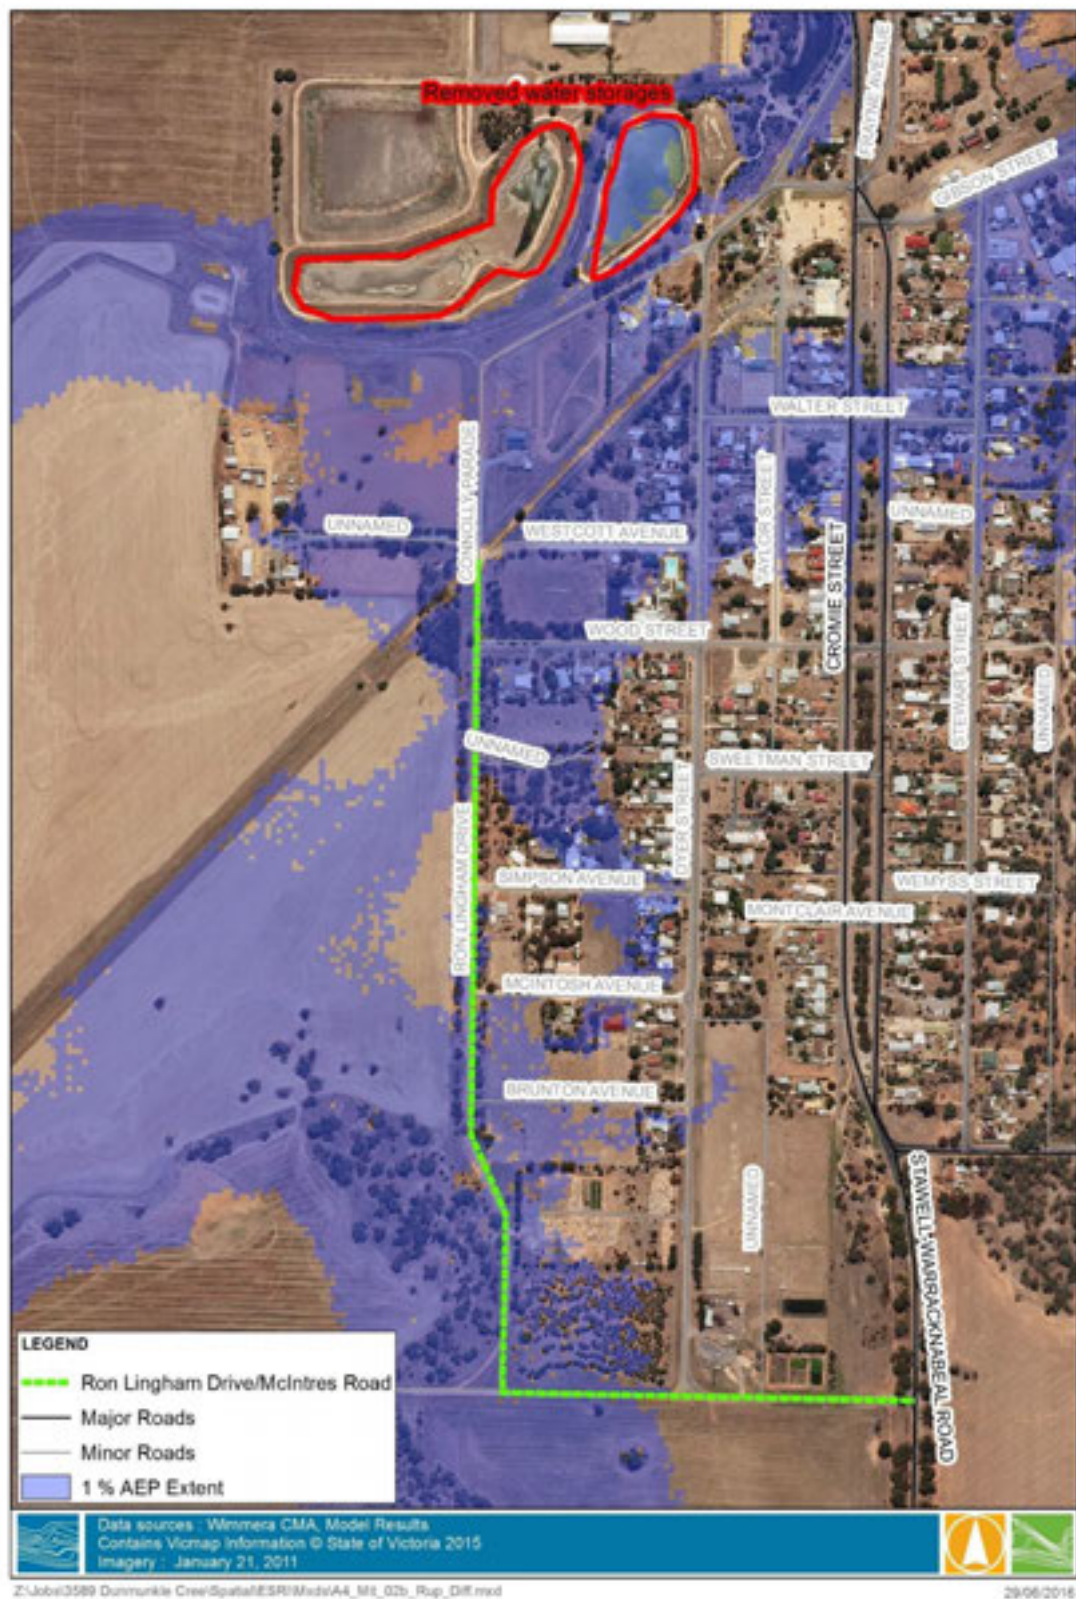
Figure 8-28 Water storage removal and increase to Ron Lingham Drive and McIntyres Road

The combination of removing the water storages and an increase to Ron Lingham Drive and McIntyres Road has completely removed inundation from the Rupanyup residential area. The same increases downstream of the Wimmera Highway were observed as the removal of the water storages alone, ranging from 2-5 cm at downstream buildings. The buildings impacted by slight increases in water level were still not flooded above floor.

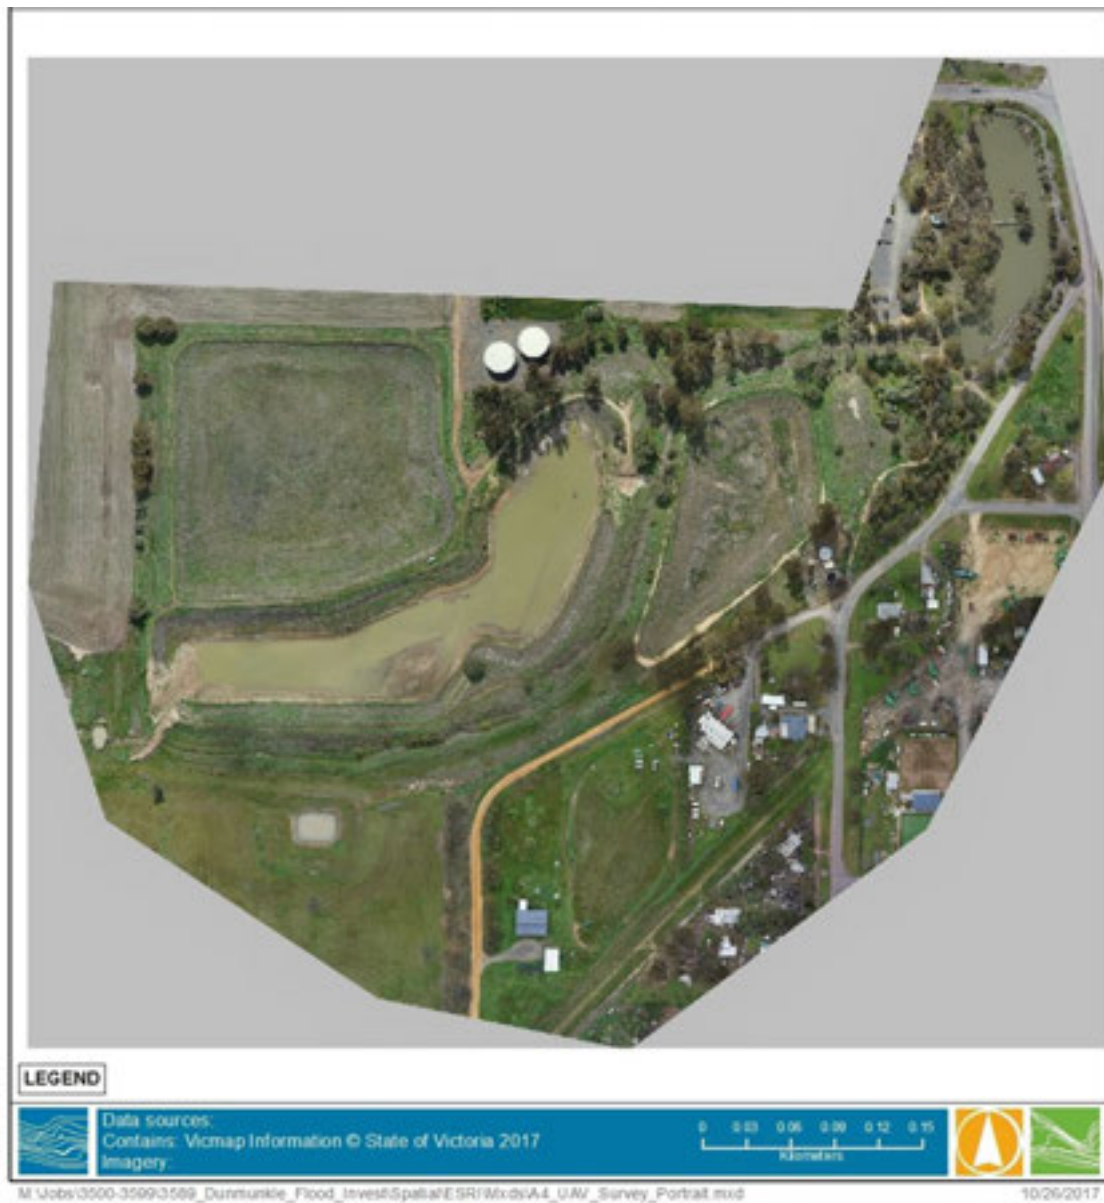
Figure 8-32 Aerial image of the Rupanyup water storages captured during the UAV survey
