Dunmunkle Creek Final Report

Wimmera CMA

May 2018

This report is the Final Report for the Dunmunkle Creek Flood Investigation. This report supersedes all other reports during the progress of the flood investigation.

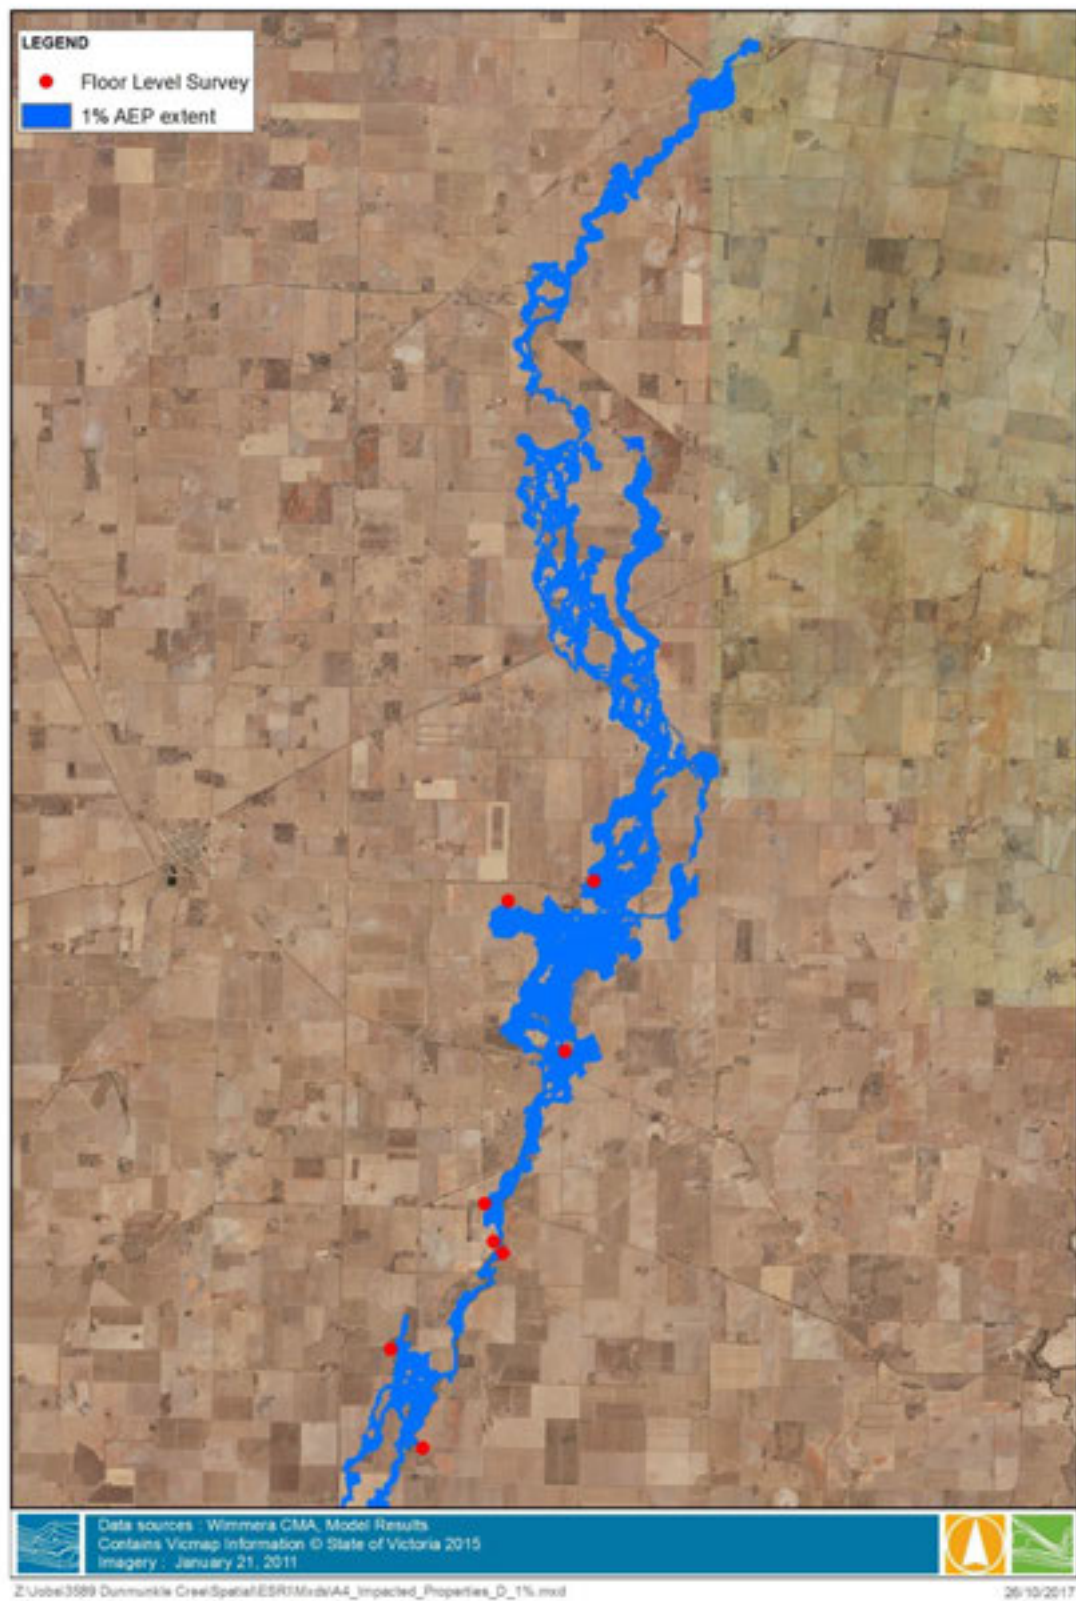
Figure 8-34 Model D – 1% AEP extent and properties impacted

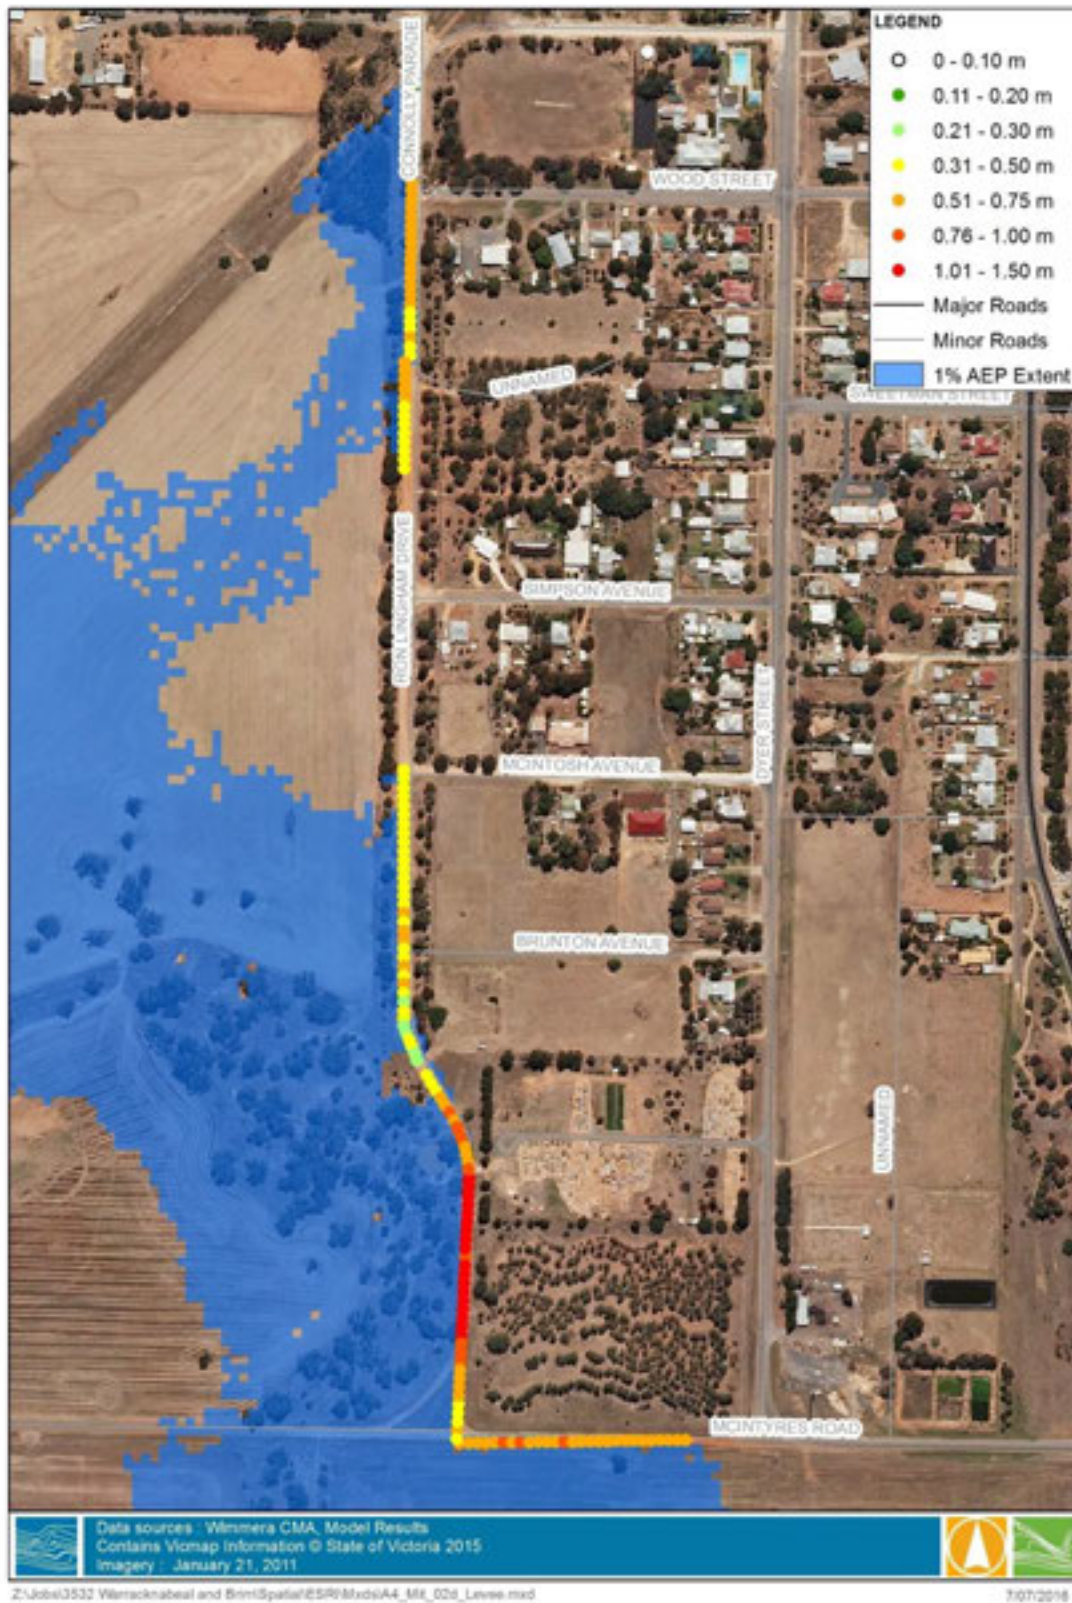
Figure 8-38 Required road height increases including 0.3 m freeboard above the 1% AEP flood level

The level of road height increase was calculated using a 0.3 m freeboard above the 1% AEP flood level, the length of road to be increased in height is shown in Figure 8-38. The increases are colour coded according to the increase required along the road. The increases vary from 0.2 m to 1.2 m at the southern end of Ron Lingham Drive. There may be some potential to reduce the level of road deck increase by limiting the protection to exclude the cemetery. However, levees would be required on private property.

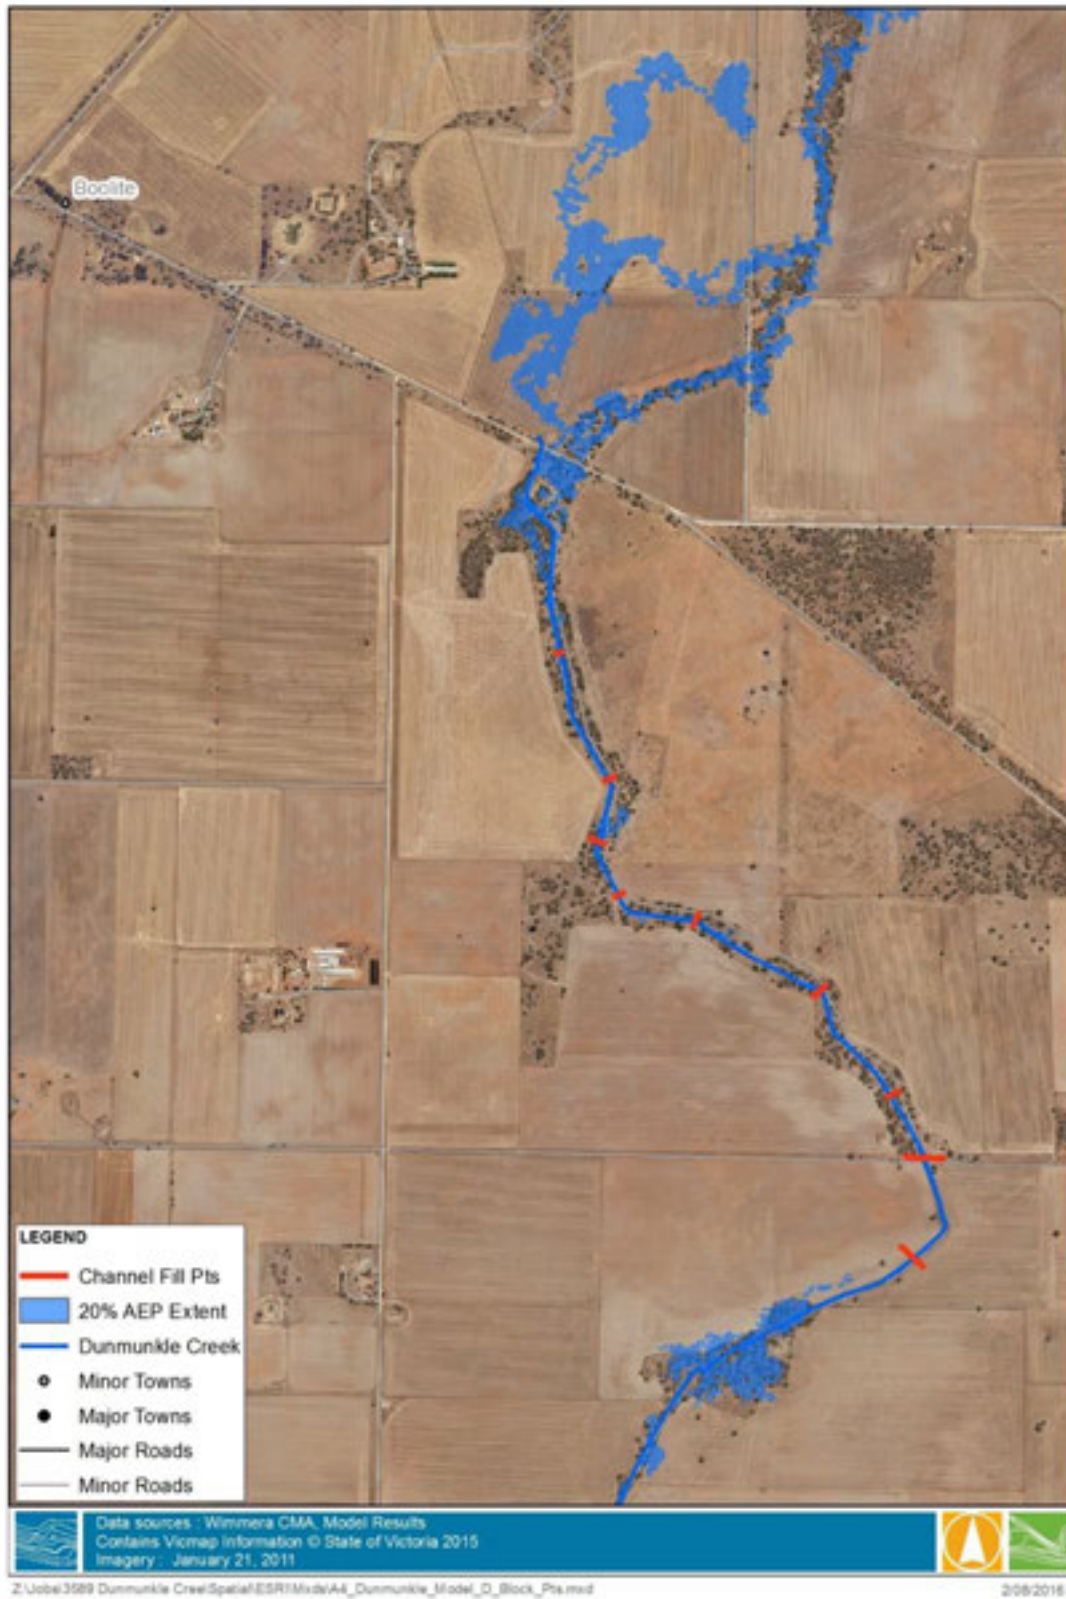
Figure 8-41 Channel block locations south of Lawler Road, Boolite

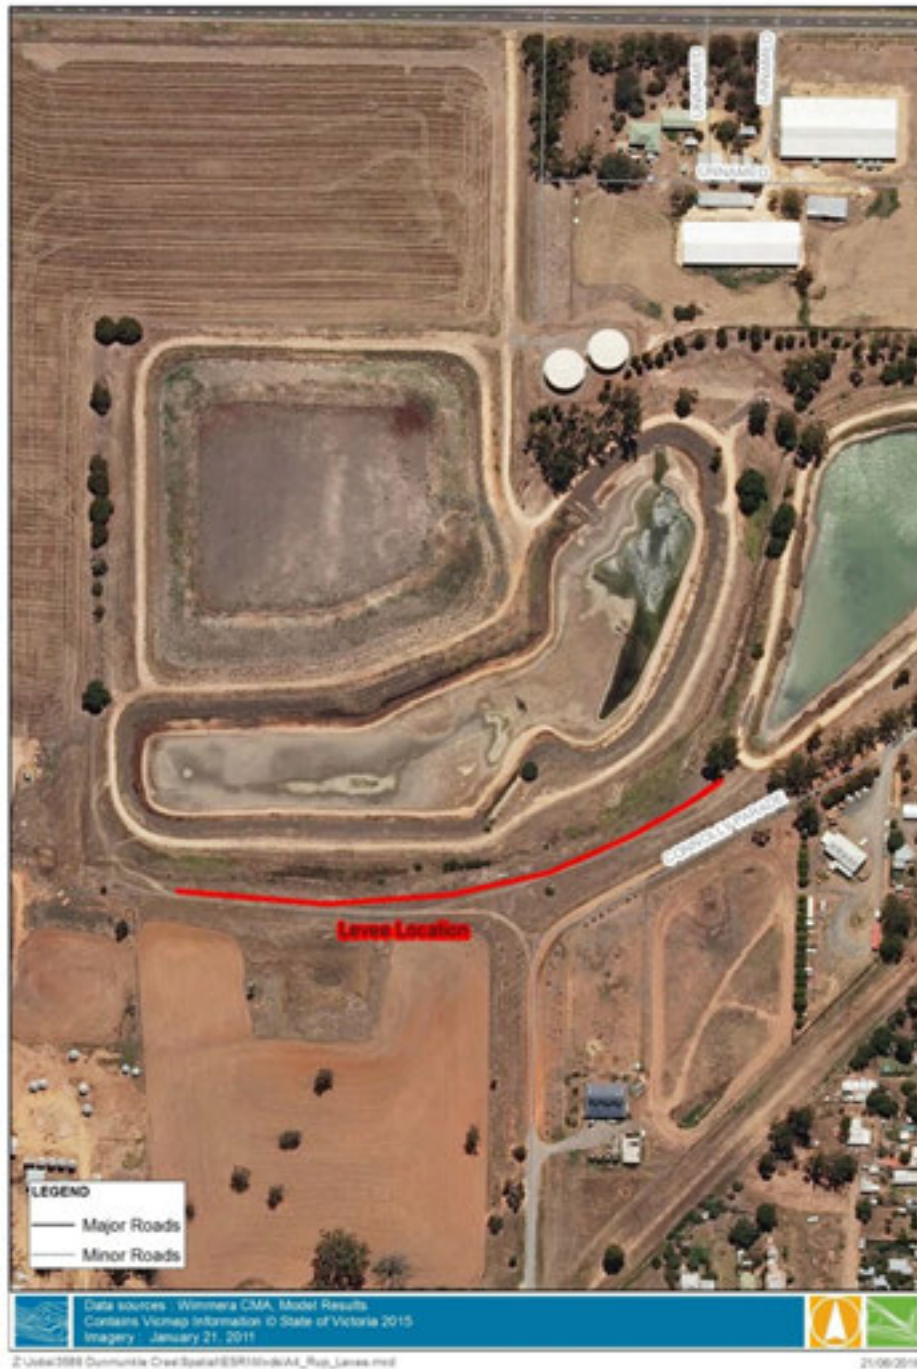
Figure 9-2 Remnant sections of levee

There is only one set of purpose built levees along Dunmunkle Creek, located at Rupanyup. During January 2011 the levee was only partially constructed and overtopped, there are no formal management arrangements for the levee or agreed levee crest height, the works completed in September 2016 allows **some** water to be bypassed to the north of the levee through the Rupanyup Reservoir. The levee location is shown in Figure 9-2.

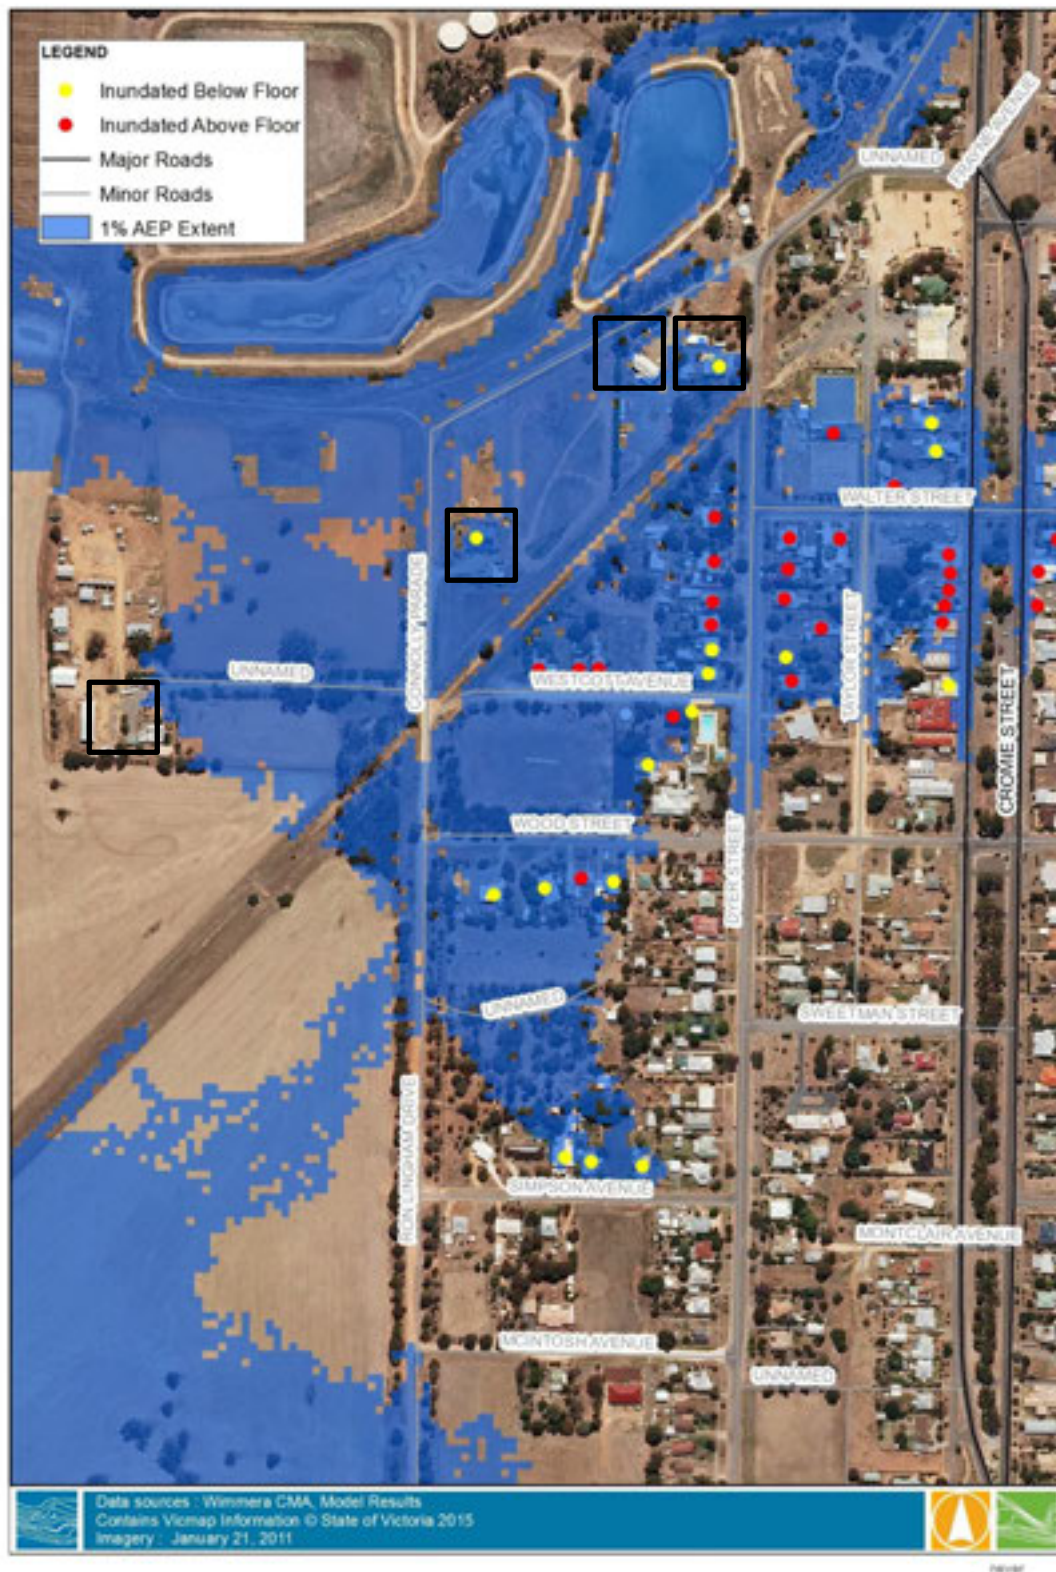
Figure 9-4 Properties requiring specific individual flood mitigation if railway embankment culverts are blocked – mapping shows the 1% AEP extent

Blocking of these culverts in future flood events should be carefully considered. While it does provide benefit to the majority of residents in Rupanyup it will detrimentally impact on those north of the railway line (by several centimetres). If the culverts were blocked it is recommended specific flood mitigation be undertaken at the properties shown in Figure 9-4.
