## Dimboola Flood Study

**Report No. J035/R2 Final A**

**February 2003**

**WATER TECHNOLOGY PTY LTD**

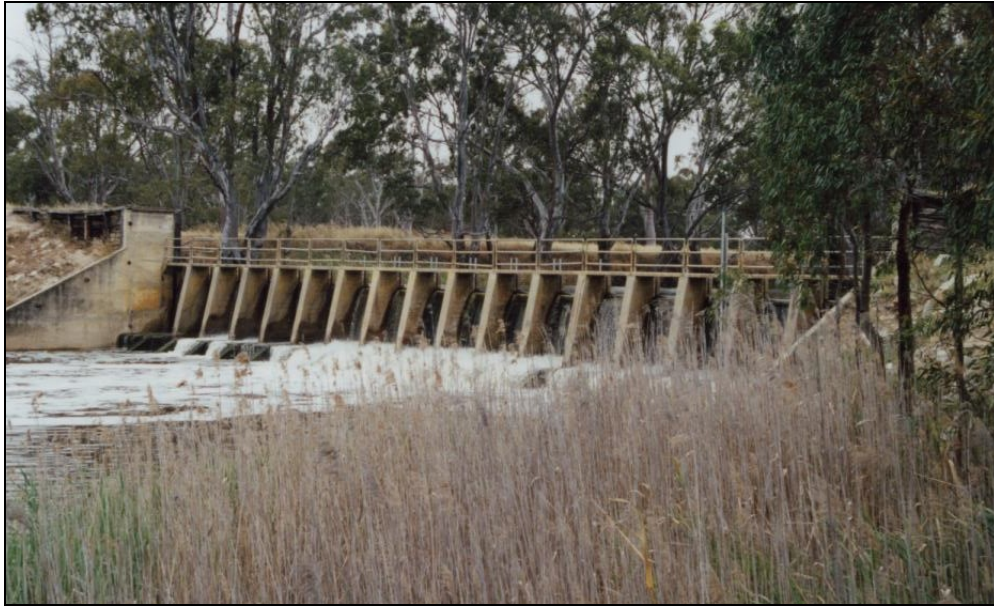
**Figure 6.2 Dimboola Weir**

At low flows, the profile of the Wimmera River through Dimboola is governed by backwater from the town weir. In the late 60's, the Rural Water Commission recommended that the then existing timber structure be replaced by a concrete structure. This reconstruction was undertaken in 1975. The weir in low flow conditions is presented in Figure 6.2.

Construction drawings are still available for the remodelling of the weir. These are referenced to "Commission" Datum. In several places in the available files, the conversion from Commission Datum to AHD is given as:

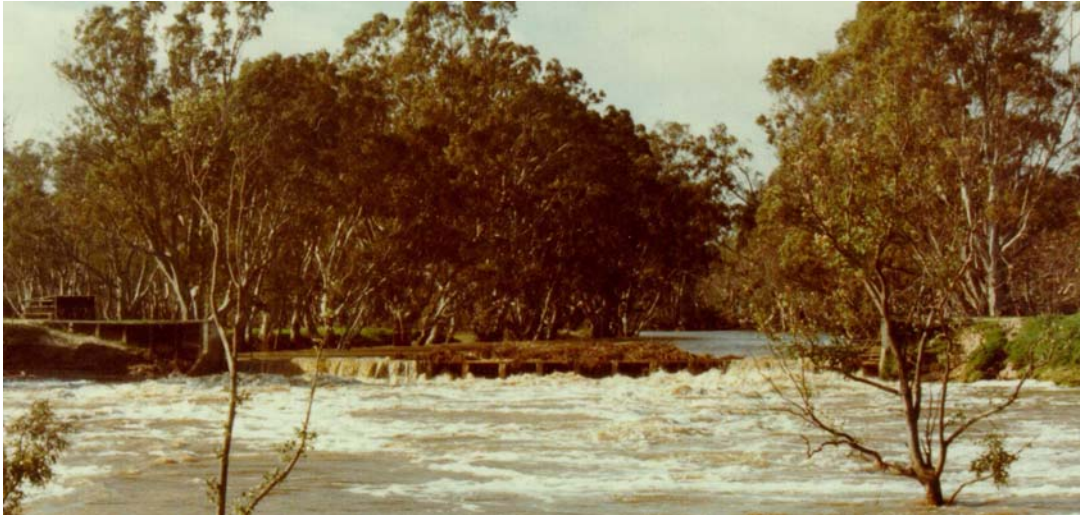
**Figure 6.3 Dimboola Weir during the 1981 flood event (1)**

There is also anecdotal evidence to suggest that there has been significant debris loads caught on the weir structure during previous flood events. Figures 6.3 and 6.4 show the weir during the 1981 event with some debris back up.
