Halls Gap Flood Study Study Report

Report No. J521/R01

June 2008

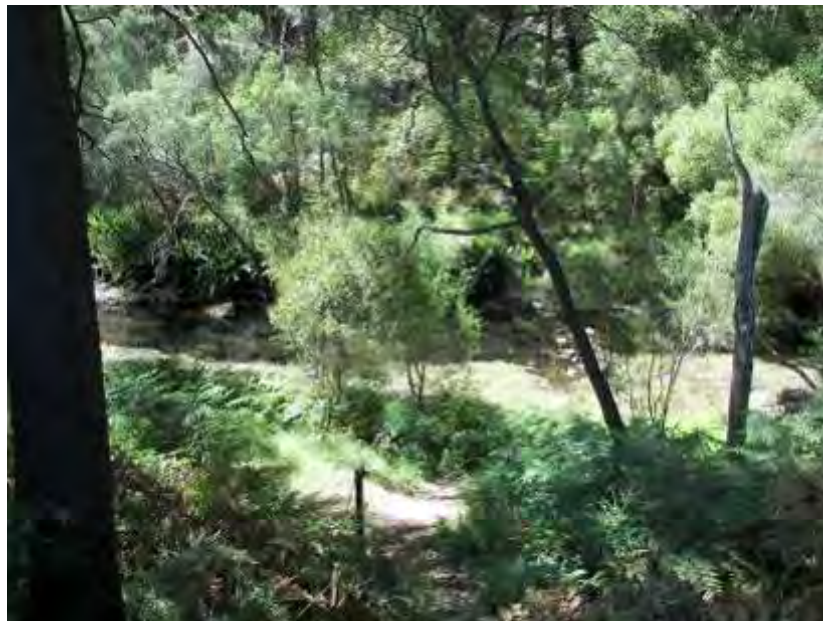
Figure 2-1 Fyans Creek Channel downstream of Lake Bellfield (Note the cable way used for streamflow gauging)

Halls Gap is located in a confined valley between the Mount William Range to the east and the Mount Difficult Range to the west. Fyans Creek flows to the east of the township in a northerly direction along the valley floor. Lake Bellfield, located some 2 - 3 kilometres upstream (to the south) of the township is a major water supply dam for the Wimmera Mallee Stock and Domestic Water Supply System. The storage is operated by GWMWater. Since the construction of Lake Bellfield, the flow regime of Fyans Creek has been significantly altered. Significant incision of the Fyans Creek channel has occurred. This incision has considerably increased the bankfull flow capacity of Fyans Creek. As a result, flooding of the valley floor due to Fyans Creek flows is limited from rare to extreme flood events, excess of 1 in 200 year ARI events. Figure 2-1 and Figure 2-2 show the large dimensions of the Fyans Creek channel.

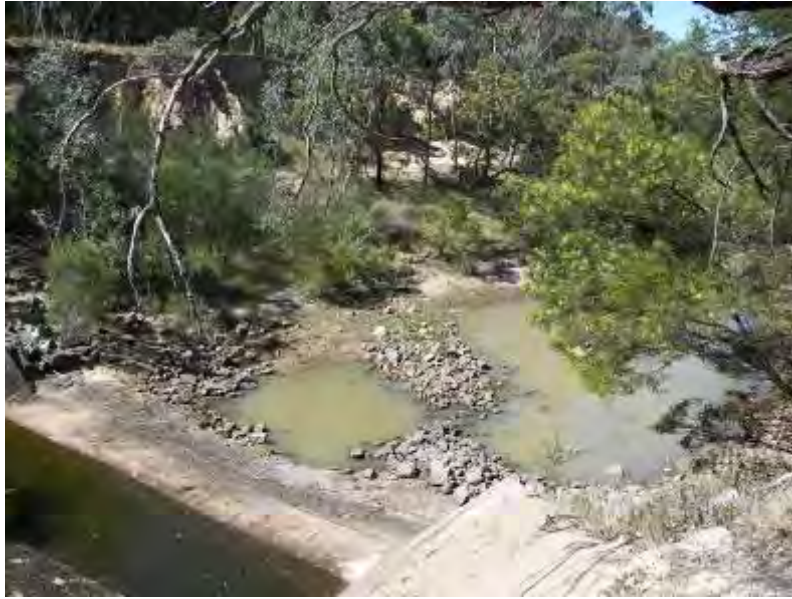
Figure 2-2 Fyans Creek Channel immediately upstream from Delley's Bridge

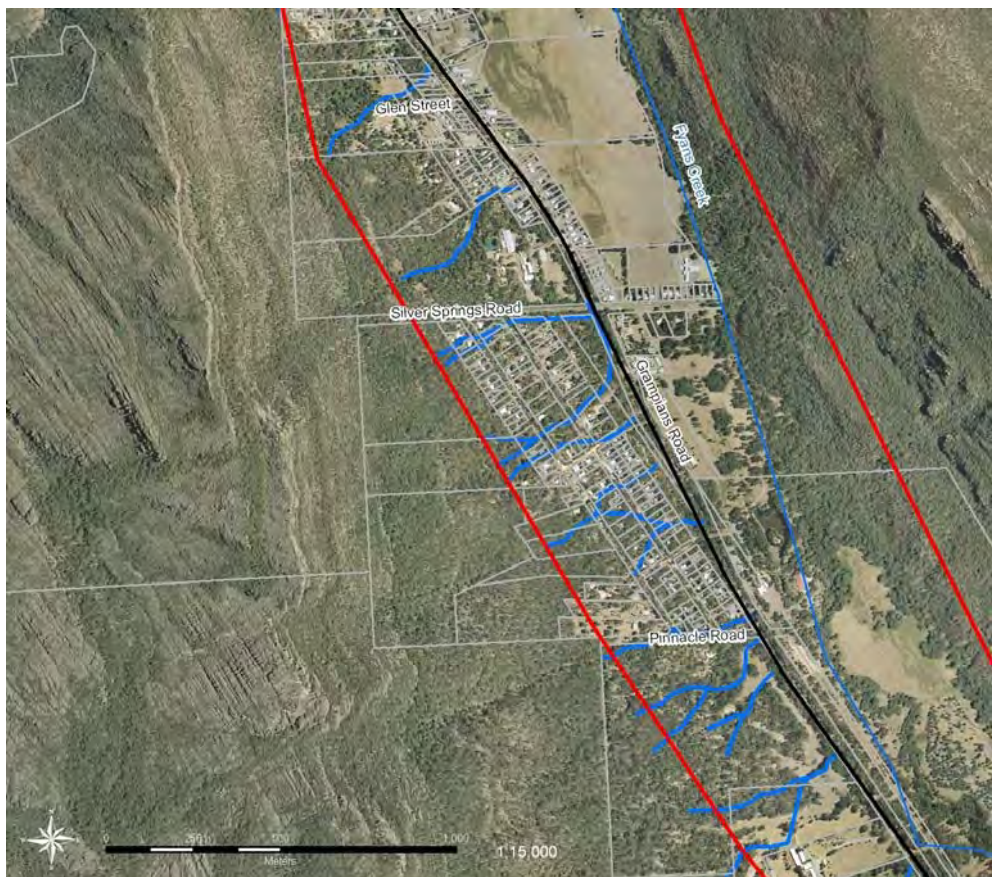
Figure 2-3 Mount Difficult gullies south of Glen Street

Downstream of Lake Bellfield, numerous gullies drain the Mount William and Mount Difficult Ranges. In particular, the gullies draining along the Mount Difficult Range flow through developed areas of the Halls Gap township. During a heavy rainfall event, considerable runoff is generated from the steep escarpments of the Mount Difficult Range. Figure 2-3 displays the major gully lines to the south of Glen Street.

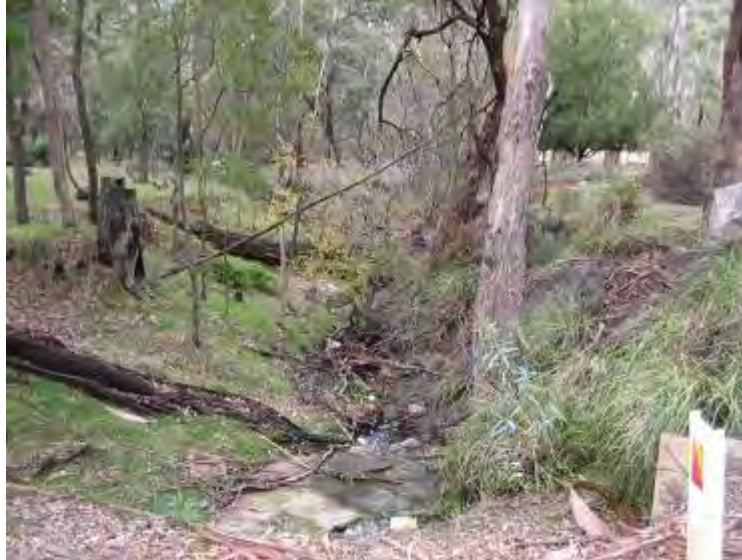
Figure 2-4 Typical gully draining along Mount Difficult Range (High Street south of Koala Road)

This surface runoff generally flows overland as sheet flow before concentrating into gullies. The gullies typically are well vegetated with some large boulders within the waterway. At Grampians Road, these gullies tend to flatten out with some ponding occurring on the western (upstream) side of Grampians Road. The overland flows can carry considerable sediment load, particularly wash off from unsealed roads and ash from the recent (December 2005 – January 2006) bushfires. This sediment can block pipes and culverts. Figure 2-4, Figure 2-5, Figure 2-6 and Figure 2-7 show typical gullies draining the Mount Difficult Range and pondage area adjacent to Grampians Road.

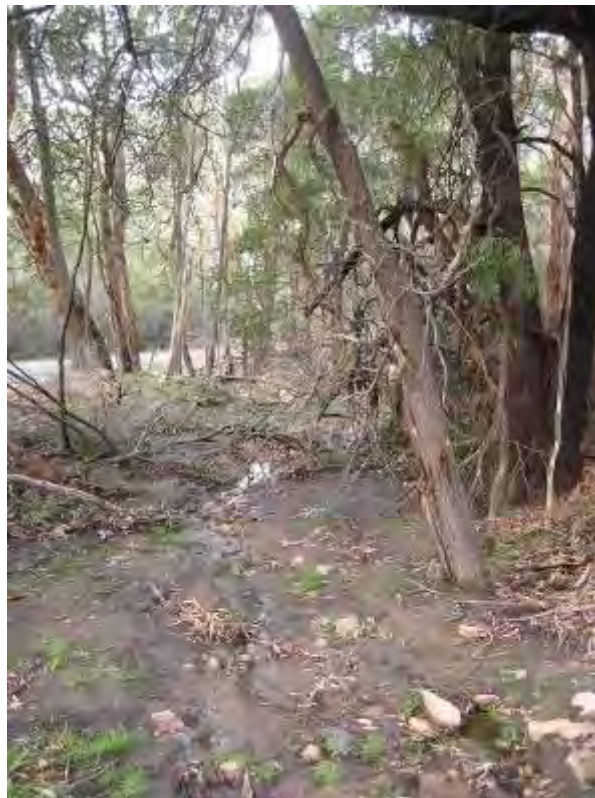
Figure 2-5 Gully at Royston Street near Silver Springs Road (note considerable sediment)

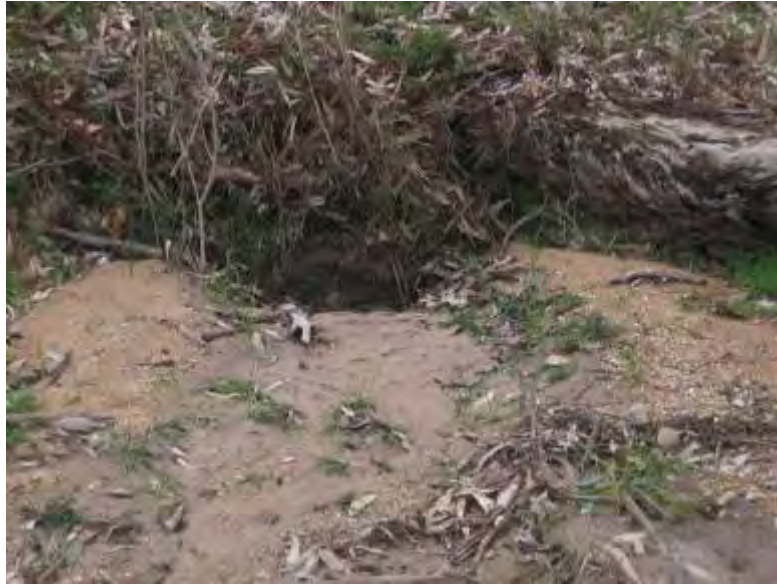
Figure 2-6 Pipe culvert under Grampians Road near Young Road. Completely blocked with sediment

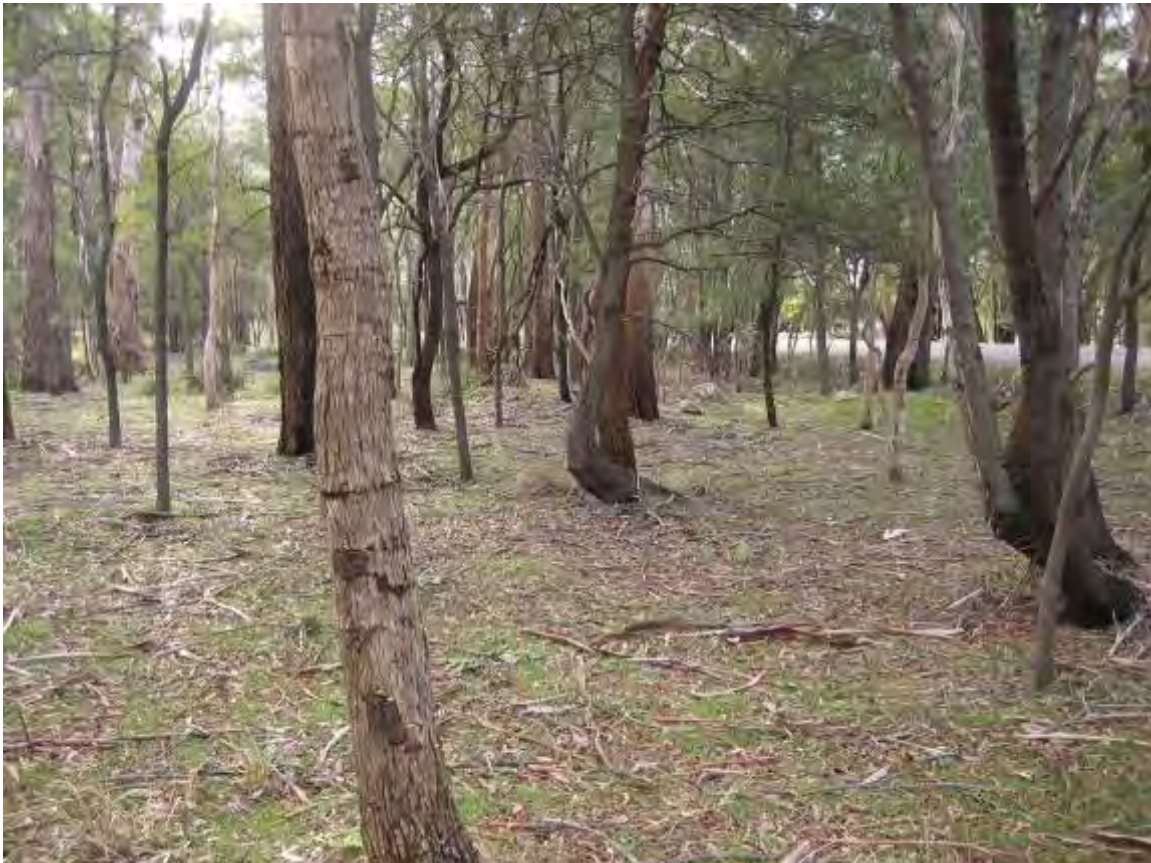
Figure 2-7 Ponding area on the western side of Grampians Road near Wattletree Road

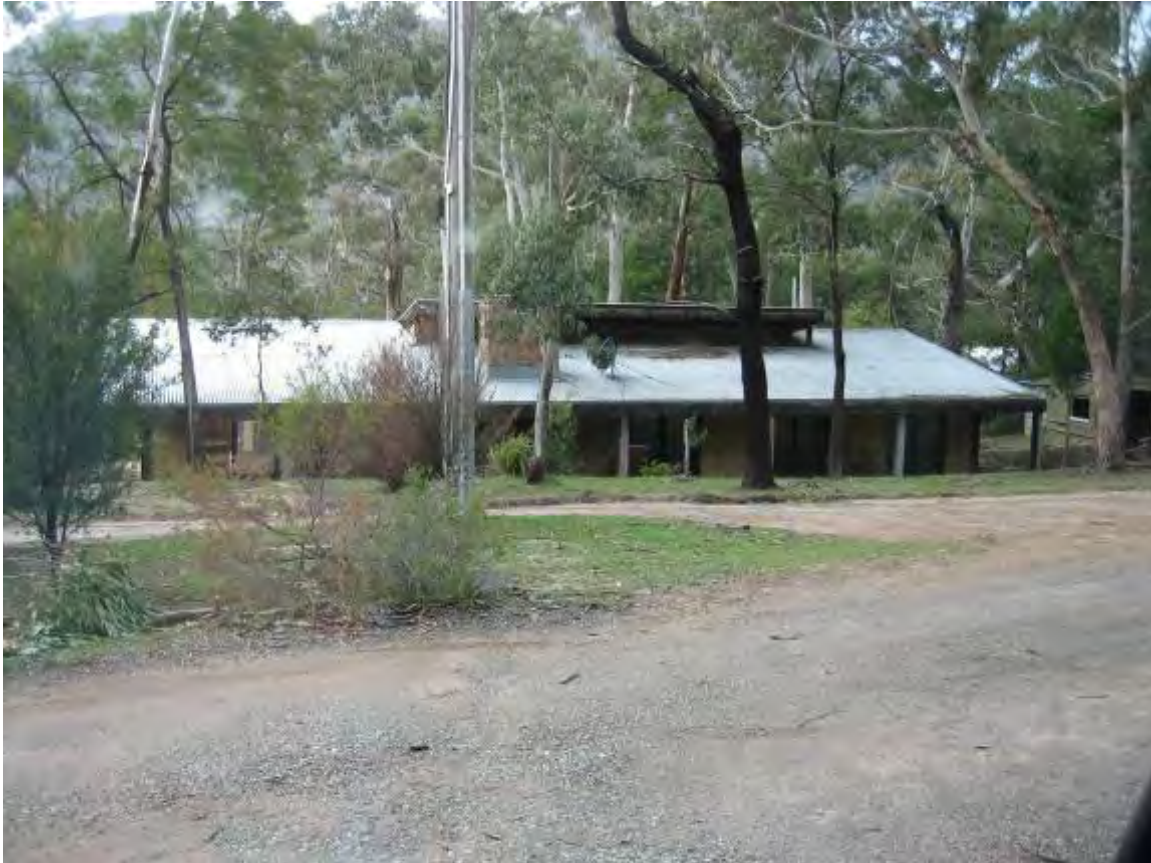
Figure 2-8 Dwelling in High Street

(Note Dwelling floor level lower than upslope ground level)

formed by cutting into the hill slope or constructed on piles where the front/back of the building is at the upslope ground level. These construction techniques can give rise to overland flows entering the building in the absence of upslope bunding/landscaping to divert overland flow. Figure 2-8 shows a dwelling where the building pad was formed by cutting into slope.

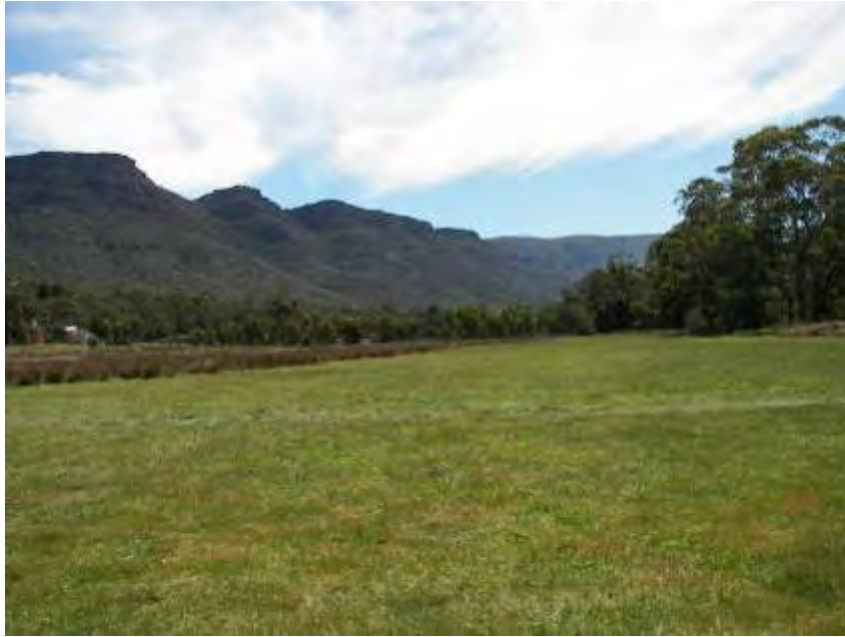
**Figure 2-9 Valley floor north of the Lakeside Caravan Park
(Fyans Creek is located on the right edge of the photo)**

As outlined, the terrain flattens out adjacent to Grampians Road, the elevated nature of Grampians Road results in some ponding of overland flows on the western side of Grampians Road. The flow to the eastern side of Grampians Road occurs through a number of culverts and by overtopping the road. This shallow overland flow continues to the east and onto the valley floor. The valley floor is relatively flat with a gentle gradient from south to north. The valley floor contains numerous shallow flow paths. These shallow flow paths are likely to be remanent of a chain of ponds morphology. Considerable earthworks have been undertaken on the valley floor with the construction of small dams and/or wetlands. A number of wetlands have been constructed adjacent to the Parks Victoria and Brambuk Cultural Centre buildings. Figure 2-9 shows the flat nature of the valley floor.

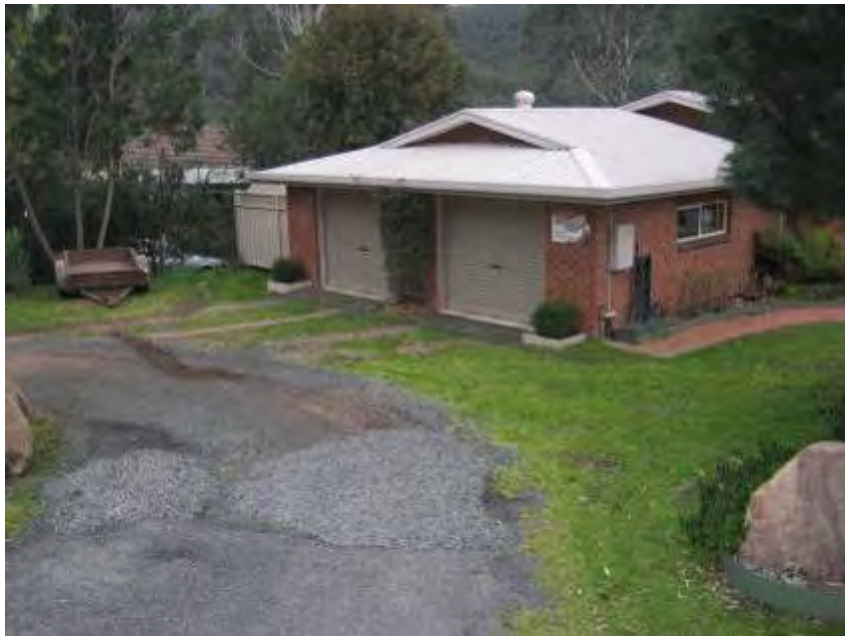
**Figure 2-10 Dwelling on eastern side of Grampians Road
(Note Dwelling floor level at ground level)**

Flooding to buildings/dwellings can occur on the eastern side of Grampians Road due to the overland flows across the road. Similar to buildings/dwellings west of Grampians Road, the nature of the building construction can contribute to flooding exposure. Buildings constructed at ground level and/or with a slab on ground technique can be exposed to overland flooding. Figure 2-10 displays a dwelling on eastern side of Grampians Road.

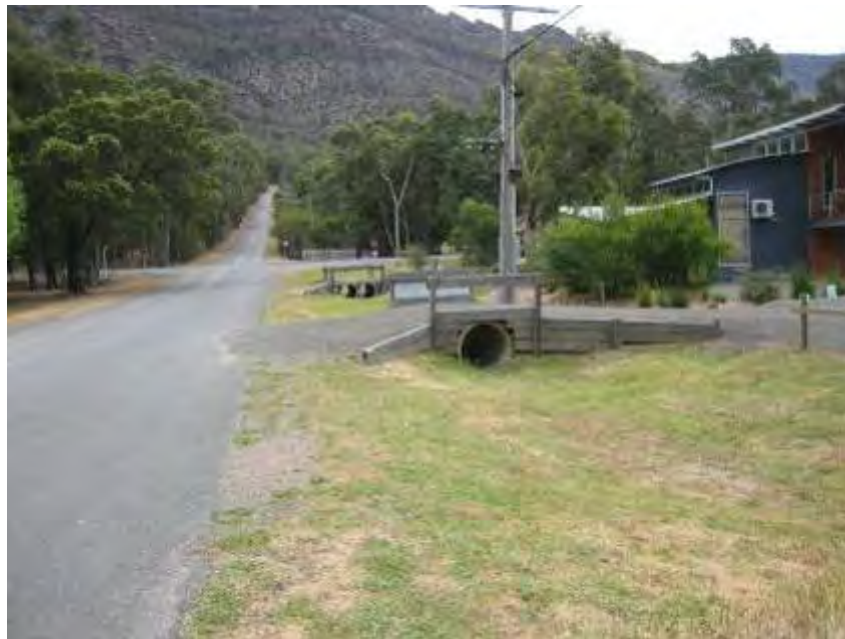
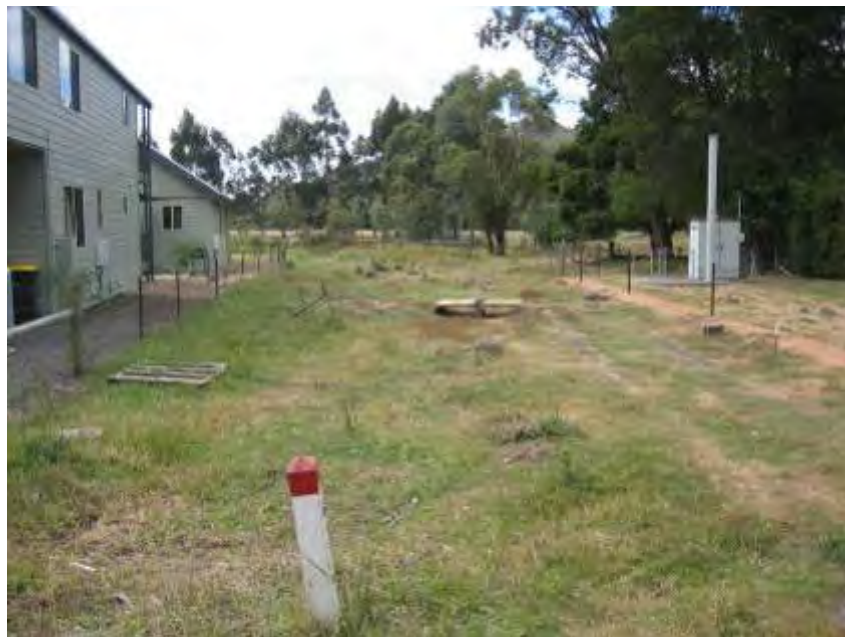
Figure 2-11 Swale drain adjacent to Tandara Road

Figure 2-12 Swale drain adjacent to Tandara Road

intersection. Swale drains have been formed along Tandara Road to accommodate frequent overland flows. Figure 2-11 and Figure 2-12 show the swale drains adjacent to Tandara Road.

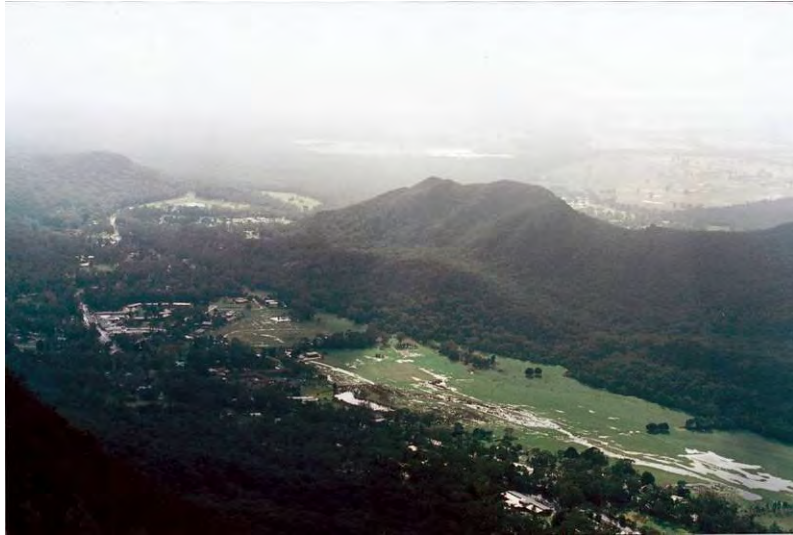
Figure 2-13 Valley floor inundation (source Margo Sietsma)

The overland flow across Grampians Road at Tandara Road joins overland flow along the valley floor from the south. This combined shallow overland flow may threaten dwellings adjacent to Tandara Road where the floor levels are at ground level. From Tandara Road, the overland flow continues along the valley floor to the north. Figure 2-13 shows the inundation across the valley floor.

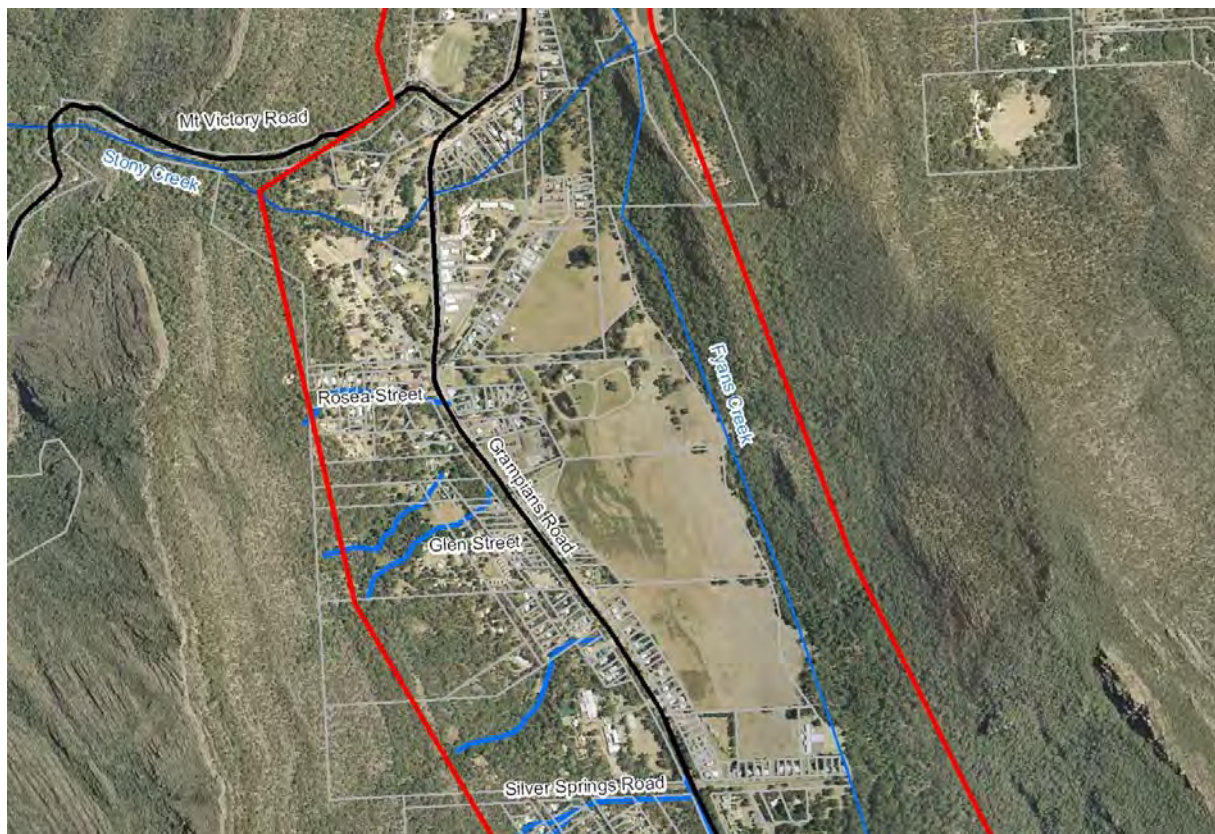
Figure 2-14 Mount Difficult Range gullies Glen Street to Stony Creek

Similar to the south of Glen Street, several gullies and overland flow paths drain from the Mount Difficult Range between Glen Street and Stony Creek. In this area, the gullies are not as well defined as to the south of Glen Street. Figure 2-14 shows the significant gullies from Glen Street to Stony Creek.

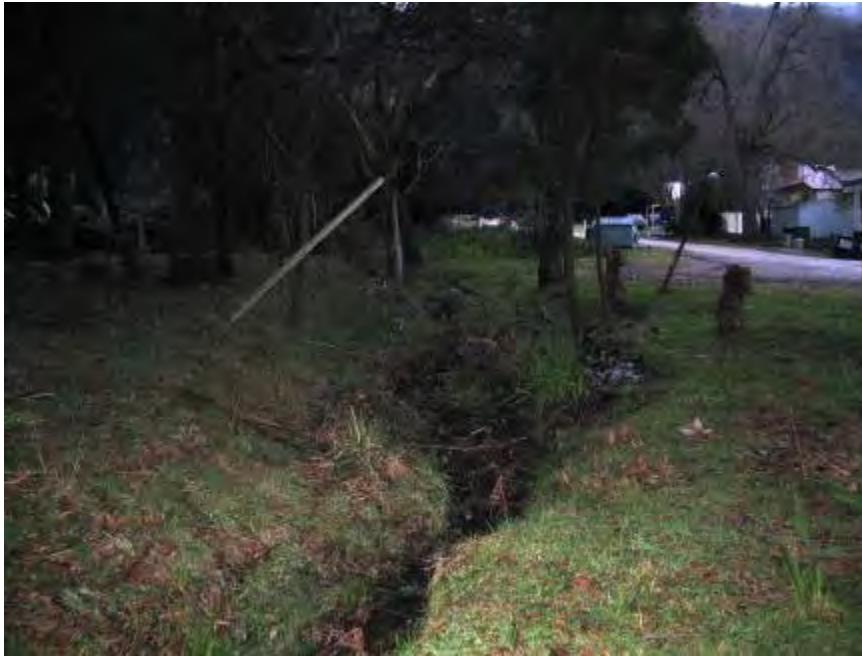
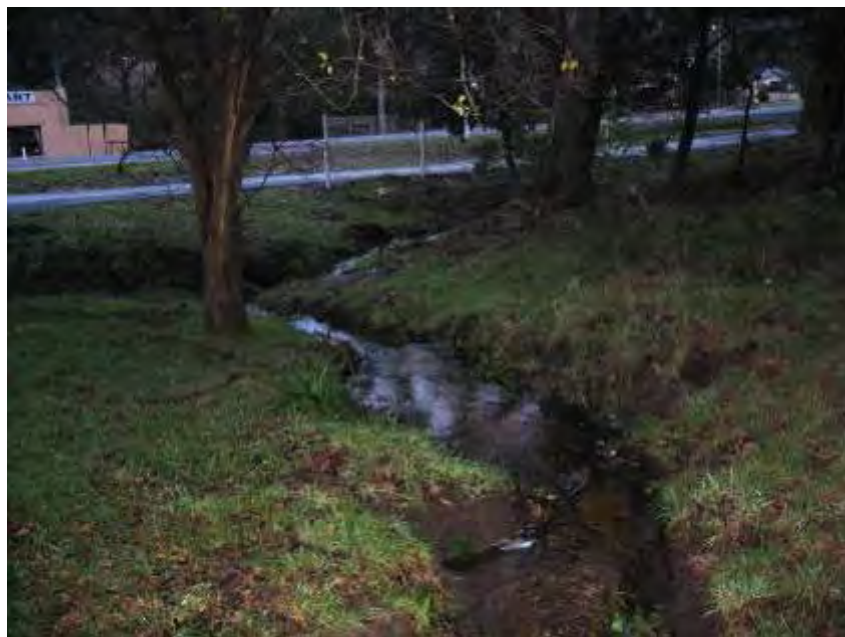
Figure 2-15 Overland flow path adjacent to Rosea Street (looking upstream)

Figure 2-16 Overland flow path adjacent to Rosea Street (looking downstream across Grampians Road)

A considerable overland path occurs adjacent to Rosea Street. The course of this flow path has been significantly altered by development. The overland flow path crosses Grampians Road at Rosea Street. A pipe culvert conveys low flows to an open channel on the eastern

side of Grampians Road. During high runoff events, overtopping of Grampians Road occurs with overland flows potentially affecting several buildings. Significant sediment load carried with the overland flow can block pipe culverts, and thus restricting the capacity of the drainage infrastructure. Figure 2-15 and Figure 2-16 show the overland flow path adjacent to Rosea Street.

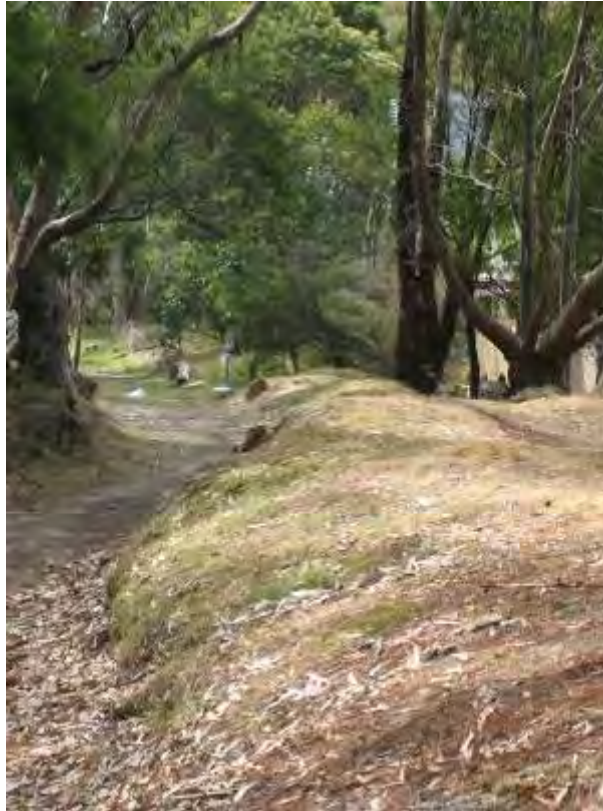
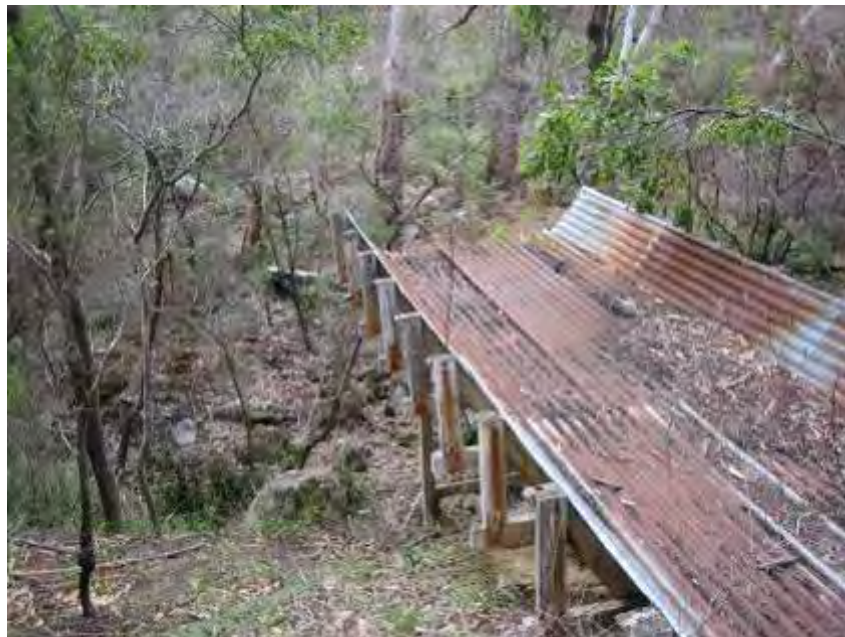
Figure 2-17 Bund along western limit of caravan park

Figure 2-18 Outfall of the Caravan Park bund to Stony Creek

A constructed bund is located to the west of the Halls Gap Caravan Park and runs from Mackeys Peak Road to Stony Creek. The bund captures overland flows generated upslope from the caravan park and re-directs these flows to Stony Creek. Thus reduces overland flows across the caravan park and associated flood hazard to campers. Figure 2-17 and Figure 2-18 show the bund along the Halls Gap Caravan Park.

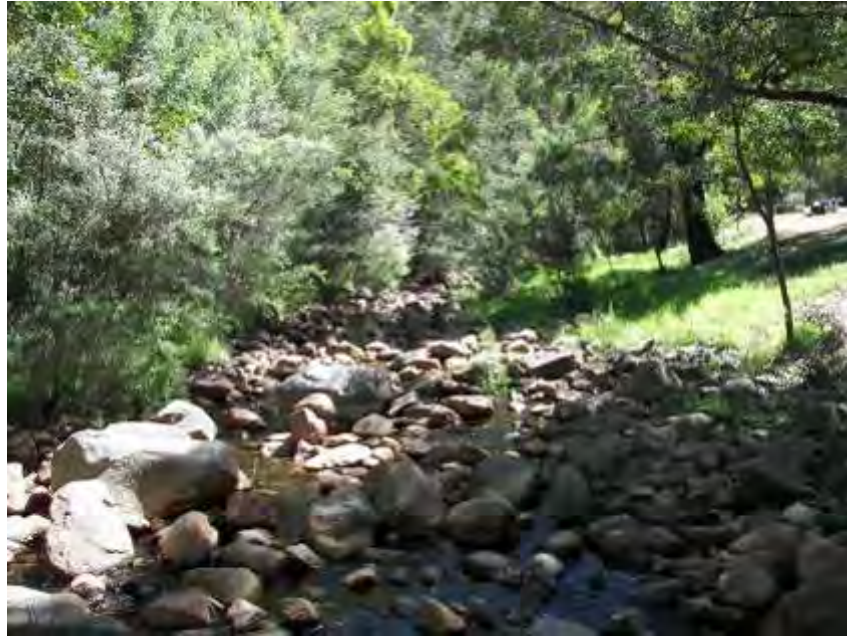
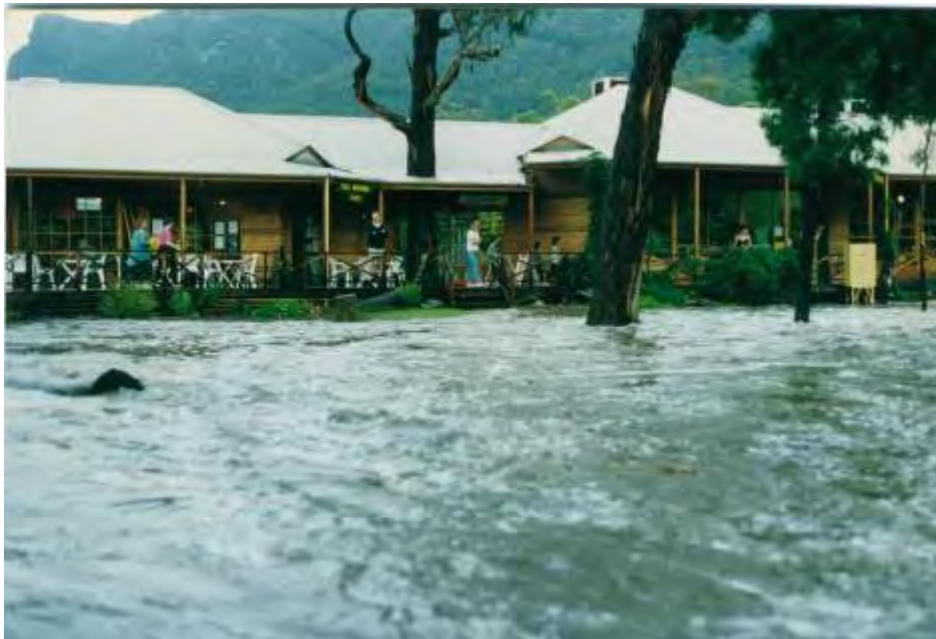
Figure 2-19 Stony Creek upstream from Grampians Road

Figure 2-20 Stony Creek during December 1992 flood downstream of Grampians Road (Source Wimmera CMA)

Stony Creek is the largest tributary to Fyans Creek joining within the study area. The waterway is relatively steep and confined with a cobble and boulder lining. Figure 2-19 shows a typical section of Stony Creek upstream from Grampians Road. Stony Creek crosses Grampians Road adjacent to the commercial area. During a flood event in December 1992, Stony Creek threatened a number of commercial buildings to the east of Grampians Road. Figure 2-20 shows the flooding along Stony Creek in the December 1992 flood event.

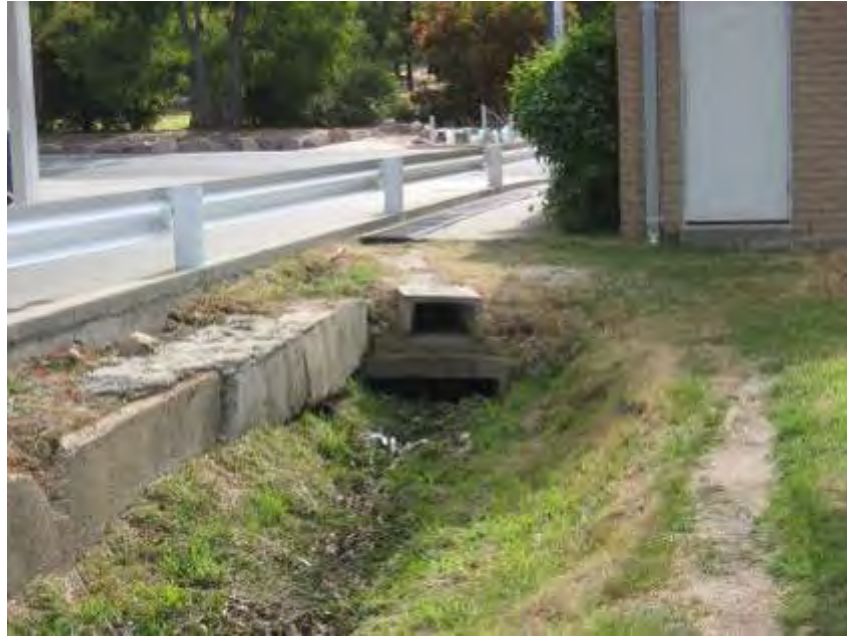
Figure 2-21 Drainage infrastructure adjacent to retail buildings through to Heath Street. Grampians Road in the background

Significant ponding has occurred along Grampians Road in front of the commercial and retail buildings. This ponding arises from overland flow generated runoff from the adjacent impervious areas (car park) and from the upslope catchment. Drainage infrastructure (pipes and culverts) convey lower flows from Grampians Road through to Heath Street with higher flows resulting in ponding.

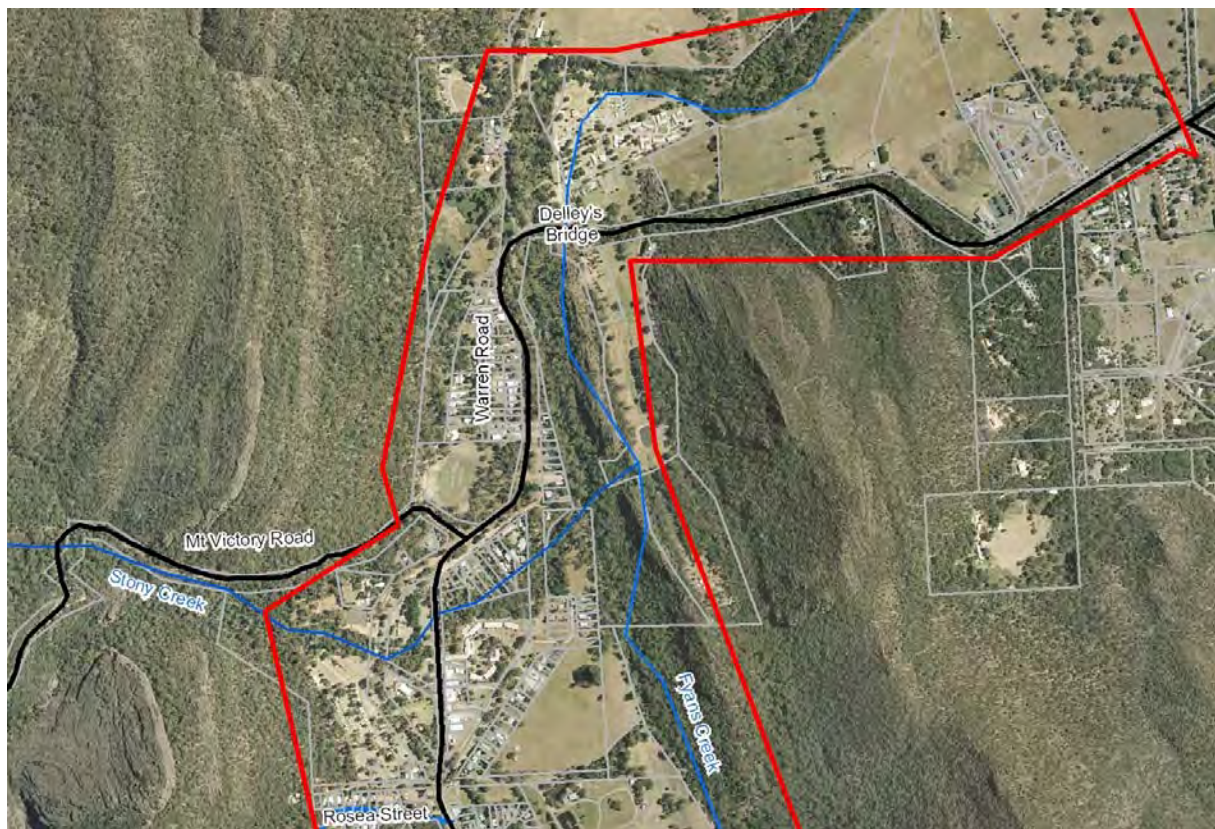
Figure 2-22 Delley's Bridge and Warren Road features

Discussions with community members suggests, before being diverted along the current course, Stony Creek once turned to the north before Grampians Road and flowed through the current recreation reserve, and continued adjacent to Warren Road to join Fyans Creek downstream of Delley's Bridge, refer to Figure 2-22.

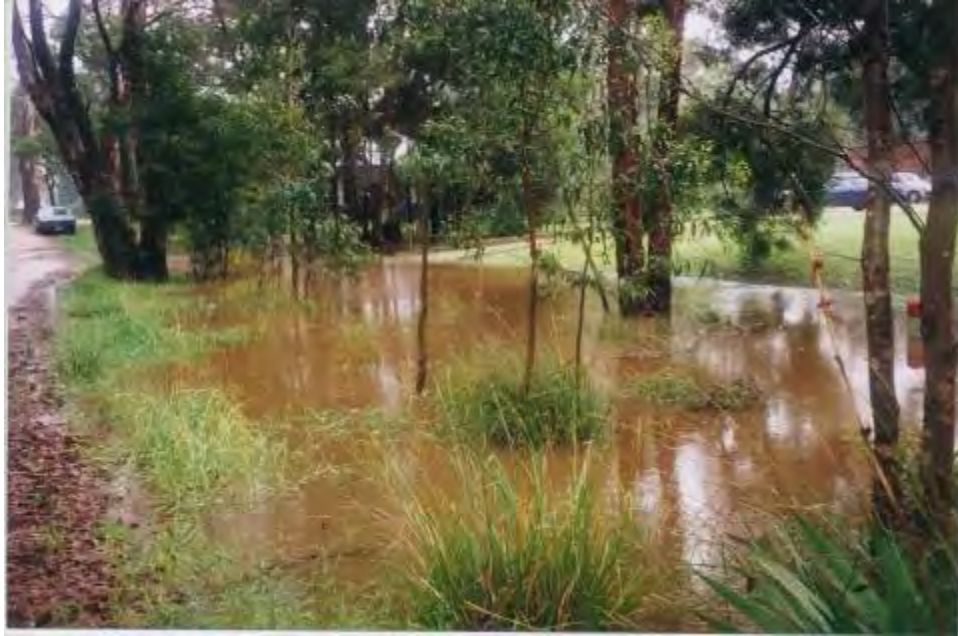
Figure 2-23 Ponding along Warren Road

Under current conditions, overland flow from the Mount Difficult Range to the north of Stony Creek, flows along this prior course of Stony Creek. Significant ponding occurs within the Recreation reserve and along Warren Road. The ponding along Warren road arises due to several constrictions in the waterway. Figure 2-23 shows ponding along Warren Road.

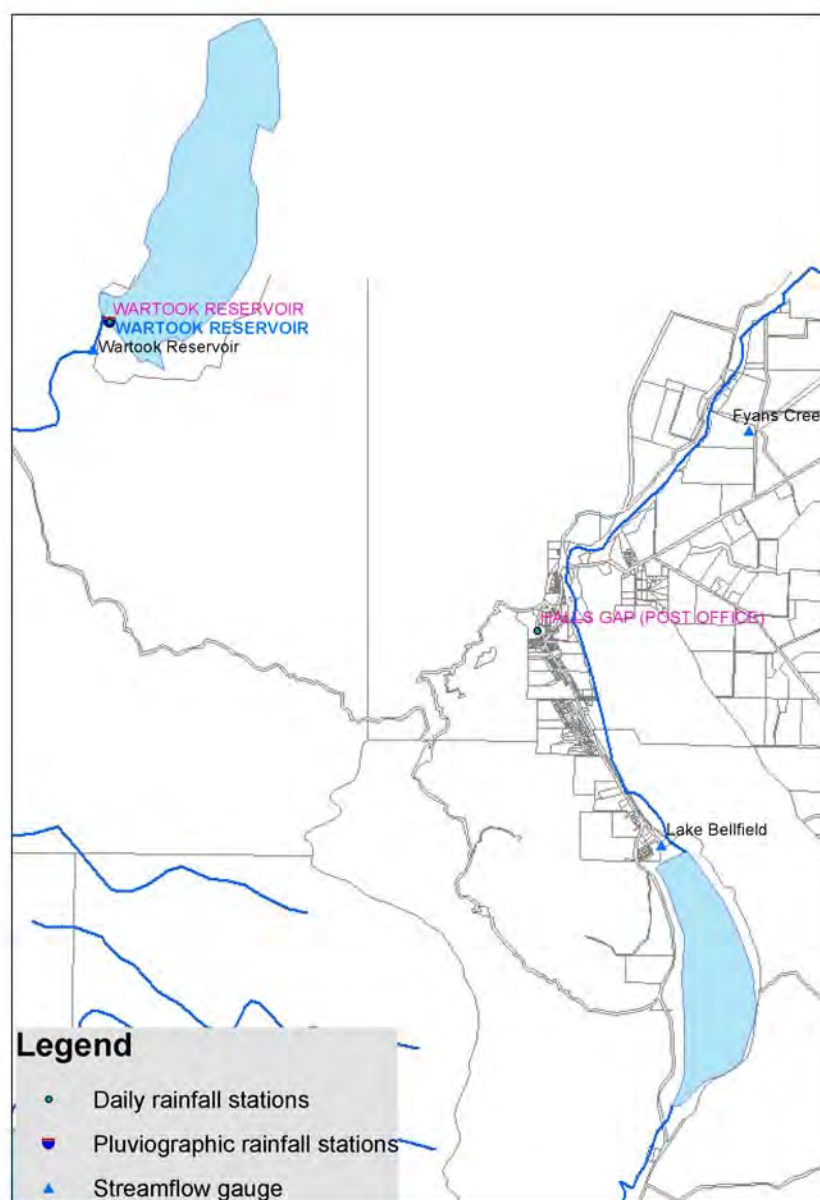
**Figure 3-1 Streamflow and rainfall gauges**

Figure 3-1 shows the location of the above rainfall and streamflow gauges. The use of the above data in the hydrologic analysis is outlined in Section 5.

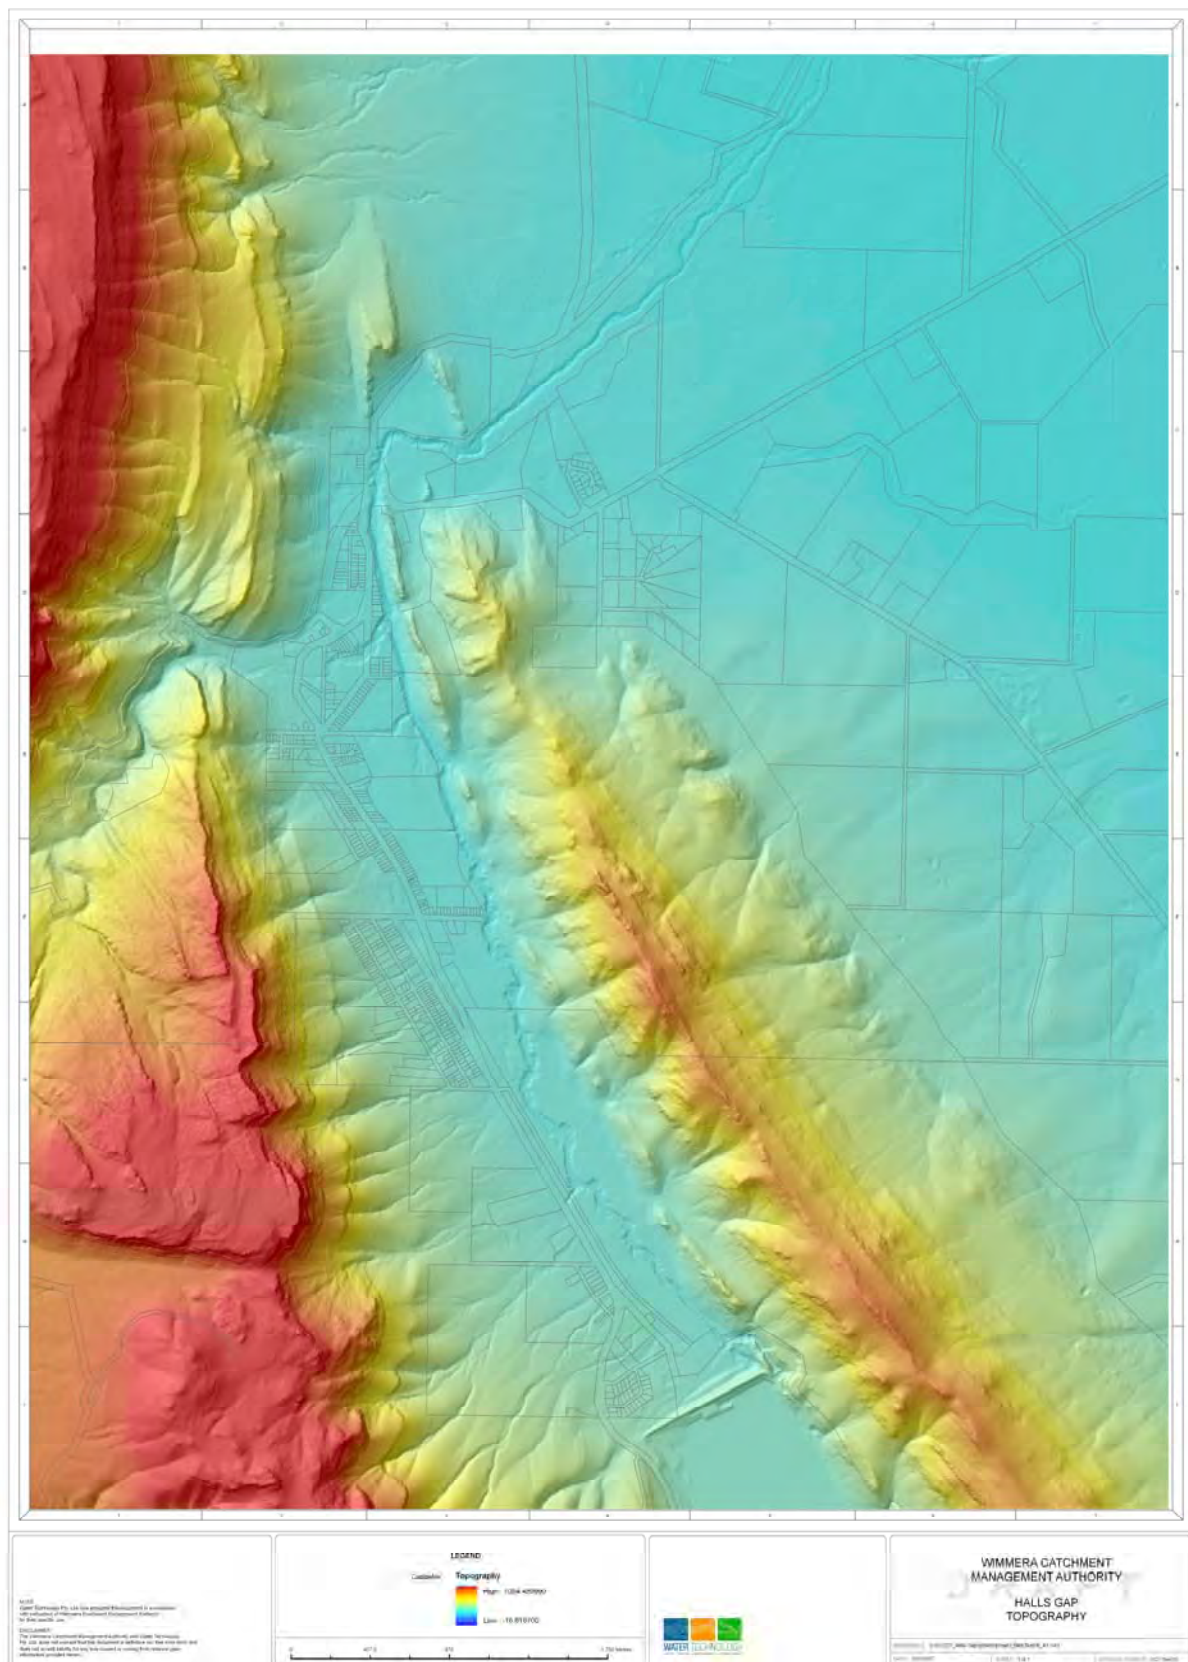
Figure 6-1 Halls Gap hydraulic model topography

The model was developed with a grid size of 5 m and the topographic grid is shown in Figure 6-1.

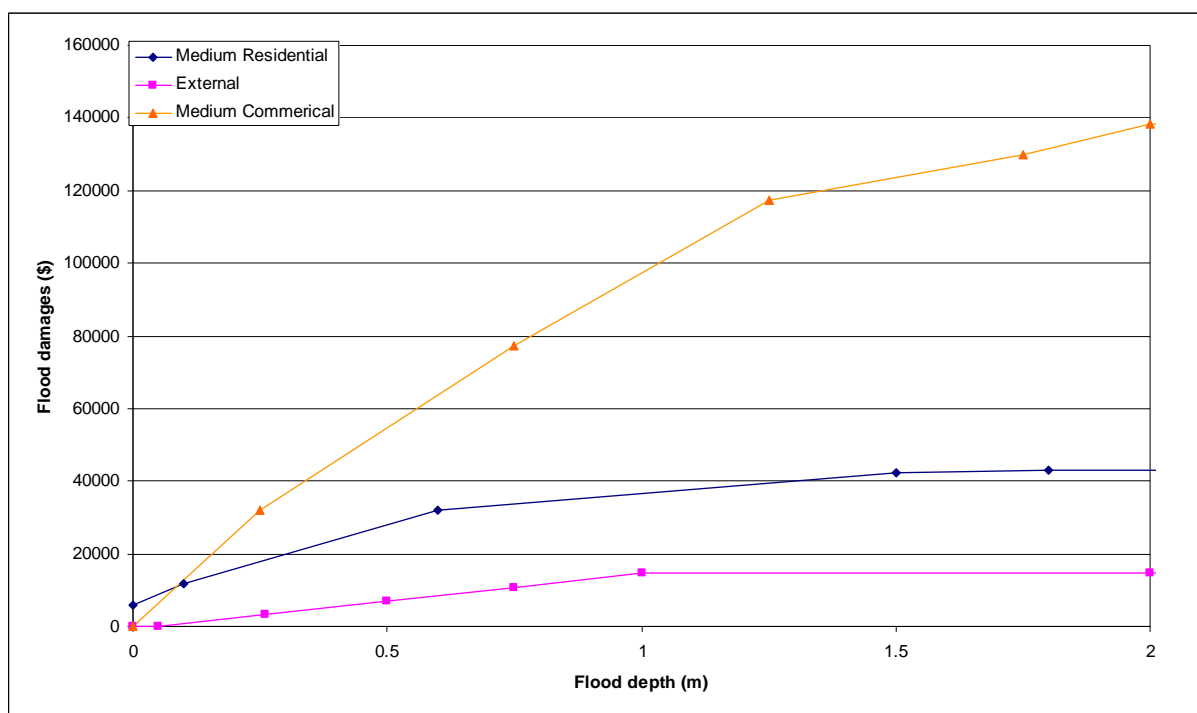
Figure 7-2 Adopted Stage-Damage Curves for Residential, Commercial and External Flooding

The stage-damage curves were applied to each inundated property and the costs summed to calculate the total direct potential flood damage cost.

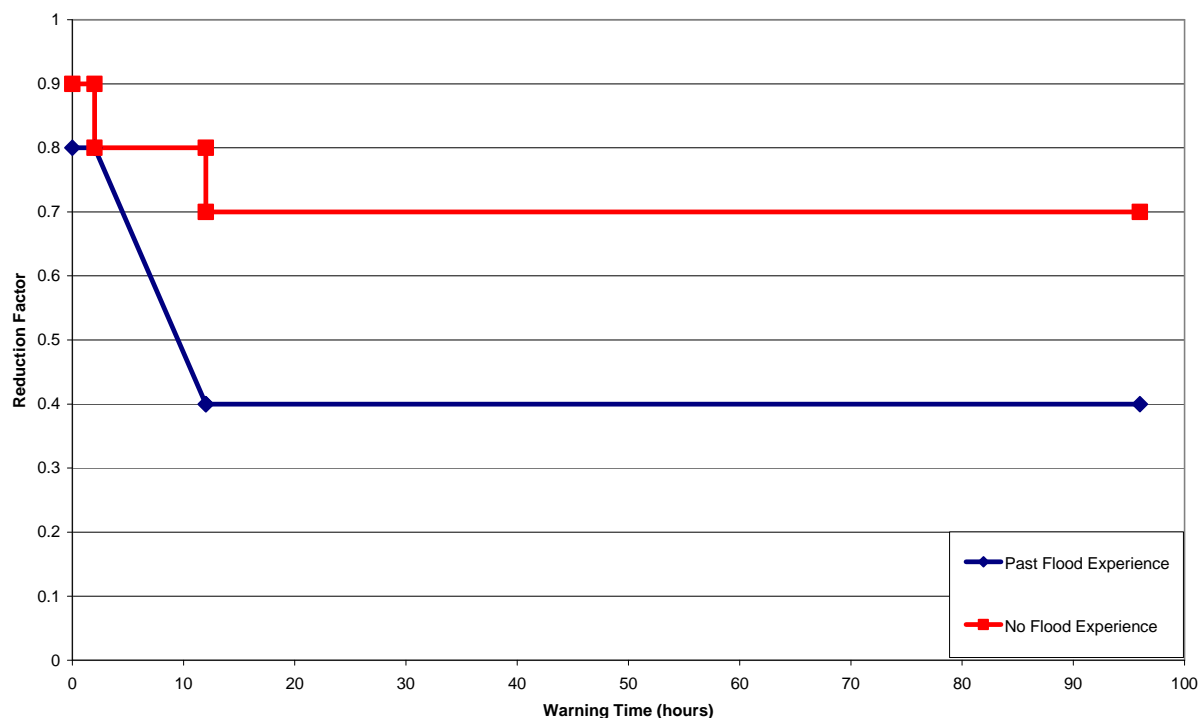
Figure 7-3 Reduction Factor Curves for Potential to Actual Direct Damage Ratio

The total direct potential flood damage cost is the cost that would be incurred if no mitigation measures are taken prior to or during a flood. In reality communities generally have some degree of warning, and particularly if a community has had previous flood experience, it may reduce the effect of the flood significantly. Measures such as evacuation, doorstep sandbagging or the removal of valuable items to a safe level above flood waters have the potential to reduce the flood damage cost. The flash flooding nature of events in Halls Gap limits the response time of residents and landholders. To reflect this limited warning and response time, a potential to actual direct flood damage reduction factor from RAM (DNRE, 2000) of 0.9 was adopted. This conservatively assumes that the community has no flood experience and have less than 2 hours warning time, as shown in Figure 7-3.

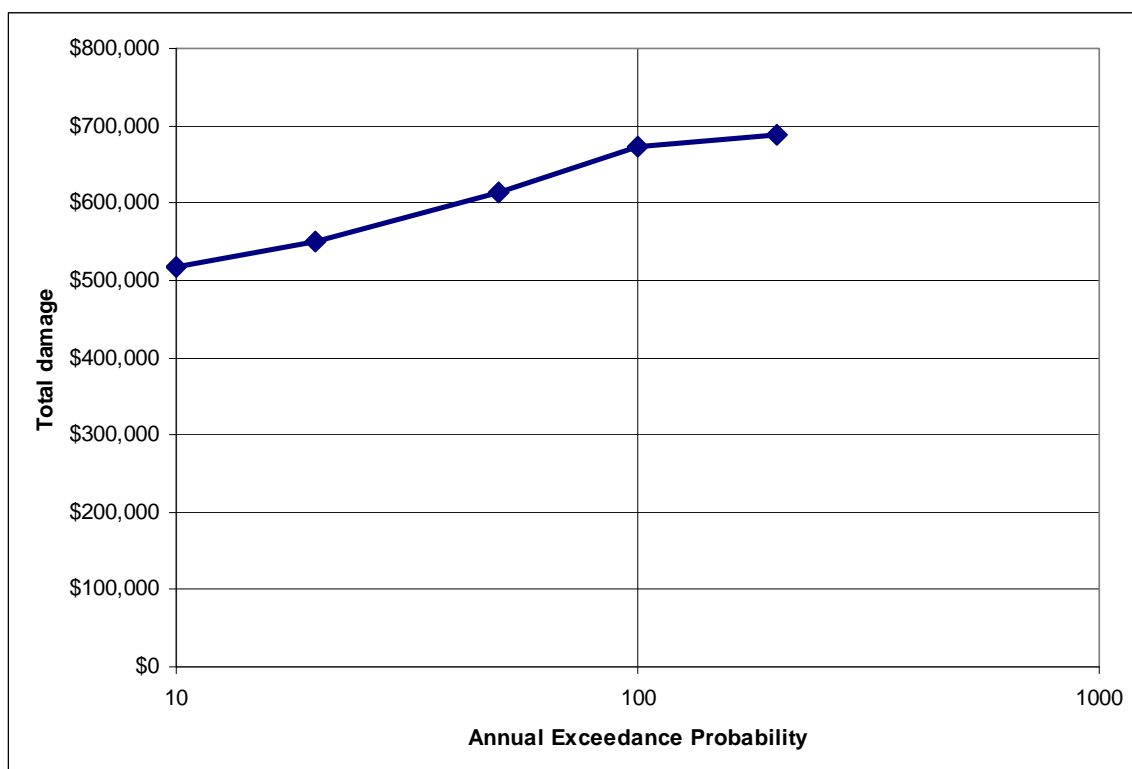
Figure 7-4 Flood damage summary

The average annual damages were estimated at \$54,000.
