Halls Gap Flood Study Study Report

Report No. J521/R01

June 2008

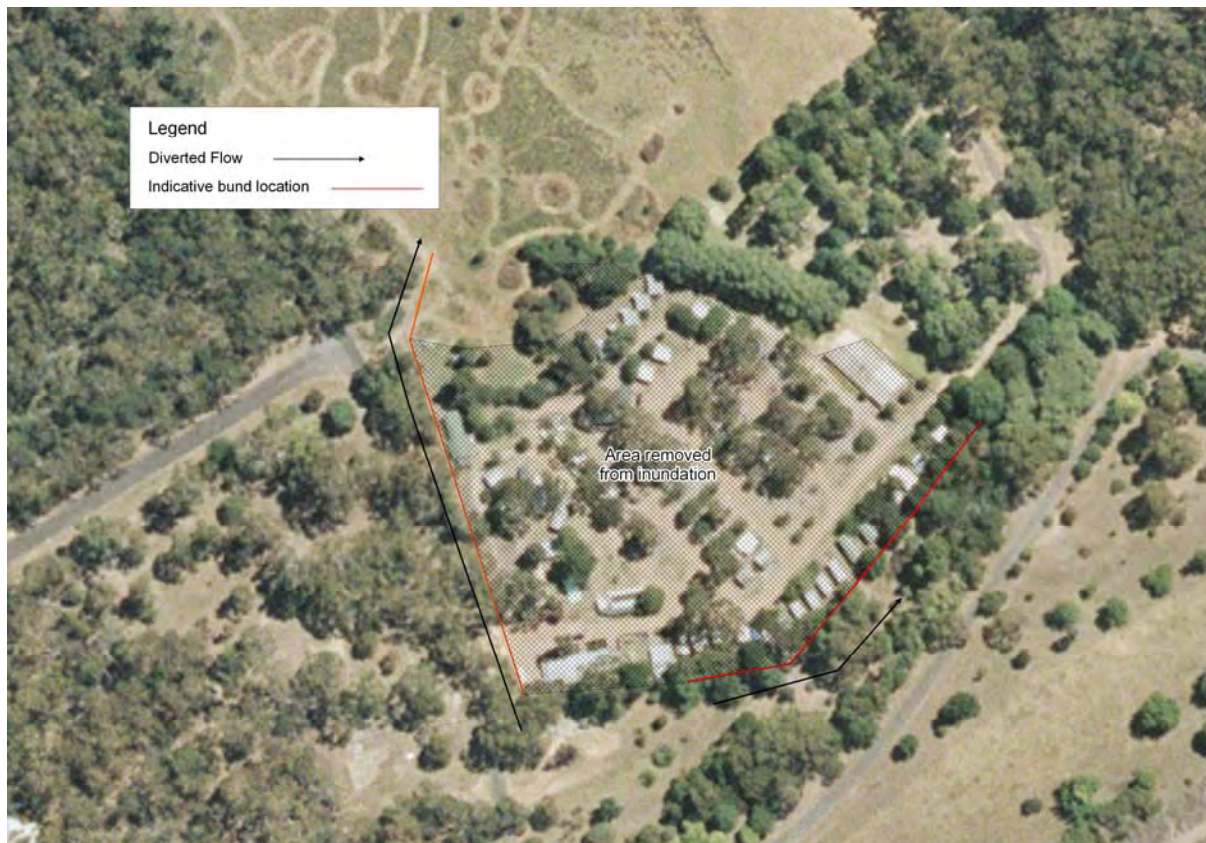
Figure 8-1 Potential mitigation measure – Lakeside Caravan Park

The study team recommends NGSC assess the feasibility of a small diversion bund along the indicative alignment shown in Figure 8-1 . This assessment should consider any adverse flooding on adjacent properties due to flow re-direction.

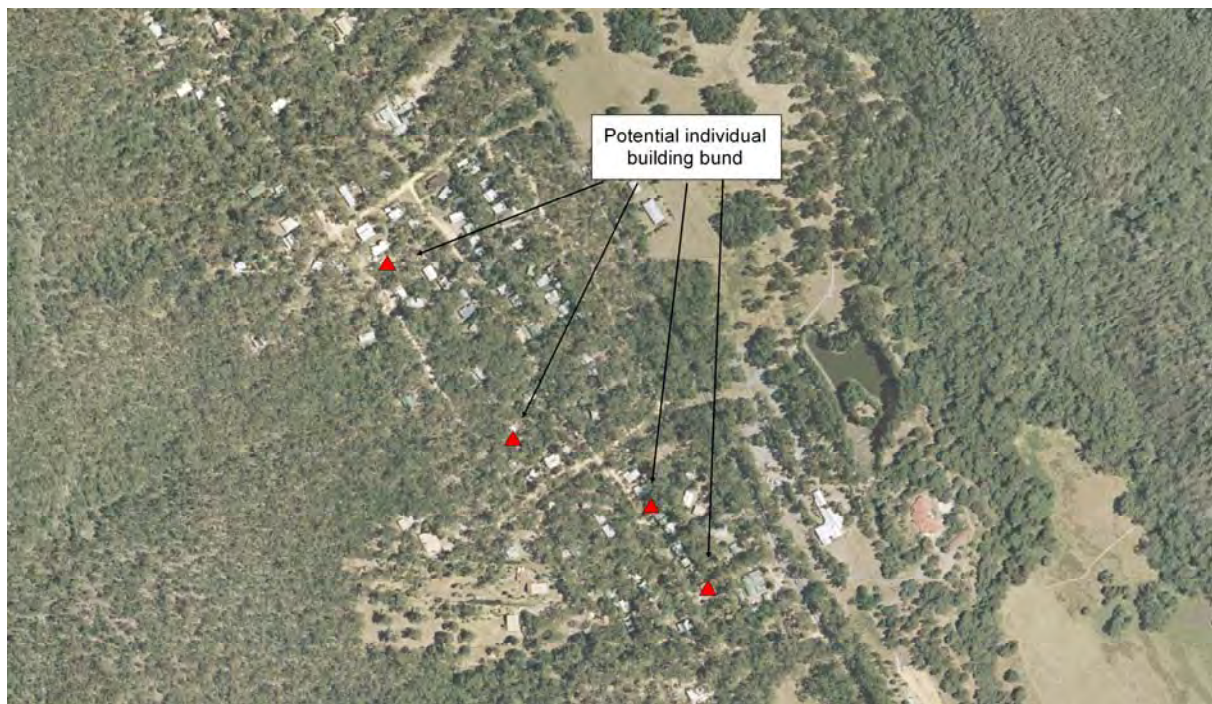
Figure 8-2 Potential mitigation measure – Pinnacle Road to Silversprings Road – Individual building bunds

The study team recommends NGSC assess the feasibility of small diversion bunds. This assessment should consider any adverse flooding on adjacent properties due to flow re-direction.

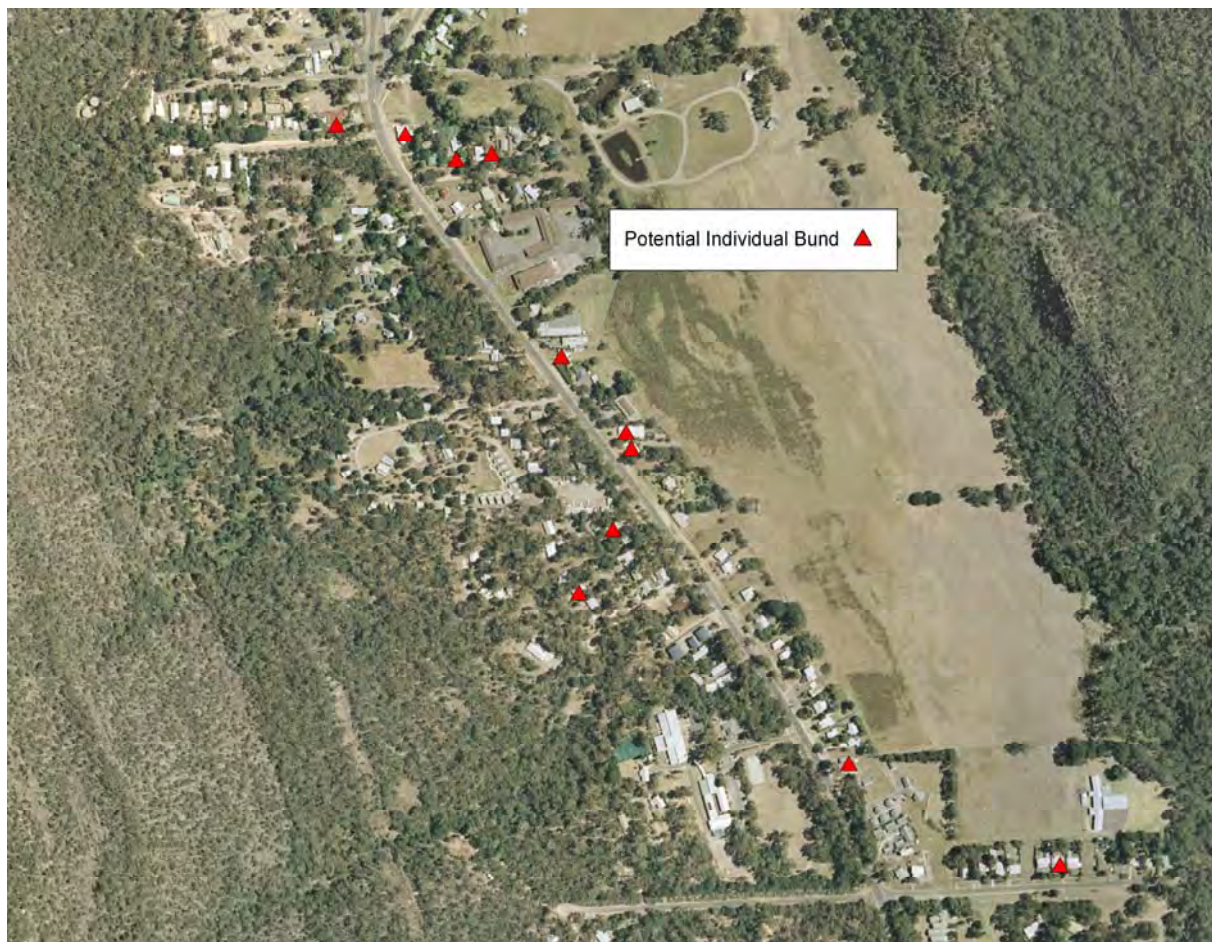
Figure 8-3 Potential mitigation measure – Silversprings Road to Rosea Street – Individual building bunds

The study team recommends NGSC assess the feasibility of small diversion. This assessment should consider any adverse flooding on adjacent properties due to flow re-direction.

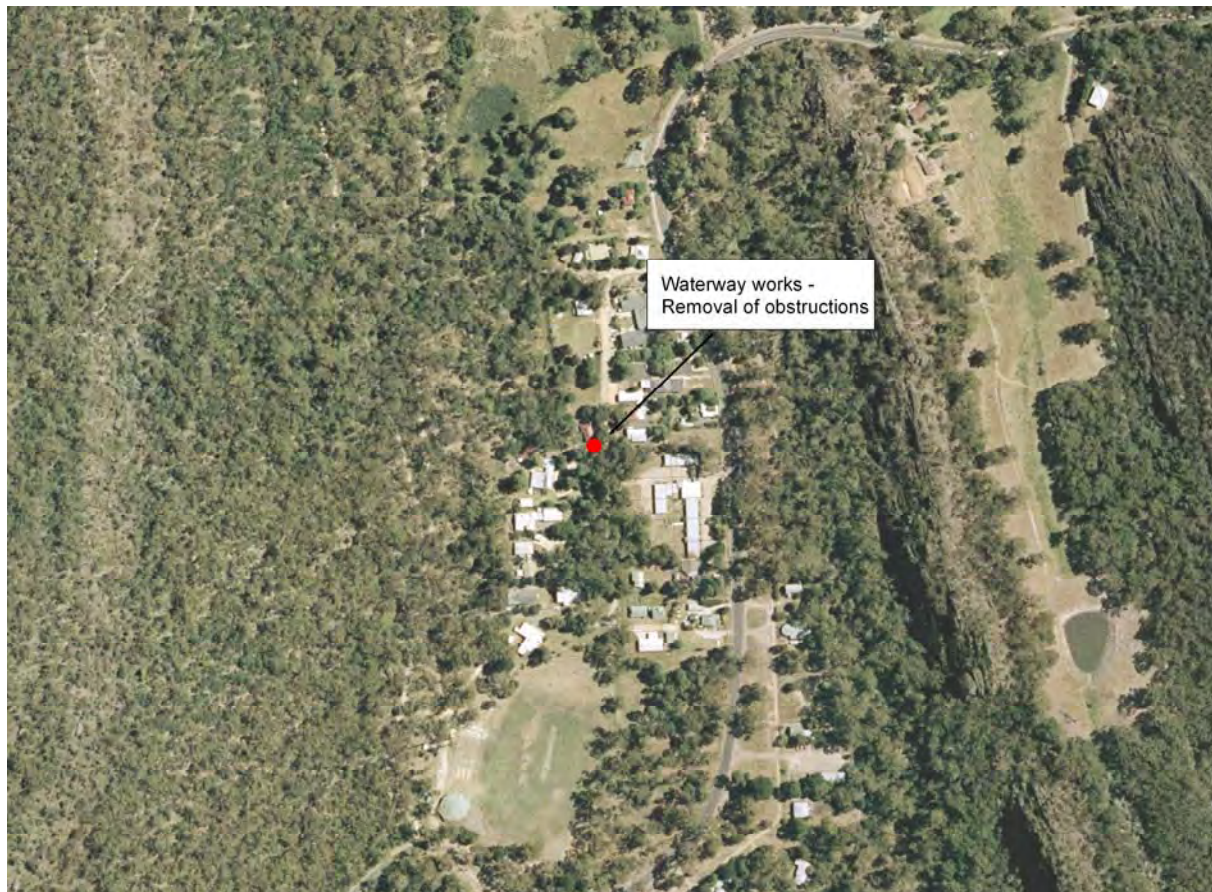
Figure 8-4 Potential mitigation measure – Warren Road – Waterway works

The study team supports the drainage augmentation as proposed by NGSC.

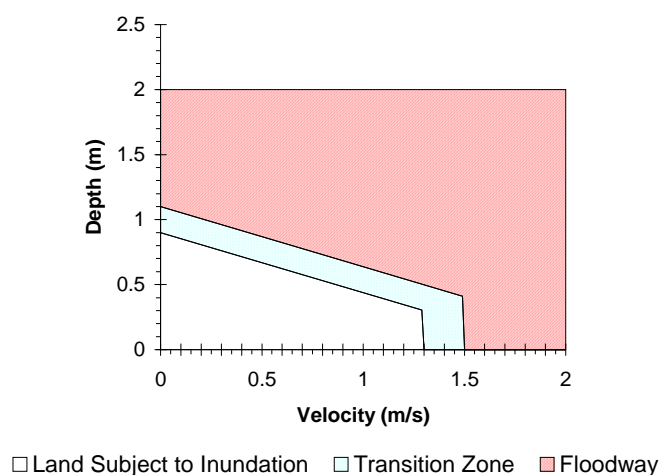
Figure 8-7 Floodway overlay flood hazard criteria

Flood hazard combines the flood depth and flow speed for a given design flood event. The advisory notes (DNRE 1998b) for delineating the floodway based on flood hazard. The flood hazard for the 1 in 100 year ARI event was considered for this study. Figure 8-7 displays the flood hazard criteria for floodway delineation.

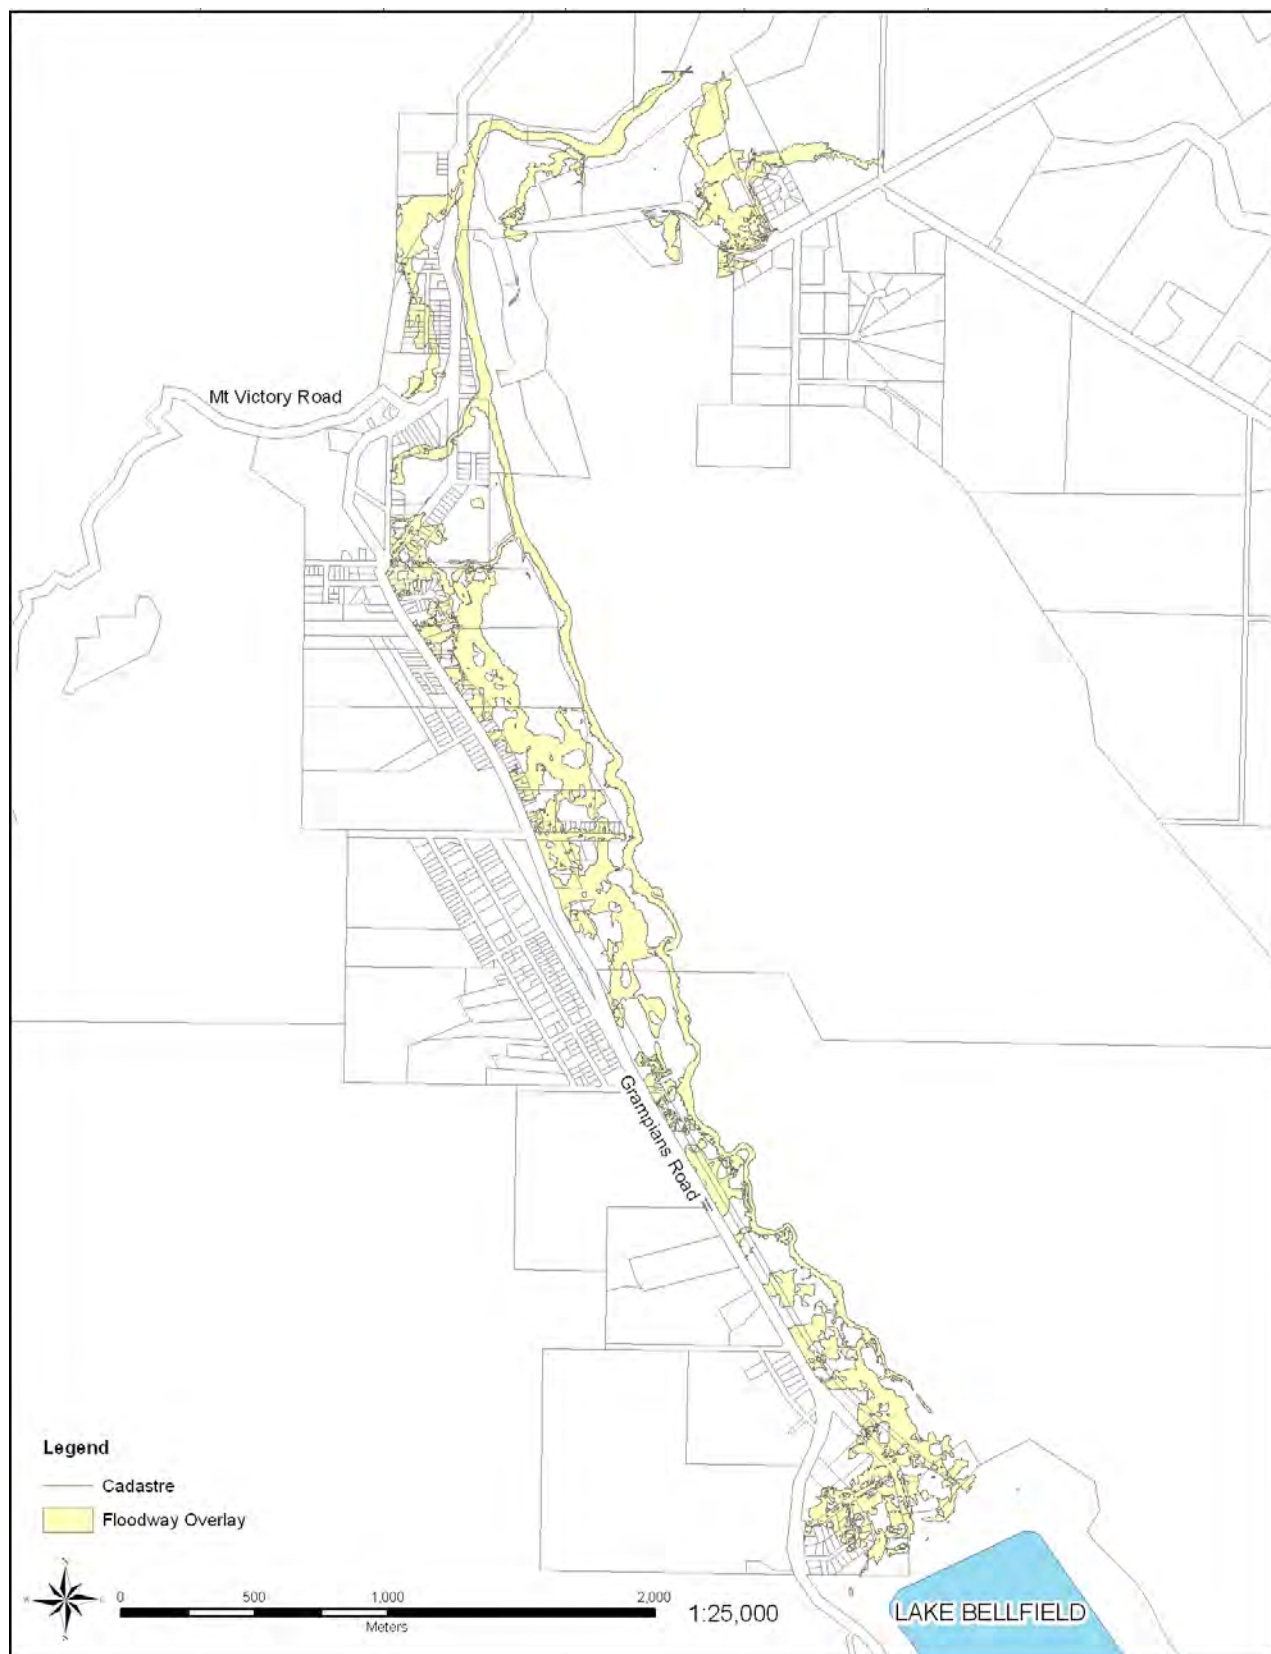
Figure 8-8 Draft FO delineation

Figure 8-8 shows the draft FO delineation for consideration by NGSC and Wimmera CMA.
