Horsham Flood Study

Report No. J035/R3 Final, Ver. A

February 2003

WATER TECHNOLOGY PTY LTD
Specialist Water and Coastal Engineering Consultants

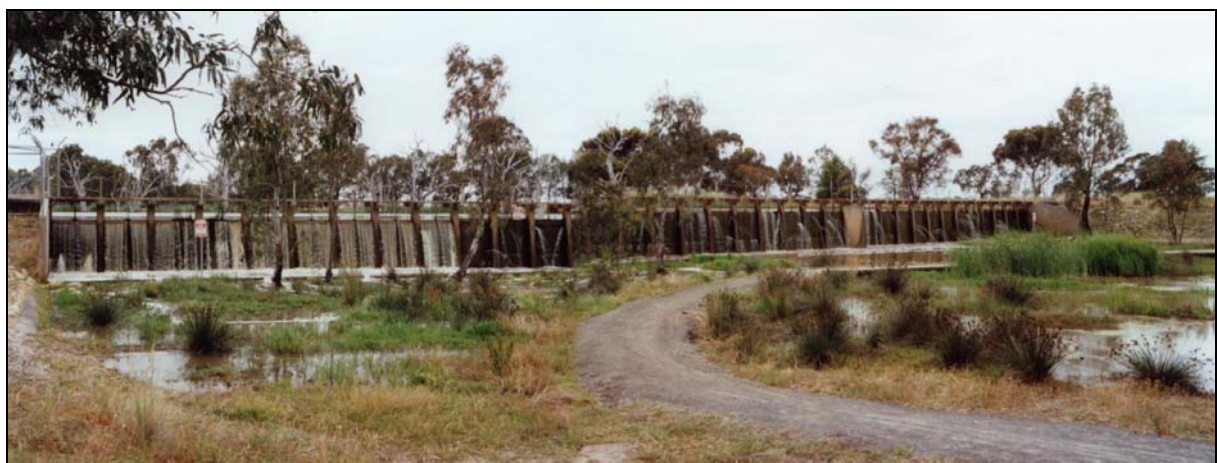
Figure 6.2 Horsham Town weir – looking upstream at low flow

The town weir is located on the Wimmera River just downstream of Drummond Street. The weir is a concrete structure with a number of removable stop boards. Figure 6.2 is a photograph of the weir looking upstream for a low flow in the Wimmera River.

During low flow periods the water levels in the Wimmera River through the town are controlled by the Horsham Town Weir. The influence of the weir during low flows also extends to the lower reach of Burnt Creek downstream of Williams Road.

Current operating rules for Horsham Weir are designed to minimise the impact of the weir at high flows. Removal of the weir stop boards commences when the Wimmera River flow reaches 613 ML/d ($7 \text{ m}^3/\text{s}$). All stop boards are removed when the Wimmera River flows reaches 5,145 ML/d ($60 \text{ m}^3/\text{s}$). A flow of 5,145 ML/d corresponds approximately to a 50 % AEP or 2 year ARI flow.

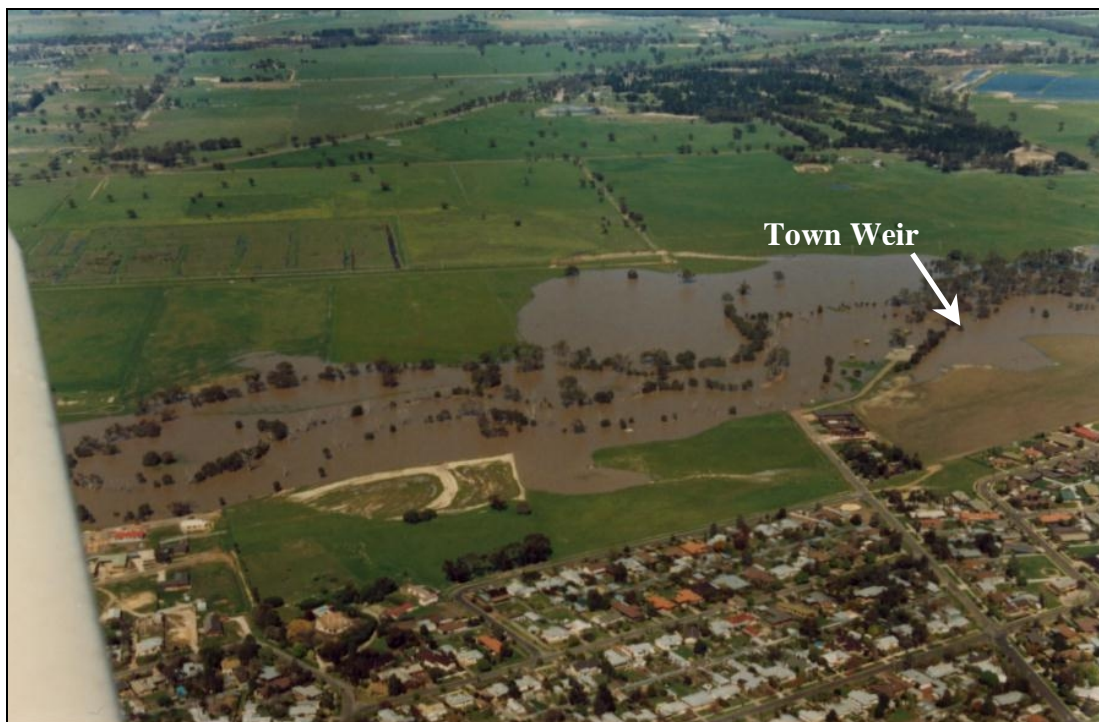
Figure 6.3 Aerial View of Horsham Town Weir looking south during Sep. 1988 flood

The weir has no significant impact on water levels at high flows due to the removal of the stop boards and drowning out of the weir. Figure 6.3 is an aerial view (looking south) over the Wimmera River adjacent to the weir during the September 1988. The figure shows the complete drowning of the weir.

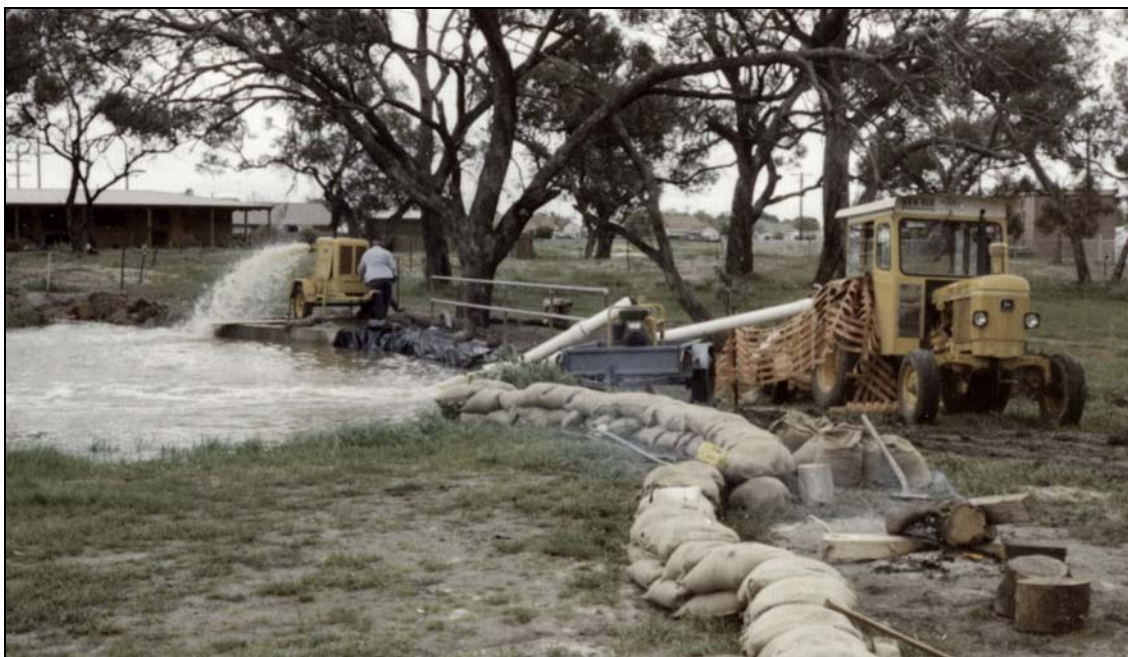
Figure 6.7 Wotonga Basin Pump Out Operations

Following notification by Wimmera Mallee Water of impending flooding, Council personnel install drop boards to prevent backwater into the anabranh area. This provides a weir level of approximately 125.9m AHD. During flood events, the area behind the weir is pumped out to maintain capacity in the stormwater system. Figure 6.7 illustrates this operation in 1983.
