# Mount William Creek Flood Investigation Final Report

Reference: R.M20045.007.01.FinalReport.docx  
Date: December 2014

Prepared for: Wimmera Catchment Management Authority

Prepared by: BMT WBM Pty Ltd (Member of the BMT group of companies)

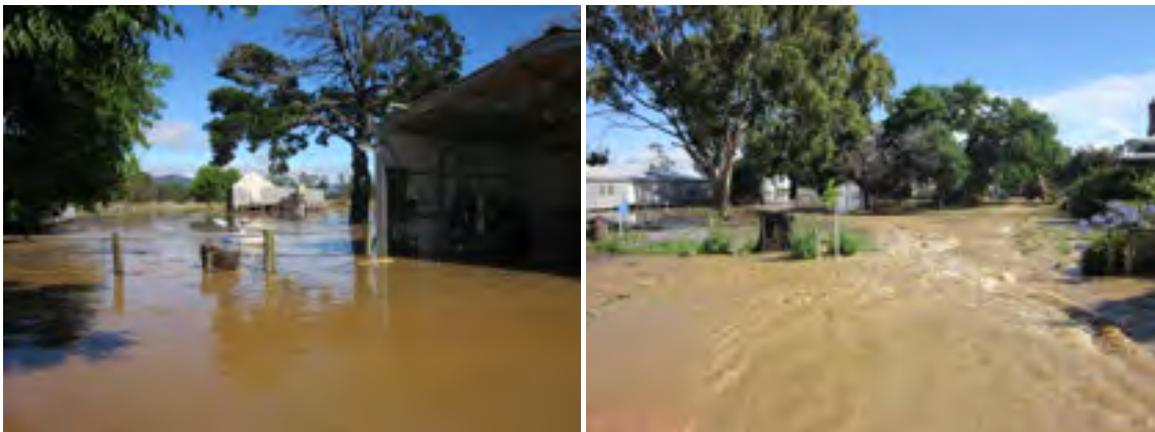
Figure 3 Flooding of a property on Ararat – Halls Gap Road, Jallukar (left photo 1, right photo 2)

When calibrating the hydraulic model up stream of Lake Lonsdale more weight was applied to the photographs and flood marks rather than the stream gauge records. During large flood events such as the January 2011 event, stream gauge data for Mokepilly, Fyans Creek and Mount William tail gauge was deemed not accurate. As shown in Figure 4, Figure 5 and Figure 6, during large flood events floodwater was found to break out of these waterways upstream of the gauges, bypassing the stream gauge. During large flood events the stream record for these gauges is not representative of the flood behaviour.

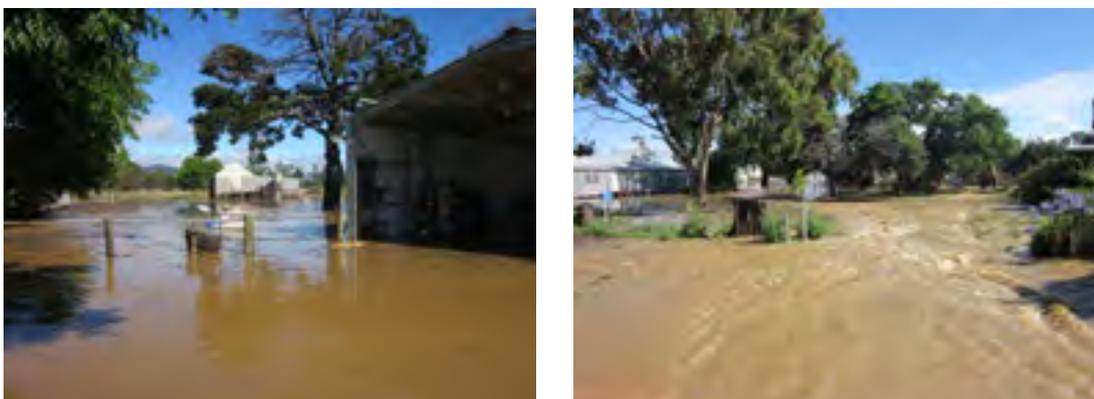
**Figure 5-14 Flooding of a property on Ararat – Halls Gap Road, Jallukar**

Figure 5-13 and Figure 5-14 clearly show that the initial calibration of the January 2011 flood event does not adequately reproduce the flooding of Mount William Creek in the Jallukar region. The amendment of the hydrologic model calibration parameters (as discussed in section 5.3.4.3) resulted in increased flow along this section of Mount William Creek which ultimately resulted in a flood extent and flood depths that better reflected the obtained survey marks and flood photography.

The flood marks and photographs that were collected in the Jallukar region indicated that there were a number of serious discrepancies between the initial calibration result and the January 2011 flood event. Figure 5-13 shows how the initial calibration (shown in red) compares to the final calibration (shown in blue). The initial model calibration shows flooding confined to Mount William Creek which does not extend into the surrounding floodplain. This property is located on the Ararat – Halls Gap Road, between Pomonal and Moyston. The pink dots in this figure represent surveyed flood marks that were captured following the January 2011 flooding and Figure 5-14 shows a selection of photographs at this location.

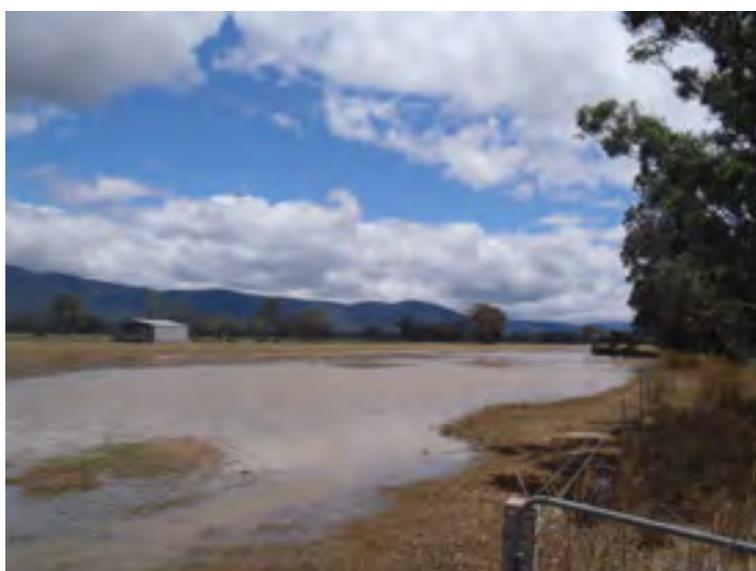
Figure 5-16 Flooding of the Air Strip on Ararat – Halls Gap Road, Jallukar

Additional flood marks and photography were provided for an air strip and aircraft hangar (also located on Ararat – Halls Gap Road). Figure 5-15 shows how the initial calibration (shown in red) compares to the final calibration (shown in blue) at this location. In a similar vein to the previous example, Figure 5-15 and Figure 5-16 show that the final calibration provides a much better representation of the flooding at this location when compared to the initial calibration. The provided photo (Figure 5-16) was taken after the flood peak (at approximately at the same time at the peak flood height was recorded at the Mokepilly gauge, approximately 20 kilometres downstream) and hence does not depict the peak inundation at this site.

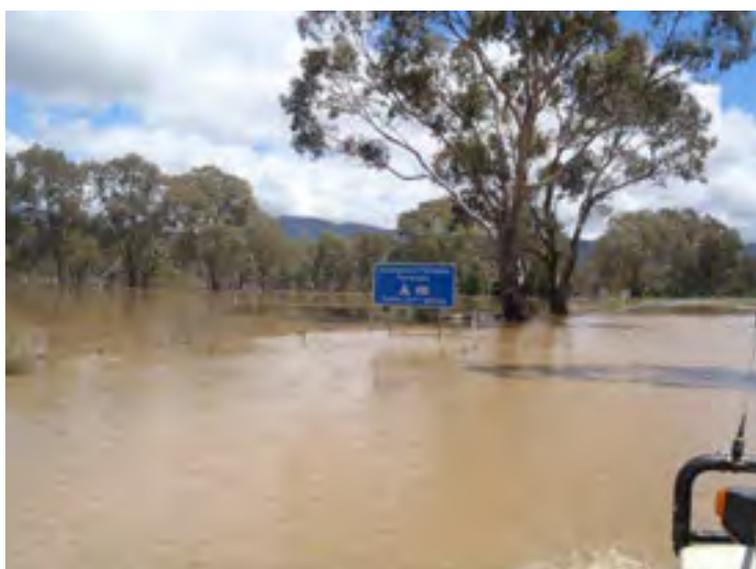
Figure 5-18 Flooding of Ararat – Halls Gap Road (East of Lady Summers Bridge)

photograph shown in Figure 5-18 was taken. Although there photograph metadata did not include a time stamp, it clearly shows inundation of the Ararat – Halls Gap Road to a degree only reproduced by the final calibration.

Further photography was provided along Ararat – Halls Gap Road in the vicinity of Lady Summers Bridge. This region of the catchment experienced extensive flooding during the January 2011 flood event resulting in the road closure of the Ararat – Halls Gap Road at this location. Like the previous comparisons, Figure 5-17, shows significant variation in the flood extents based upon the initial calibration (shown in red) and the final calibration (shown in blue). The initial calibration only shows flood water at the site of the bridge itself, with no inundation of the approach road either to the north-west or to the east. The green dot in Figure 5-17 shows the approximate location where the

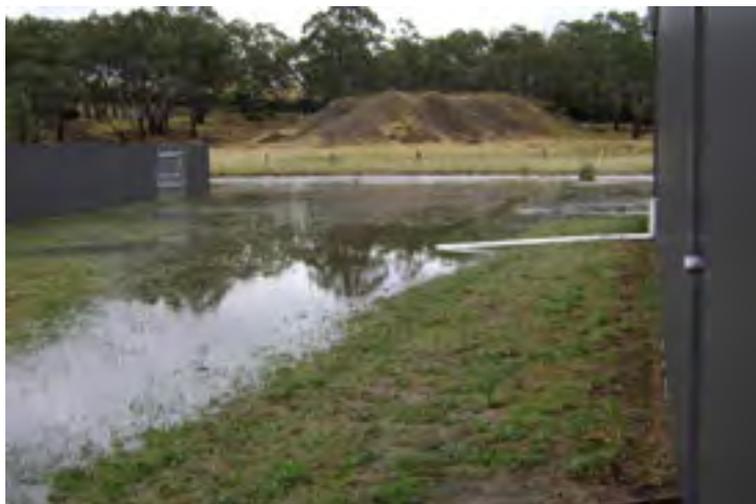
**Figure 5-20 Flooding between house and shed - Presbyterian Church Road, Moyston**

Figure 5-19 shows the comparison between the initial calibration (shown in red) and the final calibration (shown in blue) for a house and shed in on Presbyterian Road, Moyston. The local resident also provided some photographs, one of which is shown in Figure 5-20, of the flooding around the property. The photographs were taken the morning following the peak inundation (the peak occurred during the night at Moyston), and therefore do not show the peak inundation of the property. However, the photograph shows water between the house and shed, a pattern of inundation not shown in the initial calibration but reflected in the final calibration of the January 2011 flood event.

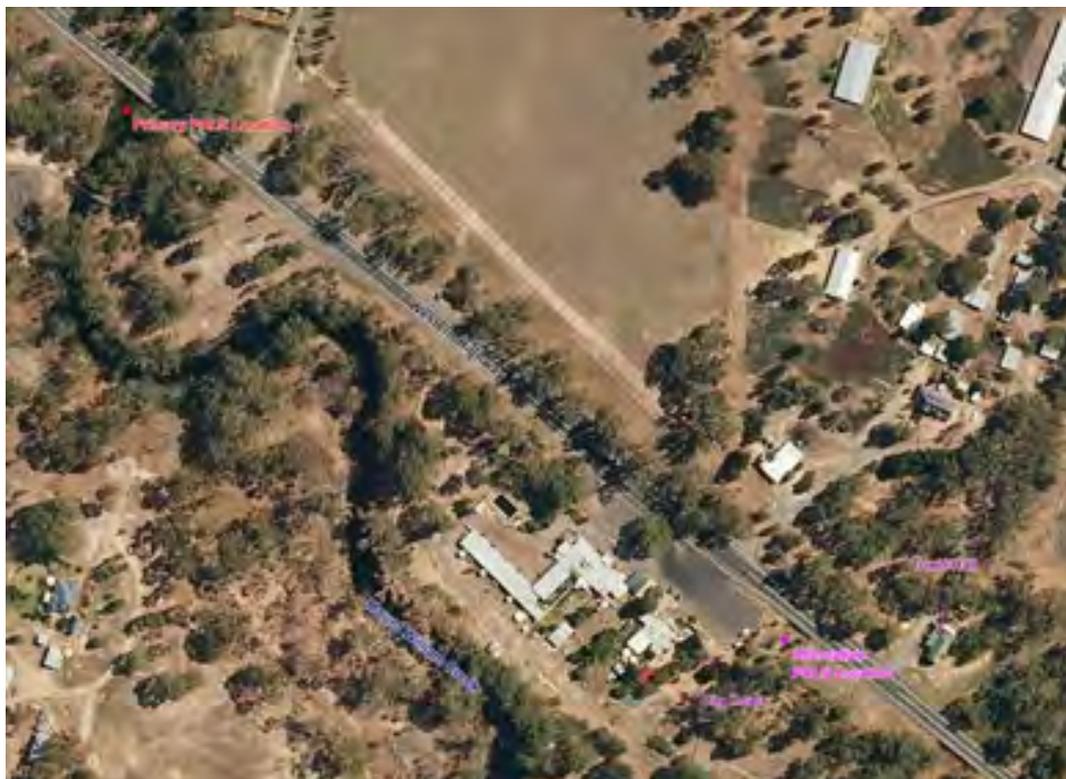
Figure 10-1 Potential PALS locations for Dadswells Bridge
