Wimmera
Catchment Management
Authority

Burnt Creek Waterway Action Plan

Oct 2005

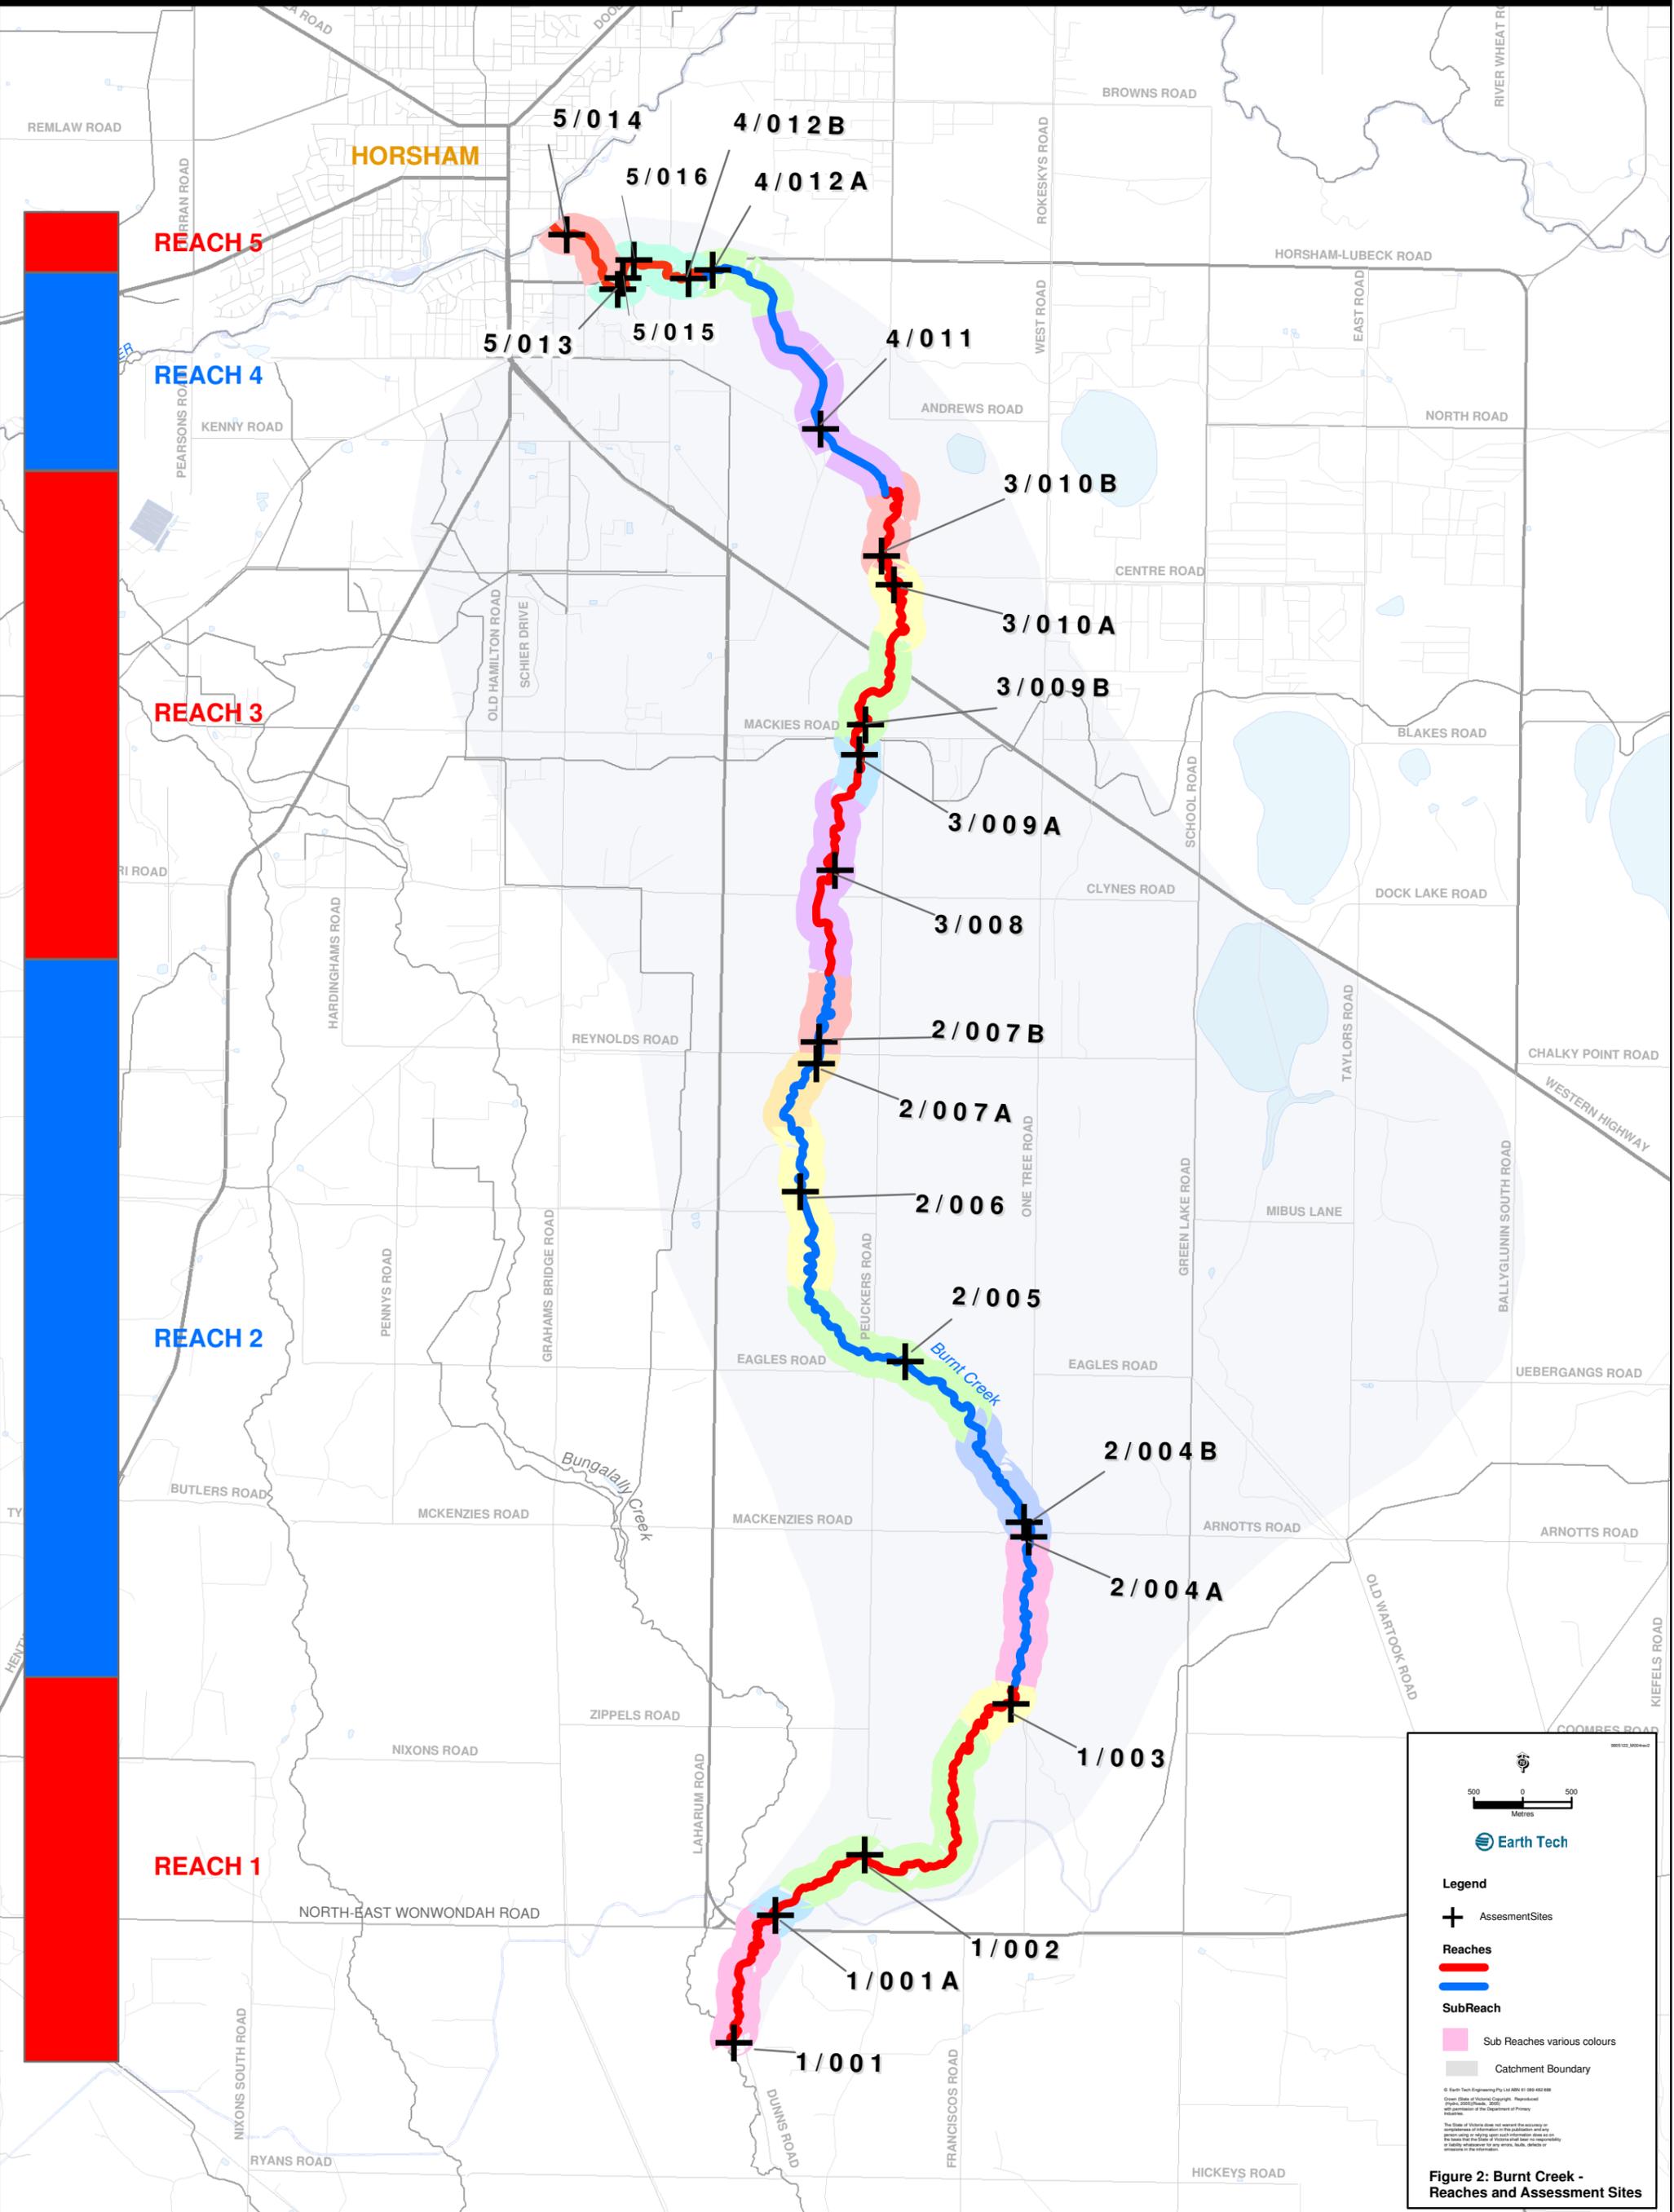
Reaches and SubReaches

In recognition that both field assessments and the management of Burnt Creek is best conducted at a reach scale, Burnt Creek was divided into five reaches of similar physical character. The delineation of reaches was based on a combination of changes in planform, landuse, hydrology and vegetation density (Table 1). The location and extent of each reach is shown on Figure 2.

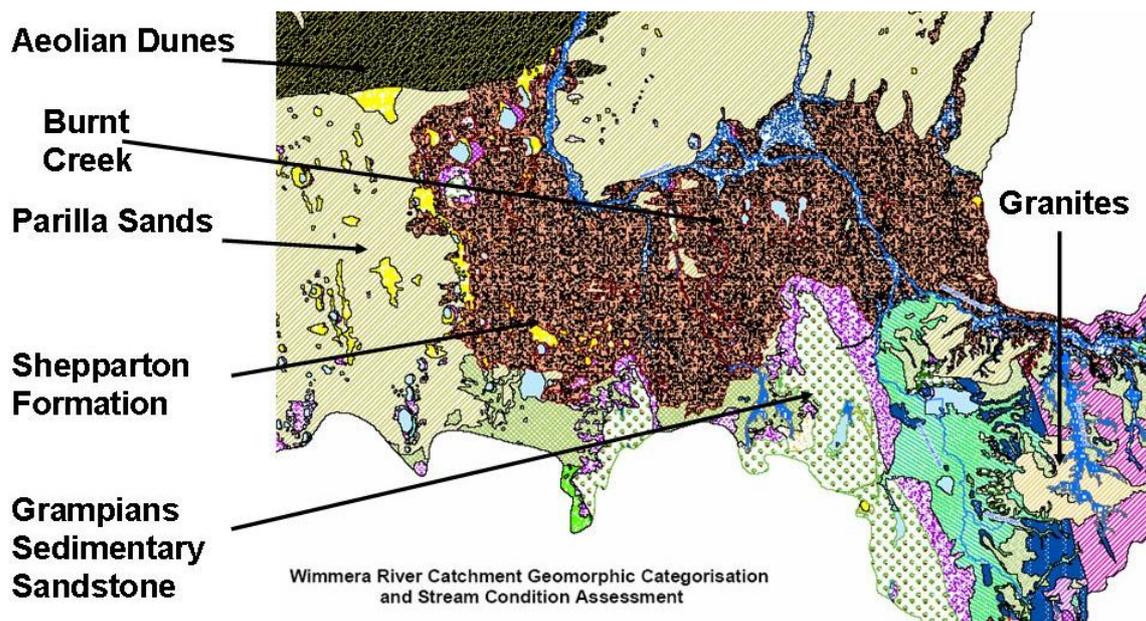
Figure 6. The extent of the Shepparton Formation with respect to Burnt Creek (Earth Tech 2003)

Burnt Creek distributes from the MacKenzie river flowing across the Shepparton Formation toward the Wimmera River. The Creek travels through a narrow band of recently deposited sediments which are dominated by clays and sands. Unlike the main stem of the MacKenzie River, Burnt Creek is not flanked by deposits of the Parilla sand, yet the channel is still restricted to a zone which is typically less than 200 m wide.

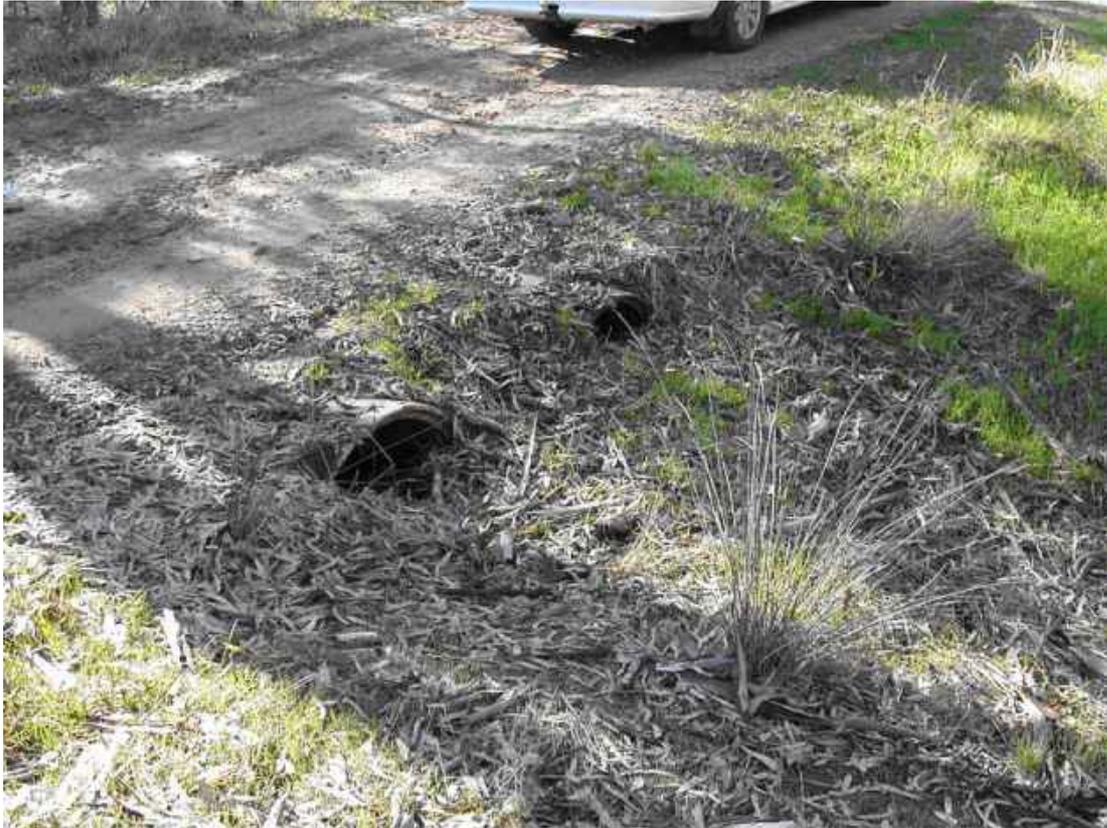
Figure 7. MacKenzies Rd Crossing of Burnt Creek

The management of road crossings in this reach may provide an impediment to environmental flows should they be released. At site 5, an earthen bank has been constructed in the upstream side of the road crossing which will increase the height of the river upstream, change the erosion and flooding character of the stream. At the MacKenzies Rd crossing sediment is built up on each side of the culverts making the passing of any flows difficult (Figure 7).

Existing road culverts could be replaced with 600mm RCP pipes culverts or 600x450 box culverts laid at a grade of 1:150 to enable passage of a 45ML/day flow.

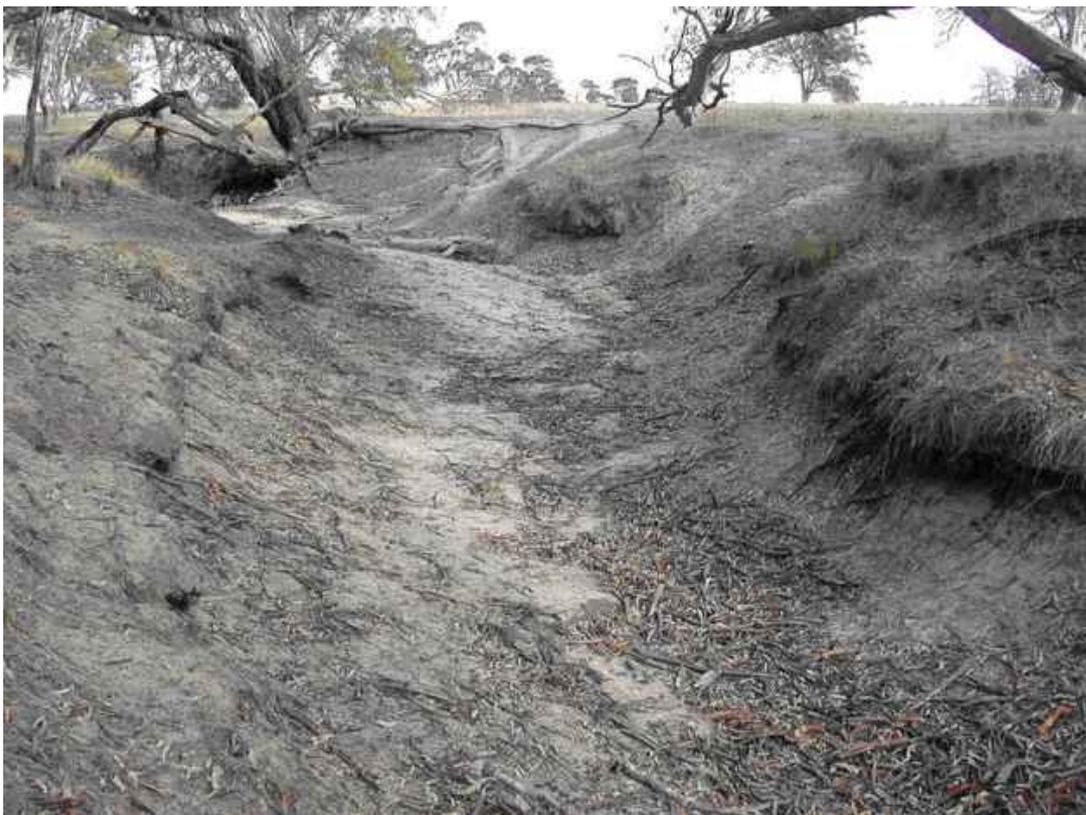
The creek generally has very steep to almost vertical banks with only a few sites displaying moderate bank slopes. It is unlikely that in its natural state, the creek would have showed the same depth of incision and this is most likely to have been caused by widespread clearing following European settlement. There is an obvious contraction in the active channel but the extended dry period and complete cessation of flows has prevented substantial vegetation encroachment into the channel. Some bank instability and slumping is occurring as the new active channel is undercutting the steep banks of the creek (Figure 8). The steep banks are at risk of erosion if the vegetation cover is not maintained to protect them.

Figure 8. Undercutting of banks at site 10.

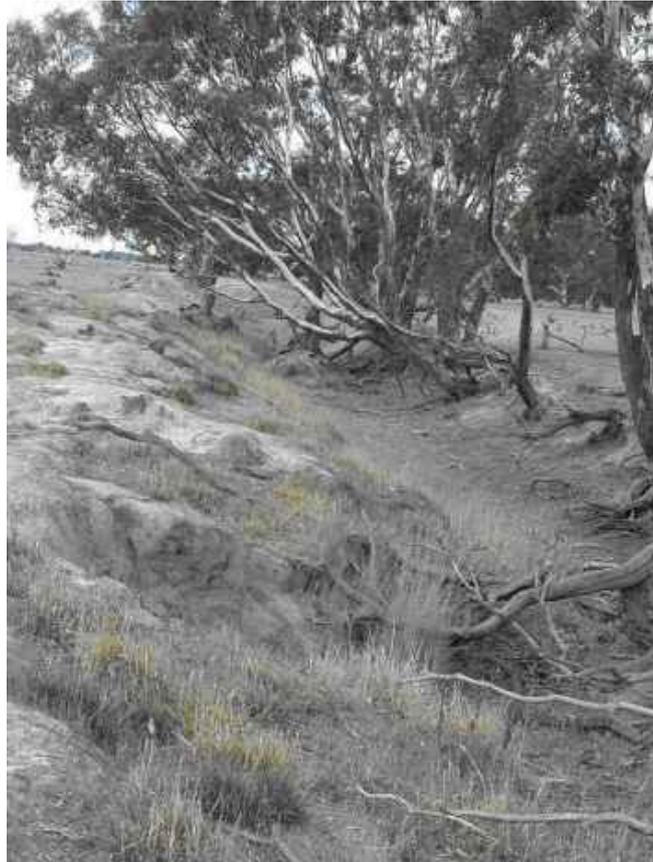
The vegetation in this reach is largely dominated by exotic weeds, with very few remaining native trees. Occasional Black Box *Eucalyptus largiflorens* indicate the former open Grassy Woodland community that would have occurred. No listed significant species were recorded for this reach although a number of locally rare species were observed. Areas that have been fenced out and replanted with indigenous trees and shrubs exhibit remarkable recolonisation with native grasses and herbaceous species, however here also these are being threatened with invading exotic weeds particularly *Phalaris aquatica*.

Figure 9. Bank Erosion Site 11.

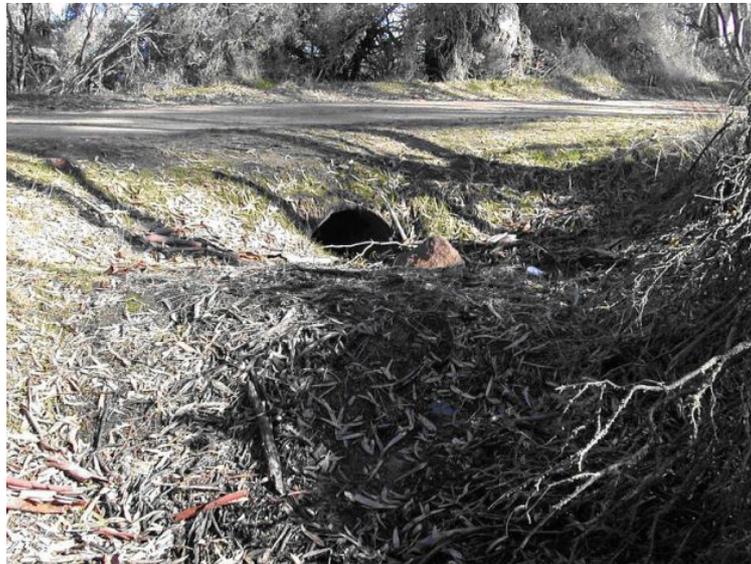
- Peuckers Rd crossing – 450 mm under road pipe with an earthen bank pushed up on the upstream side to deepen a pool for pumping (Figure 10).
- Mackies Rd crossing – two culverts blocked with organic matter and rubble has been dumped on the downstream side (Figure 11).
- MacKenzies Rd crossing – two pipes under road filled with sediment, possibly pushed up (Figure 12).
- A dam across the creek at site 8 and the diversion activities at site 5 will impede the passage of flows.

Figure 10. Peuckers Rd crossing of Burnt Creeks showing the bank constructed on the upstream side

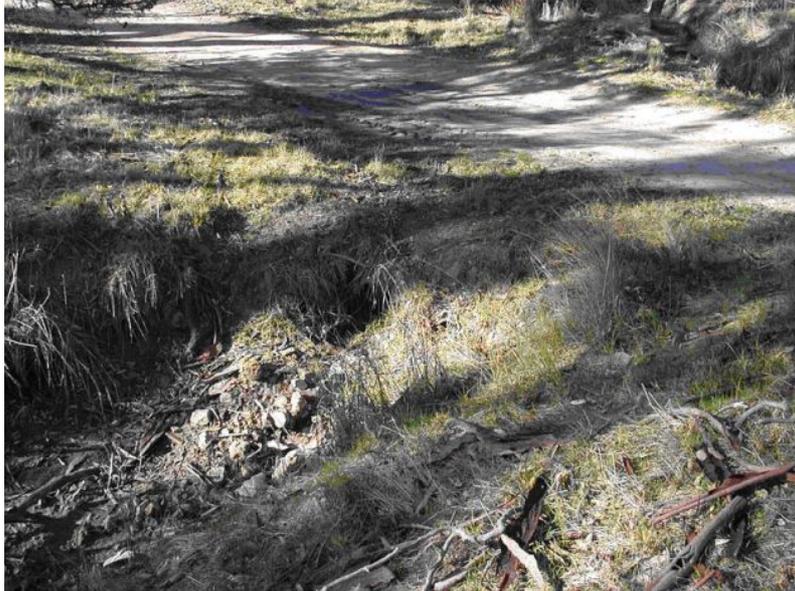
Figure 11. Mackies Rd crossing of Burnt Creek showing rubble dumped downstream of crossing

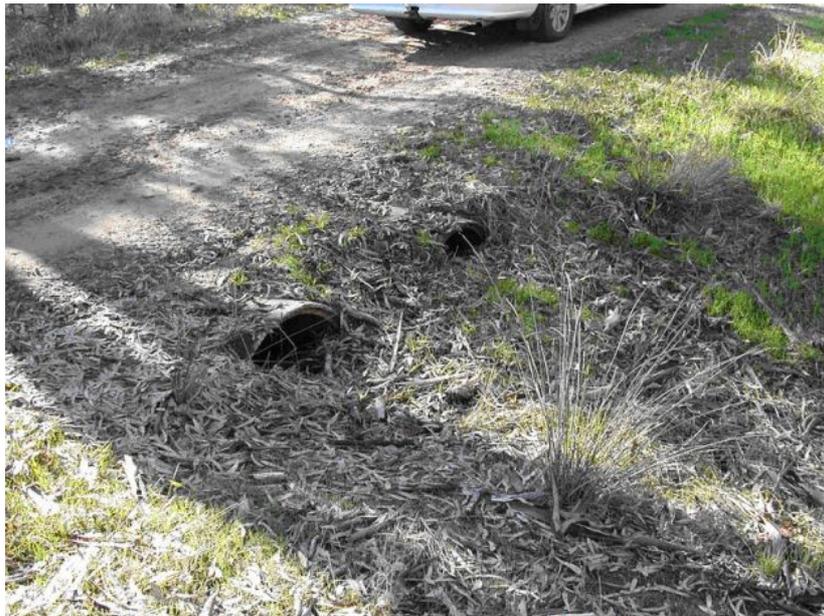
Figure 12. MacKenzies Rd crossing of Burnt Creek, upstream view. Downstream view is similar
