Concongella Creek Waterway Action Plan

Job 2901049.013

April 2003

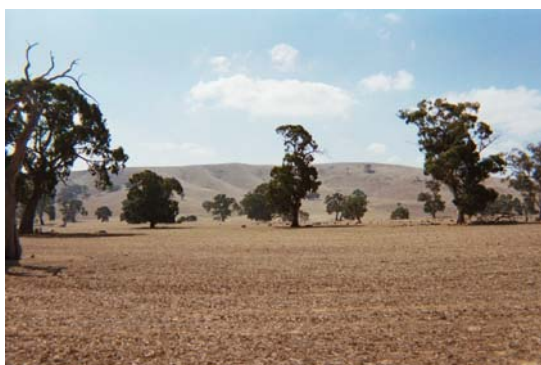
Figure 1: Granitic hills in the Concongella Creek catchment

The geology in the catchment varies throughout the length of Concongella Creek. The upper sections of the catchment are comprised of sandstone and siltstone. The mid section, around Great Western, is dominated by granodiorite. The lower sections are comprised of siltstone and sandstone, with fluvial gravels, sands and silts.

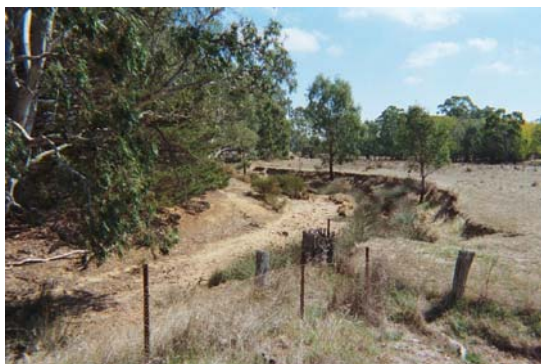
Figure 4: Concongella Creek downstream from Allanvale - Dunworthy Road

Water quality is likely to vary throughout this reach, depending on stock access, extent of riparian vegetation and exposed bed or banks. Overall, quality is regarded as low due to stock access and possible nutrient runoff from vineyards.

Spiny rush indicates the presence of saline groundwater. Whether the saline groundwater affects the lower reaches of Concongella Creek is unknown.

Opportunity to limit stock access, increase vegetation and limit erosion to protect reaches downstream.

Opportunity to increase the filtering capacity of this reach and minimise the effects on reaches downstream.

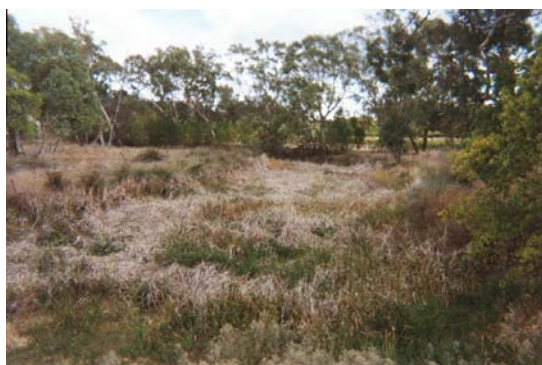
Figure 8: Concongella Creek upstream from Western Hwy at Great Western

Concongella Creek contains a natural constriction that makes Great Western prone to flooding. Reach 2 has an active sand bed. The banks are in good condition. The bedload in the channel is sandy and appears to be elevated. Although the sandy bed load affects the geomorphic features of the channel, it does not appear to have completely compromised the channel's natural form.

In-stream habitat in Reach 2 is compromised by the elevated sand bedload in combination with stock access. It is in better condition in the sections where stock has been excluded and in-stream vegetation has established, stabilising the active channel sediment load.

Water quality is generally satisfactory in Reach 2, due to the presence of riparian vegetation along the channel of Concongella Creek. Where the water quality is in poor condition, it is likely to be due to unvegetated tributaries and stock access.

Management Actions	Priority for Works
Treat active erosion in right bank tributary adjacent to Bulgana Road.	Medium
Investigate stability of any drop structures and repair or maintain as appropriate.	Medium
Monitor the condition of drop structures.	Medium
Fence and revegetate Concongella Creek and tributaries.	Medium

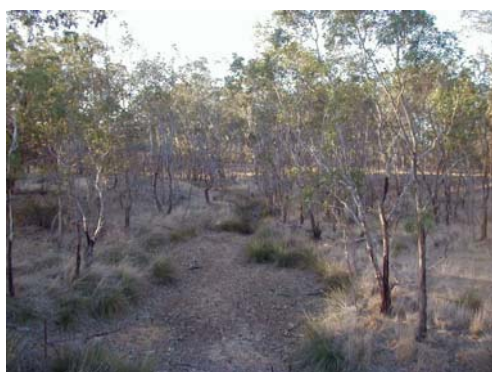
Figure 12: Concongella Creek downstream from Landsborough Road

Riparian vegetation in this reach is good, with much of the creek fenced off. The small right bank tributary is unfenced and in poor condition in its downstream section.

Stock access and sediment pose the largest risks. However, overall, this is a small risk.

Management Actions	Priority for Works
Treat active erosion in right bank tributary downstream from Sycamores Road.	Medium
Fence and revegetate Concongella Creek and tributaries.	Medium
Investigate stability of any drop structures and repair or maintain as appropriate.	Low
Monitor the condition of drop structures.	Low
Fence and revegetate tributaries (excluding Wattle Creek).	Low

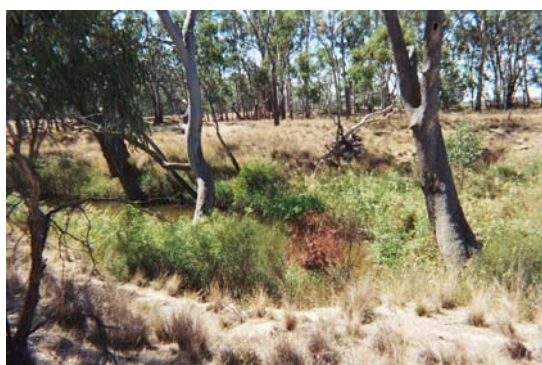
Figure 16: Confluence of Wimmera River and Concongella Creek

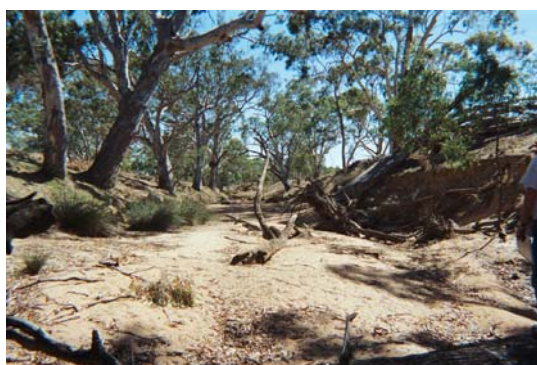
A significant sand 'slug' is currently migrating through the reach. The downstream end of the sand 'slug' occurs near to the confluence with the Wimmera River. The sand 'slug' has caused the channel to be overloaded with mobile sand. The sand has blanketed in-stream geomorphic features, including pools, scours, point bars and features commonly found on stream bends and around LWD. The reduction of in-stream geomorphic features and associated vegetation is having a significant effect on in-stream habitat and ecological diversity. Downstream from the sand 'slug', the channel has a series of pools that do not show any evidence of mobile sediment. These downstream pools and the channel between them are fringed by thick stands of reeds.

The sand within the creek is having a major impact on in-stream habitat. The creek just upstream from the confluence is a good example of the condition of the channel and in-stream habitat without the effects of the additional sand load.

Figure 17: Sediment load in high value Reach 4 of Concongella Creek

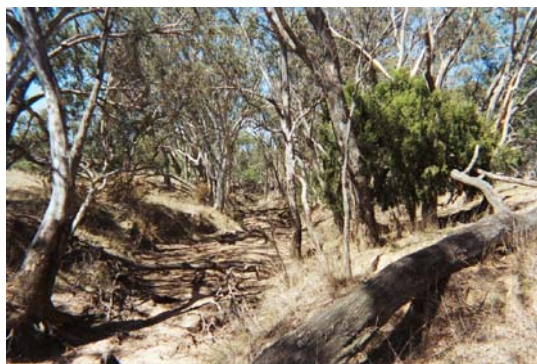
Figure 19: Concongella Creek on property of L. Kingston

The riparian zone throughout Reach 4 is generally good. It is very good in the lower section, with significant overstorey vegetation. Ground cover is in moderate condition, due to stock access. The groundcover is in relatively good condition compared to other sections of Concongella Creek. The creek is well fenced in this reach.

Opportunities to significantly improve water quality from within the reach are limited to restricting stock access. However, managing the sand would significantly reduce possible negative water quality impacts in Reach 7 of the Wimmera River.

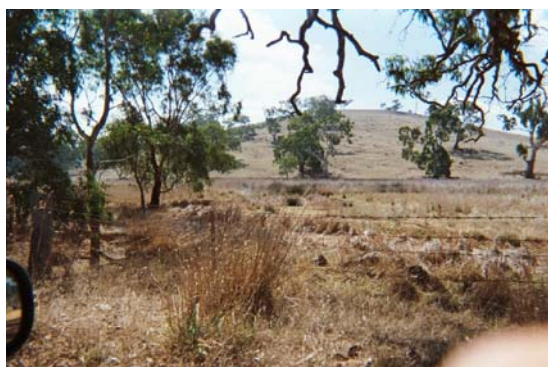
Figure 20: Stabilised sediments in the upper sections of Allanvale Creek

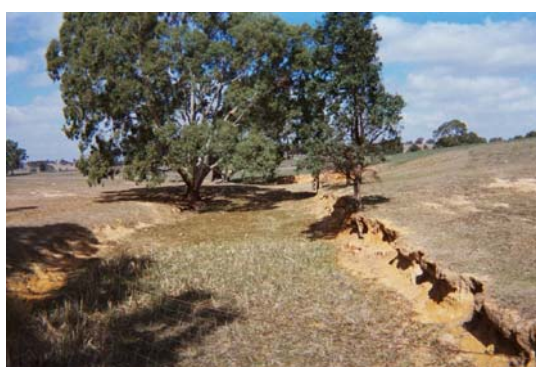
Figure 21: Stabilised sediments in Allanvale Creek, upstream from Sinnots Road

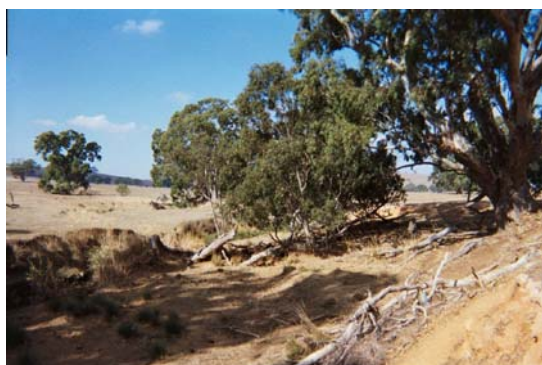
Risk of deterioration of riparian vegetation from stock access.

Figure 22: Effect of uncontrolled stock access to lower sections of Allanvale Creek

Management Actions	Priority for Works
Treat active erosion heads in the upstream reaches of Allanvale Creek and in the right bank tributary upstream from McKays Woolshed Road.	Medium
Investigate stability of any drop structures and repair or maintain as appropriate.	Medium
Monitor the condition of drop structures.	Medium
Fence and revegetate downstream sections of Allanvale Creek.	Medium

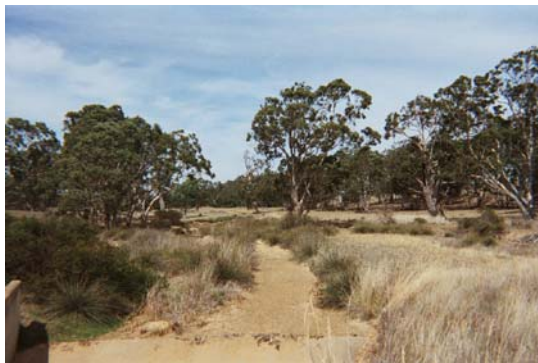
The upstream reaches of the Salt Creek catchment are noted for their mobile sand bedload and active scouring in parts. In particular, the channel adjacent to the most upstream crossing by the Salt Creek Road has evidence of active scour and mobile sand bedload. The sand bed load has a significant effect on the geomorphic form of the channel bed, smothering in-stream scour features and preventing the establishment of vegetation within the channel. The unstable bedload is exacerbated by stock access, which affects the already unstable banks and, through grazing, restricts the development of in-stream vegetation.

The presence of spiny rush and anecdotal evidence gathered by landholders indicates the presence of saline groundwater. Water quality is considered poor due to the effects of saline groundwater, unrestricted stock access and sparse groundcover.

Figure 24: Sediment load and spiny rush in Salt Creek

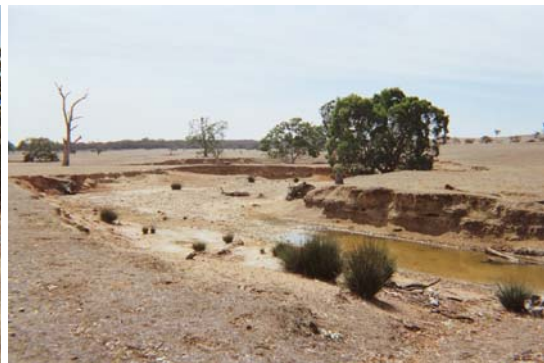
The downstream reaches of Salt Creek are in moderate physical condition. The major physical problem in the downstream reaches is bank instability related to stock access to the waterway.

Figure 25: Uncontrolled stock access to Salt Creek

Risk - Continued uncontrolled stock access to Salt Creek will further deteriorate the riparian zone.

Management Actions	Priority for Works
Treat active scour on property of C. West.	High
Fence and revegetate along Salt Creek.	Medium
Investigate stability of any drop structures and repair or maintain as appropriate.	Medium
Monitor the condition of structures.	Low

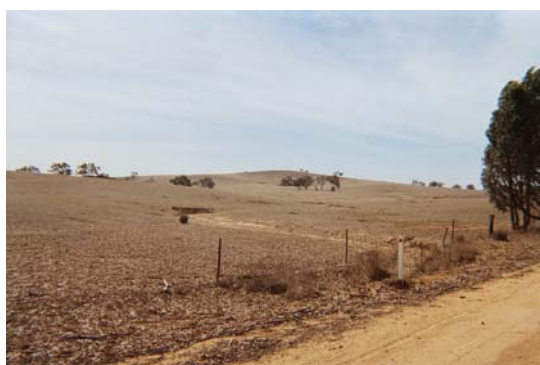
Figure 26: Minor headward erosion in a tributary of Salt Creek

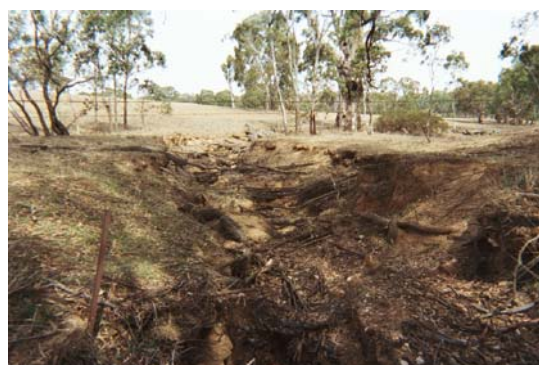
Figure 27: Erosion in tributary of Salt Creek

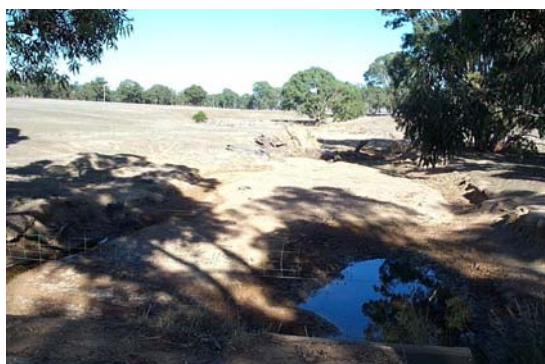
Figure 28: Wattle Creek downstream from Wyndarra Road

Water quality is expected to be poor with stock having access, limited vegetation cover to filter overland flow and sediment within the channel.

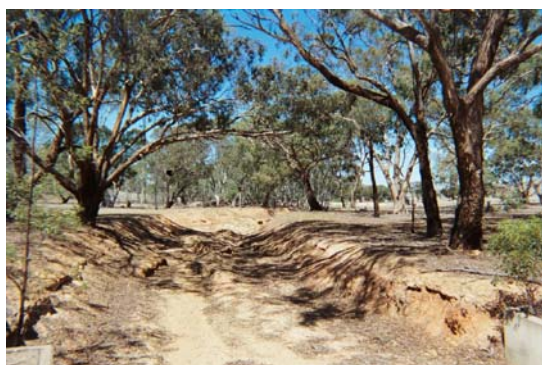
Figure 30: Kirkella Creek upstream from Vineyard Road

Water quality is expected to be poor due to stock access to the creek in the mid section.

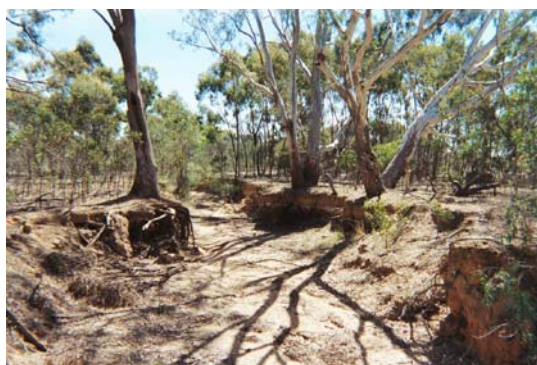
Figure 31: Kirkella Creek in its mid section

Management Actions	Priority for Works
Fence and revegetate along Kirkella Creek between Doctors Creek Kirkella Creek Road.	Medium
Monitor the condition of structures.	Medium
Opportunistic fencing and revegetation.	Low
