Wimmera River Reach 6.2 Waterway Action Plan

November 2002

Wimmera Catchment Management Authority

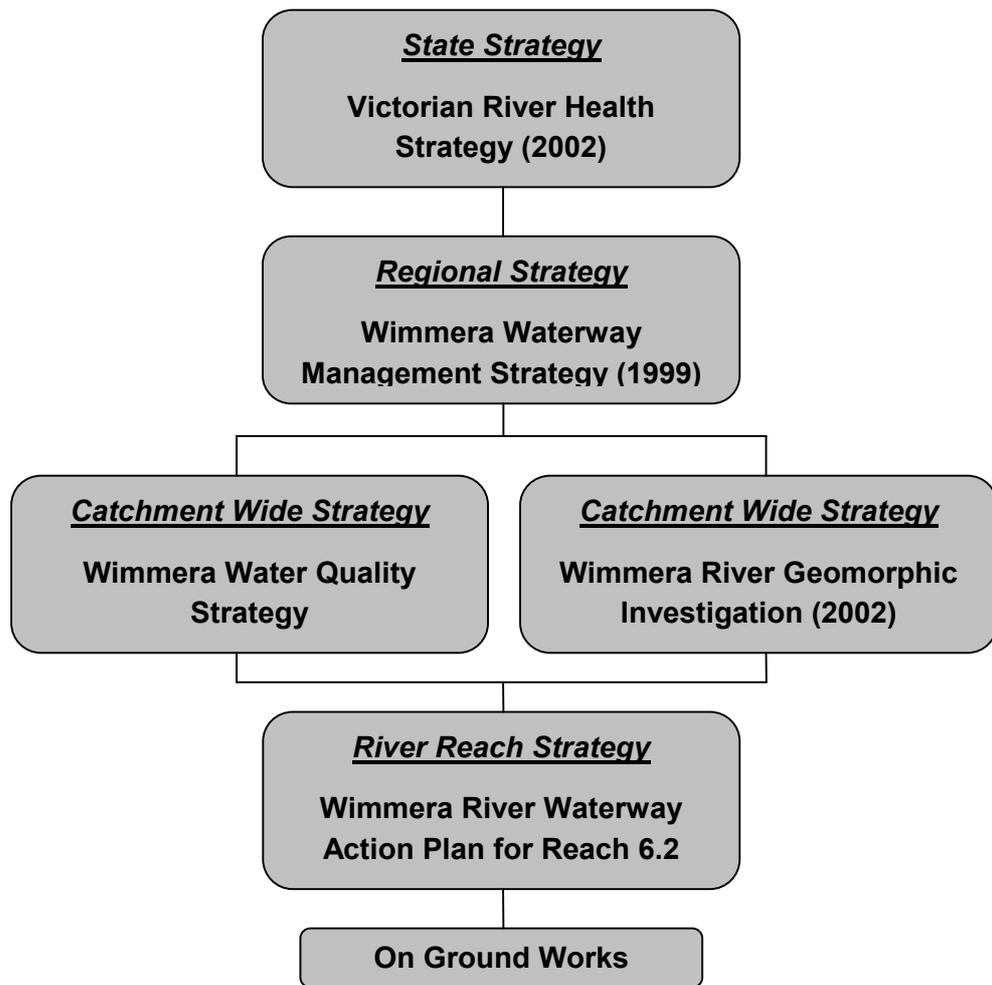
Table 1 summarises this review of strategies which guide and contribute to the Wimmera River Waterway Action Plan for Reach 6.2. Figure 2.1 illustrates the relationship between these reports and the Waterway Action Plans.

Figure 2.1 Relationships between reports used to compile the Wimmera River Waterway Action Plan for Reach 6.2.

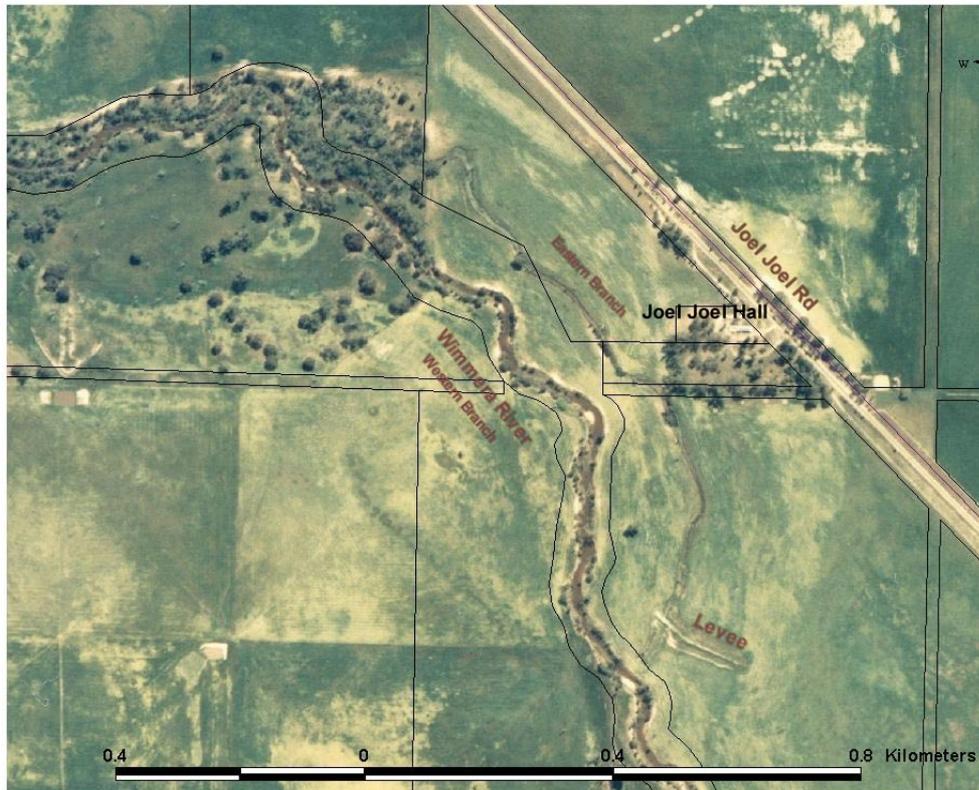
Figure 4. Aerial photo illustrating the good riparian vegetation downstream of Joel Joel hall, and poor riparian vegetation upstream (WCMA Aerial Photo)

For a distance of approximately 1.8km upstream of the fence, the riparian vegetation in Reach 6.2 is in very poor condition (Figure 4). Cropping activity, for stock feed purposes, takes place on the surrounding land which is cleared and cropped to within 2m of the top of the river banks. Some sediment transport into this part of Reach 6.2 is likely to occur from bare soil at immature stages of crop growth. Due to a lack of fencing, when stock are allowed into the area they can enter the stream bed, contributing to bank erosion. Stock are also likely to eat and trample reeds in the stream bed. Toward the upstream end of Reach 6.2 there are some fenced areas, although these are often discontinuous.

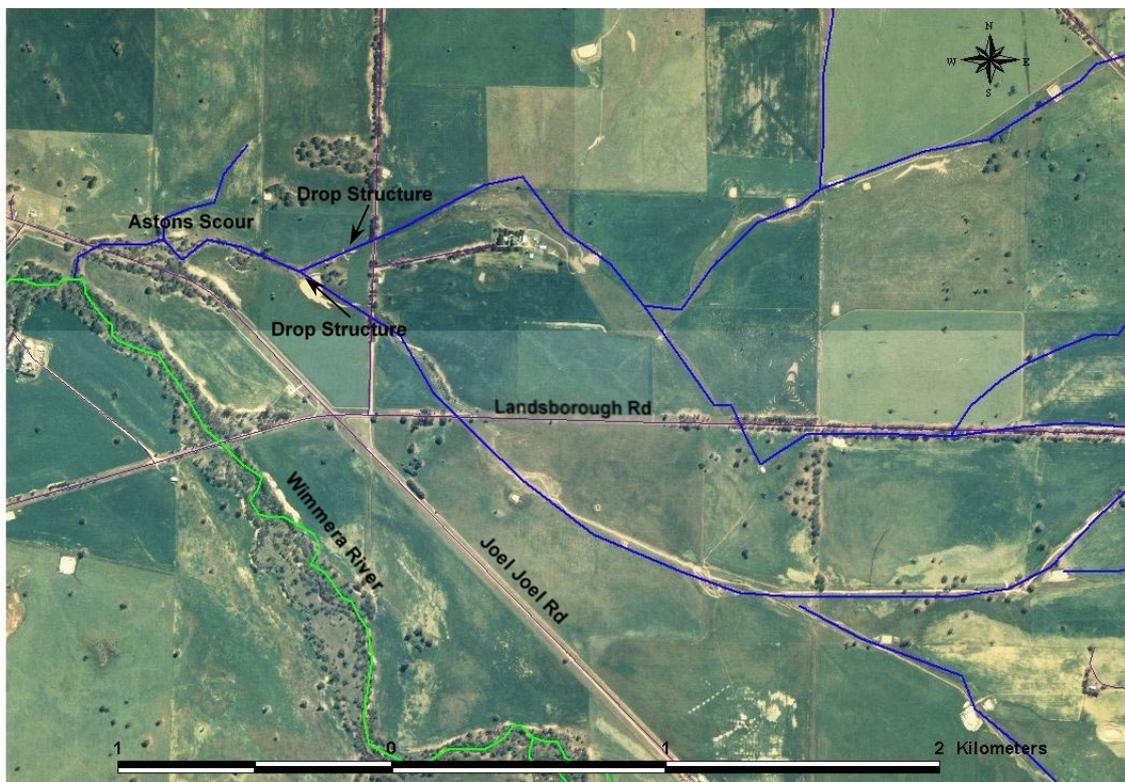
Figure 6. Aerial photo of the downstream end of Astons Scour. The blue line marks the approximate centre of the floodout zones which begins immediately upstream (to the east) of the drop structures.

Sediment is currently prevented from entering the Wimmera River by two concrete drop structures as shown in Figure 6. Therefore the only requirement for works on Astons Scour should be to maintain the integrity of the drop structures and the floodout zone.

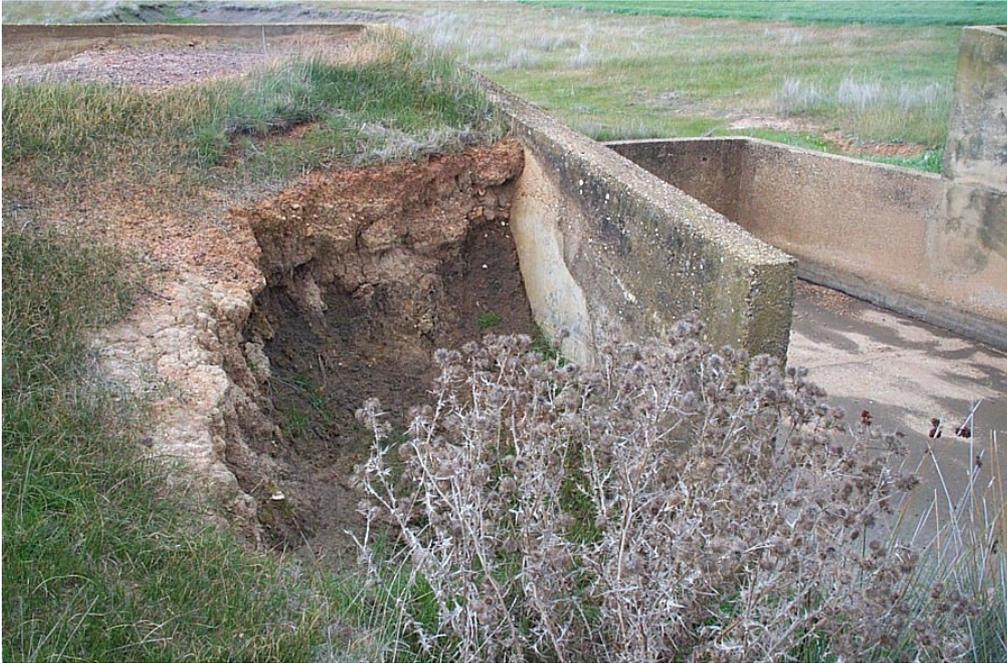
The smaller of two drop structures is located 1 020m from the bridge crossing Astons Scour on the Greens Creek-Joel Joel Road, at position E 678 158 N 5 902 294. This structure is in immediate need of repair as a major storm event could lead to failure and the release of large volumes of sediment to the downstream reach.

- The wing on the right bank of the downstream end of the structure is missing and must be replaced. A scour hole is active around the remaining wall of the structure upstream of the where the wing used to be (figure 7);
- The wing on the left bank of the downstream end of the structure is cracked and in danger of breaking away (figure 8). This crack must be repaired as a matter of urgency.

Figure 7. Scour hole on the right bank of the downstream end of the smaller Astons Scour drop structure. The missing wing would have been attached to the end of the concrete wall beside the scour hole.

- Approximately 2m³ of rock to fill the scour hole;
- Sufficient concrete and reinforcing steel to construct a new wing, and
- Steel plates and bolts to repair the crack in the remaining wing.

It is recommended that this work be carried out in conjunction with the construction of a grade control structure that is required on Six Mile Creek. This will lead to cost savings, as machinery, labour and materials will be in the vicinity.

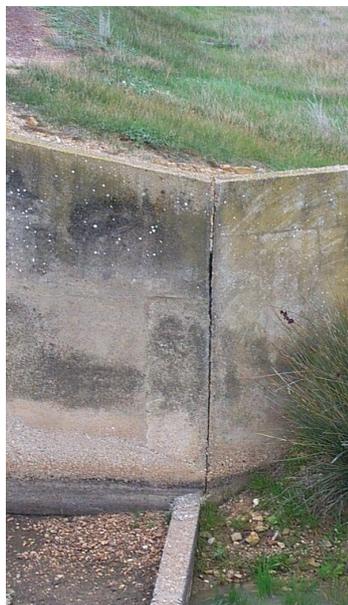
Figure 8. Crack in the left bank downstream end of the smaller drop structure on Astons Scour.

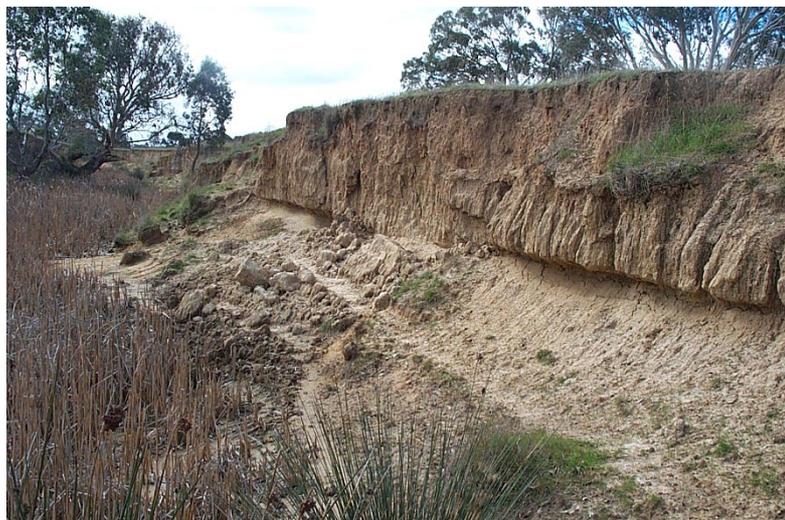
From this point, upstream for a distance of 1.175 km Six Mile Creek is incised to depths of three metres. Undercutting of vertical gully walls is leading to large volumes of sediment becoming mobilized. Figure 10 illustrates a recent collapse of the gully wall within the affected reach. Figure 11 shows the extent of soil loss around the foundations of a bridge which has been in place across the creek for 10 years.

Figure 10. Undercutting and collapse of gully walls in the Six Mile Creek (6 Oct 2002) .

Start of Works		End of Works	
Easting	Northing	Easting	Northing
675 456	5 900 843	675 879	5 900 176
Length of fence required = 2 350m

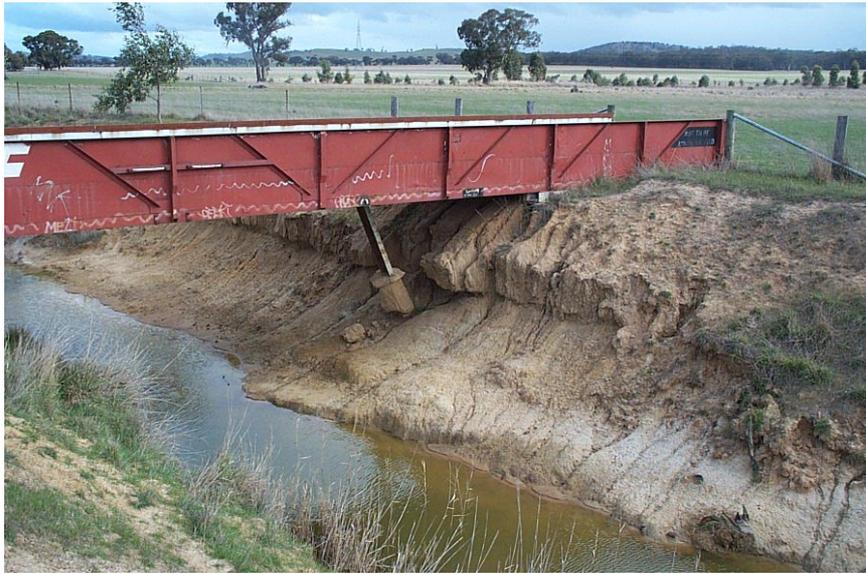
Figure 11. Soil loss around the supports of a private bridge crossing Six Mile Creek
