## Wimmera River Geomorphic Investigation Sediment Sources, Transport and Fate

This is an investigation undertaken by ID&A Pty Ltd for the Wimmera Catchment Management Authority. The investigation comprises a revue of and analysis of sediment processes within the Wimmera Catchment. The purpose of the investigation has been to increase the understanding of processes to assist the ongoing management of the Wimmera River and Tributaries.

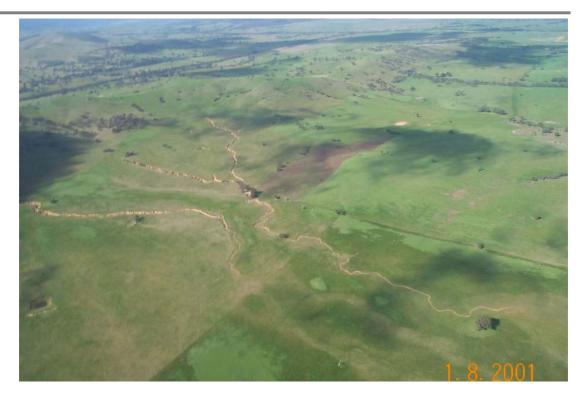
Severe gully erosion floods out at reduction of slope, depositing sediment

Gully erosion liberates large quantities of sediment that degrades water quality, damages aquatic ecosystems and has the potential to substantially alter the geomorphic character and behaviour of the major streams of the drainage network **if** the sediment is delivered to them. Within the Wimmera River catchment, not all gullies (and subcatchments) are delivering sediment to the river, many of them floodout (see Photo 2.1).

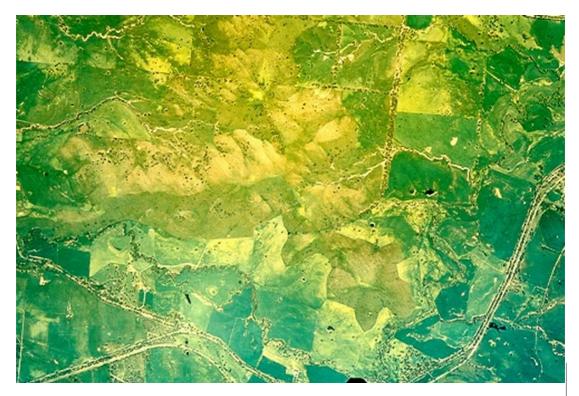
Aerial Photo, Wimmera River Reach 3, adjacent Pyrenees Highway

Riparian overstorey vegetation is discontinuous, however much more abundant than upstream. Stock access is not controlled, however ground conditions are less favourable for unrestricted access.

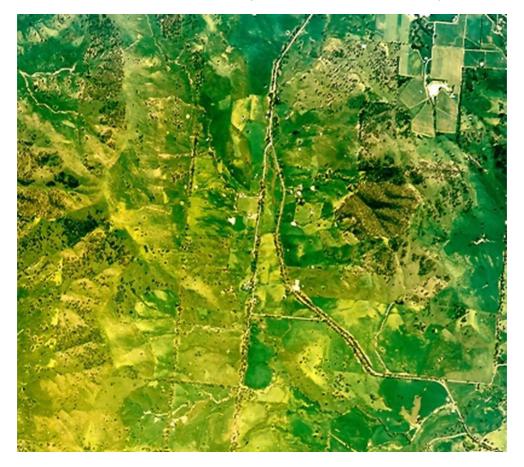
#### Aerial Photo, Glenlofty Creek

One of the reasons why this chain of ponds has not been subject to contemporary incision processes is that its downstream controls, the geologically incised Wimmera River, have been relatively insensitive to changes, hence Glenlofty Creek has adjusted to those conditions over a geological timeframe. It also appears no deliberate attempts to drain Glenlofty Creek have been made as yet.

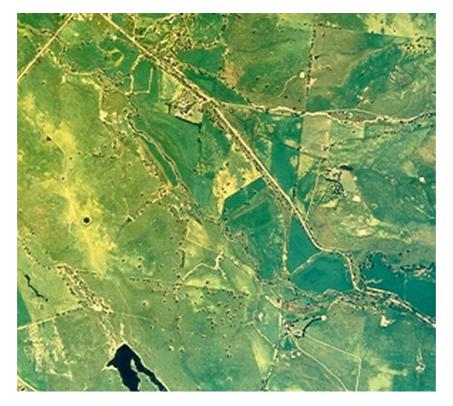
Aerial Photo, Wimmera River Reach 4

This formation of a continuous, incised channel in this reach may have been by excavation of a channel and/or headward incision from downstream in combination with vegetation clearance and land use change. A major tributary sediment input at the downstream end of this reach may contemporally be assisting in the filling of this reach by backwater effects. This tributary (Spring Creek) may have also been the long-term cause of the local floodplain expansion.

There is very little riparian vegetation and the floodplain is cultivated to top of bank.

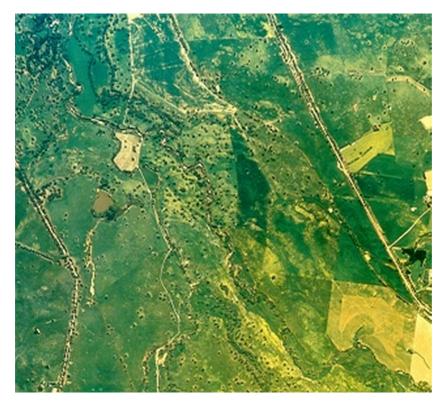
Aerial Photo, Wimmera River Reach 5

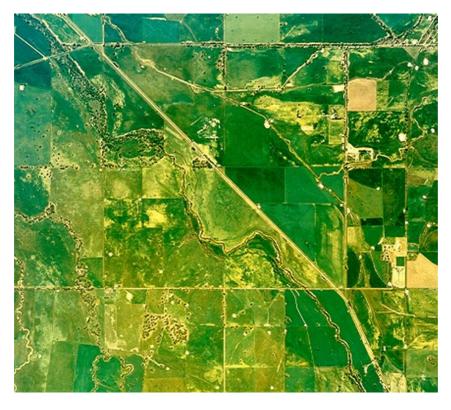
Aerial Photo, Wimmera River Reach 6 (Joel Joel Bridge top left)

This reach is a recovering fill/chain of ponds (see Joel Joel Bridge), it also represents the transition zone into the markedly different character of reach 7. The same sediment layers are present in the banks as in reach 6.1, indicating a swampy environment and contemporary deposition on the floodplain. Lateral migration of the contemporary, continuous channel is more active than in reach 6.1. The recovering form appears to be adopting a pool-riffle sequence (see near Six Mile Creek confluence), with macrophytes colonising the riffles and assisting in aggrading those riffles.

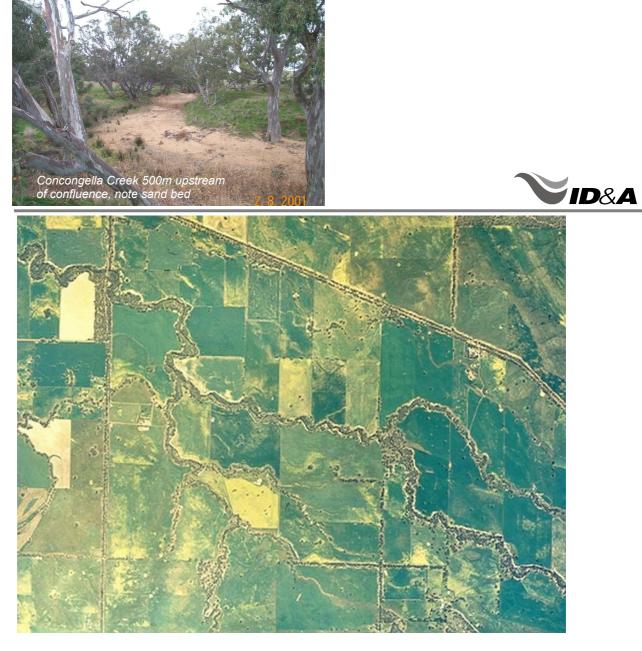
Aerial Photo, Wimmera River Reach 7, including Concongella Creek confluence

Reach 7 is characterised by a continuous dominant alluvial channel and one or more anabranches/flood channels in parallel. The main channel is similar in character to other reaches downstream, deep, narrow and dominated by vertical processes. The banks of this reach are generally very stable due to the presence of mud drapes (and vegetation), where they are not present banks may be unstable. Some of the outbank erosion observed in this reach may also be attributable to saline groundwater. In channel geomorphic units are generally pools and riffles or runs, there are also occasional lateral and vertical bedrock controls.

Anabranches in this reach may take the form of developing flood channels, decaying paleochannels (often observed as channelised Chain of Ponds) or deferred tributary confluences.

The first major distributary of the Wimmera River, Dunmunkle Creek, occurs in this reach, flow commences into this system at near bankfull flows in the river. In close proximity to this an inter basin transfer channel has been constructed, this takes flows into Swedes Creek, a tributary of the Richardson River. This channel would commence to flow at approximately 85% bankfull in the Wimmera River. It is possible that high flood flows may have made their way to Swedes Creek under natural conditions anyhow.

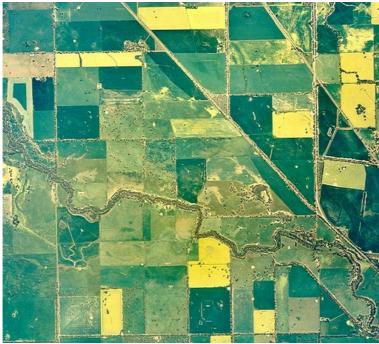
Aerial Photo, Wimmera River Reach 8, Company's Bridge area

This reach contains a short section with bedrock controls downstream of Glenorchy, restricting both incision and lateral migration in the Company's Bridge area. It is not known what geologic formation this bedrock belongs to however, it is likely to be a ferruginized layer of Parilla Sands (refer Drawing No.2701046-016). The Parilla Sands are mapped on the surface in this area on the south side of the river where no surface drainage channels are seen on the map (refer Drawing No. 2701046-014). The Parilla Sands will supply quartzose sands to the Wimmera River.

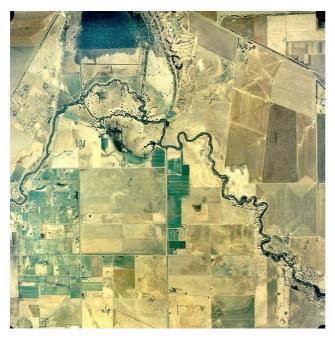
Aerial Photo, Wimmera River Reach 10 at Dooen Swamp (top)

The Wimmera River transforms from a series of multiple poorly defined channels through Marma State Forest to essentially a single channel across the southern end of a triangular landform, which has Yarriambiack Creek along its eastern boundary and leaving at its northern apex. Associated with this dominant channel are actively developing and decaying flood channels.

The downstream control on this reach is a lunette ridge, which may have temporarily blocked the Wimmera River during the period of land surface evolution dominated by Aeolian processes in this region. The temporary blocking of the Wimmera may have lead to the formation of a lake in the near triangular land surface feature. A series of north-south ridges are present in this depression. Yarriambiack Creek development may have been associated with this transient feature, acting as the escape channel from the Darlot Swamp area.

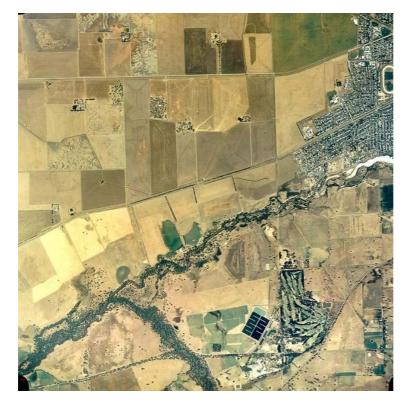
Aerial Photo, Wimmera River Reach 11 downstream of Horsham

This reach extends from the lunette ridge of Reach 10 to Francis Swamp. It is characterised by a single (except in Dooen Swamp) well-developed channel. The channel trench is more developed at the downstream end, with an incised compound cross section, containing several floodplain surfaces. The river is laterally inactive, dominated by vertical floodplain accretion processes. The river follows the boundary between Parilla Sands and Shepparton Formation for most of this reach. The downstream extent of the reach is associated with an outlier of the Lowan Formation dune field encroaching onto the floodplain.

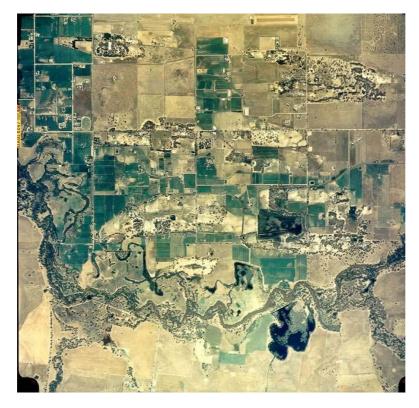
Aerial Photo, Wimmera River at Vectis South (note Lowan Formation east – west sand dunes)

Reach 12 through Vectis South begins near Francis Swamp, adjacent where a Lowan Formation outcrop remains on the north side of the river. The floodplain width is substantial in this reach, containing multiple level surfaces creating a compound cross section. There is a dominant channel and one or more flood channels (which are most likely paleochannels), which activate at greater than half bank full flows. One of these channels abuts the floodplain margin against the Lowan Formation. The river is more laterally active than in reach 11.

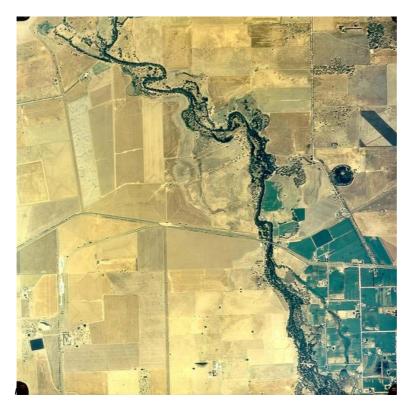
Aerial Photo, Wimmera River at Wimmera Highway

Reach 13 contains a single, well-developed channel. The channel belt follows the boundary between Parilla Sands and Shepparton Formation, as per Reach 11. This reach has a sand bed, likely to be sourced from the dune sands upstream and local marine sands. Some meander cut-offs have occurred in this reach, however rates of geomorphic change are very slow. Low sediment supply may also hinder the rate at which infilling of abandoned channels occurs.

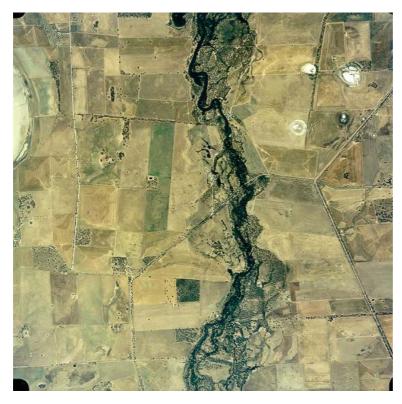
Aerial Photo, Wimmera River at Polkemmet Bridge (centre)

Reach 14 is an anastomosing reach with 2 or more channels activated well below floodplain level flows. Rates of channel development and decay appear more rapid than nearby upstream reaches, most likely due to the easily mobilised sands that make up the floodplain. The channels contain short deep pools separated by sandy riffles mostly colonised by phragmites and tea tree. These channels are contained within a relatively broad nearly straight channel belt that follows the boundary of Shepparton Formation sediments and the Aeolian sands of the Woorinen Formation.

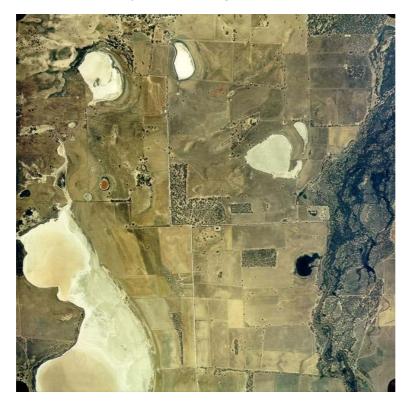
Aerial Photo, Wimmera River at Duchembegarra

Reach 15 is characterised by a single dominant channel in a locally contracted floodplain. The channel is well developed and is substantially larger than channels found in adjoining reaches. The character of this reach is likely to be influenced by the close proximity of lunette ridges at the western floodplain margin.

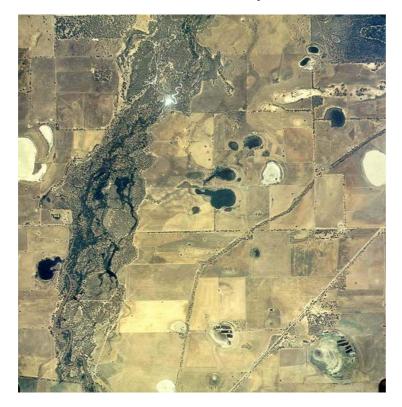
Reach 16 extends from Duchembegarra to Ellis Crossing. It is an anastomosing reach, containing sections of dominant channel and poorly developed or decaying anabranches and sections where all channels are immature or nearly infilled and operate at equal flow levels.

The underlying marine Parilla Sands exert soft bedrock controls on this reach, incision and lateral migration of the channel belt is controlled by the sandstone that is often ferruginized (iron cemented). This is the case at the invert of the offtake of one of the anabranches near Mackleys Road.

Aerial Photo, Wimmera River at Ellis Crossing (top)

Works have been undertaken near Mackleys Rd by the WCMA in an attempt to prevent an 'avulsion' where it was perceived by landholders that a channel, which flows along the western margin of the channel belt, was developing rapidly. The development of this channel has been influenced by the clearing of riparian and instream vegetation, overgrazing and the ford at the end of Mackleys Rd possibly reducing sediment inputs to the downstream section. The WCMA works include the placement of rock and LWD at the upstream end of the anabranch to raise the sill level. These works are not likely to be the solution to the perceived problem. Inspection of the bed of the anabranch channel at its offtake revealed siliceous sands (Parilla Sands, lithified to sandstone), which are resistant to the erosive forces exerted by flows here. The presence of this sandstone is likely to be the reason why this channel had not developed further prior to the works.

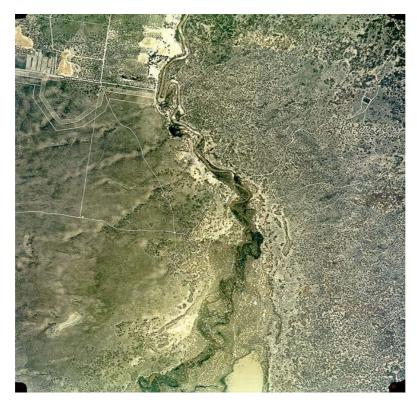
This reach corresponds with the river cutting through the east-west Lowan Formation sand dunes of the Little Desert National Park. It is characterised by a single, comparatively large (width and depth) channel within a narrow floodplain/channel belt bordered by the sand dunes covered in intact vegetation associations. Cemented Parilla Sands are supplying 'soft' gravel size fragments to the stream. Within the channel belt much of the sediment is fine grained and cohesive alluvial material. Sinuosity is irregular, there are long pools or runs, sometimes separated by short high angle bends with sandy point bars on the inside. On the whole geomorphic processes happen at very slow rates. More open water pools are present within this reach than in reaches 13 through 16.

Lateral migration of the Wimmera River in this reach is controlled by the sandstone (Parilla Sands), which has been uplifted on the west side of the river by the Hindmarsh Fault.

Aerial Photo, Wimmera River in Little Desert National Park

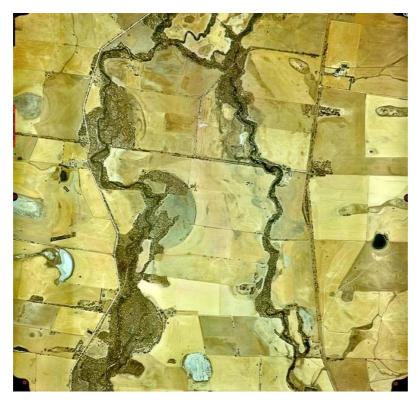
This reach corresponds with the extents of the anabranch known as Datchak Creek, shortly downstream of Dimboola to Antwerp. The anastomosing character of this reach is different to the other anastomosing reaches described here. Distinct from those reaches where the multiple channels are contained within a channel belt less than several hundred metres wide, the main channel and Datchak Creek here are separated by a large island several kilometres wide. The island has aeolian units on its surface, above floodplain level.

The main channel of the river flows through the windward (western) side of several small lunette lakes in this reach, several flood channels are present through the lakes. Lateral migration of the channel is limited in the former lakes by the calcareous clays and sands.

Aerial Photo, Wimmera River and Datchak Creek (note lunette lakes)

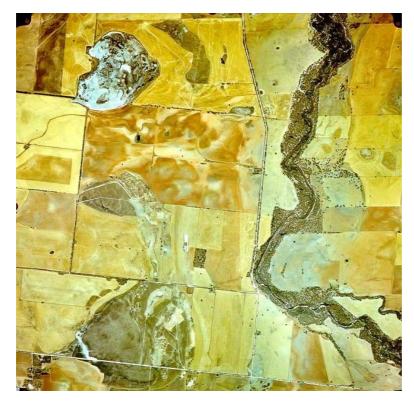
Reach 19 is characterised by a single dominant, well-developed, laterally inactive, low sinuosity channel in a reach with locally variable features. Sandy point and longitudinal bank attached bars are the prevalent instream geomorphic units with long pools and runs. Flood channels (probably paleo channels) are present across the floodplain, which become activated at bank full flows. One flood channel at Tarranyurk is separated by up to a kilometre of floodplain, this channel appears to be decaying at its upstream end.

Occasionally the channel reduces in capacity and splits into 2 channels around vegetatated islands in the channel belt for short (<1km) reaches. There are many benches in these reaches creating a compound cross section.

Aerial Photo, Wimmera River downstream of Tarranyurk

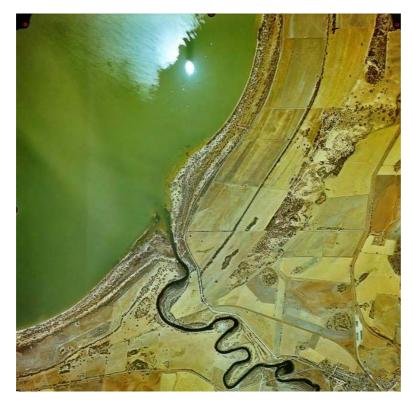
The last reach of the river before entering Lake Hindmarsh is extensively influenced by backwater effects of either the lake containing water, Jeparit weir and/or the deltaic deposits at the river mouth. The river is sinuous, has many meander cut-offs, billabongs, concave benches, islands and point benches.

Aerial Photo, Wimmera River entering Lake Hindmarsh when full
