Final Report

Green Lake Waterway Action Plan

Wimmera Catchment Management Authority

19 March 2024

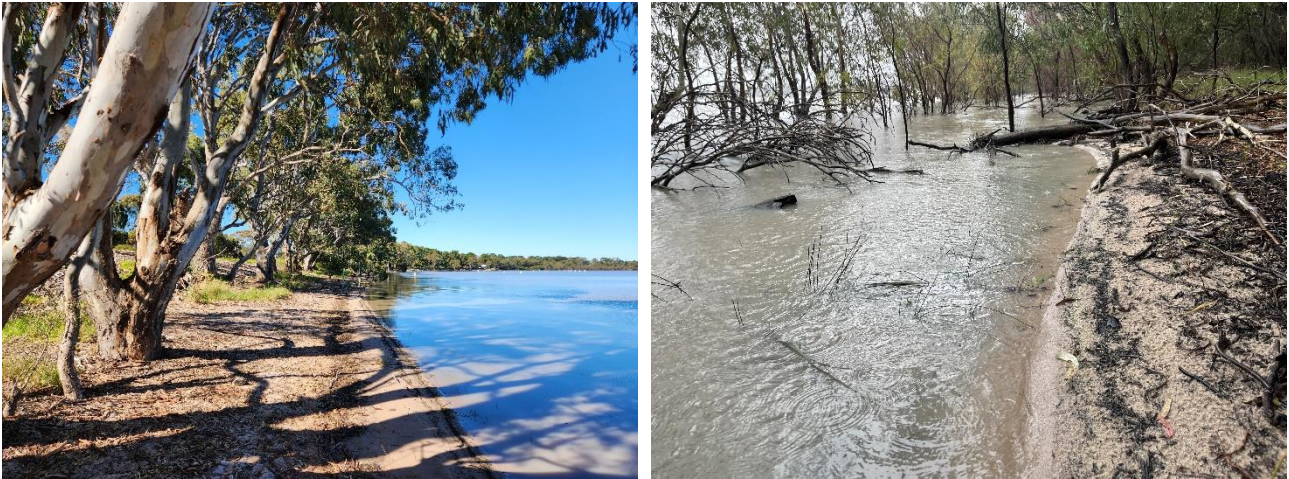
Lunettes are crescent shaped aeolian deposits of fine sediment located on the eastern (or lee) side of lake beds or playas in semi-arid areas of southern Australia (VRO 2023a). The north eastern lunette margin has a mostly gentle sloping sandy shoreline, with a high lunette sandy ridge behind (Figure 5-3).

Figure 5-3 Gentle sloping sandy lake margin adjacent to the lunette

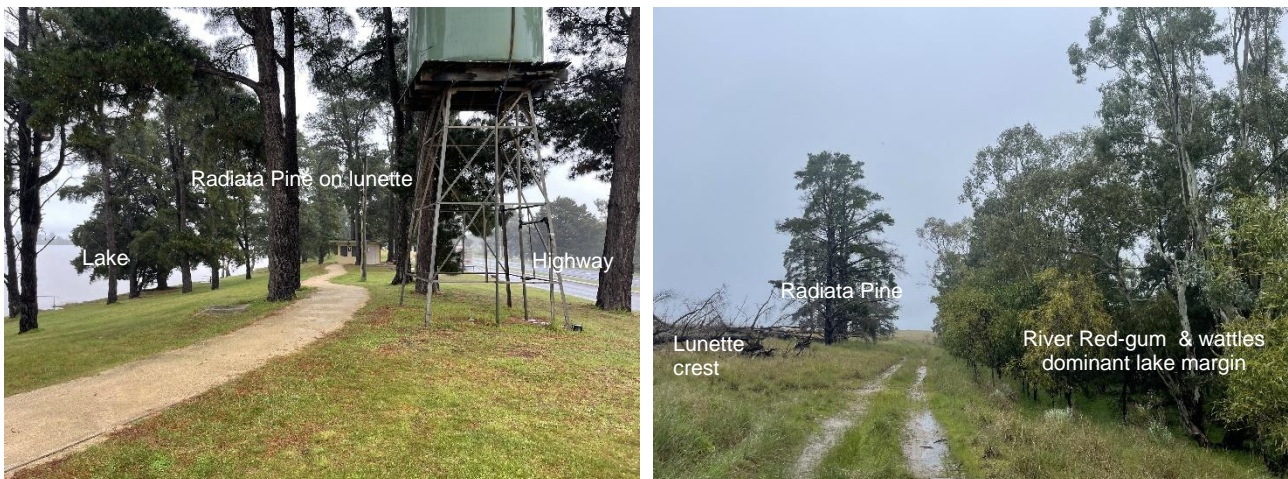
River Red-gum's dominate the margins of the lake adjacent to the lunette where they have regular, if not continuous, access to water within the lake sands. The lunette vegetation is highly disturbed, particularly around the Recreational Precinct between the Horsham Yacht Club and the Boat Ramp. The lunette vegetation has been impacted by the development and exotic species often dominate the precinct, including exotic Radiata Pine trees (Figure 5-5). Native Cypress Pines and wattles were observed along the lunette south of the Yacht Club. The invasive weed Bridal Creeper was also observed in patches across the lunette behind and south of the Yacht Club.

Figure 5-5 Pines dominate the lunette within recreational precinct (left), River Red-gum and wattles dominate the lake margin adjacent to a mostly cleared lunette (right)

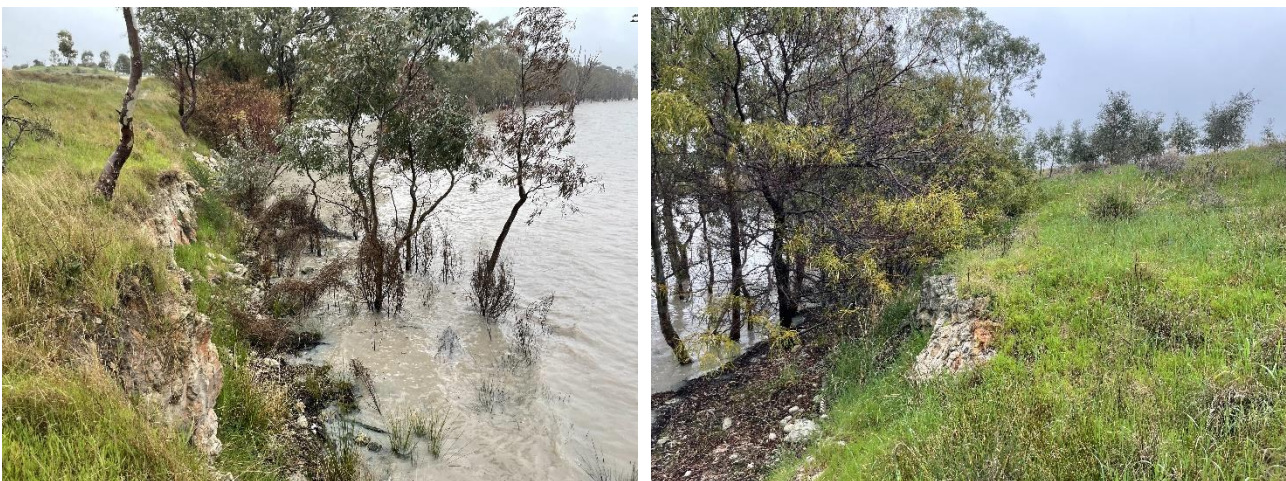
Figure 5-6 Steep edged margins on the western (left) and northwestern (right) sides of the lake

The lake margin away from the lunette (e.g., along the western, southern and southeastern edges) are characterised by a steep drop-off, typically about 3-5 m high). It is presumed the lakebed slowly deepens from the toe of the bank and wattles were often observed growing out into the water for a distance up to 10 m. Note that Green Lake was almost full (92% full) at the time of assessment. It is likely that the lakebed inside the wattle and eucalypt regrowth stays saturated for extended periods preventing further expansion of woody vegetation (terrestrialisation) into the lake. It is also likely that this woody vegetation growing in the water at the edge of the lake (as shown in Figure 5-3 & Figure 5-6) would drown if water levels were maintained above 90% for extended periods (i.e. > 1 year).

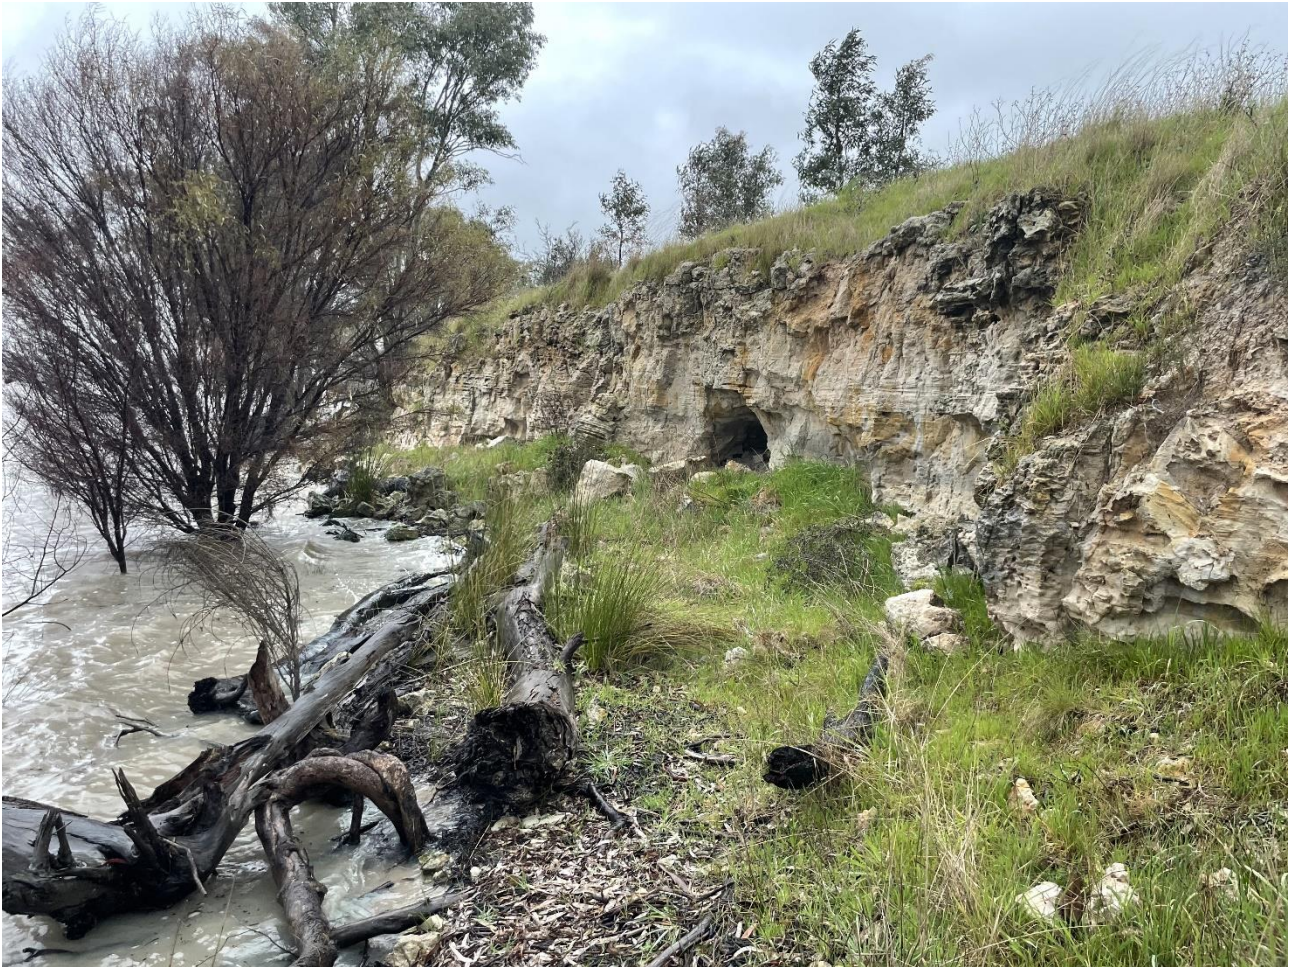
Figure 5-7 Western side wall of Green Lake showing sodic older alluvial plain material

Green Lake forms part of the 'Horsham Lakes lunette clusters' landform unit. *"This low depositional complex unit is part of the Northern Riverine Plains. These swamps/swales/playa and lunette complexes of Quaternary sediments occur as depressions within the fan material of the older alluvial plain. Site drainage is slow to very slow but moderately well drained on the lunettes. Soils are sodic yellow, brown and grey texture contrast soils (Sodosols) with grey cracking clay soils (Vertosols), with sodic red contrast soils also found on the lunettes."* (VRO 2023b). What we see on these side walls (banks) of the lake (Figure 5-7) is the exposed older alluvial plain clays. These clays are dispersive and the bank shows signs of undercutting, likely due to wave action from wind and boat wash, and subsequent collapse. Blocks of collapsed bank material are evident at the toe of the bank. This dispersive bank material is a likely contributor to Green Lake's milky water appearance.

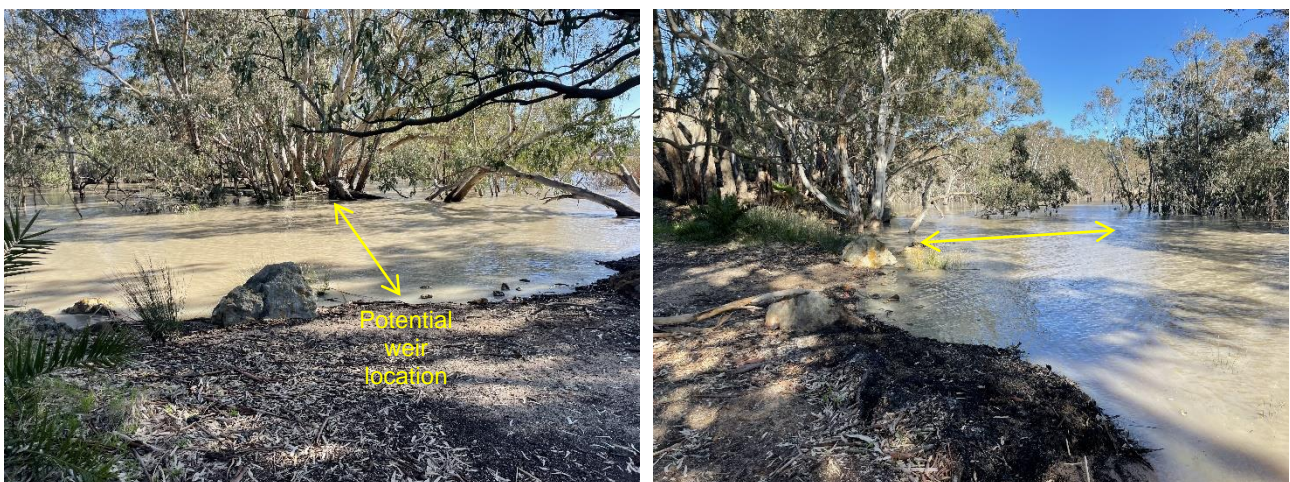
Figure 5-9 Creeklane/wetland entry point to Green Lake showing potential weir location

This area has potential for the creation of a well vegetated wetland to help capture sediment and nutrient from the creek inflows prior to entering the lake. A treatment wetland might be created by installing a weir structure that would provide the ability to control the water level and inundation duration. The concept would not involve damming and elevating water level, but installing a weir structure that could maintain water longer to support aquatic/emergent native vegetation, which in turn provides the filtering and nutrient stripping that would help to reduce the likelihood of blue-green algae blooms. The main outlet between the creeks and Green Lake is a relatively narrow passage less than 15 m (Figure 5-9).

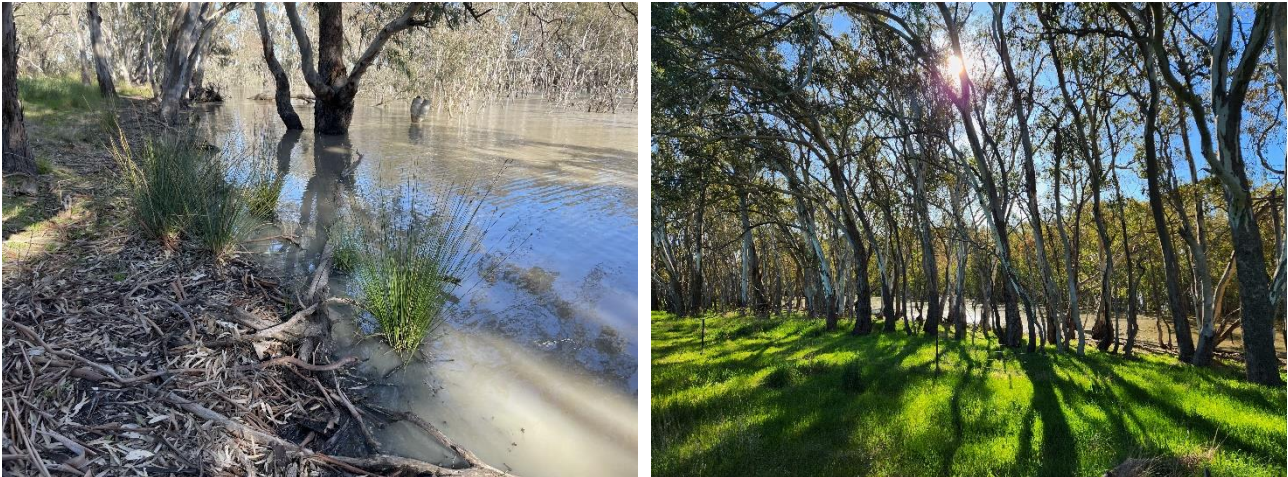
The water level was relatively high at the time of the field inspection. It was difficult to get a clear understanding of the weir location and potential size. Similarly, the extent of inundation and number of trees that might be affected by a more continuous water level/inundation could not be determined. Observing the number of live trees observed sitting in the water at the time of inspection (Figure 5-10) suggests that the high water level (92% full) does not occur frequently, or that the water naturally draws down relatively quickly thereby preventing drowning.

Figure 5-10 View up the Mibus Ck arm (left) and the Diggers Ck arm (right)

This potential wetland area requires further investigation to determine feasibility of the concept.

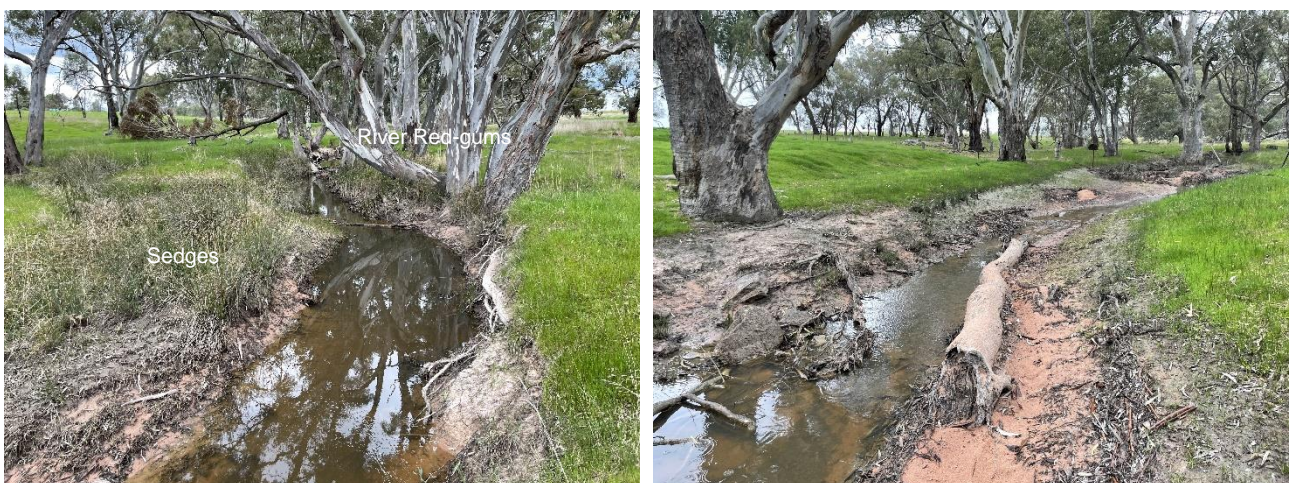
Figure 5-11 Typical Diggers Creek channel within Reach 3

This reach extends from the upstream inundation extent of the potential wetland to Bungalally Bushland Reserve. The creek is approximately 5-7 m wide and 1.2-1.5 m deep and the native vegetation was confirmed as having affinities with EVC 640 Creekline Sedgy Woodland with River Red-gums being the dominant tree canopy over native rushes, sedges and a variety of grass species (Figure 5-11). Yellow box were also observed, mostly slightly higher on the floodplain. Grazing pressure around the creekline, particularly in the downstream half of this reach, was light, allowing a diversity of ground layer species to remain. However, natural recruitment of woody species was scarce to absent, suggesting grazing or macropod browsing is limiting regeneration. The shrub understorey, which is naturally quite sparse, was virtually absent.

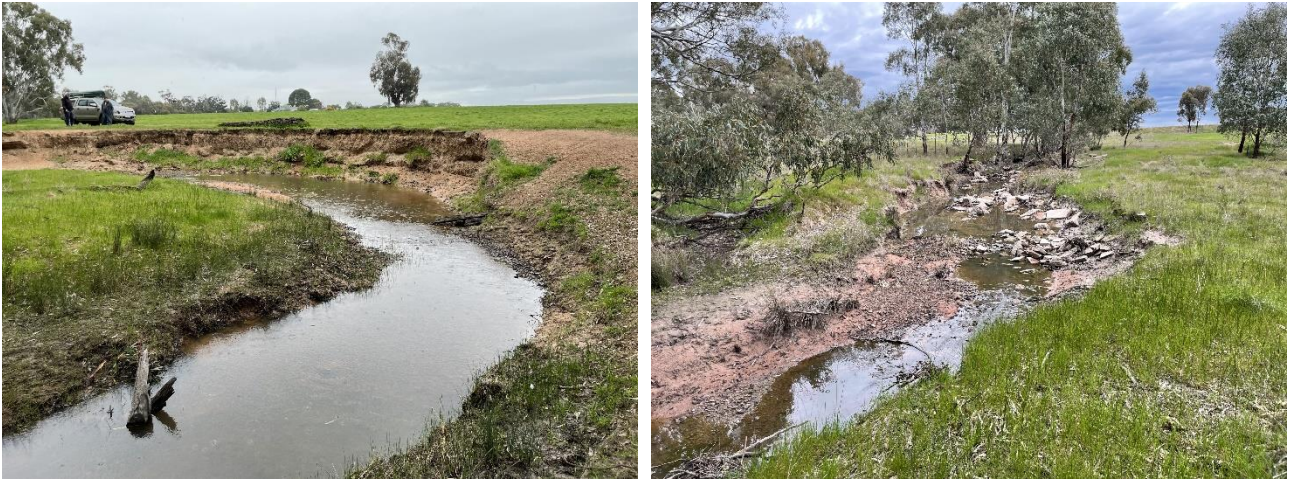
Figure 5-12 Erosion sites including a deepening meander cutoff (left), and outside bend migration (right)

Several discrete bank erosion sites were observed within this reach, which are primarily located on outside bends with very little woody riparian vegetation capable of assisting channel stability (Figure 5-12). These erosion sites have the potential to contribute on-going sediment and nutrients into the Diggers Creek and Green Lake system. Notably, this reach also comprised a section of floodplain erosion associated earthworks undertaken several decades ago. A secondary flow path has formed as a result of the primary channel having been blocked. This has subsequently led to a new channel being eroded that likely now acts as the primary flow path. On-going erosion at this location is contributing both sediment and nutrients into downstream reaches. Concrete rubble has been placed in the floodplain channel, however this is having limited benefit to managing the erosion (Figure 5-12).

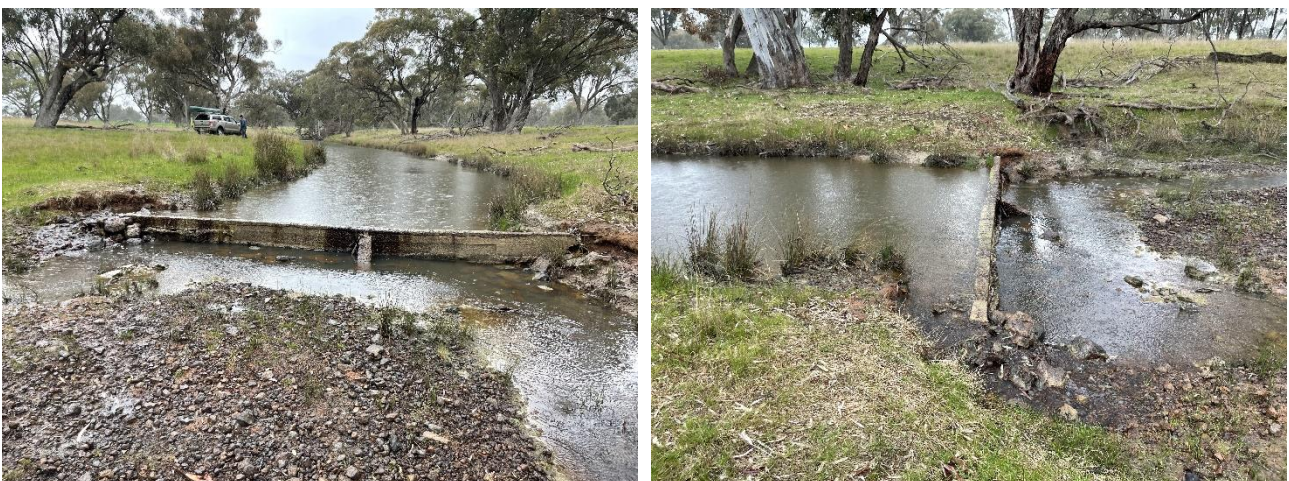
Figure 5-13 Small weir and weir pool

Towards the upstream end of this reach a small fixed-crest weir was observed. This is an old structure which was in disrepair, being outflanked on both ends. Despite being damaged the weir was holding water to crest height and providing pool habitat upstream and potential refuge for aquatic life.

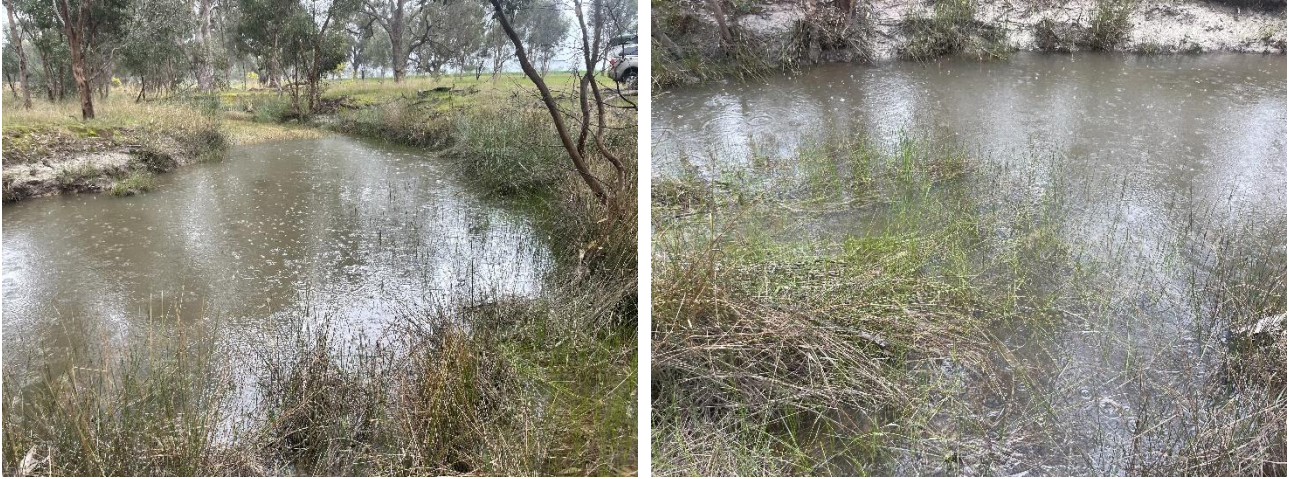
stable, with well vegetated banks and bedrock outcropping in the base of the channel. Instream habitat diversity was evident with fringing and aquatic species present, overhanging vegetation, pools, and riffles (Figure 5-14). Frogs were heard calling from the pools with abundant fringing vegetation.

Figure 5-14 Pool with fringing and emergent native vegetation providing important habitats for aquatic life

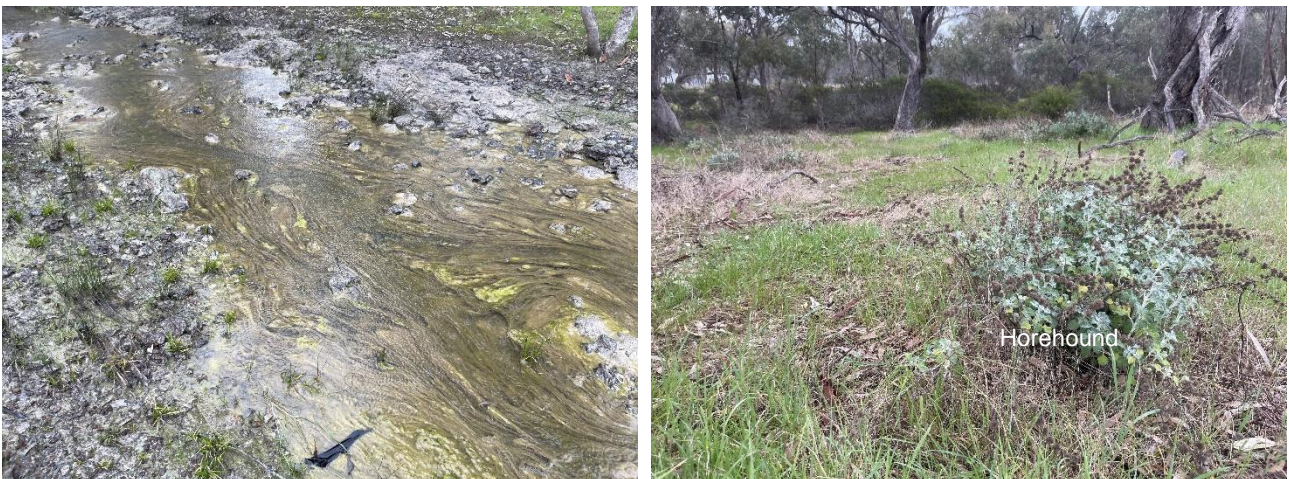
Despite the well vegetated and ungrazed channel, filamentous algae was observed in the bed of the creek. The presence of algae suggests high nutrient loads within Diggers Creek. The algae was evident on the outcropping rock bar, so its presence may be due to having a stable substrate on which to attach. This might explain why this filamentous algae was not observed in the sandy bed stream reaches downstream. The highly invasive weed Horehound *Marrubium vulgare* was observed within the reserve (Figure 5-15). This listed environmental weed can disperse rapidly and should be controlled.

Figure 5-15 Algae on rock bar instream (left) and Horehound weed (right)

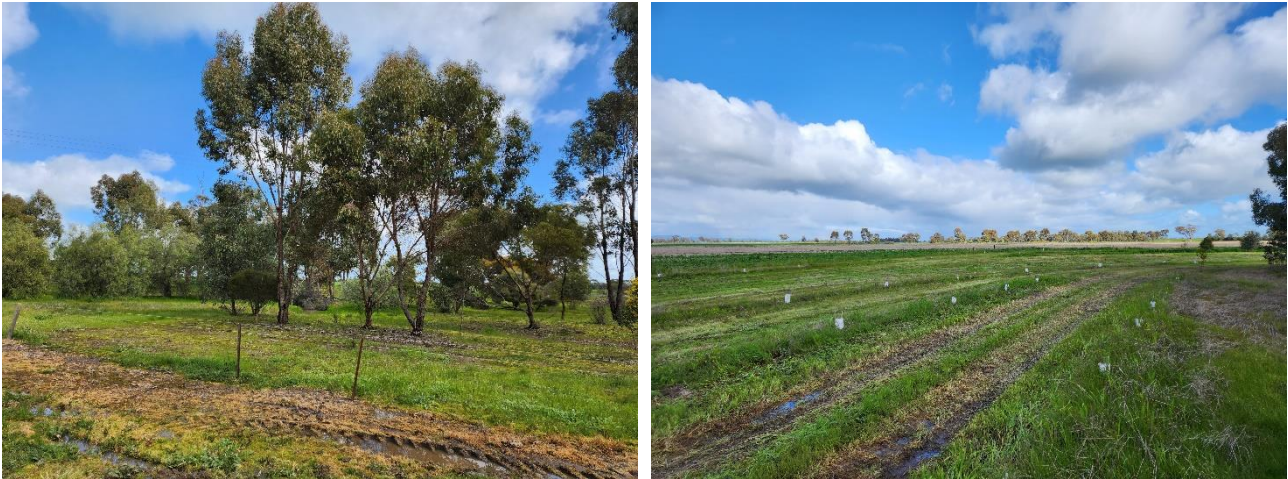
This reach includes Diggers Creek and at least two tributaries upstream of Old Wartook Road. All waterways on the upper Diggers Creek from the Old Wartook Road to the Toolondo Channel have been revegetated with native trees and shrubs (Figure 5-16). The channel size is much reduced as this reach is not receiving the water from the Toolondo Channel and is bypassed by the Green Lake Channel (Reach 6).

Figure 5-16 20-year-old plantings on Diggers Ck (left) and recent revegetation on a tributary (right)

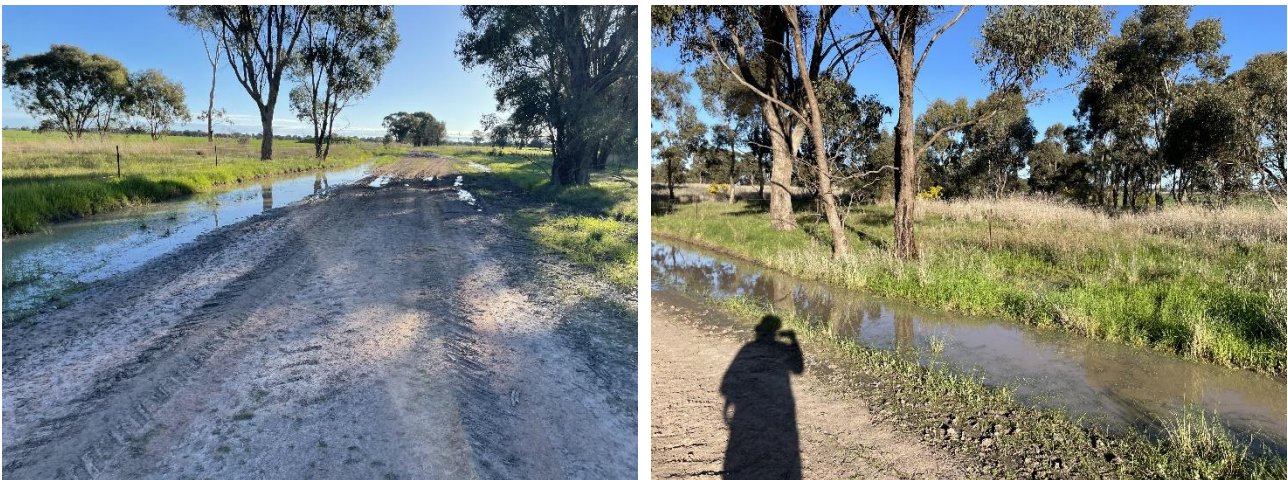
Figure 5-17 Arnotts Road crossing of Diggers Ck (left), looking up the ill-defined Diggers Ck from Arnotts Road (right)

There are no known erosion issues in this reach, however, Diggers Creek passes over Arnotts Road (effectively a ford) and becomes impassable in very wet conditions (Figure 5-17). It is understood that funds have been committed to provide a new culvert at this location. Despite no fish being recorded in this section of creek, the proposed culvert should be made wildlife friendly. This might be achieved with use of an inverted box culvert with steel mesh over the top to allow light in and encourage fish and other fauna to travel through the culvert unimpeded.

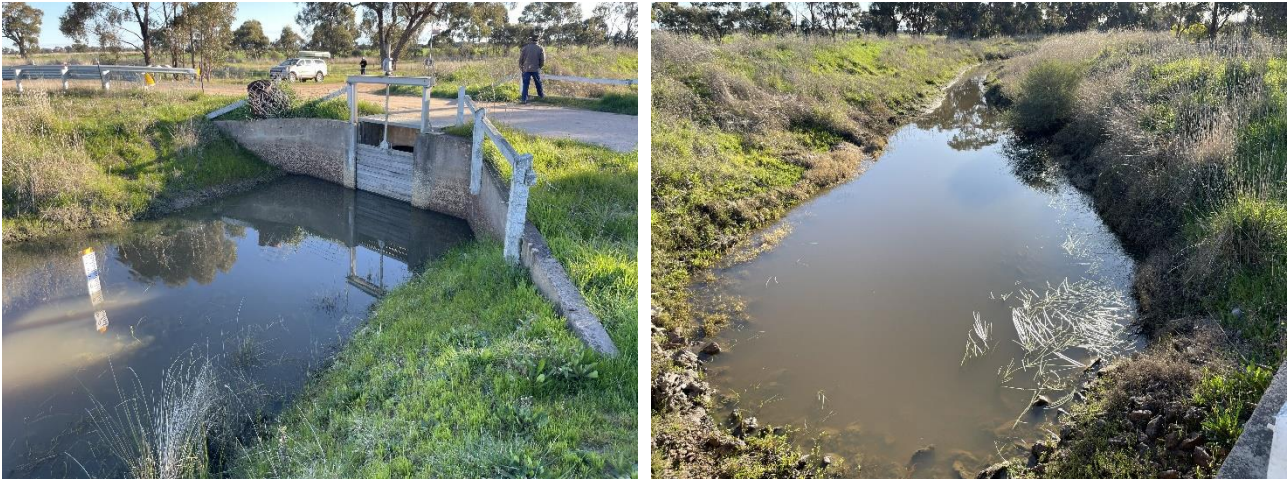
Figure 5-18 Offtake penstock gate and earthen channel immediately downstream.

The Green Lake Channel receives water from the Toolondo Channel via a penstock gated structure (Figure 5-18) and delivers it into the natural Diggers Creek alignment. The channel is mostly straight, running parallel with Old Wartook Road, and is approximately 1.4 km long in total. It is an earthen channel from the gate until the final 250 m, where it becomes a rock-lined and concrete-lined channel (the remaining concrete-lined channel is in disrepair), before plunging over a drop structure (approximately 1 m high) as it meets the natural Diggers Creek.

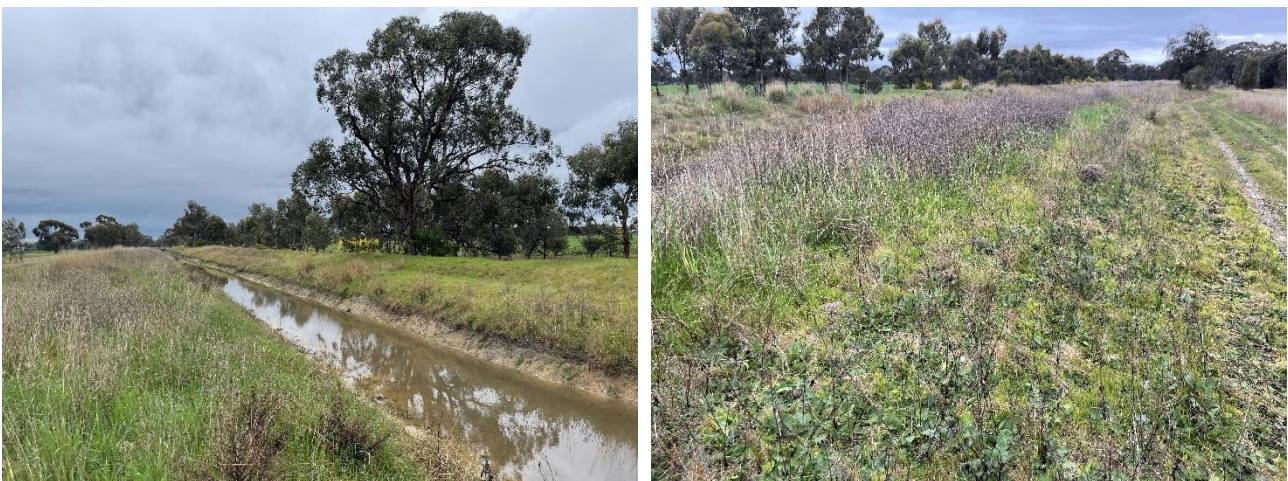
Figure 5-19 Earthen section of channel (left), open space along the southern edge of the channel

The upstream 1.15 km earthen section of the channel is relatively flat and contains some native plants, including water ribbons *Cycnogeton* sp., however, the regular ‘cleaning out’ of the channel appears to limit aquatic vegetation colonisation of the channel. This section of channel may provide opportunity for the creation of a sediment pond and linear treatment wetland as there is ample open space along the southern side of the channel. This opportunity is further discussed in Section 7.

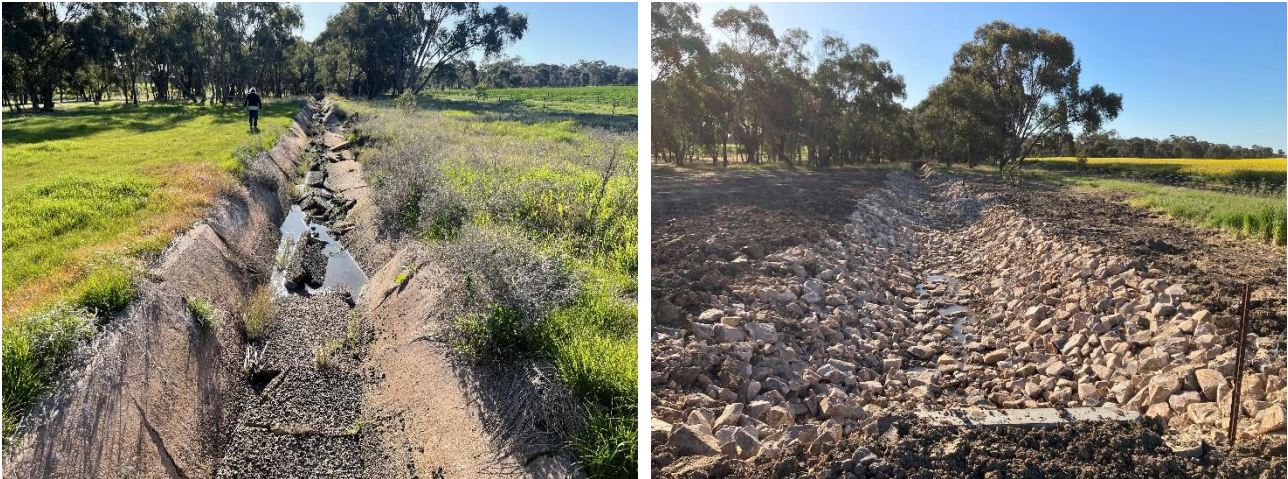
Figure 5-20 Upper concrete lined section of channel, before and after replacement with rockwork

The upstream half of the concrete lined section has recently been removed and replaced with rockwork (Figure 5-20). A larger capacity culvert has also been installed at the upstream end of the rockwork. It is for reference prior to meeting presumed this downstream section of the channel is steeper as it transitions down to the drop structure and Diggers Creek, and therefore requires engineered bed and bank stability.

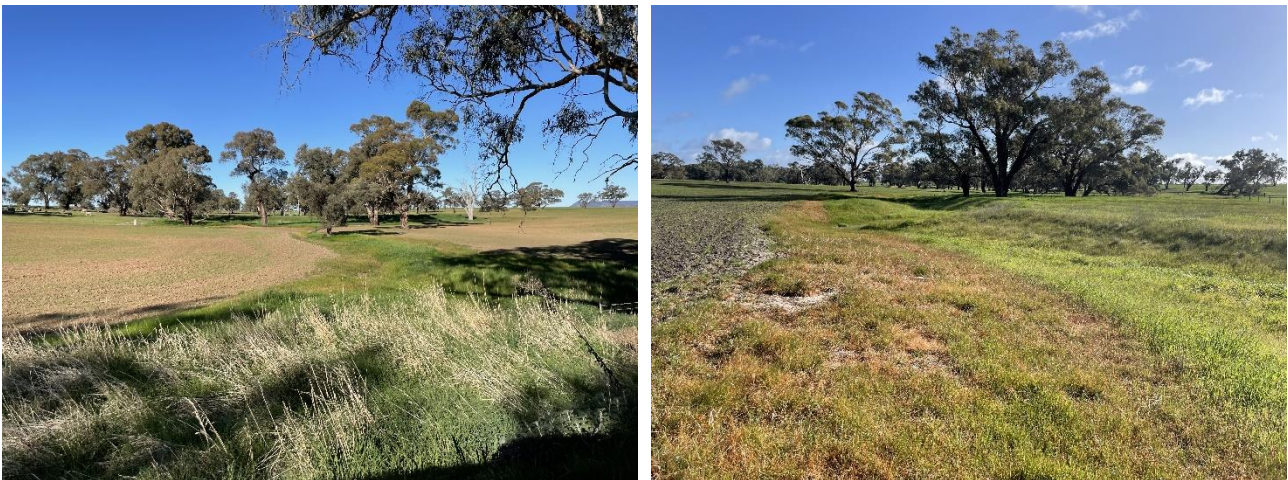
The lower Mibus Creek reach extends upstream from Taylors Road for a distance of approximately 1 km. This reach is unfenced and meanders through an open paddock with scattered mature trees on or near the tree line. There is no evidence of tree recruitment and woody understorey is absent. Cultivation of the surrounding paddocks extends relatively close to the top of bank (i.e., <10 m).

Figure 5-21 Looking upstream from Taylors Rd (left), looking downstream from upstream end of Reach 7 (right)

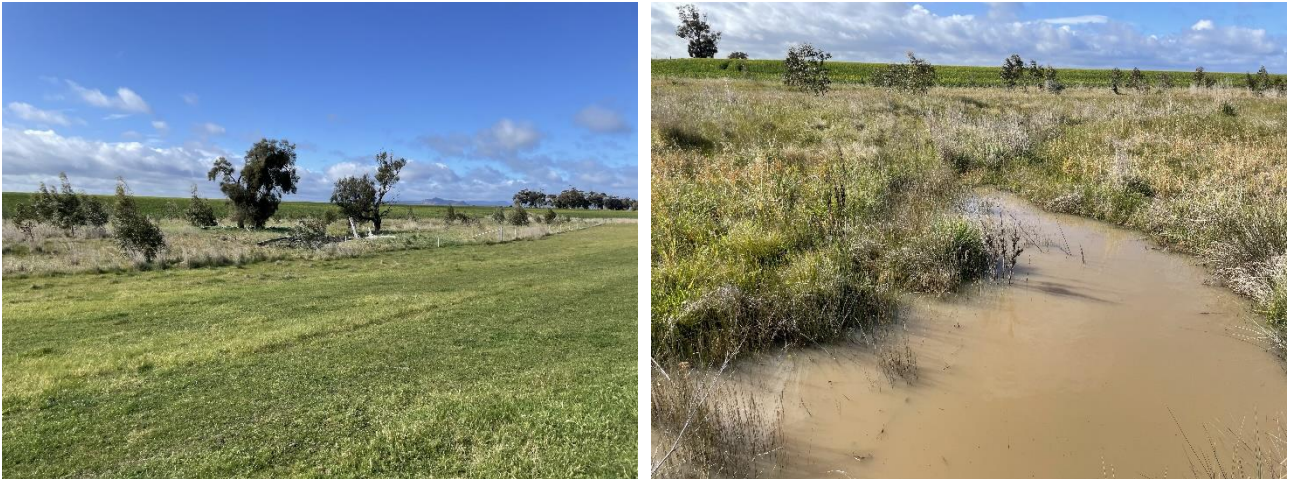
This reach has been separated from the reaches upstream and downstream as it is in the one landholding and has been fenced and recently revegetated within the downstream half. The meandering creekline has been broadly fenced to an overall width mostly between 15-50 m (Figure 5-22). The revegetation is relatively young and includes trees, shrubs and ground cover species. At the time of assessment there was thick ground layer grasses providing an effective buffer to help capture sediments and nutrients from adjoining paddocks. The stream channel itself was also becoming denser with vegetation and forming pools, soaks and riffle zones. Native rushes and herbs were identified naturally recruiting along the creek margin.

Figure 5-22 Looking into fenced creekline from paddock (left), view along creek within fenced area (right)

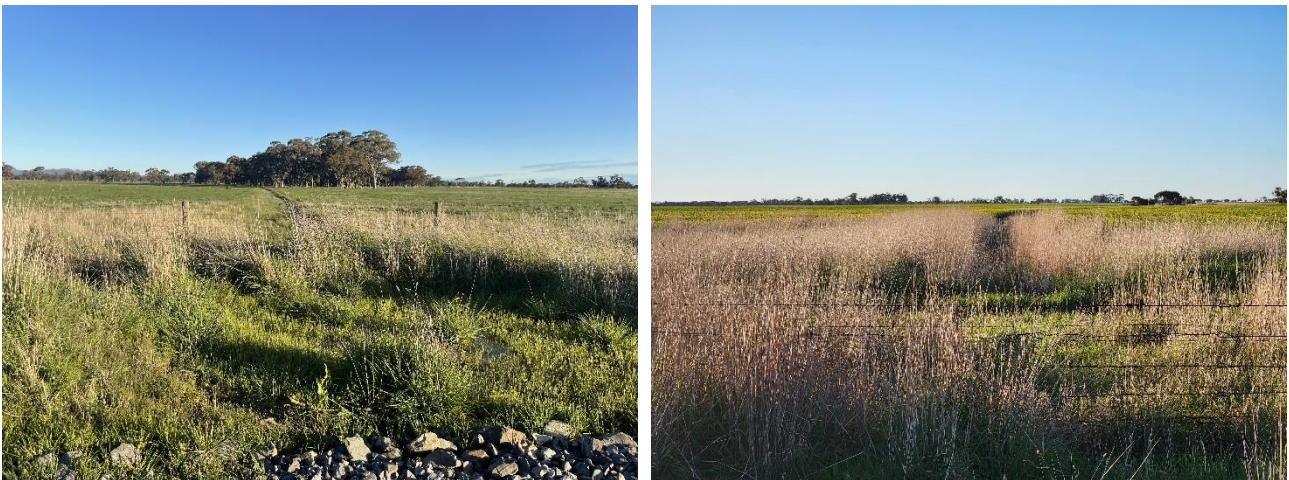
This reach traverses very flat country downstream of the Toolondo Channel. This reach includes two channels that converge just before the downstream end and much of the channel length has been straightened, or rather, the country is so flat that small drains have been cut. As the photographs in Figure 5-23 suggest, most of this reach is devoid of trees and the channel is very small. Grazing is unrestricted from the channel and cultivation is likely to occur in close proximity to the channel (i.e., within metres).

Figure 5-23 View from Uebergangs Road, south/upstream (left), north/downstream (right)

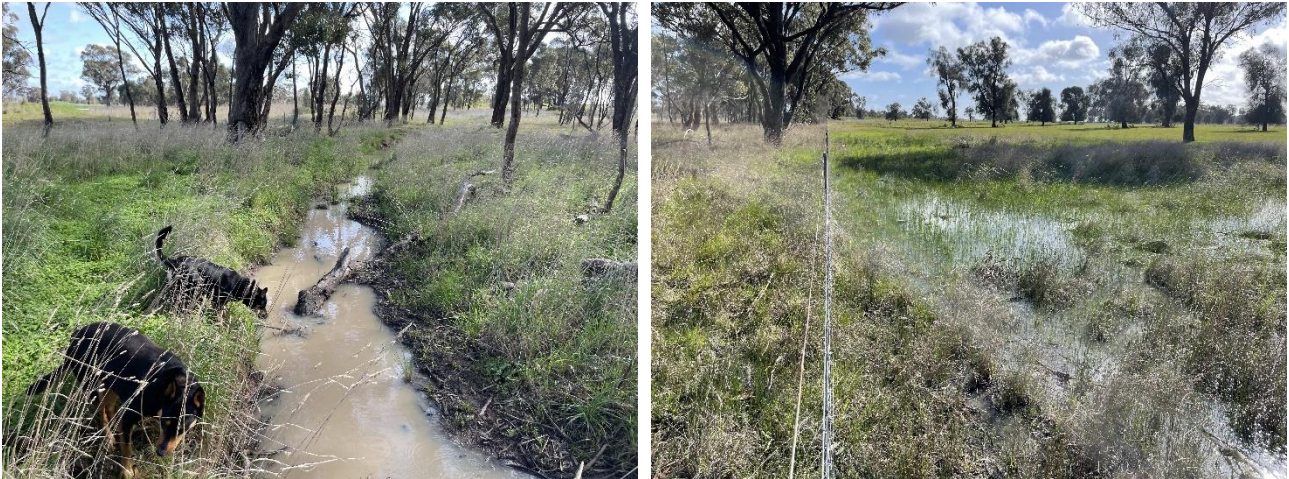
The Toolondo Channel acts like a levee across the entire catchment. All water draining north-eastward from the upper catchment needs to converge and pass through one of the numerous channel syphons in order to drain to Diggers Creek or Mibus Creek. The main channel observed during field inspection was Diggers Creek where situated within the Old Wartook Road reserve (Figure 5-24). Few of these channels were observed during field inspection, however, aerial imagery suggests very shallow ill-defined drainage lines, or small cut channels exist within this reach/area. There are scattered trees within this area however woody vegetation does not line the drainage lines. None of these drainage lines appear to be fenced and therefore stock grazing is unrestricted.

Figure 5-24 Defined creekline adjacent to Old Wartook Rd (left), ill-defined creek within paddock showing wet area (right)

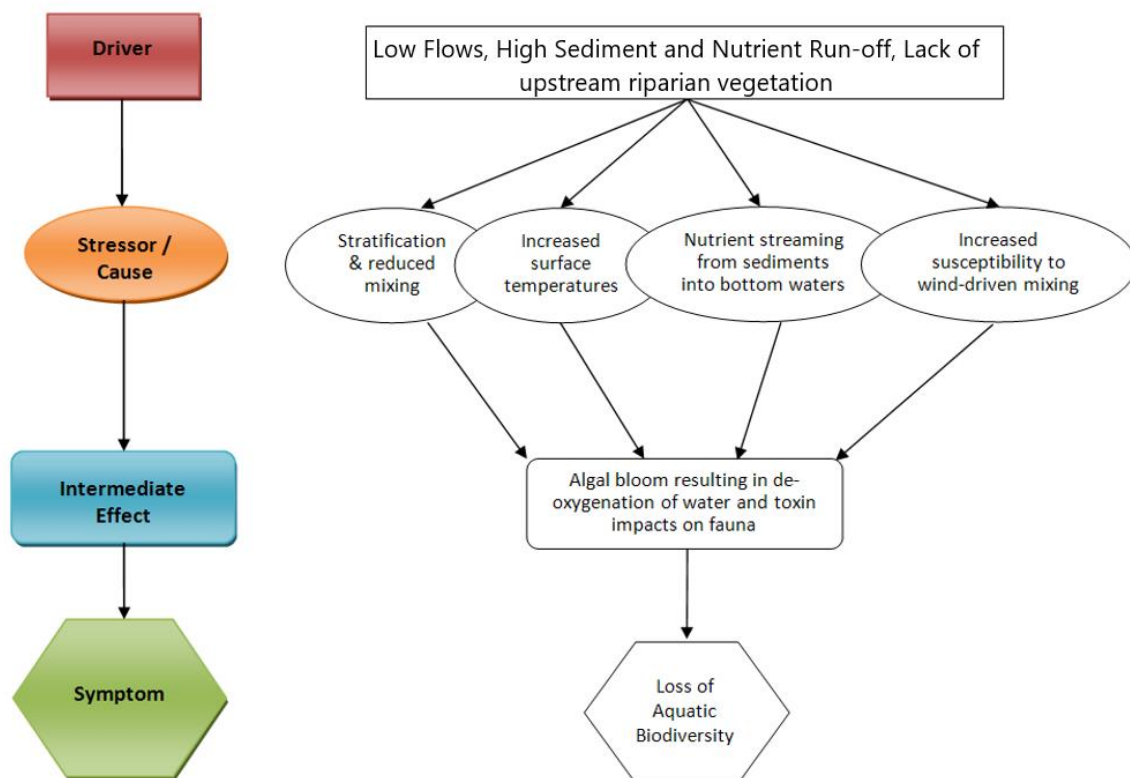
Figure 6-1 Potential ecological and human health impacts of BGA blooms

Collectively these drivers can result in stressors and impacts upon aquatic ecosystem biodiversity as well as on animal and human health. Figure 6-1 shows how nutrient pollution, warm water temperature, and stagnant conditions can lead to potential ecological and human health impacts of BGA blooms.

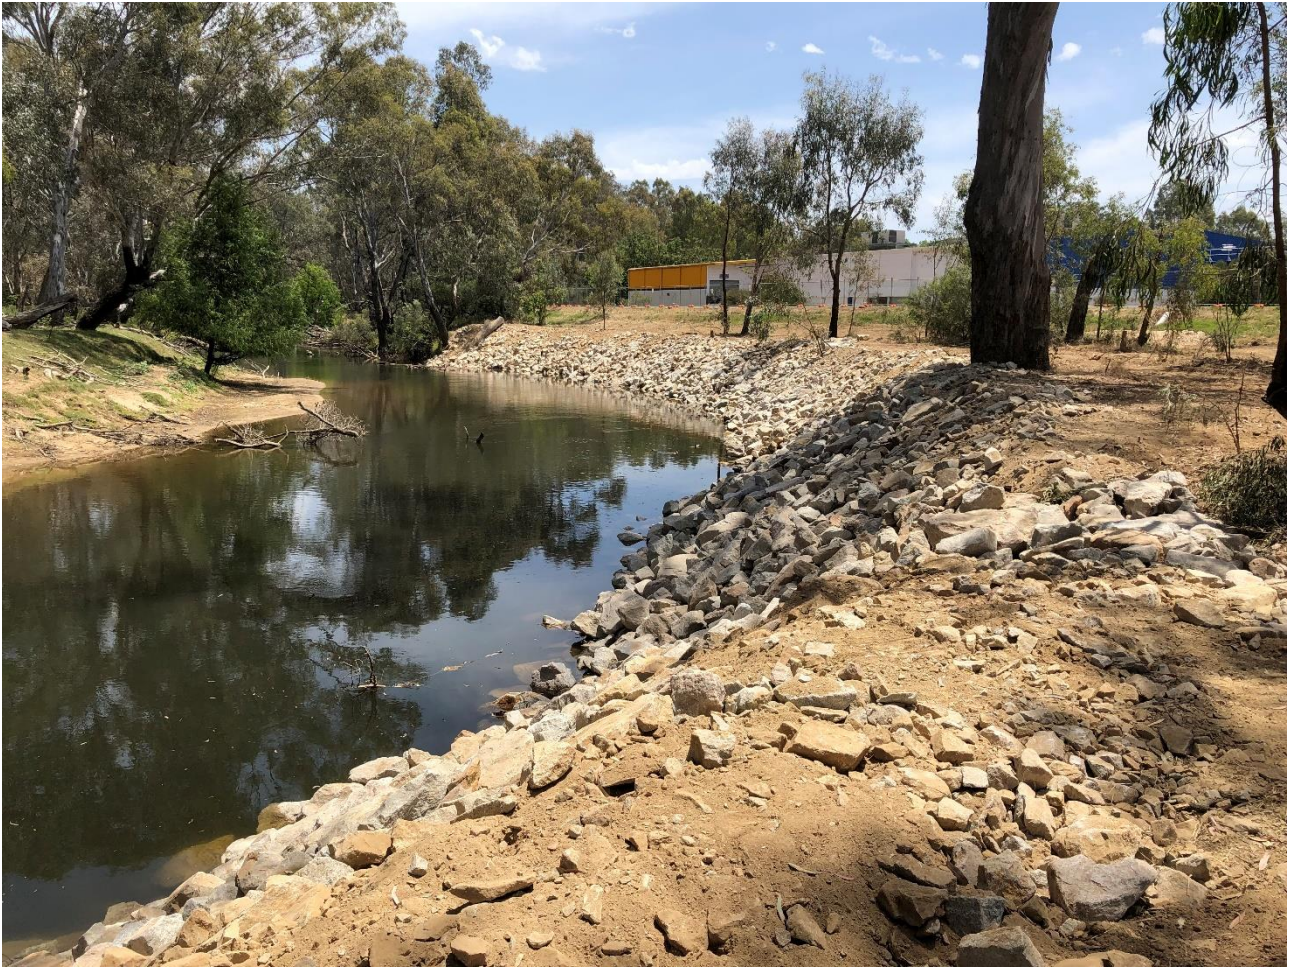
Figure 7-1 Rock beaching installed on the Ovens River at Wangaratta aimed at protecting an existing levee.

In context of the project area, rock armouring of the banks in isolation will not address the bed degradation processes (as opposed to rock chutes or timber drop structures). However, rock armouring is considered an effective management technique to provide erosion protection at and surrounding roadside/tracksides culverts and drains and to protect infrastructure threatened by bank erosion.

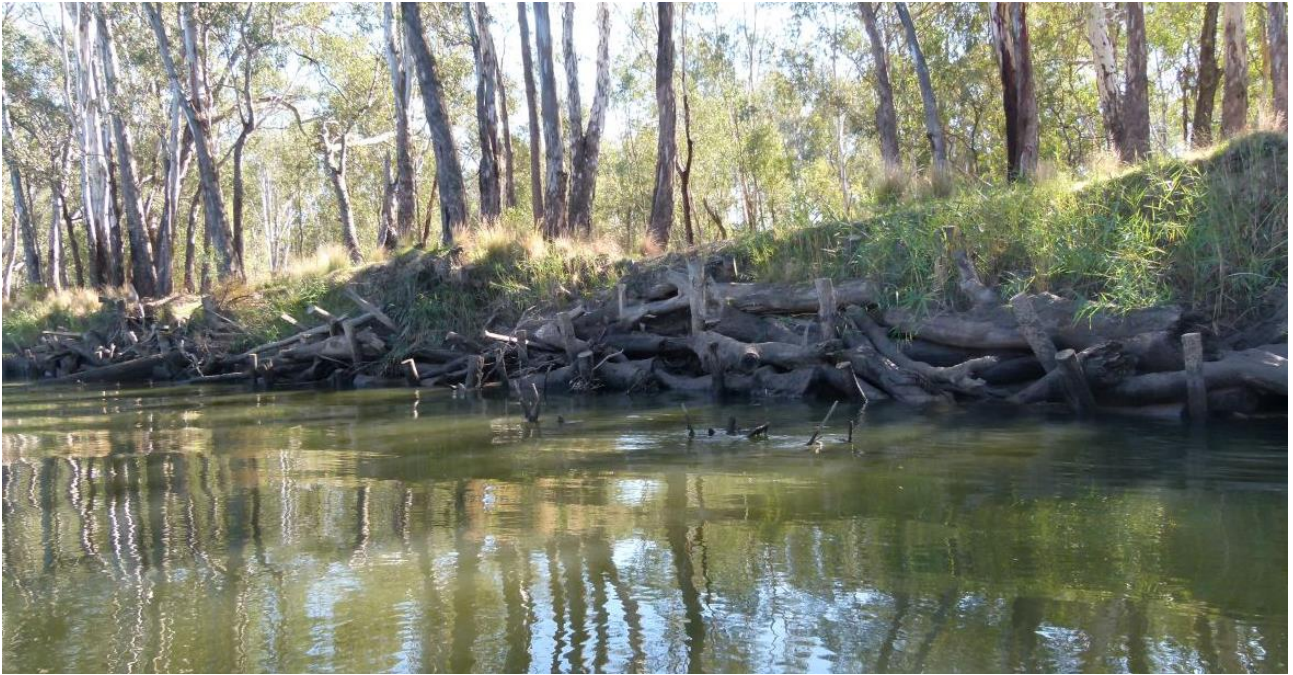
Figure 7-2 Log revetment on the Murray River (sourced from Soil Conservation Service).

Log revetment (also known as timber brushing) involves the placement of timber on a stream bank with the objective of preventing bank erosion over the short to medium term (Figure 7-2). The revetment typically extends into the bed of the stream to deal with scouring of the bed and is held onto the bank with either timber piles or cables that are anchored to stakes or piles at the top of the bank. A gravel filter layer or filter fabric can be placed under the revetment to prevent flow permeating the timber from eroding the bank material behind. Stock management and revegetation are often undertaken to complement the log revetment. Log revetments typically have a design life of approximately 10-15 years (depending on the timber used) in which revegetation should be established on and surrounding the bank. Hence, as the revetment fails the vegetation will colonise the area to provide some ongoing bank stability. In providing only interim stability to the bank the brushing has the important effect of, unlike hard engineering works (e.g. rock revetment), not locking sections of the planform of the river in position for the long term (Water Technology 2010). Once the structure fails the logs remain instream and provide habitat value.

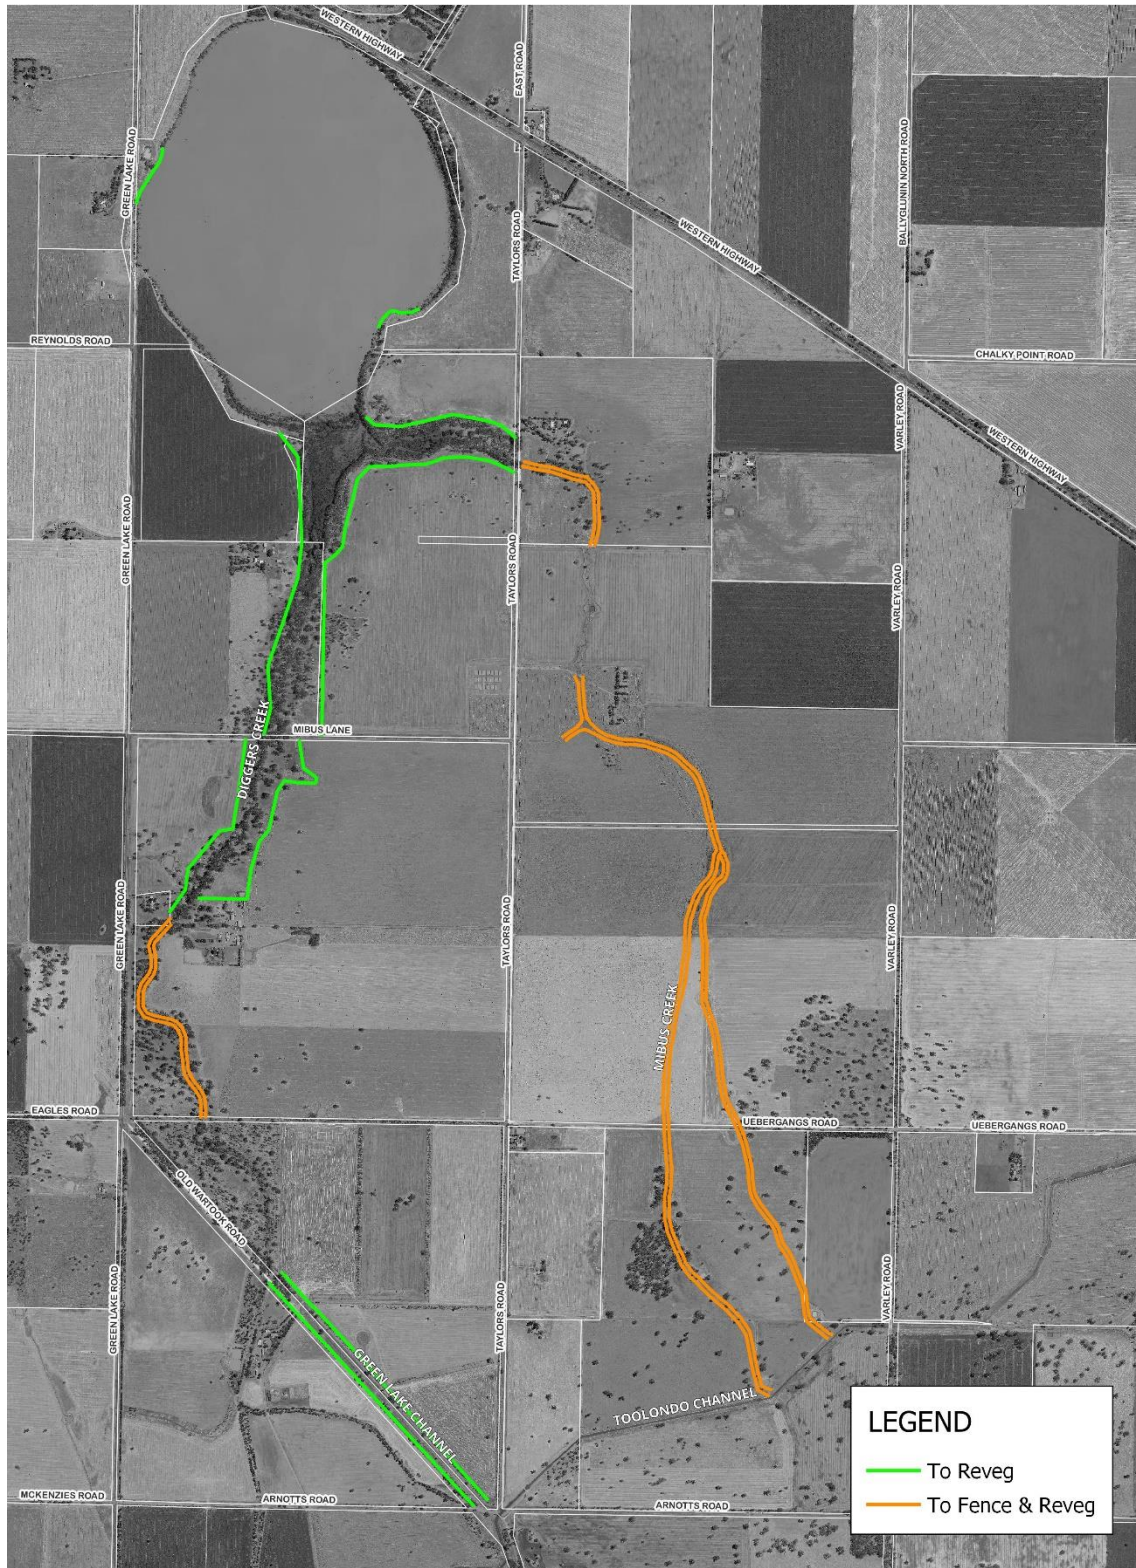
Figure 8-2 Recommended fencing and revegetation

willingness to protect and manage these revegetation areas needs to be negotiated. The implementation of revegetation in priority areas will require landholder willingness to actively support and participate in actions to enhance their creek frontage and ultimately improve the water quality of Green Lake.
