Data Review and Validation Report

Stawell Flood Investigation (C14 2022/23)

Northern Grampians Shire Council

02 December 2024

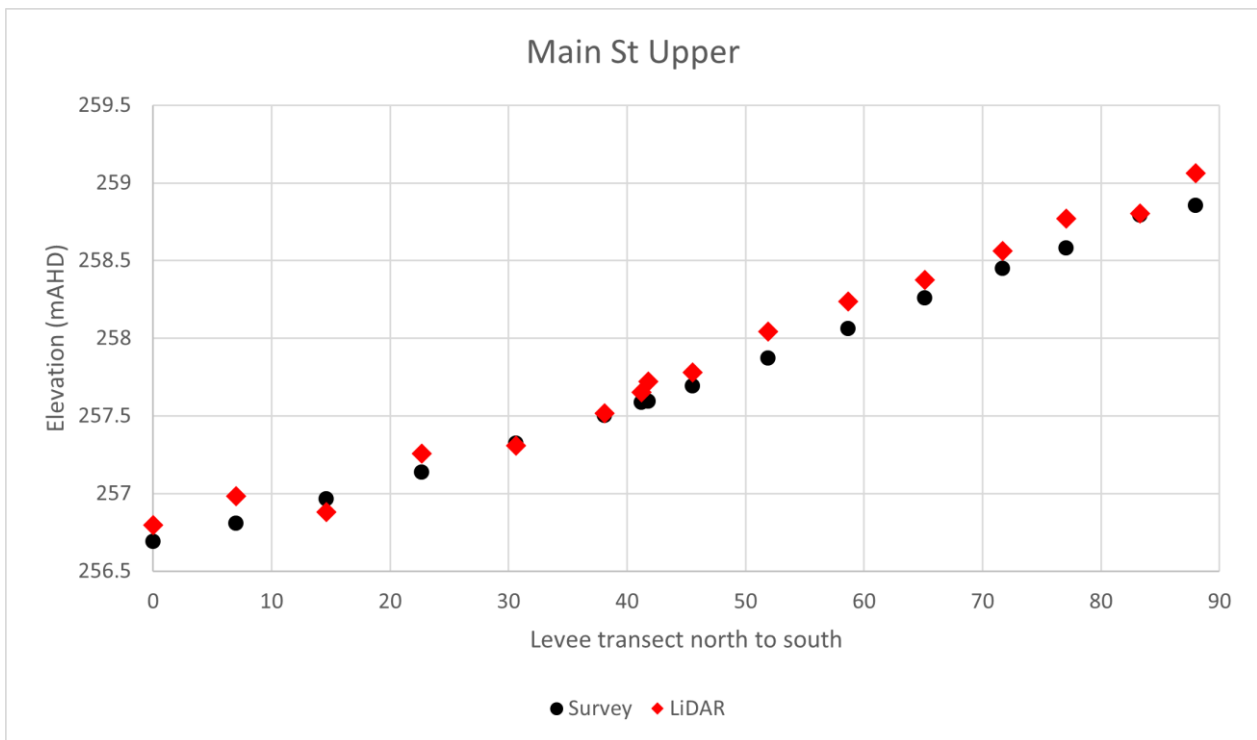
FIGURE 2-6 MAIN ST UPPER - SURVEY AND LIDAR DATA COMPARISON

Figure 2-6 to Figure 2-10 show a comparison between the LiDAR dataset and the feature survey at five surveyed locations. Transect comparisons were made at road centrelines, see Figure 2-11. The average, maximum, minimum and standard deviation of the difference between each LiDAR dataset and the surveyed levels is shown in Table 2-3.

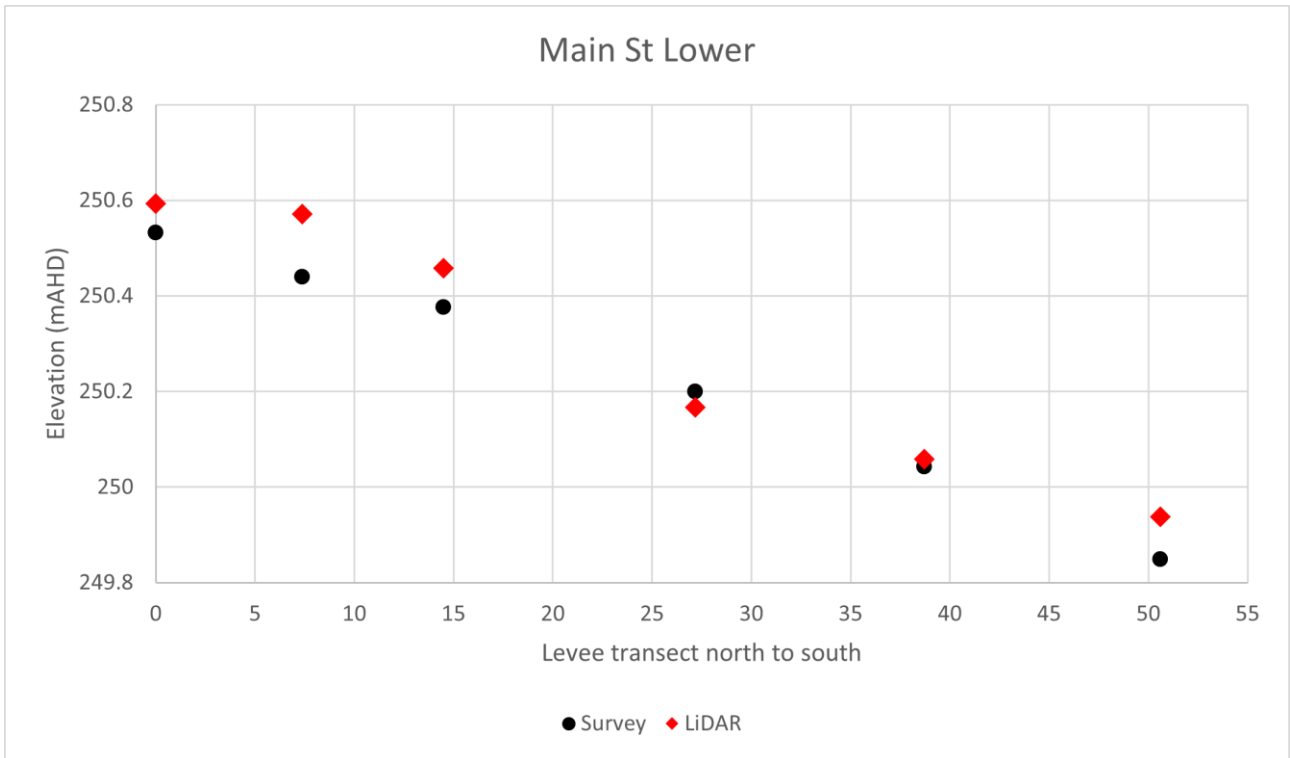
FIGURE 2-7 MAIN ST LOWER - SURVEY AND LIDAR DATA COMPARISON

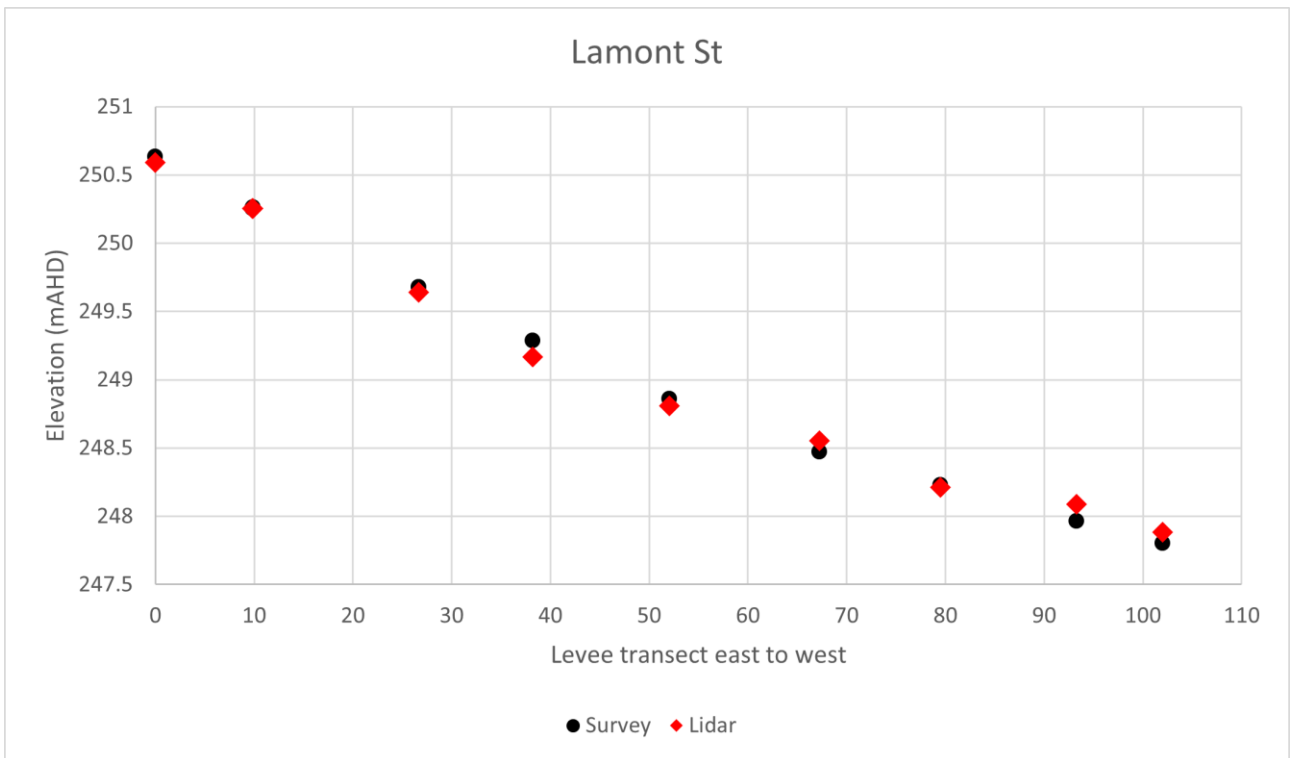
FIGURE 2-8 LAMONT ST - SURVEY AND LIDAR DATA COMPARISON

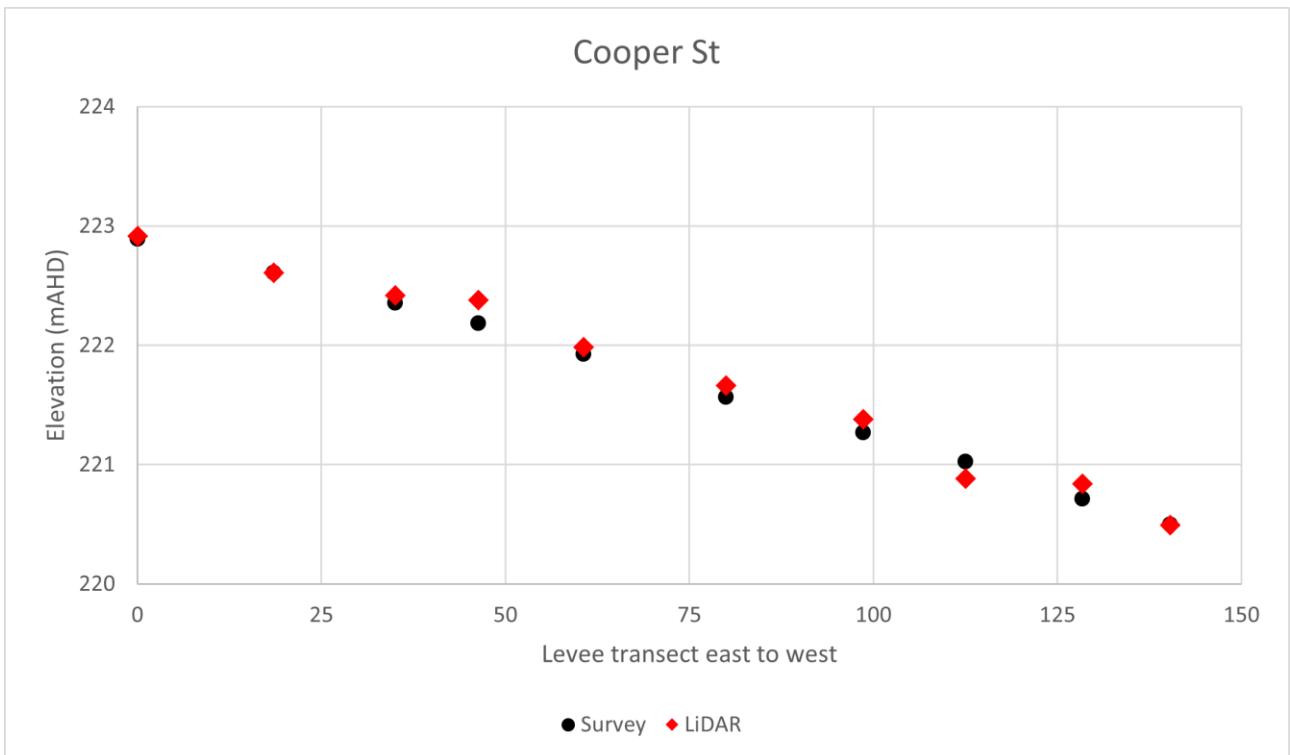
FIGURE 2-10 COOPER ST - SURVEY AND LIDAR DATA COMPARISON
