Model Development and Calibration Report

Stawell Flood Investigation (C14 2022/23)

Northern Grampians Shire Council

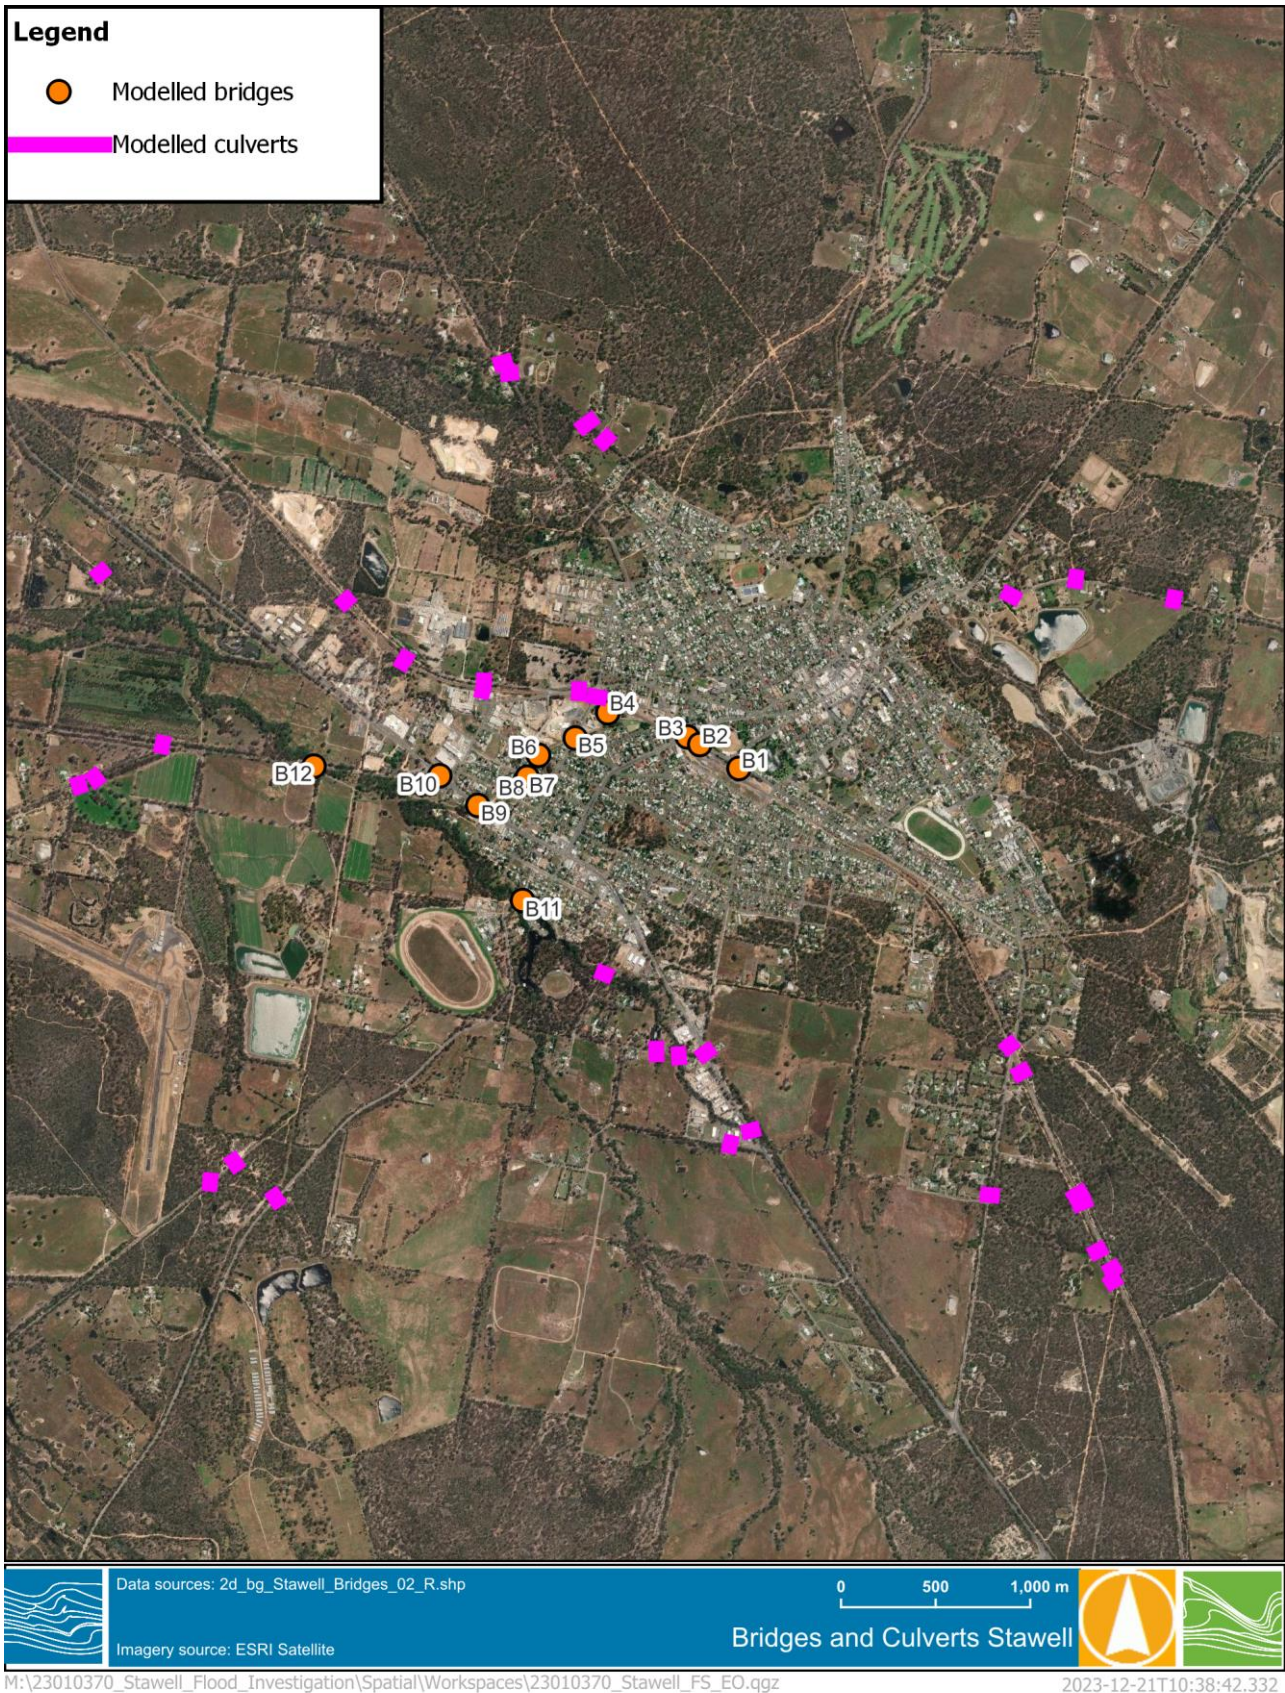
Figure 2-6 Stawell - modelled structures

12 bridges were incorporated in the hydraulic models as 2D bridge flow constrictions to represent energy losses due to piers and bridge deck. The bridge dimensions were based on existing datasets, survey data and site visit observations. Two bridges were incorporated in the golf course model (labelled BG). Figure 2-6 and Figure 2-7 show the bridge locations.

A large number of road culverts were included in the hydraulic models, as shown in Figure 2-6 and Figure 2-7. Culverts were incorporated as 1D structures directly connected to the 2D domain. Culvert dimensions were based on existing datasets, survey data and site visit observations.

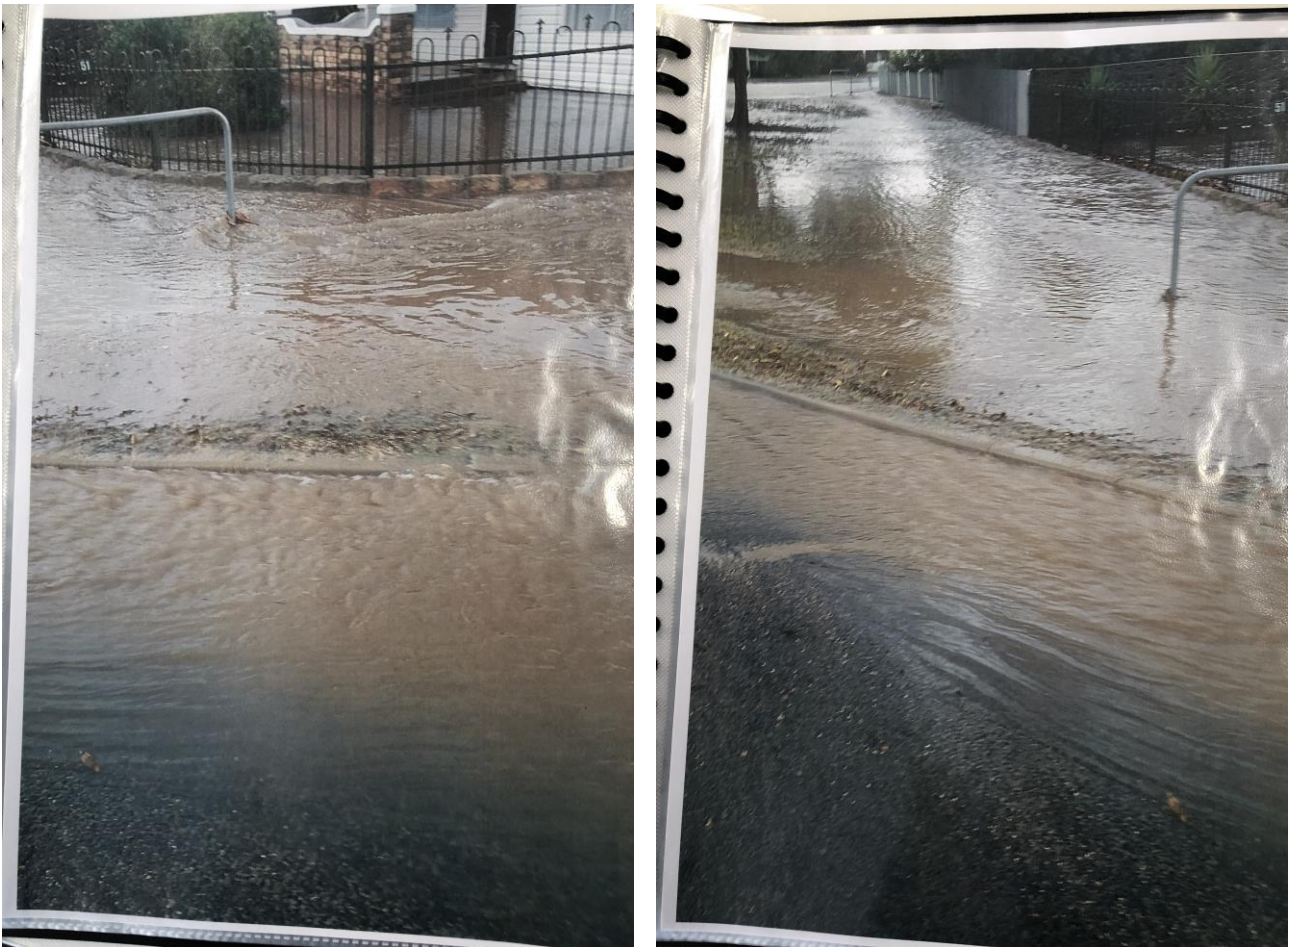
Figure 3-9 December 2011 inundation near Ligar Street / Franklin Street intersection

- No inundation of road easement near 73 White Street.
- Flooding in the paddock located behind 6 Ormston Road reached halfway up the paddock.
- Properties near 9 Franklin Street were inundated.
- Figure 3-9 shows flooding at the Ligar/Franklin Street intersection:

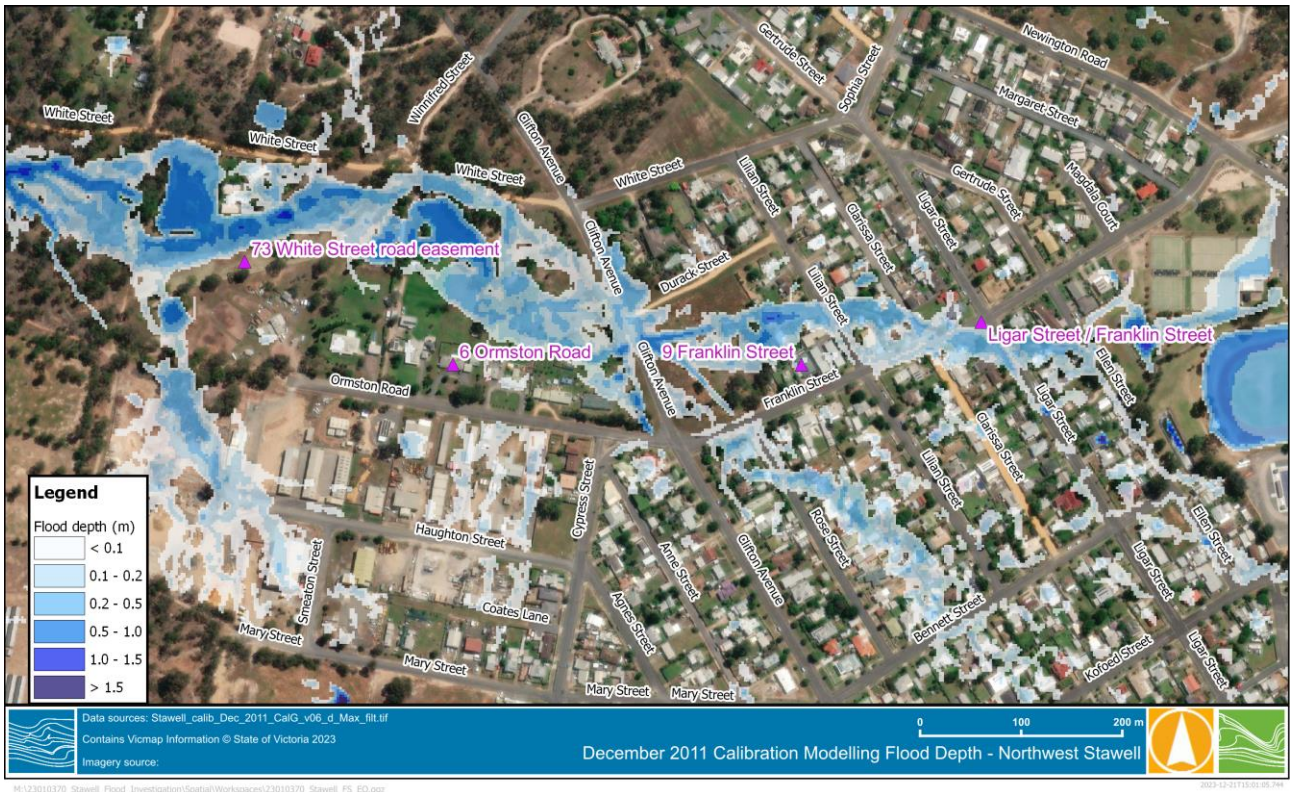
Figure 3-10 December 2011 calibration modelling flood depth – northwest Stawell

Figure 3-10 shows the modelled flood depth in this area. The flood extent and depth agrees with the anecdotal evidence and photographs.

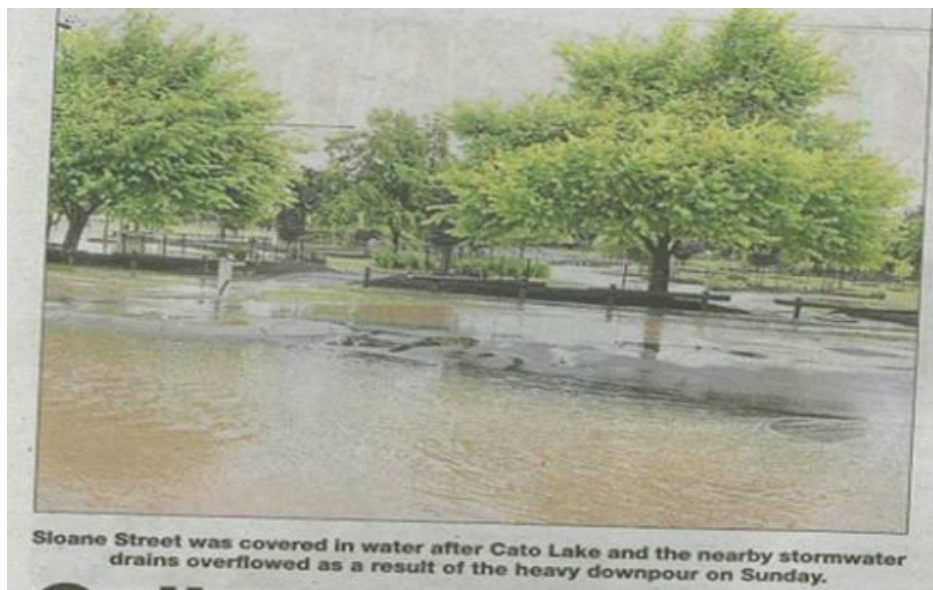
Figure 3-11 December 2011 inundation on Sloane Street at Cato Park

- Water reached front fence on 5 Mareli Street.
- Figure 3-11 shows a photo from the Stawell Times showing inundation at Cato Park:

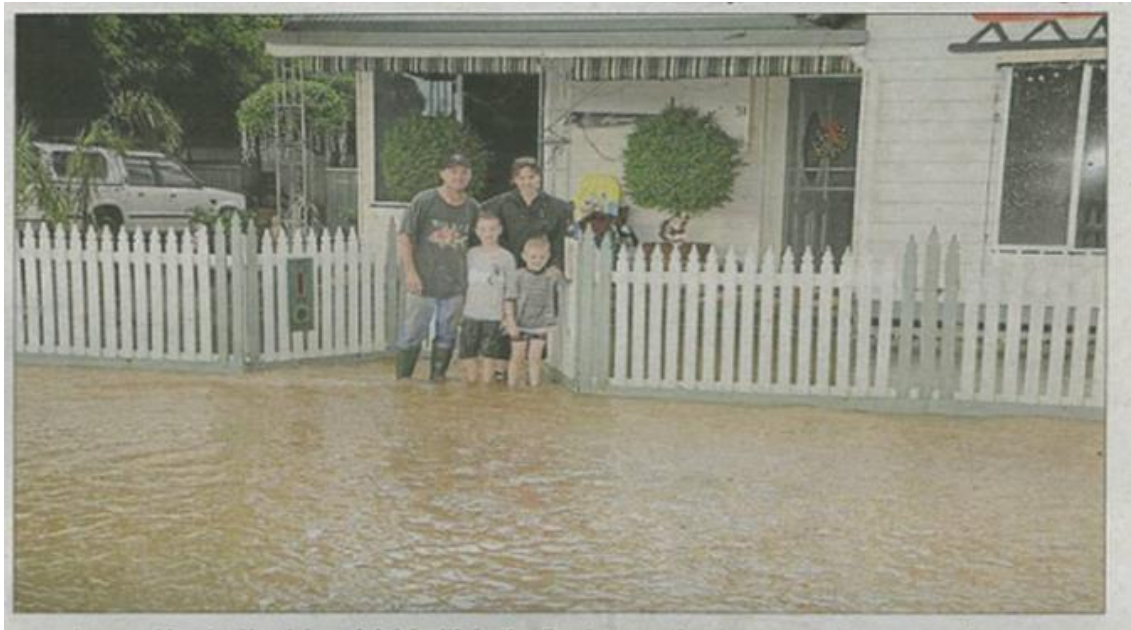
Figure 3-13 December 2011 inundation at 51 Cooper Street

- Overland flow on Freeland Avenue moved through the backyard of 2 Freeland Avenue and reached shed on 5 Lindsay Court
- There was inundation in the backyard of 43 Burgh Street
- Figure 3-13 from Stawell Times showing inundation at 51 Cooper Street:

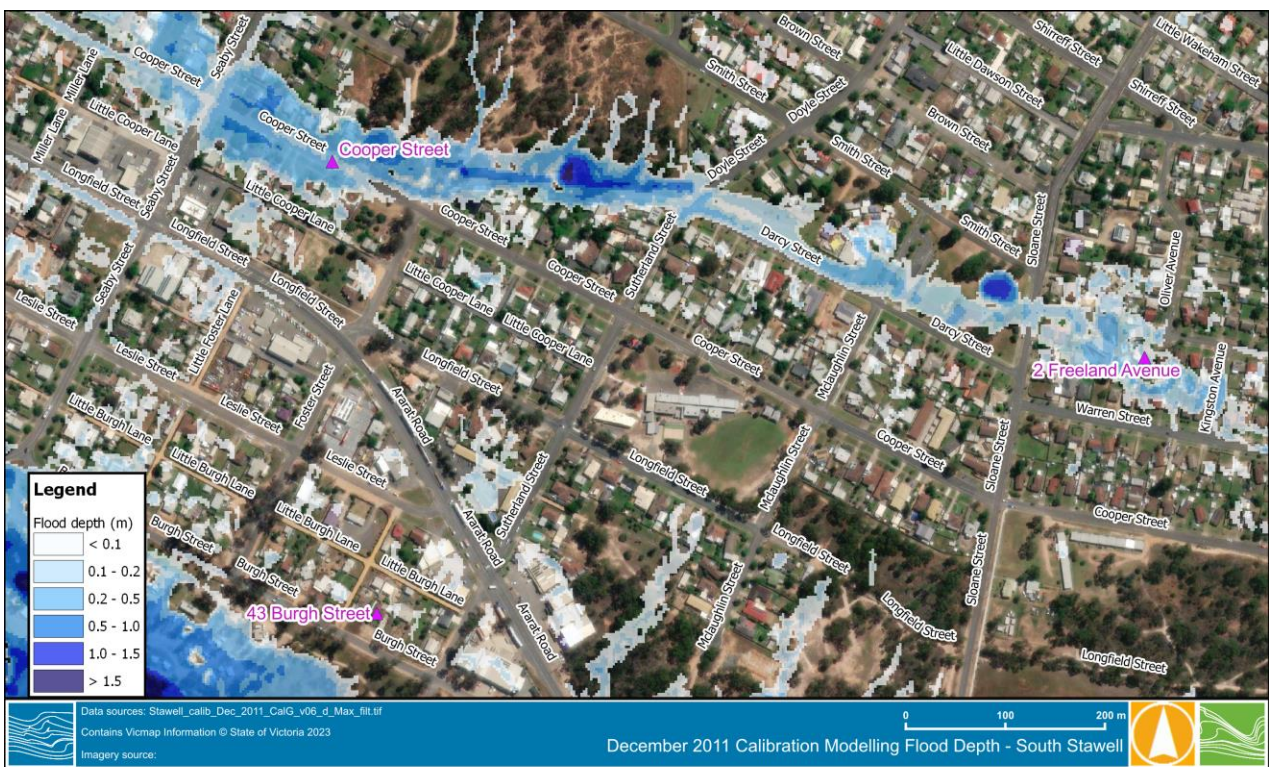
Figure 3-14 December 2011 calibration modelling flood depth – south Stawell

Figure 3-14 shows the modelled flood depth in this area. Flood depth and extent of the northern overland flow path in the map agrees with records provided, taking into account that the photograph may have been taken after the peak depth has occurred. No inundation is shown in 43 Burgh Street and there is a lack of flooding in the vicinity of this location, indicating that the model wouldn't show inundation here even if parameters are adjusted.

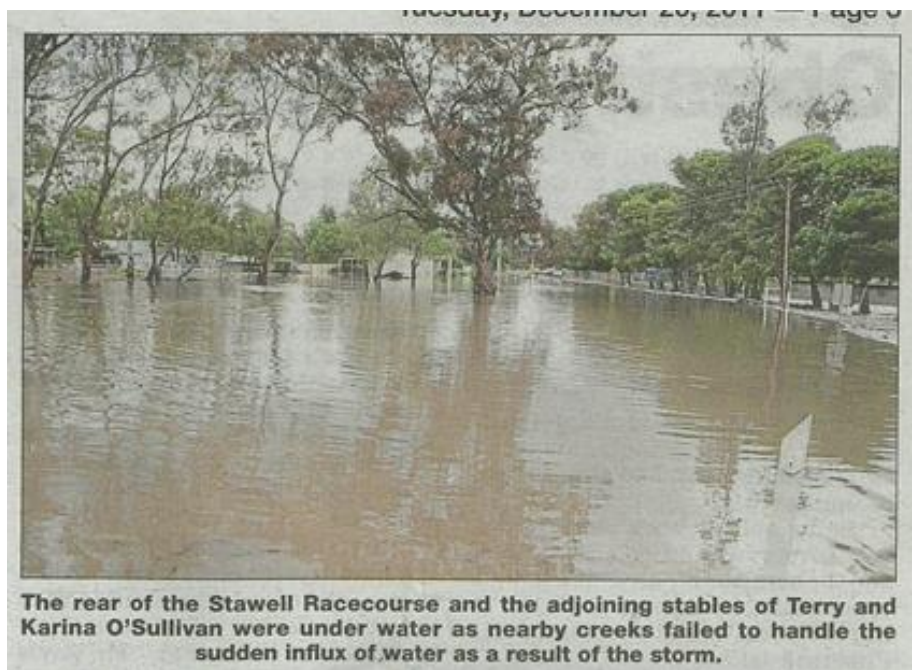
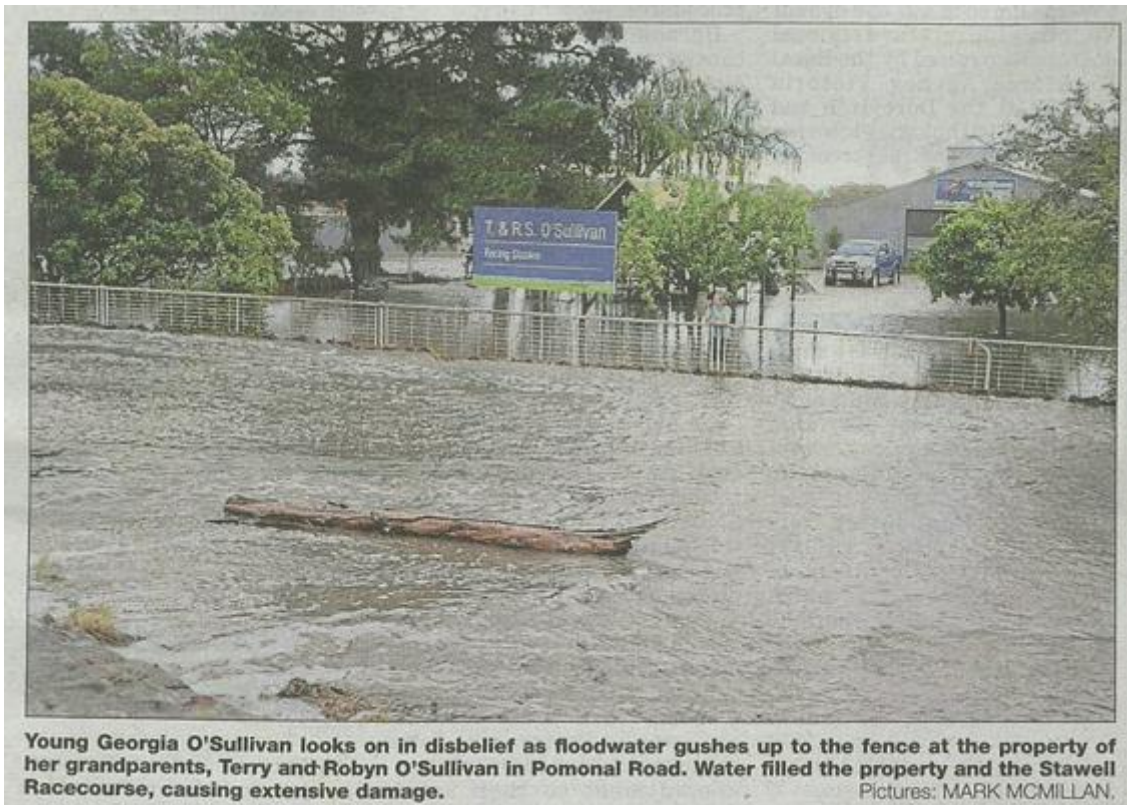
Calibration information from the racecourse included two photographs from Stawell Times showing the inundation at the racecourse as seen from Pomonal Road, as shown in Figure 3-17 and Figure 3-18.
