Flood Damages and Mitigation Report

Stawell Flood Investigation (C14 2022/23)

Northern Grampians Shire Council

2 December 2024

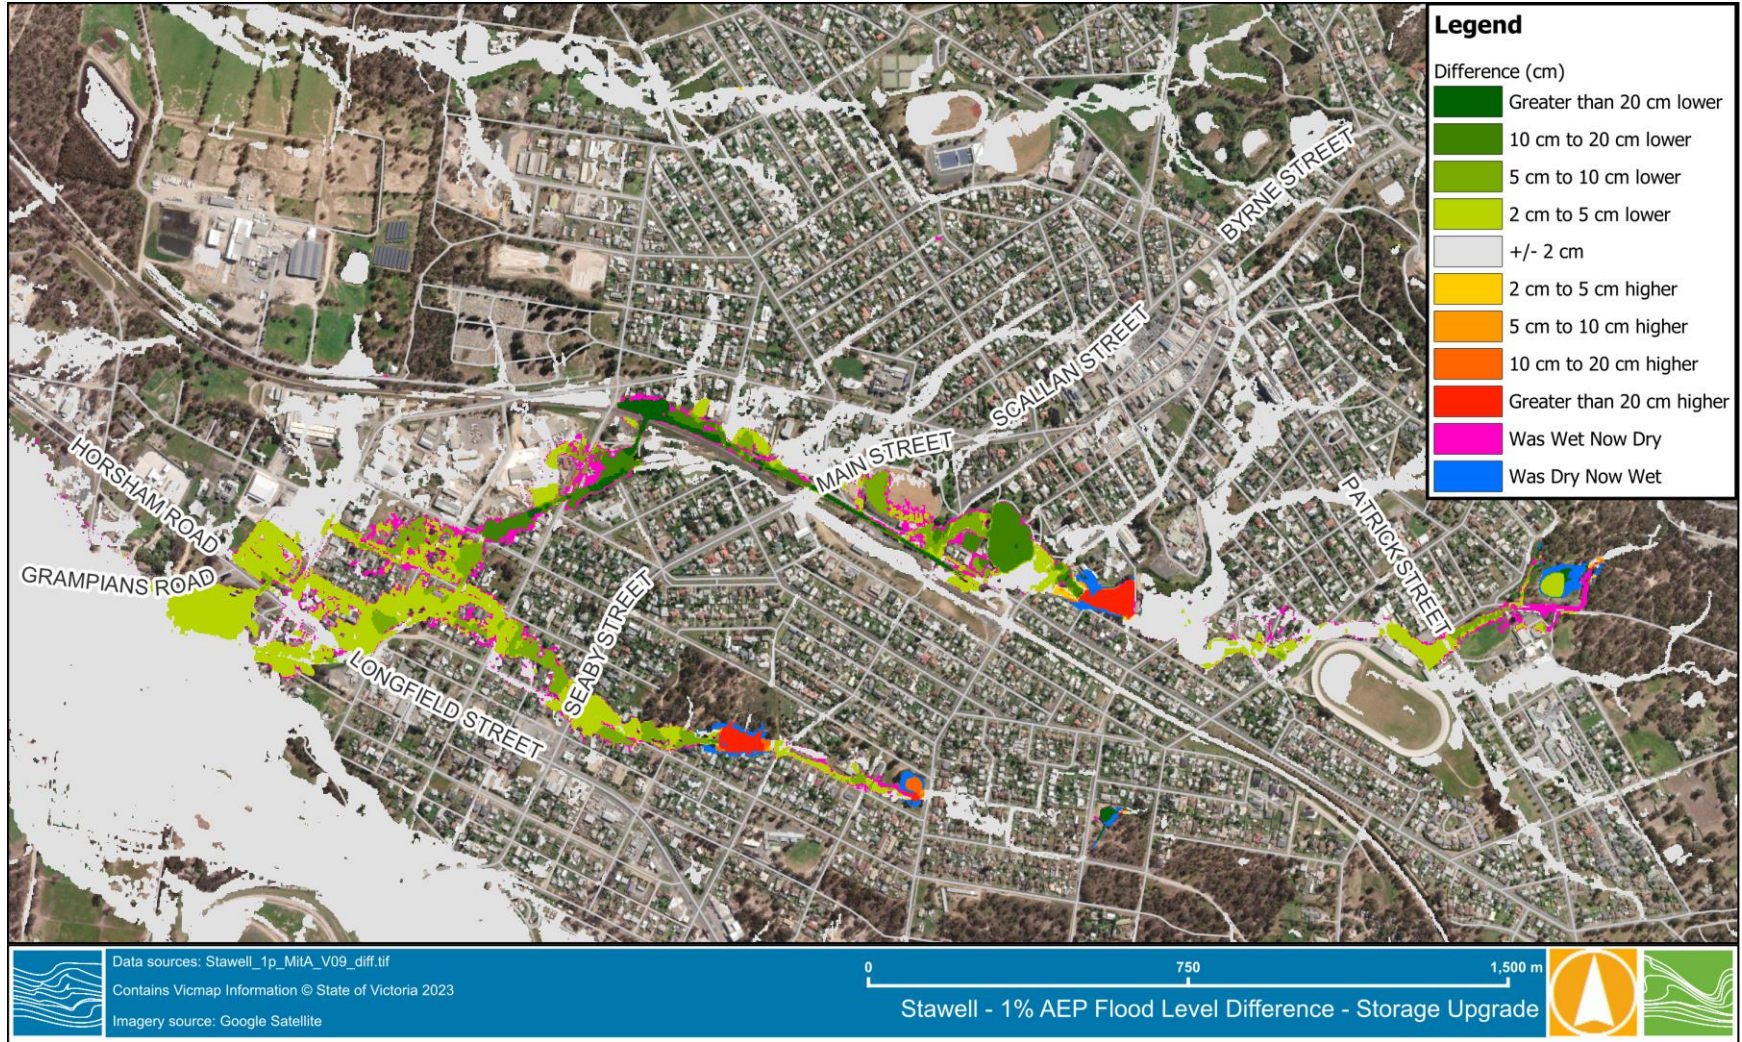
Figure 4-2 1% AEP flood level difference – Storage upgrade

The results show generally reduced flood levels in the flow paths through the upgraded dams. Flood extents are slightly reduced but not enough to reduce the number of roads overtopped in the 1% AEP scenario. Most significant reductions in depth were observed at Sloane Street, downstream of Maude Street Dam 4, and on Victoria Street downstream of Lake Cato. A reduction in and around the Main Drain was also observed, due to the detention of flows from the intercepted flow paths. The change in flood levels is shown in Figure 4-2.

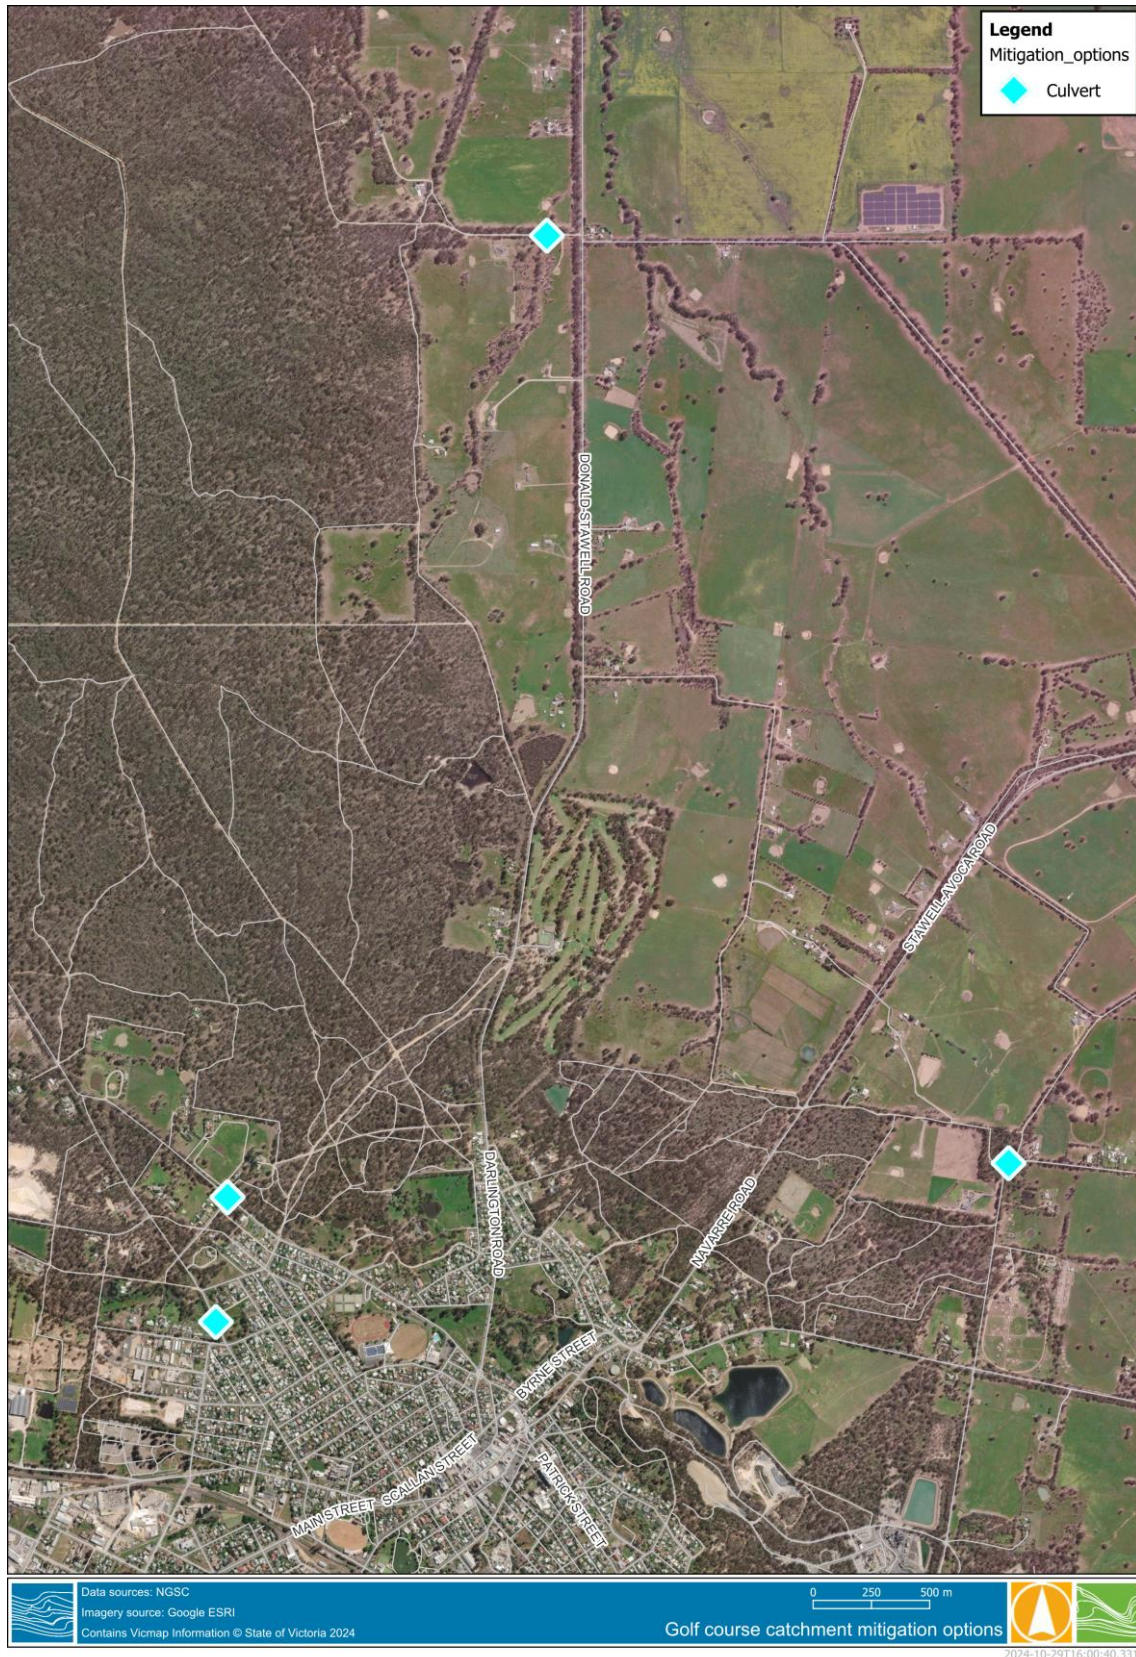
Figure 4-5 Stawell and Stawell Golf Course catchment culvert upgrades

Culvert locations are shown in Figure 4-4 and Figure 4-5 for the Pleasant Creek and Stawell/golf course catchments respectively.
