# Model Calibration Report

## Edenhope and Apsley Flood Investigation

West Wimmera Shire Council

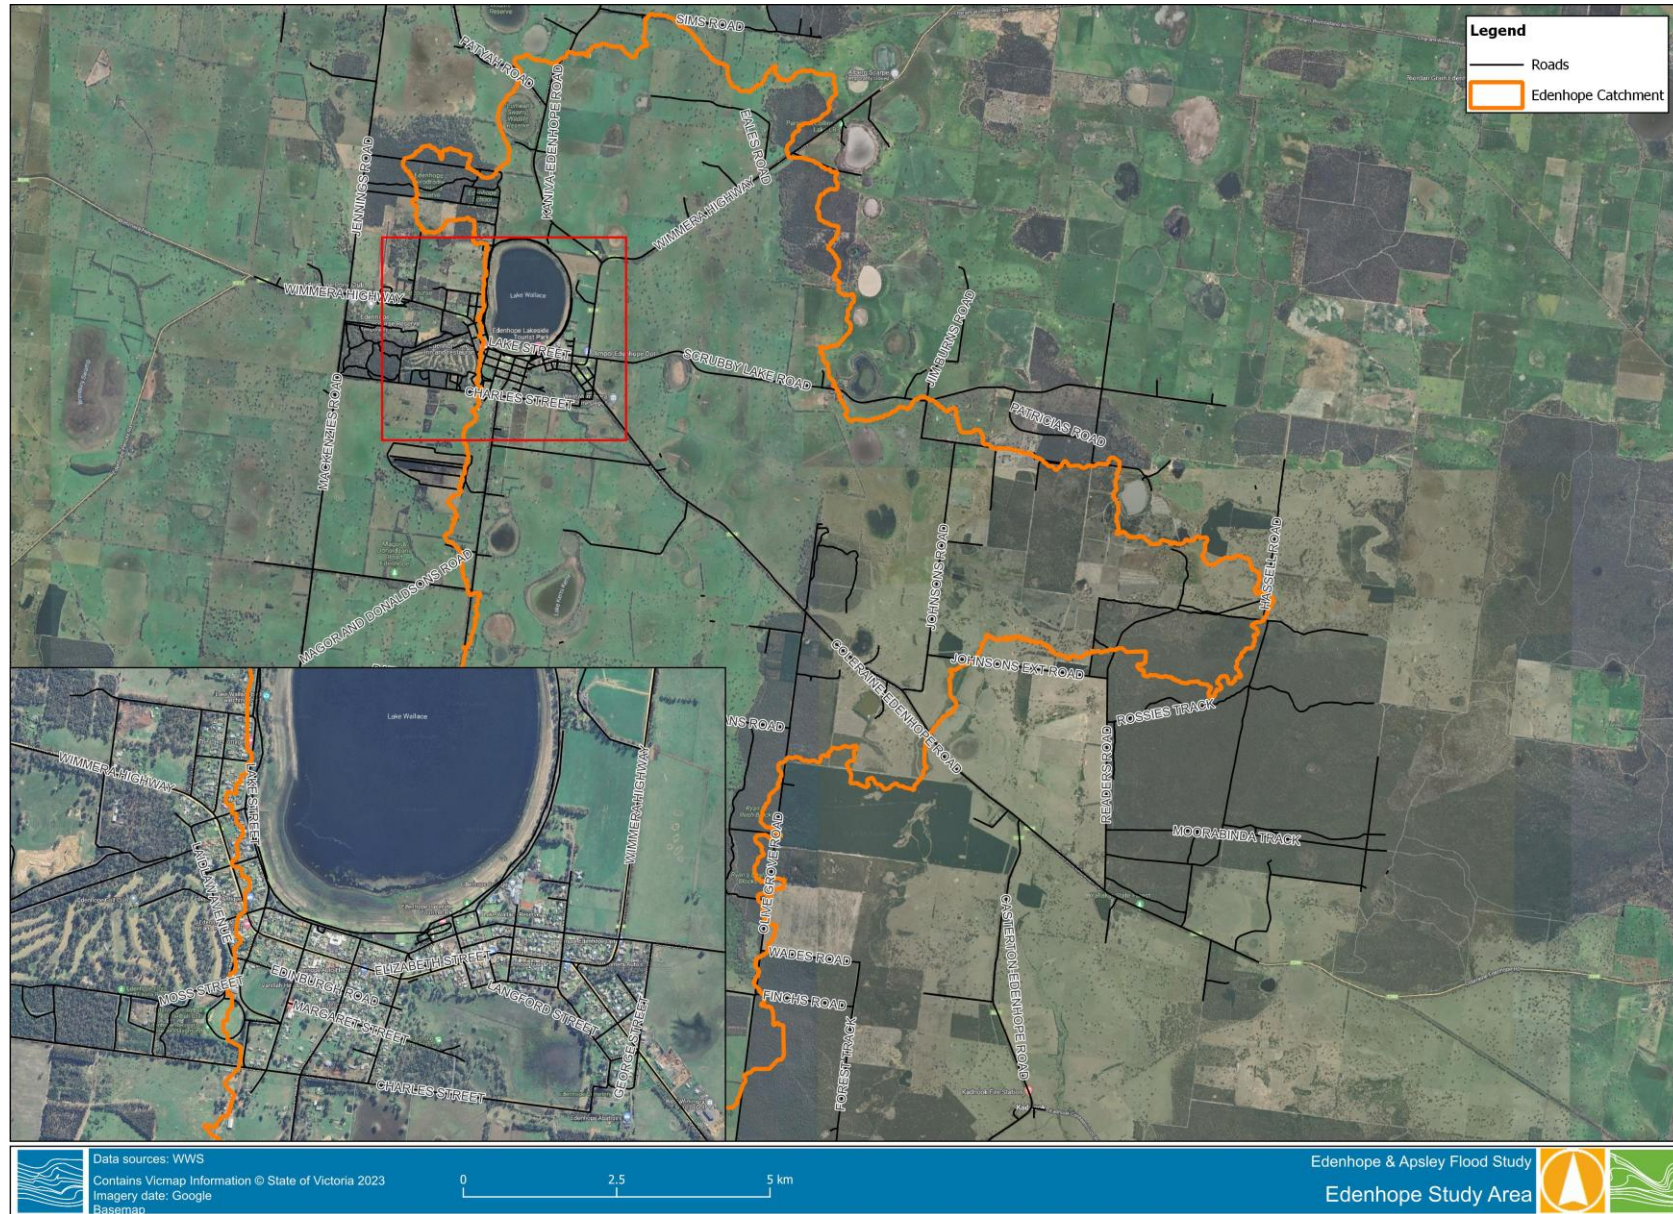
**Figure 1-2 Edenhope Study Area**

Edenhope and Apsley are both are located within western Victoria. Their locations with respect to western Victoria is shown in Figure 1-1, with the study area for Edenhope and Apsley shown in Figure 1-2 and Figure 1-3 respectively.

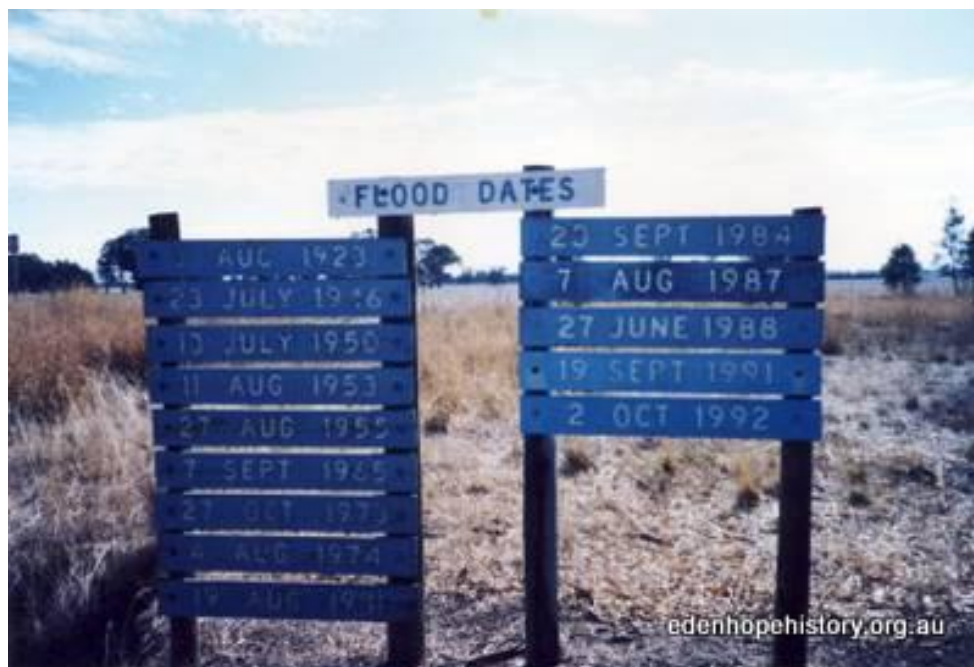
Figure 2-1 Edenhope – Lake Wallace flood record

There are two major water storages across the study area; Lake Wallace, within Edenhope and Newlands Lake immediately downstream of Apsley. There is limited recorded water level information available across both lakes but Lake Wallace does have opportunistic water level records or observed dates when the lake was either empty, full or overflowing. Most of this record has been extracted from newspaper articles/photos. Examples of this for Lake Wallace are shown in Figure 2-1 and Figure 2-2.

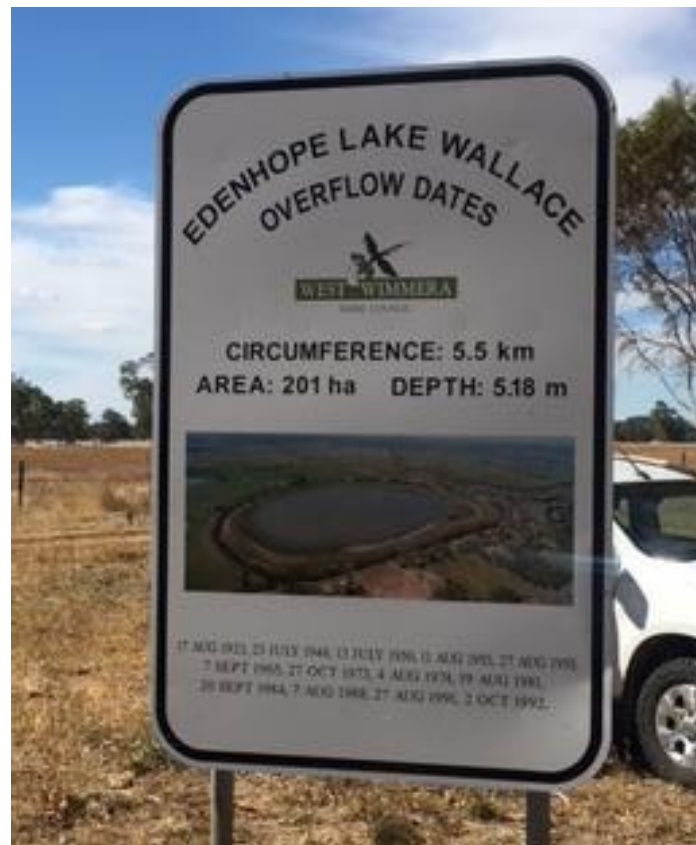
Figure 2-2 Edenhope – Lake Wallace Overflow Record

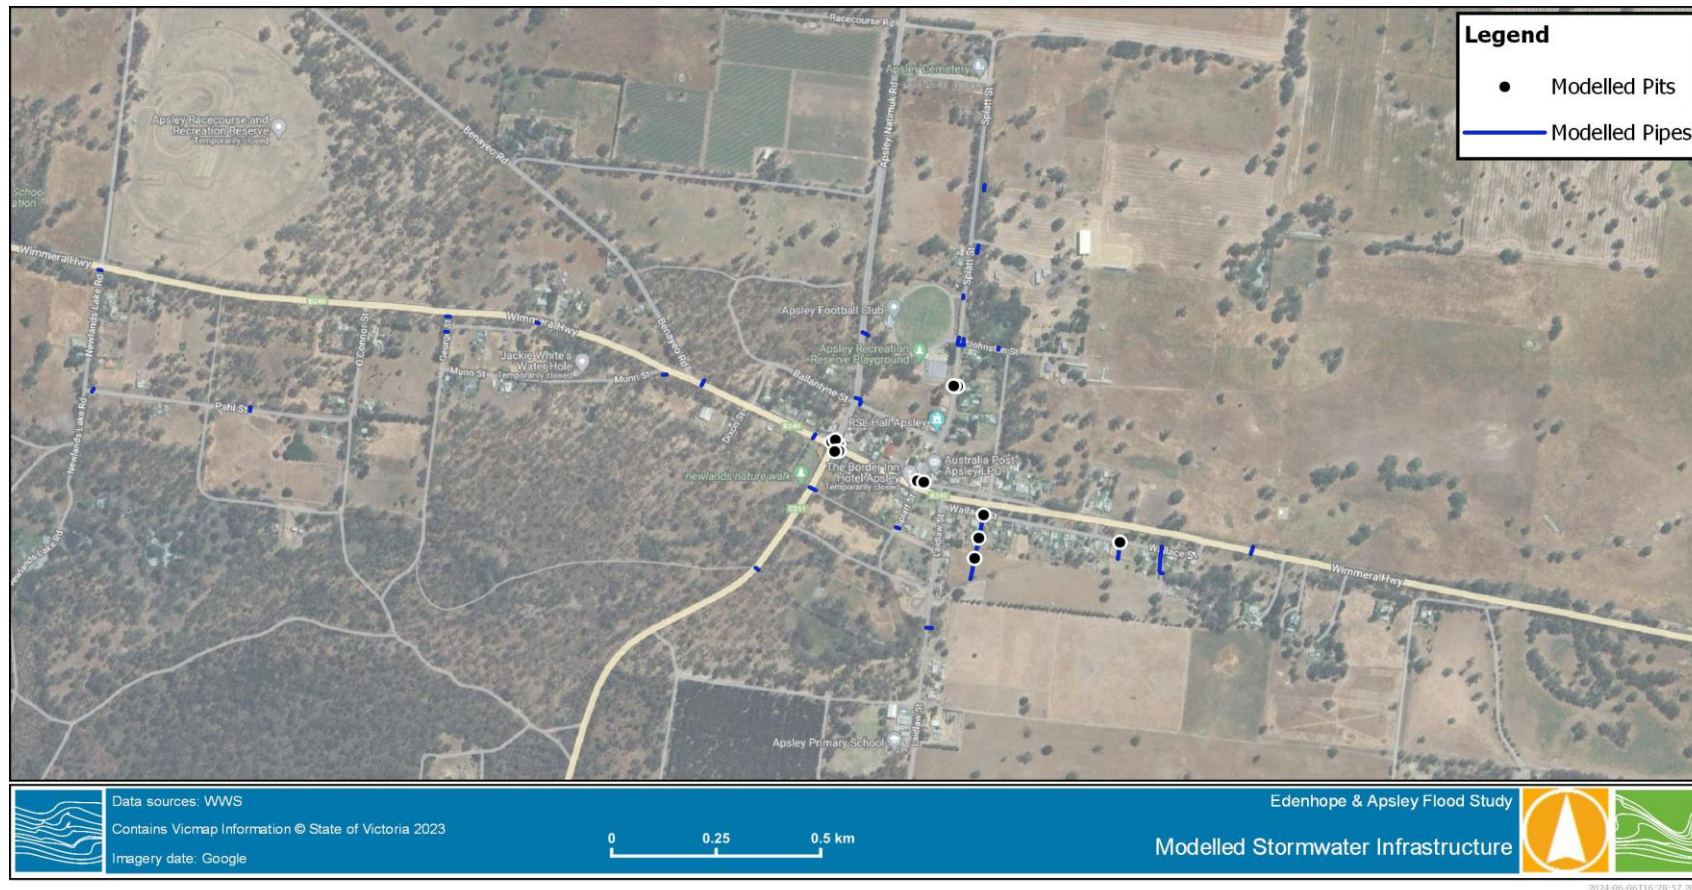
Figure 4-6 Apsley Modelled Structures

The drainage infrastructure in both Edenhope and Apsley consists of open drains, pipes, pits and bridges. The major drainage network (pits and pipes) was provided by WWSC, with the invert levels estimated based on the topography, incorporating a standard cover. Additional bridge and culvert measurements were obtained during the site visit. In total, the Edenhope model incorporates 211 pipes, 150 pits and 5 bridges. While the Apsley model incorporated 42 pipes and 13 pits. Upstream of the two townships where flow paths intercepted roadways crossing were artificially removed to ensure connectivity, unless other information was known. The blockage from the roads was incorporated by applying additional bridge structure at these locations. The modelled (township) infrastructure is provided in Figure 4-6 and Figure 4-7.

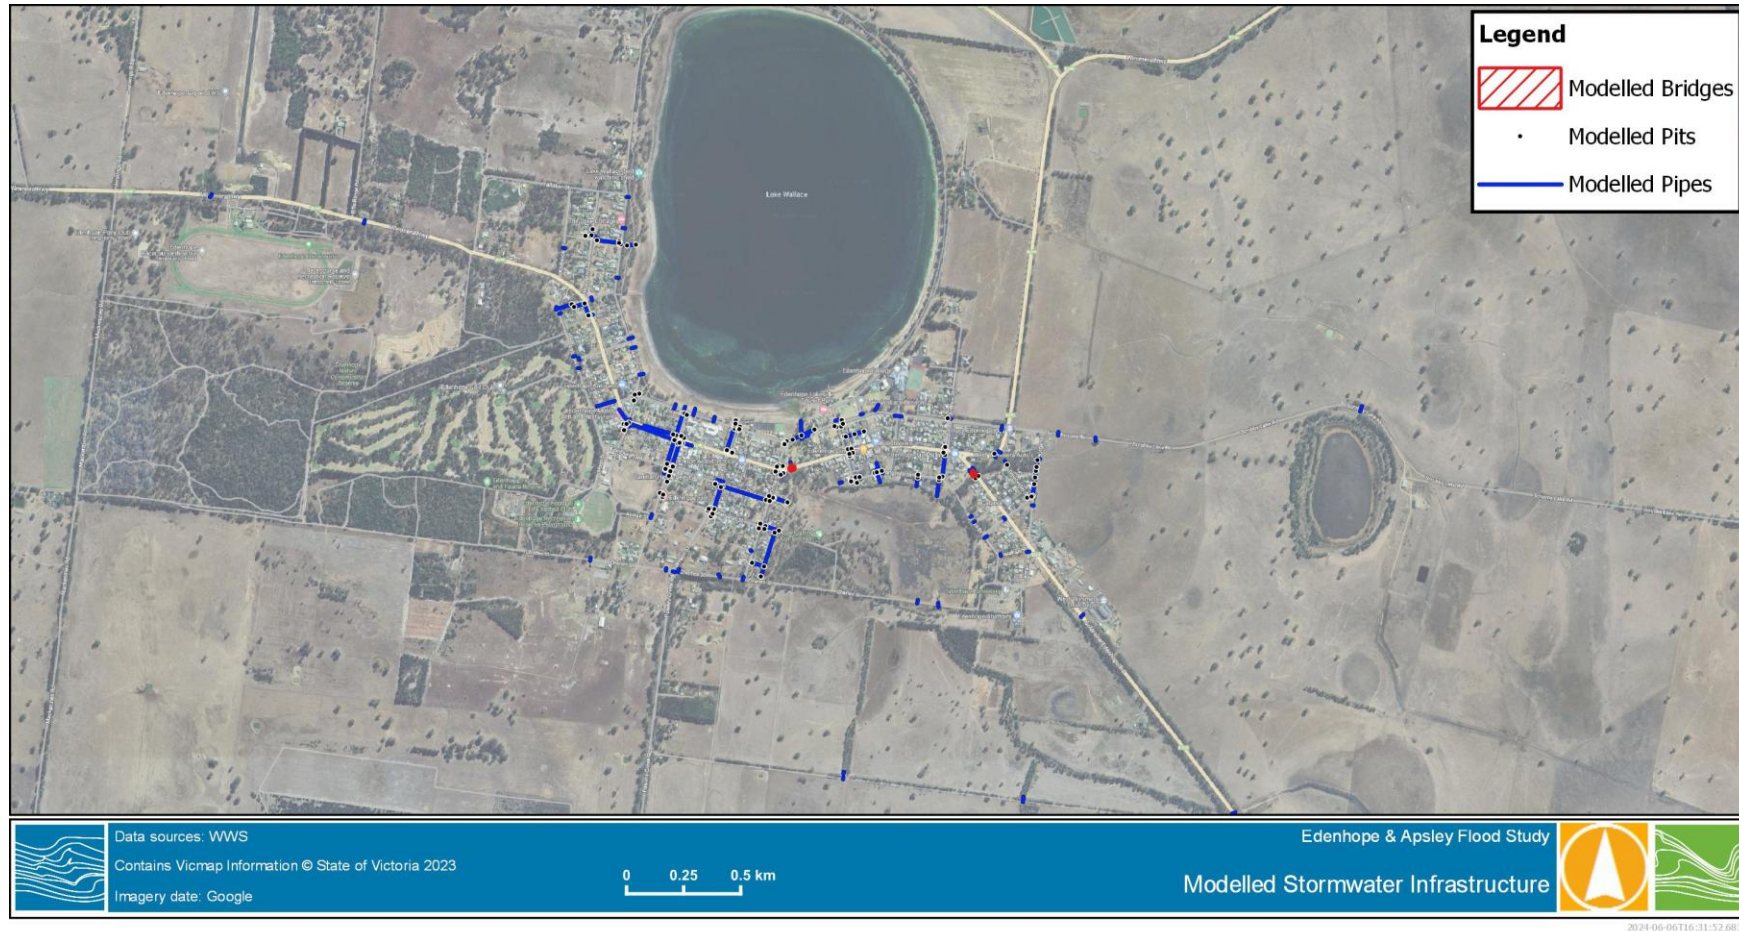
**Figure 4-7 Edenhope Modelled Structure**

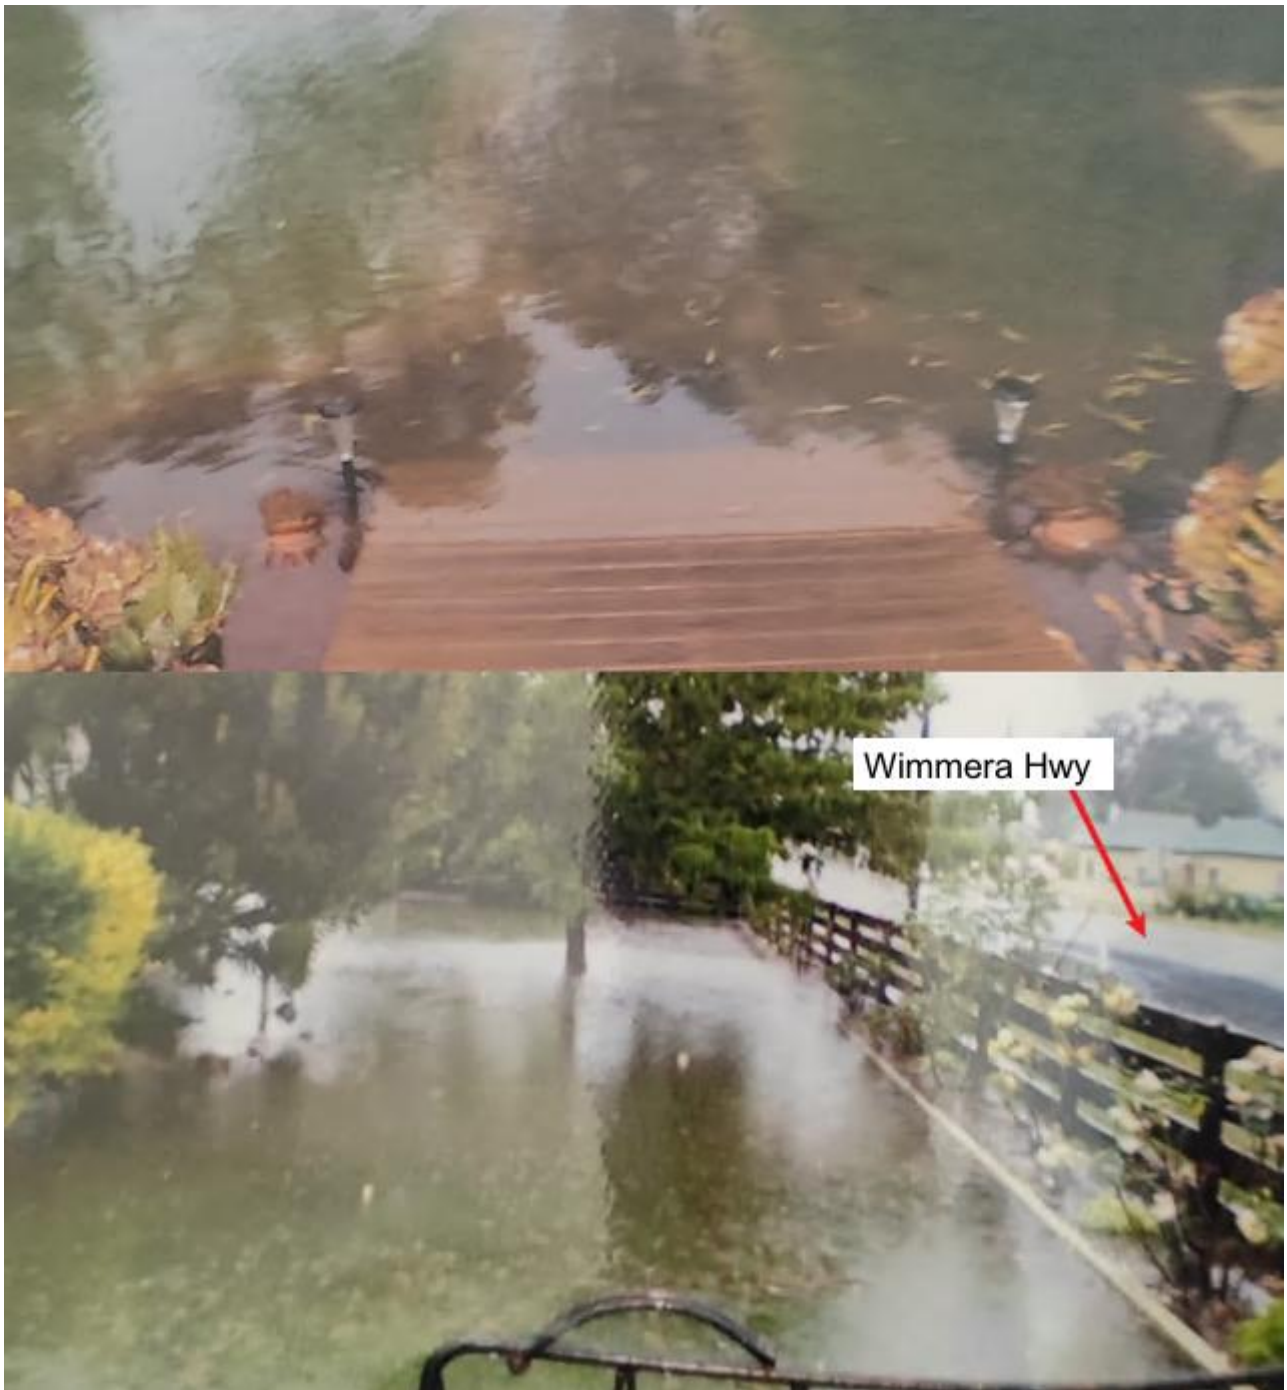
**Figure 5-5** Flooding at residences along Townsend Street

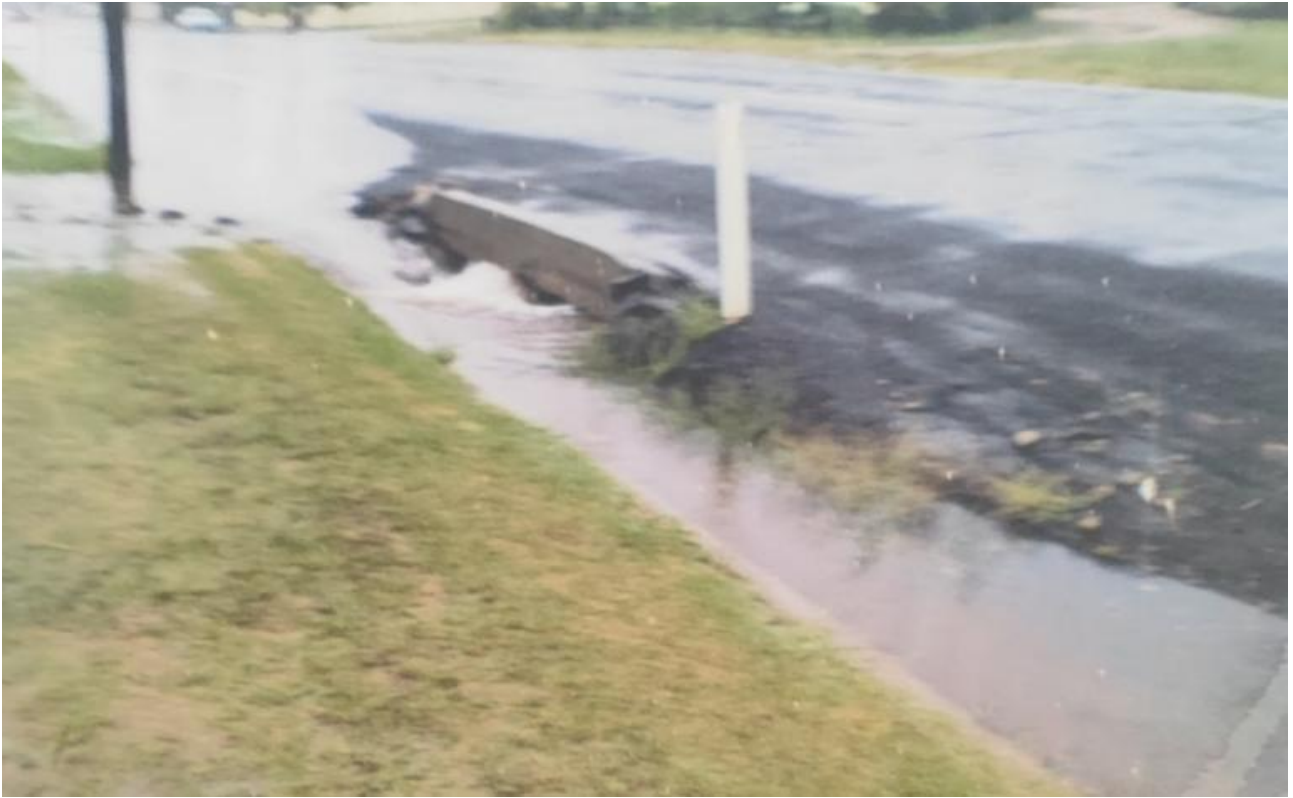
**Figure 5-6 Flooding at Wallace Street Crossing**
