Spring & Tuckers Creek Waterway Action Plan

- Final
- 4 August 2006

Sinclair Knight Merz
McGuigan Lane (rear of 153 Gray Street)
Hamilton VIC 3300 Australia
Tel: +61 3 5571 9535
Web: www.skmconsulting.com

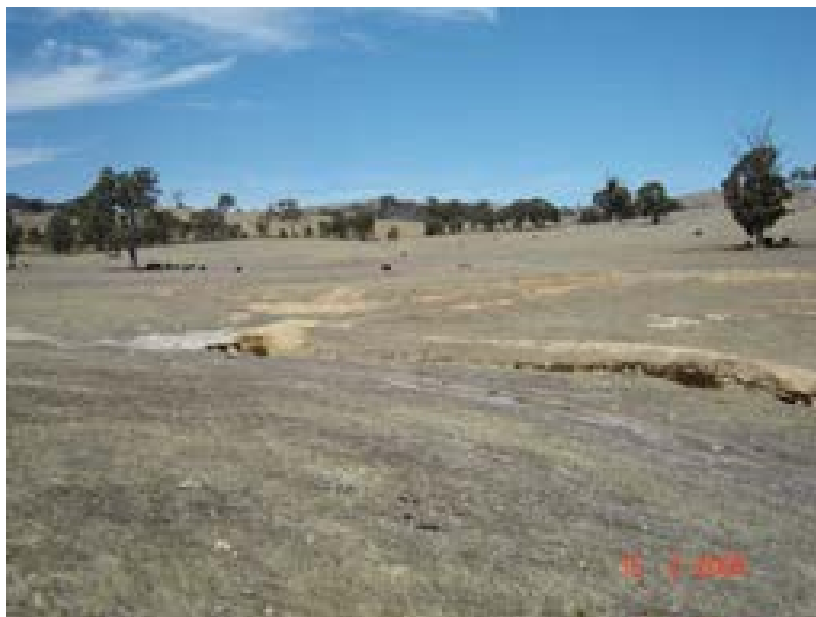
Figure 2-1 The majority of the Spring and Tuckers catchment is characterised by cleared paddocks and scattered trees.

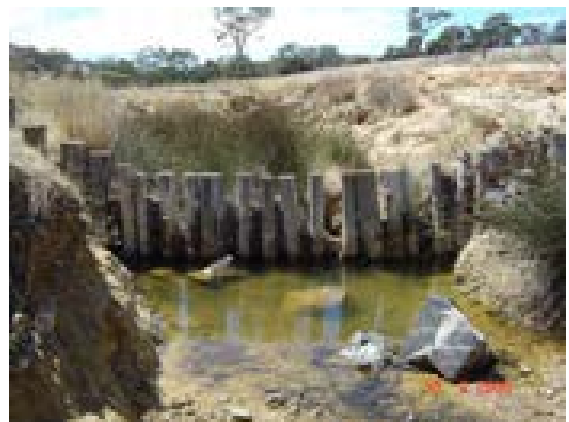
■ **Figure 5-2 Wooden Pile field**

Towards the lower end of the reach at the break of slope, sediment coarser than gravels are deposited with only smaller gravels and finer material carried on. The cobbles are imbricated in the upper reach thus serving to semi-stabilise these areas where they occur. The pile fields have broken the natural process of cobble movement and hence there are areas of scouring. The stream-form takes on a more meandering pattern as it progresses to the lower parts of the reach with the sediment store increasing as the grade changes. These stores are dynamic as the more meandering pattern within the confined valley floor constantly rework the stored material and the adjacent hillslopes. Some stabilisation of this very active area could be achieved through installation of some minor bed grade controls and bank groynes.

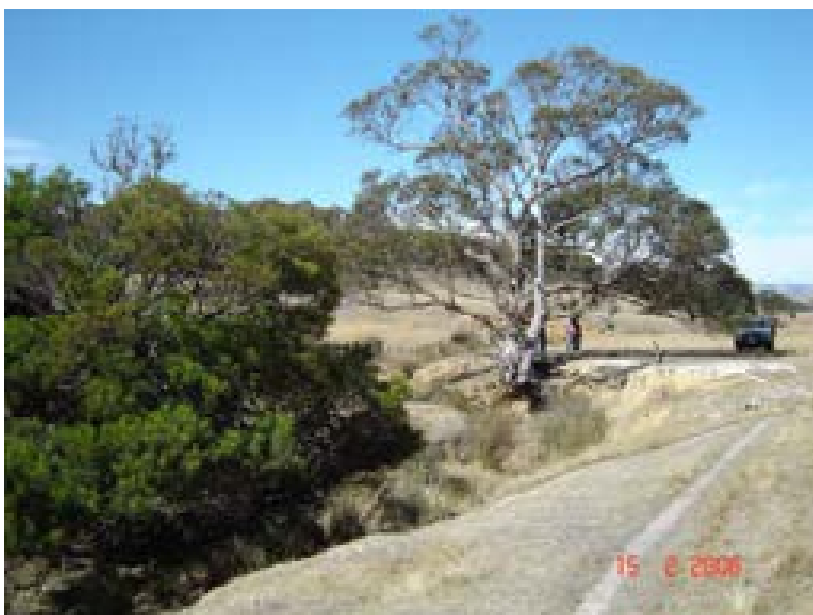
Figure 5-4 Scattered Swamp Gum (*E. ovata*) and Black Wattle (*A. melanoxylon*) are found scattered along the upper reaches of Spring Creek (Reach S2).

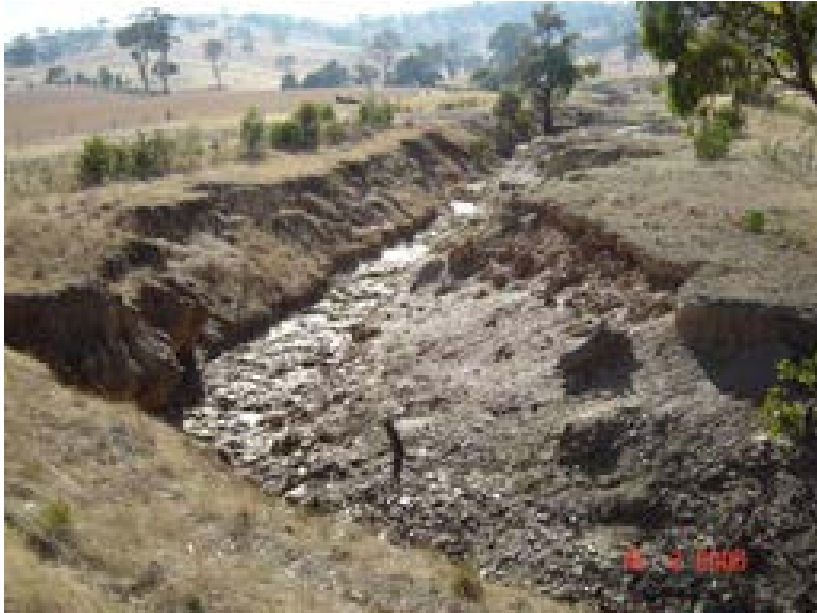
Although revegetation efforts have helped stream stability in some sections, there are extensive opportunities to expand these plantings and utilise specially selected indigenous species as substitutes to exotic species (i.e. Vitiva) (refer to Figure 6-2). Existing revegetation sites should be protected from stock and further planting should be encouraged in the voids where plants have died. A revegetation program for in-stream areas could include species such as sedges, (*Carex spp*), rushes (*Juncus spp*) and Lomandra (*Lomandra multifolia*). All of these species are found to be highly effective in soils with poor moisture and high salt content. They all have robust fine hair root systems that aids erosion control and are very drought tolerant.

Figure 6-2 Revegetation along the upper reaches of T1

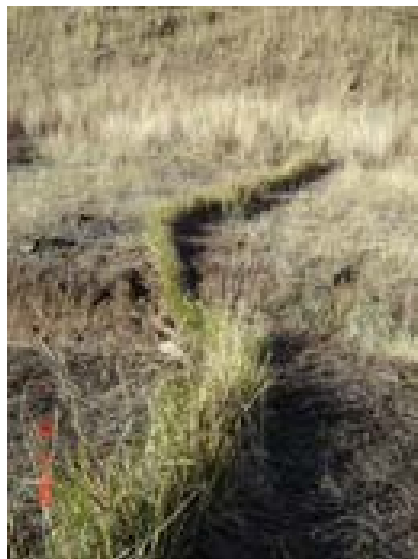
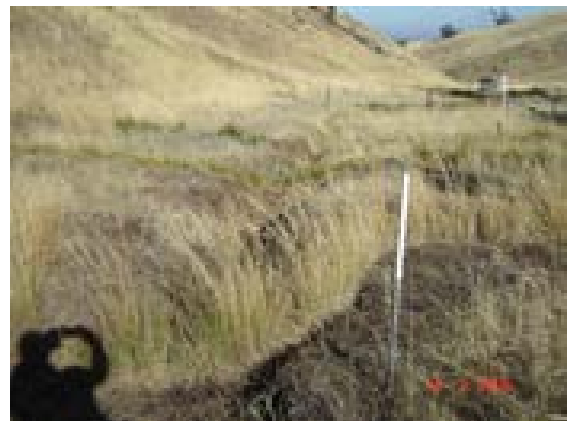
■ **Figure 6-3 Vegetation trials of Vetiver (*Vetiveria zizanioides*) along the upper valley of reach T1.**

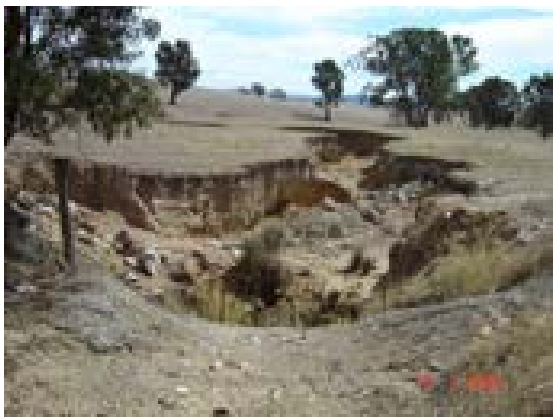
For descriptive purposes, the mainstem of this reach has been discussed in three sections. The most downstream sub-reach runs from the edge of the former floodplain and meanders its way through to near Spring Flat Road. This reach has previously been incised but the installation of an SCA drop structure appears to have arrested the process. This has allowed the channel upstream to aggrade to the point that the channel is now infilled and quite stable compared to the nearby Spring Creek. Upstream of this the channel grade steepens and incision and active bed and bank erosion is evident.

■ Figure 7-1 Effective SCA drop structure

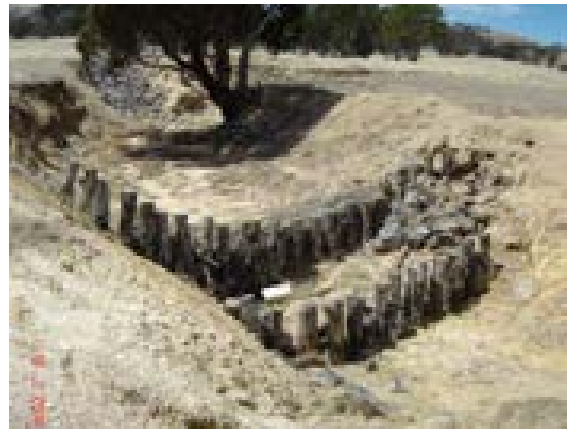
■ **Figure 7-3 Twin pile field**
