## Wimmera Catchment Management Authority

# Geomorphic Categorisation and Stream Condition Assessment of the Wimmera River Catchment

Job 2901049.008 & 2901049.009

April 2003

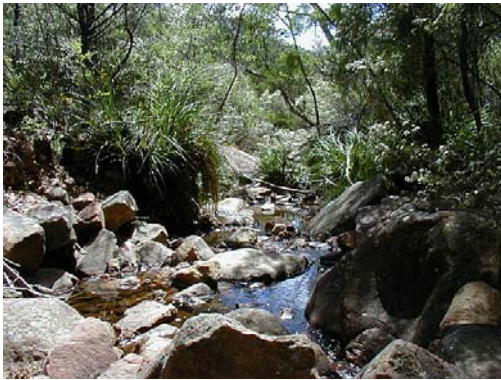
**Figure 2.3c: A steep headwater stream, Grampians National Park (ISC Site 17\_5)**

Reach near Seven Dials Track. Note the confining valley margins and the boulder and cobble bed of the stream.

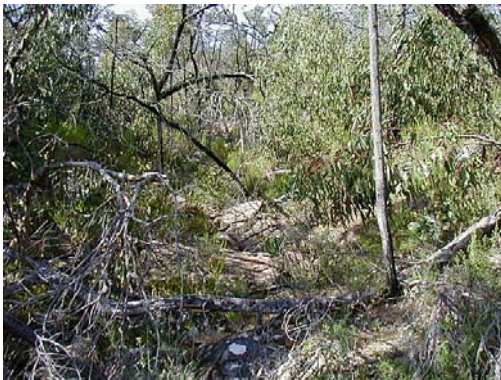
**Figure 2.3d: A steep headwater stream, Grampians National Park, (Site 20\_2)**

A steep headwater stream off the Copper Mine track, Grampians National Park. Note the angular boulder bed and the confining valley margins.

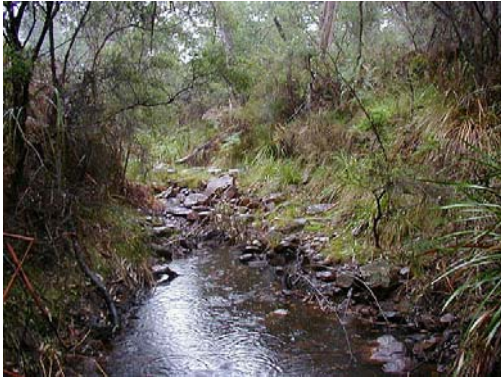
**Figure 2.4c: A confined tributary in the Grampians National Park**

A confined tributary of the MacKenzie River, note the confining banks and the sub-angular cobble bed-load. (ISC Site 12\_5)

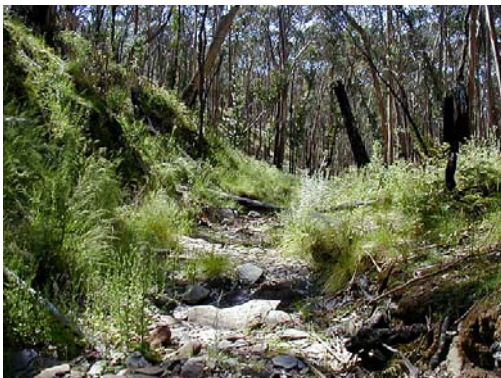
**Figure 2.4d: A confined upper reach of Glenpatrick Creek.**

A confined reach of Glenpatrick Creek, note the confining valley margins. (ISC Site 34\_4)

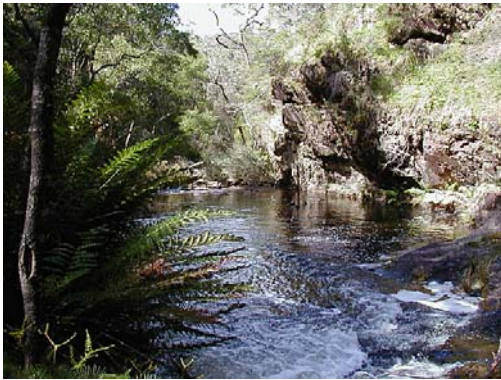
**Figure 2.5c: MacKenzie River Gorge**

The MacKenzie River gorge contains riffles, cascades, runs and significant water fall, and the channel base is covered with gravels and cobbles. The photo shows a rapid discharging into a typical pool. The Wartook Reservoir controls flows within the gorge. (ISC site14\_13)

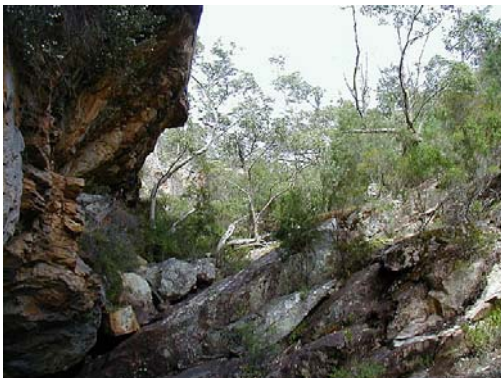
**Figure 2.5d: Golton Creek Gorge**

The Golton Creek Gorge is situated within the Grampians National Park. The gorge has a relatively steep bed grade and contains extensive bedrock sections. (ISC site 21\_11)

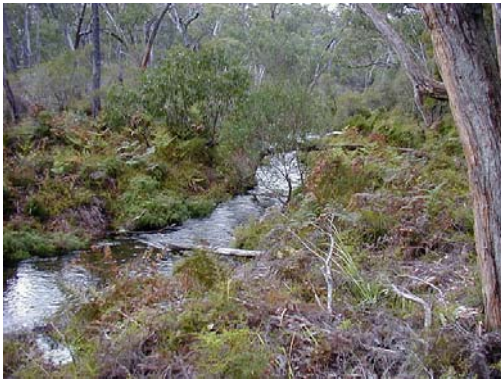
**Figure 2.6c: A Partly Confined reach of the Mackenzie River**

The partly confined MacKenzie River between the Wartook Reservoir and the MacKenzie Falls and gorge. (ISC Site 15\_1)

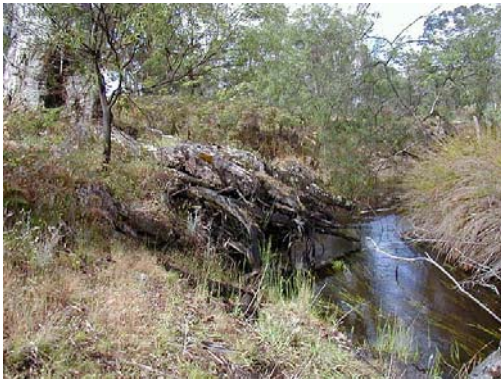
**Figure 2.7c: Lower Mackenzie River**

A partly confined reach of the MacKenzie River downstream of the MacKenzie Gorge. The water level is due to this part of the MacKenzie River being used to carry water from the Wartook reservoir to Distribution Heads. (ISC Site 13\_11)

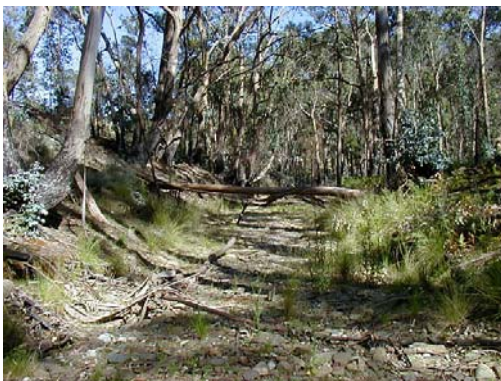
**Figure 2.7d: Glenpatrick Creek**

A partly confined reach of Glenpatrick Creek. Note the relatively uniform cobble bed which can be attributed to the past mining of the area (ISC Site 33\_5)

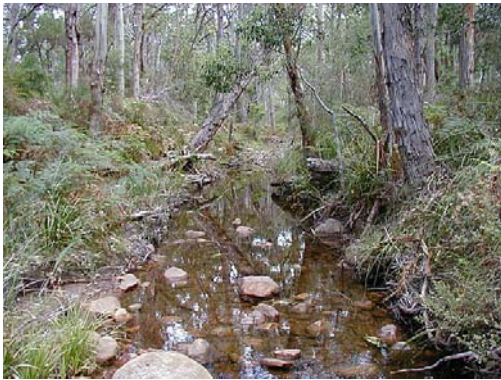
**Figure 2.8c: Upper Fyans Creek**

A partly confined reach of a Fyans Creek tributary above Lake Bellfield in the Grampians National Park. (ISC Site 16\_6)

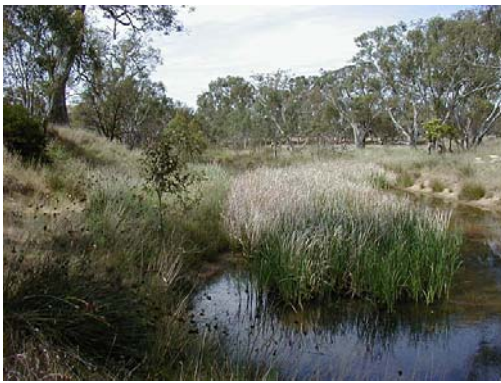
**Figure 2.8d: Wimmera River**

A partly confined reach of the Wimmera River in the upper catchment. (ISC Site 46\_2)

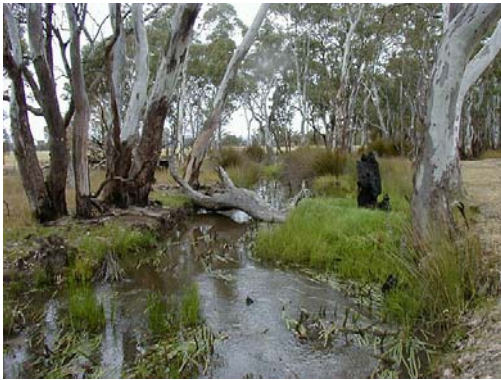
**Figure 2.9c: A low sinuosity reach of the MacKenzie River**

A low sinuosity reach of the MacKenzie River, the bank full flows are due to this part of the river being used to carry irrigation water from the Wartook Reservoir to the Distribution Heads. (ISC Site 8\_3)

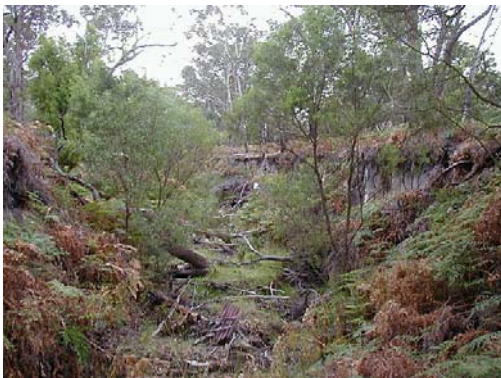
**Figure 2.9d: Reservoir Creek**

A low sinuosity reach of Reservoir Creek (ISC Site 40\_10).

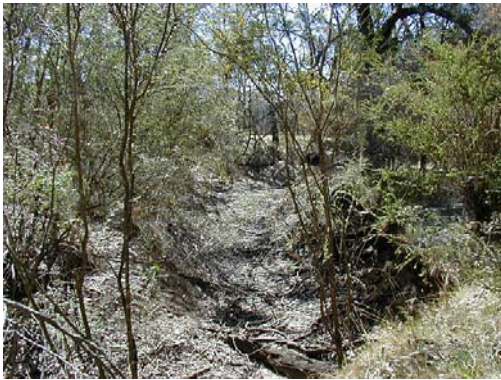
**Figure 2.10c: Mt William Creek**

A typical moderately sinuous reach of Mt William Creek (ISC Site 18\_1).

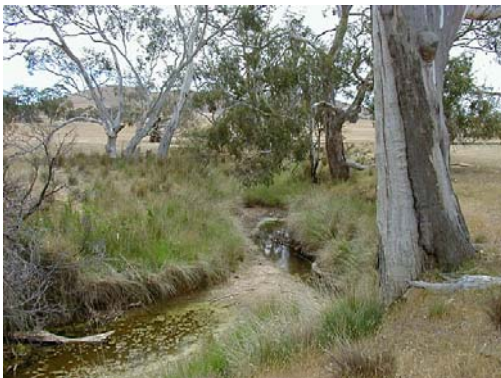
**Figure 2.10d: Seven Mile Creek**

A moderately meandering reach of Seven Mile Creek (Site 25\_6)

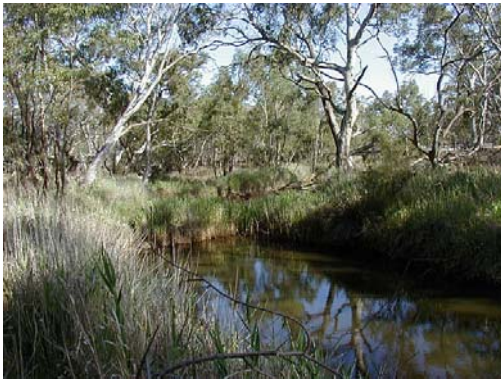
**Figure 2.12c: The Lower Wimmera River**

The main channel of the Wimmera River. The photo shows a pool and thickly vegetated bar that divides it from the next pool. (Site 27b\_8)

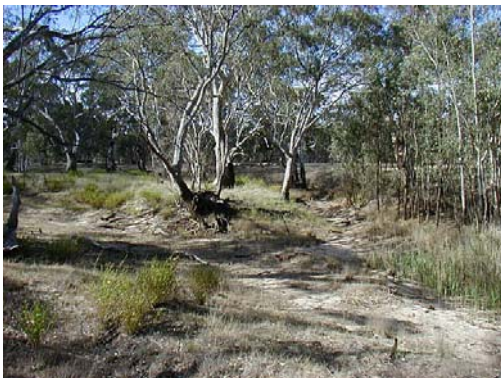
**Figure 2.12d: An anabranch of the Wimmera River**

The main anabranch / flood-channel of the Wimmera River, the photo shows splitting of the main subsidiary anabranch into two channels. (Site 27\_6)

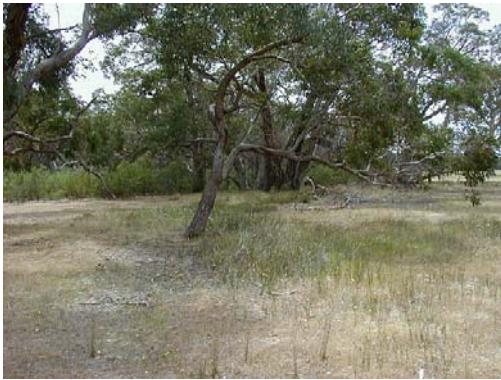
**Figure 2.13c: Intact Valley Fill**

An Intact Valley Fill system showing an indistinct preferred flow path. The Intact Valley Fill can be identified in the photo by the indistinct sandy bed and the greener grass (ISC Site 22\_4).

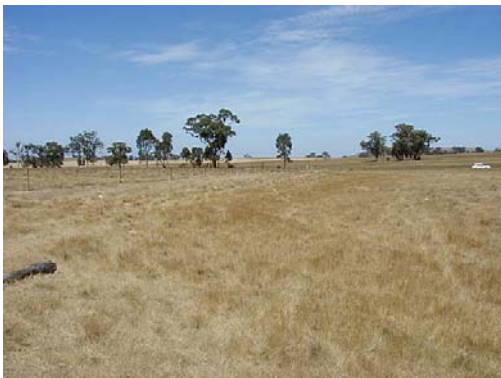
**Figure 2.13d: Intact Valley Fill, cleared farmland**

A typical Intact Valley Fill system in cleared farmland. The system is slightly inset into the surrounding countryside, and is identified by the slightly darker brown grass in the above photo (ISC Site 29\_5).

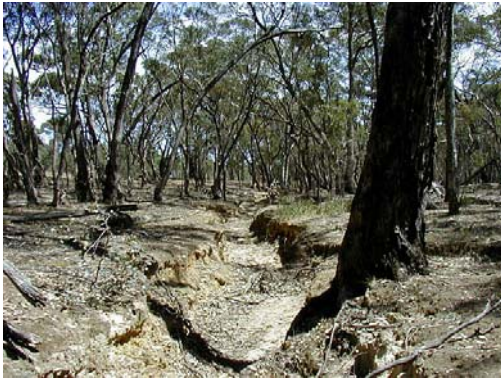
**Figure 2.15c: Lower Cut Phase**

Lower reaches cut phase on a minor stream in the Pyrenees. (ISC Site 31\_1)

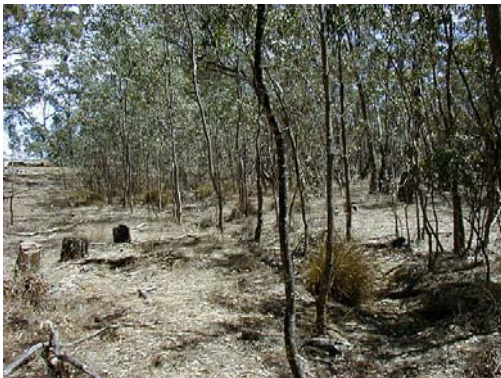
**Figure 2.15d: Floodout / Fill Phase**

Middle reaches fill phase on a minor stream in the Pyrenees (ISC Site 31\_2).

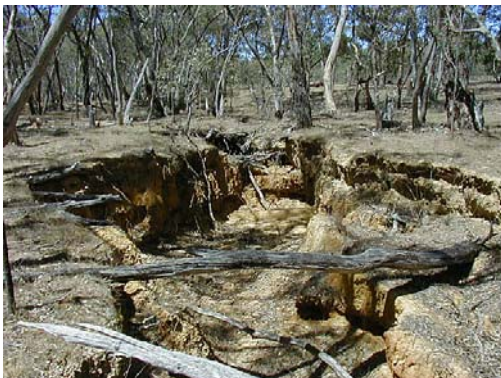
**Figure 2.15e: Upper Cut Phase**

Upper reaches cut phase on a minor stream in the Pyrenees (ISC Site 31\_4).

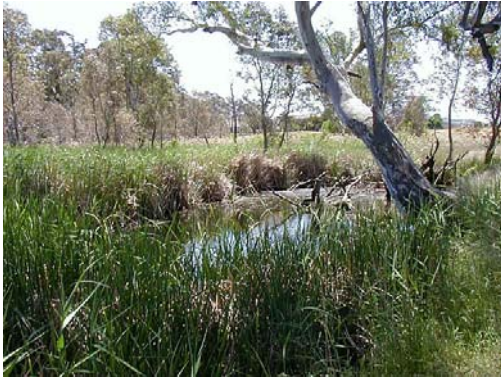
**Figure 2.14c: Glenlofty Creek, chain of ponds.**

A view of the Glenlofty Creek chain of ponds system. Note the thick reedy vegetation that surrounds the pond and the large eucalypt associated with the pool. (ISC Site38\_3)

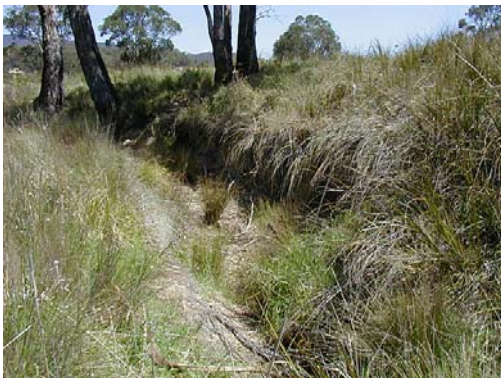
**Figure 2.14d: Upper Glenlofty Creek**

A view of the upper parts of Glenlofty Creek. Note the thick vegetation of the inset channel and the dry scour pool at the base of the bank. (ISC Site 39\_2)

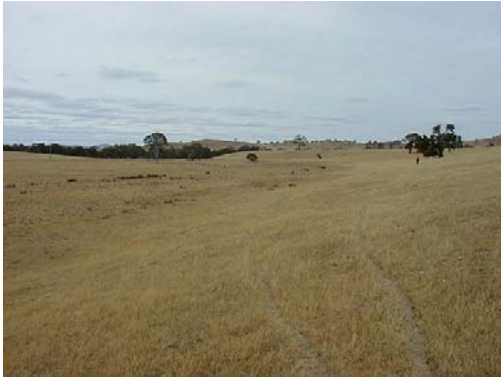
**Figure 2.16c: Downstream view of floodout**

Looking downstream over flood-out and valley margin. (ISC Site 49\_6)

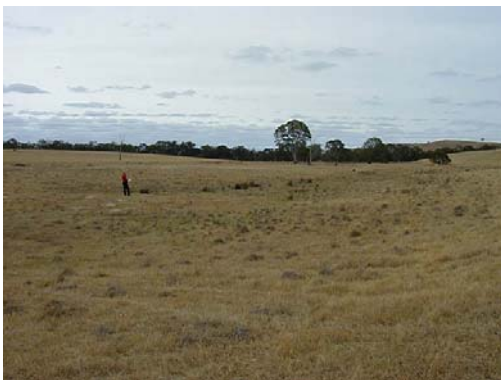
**Figure 2.16d: Cross-sectional view of floodout.**

Lobate front of flood-out. (ISC Site 49\_8)

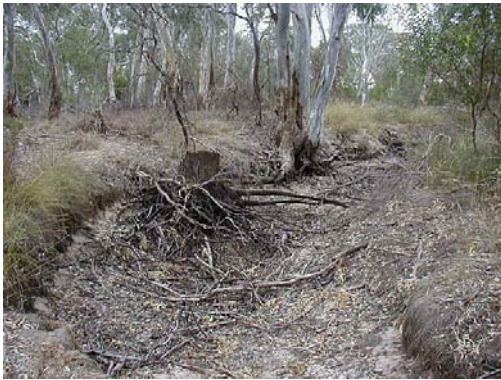
**Figure 2.17c: Lower MacKenzie River**

A major flow path with ponds of the MacKenzie River above its confluence with the Wimmera River. (ISC Site 6\_3)

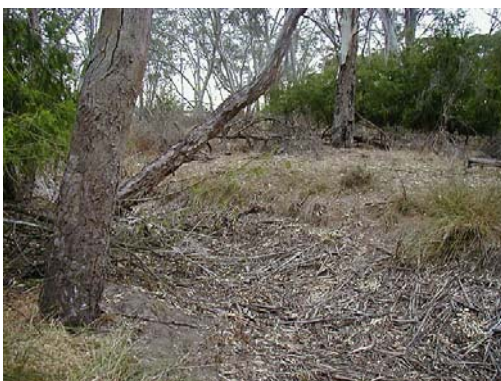
**Figure 2.17d Lower Mackenzie River, flood channel.**

The MacKenzie Rivers floodplain, note one of the numerous associated channels and flood-channels. (ISC Site 6\_7)

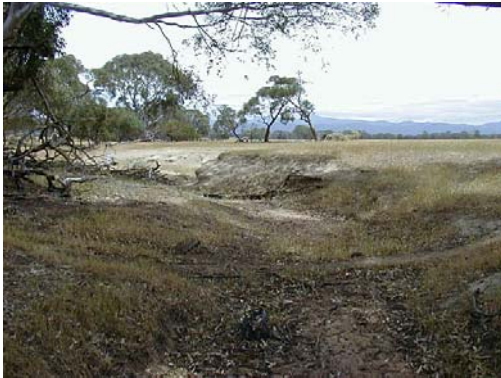
**Figure 2.18c: A recovering incised system**

A stabile incised discontinuous system, note that banks are generally vegetated and at a stable slope in parts and only non-vegetated part of the channel is on the outer bank of the meander bend. (ISC Site 23\_1)

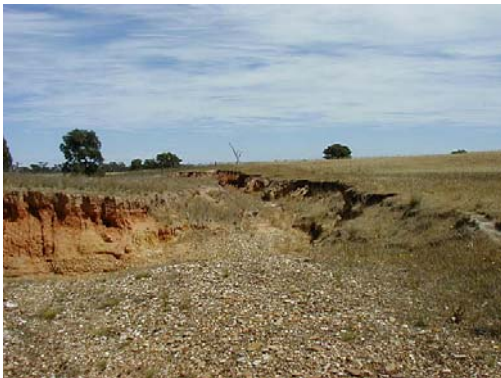
**Figure 2.18d: An incised system beginning to recover**

An actively incising discontinuous system. Note the gravel point bar and bed armouring, derived from in-situ material and the actively eroding over steep bank. (ISC Site 30\_7)

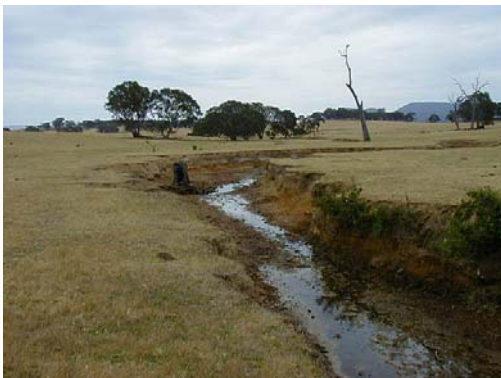
**Figure 2.18e: An actively incising system**

An actively incising discontinuous system in farmland, note the unstable vegetation bare over steep banks and minor gravel bar in the channel. The gravel is derived from the erosion of in-situ material. (ISC Site 42\_8) An actively incising system

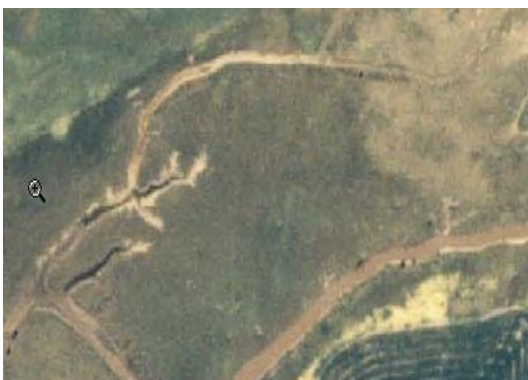
**Figure 2.18f: An aerial view of an actively incising system**

An aerial view of an incising stream in the Wattle Creek catchment

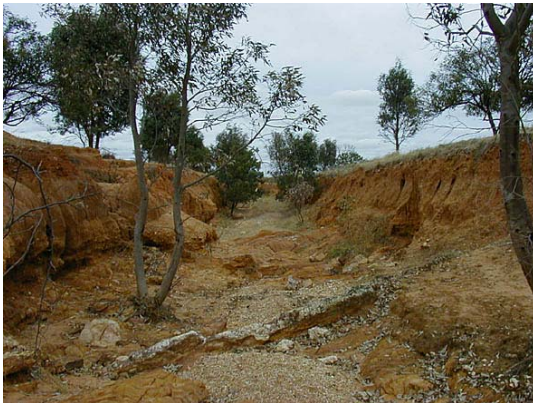
**FS#48 – Unknown 12**

Physical Form Score: 1/10

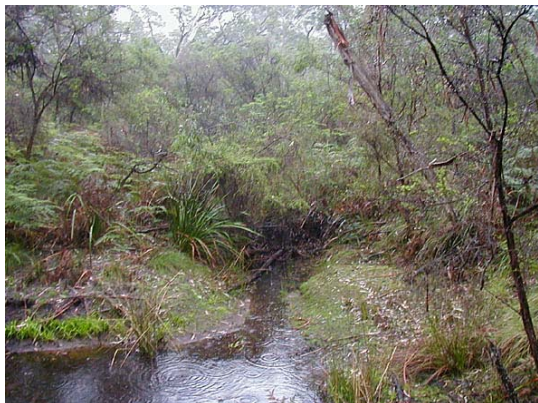
**FS#12 – Boggie Creek**

Physical Form Score: 8/10

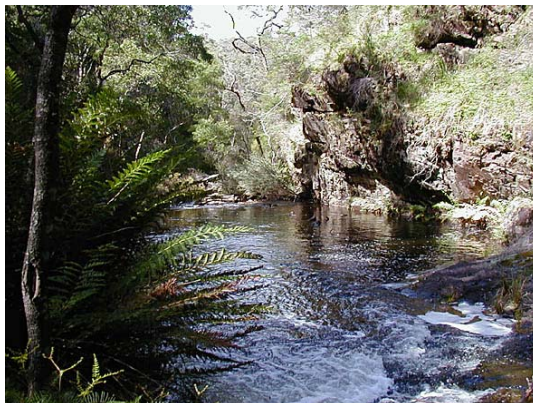
**FS#14 – MacKenzie Creek**

Physical Form Score: 8/10

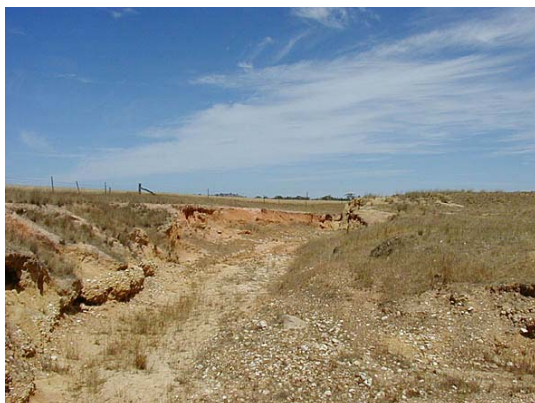
**FS#30 – Unknown 6**

Streamside Zone Score: 3/10

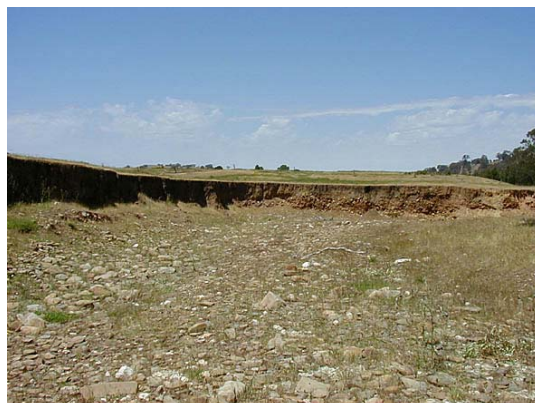
**FS# – 36 – Nowhere Creek**

Streamside Zone Score: 3/10

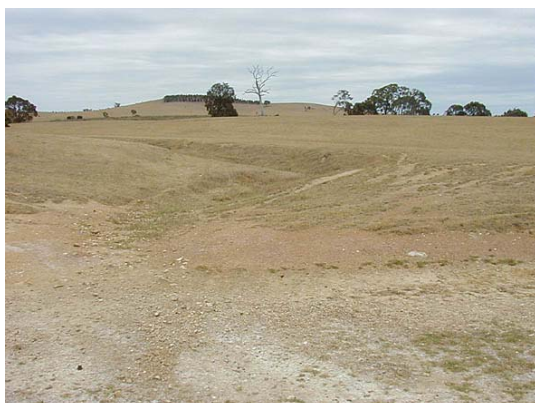
**FS#44 – Unknown 11**

Streamside Zone Score: 3/10

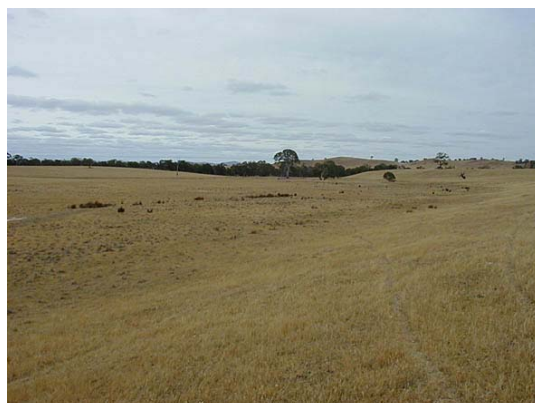
**FS#49 – Unknown 13**

Streamside Zone Score: 3/10

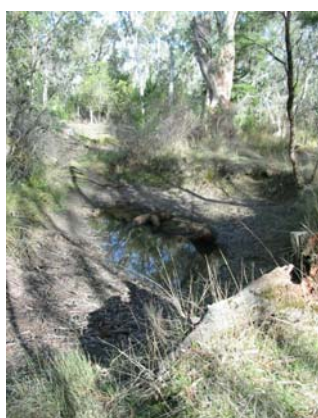
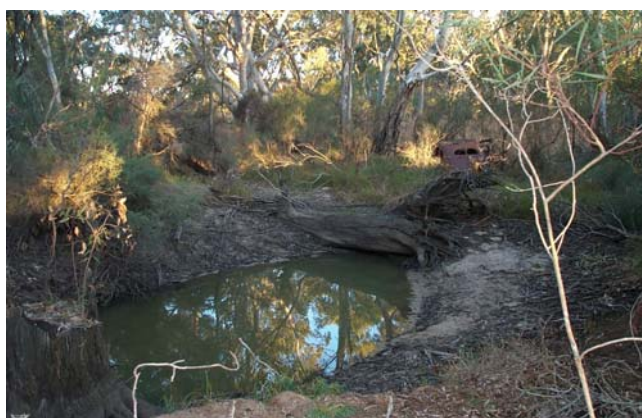
#### Figure 4.1: Discontinuous Anabranching Chain of Ponds

The sand-bedded lower MacKenzie River still has an intact channel system. The system shows no evidence of instability, excessive incision or deposition. Similar systems have been identified in the Mt Lofty Ranges of South Australia (see Figure 4.1). The two systems contain similar geomorphic forms and riparian vegetation.

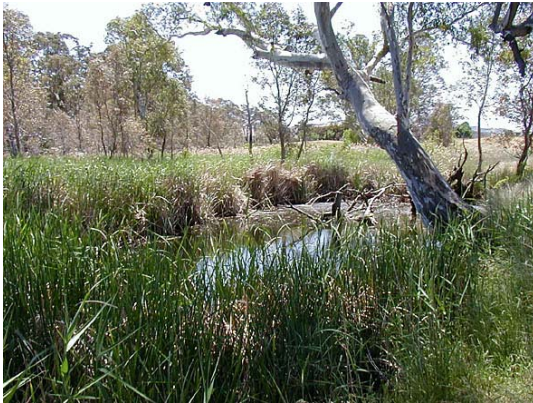
FS #38: Glenlofty Creek

**Figure 4.4: Example of a Chain of Ponds**
