Wimmera
Catchment Management
Authority

Glendhu Creek Waterway Action Plan

November 2004

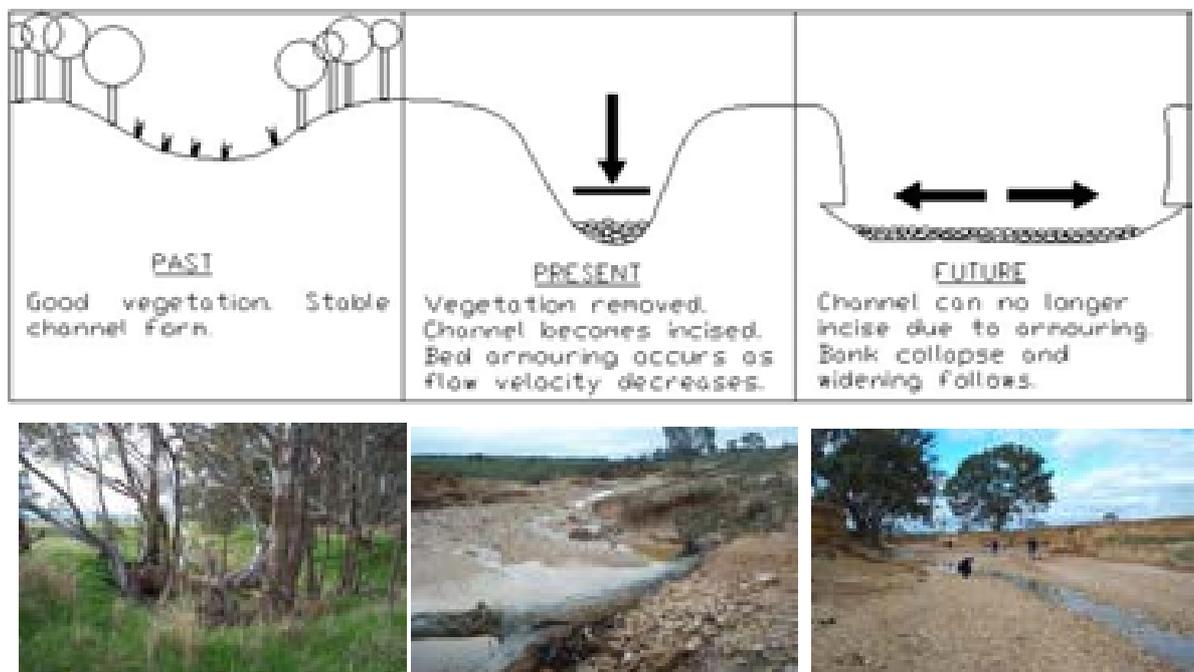
In the upper catchment of Glendhu Creek a combination of poor vegetation and the steepness of slopes results in a rapid concentration of rainfall runoff. Short high intensity rainfall events under these conditions have high stream powers that erode bare banks and transport large volumes of all sizes of sediment. Smaller events that occur following a larger event then have the potential to remove (winnow) finer sediment from the bed and deposit it further downstream. This leaves the coarser material in the bed (as lower flow velocities do not have the capacity to mobilise larger sediments), to form an armouring gravel layer. When left undisturbed, this gravel layer has the ability to limit further bed incision. Once bed armouring is established the streambed is less likely to deepen further, and unless otherwise restricted, the channel will undergo a process of widening as illustrated in Figure 5. Examples of active stream widening as a result of this mechanism can be found at a number of locations on Glendhu Creek.

Figure 5. The process of vegetation removal that leads to stream incision and later bed armouring in the upper catchment of Glendhu Creek.

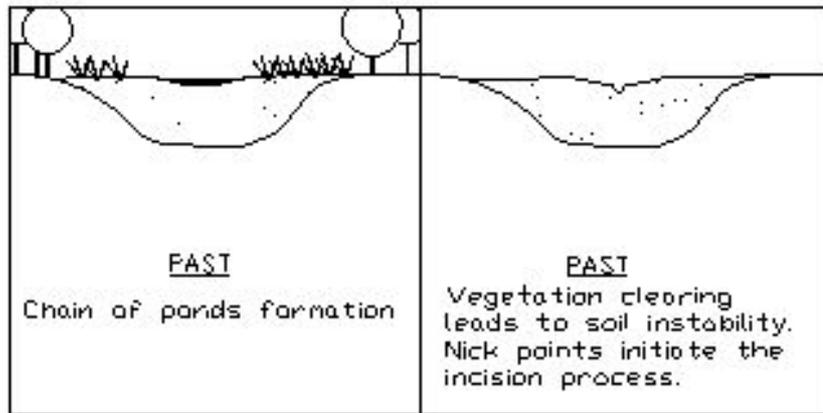
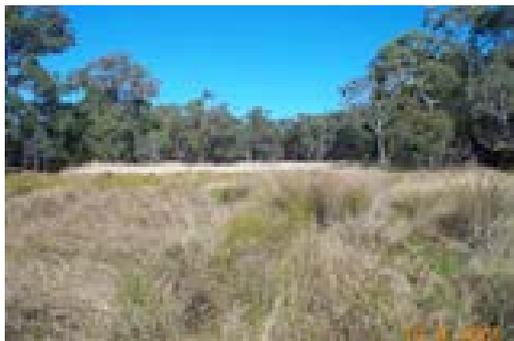
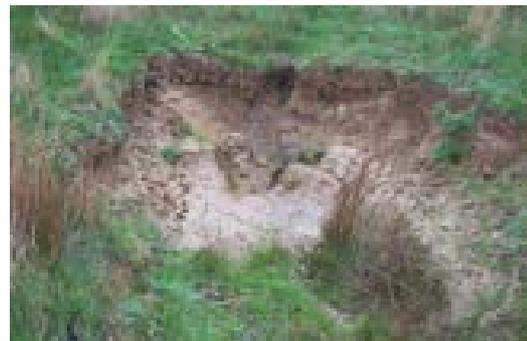
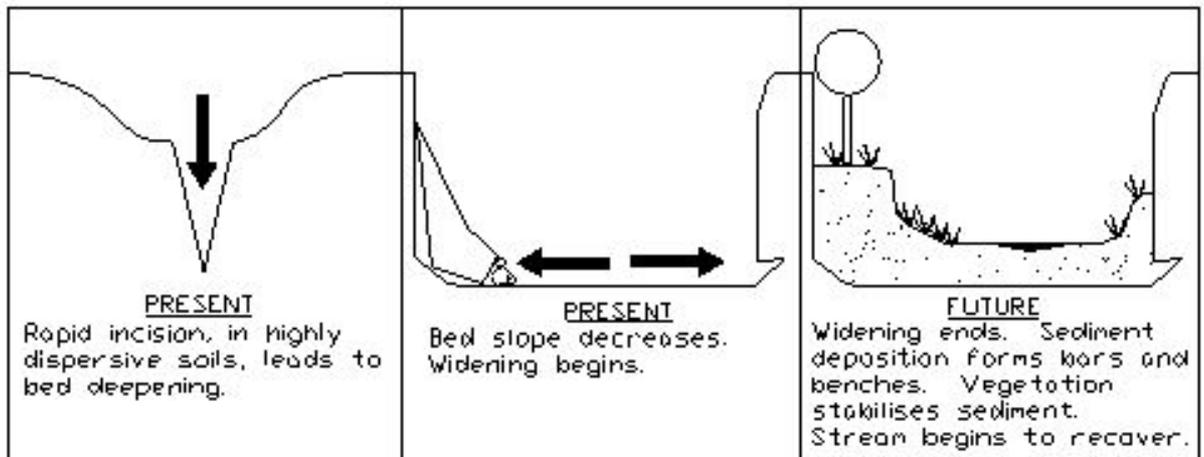
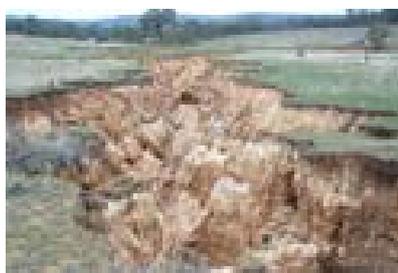
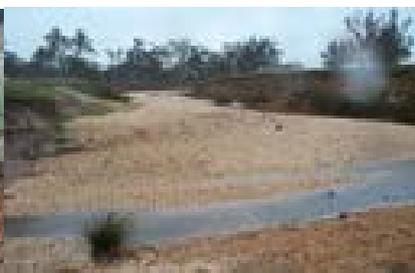
At the time of European settlement, a chain of ponds river style dominated much of the lower catchment creek system. Wide scale clearing and in some cases the digging of drainage channels, led to rapid incision and deepening of the streambed. This process has changed the stream from a discontinuous form to a continuous channel that can readily convey sediment to the Wimmera River. The deepening process has stopped where either the bed gradient has become too flat for incision to continue, or where there exists a bed control in the form of bedrock or armouring and/or where there is more sediment than the stream can transport. At these locations the channel has or is undergoing a process of widening. Widening will continue until flow in the over enlarged channel no longer has the capacity to cause further erosion. At this point sediment deposition will lead to the development of instream geomorphic units such as bars and benches. This process is illustrated in Figure 6.

Figure 6. Steps in the process of stream degradation and recovery occurring in the lower reaches of Glendhu Creek.

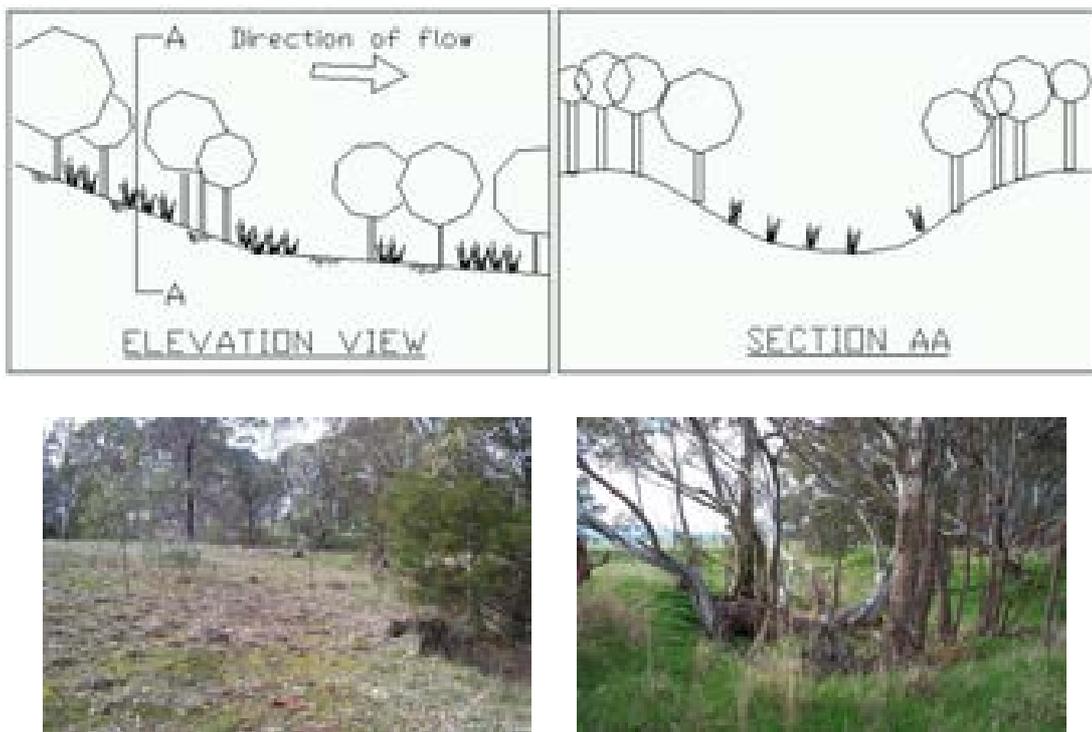
Figure 11a. Waterway conditions prior to vegetation clearing.

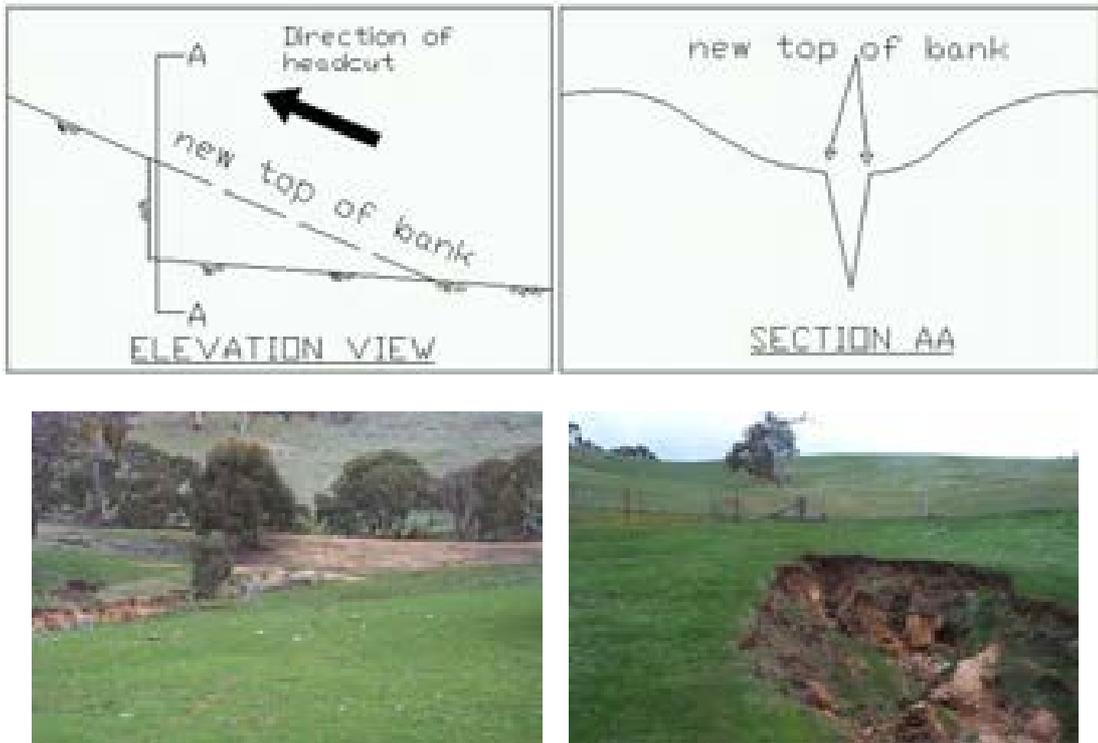
Figure 11b. Waterway conditions following vegetation clearing. Incision begins.

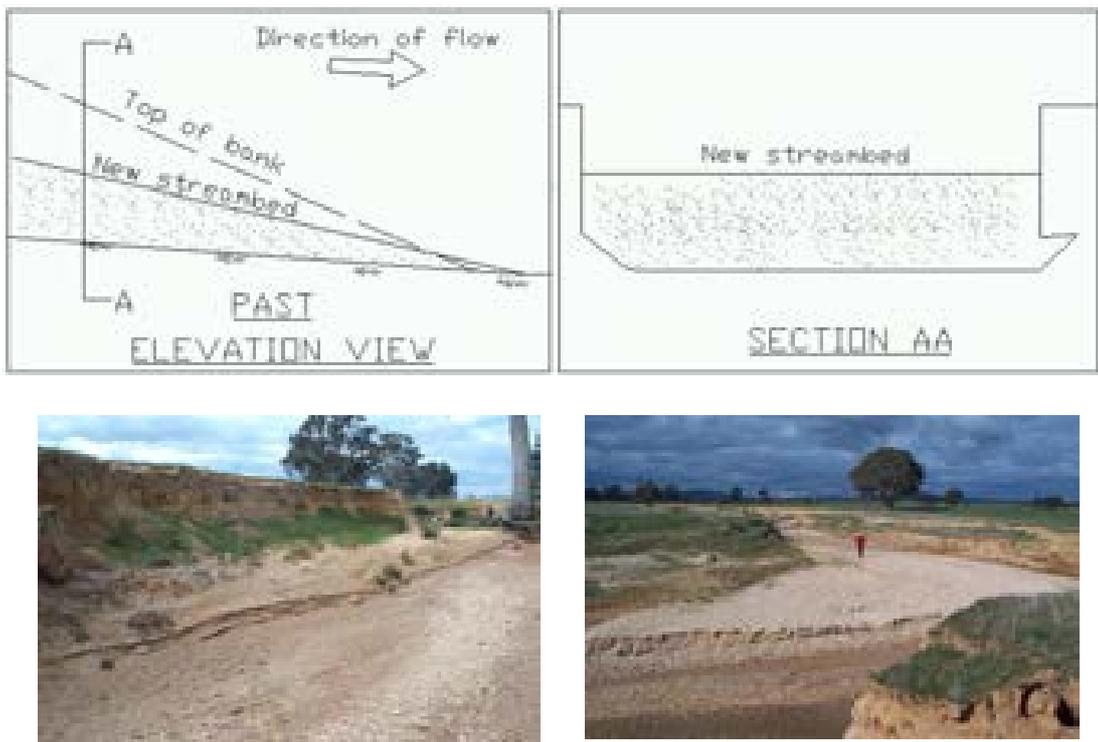
Figure 11c. Incision and widening stops. Sediment from upstream fills the streambed and the stream begins to recover.

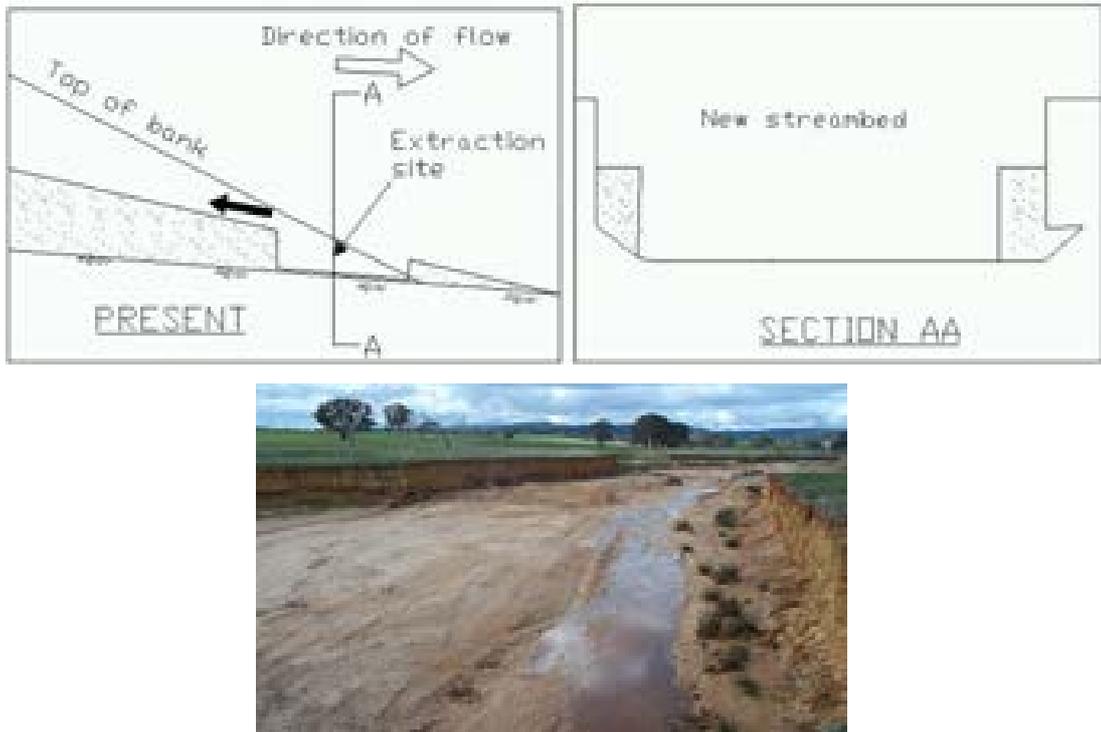
Large scale sediment extraction significantly increases sediment mobilisation through the rejuvenation of instream headcuts which then extend back upstream. As a result, the channel upstream deepens which in turn leads to stream widening through the process of bank collapse. The sediment generated is then mobilised in the next flow event and moves through the extraction site, affecting downstream reaches of the creek. The series of figures and photos that follow (Figure 11a, b, c, d and e) illustrate this de-stabilising effect of sediment extraction. The presence of a three box culvert road crossing on the Ararat-St Arnaud Road, is acting to limit the upstream extent of the de-stabilising effect of the gravel extraction operation.

Figure 11d. Sediment extraction causes deepening in a localised section of streambed. This results in a sudden change in bed level at the upstream end of the extraction site, which in turn leads to headward erosion into the upstream reaches of the stream.

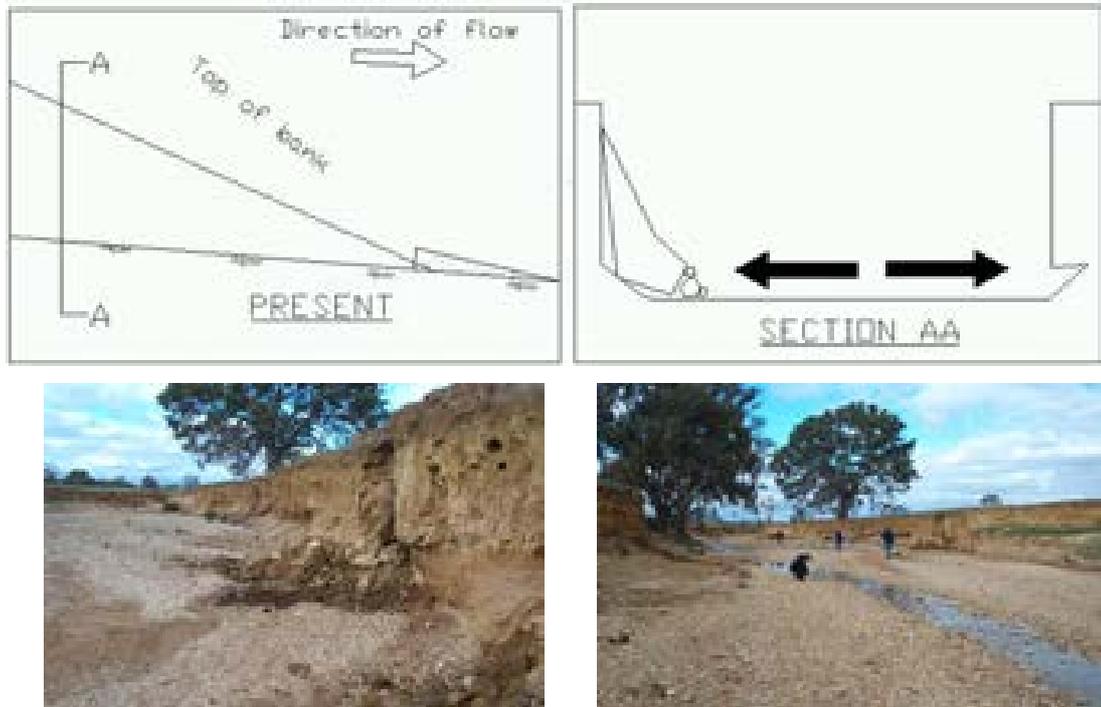
Figure 11e. Bed deepening upstream causes bank collapse and stream widening, leading to a loss of land and the generation of large volumes of sediment.
