## Glenpatrick & Nowhere Creek Waterway Action Plan

- Final
- 4 August 2006

Wimmera  
Catchment Management  
Authority

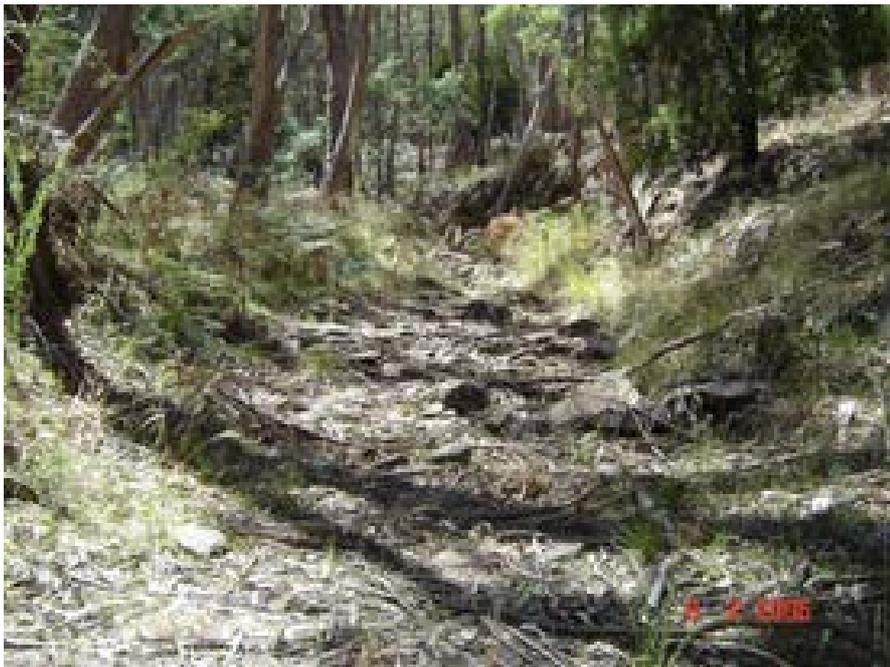
■ **Figure 2-1 Healthy streams in the upper forested catchment areas**

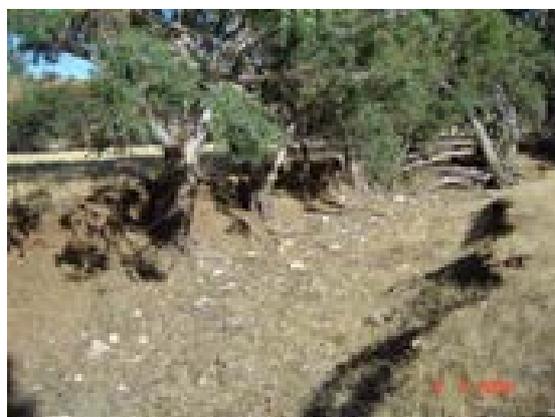
■ **Figure 4-2 Instream River Red Gums and cobble creek bed**

Uncontrolled stock access is denuding and eroding the stream bed and banks through this area. Progressing upstream cobbles are the dominant bed load as bed steepens and the valley becomes more confined. Here, the channel appears to be stable and aggrading except where the channel has some large woody debris or a sharp radius bend that causes the formation of scour holes. A typical unstable bend exists upstream where the combination of a large tree and a sharp bend has activated bank erosion. This is being exacerbated by a strong point bar formation that is directing the flows into the steep bank. Some simple rearrangement of the large woody debris would alleviate this issue. This is repeated several times through this reach.

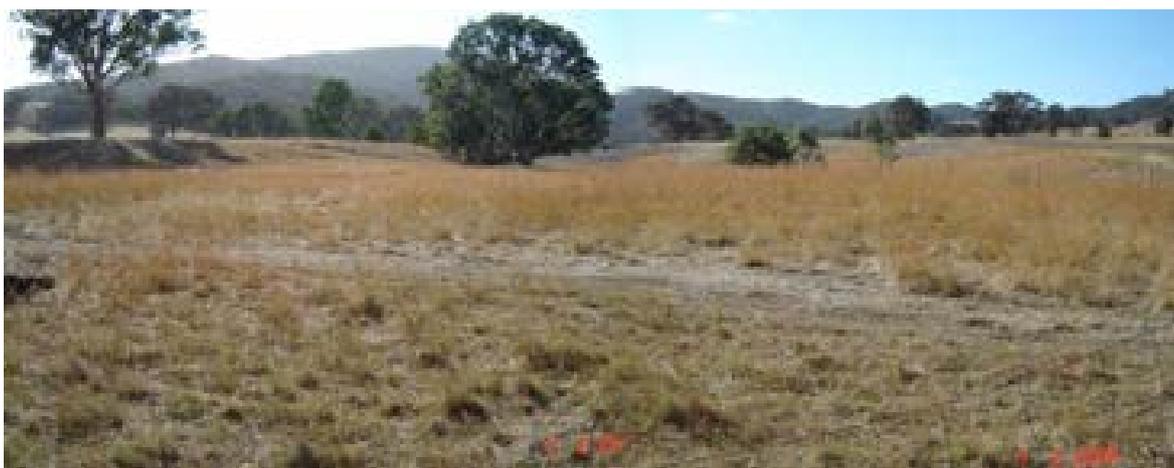
portions of the mainstem contains a rich cover of mid storey and ground layer species, including Black Wattle (*Acacia mearnsii*), Blackwood (*Acacia melanoxylon*) and Tussock Grass (*Poa labillardieri*) all of which frequently occurring in-channel. Large remnant Kangaroo Grass (*Themeda australis*) patches occur in the upper reaches of the mainstem and on G1/3 in areas that receive extra water in the form of run-on.

■ **Figure 4-6 Kangaroo Grass (*Themeda australis*) on G1/3**

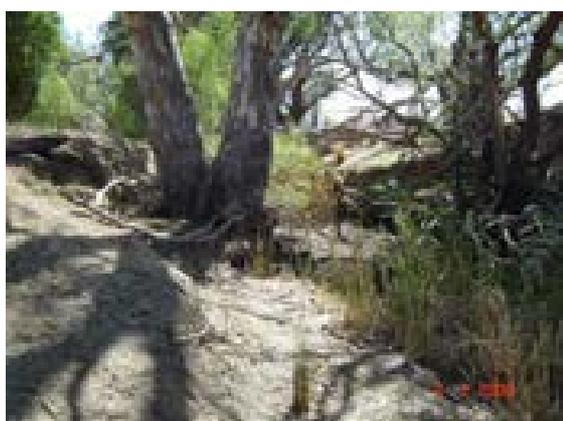
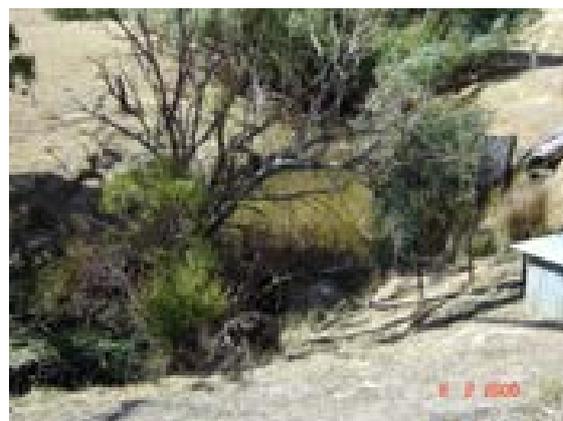
In-stream vegetation is mainly restricted to the lower parts of the mainstem where small pools contain a good diversity of species, particularly in areas downstream of Keams Lane (Refer to Figure 4-8 **Error! Reference source not found.**). Dominant aquatic vegetation included Phragmites (*Phragmites australis*), pockets of Cumbungi (*Typha domingensis*), Small Spike Sedge (*Eleocharis pusilla*), Common Spike Sedge (*Eleocharis acuta*) and Common Water-Milfoil (*Myriophyllum propinquum*).

■ **Figure 4-8 Riparian vegetation along the lower reach of Glenpatrick Creek.**

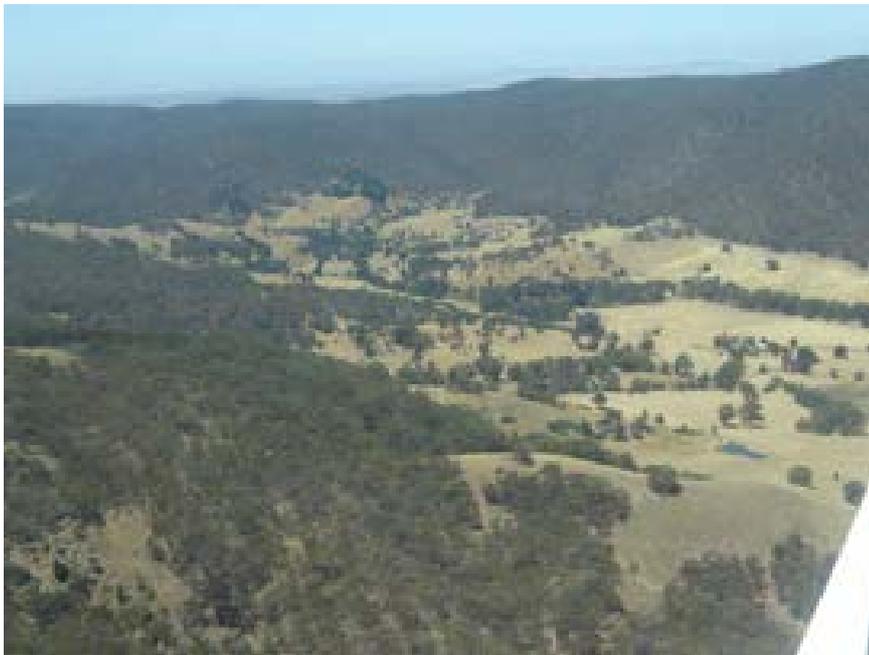
■ **Figure 5-1 Upper reach of Glenpatrick Creek catchment**

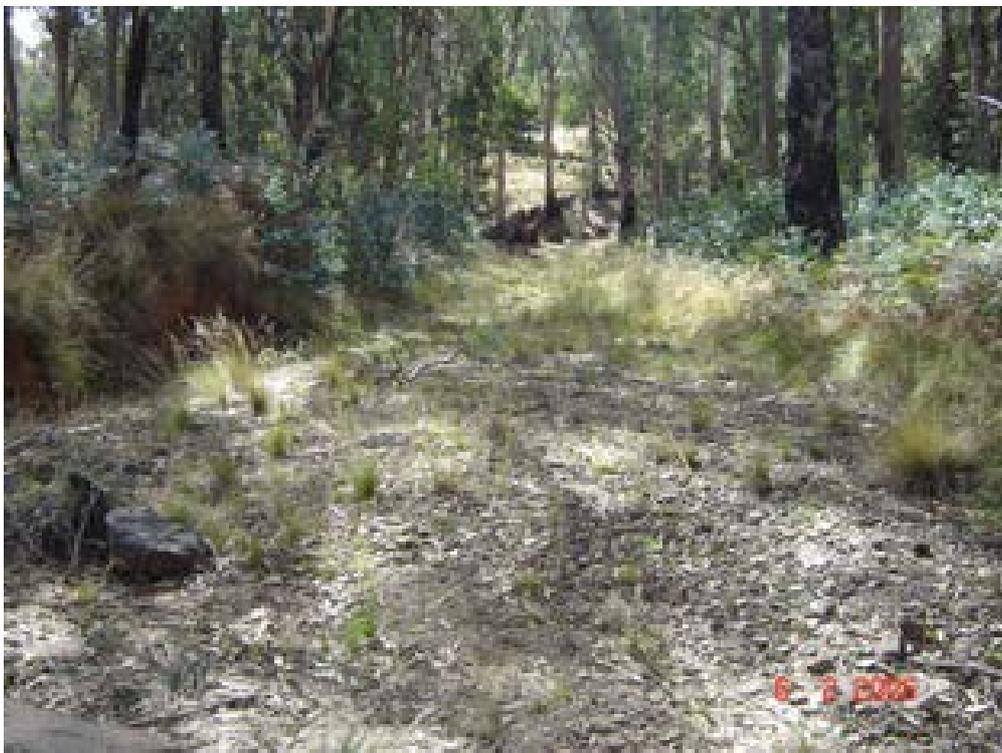
Due to the ephemeral nature of this reach, the waterway is dry for most of the year. Therefore, the conditions are not suitable for aquatic species and dryland species such as Poa Grass (*Poa labillardieri*) was often found scattered in the stream bed (Refer to Figure Figure 5-5). Rush (*Juncus spp*) and Sedge (*Carex spp.*) were occasionally observed in the lower reaches of the mainstem.

■ **Figure 5-5 Blue Gum (*Eucalyptus globulus var globulus*) and native Poa Grass (*Poa labillardieri*) were the dominant species along the mid-sections of Glenpatrick Creek.**

Although the reach is largely unfenced, there have been minimal impacts from grazing activities, which is indicated by a healthy understorey and groundcover along the majority of the reach. The control, management and on-going monitoring of weed species such as Blackberry, Sweet Briar, Tagasaste and Gorse should be a priority for this reach. A coordinated management regime should be established with the local landholders, DSE and DPI to effectively control these species.

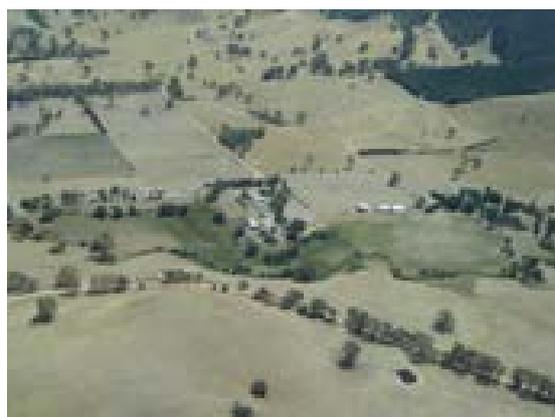
■ **Figure 6-2 Swamp area on N1 serves an important water quality function.**

A swampland of native Rush (*Juncus spp.*) and Sedge (*Carex spp.*) exists at the confluence of N1/2 which is currently unfenced and currently grazed. This area acts as an important vegetation buffer to enable the filtration of sediments before entering the waterway (refer to Figure 6-2). Additionally, this area would provide an important habitat linkage to the waterway for native fauna. It is recommended that this area is protected by fencing to restrict grazing.

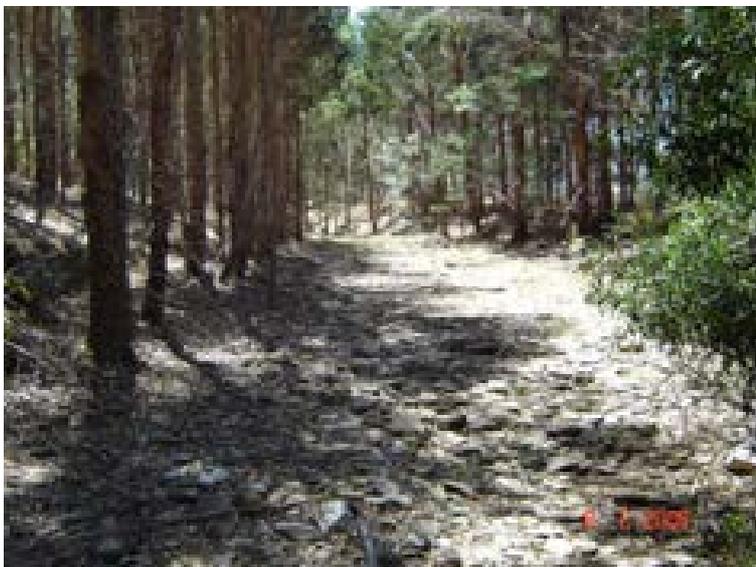
One property owner has undertaken a long-term and personal initiative of stabilisation of the bed and banks with generally outstanding results. The fencing and revegetation through this area is commendable and demonstrates the benefits of this activity as well as that of the landowner's commitment. Notwithstanding the good work in this segment there are signs of cobble movement and scour hole appearing in the bed, plus potential problems due to Elm sucker infestation in the lower segment of this area that may cause blockages and scouring. The changes in channel through the rehabilitated area appear natural and may not need intervention, but a watching brief should be maintained.

■ **Figure 7-3 Tree planting and effective management has improved stream stability where appropriate techniques have been applied**

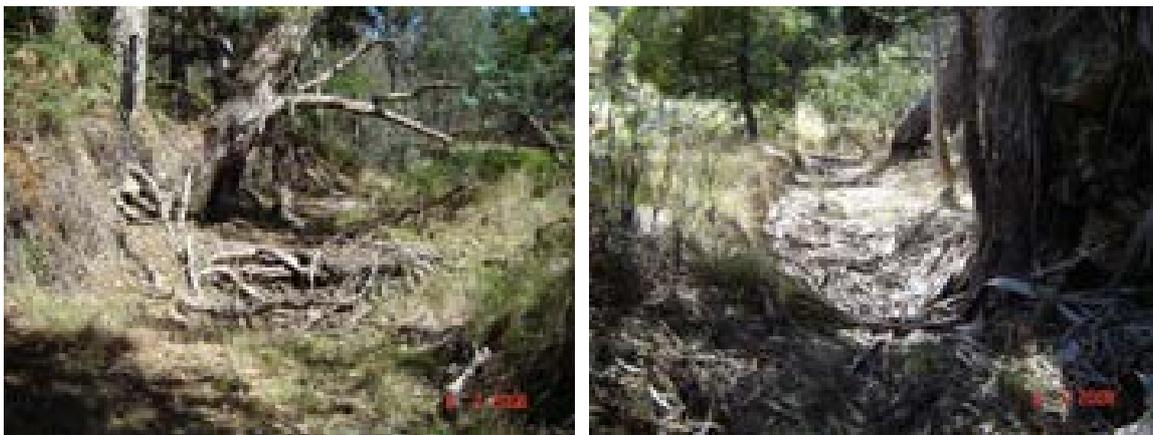
The vegetation of the upper section of Nowhere Creek occurs mainly within the steeper hills of the upper catchment, with the valley floor being contained within the hills on each side. Remnant vegetation is largely restricted to the upper areas of the reach, where land use pressures have been minimal due to the steeper nature of the area. The dominant canopy species in the higher valleys include Blue Gum (*Eucalyptus globulus var globulus*) and Mountain Grey Gum (*Eucalyptus cypellocarpa*). These stands were mainly associated with an understorey of Blackwood (*Acacia melanoxylon*), Black Wattle (*Acacia mearnsii*), Hedge Wattle (*Acacia paradoxa*), Drooping Cassinia (*Cassinia arcuata*), Gorse Bitter-pea (*Daviesia ulicifolia*), Cranberry Heath (*Astroloma humifusum*), Black-anther Flax Lily (*Dianella revoluta s.l.*), Bracken (*Pteridium esculentum*) and Poa (*Poa labillardieri*) (Refer to Figure 7-5).

■ **Figure 7-5 Riparian vegetation along the upper reaches of Nowhere Creek.**
