Wimmera
Catchment Management
Authority

Shays Creek Waterway Action Plan

November 2004

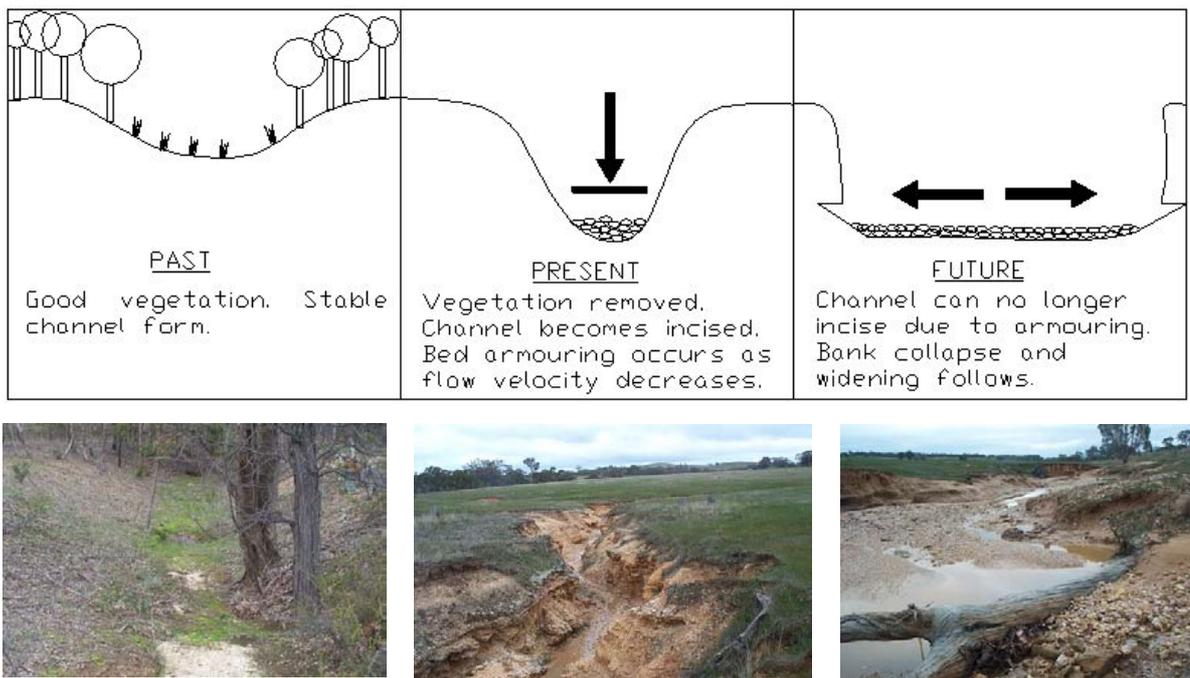
Figure 3. The process of vegetation removal that leads to stream incision and later bed armouring in the upper catchment of Shays Creek.

In the upper catchment of Shays Creek a combination of poorly vegetated slopes controlling the capacity for infiltration, and the steep nature of the upper portion of the catchment, results in the rapid concentration of rainfall runoff. Short high intensity rainfall events under these conditions have high stream powers that erode bare banks and transport large volumes of all sizes of sediment. Smaller events that occur following a larger event then have the potential to remove (winnow) finer sediment from the bed and deposit it further downstream. This leaves the coarser material in the bed (as lower flow velocities do not have the capacity to mobilise larger sediments), to form an armouring gravel layer. When left undisturbed, this gravel layer has the ability to limit further bed incision. Once bed armouring is established the streambed is less likely to deepen further, and unless otherwise restricted, the channel will undergo a process of widening as illustrated in Figure 3. Examples of active stream widening as a result of this mechanism can be found at a number of locations on Shays Creek.

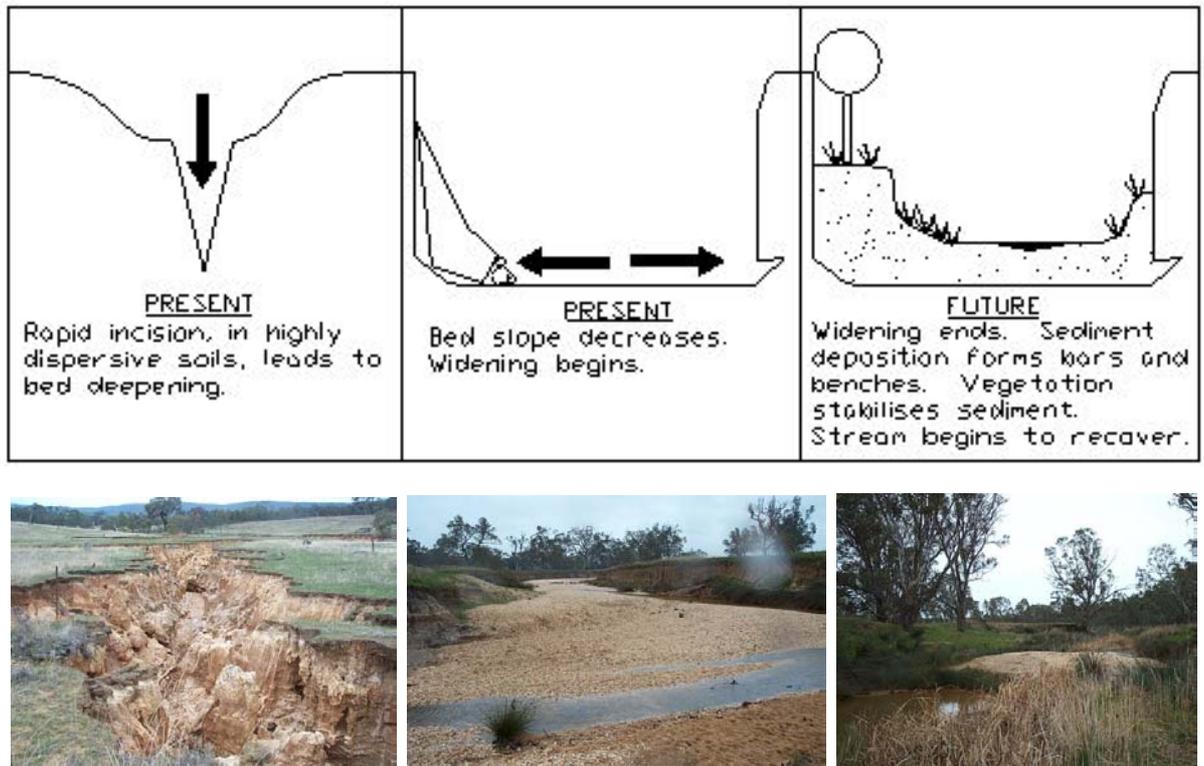
Figure 4. Steps in the process of stream degradation and recovery occurring in the lower reaches of Shays Creek.

The native vegetation along the majority of Shays Creek is of poor quality . The riparian zone is dominated by exotic pasture species with an overstorey of scattered, mature River Red Gums (*Eucalyptus camaldulensis*). Occasional remnant patches of indigenous grasses and herbs are located where stock access is limited. Shrubs and woody species recruitment is absent along most of the stream frontage and on the adjacent floodplain. The quality and abundance of indigenous vegetation remnants increases further upstream in the catchment.
