Six Mile Creek Waterway Action Plan

Job 6003046

September 2003

Wimmera Catchment Management Authority

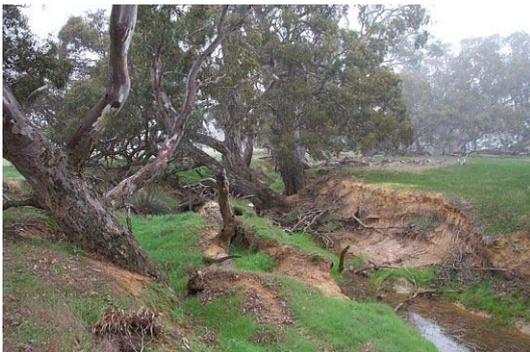
Figure 18: Reach 4

Six Mile Creek is a left bank tributary which joins the Wimmera River approximately 1.8km north of the Six Mile Creek bridge on the Landsborough Road. With a catchment area of approximately 88km², Six Mile Creek is a low capacity channel incorporating a long, low gradient reach toward its downstream end (ID&A, 2002). The Wimmera River Geomorphic Investigation (ID&A, 2002) notes that the Six Mile Creek also has a, “natural floodout zone where sediment accumulation occurs. This reach has had a drain excavated through it several times in an attempt to address repeated infilling and local waterlogging associated with the low gradient and excess sediment inputs from upstream”.

Six Mile Creek has the potential to contribute large volumes of sediment to the Wimmera River. The works program therefore aims to trap and hold sediment within the lower reaches of Six Mile Creek. As the creek is heavily incised through its original floodplain, reed growth should be encouraged within the stream bed. Riparian vegetation should be maintained where it exists and encouraged on reaches where clearing has occurred.
