# Glenlofty Creek Waterway Action Plan

December 2002

This Waterway Action Plan for Glenlofty Creek has been prepared by Earth Tech Engineering for the Wimmera Catchment Management Authority.

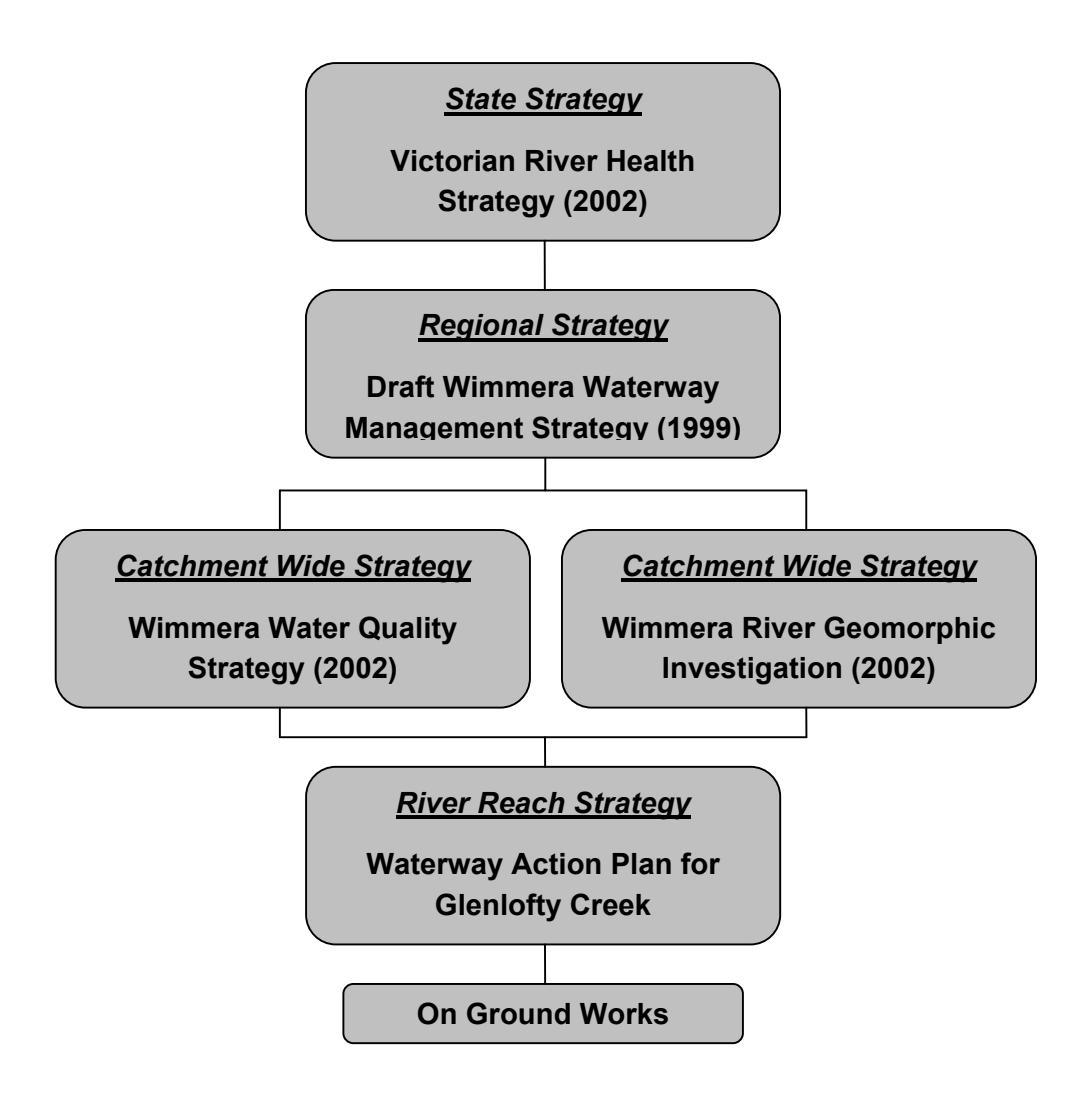
### Relationships between reports used to compile the Waterway Action Plan for Glenlofty Creek

Table 1 summarises this review of strategies which guide and contribute to the Waterway Action Plan for Glenlofty creek. The figure on the following page illustrates the relationship between these reports and the Waterway Action Plans.

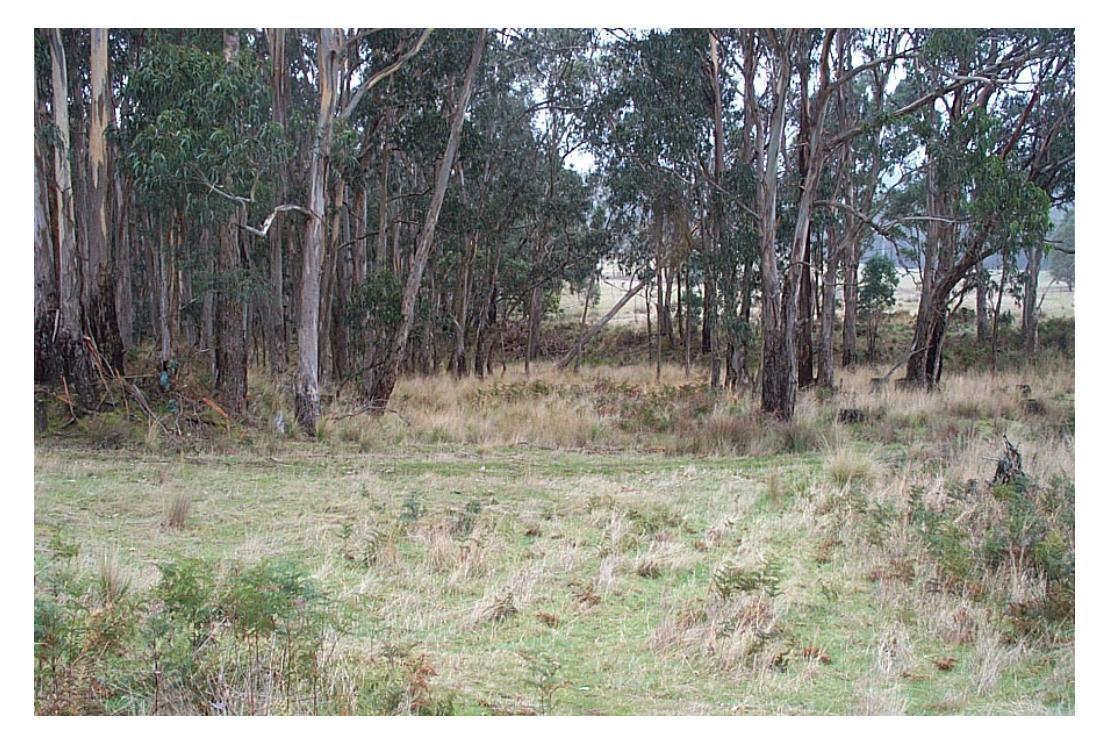
Figure 2. Looking upstream into forested area at the downstream end of Sub-reach .1

The creek is stable throughout the sub reach with no sediment contributed from upstream. Within the State Forest there are no signs of instability.

Overstorey riparian vegetation outside of forested areas is rated as poor consisting predominantly of individual trees and small clumps. There is a good coverage of understorey particularly rushes, grasses and bracken within the riparian zone, Within private property there is light grazing by cattle which may threaten bed and bank stability and vegetation cover, if overgrazed.

The in stream habitat is rated as moderate which reflects the swampy nature of the creek outside of the forested areas. Habitat values in this section of the creek would be improved by the provision of an overstorey which would provide shelter and shading to reduce the rate of drying of the creek.

Due to its stable nature and the presence of a well vegetated understorey, water quality is rated as good.

- To reduce impact of stock on ecological values of the stream.
- · Protect geomorphological character of stream
- Enhance riparian zone of stream

- Restrict stock access through fencing
- Revegetate the riparian zone with overstorey species
- Extend the riparian zone, from the existing native forest, by revegetation
- · Monitor the sub reach for sediment inputs from the State Forest

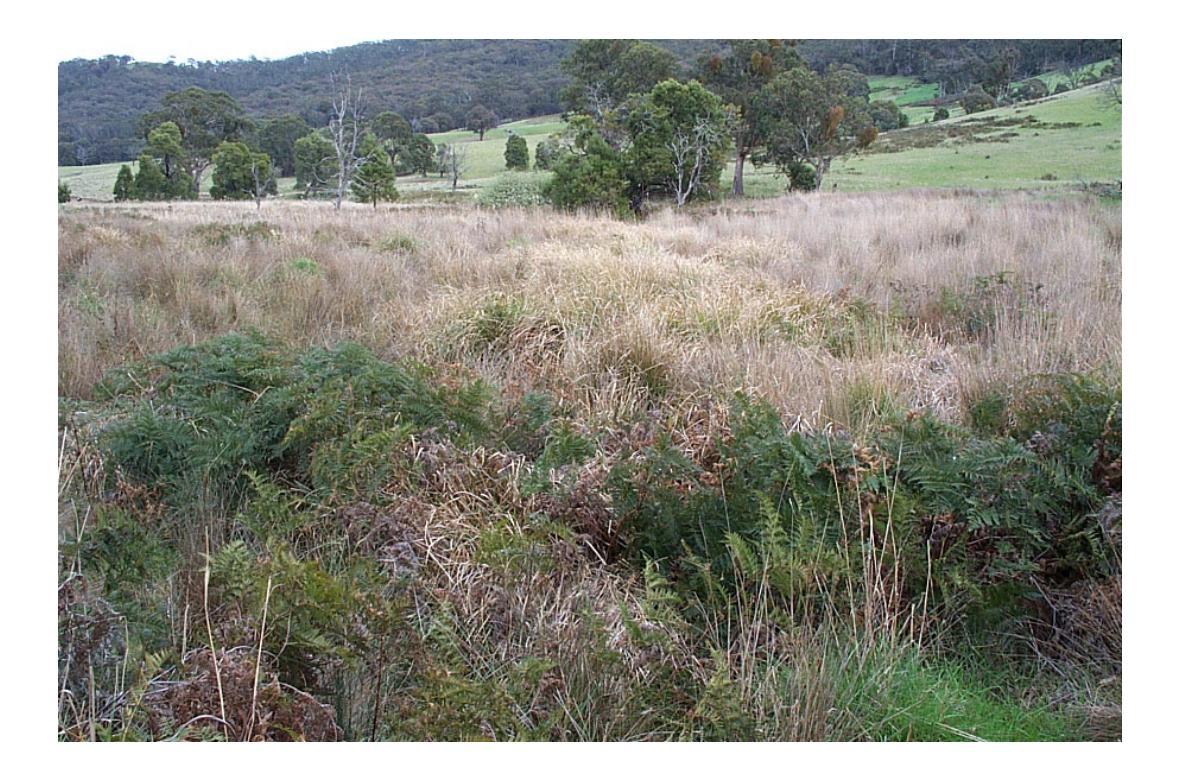
Figure 3. Looking downstream from the upstream end of Sub-reach 2.

The creek within this reach has localised instabilities which appear to be associated with stock accessing pools.

Overstorey riparian vegetation is rated as poor consisting predominantly of individual trees and small clumps. There is an extensive coverage of understorey, particularly rushes, sedges and grasses.

The in stream habitat is rated as poor. The creek is predominantly swampy in nature although pools are appearing within this sub reach. The sub reach is grazed and as a result stock are significantly impacting on pools through reduced vegetative cover and bank disturbance. Habitat values in this section of the creek would be improved by the provision of overstorey, as per sub reach 1, and stock control.

As with in stream habitat, water quality is greatly impacted upon by grazing. Overall water quality is rated as moderate.

- Protect geomorphological character of stream
- Reduce grazing impacts on pools
- Enhance the riparian zone of the stream
- Enhance in stream habitat of pools

- Restrict stock access, particularly to pools
- Provide off stream watering if appropriate
- Revegetate with overstorey species particularly around pools

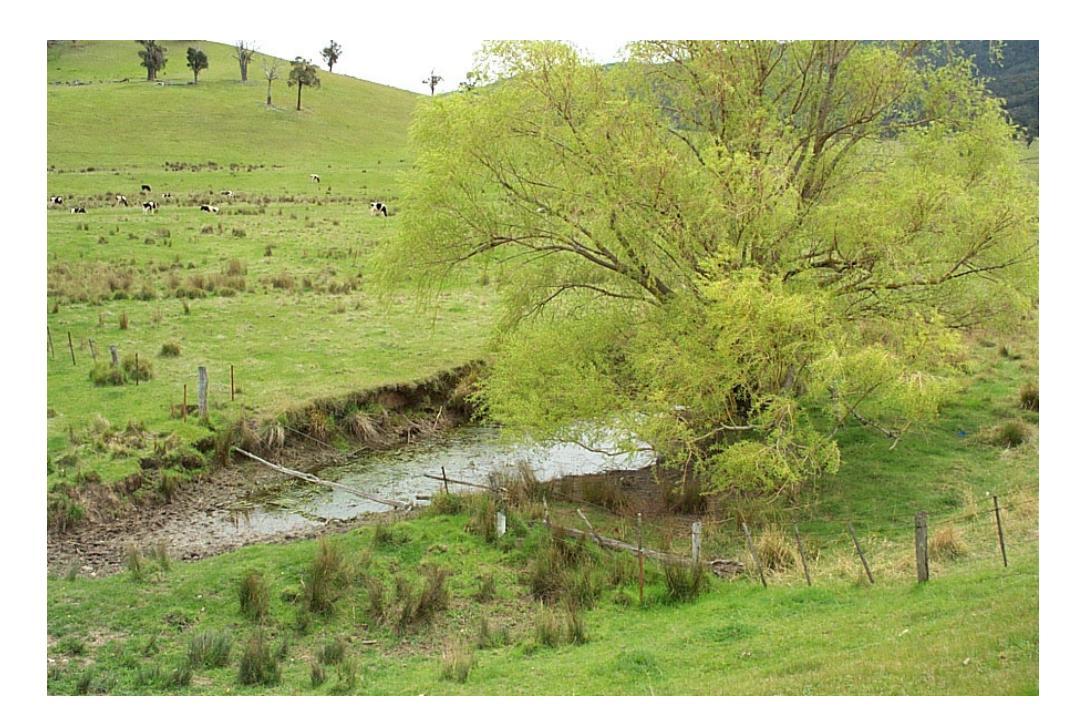
Figure 4. Crack Willows and stock damage to stream banks in Sub-reach 3.

Bed and banks within this sub reach are moderately stable. Bank instability occurs in localised areas associated with stock access. The stream is characteristically channelised without the large areas of grasses, sedges and rushes which occur in upstream sections.

Overstorey riparian vegetation is poor. The sub reach contains scattered weeping and crack willow with scattered clumps of native vegetation. Understorey is less swampy in nature than upstream reaches and consists predominantly of grasses with clumps of rushes.

In stream habitat is rated as poor. Grazing has reduced groundcover along stream beds and trampling by stock has damaged stream banks.

Water quality is rated as poor to moderate due to grazing impacts, bulk nutrient inputs and deoxygenation associated with leaf drop by exotic trees.

- To protect and enhance the ecological values of the stream.
- Reduce grazing impacts
- Reduce the threat and spread of exotics
- Protect the geomorphological character of the stream
- Enhance the riparian zone of the stream
- Enhance in stream habitat of pools

- Restrict stock access
- Provide off stream watering if appropriate
- Revegetate with overstorey species
- Remove willows and other exotics

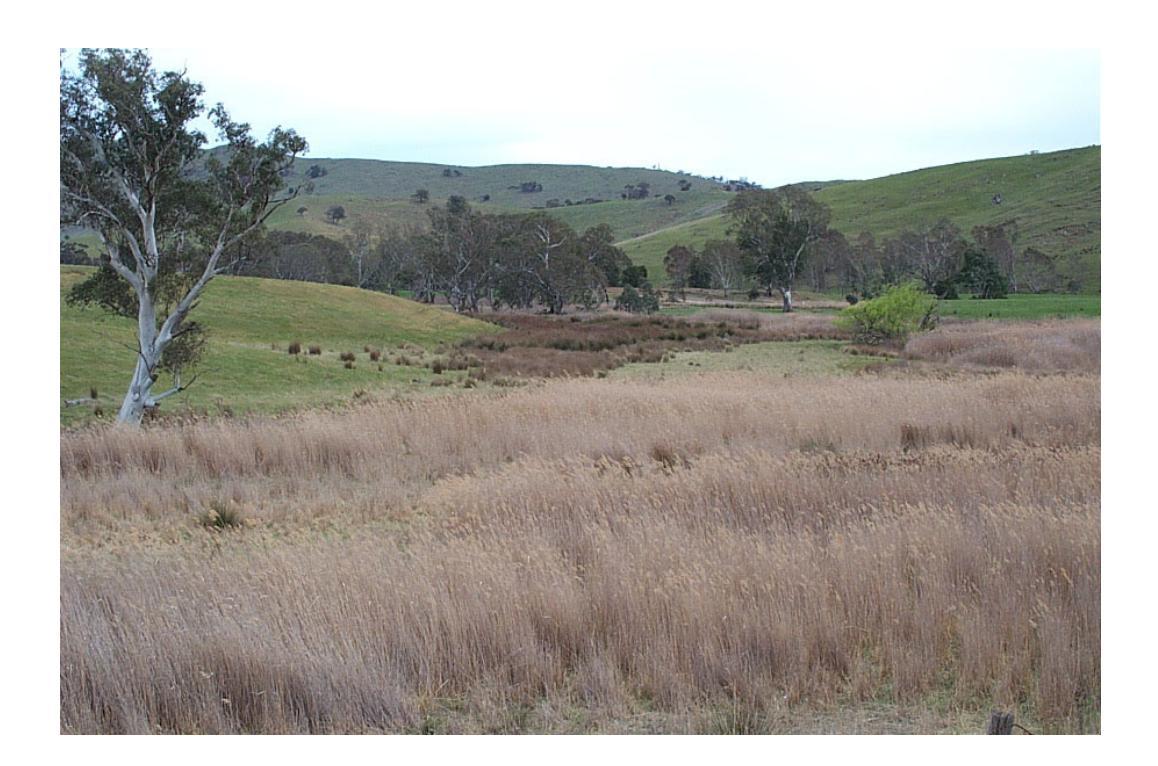
Figure 5. Chain of ponds formation at the downstream end of Sub-reach 4

The creek within this reach is currently stable. There is isolated erosion as a result of grazing which has the potential to initiate erosion heads.

Overstorey riparian vegetation is limited to individual trees and small clumps of trees. The understorey coverage is extensive with large occurrences of grass and phragmites. Willows and other exotics occur regularly within the reach. Overgrazing does pose a threat to the vegetation.

As with upstream sub reaches, in stream habitat is compromised due to little or no overstorey cover. Extensive grass and reed areas particularly around pools provide good habitat for amphibians, small birds and macroinvertebrates.

The greatest impact upon water quality appears to be grazing. There is the potential for further impact on water quality due to runoff from the vineyard in the lower section of the reach. Decreasing water quality from overland flows is less of an issue where there is extensive grass cover.

- To protect and enhance the ecological values of the stream.
- Protect the geomorphological character of the stream
- Reduce grazing impacts on pools
- Enhance riparian zone of stream
- Enhance in stream habitat of pools

- Restrict stock access, particularly to pools
- Provide off stream watering if appropriate
- Revegetate with overstorey species

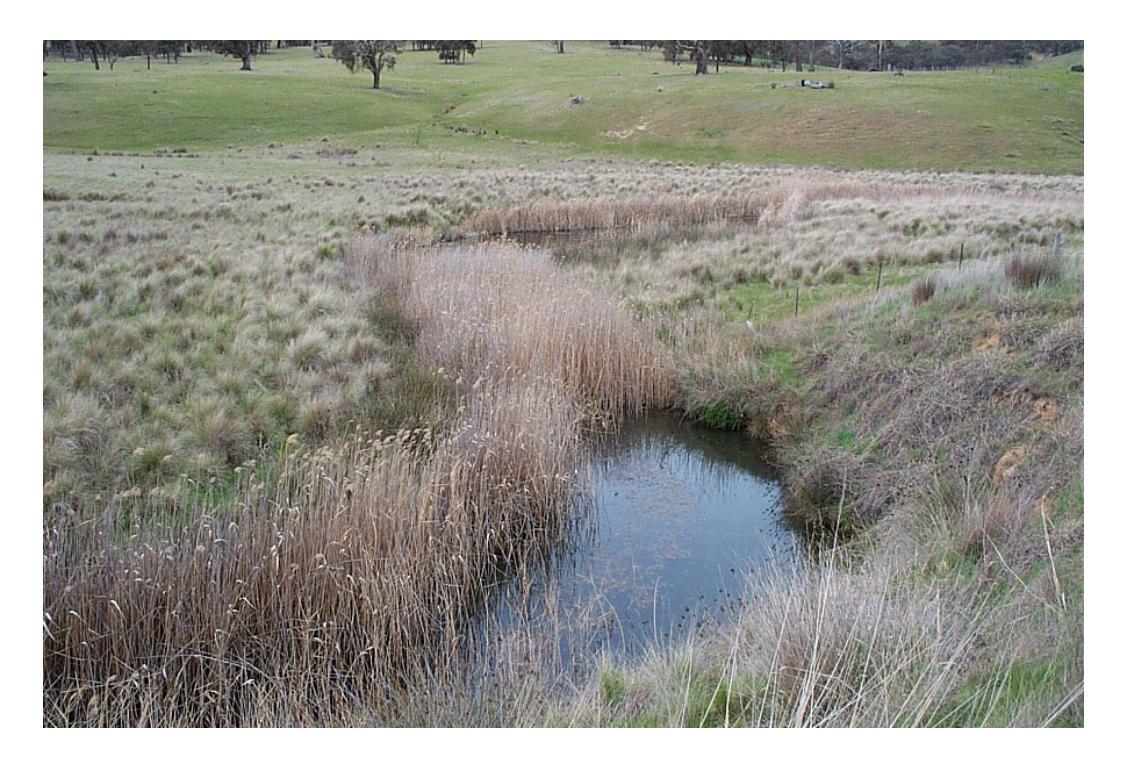
Figure 6. Stable pools flanked by Phragmites and sedges in Sub-reach 5.

The creek within sub reach 5 is rated as stable. The channel is continuous in most parts. The creek contains many pools which are flanked by phragmites and sedges. Grazing may present a risk

Overstorey riparian vegetation is more extensive than upstream sub reaches. There are good stands of blackwood. Willows and poplars occur often along the creek. Stands of spiny rush indicate that salinity may be an issue in this sub reach.

In stream habitat is rated as good. Pools are commonly long and deep and expected to support fish species. Habitat is restricted by the absence of overstorey species which would provide shade and shelter.

Water quality is rated as good. Extensive grassed areas provide good filtration. Stock have access in isolated locations and this may reduce water quality values. Salinity may be an issue and further investigation is recommended.

- To protect and enhance the ecological values of the stream.
- Reduce grazing impacts on pools
- Determine the impact of salinity on ecological values of the stream
- · Reduce the threat and spread of exotics
- Protect the geomorphological character of the stream
- Enhance the riparian zone of the stream
- Enhance in stream habitat of pools

- Restrict stock access, particularly to pools
- Provide off stream watering if appropriate
- Revegetate with overstorey species
- · Monitor salinity levels within the reach to determine potential impacts
- Remove willows and exotics

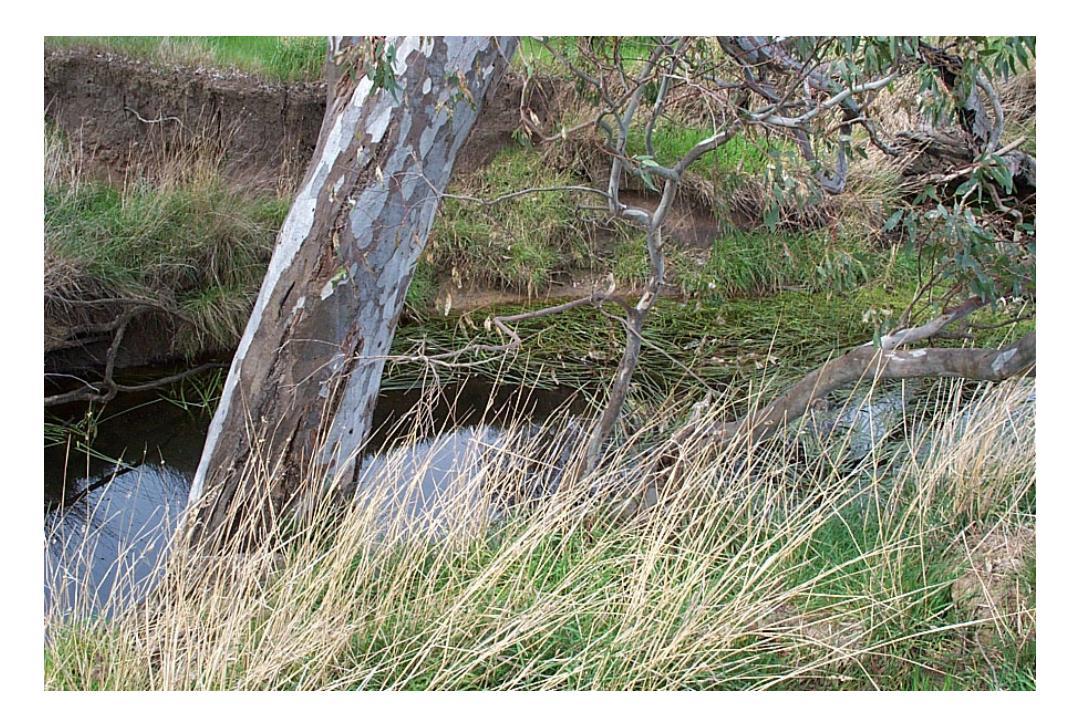
Figure 7. An example of a stable incised channel, often containing large woody debris, in Sub-reach 6 of Glenlofty Creek.

The creek within this reach is a stable incised channel. There are pool riffle sequences containing large woody debris. Localised erosion occurs where trees have fallen into the creek and there are localised instabilities where stock have access. There is an eroding tributary containing a small erosion head contributing sediment into the reach at E 694 850, N 5 886 200. Immediately downstream of the tributary there are several pools, which have been fenced, and which are in very good condition.

Overstorey riparian vegetation is rated as moderate. There are more continuous ribbons of native overstorey vegetation although willows and other exotics are present. The understorey is dominated by phalaris with isolated occurrences of native grasses.

An in stream habitat rating of very good reflects the occurrence of large woody debris, pool and riffle sequences and significant shading provided by overstorey vegetation.

Water quality is rated as moderate to good, reflecting the values listed above. Some sections of the sub reach are also fenced, and therefore there is significantly less impact from stock.
