Upper Wimmera Flood Investigation Final Report

Reference: R.M8460.009.01.Final.docx
Date: 30 June 2014

Prepared for: Wimmera Catchment Management Authority

Prepared by: BMT WBM Pty Ltd (Member of the BMT group of companies)
In association with Michael Cawood and Associates

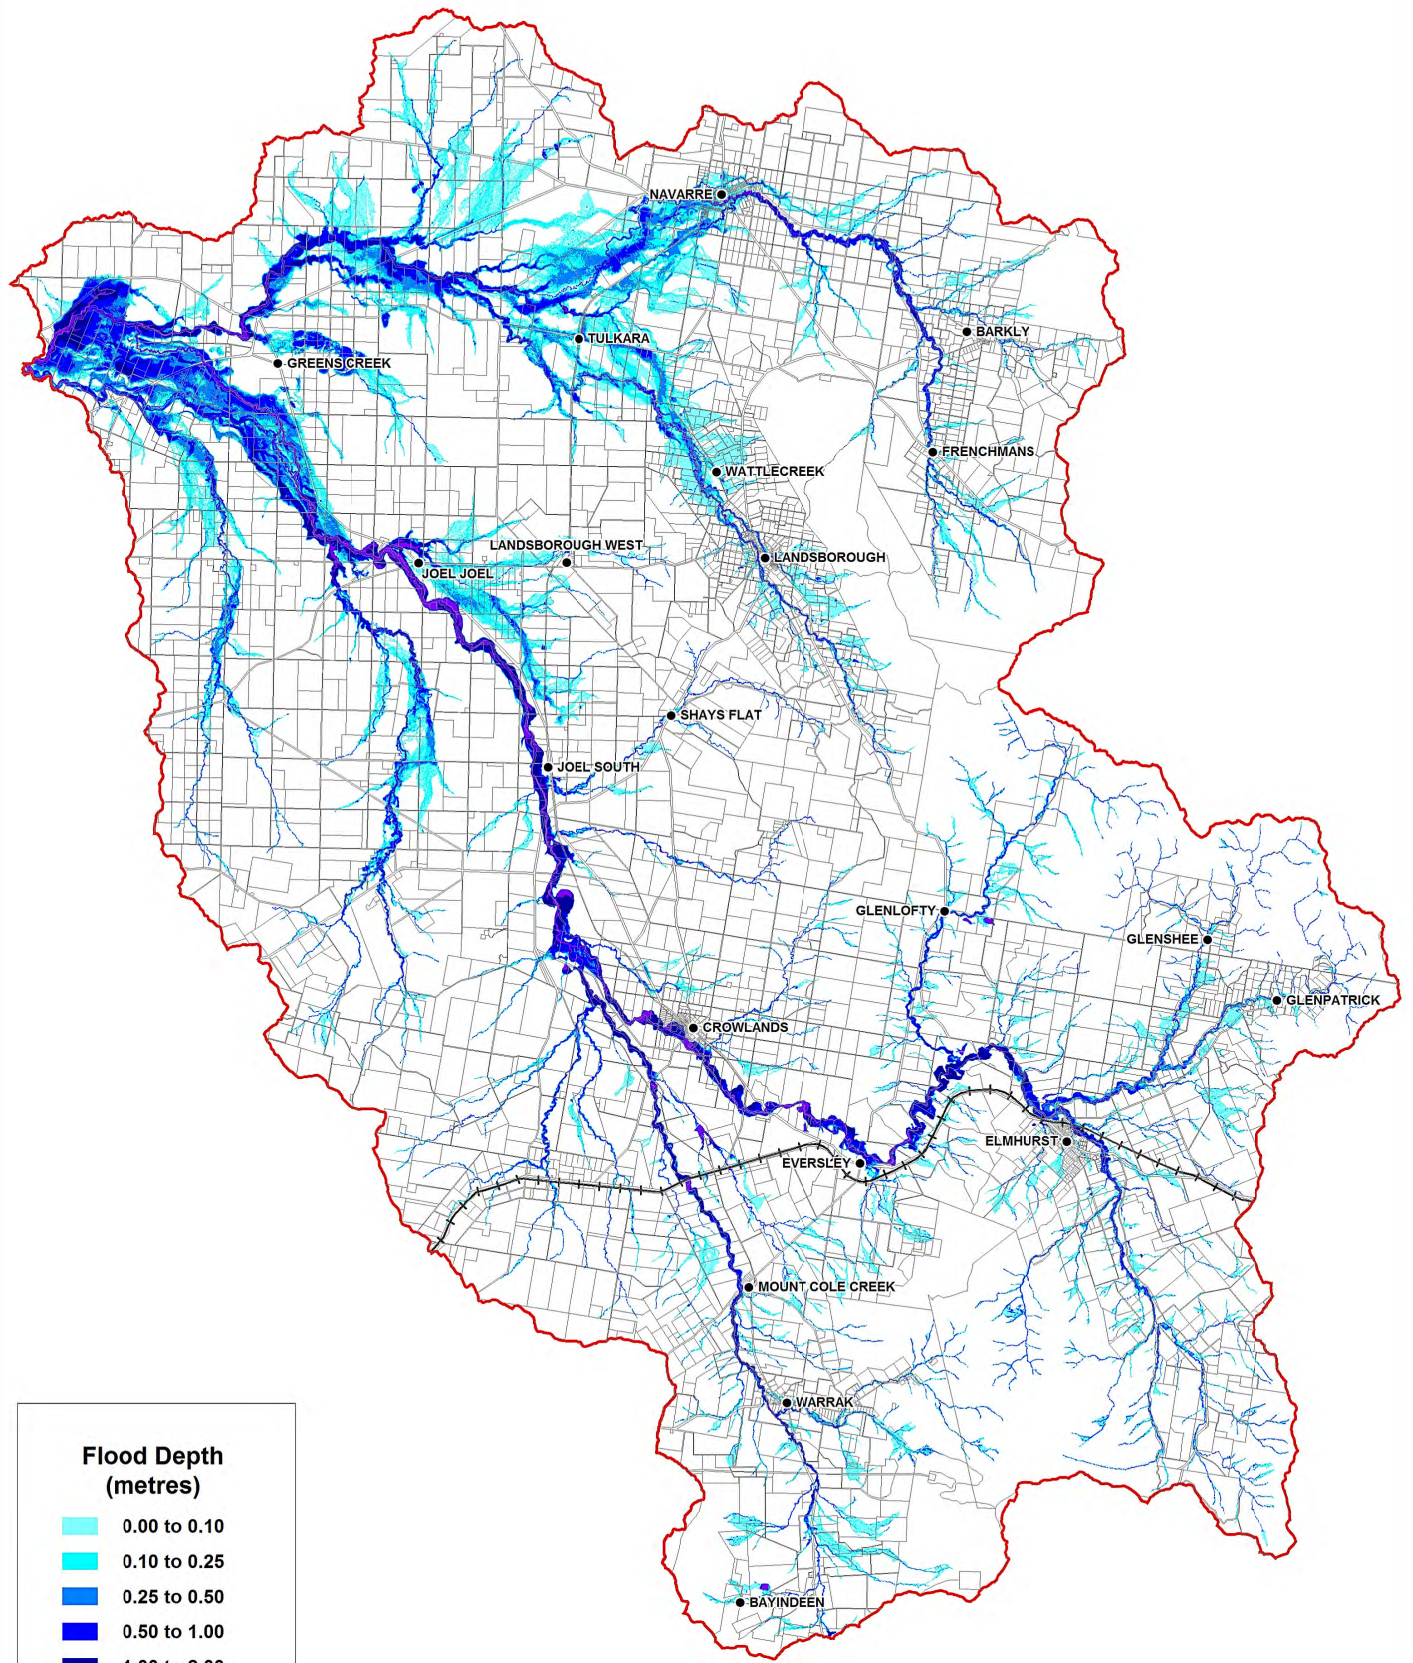
Figure:
2

Title:
Upper Wimmera Flood Investigation
1% AEP Design Flood Depths - Catchment

The flood model was run for the 20%, 10%, 5%, 2%, 1% and 0.5% AEP design flood events (existing conditions) along with the PMF event. For each of these design flood events a suite of flood mapping outputs was generated including: flood depth, flood level, flood velocity, flood hazard and flood affected properties and buildings. Existing conditions peak flood depth for the 1% AEP event is presented in Figure 2.

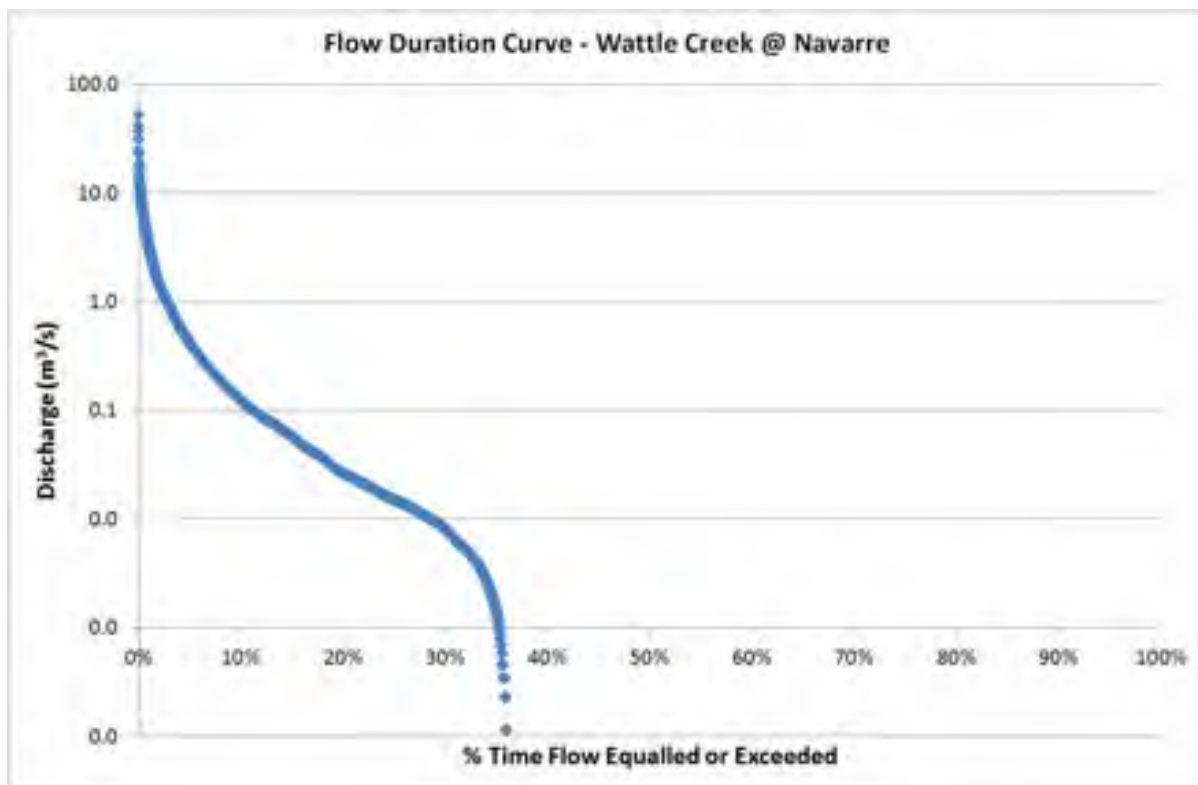
Figure 3-5 Flow Duration Curve - Wattle Creek at Navarre

To determine mean daily discharge values below which to censor data, flow duration curves were prepared for each of the four gauges being analysed and these are presented in Figure 3-5 to Figure 3-8 for each of four gauges. The updated mean daily flow as provided by Thiess Services was used for censoring data. Only the mean daily flows that were equalled or exceeded 5% of the time on the flow duration curve were used in the FFA, these flow values are presented in Table 3-3.

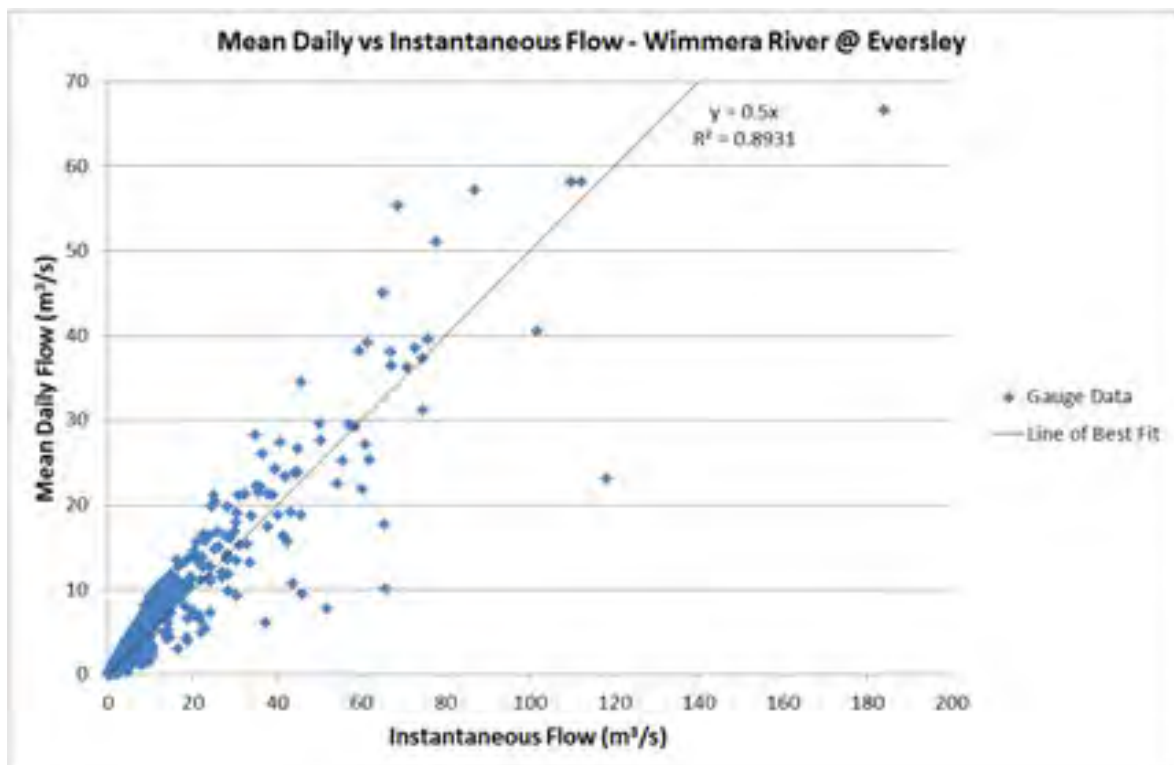
Figure 3-9 Mean Daily vs Instantaneous Flow - Wimmera River at Eversley

From this a relationship was derived and then applied to the historic mean daily flow record to estimate the peak flow on the day. The estimated peak flow was used in the FFA to extend the record in years where instantaneous flow data was not collected. The derived relationship was only applied where instantaneous flow records were unavailable.

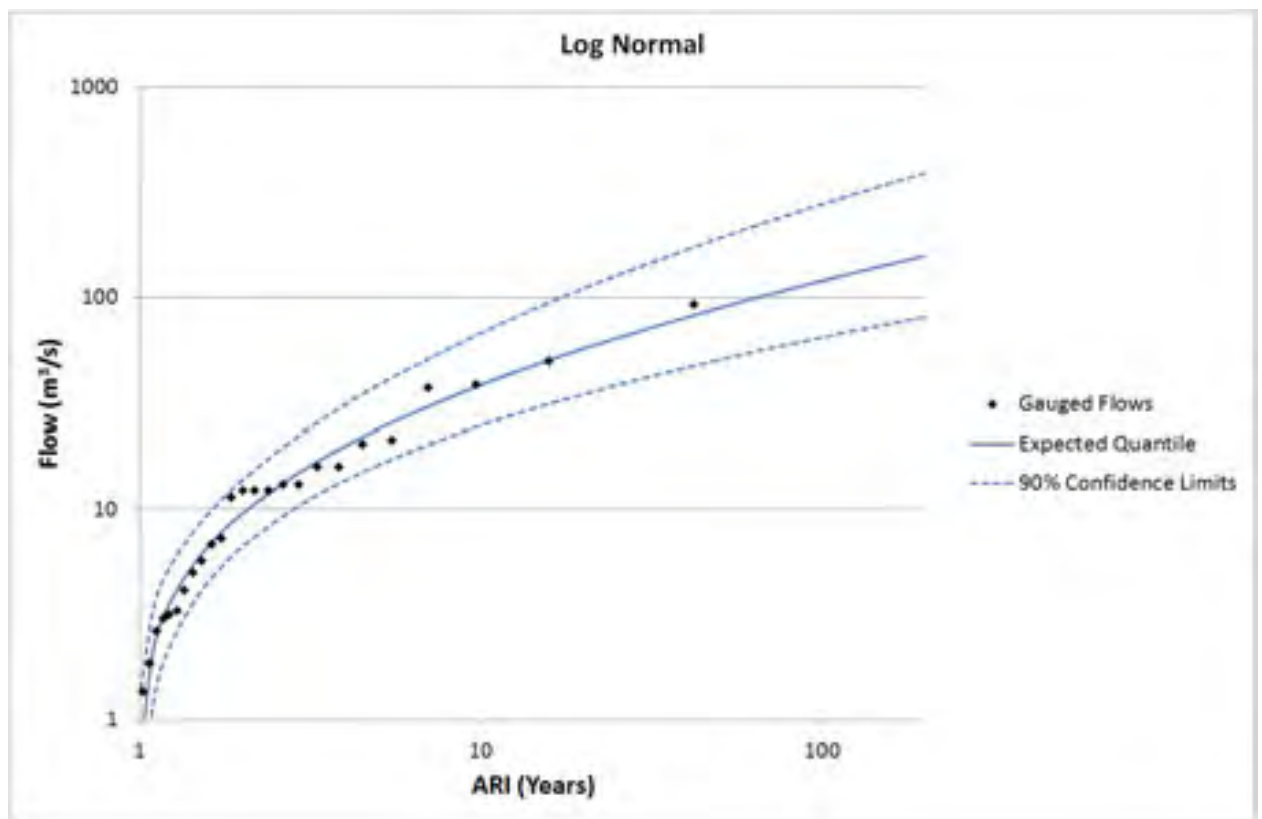
Figure 3-16 FFA Results: Mount Cole Creek at Crowlands - Log Normal Fitting

Inspection of the results presented in Figure 3-16 to Figure 3-20 indicates that acceptable fits are provided by all distributions with the exception of only the Gumbel distribution (Figure 3-18).

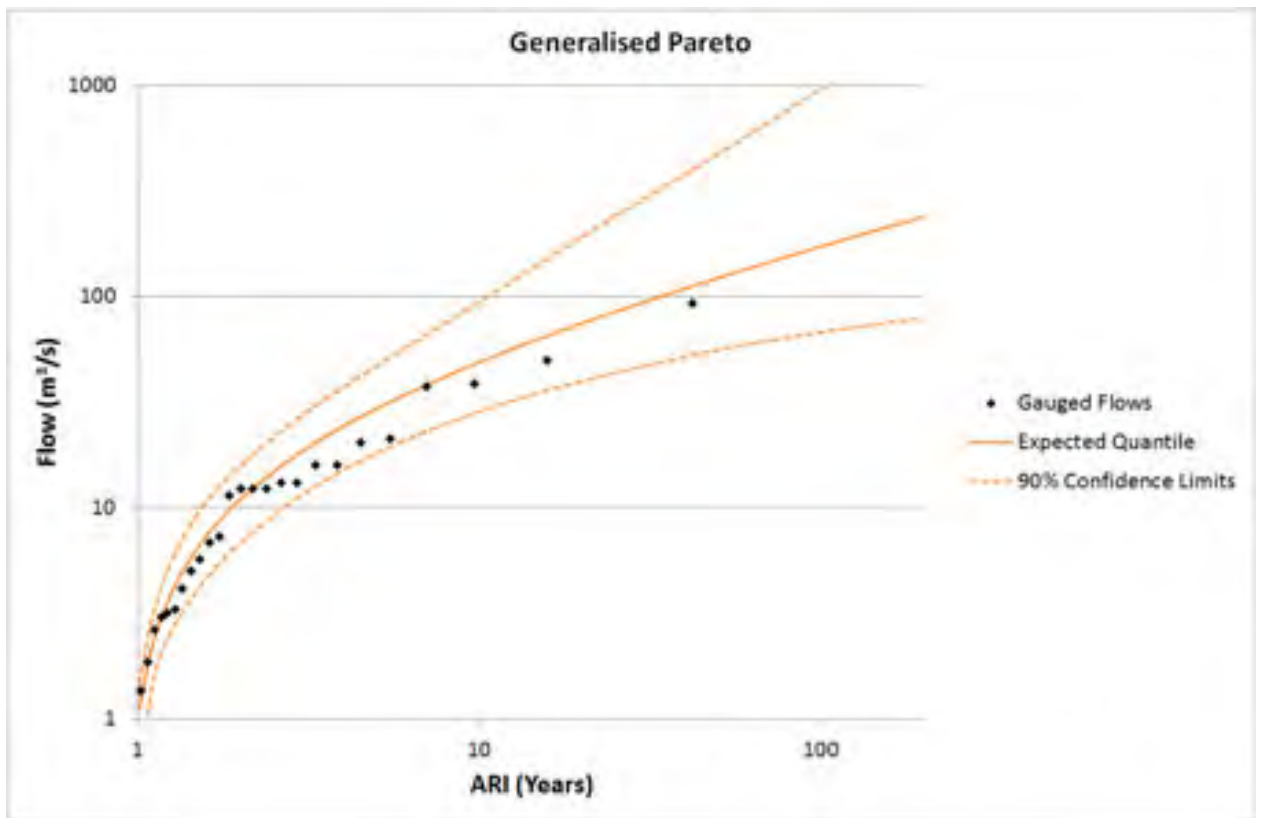
Figure 3-20 FFA Results: Mount Cole Creek at Crowlands - Generalised Pareto Fitting

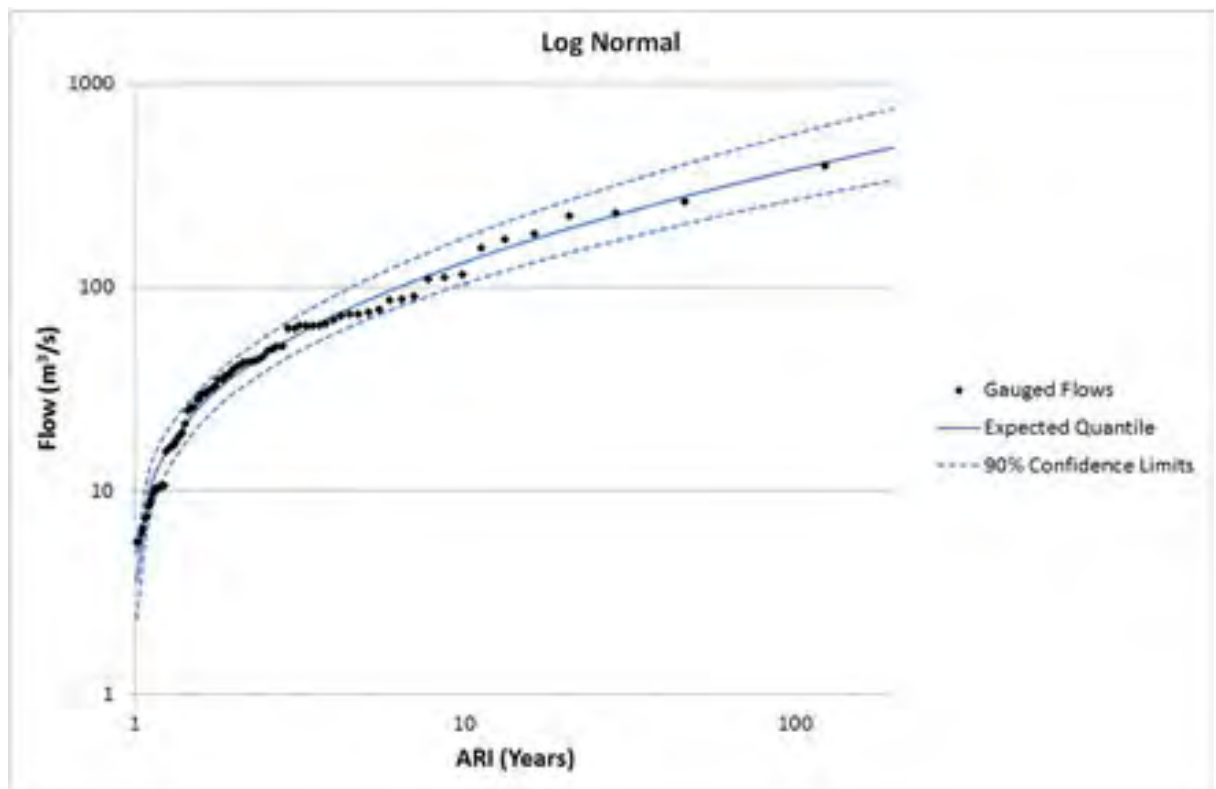
Figure 3-21 FFA Results: Wimmera River at Eversley - Log Normal Fitting

Inspection of the results presented in Figure 3-21 to Figure 3-25 indicates that acceptable fits are provided by all distributions with the exception of the Gumbel (Figure 3-23) distribution.

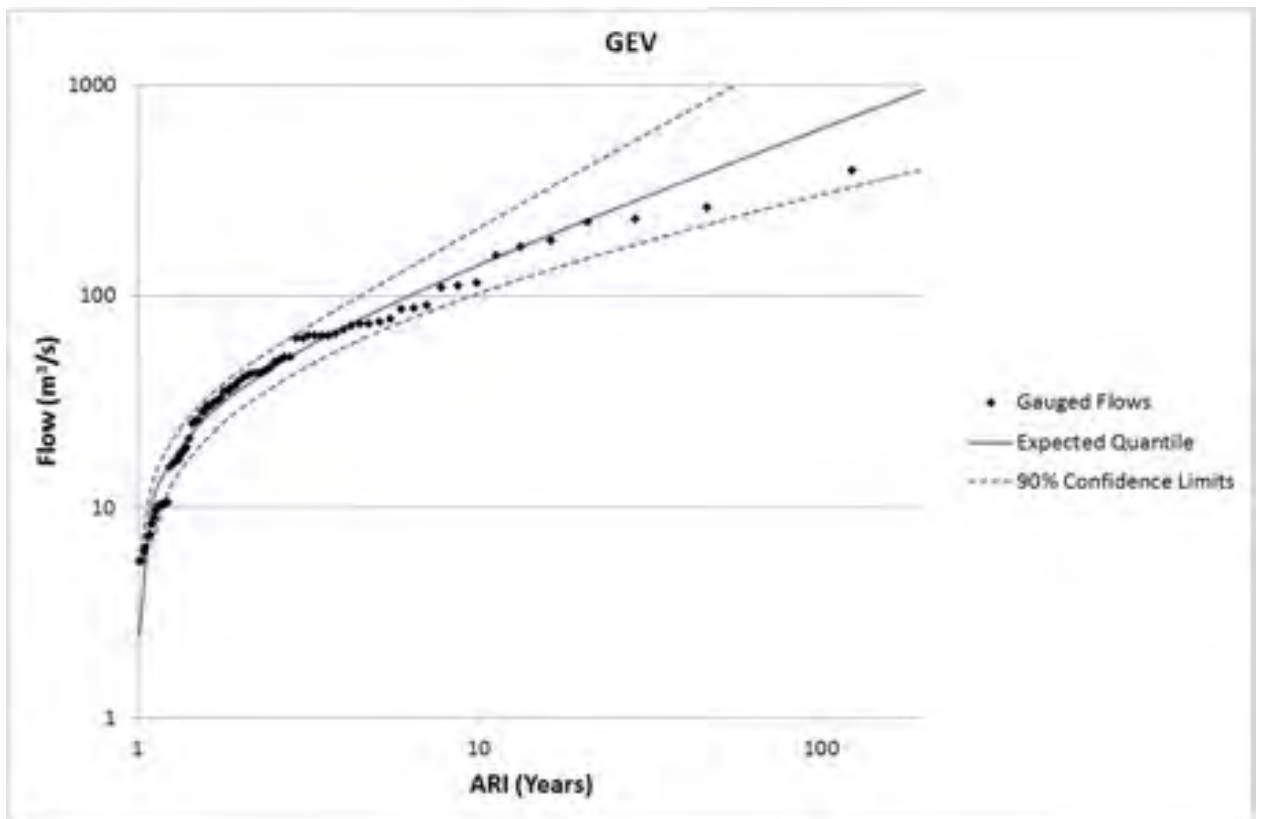
Figure 3-24 FFA Results: Wimmera River at Eversley - GEV Fitting

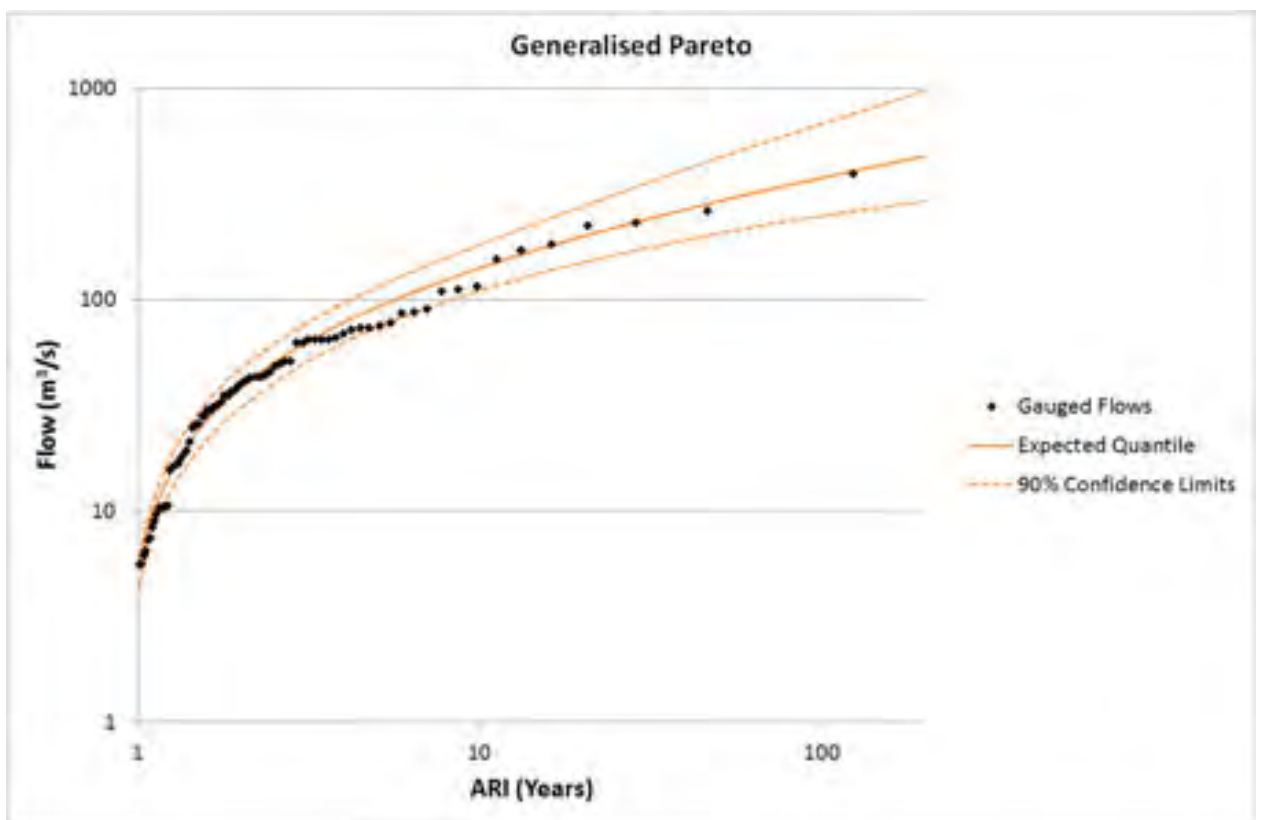
Figure 3-25 FFA Results: Wimmera River at Eversley - Generalised Pareto Fitting

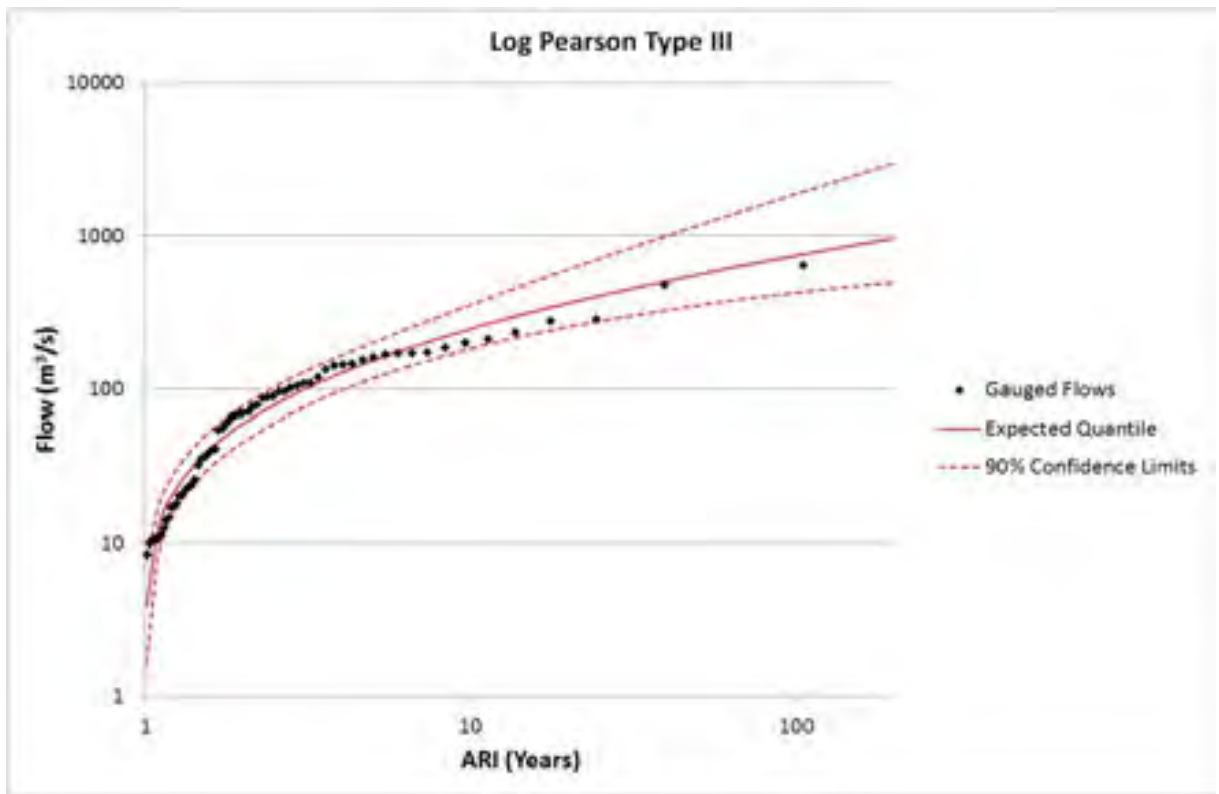
Figure 3-27 FFA Results: Wimmera River at Glynwylln - LP3 Fitting

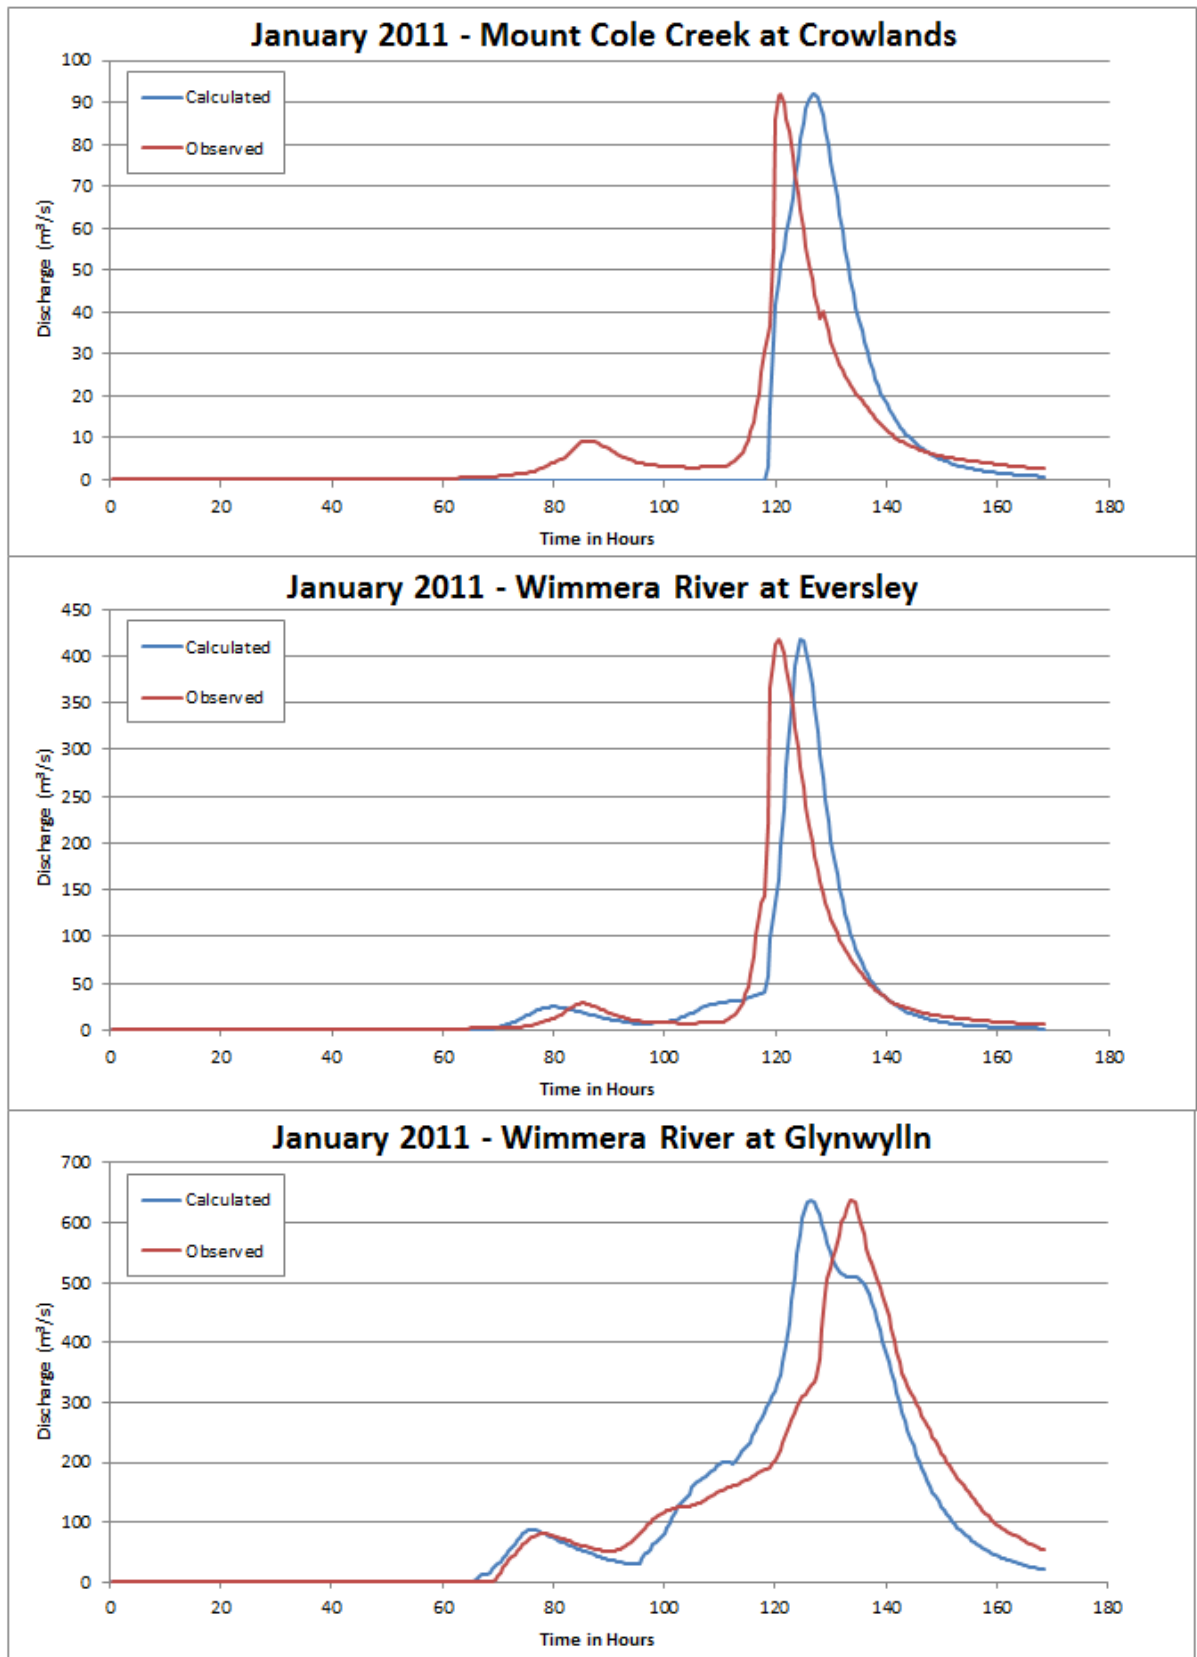
Figure 3-34 Calibrated Hydrograph Comparison for January 2011

As noted previously, there is a level of uncertainty regarding the accuracy of stream gauges and the temporal distributions of the rainfall within the catchment. A significant error in the estimate of the flow, combined with poor spatial and temporal representation of the rainfall, could lead to the range of loss parameters (displayed in Table 3-14) for each interstation area.

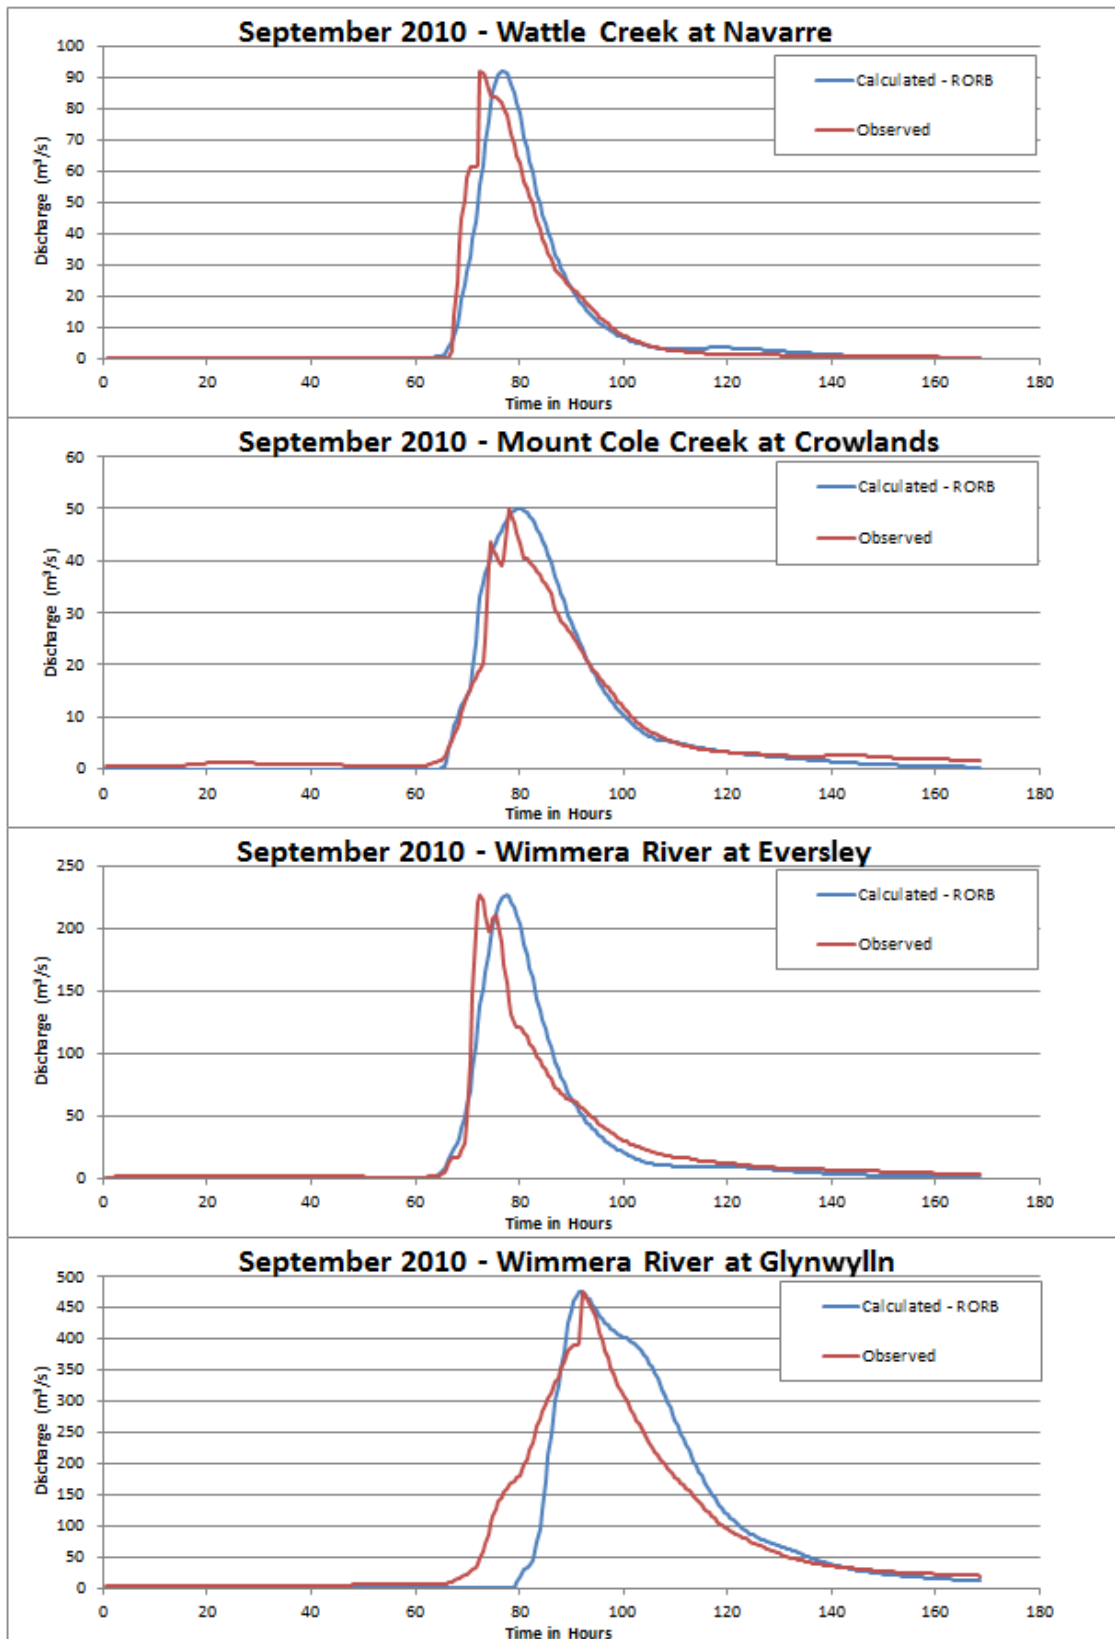
Figure 3-35 Calibrated Hydrograph Comparison for September 2010

As noted previously, there is a level of uncertainty regarding the accuracy of stream gauges and the temporal distributions of the rainfall within the catchment. A significant error in the estimate of the flow, combined with poor spatial and temporal representation of the rainfall, could lead to the range of loss parameters (displayed in Table 3-16) for each interstation area. This is particularly true for the September 2010 event where only a single pluviograph record was operational during the event.

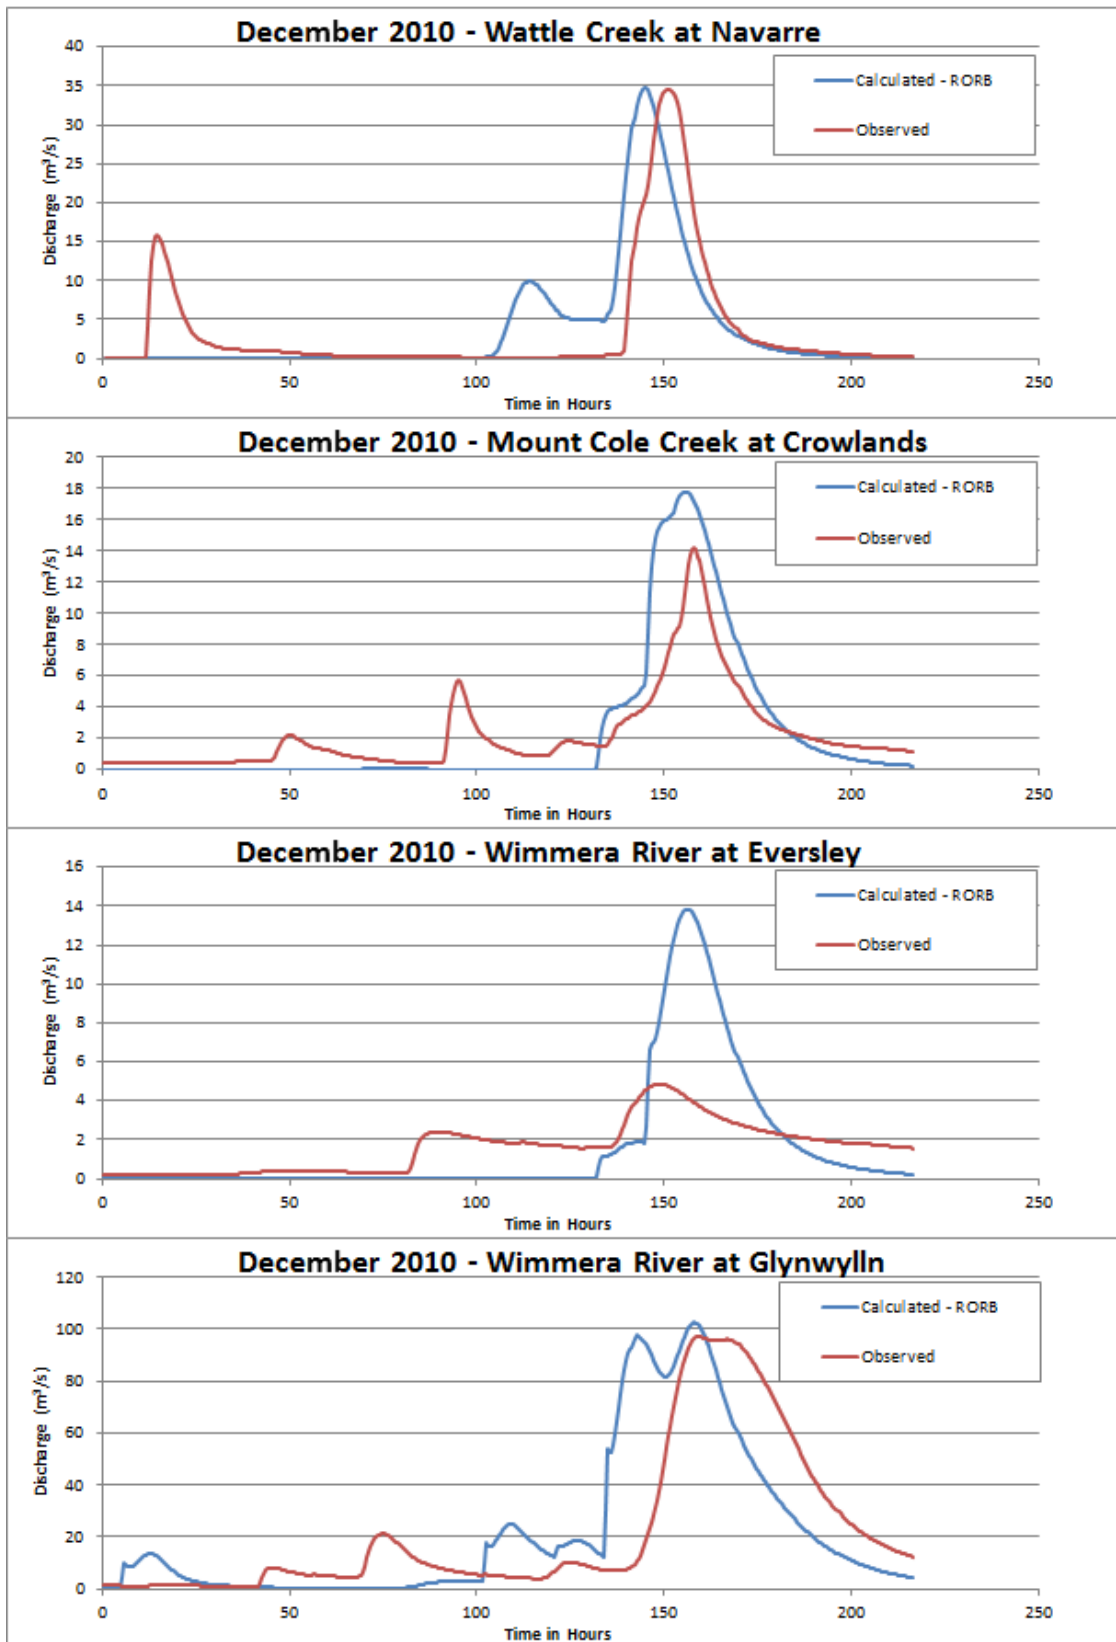
Figure 3-36 Validated Hydrograph Comparison for December 2010

The FFA for the Glynwylln gauge estimates that the December 2010 event has an AEP of approximately 33%. It is therefore possible that the k_c and m parameters are not as well suited to smaller, more frequent flood events.

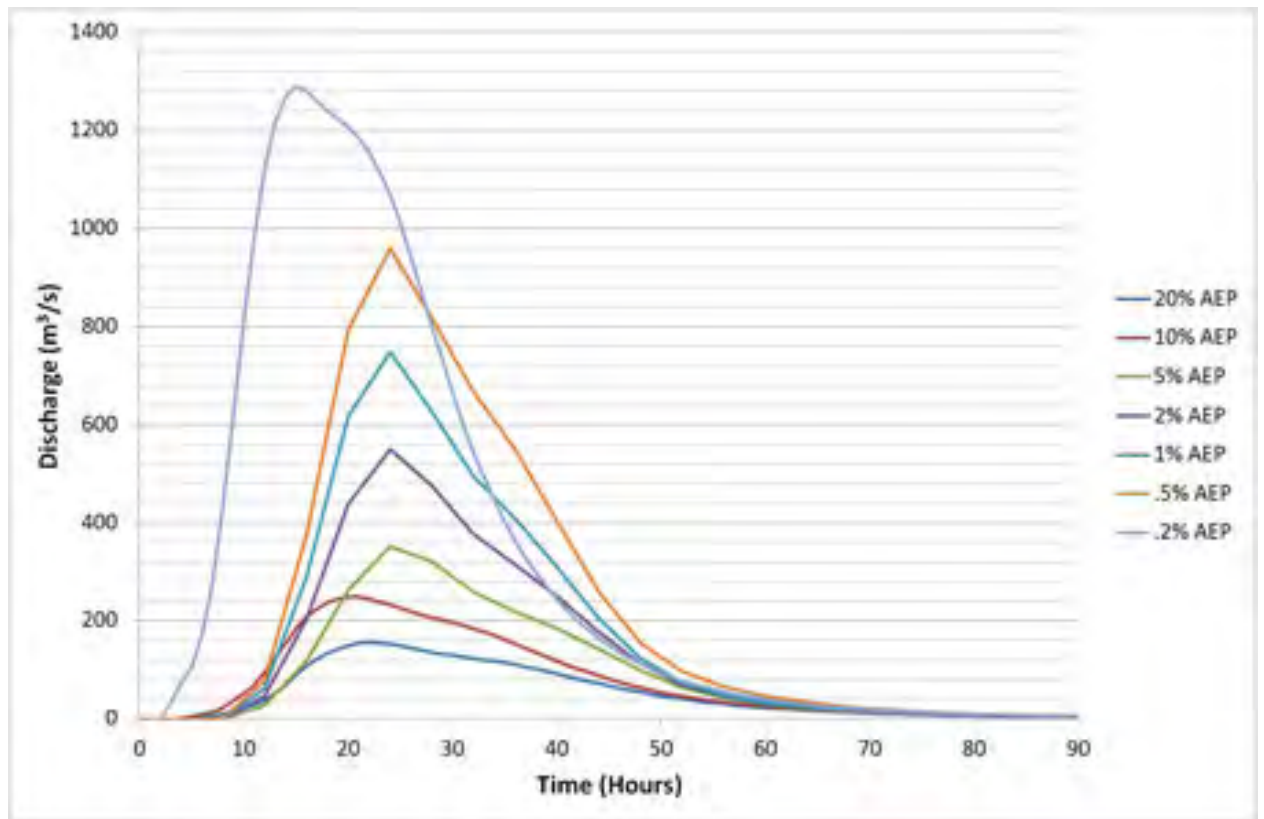
Figure 3-37 72 Hour Design Hydrographs

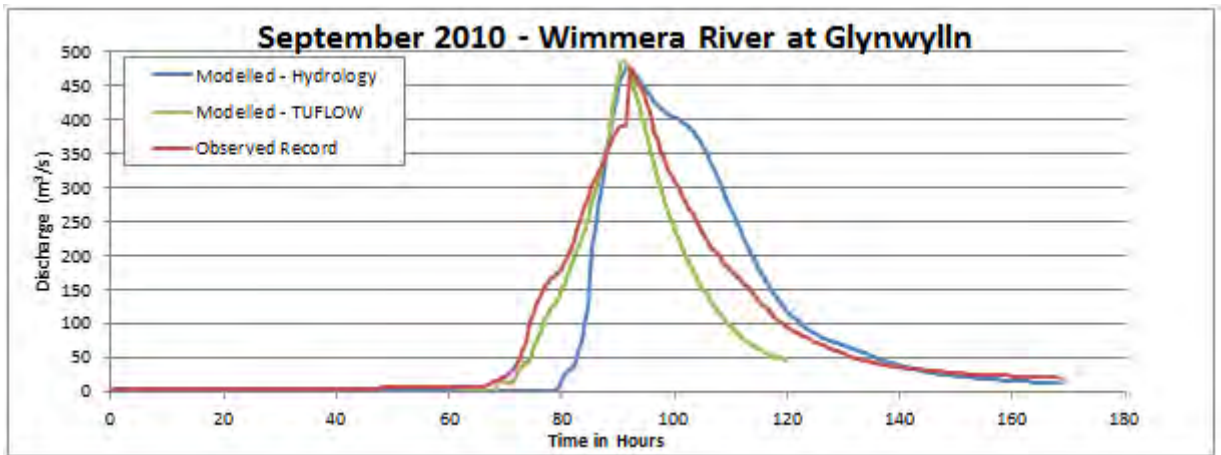
Figure 4-3 September 2010 Calibration Event Flow Rate Comparison

Both the hydraulic TUFLOW and hydrologic RORB model flow results from the calibration event were compared in Figure 4-3 to the observed September 2010 records. The flow rate predicted by TUFLOW at the Glynwylln stream gauge shows a very good fit with respect to the observed record. The rising limb matches very well with the observed record; however the falling limb recedes slightly faster than the observed records.

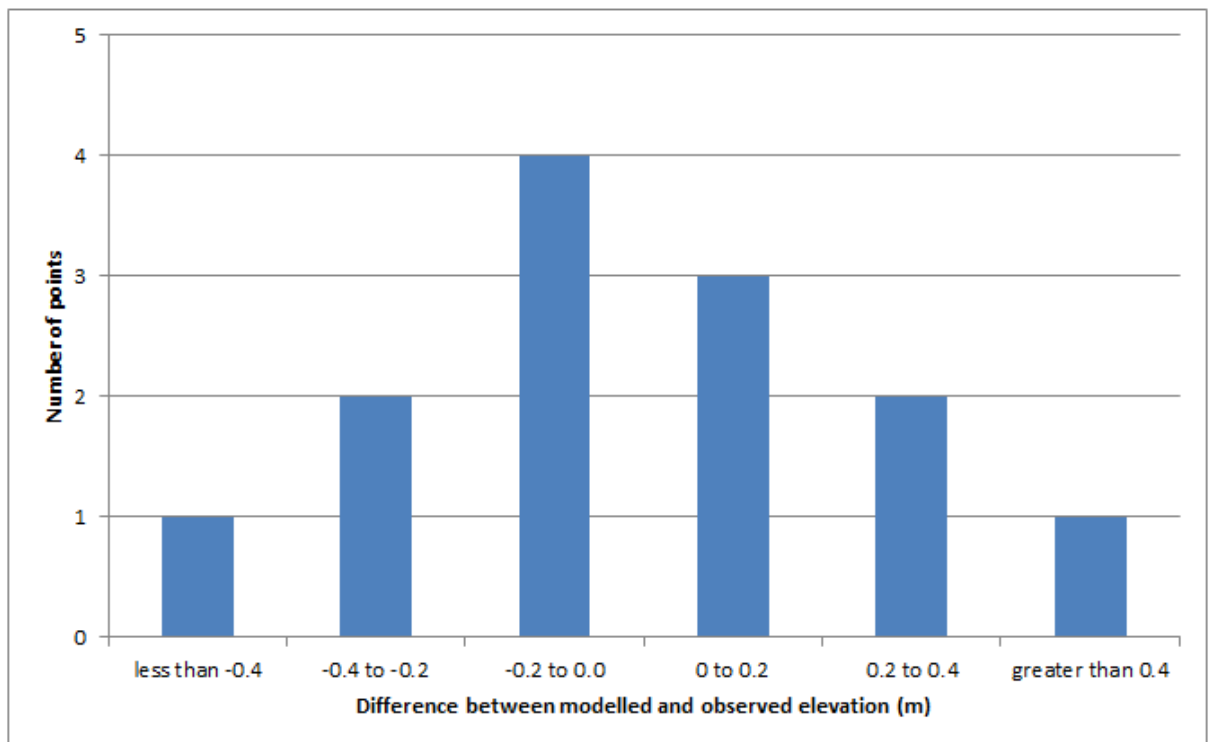
Figure 4-4 Distribution of Surveyed Flood Marks

A graphical summary of the 13 surveyed flood marks is shown below in Figure 4-4. The flood marks from in and around Landsborough have been excluded from this analysis. The distribution shows that the majority of points are within the $\pm 0.2\text{m}$ calibration tolerance, whilst the remainder are normally distributed between over and under-estimating the peak flood level. The distribution of the differences between the surveyed flood marks and the observed flood marks indicate that the error is of a random nature, rather than a systematic error within the model.

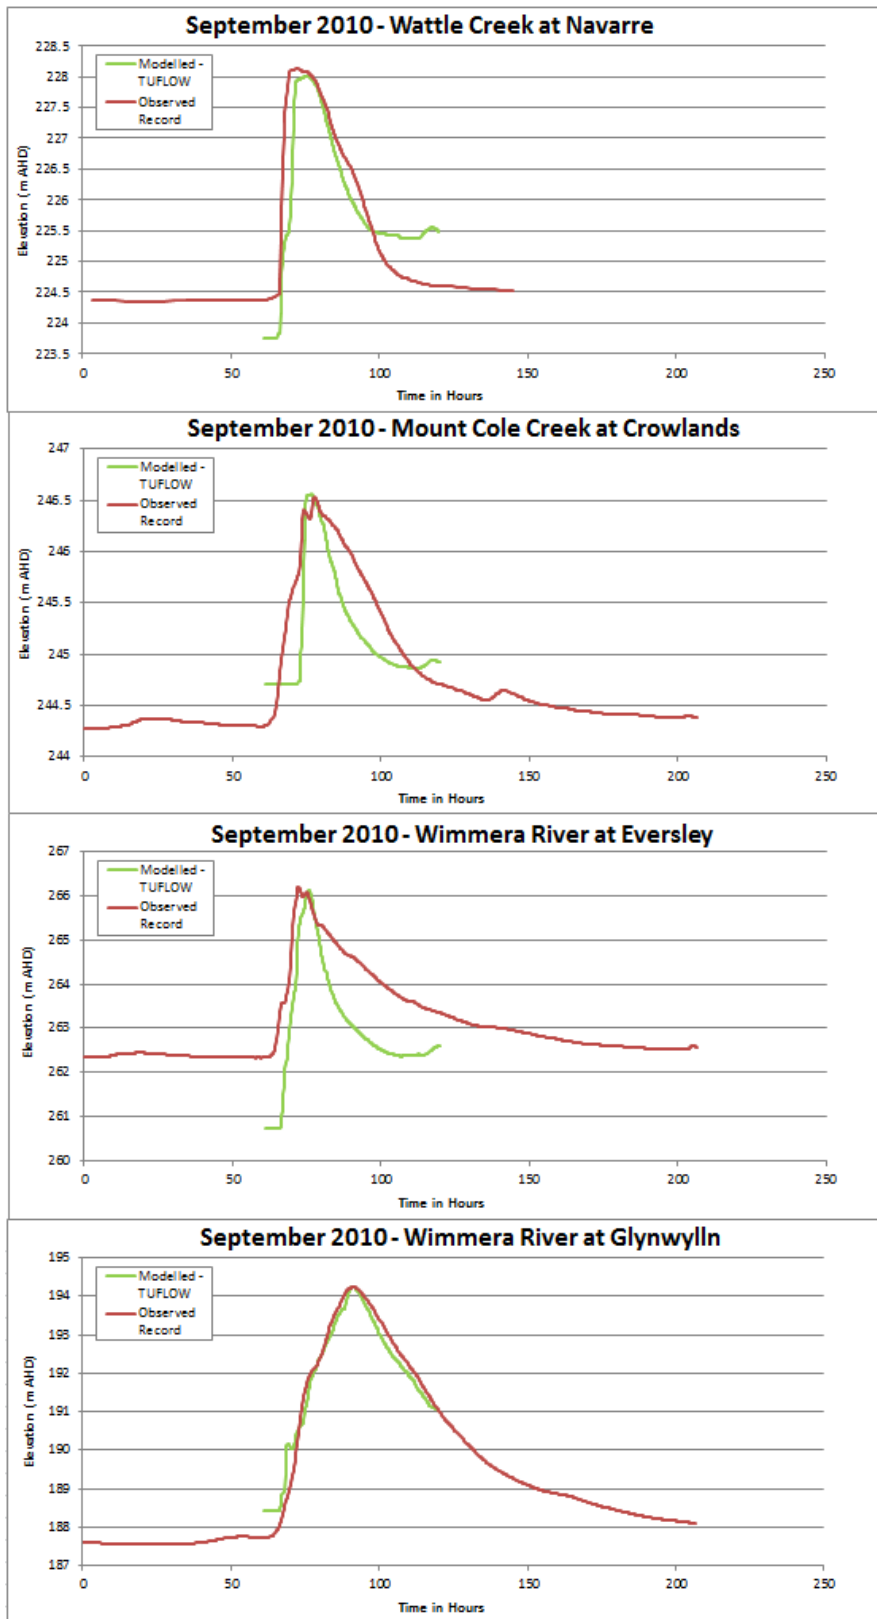
Figure 4-5 Calibration 2010 Validation Event Flow Comparison

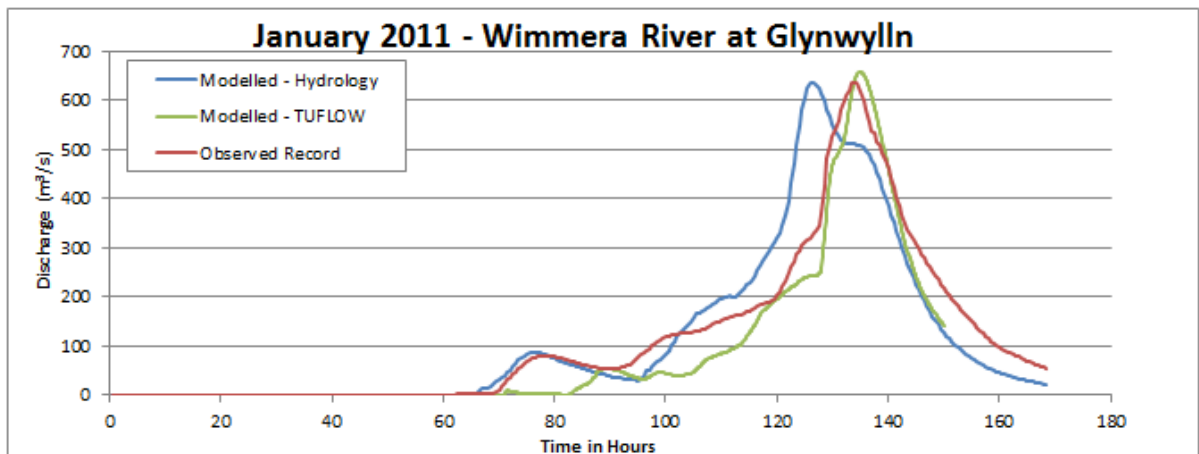
Figure 4-9 January 2011 Verification Flow Rate Comparison

As can be seen in Figure 4-9 the flow rates for across the Glynwylln gauge during the January 2011 event is presented along with both the modelled hydrologic flows and the modelled hydraulic flows reported by TUFLOW. Compared to the September 2010 calibration event the January 2011 validation event shows a similarly good match. The rising limb matches very well with the observed record, however the falling limb recedes slightly faster than the observed records. As was found with the January 2011 calibration event, the hydraulic model was found to better match the shape and timing of the observed records than the hydrologic RORB model due to the hydraulic model being able to control the routing of the catchment by spatially varying the catchment roughness.
