Upper Wimmera Flood Investigation Final Report

Reference: R.M8460.009.01.Final.docx
Date: 30 June 2014

Prepared for: Wimmera Catchment Management Authority

Prepared by: BMT WBM Pty Ltd (Member of the BMT group of companies)
In association with Michael Cawood and Associates

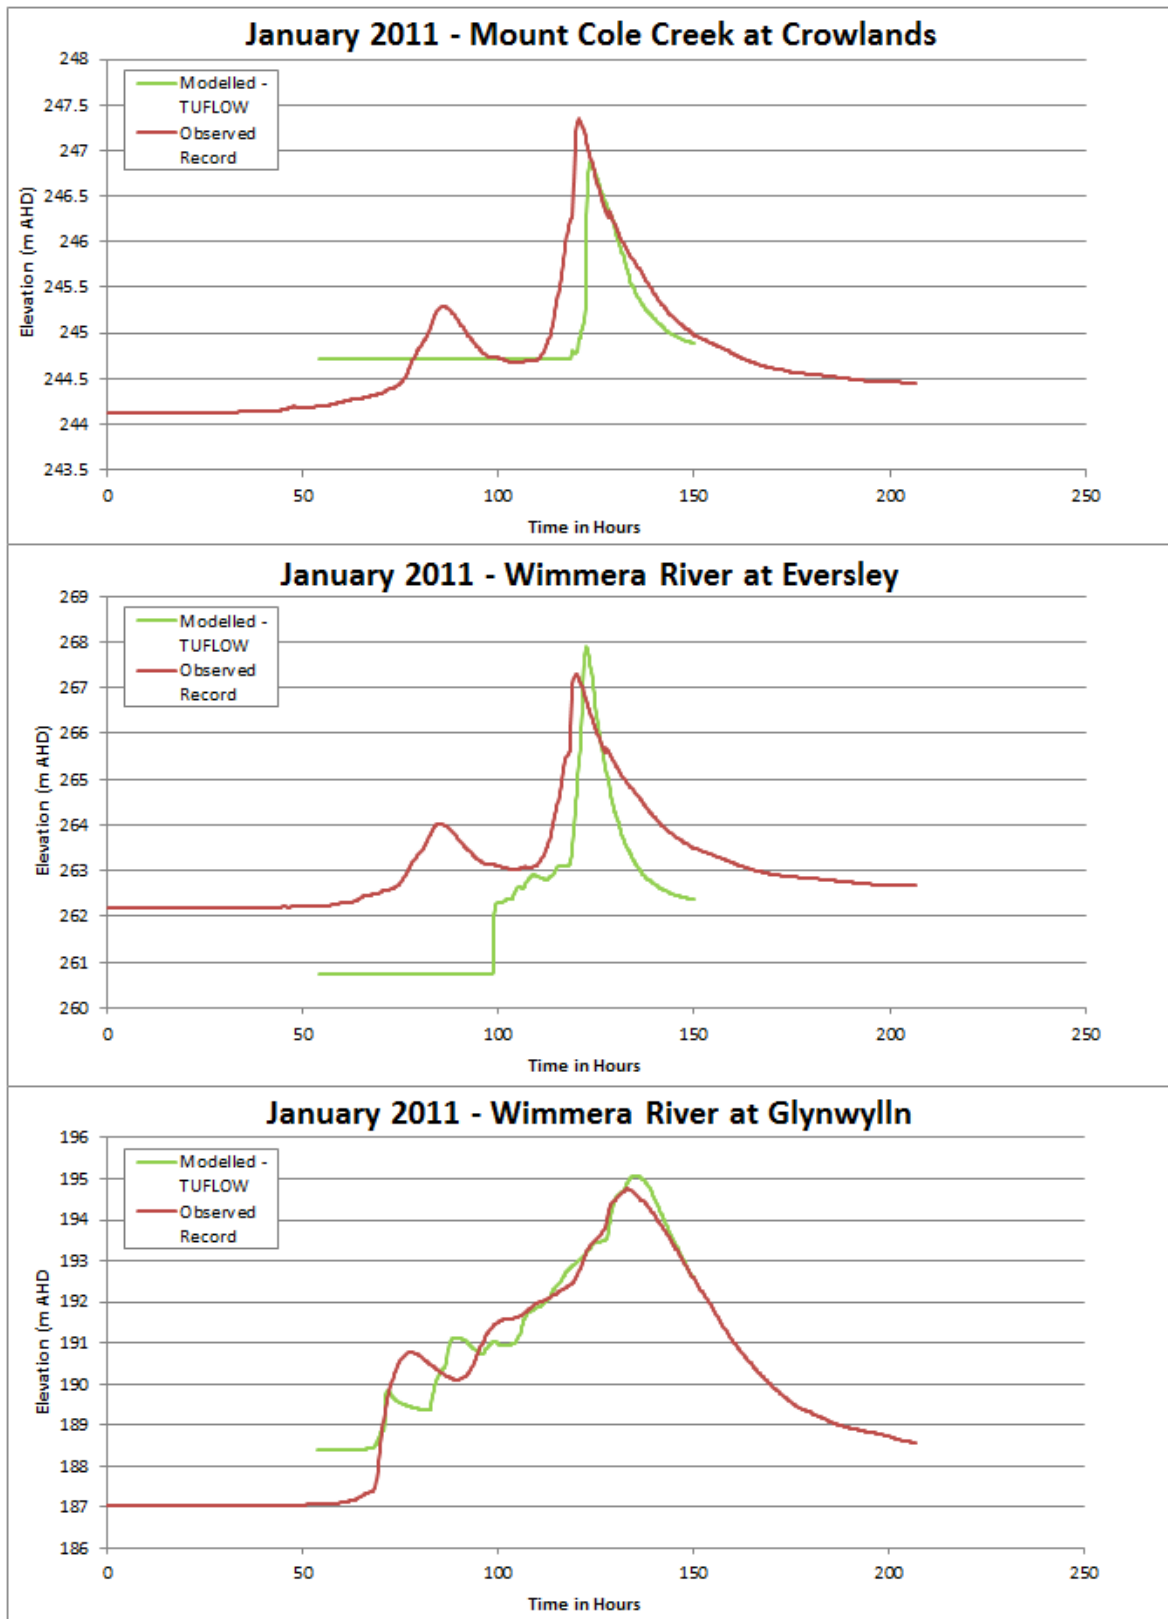
Figure 4-10 January 2011 Verification Event Level Comparison

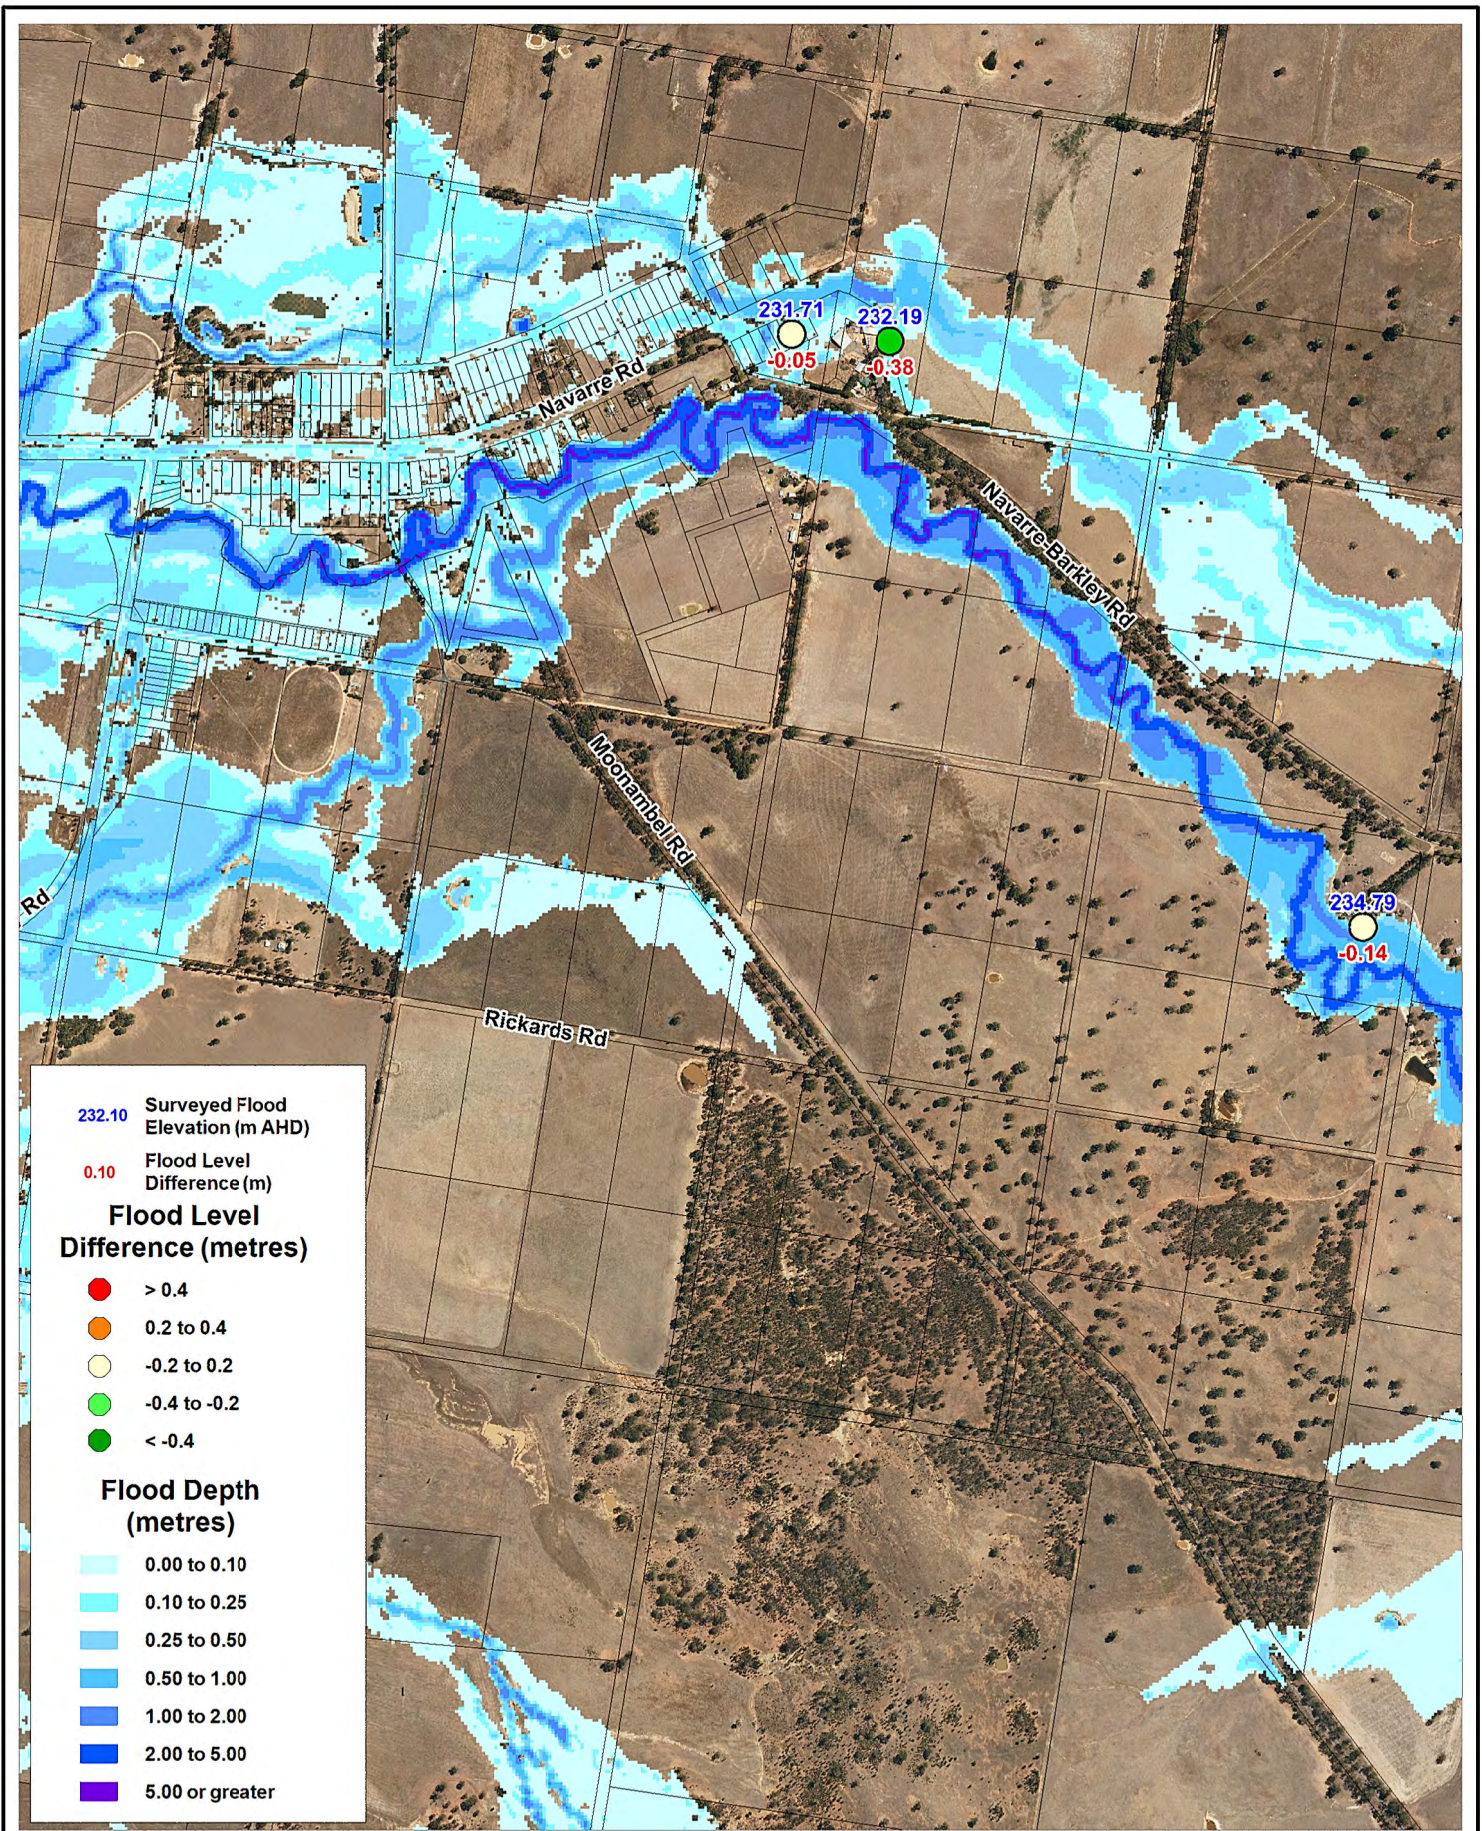
Title:
Upper Wimmera Flood Investigation
January 2011 Verification - Surveyed - Navarre

For the Navarre Township only the three flood marks were surveyed by a trained survey team (Figure 4-11). All three points flood heights were found to be slightly underestimated by the model. However, two points were found to be within $\pm 0.15\text{m}$, with a larger difference between the observed and modelled results for the remaining point.

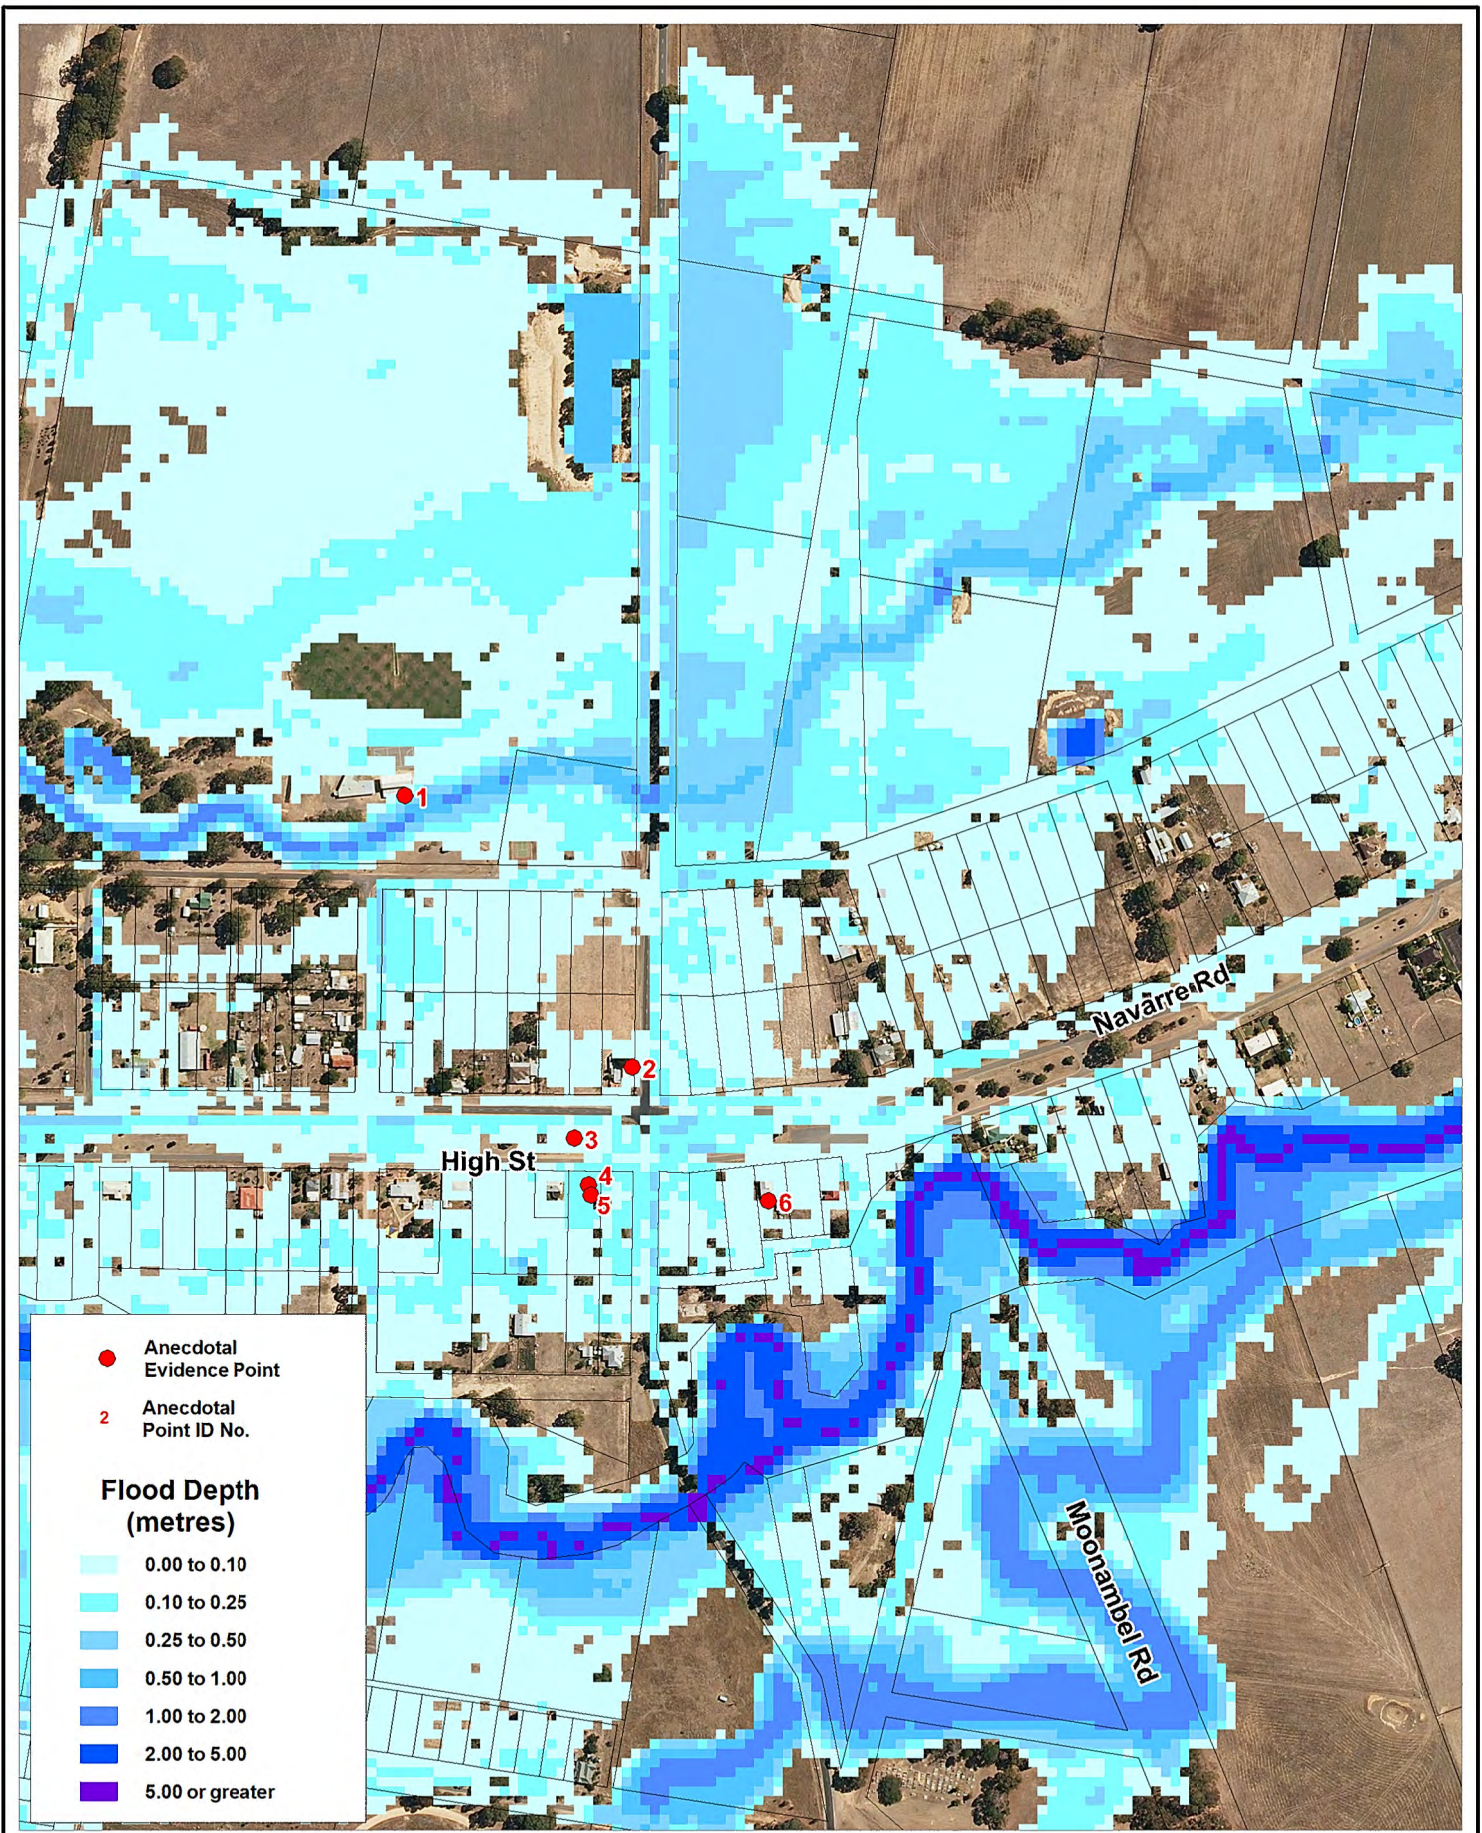
Title:
**Upper Wimmera Flood Investigation
 January 2011 Verification - Anecdotal - Navarre**

Flood levels to the north of town (point 1 located at the sports oval) was found to closely match the resident's recollection. Further in the town and to the south the model tended to underestimate the flood levels. The exception is the flood mark on the eastern edge of the church which was within 3cm. The flood levels in the town are generally shallow and the modelled results are highly dependent on the DEM, and the filtering around buildings may be a cause of the discrepancy between the modelled and observed flood marks. This is especially important when comparing flood depths as the filtering routines may have influenced the DEM ground levels in and around the building footprints.

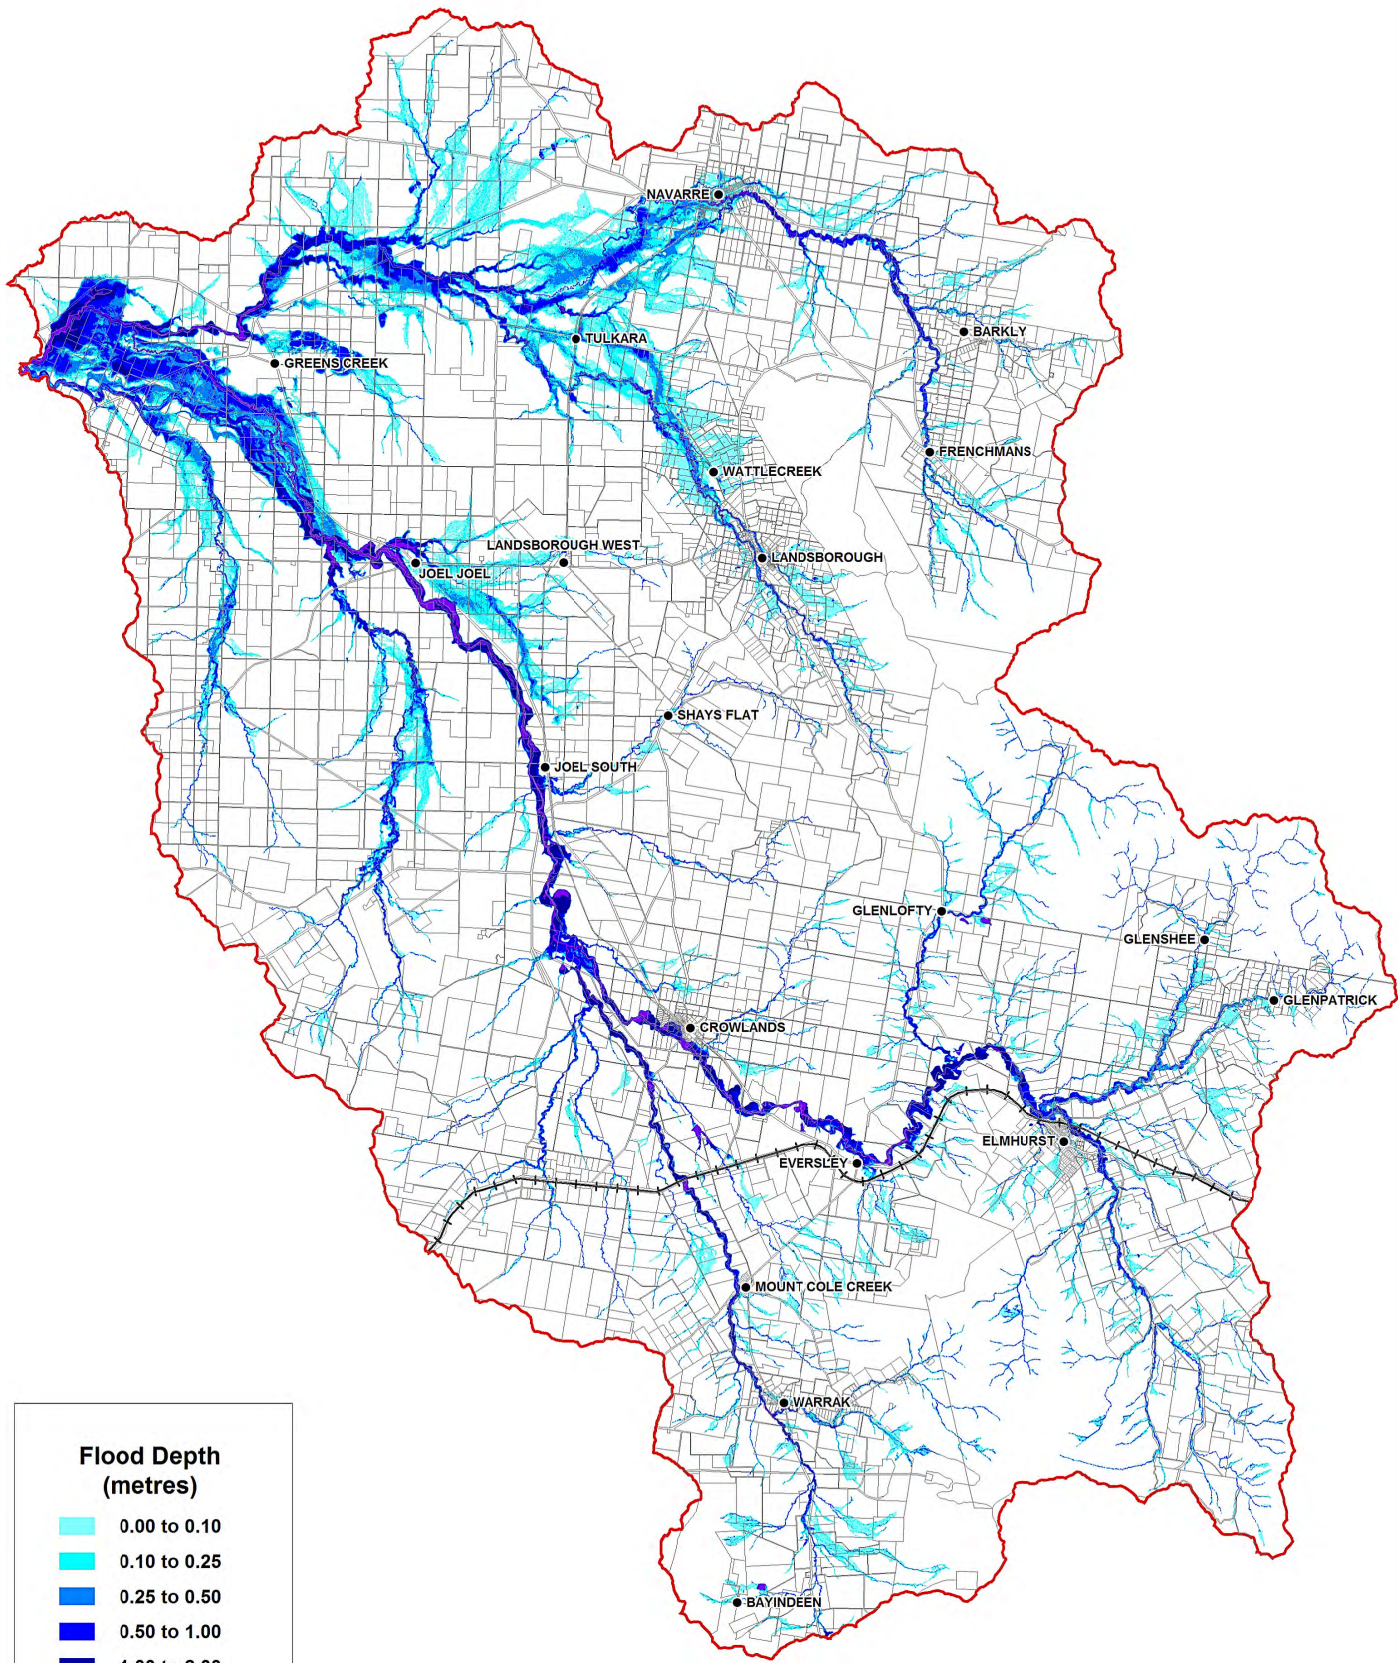
Title:
Upper Wimmera Flood Investigation
1% AEP Design Flood Depths - Catchment

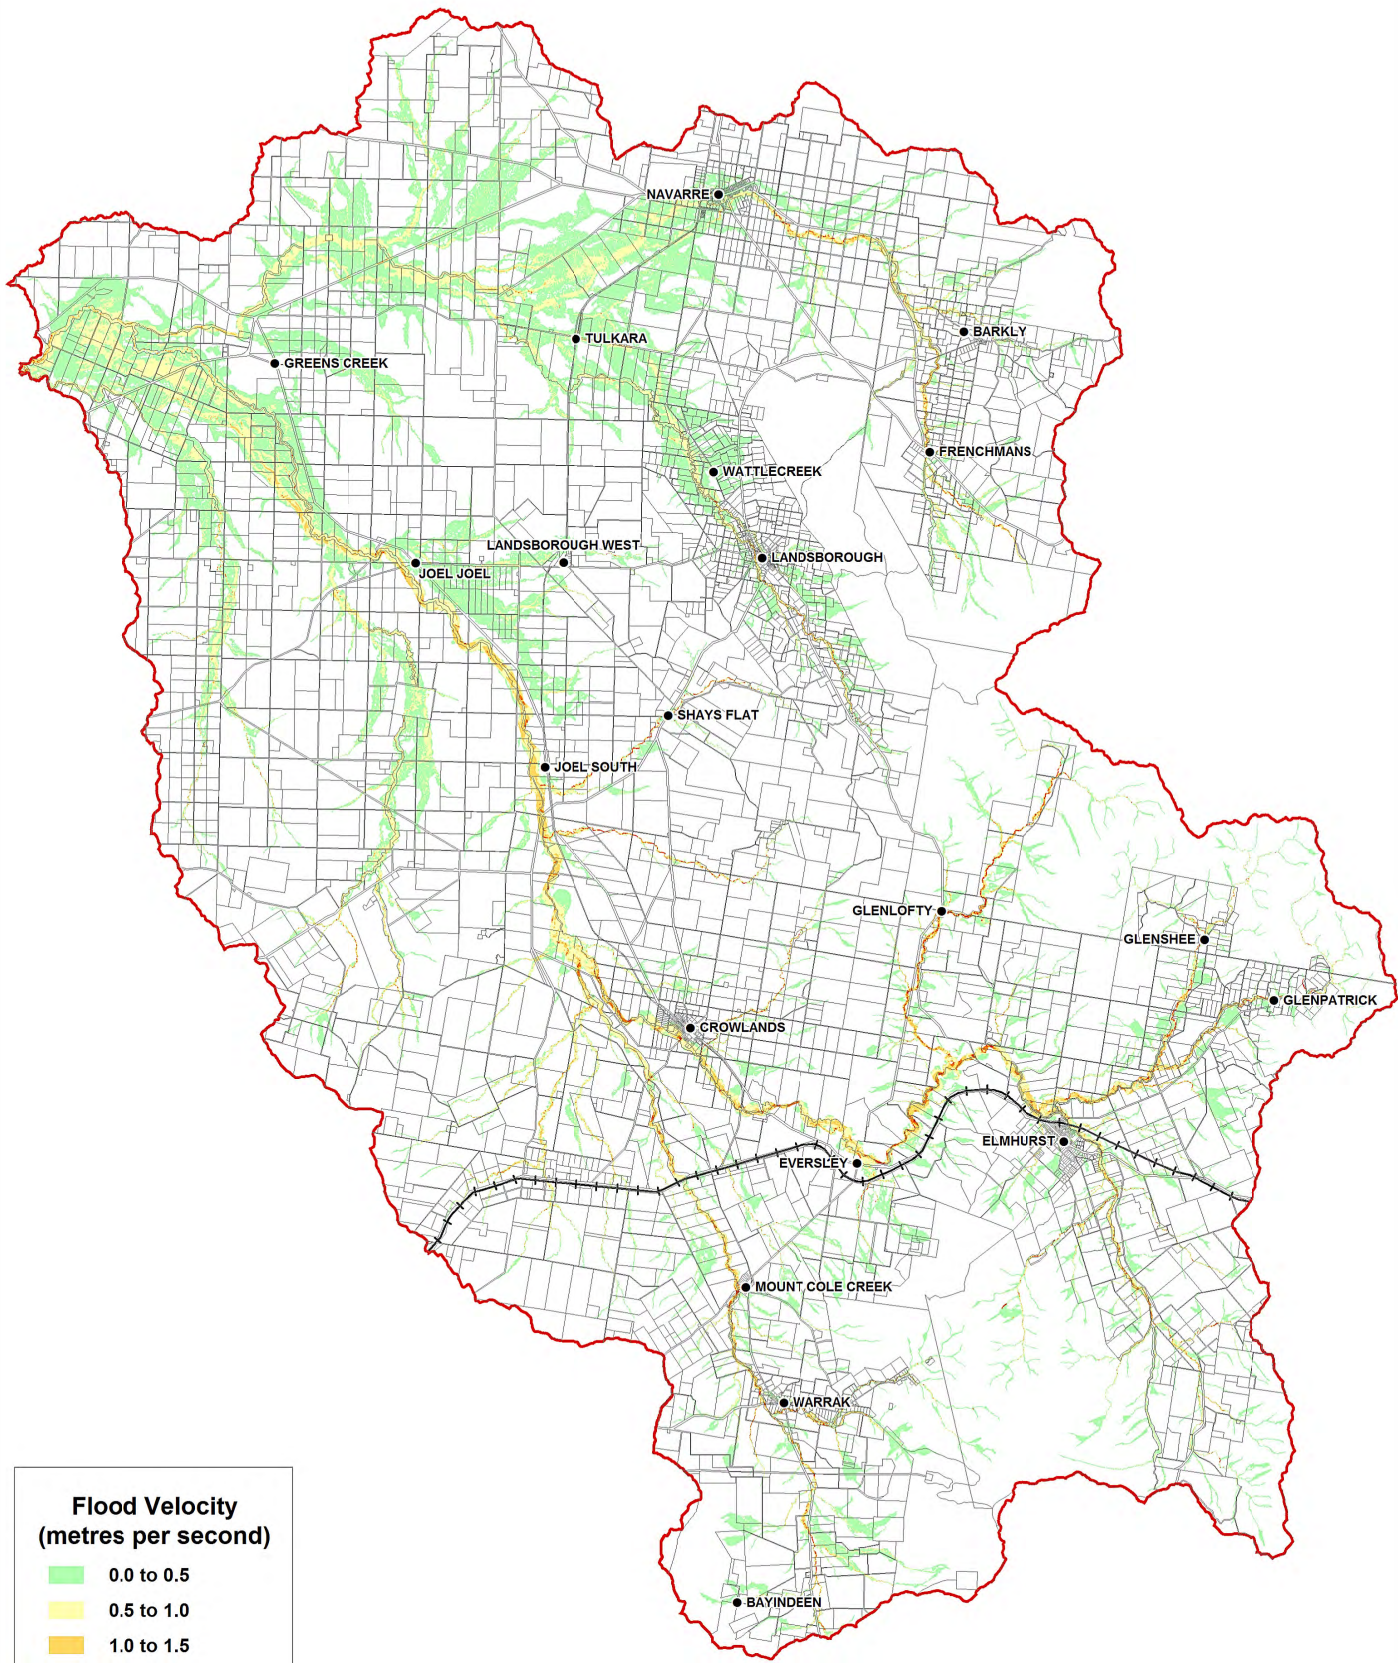
Title:
Upper Wimmera Flood Investigation
1% AEP Design Flood Velocity - Catchment

Flood velocity mapping is useful in determining the areas of flood risk, identifying flowpaths and identifying the direction of flow.

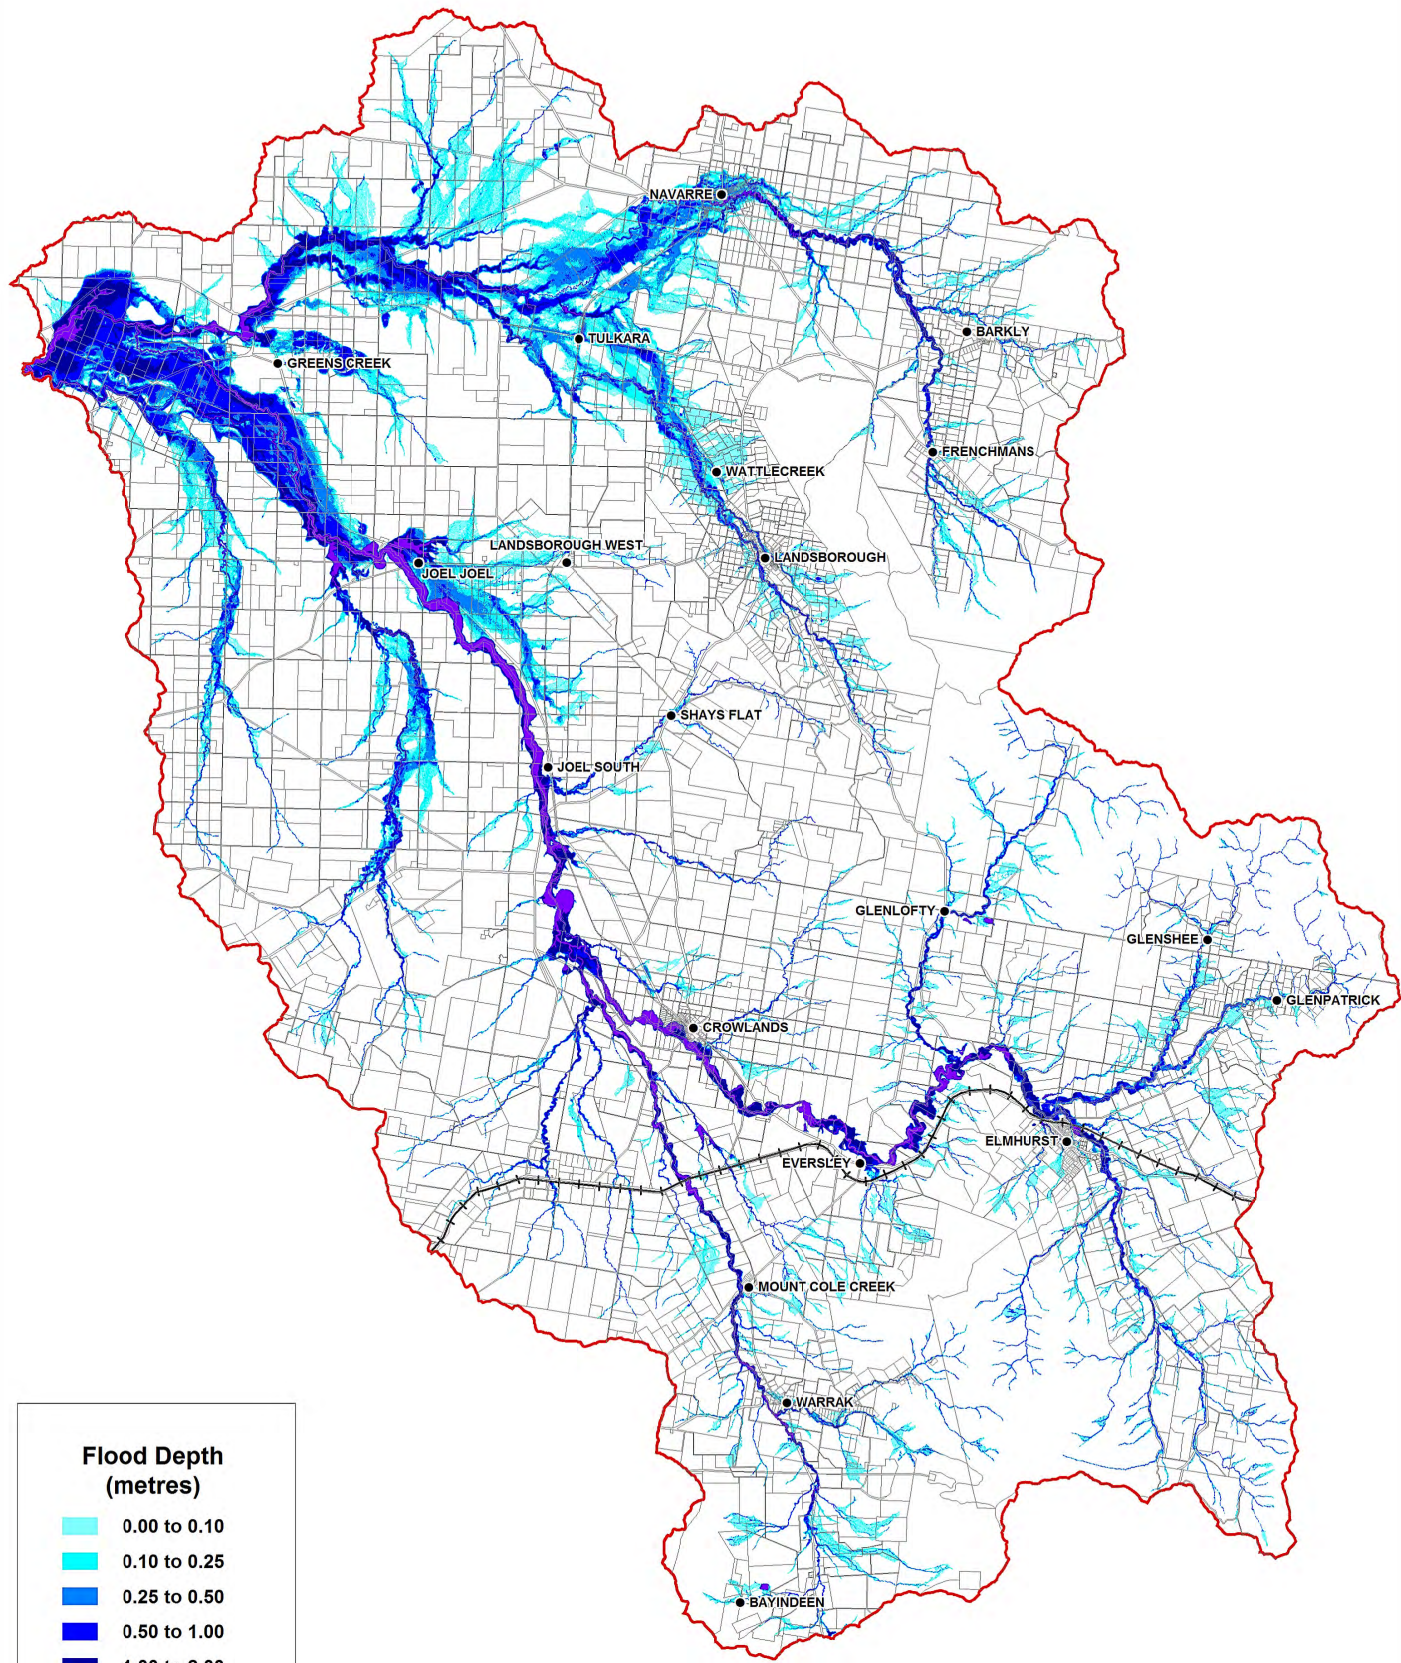
Title:
**Upper Wimmera Flood Investigation - Climate Change
 1% AEP Design Flood Depths - Catchment**

The increased rainfall intensity sensitivity analysis was undertaken using a rainfall intensity increase of 32%. For details on the adjusted parameters refer to Section 3.4.3.

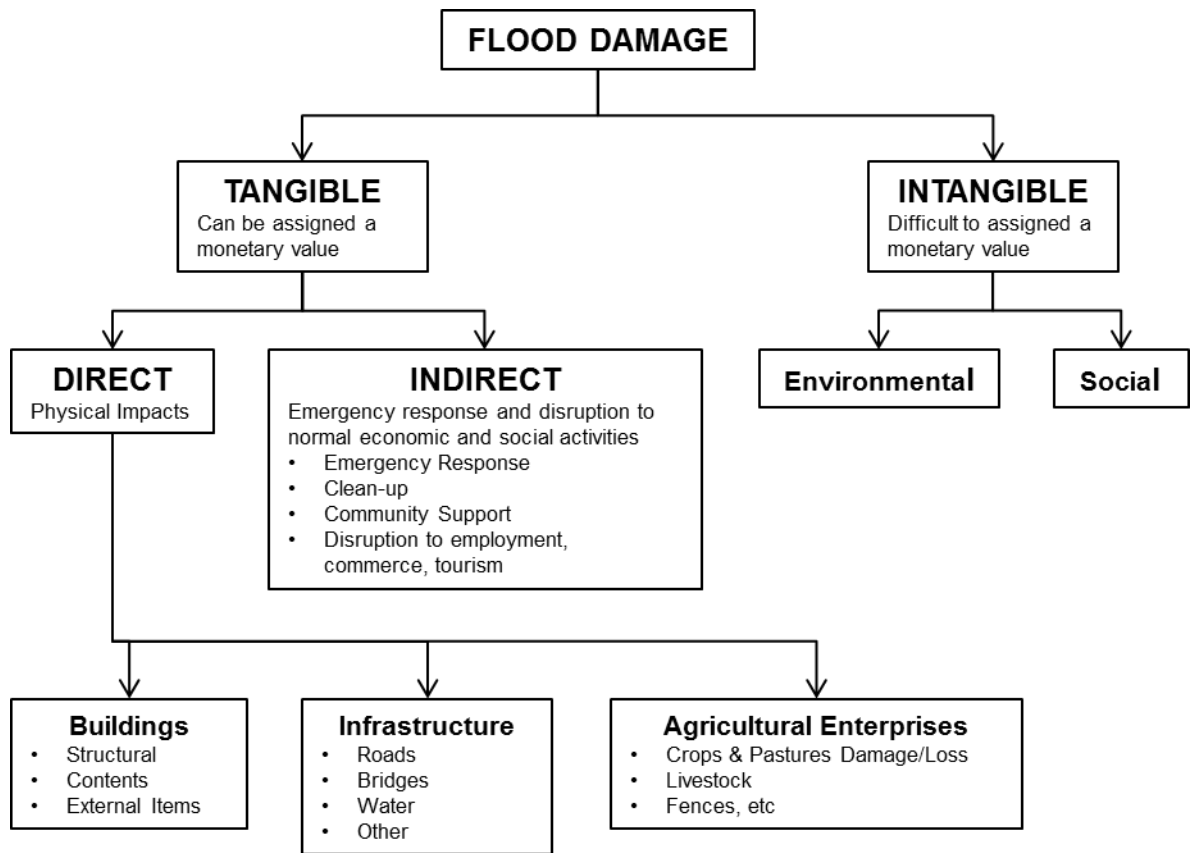
Figure 7-1 Types and Categorisation of Flood Damage Costs - Reproduced from *Rapid Appraisal Method (RAM) For Floodplain Management* (NRE 2000).

The types of flood damages along with their categorisation are shown in Figure 7-1.

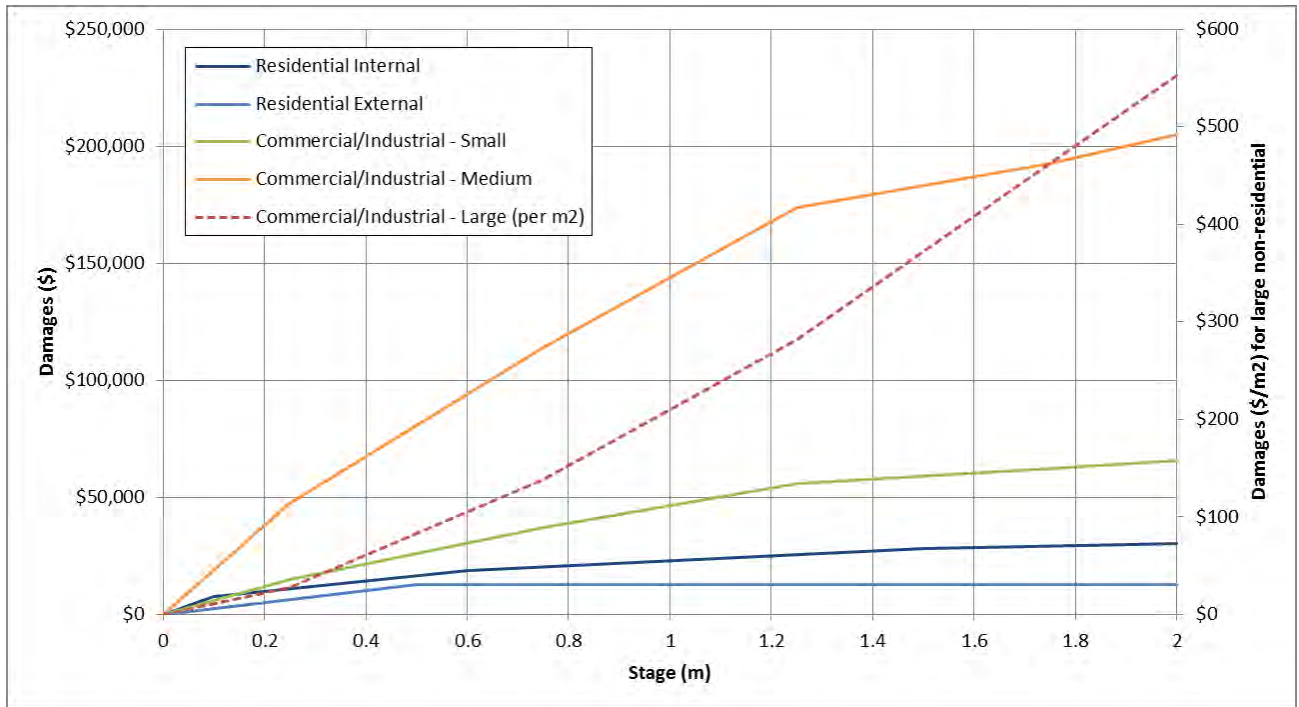
Figure 7-2 ANUFLOOD Stage-Damage Curves

As with the residential damages, the non-residential damages have been increased by 60% and factored by 0.8 to convert from potential to actual damages.

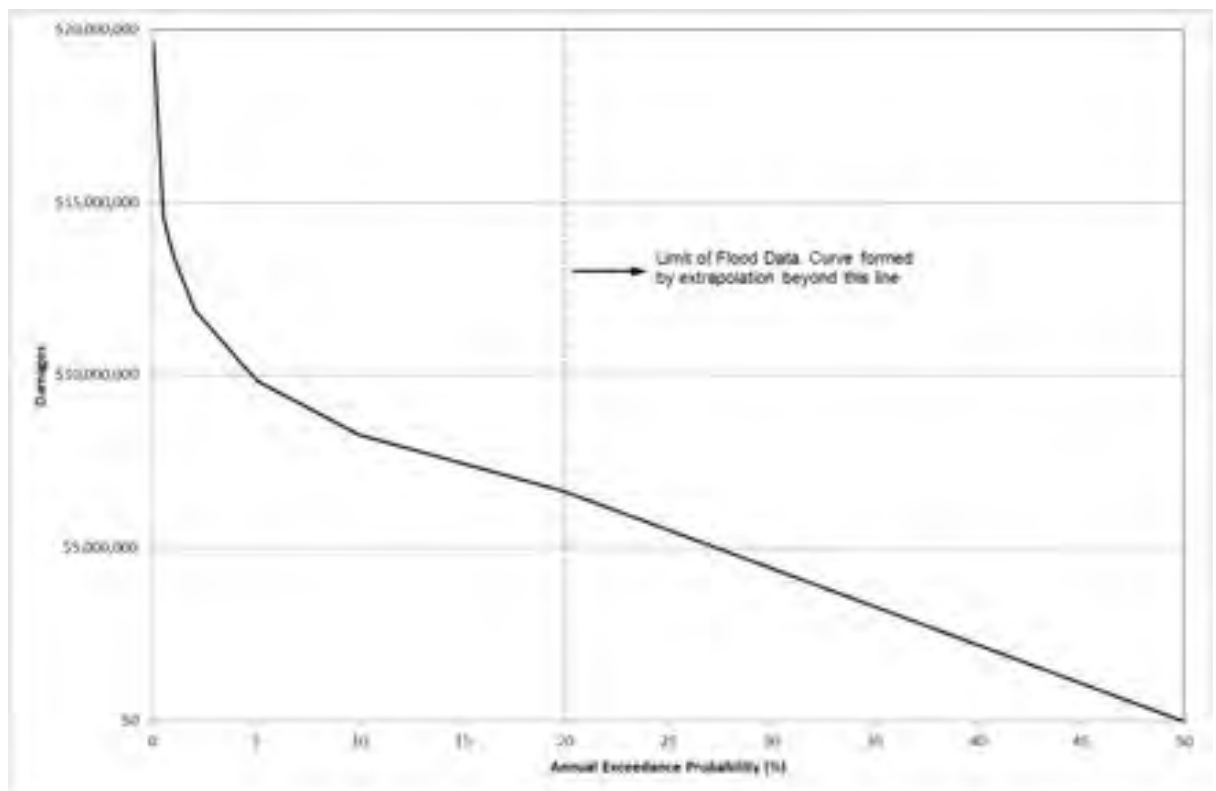
Figure 7-3 Existing Condition Probability-Damages Curve

Event (AEP)	ANUFLOOD Building Damages	RAM Agricultural Damages	RAM Road Infrastructure Damages	Indirect Damages	Total Damages	Contribution to AAD
PMF	\$924,400	\$11,000,100	\$4,406,600	\$4,937,700	\$21,230,400	
0.5%	\$158,100	\$9,033,700	\$2,779,400	\$3,628,800	\$15,562,600	\$92,000
1%	\$88,500	\$8,369,000	\$2,354,200	\$3,301,700	\$14,055,200	\$74,000
2%	\$50,300	\$7,583,100	\$1,950,200	\$2,904,000	\$12,458,700	\$132,600
5%	\$17,300	\$6,340,200	\$1,544,500	\$2,394,900	\$10,272,600	\$341,000
10%	\$11,800	\$5,340,900	\$1,285,000	\$2,010,900	\$8,629,000	\$472,500
20%	\$11,800	\$4,248,200	\$1,058,100	\$1,608,800	\$6,913,500	\$777,100
50%	-	-	-	-	-	\$1,037,000
Average Annual Damages						\$2,926,300

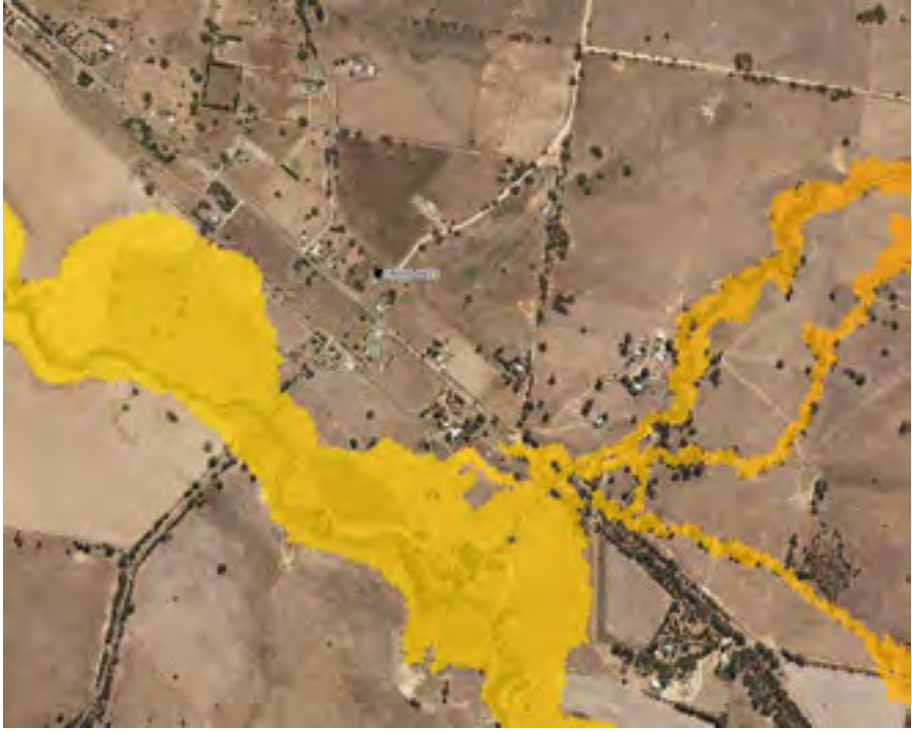
Management Option / Focus Area	Description	Further Assessment
Crowlands	<p>The township of Crowlands is at minimal risk of flooding from the 1% AEP event (shown below). There appears to be no inundation of buildings within the area, however, road access is cut to the town and it risks isolation for a period of time. In the absence of effective structural mitigation measures, non-structural mitigation options should be adopted to manage flood risk in this township.</p>

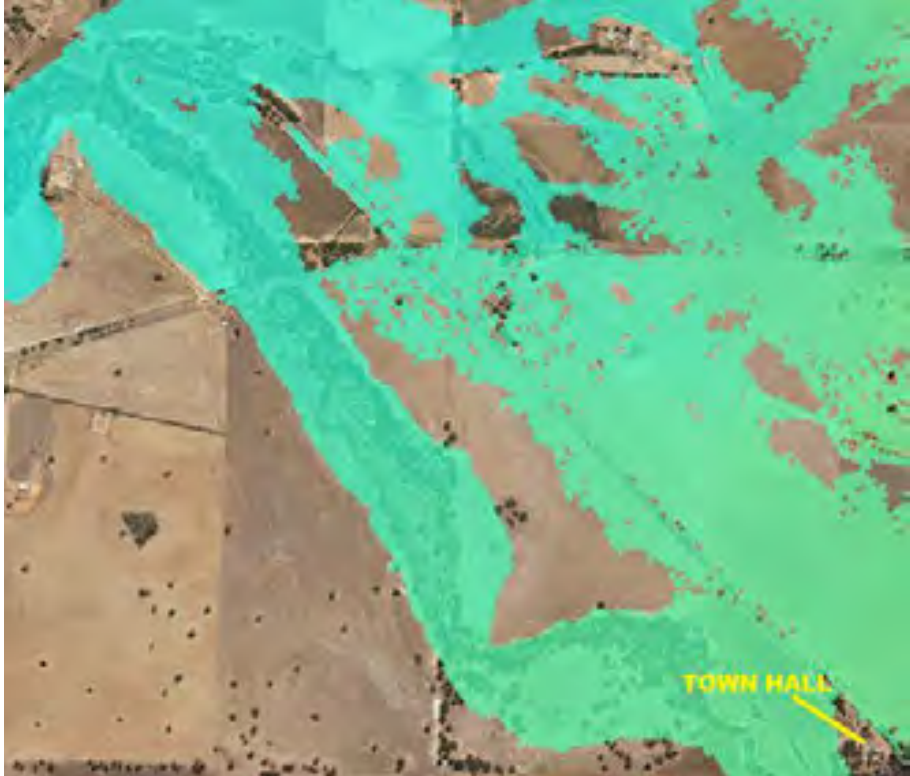
Management Option / Focus Area	Description	Further Assessment
Joel Joel	<p>The primary risk to the township of Joel Joel is caused by isolation. Whilst there appears to be no inundation of buildings from the 1% AEP event (including the town hall) there is substantial flooding within the area (shown below). Road access is cut to the town and it risks isolation for a period of time. In the absence of effective structural mitigation measures, non-structural mitigation options should be adopted to manage flood risk in this township.</p>

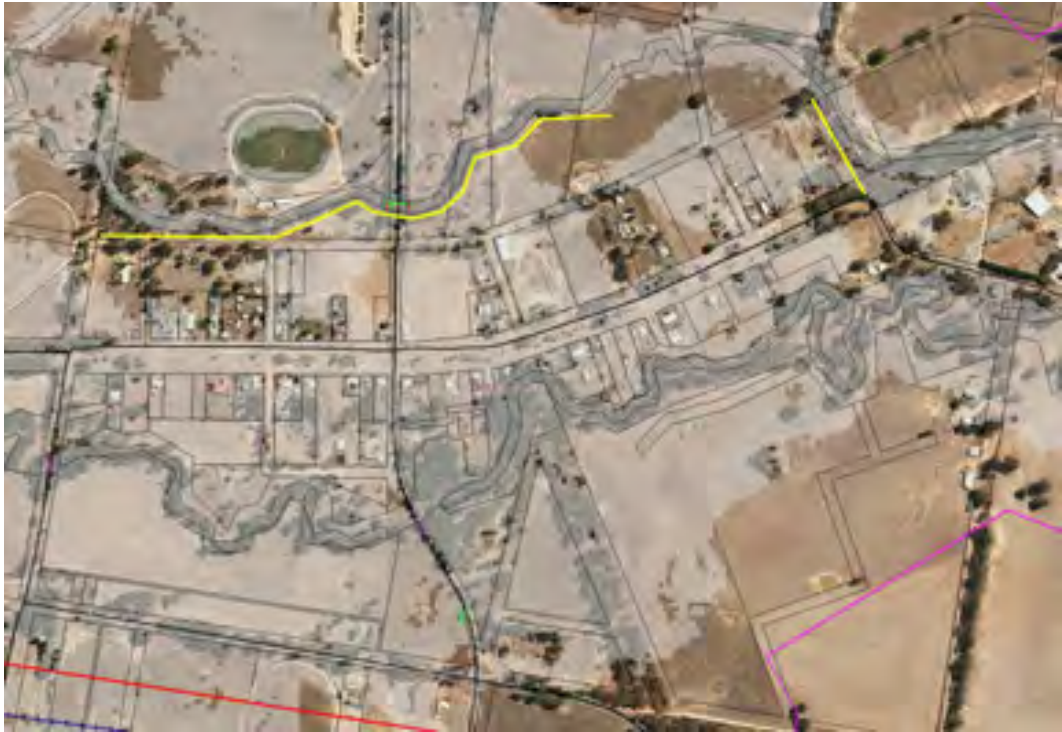
Management Option / Focus Area	Description	Further Assessment
Town Levee – Navarre North Side	<p>Navarre is situated between Wattle Creek (to the south) and Young’s Creek (to the north). The bulk of the flooding through Navarre originates from Young’s Creek in the smaller ARI events (i.e. sub 1% AEP). It could be considered that the creek causes nuisance flooding of the town. A levee built along the south bank of Young’s Creek could reduce the flooding through Navarre and consequently reduce the impact on the community. The proposed Levee would follow broadly the two yellow lines in the image below. In addition to the levee, Navarre Road would need to be raised and likely the culverts beneath it enlarged.</p>
